# **REAL ESTATE INSPECTION REPORT**

11410 Richland Ave. Los Angeles, CA 90064

Inspector - Francheska Lopez

DATE OF INSPECTION: Tuesday, August 4, 2026

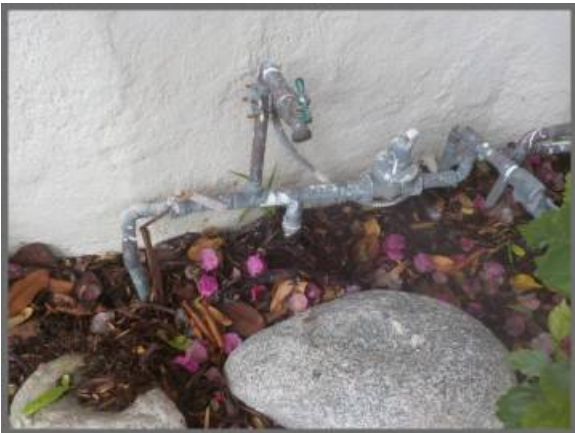
Copper piping was viewed coming out of the ground. Since the underground portion is not observable, no representation is made as to its condition or type of material.

The viewable portion of the water supply displayed no outward appearance of failure. The main water supply is almost fully underground and hidden from view (no representation is made or implied as to its condition or type of material), its condition cannot be determined during a general visual inspection. If more information is desired it is recommended to consult with a qualified plumber.

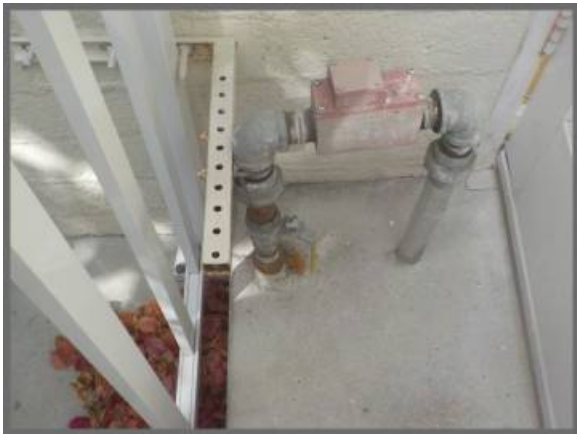
**PRESENT:** There is a seismic safety shut off valve present. This valve is not tested or operated and is not verified for correct installation. It is only noted as being in place. For information, as desired or required, it is advised to consult a qualified plumbing contractor or the gas company for more information.

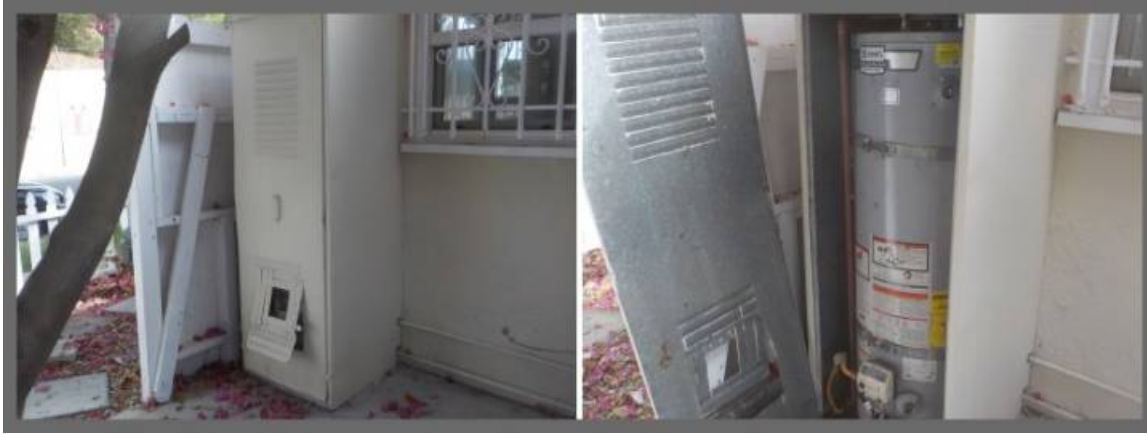
The water heater is located on the exterior of the building on the right side, in a metal enclosure.

**NEEDS ATTENTION.** While not part of a standard home inspection signs of animal droppings at the top. It is advised to have a specialist in this area examine the structure and property to determine the presence or not of any infestation and recommend any corrective measures.

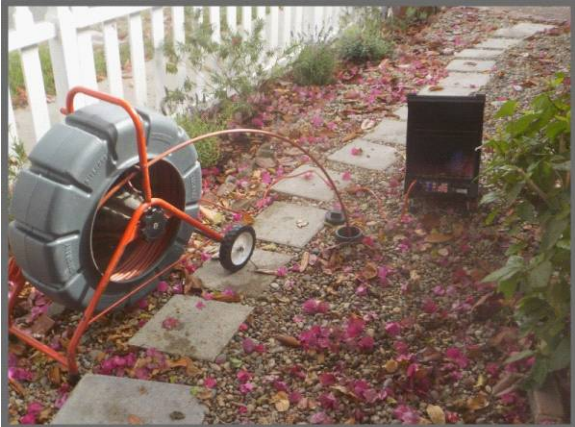
**NOTE.** It is noted that the sewer cleanout is located at the right front of the house.

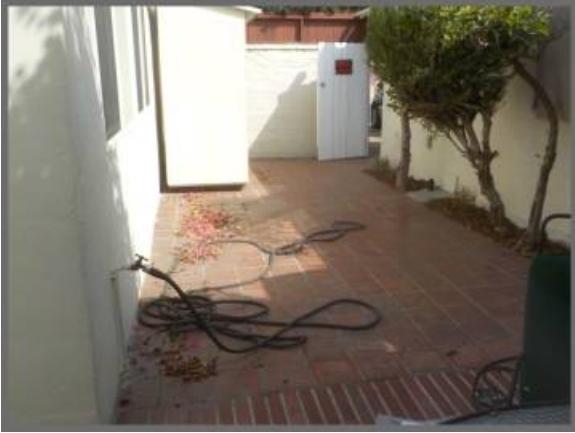
**NEEDS ATTENTION.** There are areas of cracked brick and deteriorated grout on the deck.

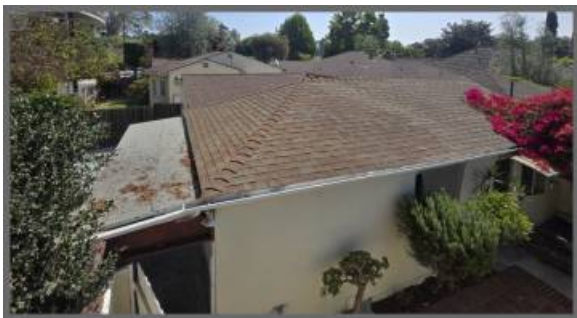
**NEEDS ATTENTION.** The shingles are older, deteriorating and losing their surface granules. It appears to be past it's expected useful service life, and while it may continue to work it is no longer considered reliable and will need to be replaced.
