# Inspection Report

32181 Paseo de Manuel  
San Juan Capistrano CA 92675

Anderson Inspections

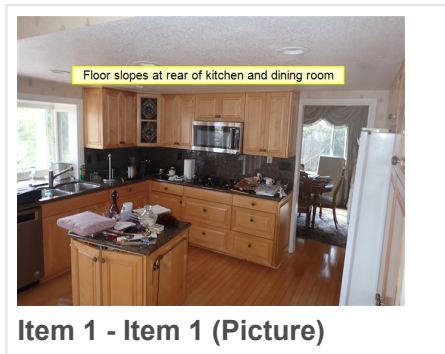
1. (2) This building is constructed on a hillside and sloping is noted at some interior floors. The evaluation of soil conditions and/or stability is not within the scope of this inspection. - For information on soil stability and/or the potential for movement, we recommend that you determine if the owner has information on the soils condition, or contact a qualified soil or geotechnical engineer who is familiar with conditions in this area.

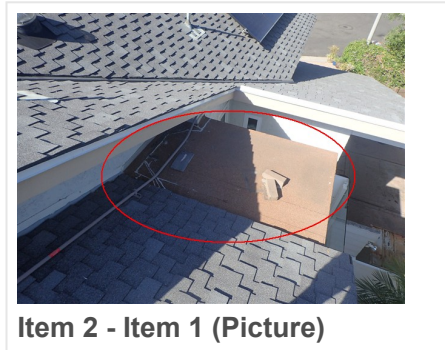
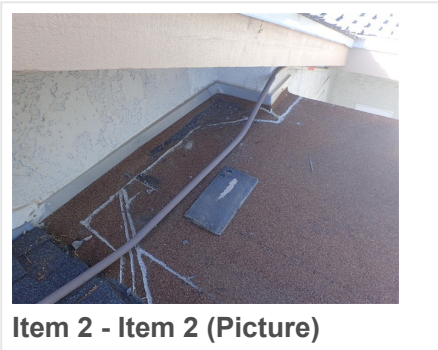
2. There is evidence that the structure has been remodeled or improved, subsequent to original construction. Verifying existence or absence of building permits is beyond the scope of this inspection. Confirmation should be obtained from the local building department that all necessary permits for construction and/or remodeling were secured and that appropriate inspections were performed.

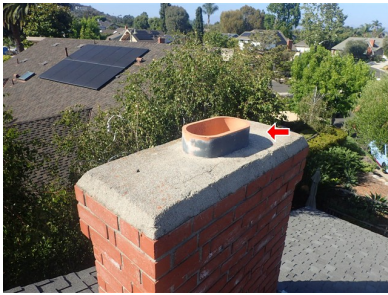
Item 19 - Item 1 (Picture)

19. (2) No spark arrestor or rain cap is installed at the chimney flue terminal(s). Caps help prevent the escape of hot embers or rain entry. - As an upgrade, a combination chimney cap/spark arrestor should be installed.

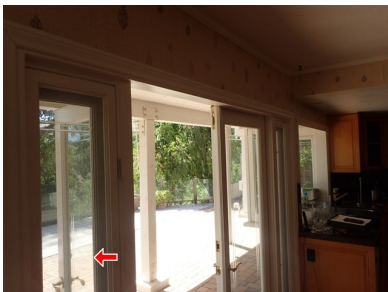
Item 20 - Item 1 (Picture)

20. (2) The exterior door deadbolt at the rear patio does not lock properly. - The hardware on all non-latching doors should be adjusted to restore full operation.

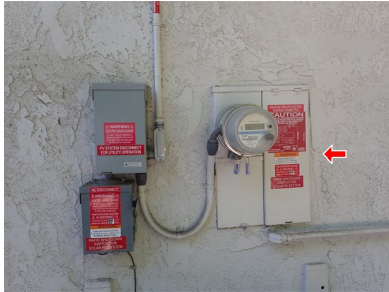
Item 37 - Item 1 (Picture)

37. Some circuits in the main service panel are labeled, some are not. We did not verify the accuracy of the labels.  
- Each circuit should be identified and labeled by a qualified electrician for safe operation of the circuit breakers.

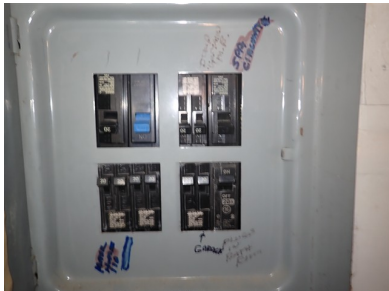
Item 38 - Item 1 (Picture)

38. Some circuits in the Garage electric subpanel are labeled, some are not. We did not verify the accuracy of the labeling. - A qualified person should check the labeling and properly label any unlabeled breakers.

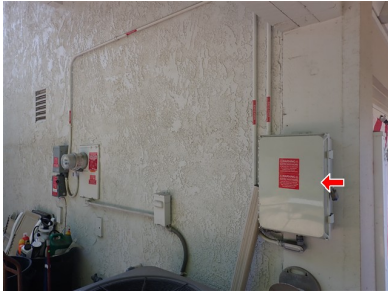
Item 40 - Item 1 (Picture)

39. (1) This property has low voltage landscape lighting and/or fixtures controlled by timers or photo cells. An evaluation of these types of lighting is beyond the scope of this inspection.  
- The function of these fixtures should be verified at or before the final walkthrough.
40. (2) A solar electrical system was installed as a supplement to the electrical utility service. This system is beyond the scope of this inspection. - We recommend having the system inspected by a qualified specialist as needed.

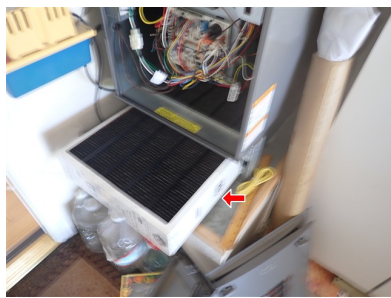
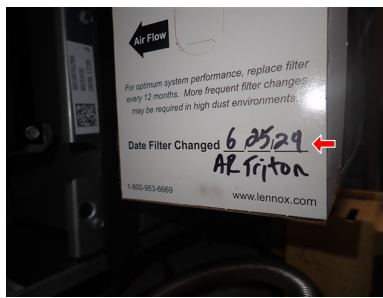
64. The filter(s) were dirty. This decreases the effectiveness of the filter and blocks airflow, making the blower work harder. -Replace (or clean washable) filters now, and at regular intervals thereafter.

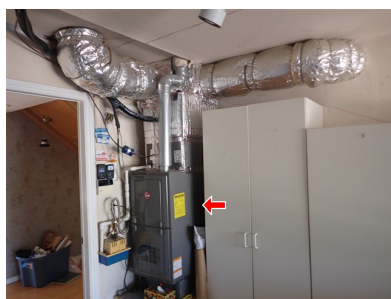
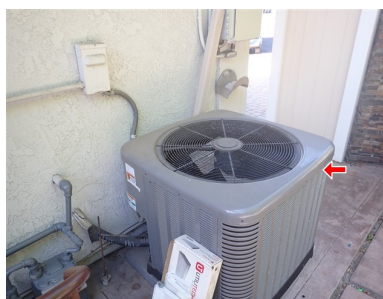
65. There is evidence that the heating and cooling system has been upgraded or replaced (Units were built in 2015/ 2016). We recommend checking with the owner or the local building department regarding necessary permits and any warranty information that may be available.

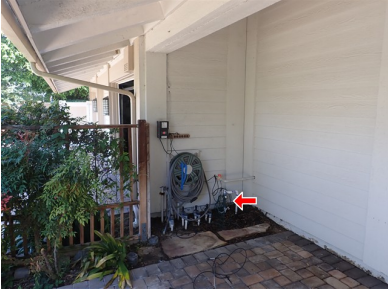
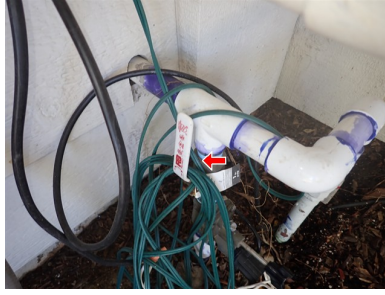
66. CLIENT INFO: The main water shut off is located at the right front of the Garage. We recommend familiarizing yourself with this location during your final walkthrough.
