# PROPERTY INSPECTION REPORT

**738 Orchard Dr**

**Date of Inspection: 8/4/2026**

**Year Built: 1985 Size: 1712**

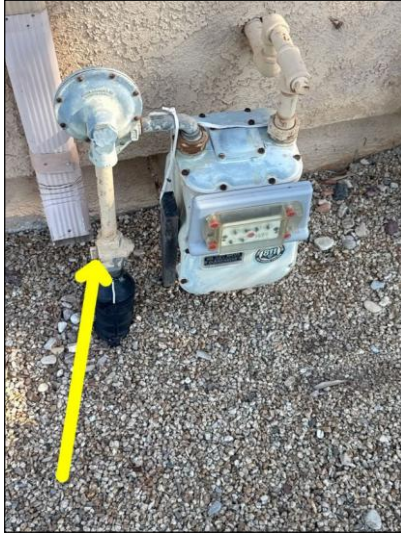
Main gas shut off to the home.

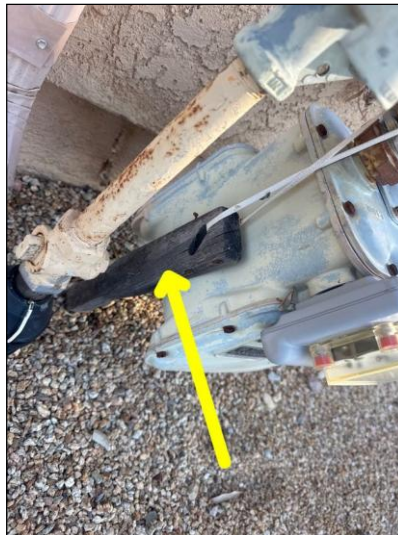
Having this gas shut off tool readily available in an emergency is recommended for safety.

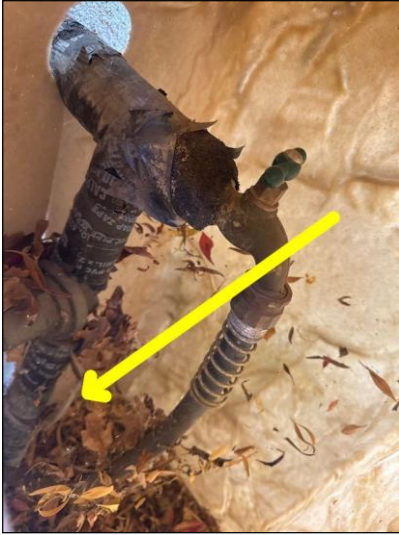
**Safety Improvement:** The main water supply shut-off valve was difficult to access. Removing the cover for easier use during an emergency.

Main water shut off to the home where the main line enters the home.

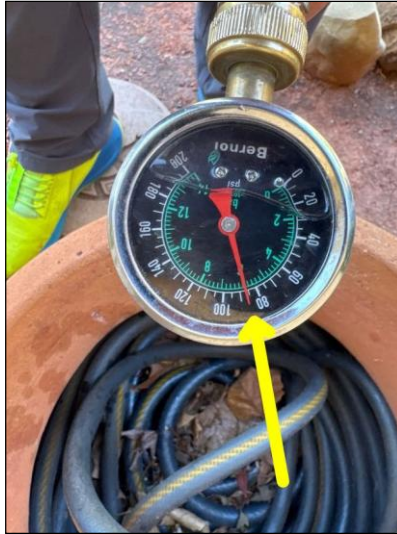
| Exterior Areas | | | |
|---|---|---|---|
| | Page 21 Item: 5 | Pressure Regulator | • The pressure regulator appears to not be functioning due to water pressure over 75 PSI when tested. A pressure regulator is designed to regulate water pressure from the city water supply to between 25-75 PSI (they are factory set at 50 PSI). Recommend repair/replacement by licensed plumber. |

- **Monitor:** High pressure: Home water supply pressure exceeded the 80 pounds per square inch (PSI) limit considered the maximum allowable by generally-accepted current standards. Excessively high water pressure is likely to cause leaks. The Inspector recommends service by a qualified plumbing contractor.
- Recommend 40-80 PSI.
- Home water pressure measured 85 pounds per square inch (psi) at the time of the inspection.

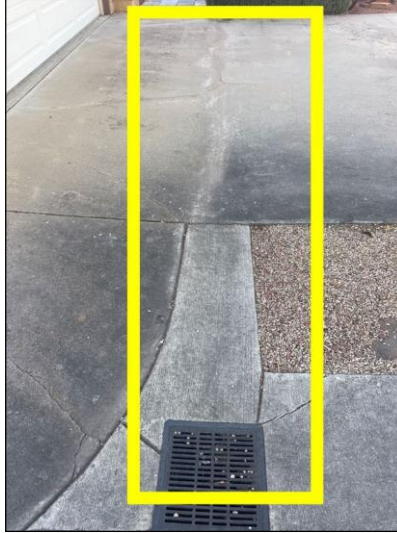
Monitor: The home's driveway has neutral or negative drainage that will route runoff from precipitation toward the garage and homes foundation. Although it appears the driveway has a drainage swale and/or a drain near the garage this area needs monitoring during heavy rain to prevent any moisture intrusion. The Inspector recommends that this area and any drains be kept clean at all times and if re-grading is needed to improve drainage we suggest doing so.

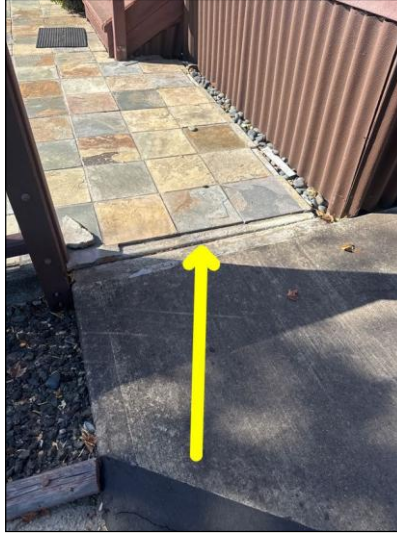
**Safety:** Uneven transitions noted at the patio during inspection. This is a potential tripping hazard. Recommend consulting with a qualified contractor to find transitions to eliminate trip hazard.

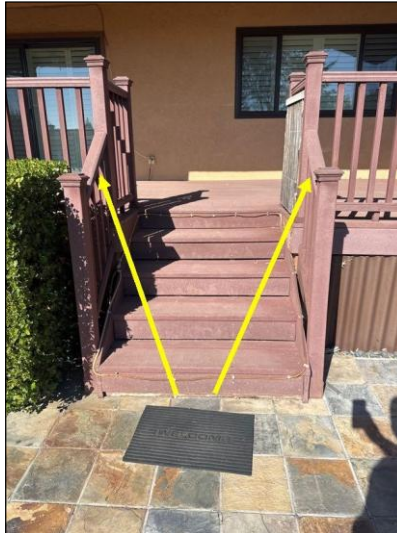
This staircase did not meet generally-accepted modern safety standards that specify the proper the size and dimensions of a grippable handrail.

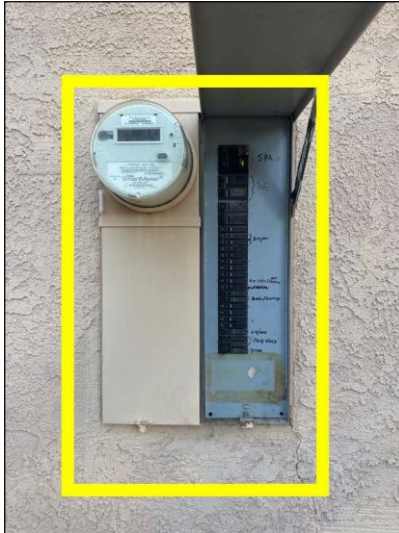
**Non-metallic conductors had loose clamps installed where they passed through knock-outs in the electrical service panel. This condition can result in damage to the conductor from contact with the sharp edges of the metal cabinet, or can result in conductors being pulled loose from connections inside the panel; a potential a shock/electrocution or fire hazard. The Inspector recommends that appropriate devices approved for this purpose be installed by a qualified electrical contractor.**

Main electrical service panel to the home.

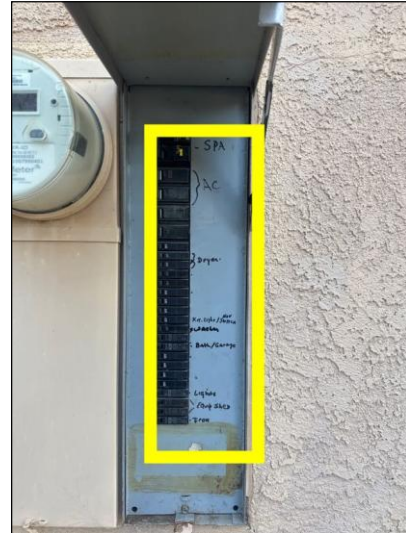
**Safety Improvement:** The Circuit Directory label identifying individual electrical circuits was not complete in the service panel, not all breakers are labeled.

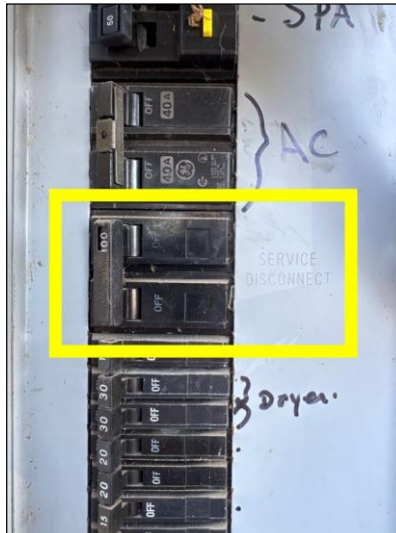
Main electrical shut off to the home

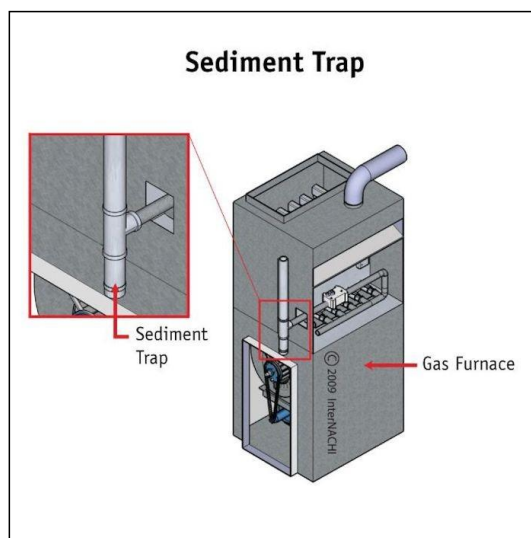
**Improvement:** The gas supply pipe contained no sediment trap.

The purpose of a sediment trap is to prevent sediment or debris particulates from entering and clogging the heaters gas valve.

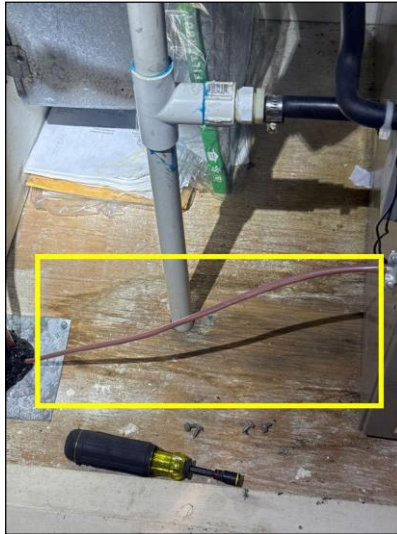
**Monitor:** Stains on the furnace platform were visible at the time of the inspection. Usually this is damage from the condensation line leaking. The moisture meter showed no elevated levels of moisture present in the stained areas at the time of the inspection (Normal moisture is considered between 5-12%), indicating that the source of moisture has been corrected.

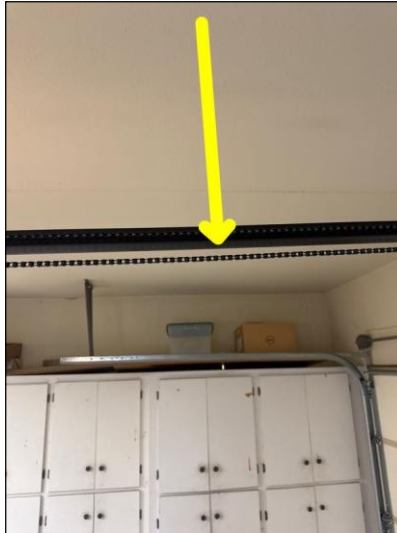
The chain tension on the overhead opener needs to be adjusted. When the chain is properly adjusted the chain will be 1/2" (for T-Rail) or 1/4 " (for Square Rail) above the base of the rail at its midpoint. Recommend adjustment by a qualified contractor.

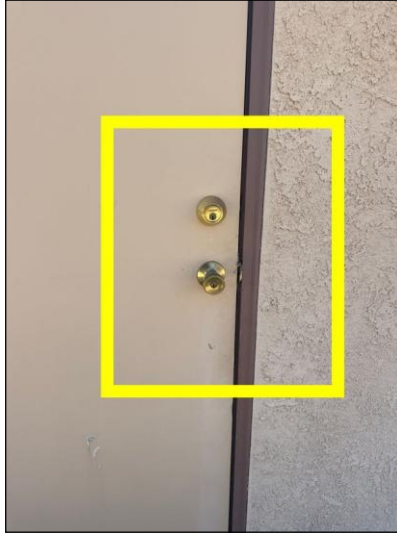
**Safety Improvement:** The exterior door opens outward and leaves the locking hardware exposed to force entry. For safety installing latch guards is one of the most effective methods of securing an outward swinging door. These are basically plate covers extending from the door's outer side to prevent forced entry.

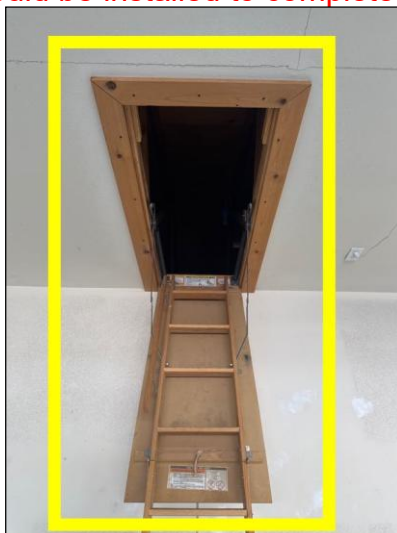
Attic access in garage is considered a breach in the fire wall. Fire walls are fundamental to the integrity of fire barriers which provide resistance to the spread of fire, smoke, and toxic gasses. This means that should a fire occur in the garage, this door does not afford protection until fire rescue people arrive. A fire rated access panel should be installed to complete the fire wall.

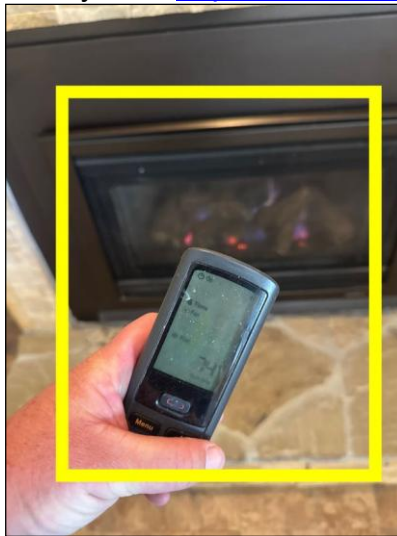
At the time of the inspection, the Inspector observed no deficiencies in the condition of the gasfueled fireplace in the Living Room. Full inspection of gas-burning fireplaces lies beyond the scope of the General Home Inspection. For a full inspection to more accurately determine the condition of the fireplace and to ensure that safe conditions exist, the Inspector recommends that you have the fireplace inspected by an inspector certified by the Chimney Safety Institute of America (CSIA).

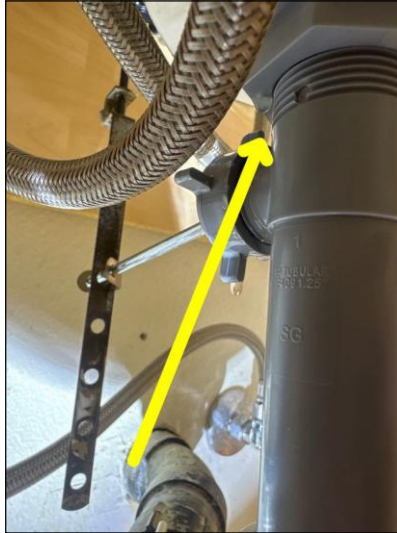
Leaking connections at the trap assembly beneath the bathroom sink should be repaired to avoid future/additional damage to the cabinet floor and possibly the wall/floor structures below. The Inspector recommends repair by a qualified plumbing contractor.
