## Harmony Inspectors

## Property Inspection Report

Property address: **250 N Monte Vista St # 3  
La Habra CA 90631-4541**

Inspection date: **Tuesday, May 12, 2026**

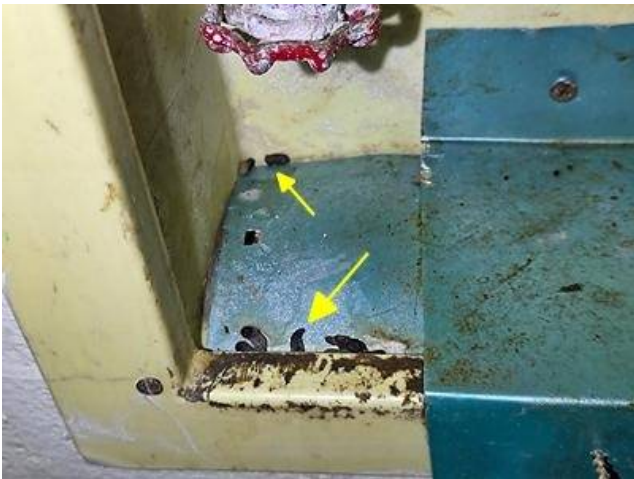
Signs of rodent activity were observed in the form of feces, dead rodents and/or damaged trim, walls in the interior rooms. Consult with the property owner about this. A qualified person should make repairs to seal openings in the structure, set traps, and clean rodent waste as necessary. Recommend following guidelines in these Center for Disease Control articles:

Photo 1-1 Laundry area

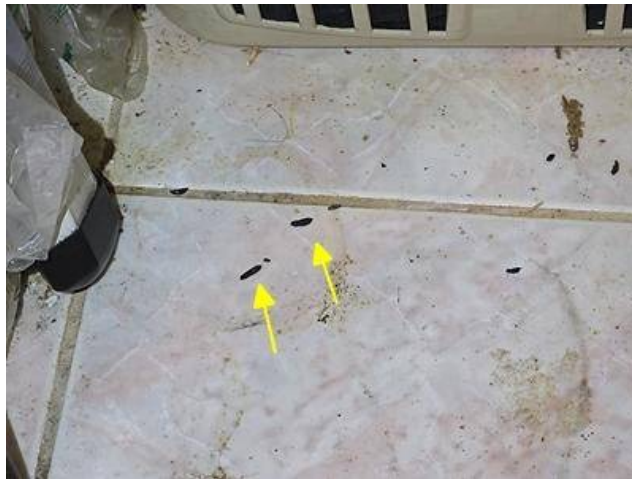
Photo 1-2 Closet below the stairs

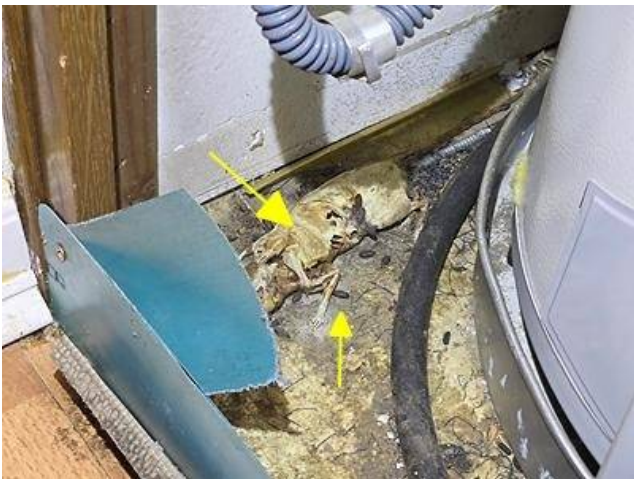
Photo 1-3 Water heater closet

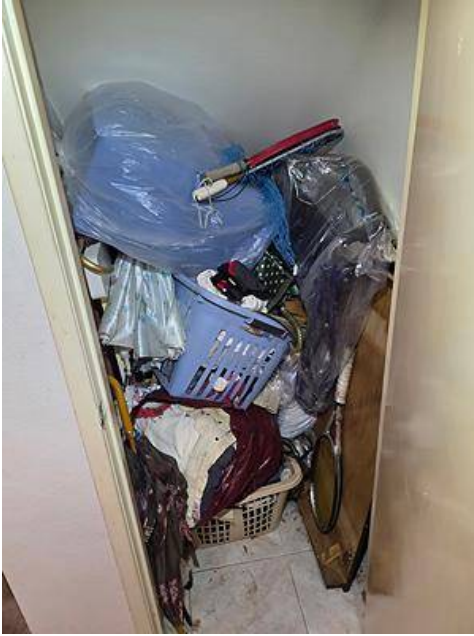
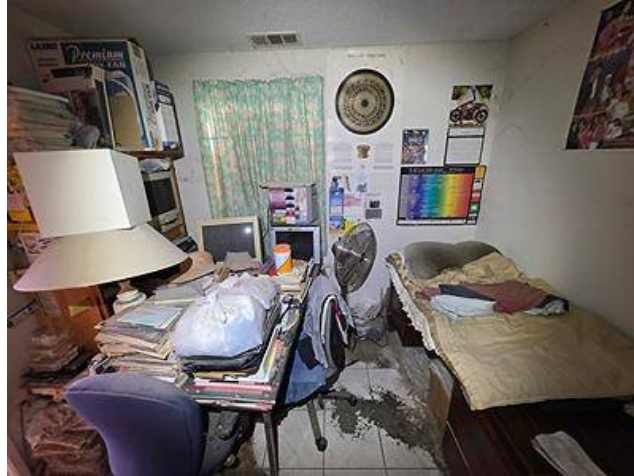
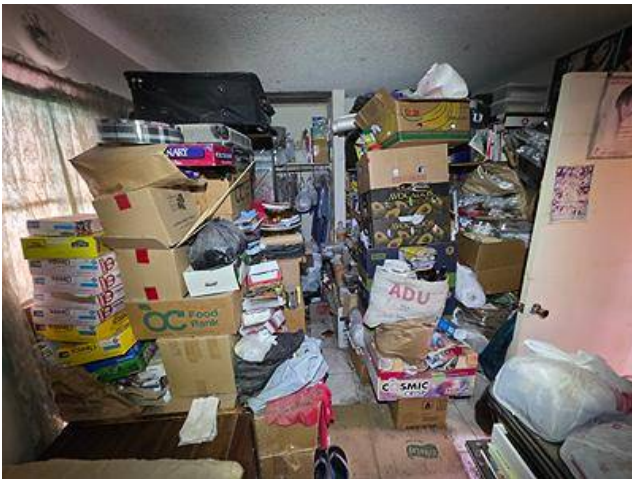
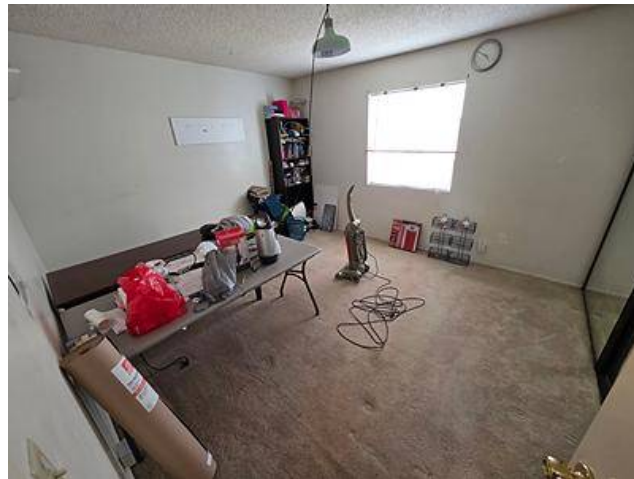
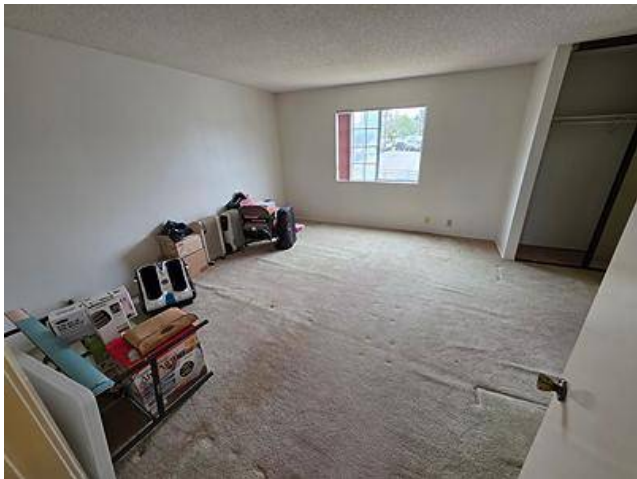
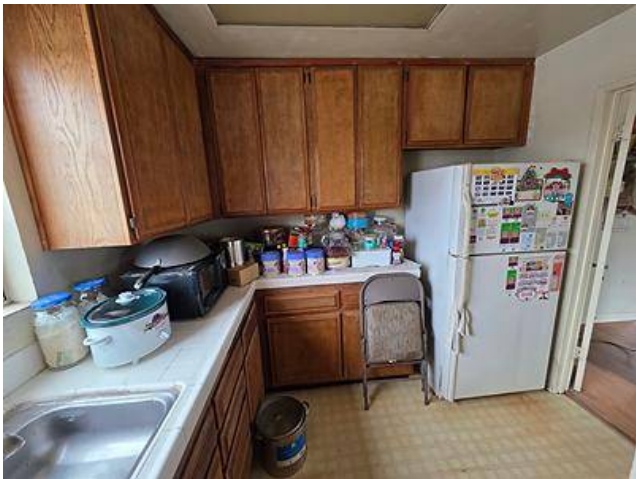
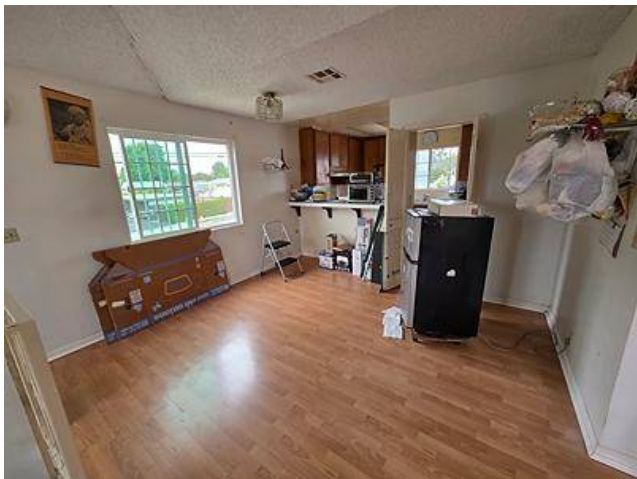
Many areas and items at this property were obscured by furniture and/or stored items. This often includes but is not limited to walls, floors, windows, inside and under cabinets, under sinks, on counter tops, in closets, behind window coverings, under rugs or carpets, and under or behind furniture. Areas around the exterior, under the structure, in the garage and in the attic may also be obscured by stored items. The inspector in general does not move personal belongings, furnishings, carpets or appliances. When furnishings, stored items or debris are present, all areas or items that are obscured, concealed or not readily accessible are excluded from the inspection. The client should be aware that when furnishings, stored items or debris are eventually moved, damage or problems that were not noted during the inspection may be found.

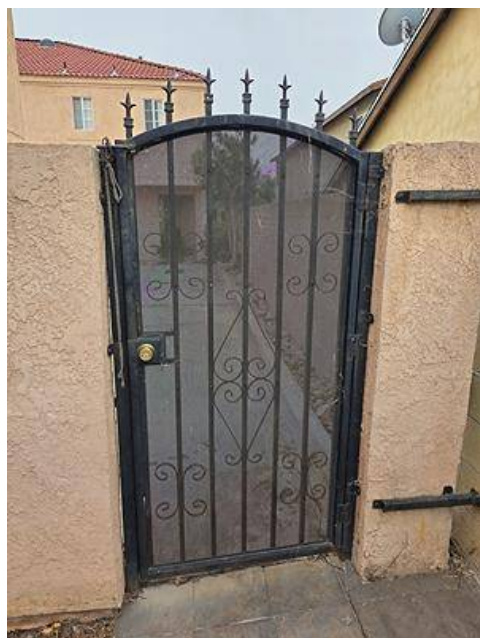
Photo 4-2

One or more gates were difficult to latch and need repair.

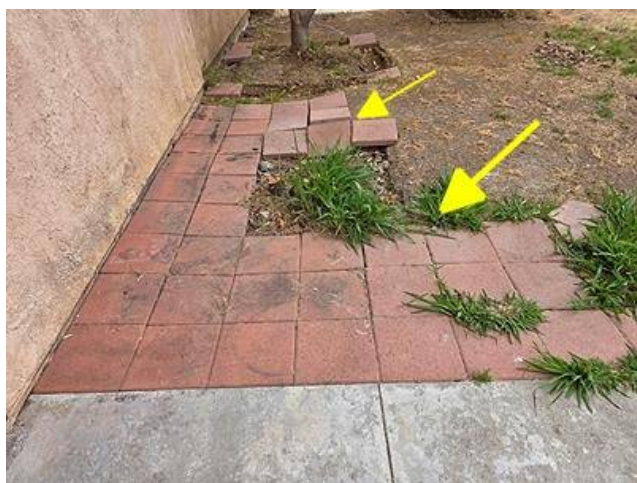
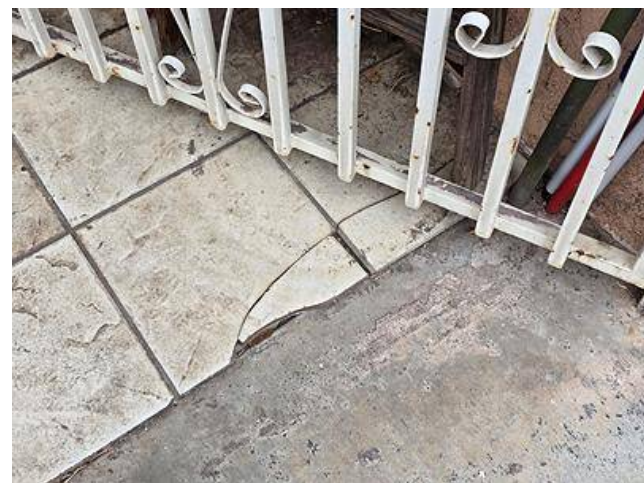
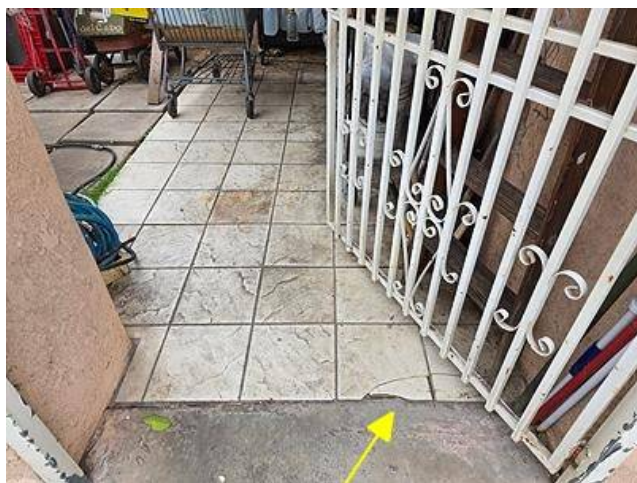
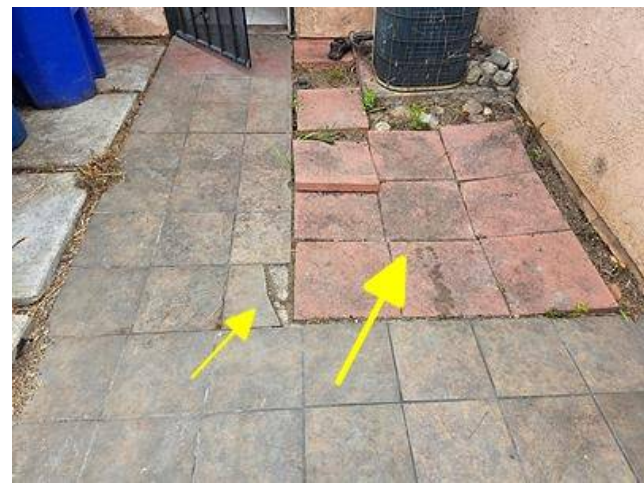
Cracks, holes, settlement, heaving and/or deterioration were found in sidewalks and/or patios. Recommend that qualified contractor repair as necessary.

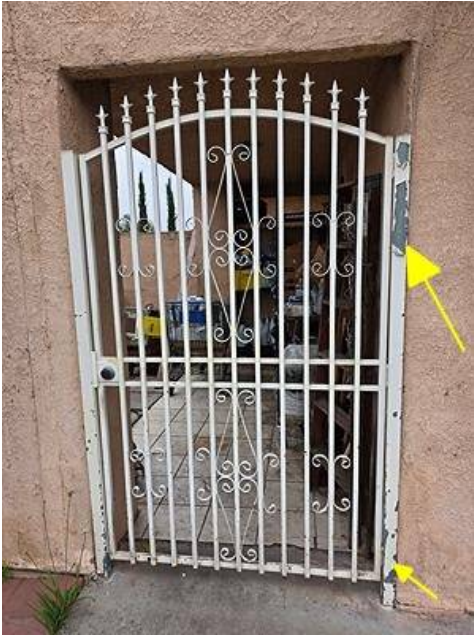
Photo 6-1

Some sections of the metal gate had failing paint and/or were unpainted. Unprotected metal surfaces are susceptible to moisture-related damage, including rust and corrosion, which can compromise the fence's structural integrity and longevity over time. It is recommended that a qualified contractor apply an appropriate protective coating (such as rust-inhibitive primer and exterior-grade paint) to all necessary areas in accordance with standard building practices.

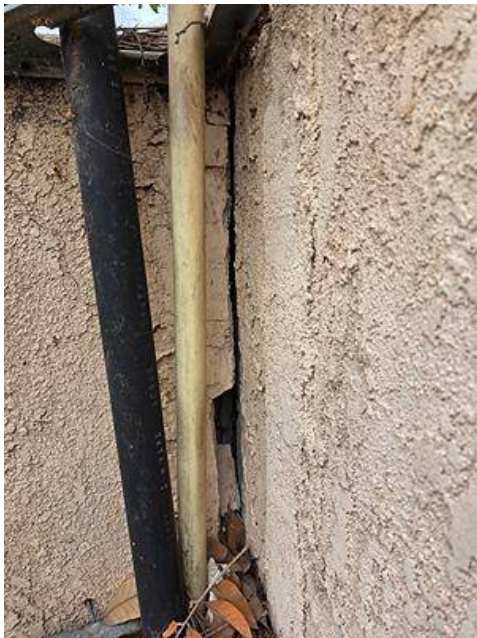
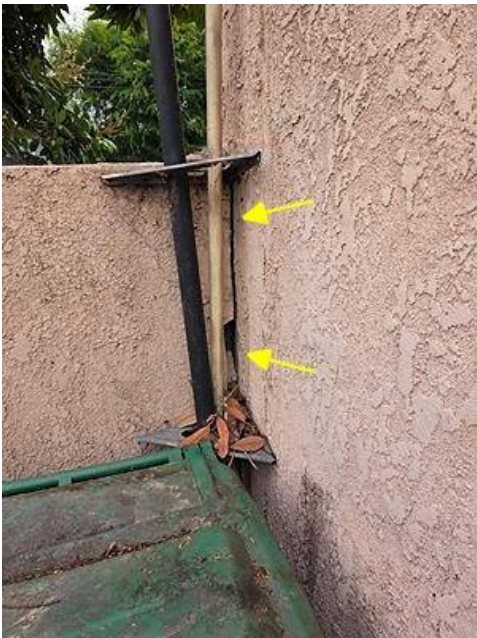
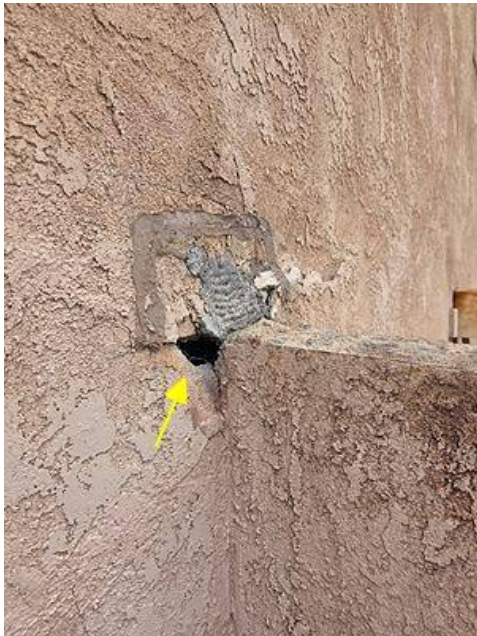
One or more holes or gaps were found in siding or trim. Vermin, insects or water may enter the structure. Recommend that a qualified person repair as necessary.

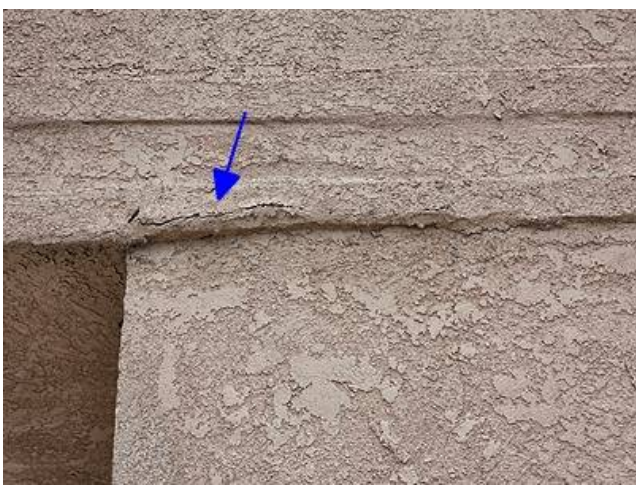
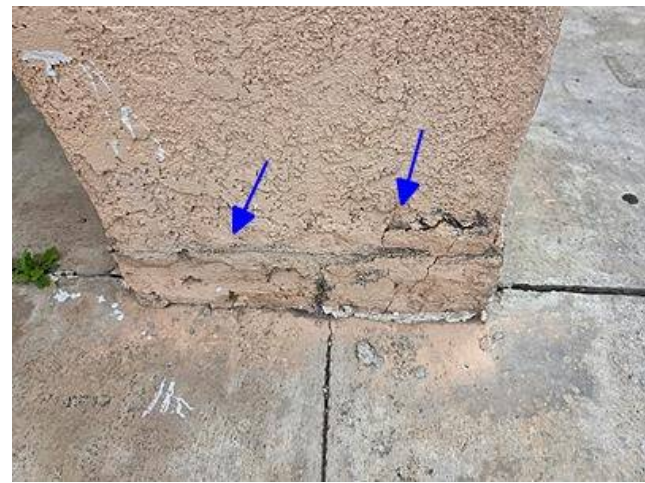
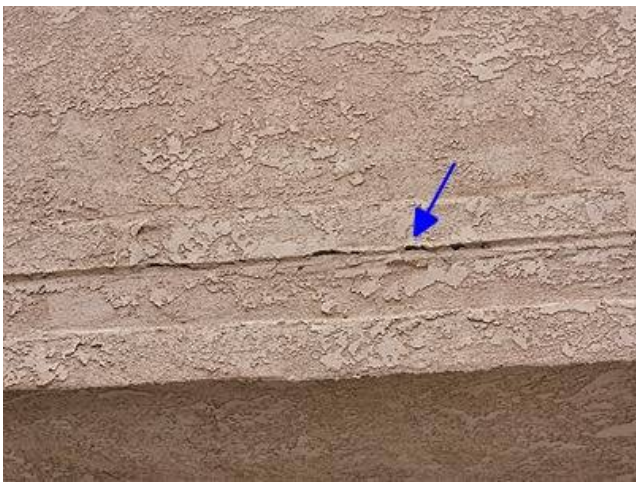
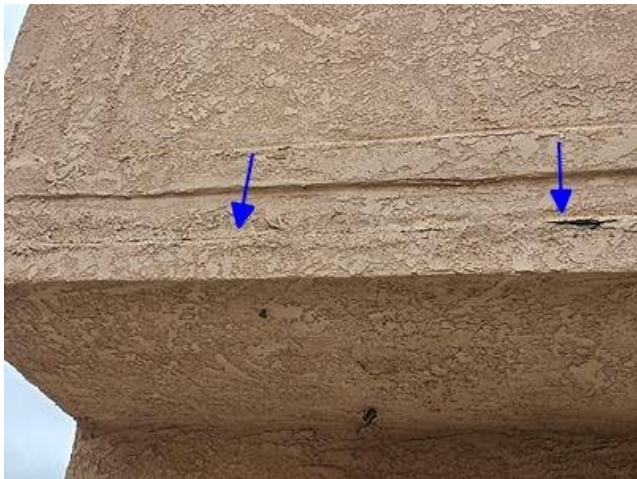
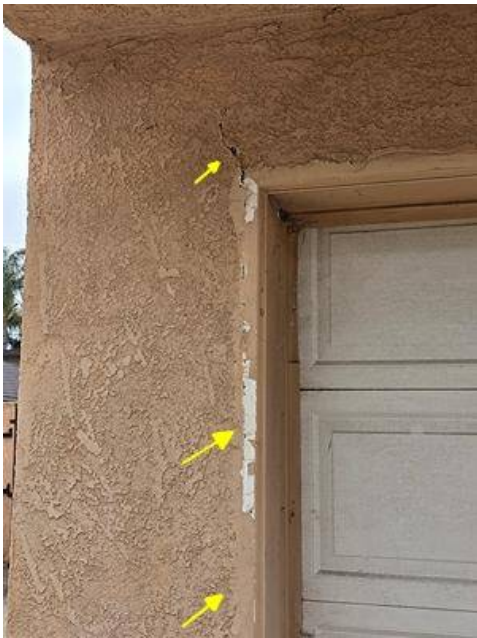
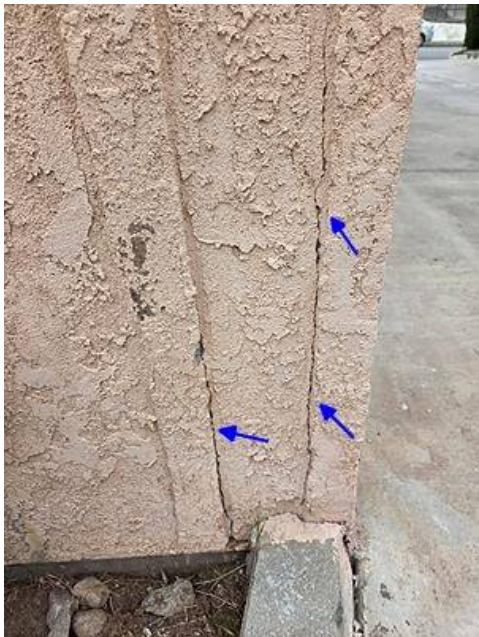
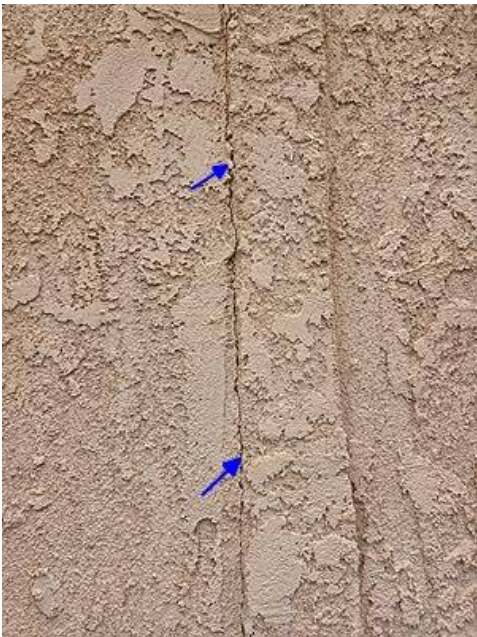
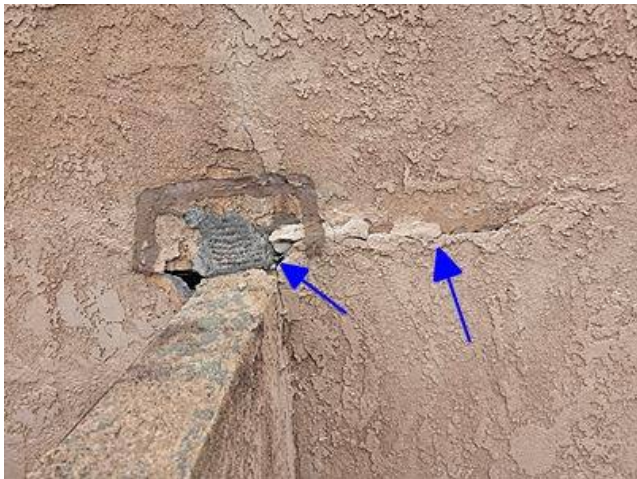
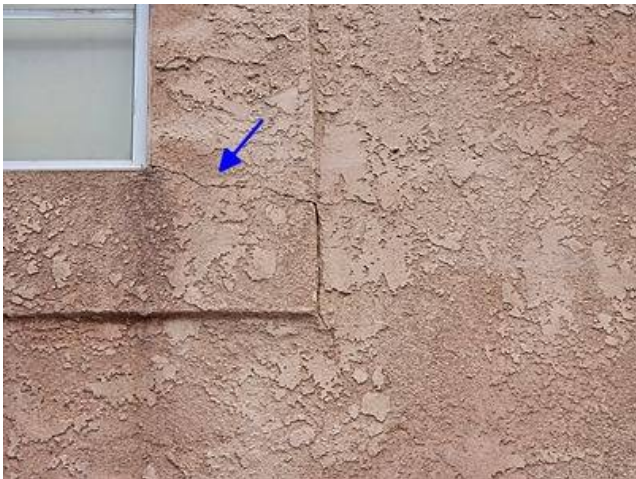
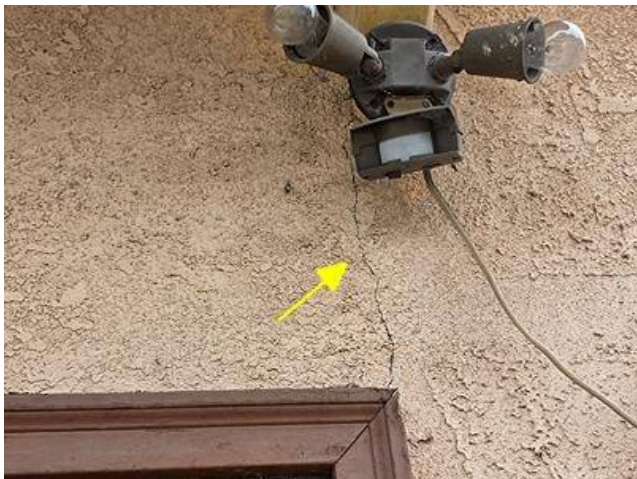
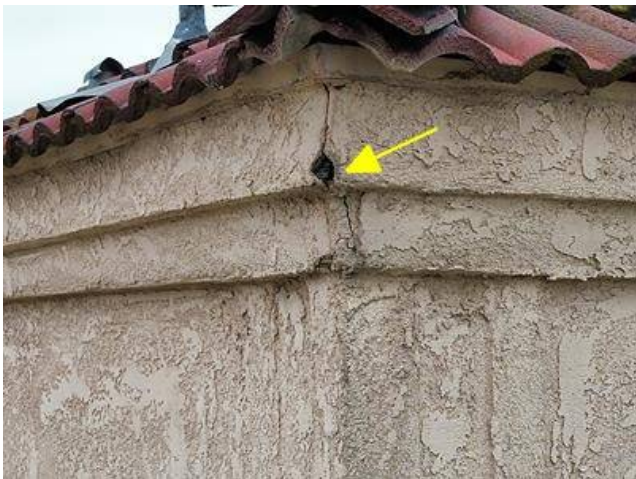
8) 🛠️💧 Cracks, deterioration and/or damage were found in one or more areas of the exterior stucco finish. In damp climates, moisture may enter cracks or damaged areas and further deteriorate the stucco. Also the wall behind the stucco may become damaged from moisture. Note that areas behind the stucco are inaccessible and excluded from this inspection. Recommend that a qualified contractor repair or replace stucco as necessary.

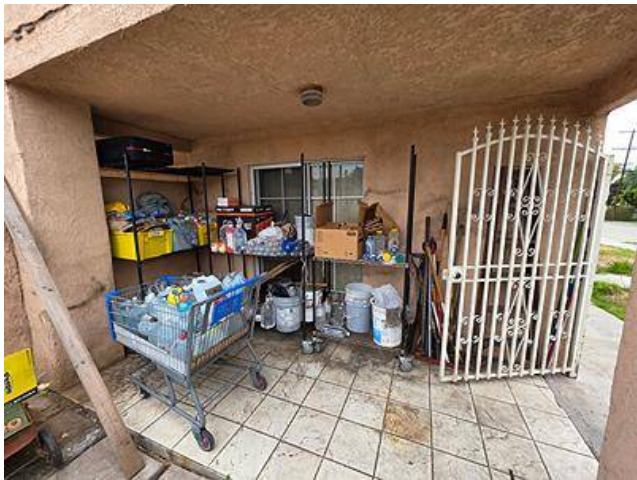
Photo 10-1

Some exterior wall sections were obscured by stored items and couldn't be fully evaluated. They are excluded from this inspection.

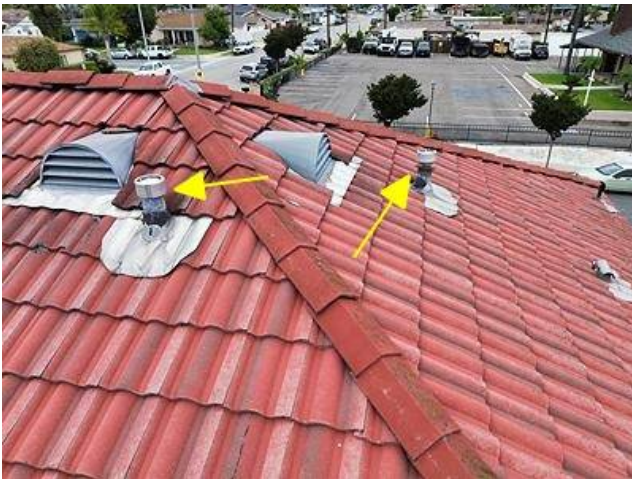
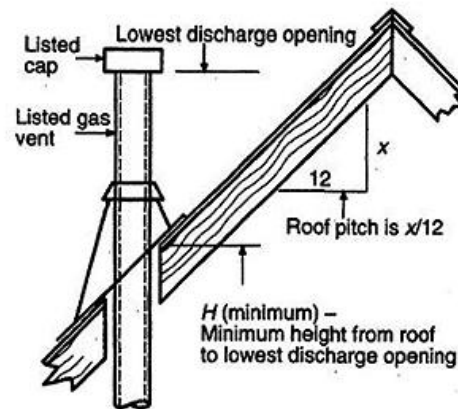
Short flues may not draft properly due to restricted free air movement. This is a potential safety hazard due to the risk of exhaust gases entering living spaces. Recommend having a qualified contractor repair per standard building practices.

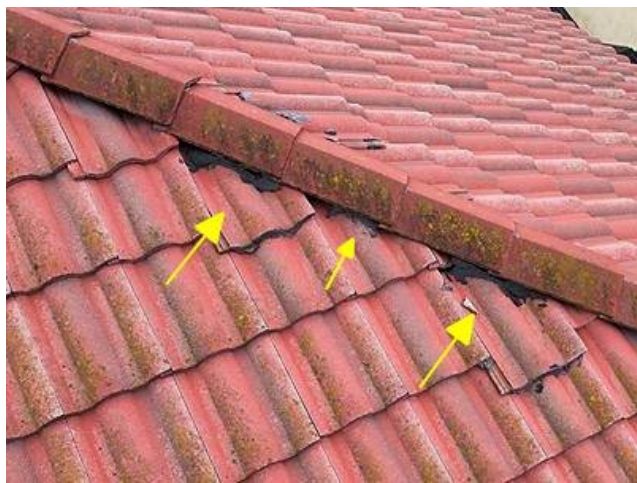
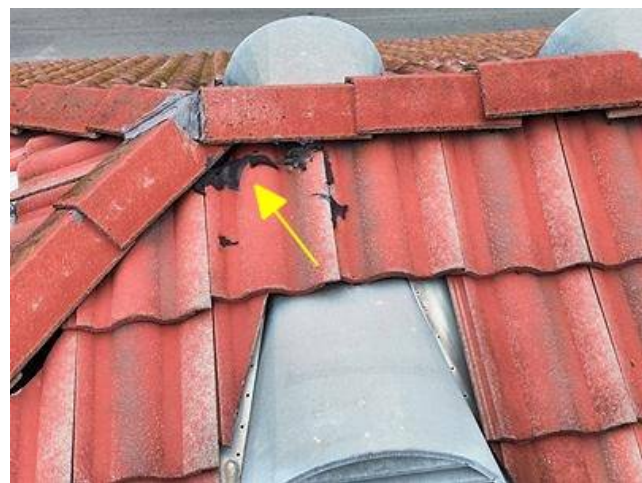
12) 🔧🔍 Substandard repairs were found at one or more locations on the concrete tile roof. Sealant was used to repair some sections of the roof and/or around flashing. Sealants may fail to adhere to dirty or wet tiles, trap moisture causing further damage, or degrade under UV exposure, lasting only 5–15 years. For significant damage, replacing tiles is better than sealing, and underlying issues like damaged underlayment must be fixed. Recommend that a qualified contractor evaluate and repair per standard building practices.

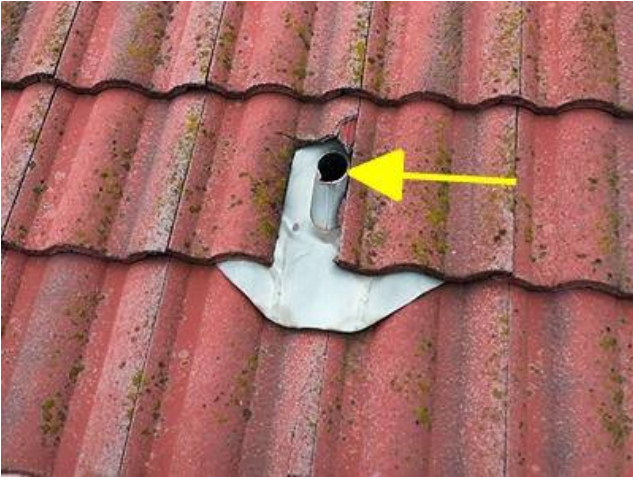
Photo 13-1

One or more roof pipe flashings were observed to be open with no vent pipe penetrating through the collar. These abandoned flashings create a direct opening in the roofing system that allows water to enter the attic space. This defect can lead to localized roof deck rot, damaged insulation, and interior ceiling stains. A qualified roofing contractor should be contacted to remove the empty flashings and properly patch the roof or install a permanent cap over the openings to ensure a watertight seal.

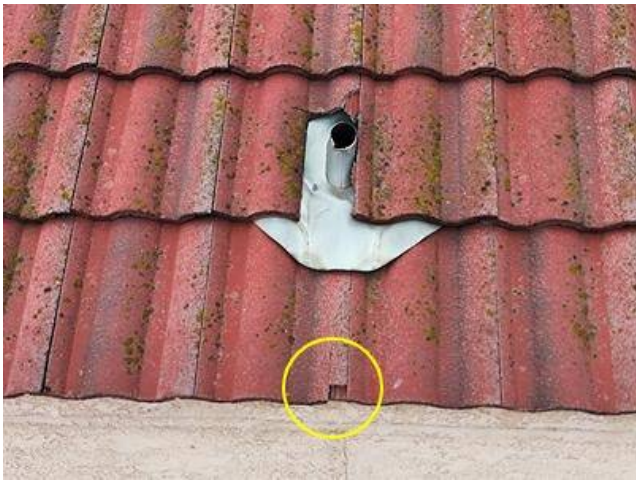
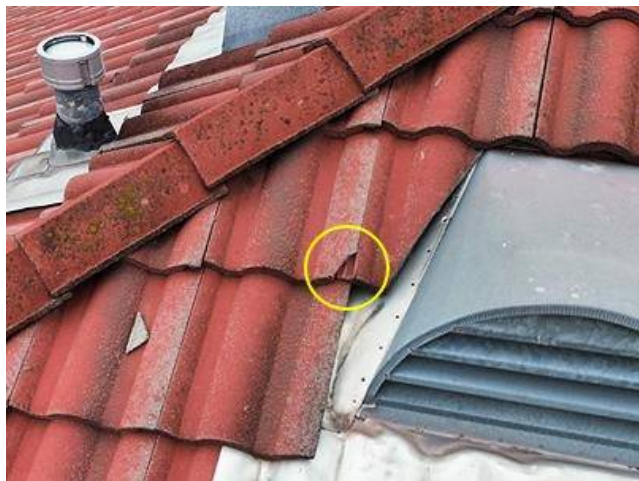
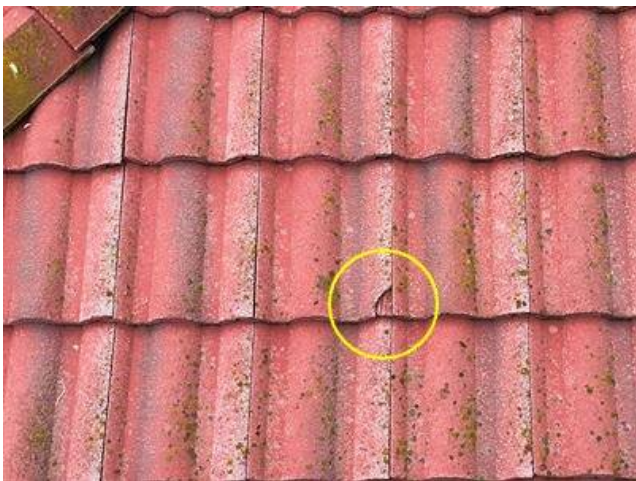
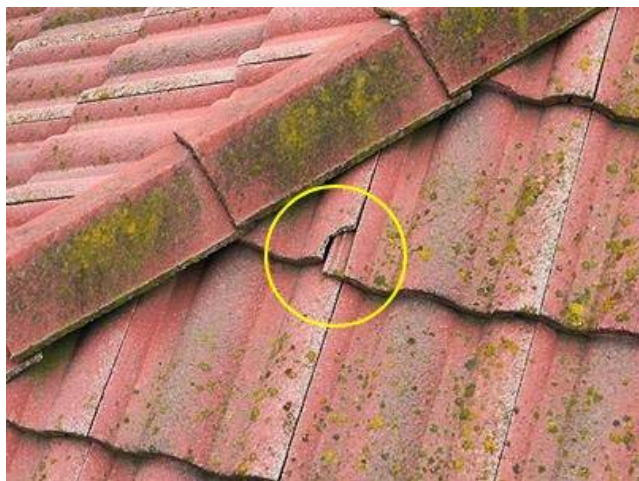
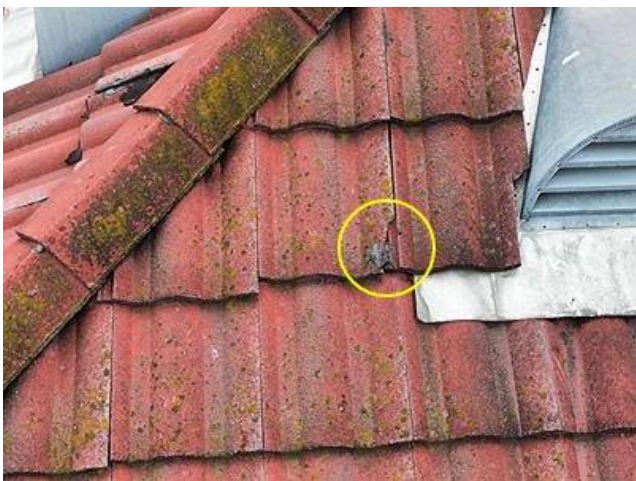
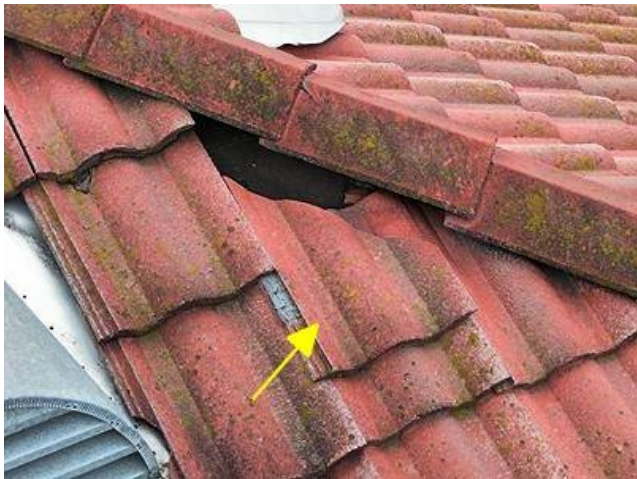
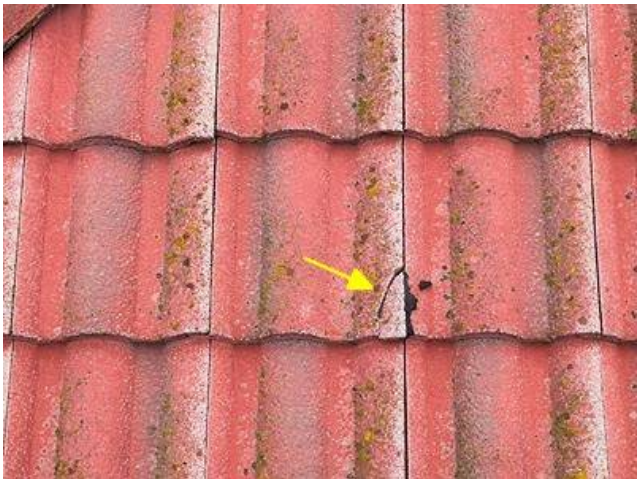
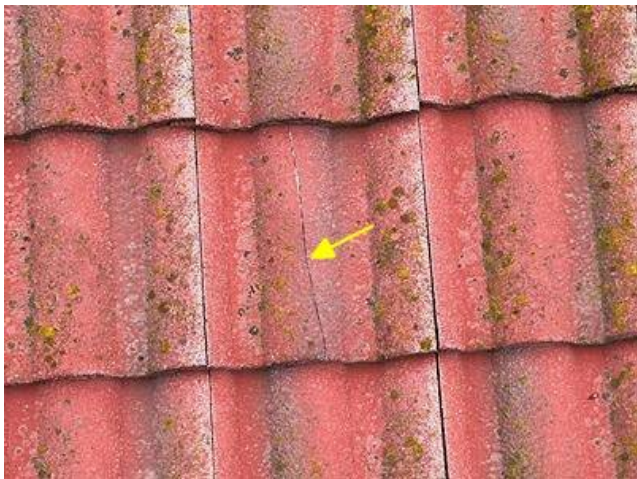
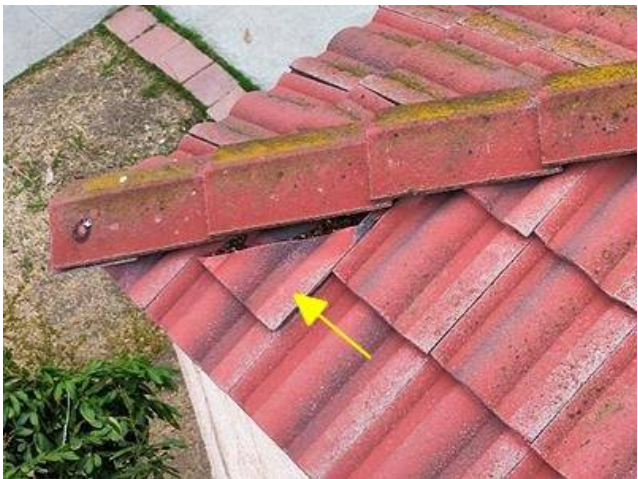
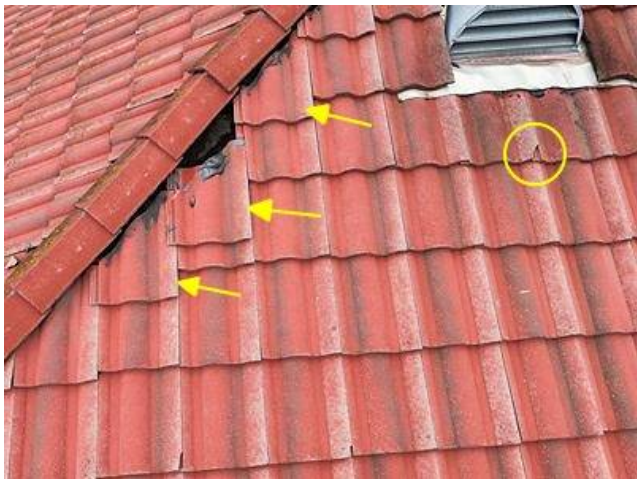
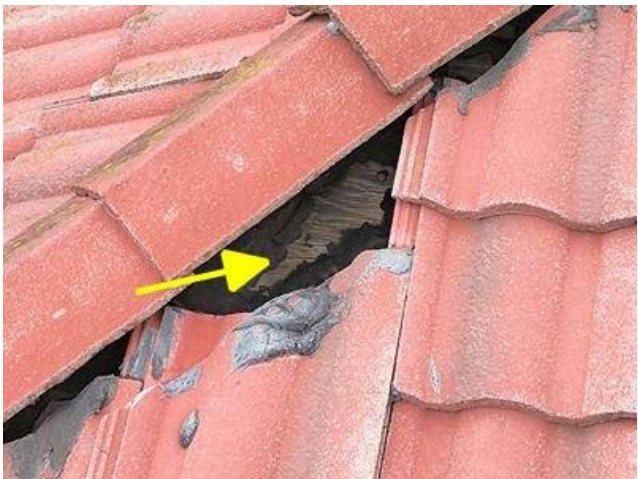
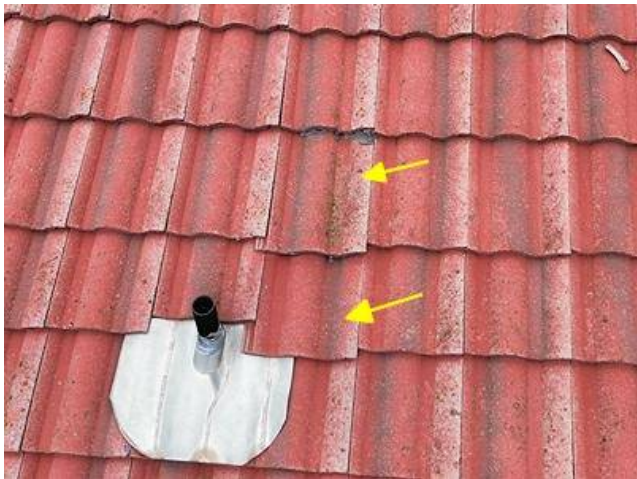
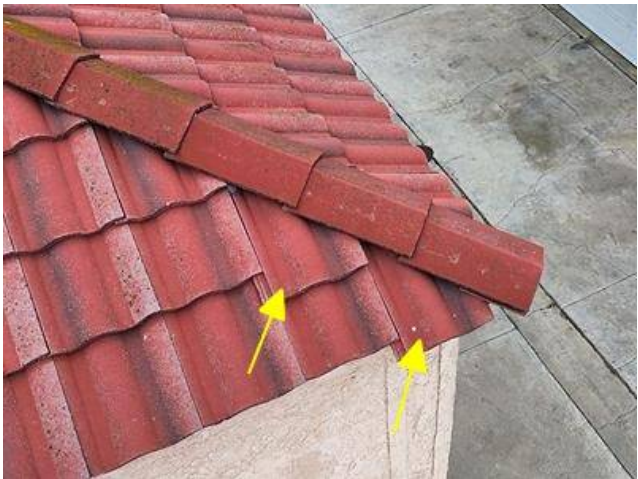
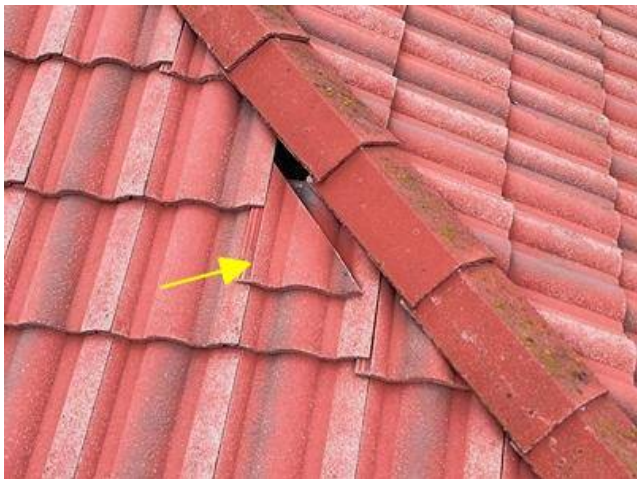
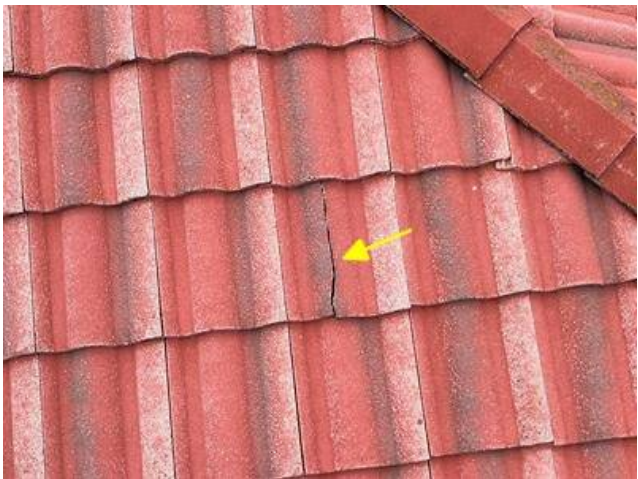
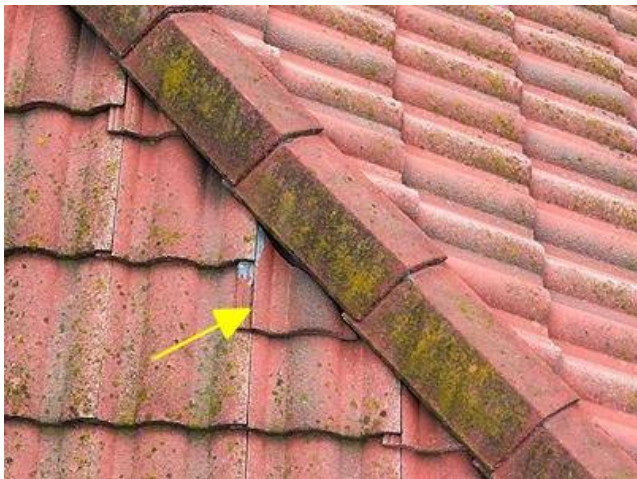
Many concrete roof tiles were broken, chipped, missing and/or loose. Leaks may occur as a result. This is a conducive condition for wood-destroying organisms. Recommend that a qualified person replace tiles or make repairs as necessary.

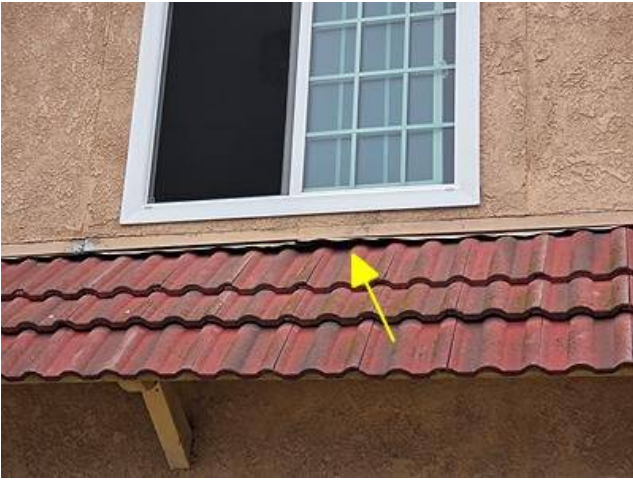
Photo 15-1

One or more roof flashings were lifting. Leaks can occur as a result. This is a conducive condition for wood-destroying organisms. Recommend that a qualified person repair as necessary.

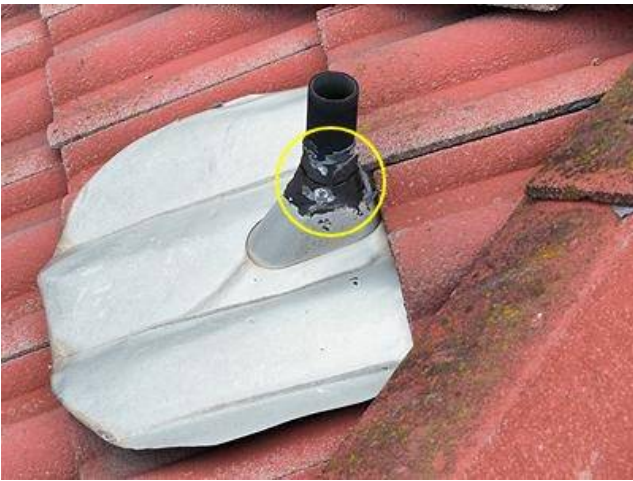
Photo 16-1

The sealant between the flashing and vent pipe was cracked and/or deteriorated. Leaks can occur as a result. This is a conducive condition for wood-destroying organisms. Recommend that a qualified person repair as necessary.

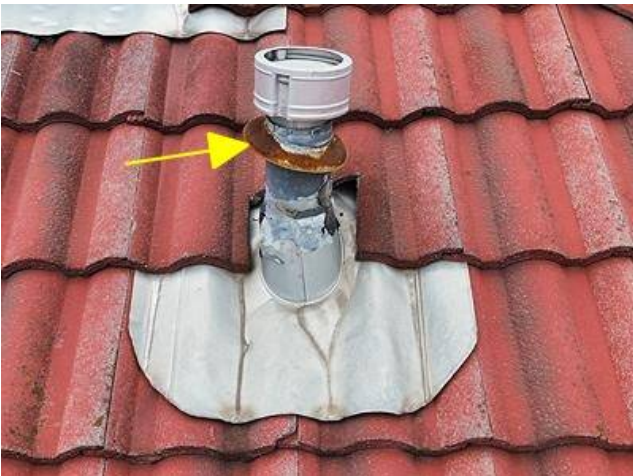
Photo 17-1

One or more flue pipe rain collars were corroded. Leaks can occur as a result. This is a conducive condition for wood-destroying organisms. Recommend that a qualified person repair as necessary.

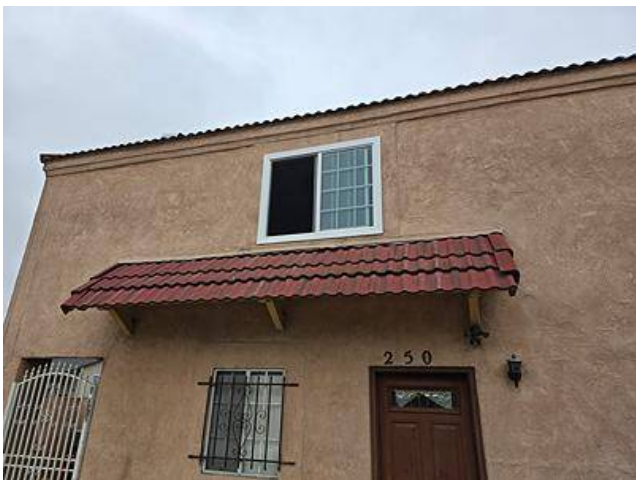
Photo 18-2

What appeared to be past water stains were visible at one or more soffit areas. The stains may have been caused by a past leak. Recommend asking the property owner about past leaks. Monitor these areas in the future, especially after heavy rains to determine if active leaks exist. If leaks are found, recommend that a qualified contractor evaluate and repair as necessary.

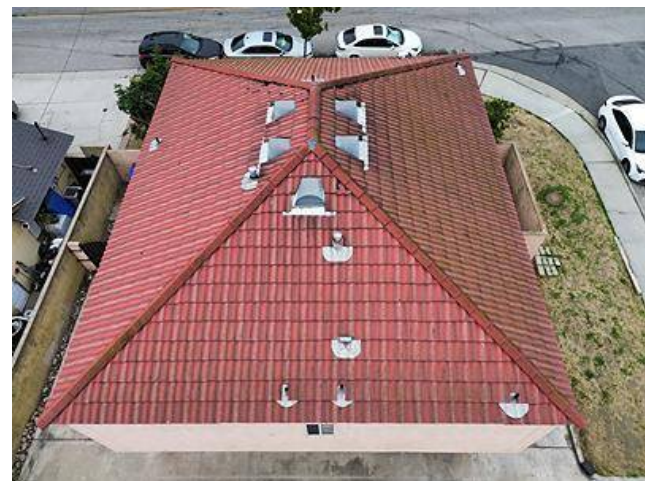
Photo 19-1

Normally the inspector attempts to traverse roof surfaces during the inspection. However, due to roof configuration (steep or very high), the inspector was unable to traverse the roof and wasn't able to fully evaluate the entire roof surface.

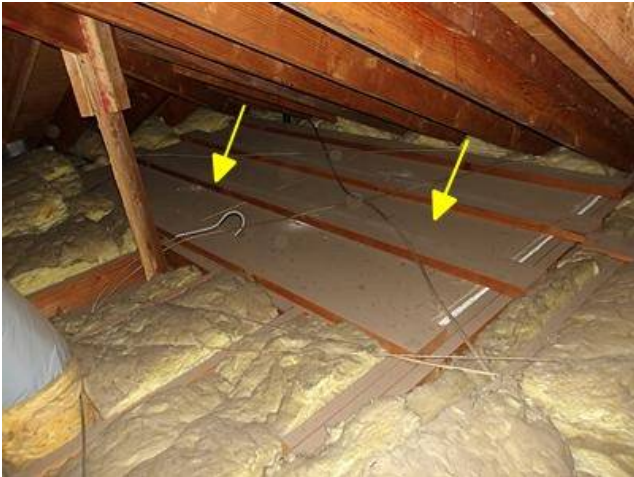
Photo 20-1

The ceiling insulation in one or more areas of the attic was missing. Heating and cooling costs may be higher due to reduced energy efficiency. Recommend that a qualified person repair, replace or install insulation as necessary and per standard building practices (typically R-38).

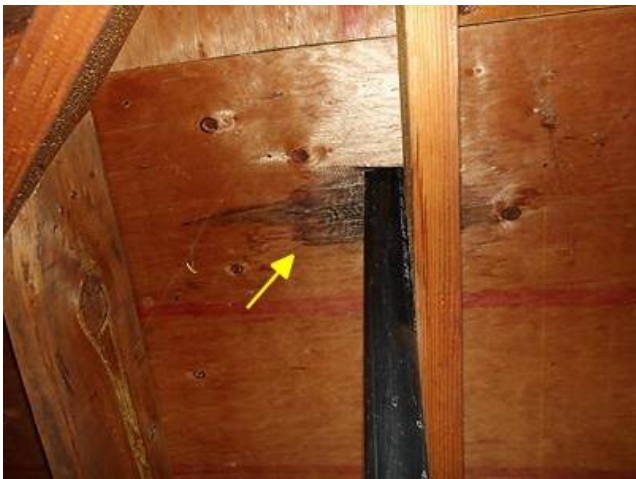
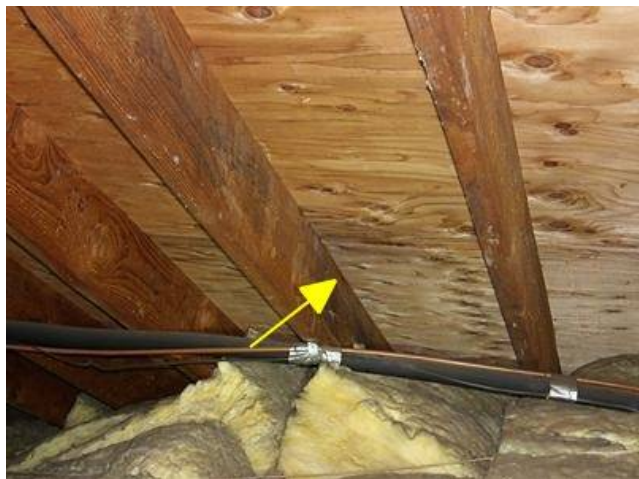
What appeared to be past water stains were visible on the roof structure at one or more locations in the attic. However, no elevated levels of moisture were found at these stains during the inspection. The stains may have been caused by a past leak. Recommend asking the property owner about past leaks. Monitor these areas in the future, especially after heavy rains to determine if active leaks exist. If leaks are found, recommend that a qualified contractor evaluate and repair as necessary.

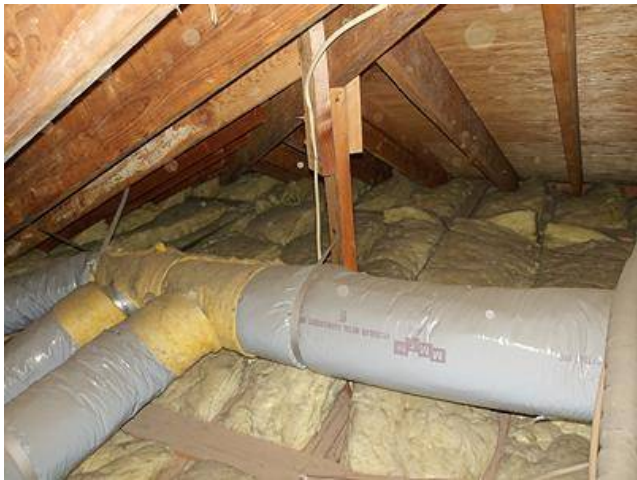
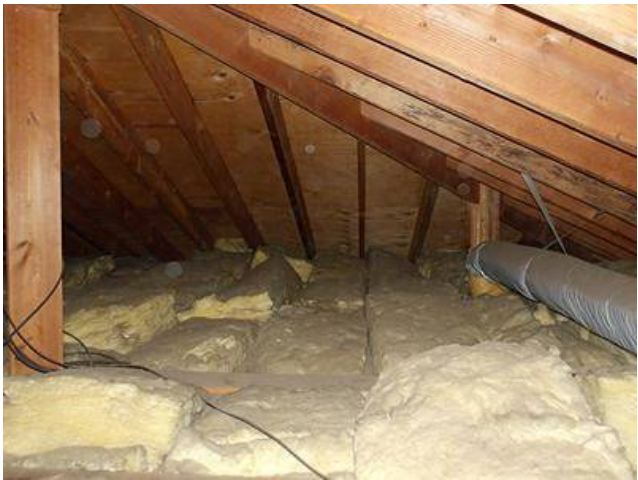
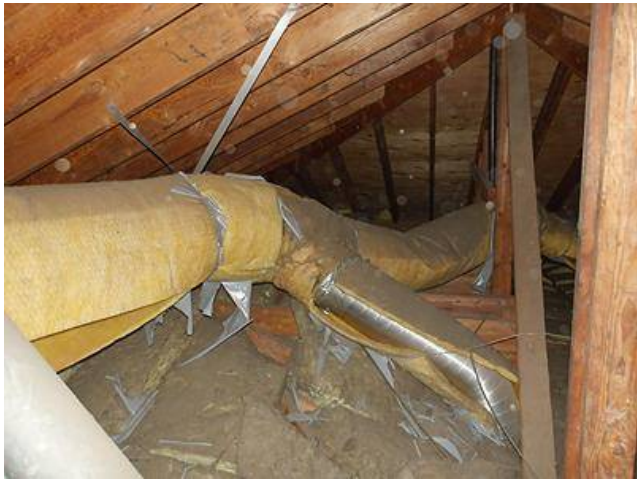
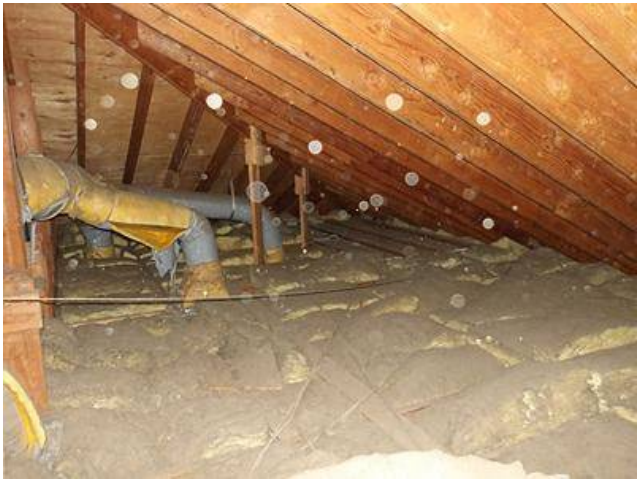
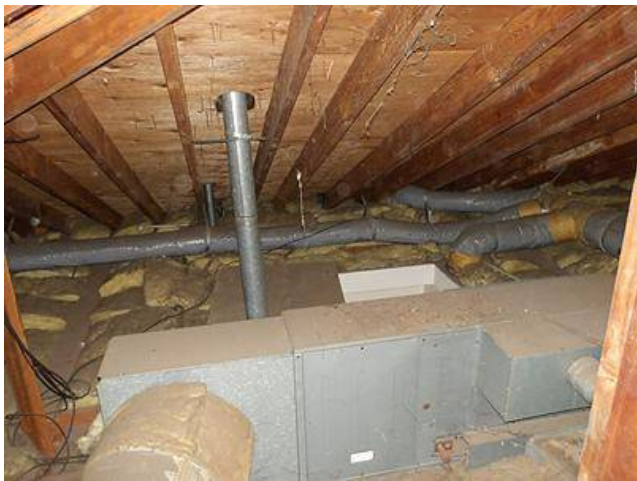
22) ⓘ All attic areas and roof structures more than 12 feet from attic access point(s) #A were inaccessible due to lack of permanent walkways and/or ducts or pipes blocking. These areas were not evaluated and are excluded from the inspection.

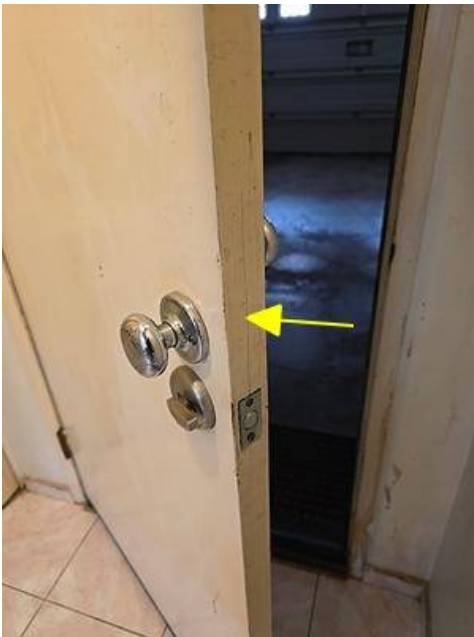
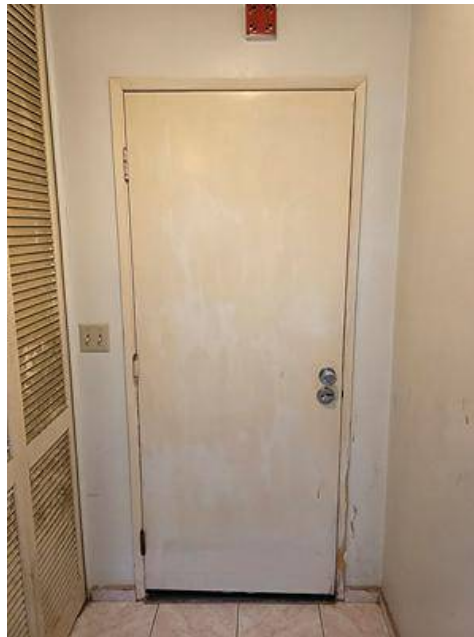
23) 🛠️ The door between the house and the garage wouldn't latch when closed. This is meant to be a fire-resistant door for safety reasons, and should latch when closed. Recommend that a qualified person repair as necessary.

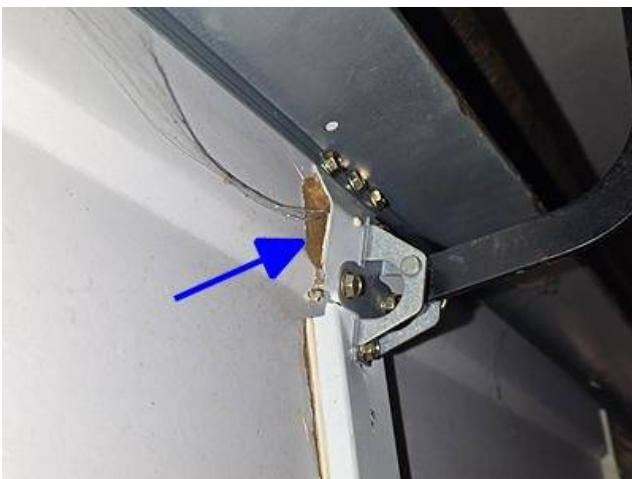
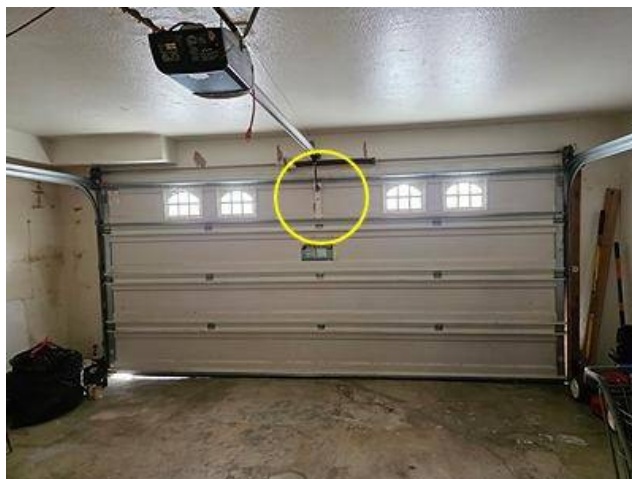
24) 🛠️ One or more garage vehicle doors were damaged or deteriorated. Recommend that a qualified contractor repair or replace door(s) as necessary.
