## Harmony Inspectors

## Property Inspection Report

Property address: **250 N Monte Vista St # 3  
La Habra CA 90631-4541**

Inspection date: **Tuesday, May 12, 2026**

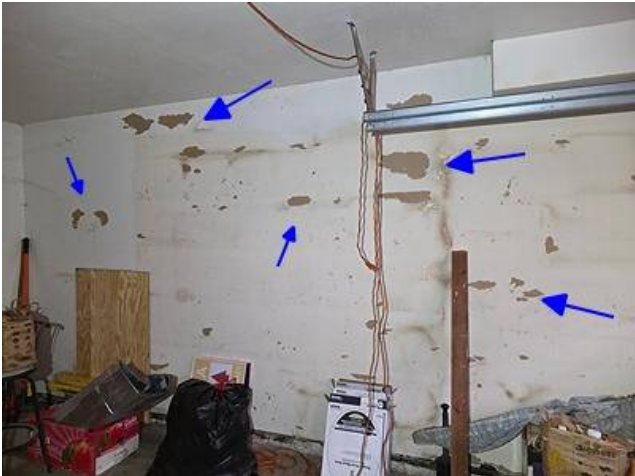
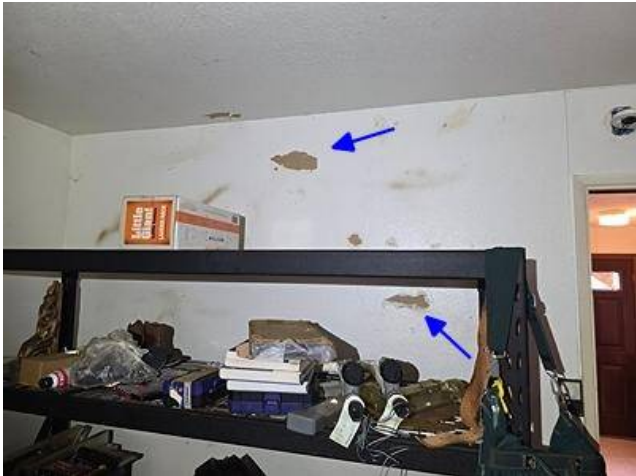
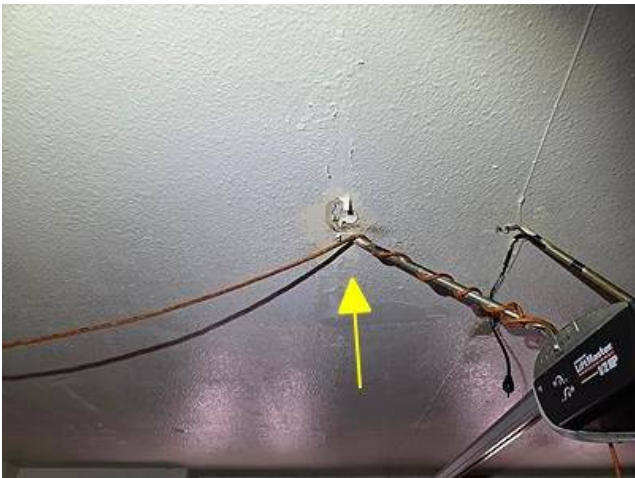
One or more walls were damaged. Recommend that a qualified person repair as necessary.

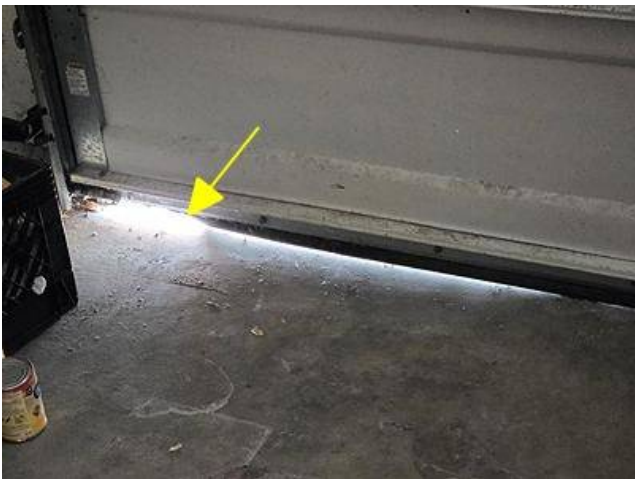
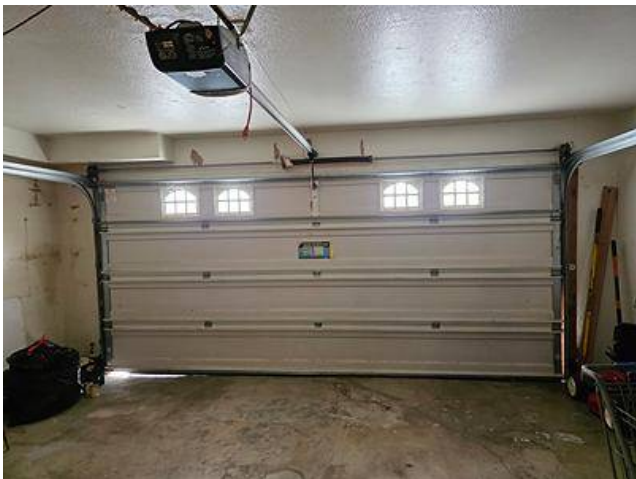
Weatherstripping sealing one or more garage vehicle doors was damaged. Recommend replacing or installing weatherstripping where necessary to prevent water and/or vermin intrusion.

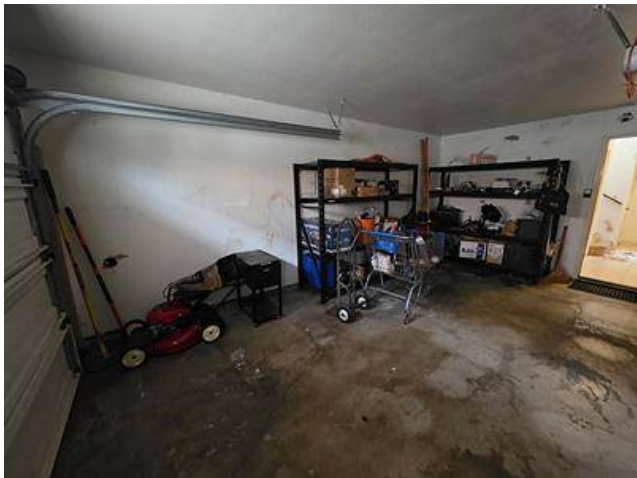
Photo 29-1

Some floor areas were obscured by stored items and couldn't be fully evaluated.

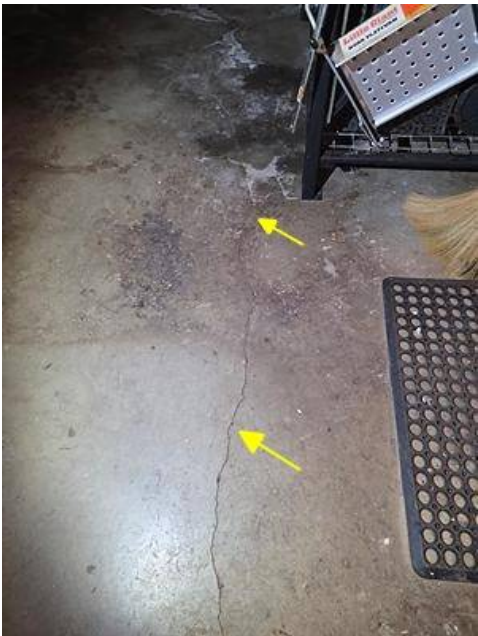
Photo 31-2

31) ⓘ Minor cracks were found in the concrete slab floor. These are common and appeared to be only a cosmetic issue.

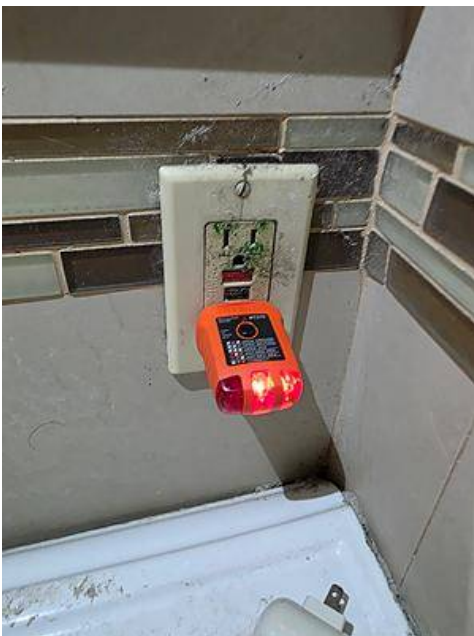
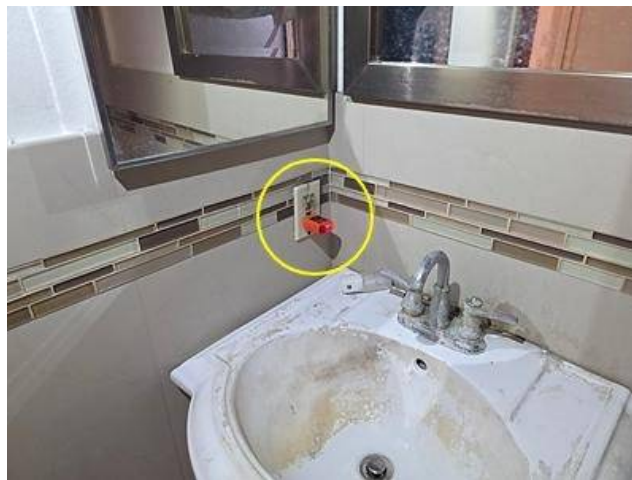
One or more ground fault circuit interrupter (GFCI) devices protecting receptacles at the bathroom(s) wouldn't trip when tested. This is a potential shock hazard. Recommend that a qualified electrician evaluate and repair as necessary.

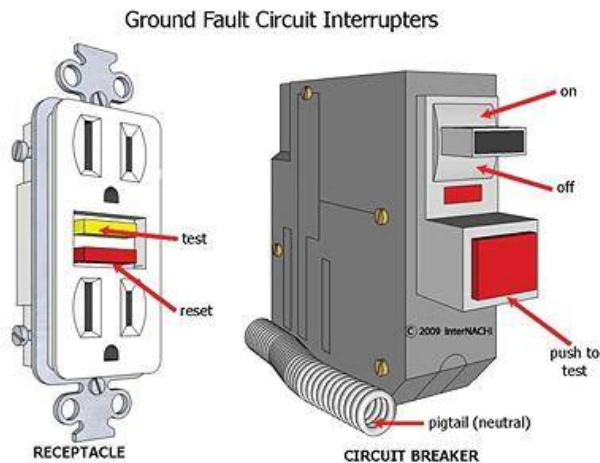
Photo 33-1

One or more electric receptacles at the kitchen and/or garage had no visible ground fault circuit interrupter (GFCI) protection, or the inspector was unable to determine if GFCI protection was present. If not GFCI-protected, receptacles in wet areas pose a shock hazard. Recommend that a qualified electrician evaluate and install GFCI protection if necessary and per standard building practices. General guidelines for GFCI-protected receptacles include the following locations:

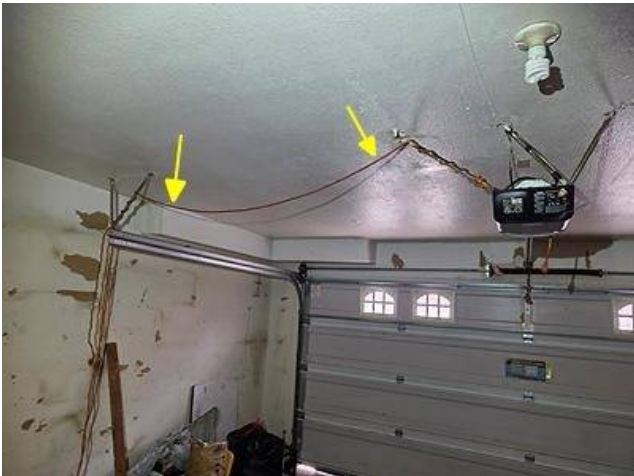
Photo 34-1 Garage

Extension cords were being used as permanent wiring at one or more locations. They should only be used for portable equipment on a temporary basis. Using extension cords as permanent wiring is a potential fire and shock hazard, and indicates that wiring is inadequate and needs updating. Extension cords may be undersized. Connections may not be secure resulting in power fluctuations, damage to equipment, overheating and sparks that could start a fire. Recommend that a qualified electrician repair per standard building practices and eliminate extension cords for permanently installed equipment.

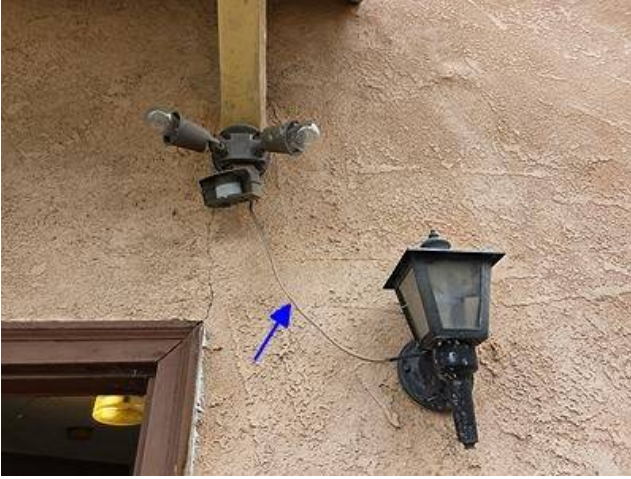
Photo 35-1 Front of unit

Flexible lamp or appliance cord was being used for permanent wiring at one or more locations. Such wiring is not intended to be used as permanent wiring and poses a safety hazard of shock and fire. Recommend that a qualified electrician repair per standard building practices.

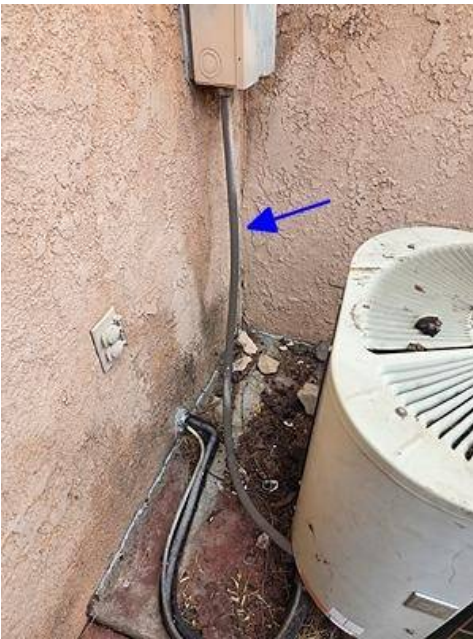
Photo 36-1 At the A/C unit

Conduit and/or fittings at one or more locations were loose. This is a potential safety hazard for shock or fire. Recommend that a qualified electrician repair as necessary.

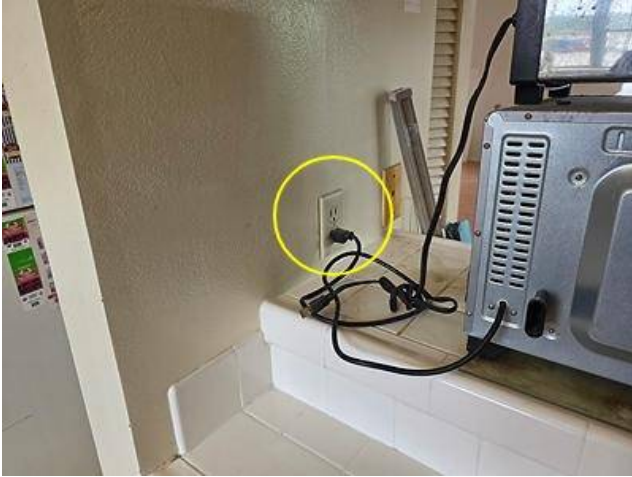
Photo 37-1 Kitchen

One or more electric receptacles and/or the boxes in which they were installed were loose and/or not securely anchored. Wire conductors can be damaged due to repeated movement and/or tension on wires, or insulation can be damaged. This is a shock and fire hazard. Recommend that a qualified electrician repair as necessary.

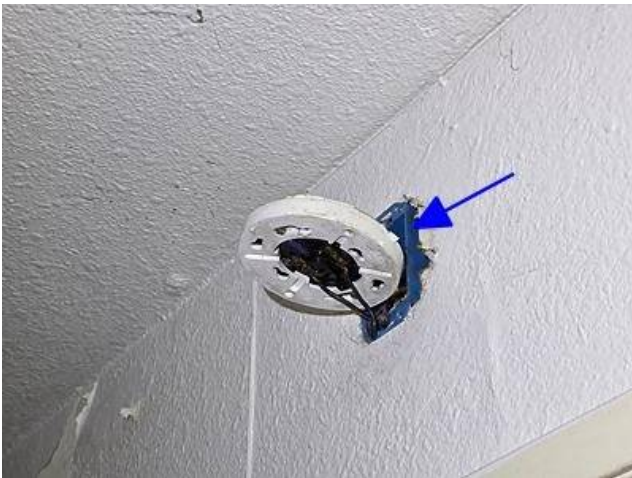
Photo 39-1 Garage

One or more cover plates for switches, receptacles or junction boxes were missing or broken. These plates are intended to contain fire and prevent electric shock from occurring due to exposed wires. Recommend that a qualified person install cover plates where necessary.

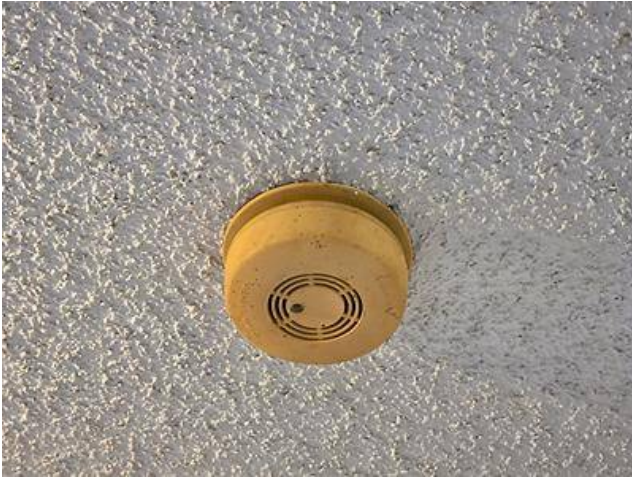
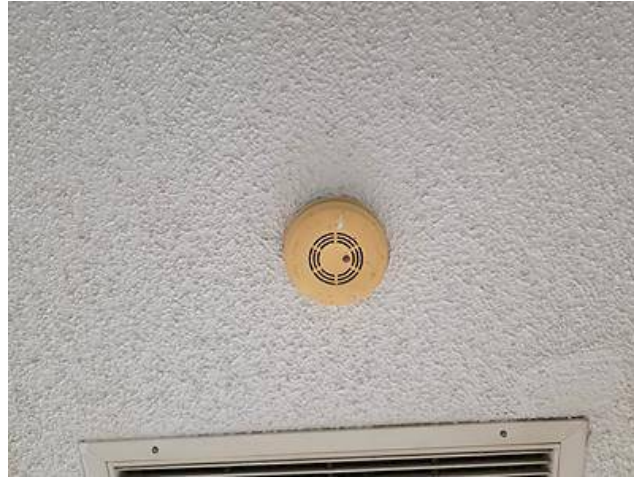
Based on the age of this structure and the appearance of existing smoke alarms, the alarms may have been installed more than 10 years ago. According to [National Fire Protection Association](https://www.nfpa.org/101), aging smoke alarms don't operate as efficiently and often are the source for nuisance alarms. Older smoke alarms are estimated to have a 30% probability of failure within the first 10 years. Newer smoke alarms do better, but should be replaced after 10 years. Unless you know that the smoke alarms are new, replacing them when moving into a new residence is also recommended by NFPA. For more information, visit: <https://www.reporthost.com/?SMKALRMLS>

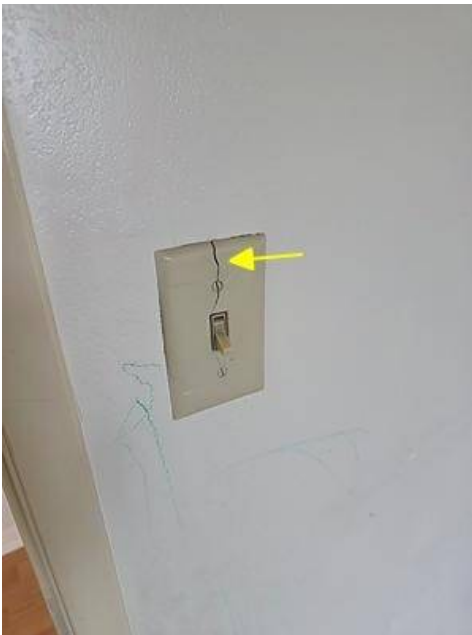
Photo 42-1 Master bedroom

One or more cover plates for switches, receptacles or junction boxes were missing or broken. These plates are intended to contain fire and prevent electric shock from occurring due to exposed wires. Recommend that a qualified person install cover plates where necessary.

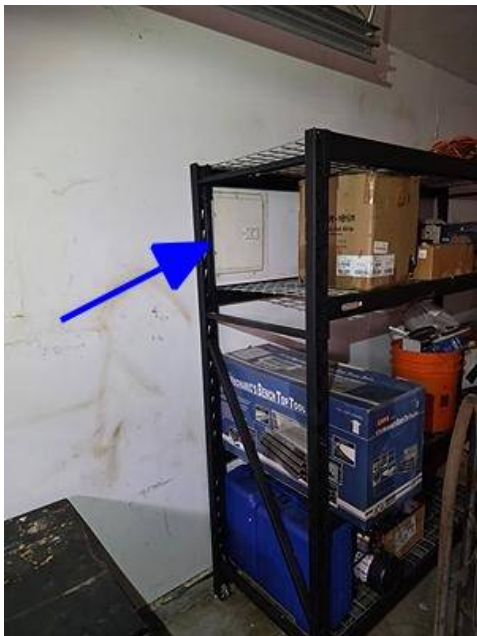
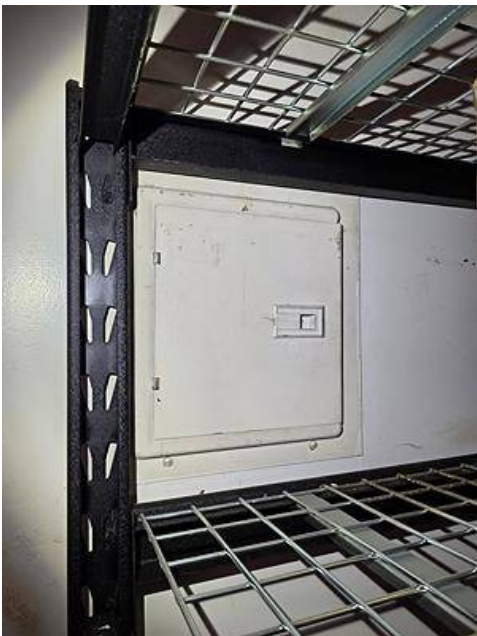
The inspector was unable to open and evaluate panel(s) #C because items were blocking access. The condition of these panel(s) is unknown and they are excluded from this inspection. Repairs may be needed. Recommend that a qualified person correct conditions, or that a qualified contractor make repairs if necessary so panels can be opened, and that a qualified person fully evaluate panel(s).

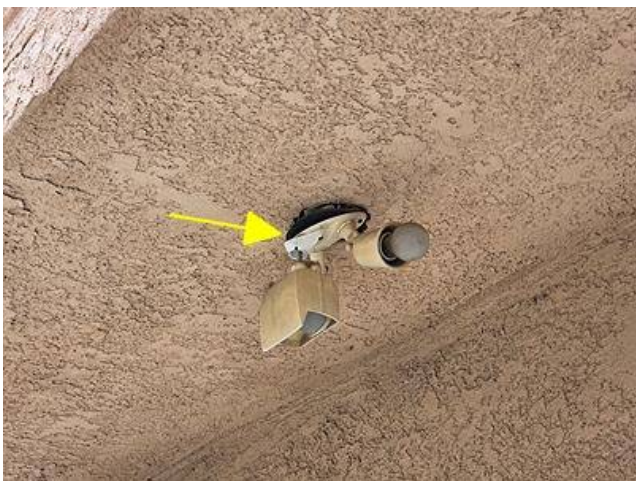
Photo 45-2

One or more light fixtures were loose and/or corroded. Recommend that a qualified electrician repair or replace light fixtures as necessary.

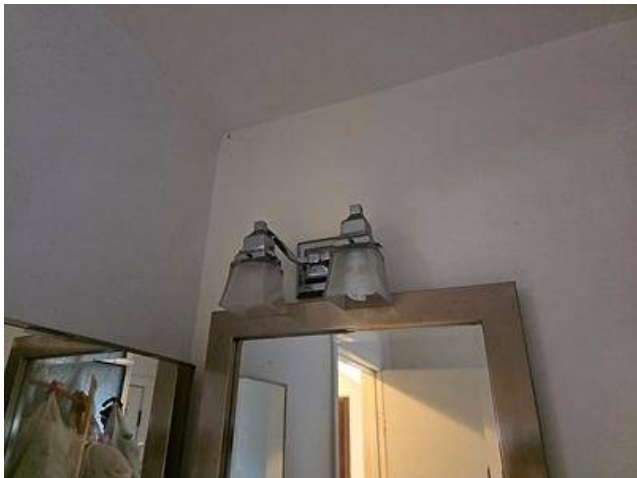
Photo 48-1 Bathroom

48) 🔍 One or more light fixtures were inoperable (didn't turn on when nearby switches were operated). Recommend further evaluation by replacing bulbs and/or consulting with the property owner. If replacing bulbs doesn't work and/or no other switch(es) can be found, then recommend that a qualified electrician evaluate and repair or replace light fixtures as necessary.

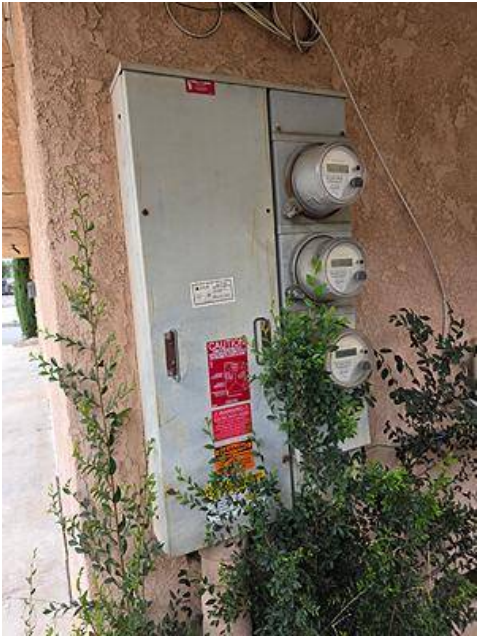
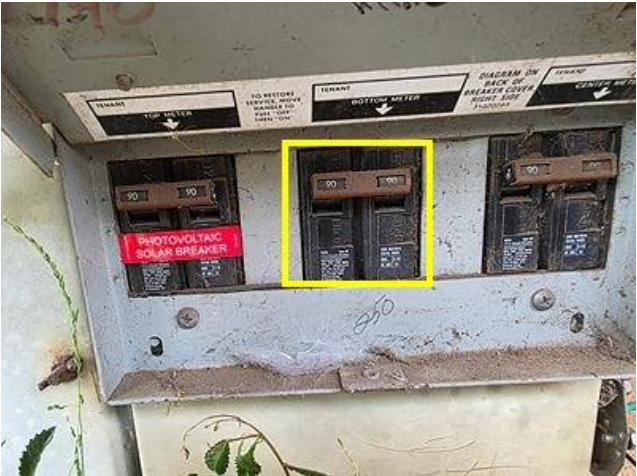
Location of the main service panel and main circuit breaker for the unit.

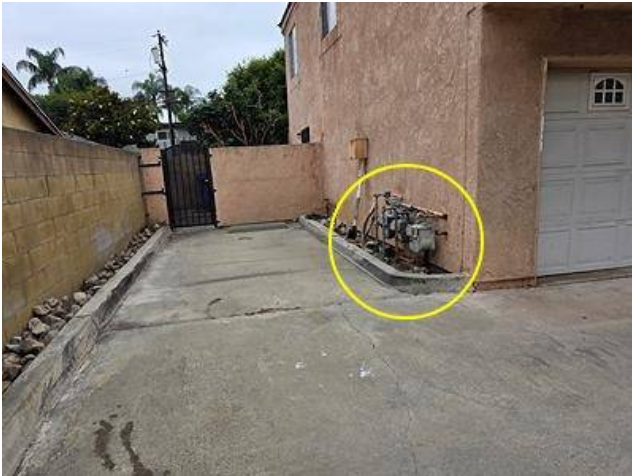
Photo 51-1

The gas meter was located where it was subject to damage from vehicles. This is a potential explosion and fire hazard. Recommend that a qualified contractor install a protective barrier per standard building practices.

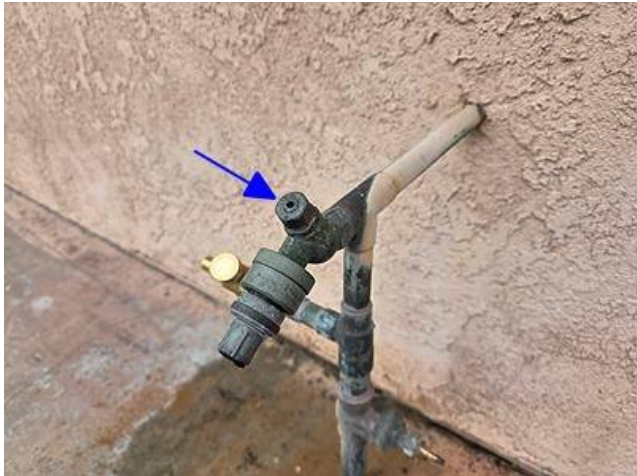
Photo 54-1

One or more hose bib handles were broken. Recommend that a qualified person replace handles or make repairs as necessary.

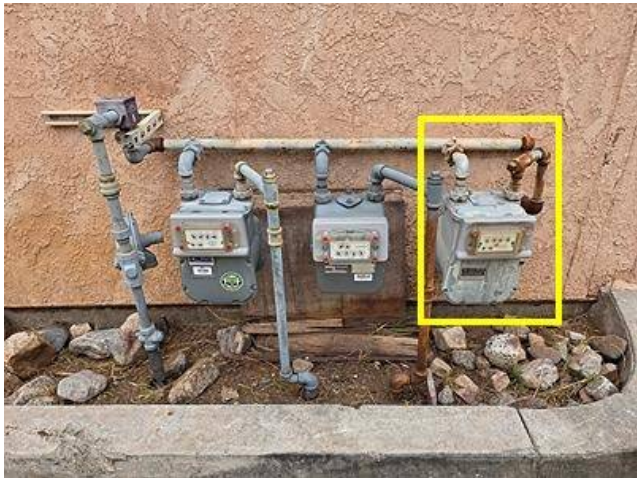
Photo 55-1

Location of main gas shut-off valve.

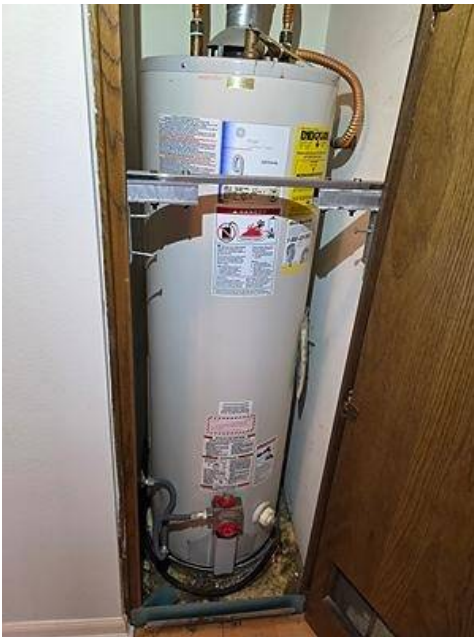
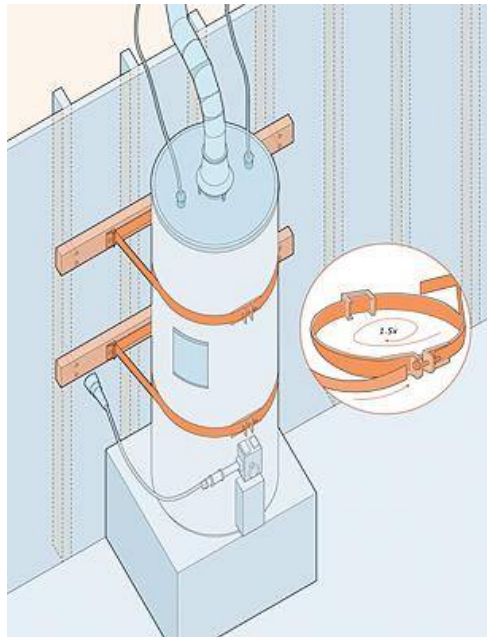
The water heater did not have earthquake straps installed. This is a potential safety hazard in the event of an earthquake due to the risk of the water heater tipping over, gas lines breaking if it's gas-fired, or electric wiring being damaged if powered by electricity. Leaks may also occur in water-supply pipes or fittings. Recommend that a qualified person install earthquake straps per standard building practices.

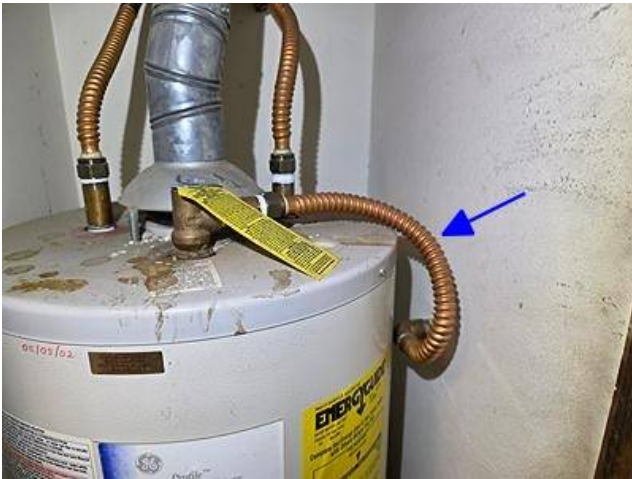
Photo 57-1

One or more flexible connectors were used for the temperature-pressure relief valve drain line. Flex connectors can be bent or kinked so as to restrict the flow of the drain line and impair the operation of the valve. They typically are not rated for the temperature and pressure of water being discharged (potentially 150 psi and 210 degrees F). Flex connectors used this way pose a potential safety hazard for explosion. Recommend that a qualified plumber repair per standard building practices. For example, by installing a drain line made of rigid copper or CPVC plastic pipe.

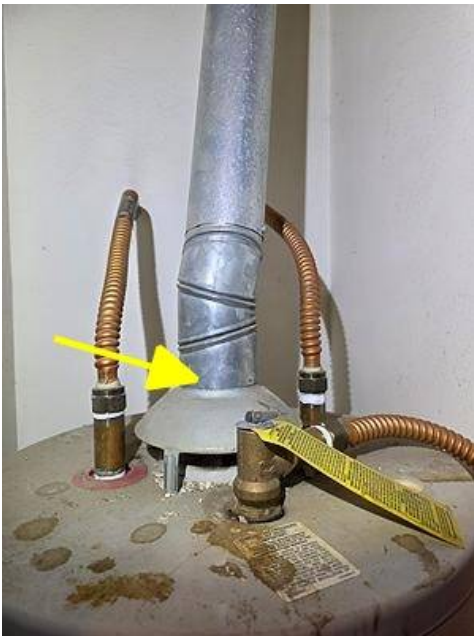
Photo 58-1

Screws were missing from one or more single-wall metal pipe joints. This is a safety hazard due to the risk of the pipe coming apart. Three screws should be installed at each joint and at the draft hood. Recommend that a qualified person repair per standard building practices.

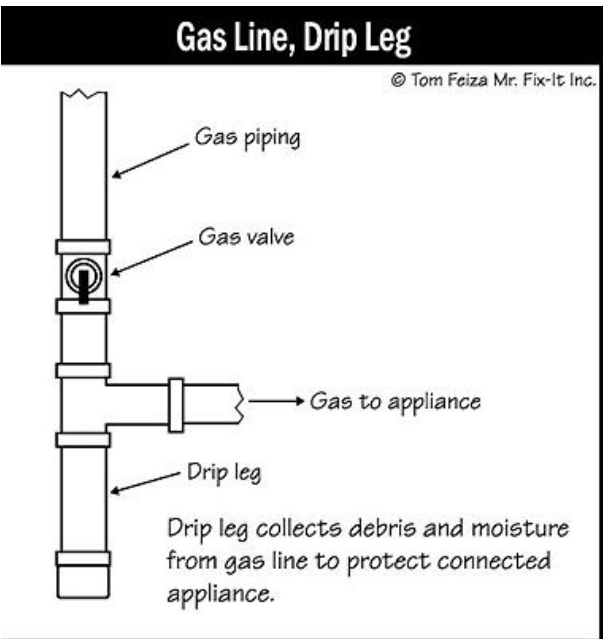
Photo 59-2

No sediment trap was installed in the gas supply line at the water heater. Sediment traps prevent damage to gas-fired appliances by trapping oil, scale, water condensation and/or debris. Recommend that a qualified contractor install a sediment trap per standard building practices.

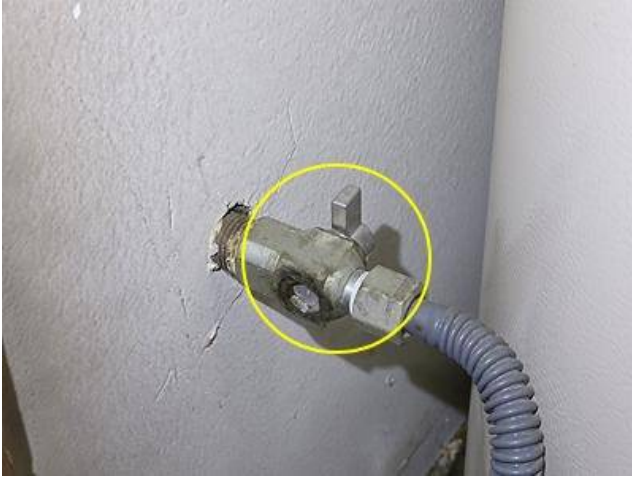
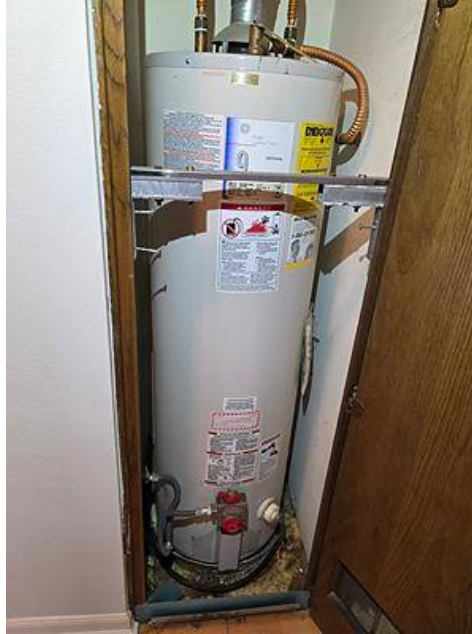
The water heater's local gas shut-off was off. The water heater and hot water supply system (e.g. faucets, controls) were not fully evaluated because of this. Recommend that a full evaluation be made by a qualified person when conditions have been corrected so the water heater is operable. Note that per the standards of practice for various professional home inspection organizations, the inspector does not operate shut-off valves, pilot lights or over-current protection devices, or any controls other than "normal controls."

The estimated useful life for most water heaters is 8-12 years. This water heater appeared to be beyond this age and/or its useful lifespan and may need replacing at any time. Recommend budgeting for a replacement in the near future, or considering replacement now before any leaks occur. The client should be aware that significant flooding can occur if the water heater fails. If not replaced now, consider having a qualified person install a catch pan and drain or a water alarm to help prevent damage if water does leak.

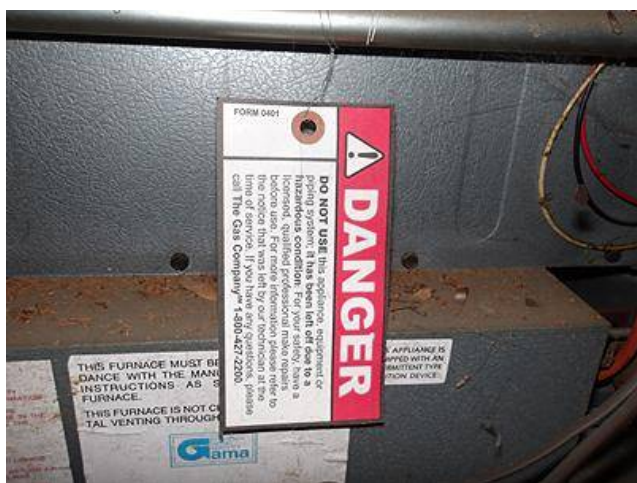
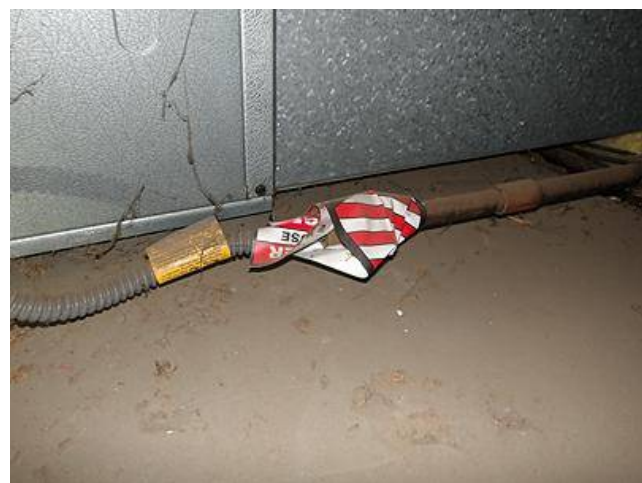
At the time of inspection, a "danger" or "red tag" was observed on the wall furnace, having been placed by the local gas utility company. As a direct result of this safety hazard, the furnace was not operated or tested during the inspection. To ensure safety and restore service, a licensed HVAC contractor or the gas company should evaluate and repair as necessary.

The estimated useful life for most forced air furnaces is 15-20 years. This furnace appeared to be beyond this age and/or its useful lifespan and may need replacing or significant repairs at any time. Recommend budgeting for a replacement in the near future.

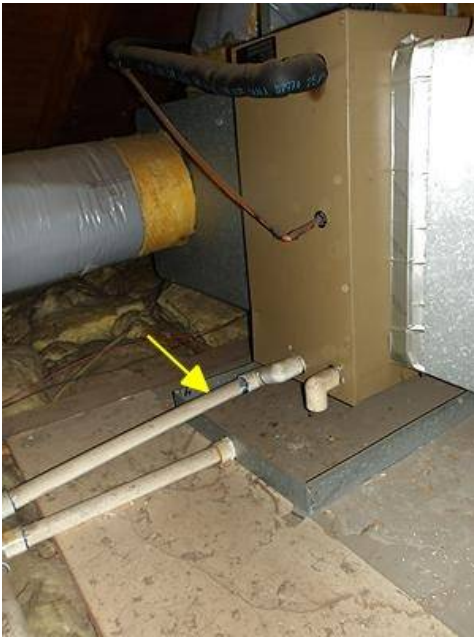
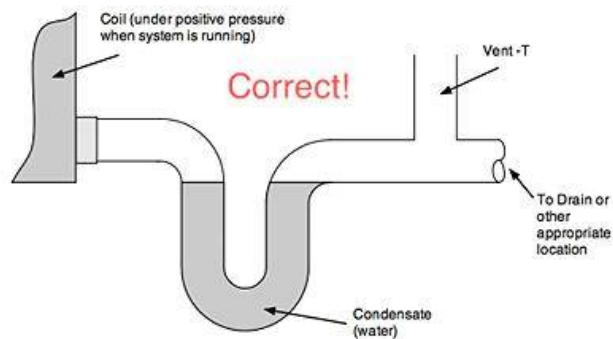
The air handler's primary condensate drain line trap was missing. A U-shaped trap with a 2-inch drop should normally be installed to prevent air from moving in or out of the air handler during operation. Without a correctly configured trap, efficiency can be reduced, or condensate water can be pulled into the equipment resulting in wet insulation or components, or microbial growth. Recommend that a qualified HVAC contractor repair per standard building practices.

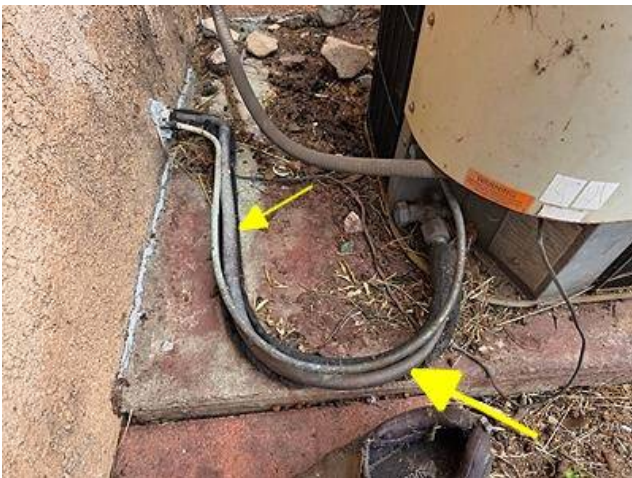
Photo 66-1

Insulation on the heat pump or air conditioning condensing unit's refrigerant lines was deteriorated or missing in some areas. This may result in reduced efficiency and increased energy costs. Recommend that a qualified person replace or install insulation as necessary.

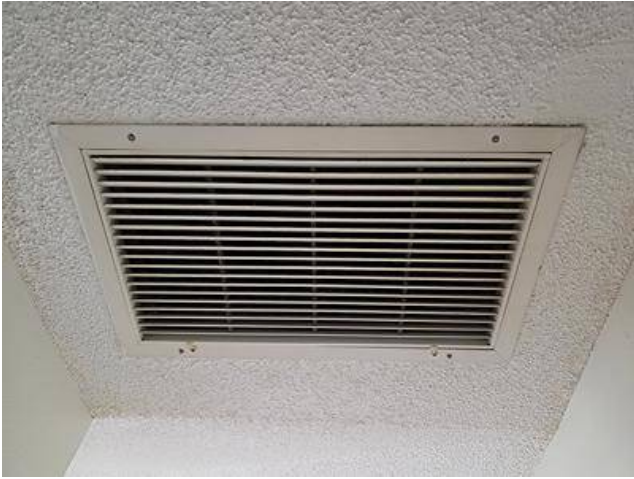
Photo 67-1

Recommend that home buyers replace or clean HVAC filters upon taking occupancy depending on the type of filters installed. Regardless of the type, recommend checking filters monthly in the future and replacing or cleaning them as necessary. How frequently they need replacing or cleaning depends on the type and quality of the filter, how the system is configured (e.g. always on vs. "Auto"), and on environmental factors (e.g. pets, smoking, frequency of house cleaning, number of occupants, the season).

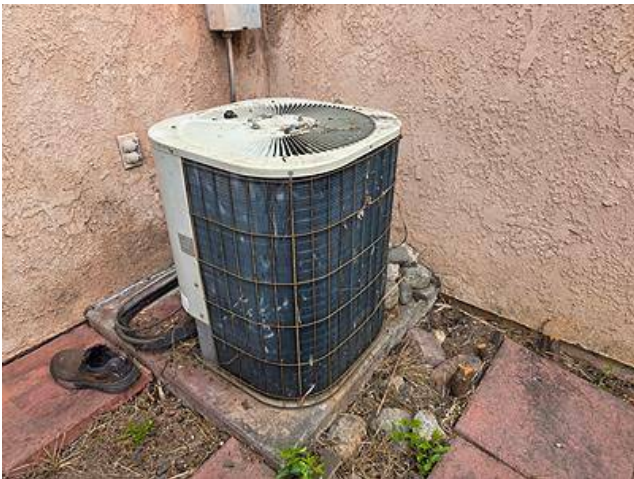
Photo 68-1

The air conditioner condensing unit was not fully evaluated because the circuit breaker was turned off. Recommend that a full evaluation be made by a qualified person when conditions have been corrected so the system is operable. Note that the inspector does not operate or replace overcurrent protection devices, or operate any controls other than normal controls (thermostat).

The estimated useful life for most heat pumps and air conditioning condensing units is 10-15 years. This unit appeared to be beyond this age and/or its useful lifespan and may need replacing or significant repairs at any time. Recommend budgeting for a replacement in the near future.

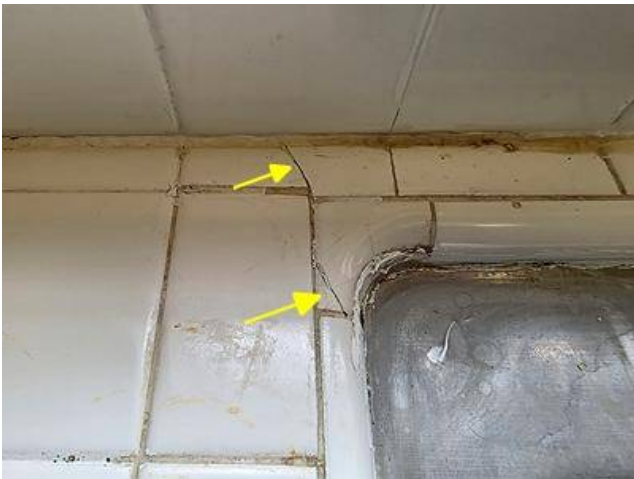
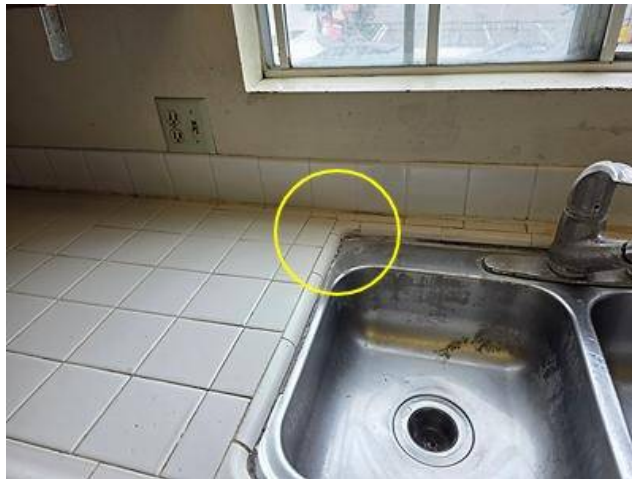
Countertops and/or backsplashes were damaged or deteriorated. Recommend repairing or replacing as necessary.

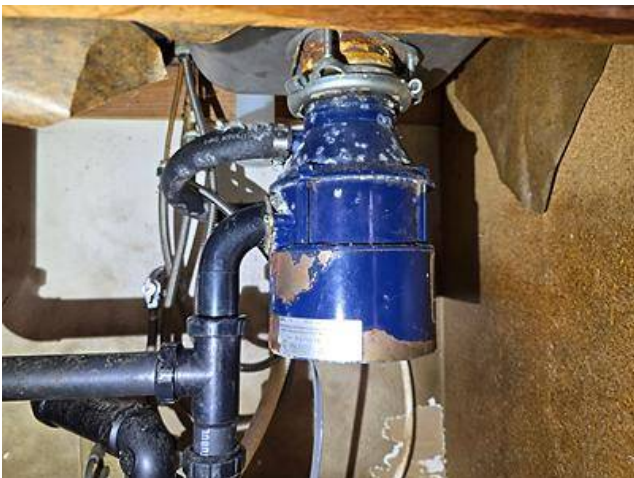
Photo 70-1

The under-sink food disposal was jammed. Recommend that a qualified contractor repair or replace as necessary.

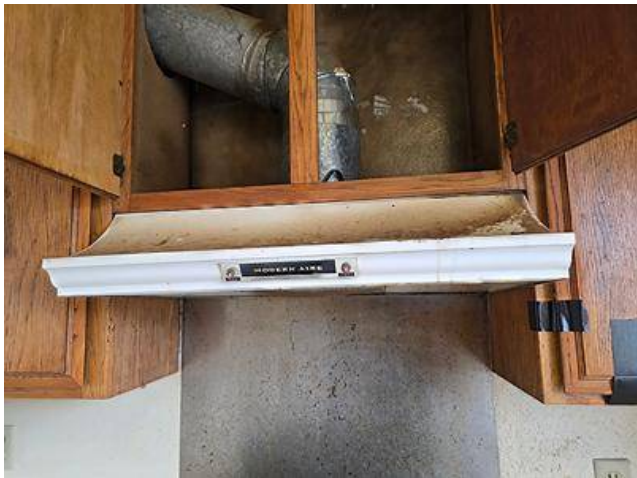
Photo 71-1

The cooktop exhaust fan was noisy or vibrated excessively. Recommend that a qualified person repair or replace as necessary.

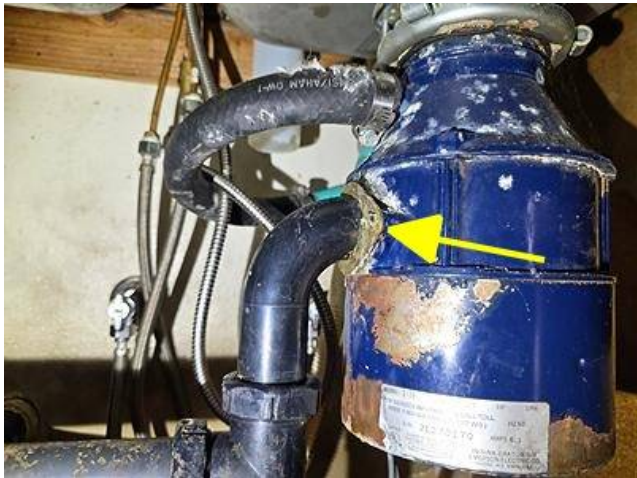
Photo 72-1

One or more sink drains were leaking. A qualified plumber should repair as necessary.

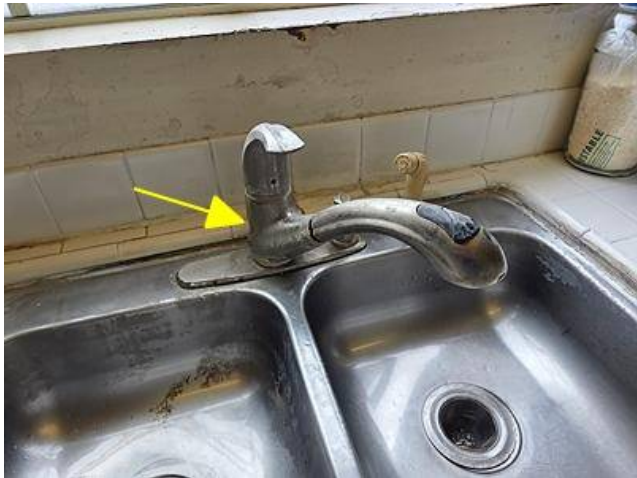
Photo 73-1

The sink faucet was stuck and could not be moved between sink sections. Recommend that a qualified person repair as necessary.

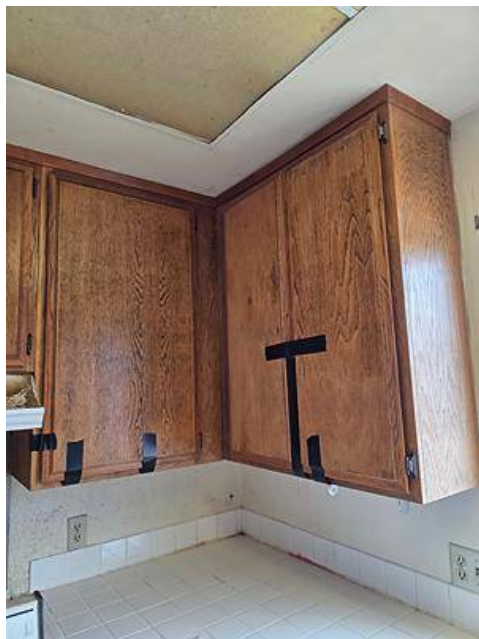
Photo 75-1

One or more cabinet doors have been taped shut, preventing full access and evaluation.

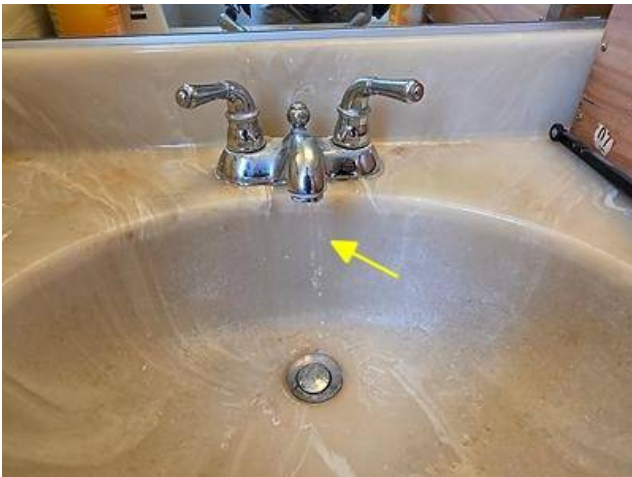
Photo 76-1

The hot and/or cold water supply flow for the sink at location(s) #C was low or inoperable. Recommend that a qualified plumber evaluate and repair as necessary.

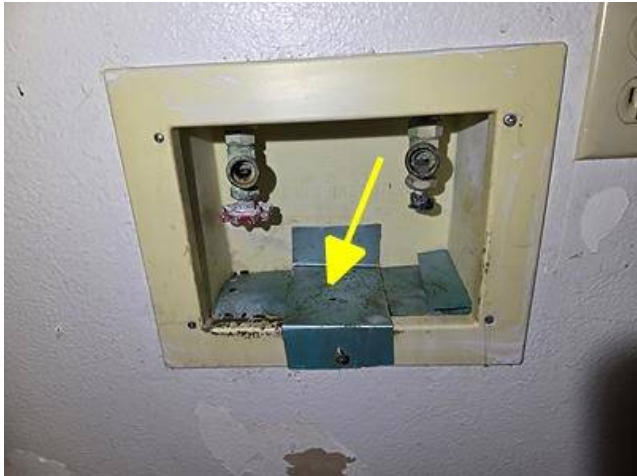
Photo 77-1

The clothes washer drain line located inside the wall outlet box has been purposely blocked. A permanent barrier was intentionally inserted into the standpipe opening, which prevents the attachment or discharge of a washing machine waste hose. A qualified plumber should evaluate and repair as necessary.

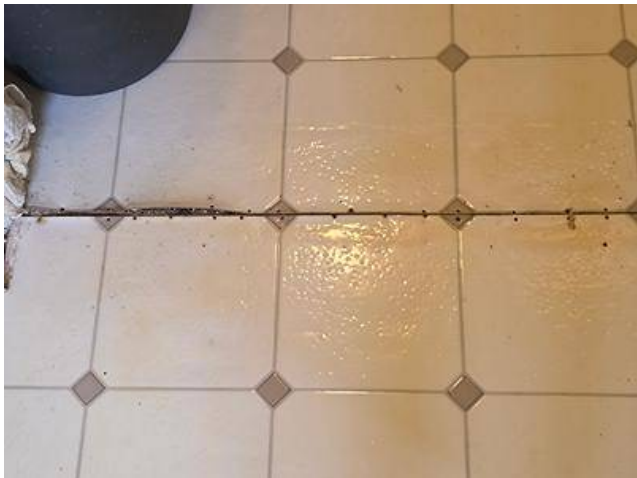
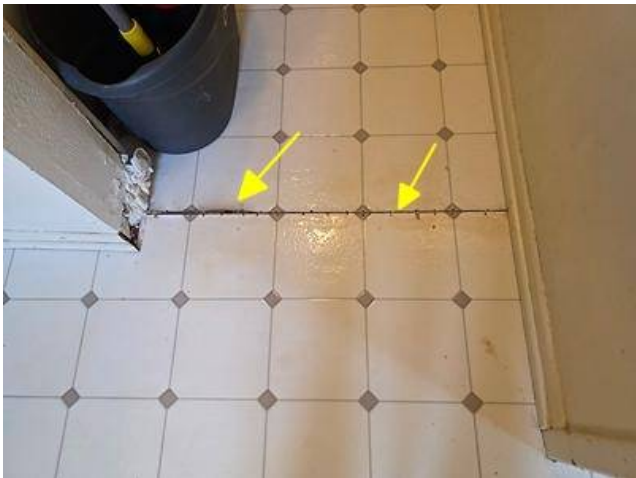
Vinyl flooring in the bathroom at location(s) #C was loose. Water can damage the sub-floor as a result. Recommend that a qualified contractor replace or repair flooring as necessary.

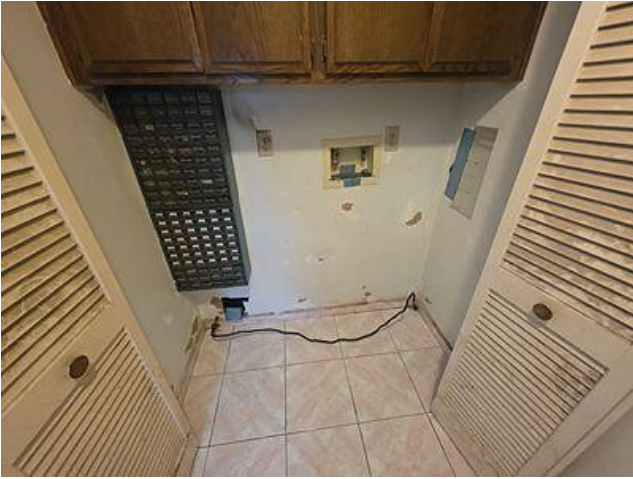
Photo 79-1

No exhaust duct was installed for the clothes dryer. Clothes dryers produce large amounts of moisture which should not enter structure interiors. Moisture can accumulate and result in mold, bacteria or fungal growth. A rigid or semi-rigid metal exhaust duct should be installed per standard building practices, and by a qualified contractor if necessary. For information, visit: <https://www.reporthost.com/?DRYER>

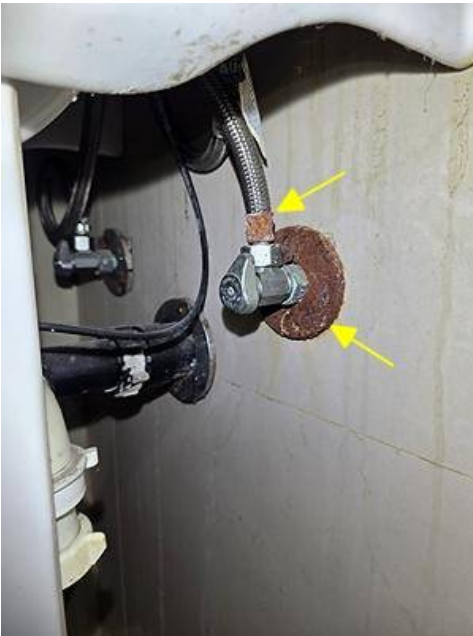
Photo 80-1

One or more water supply lines for the sink at location(s) #A were corroded. This can indicate past leaks, or that leaks are likely to occur in the future. A qualified plumber should replace as necessary.

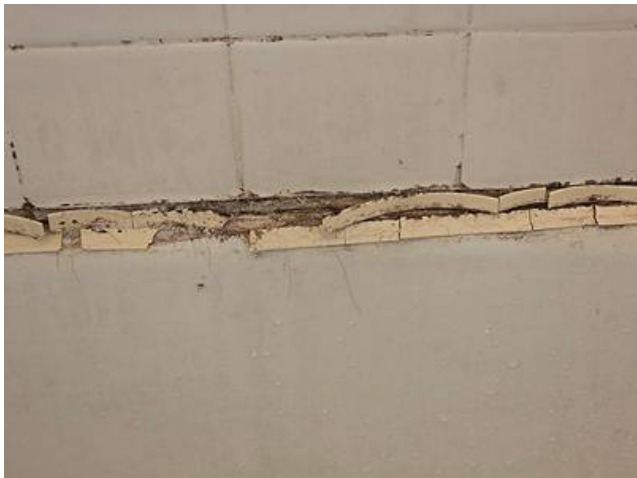
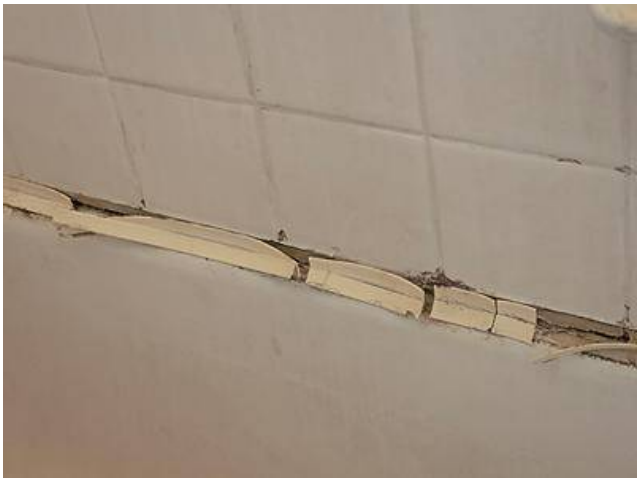
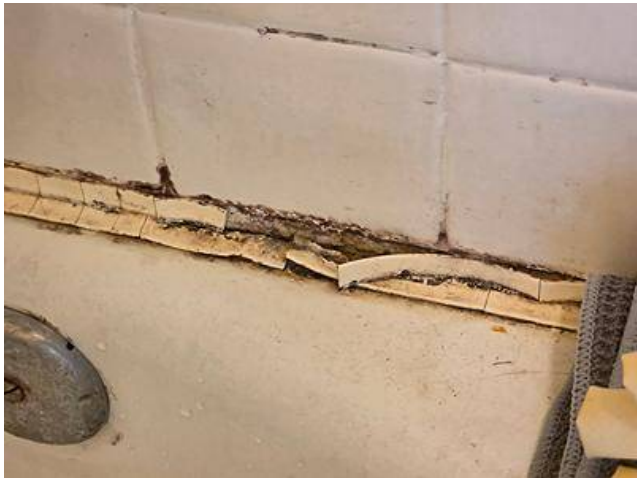
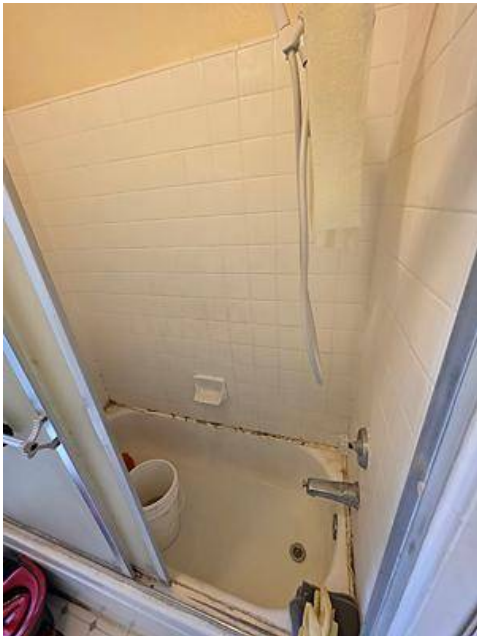
81) 🛠️💧 Tile and/or grout in the bathtub surround at location(s) #C was deteriorated (e.g. loose or cracked tiles, missing grout) or substandard. Water can damage the wall structure as a result. Recommend that a qualified contractor repair as necessary.

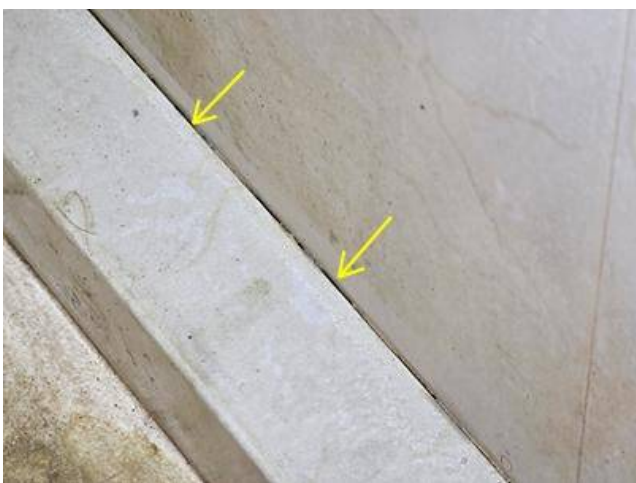
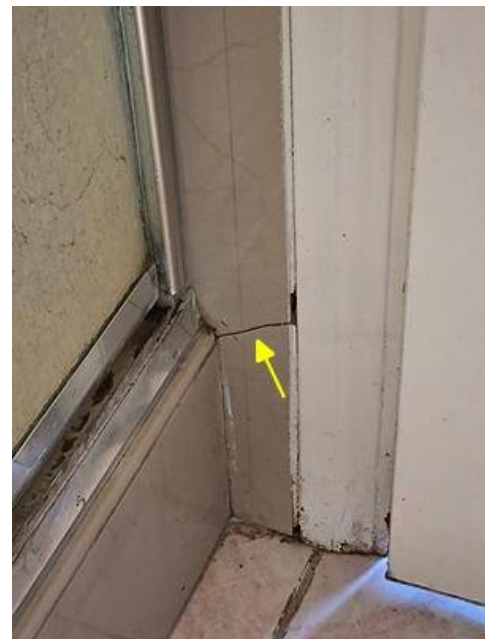
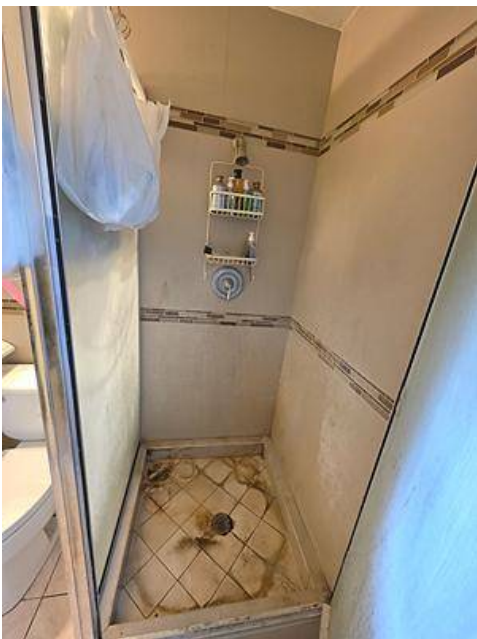
82) 🛠️💧 Tile, caulk and/or grout in the shower enclosure at location(s) #A were deteriorated (e.g. loose or cracked tiles, missing grout) or substandard. Water may leak through gaps and damage the wall or floor structure as a result. Recommend that a qualified contractor repair as necessary. Note that the condition of the structure behind and below the shower enclosure is unknown due to it being concealed.

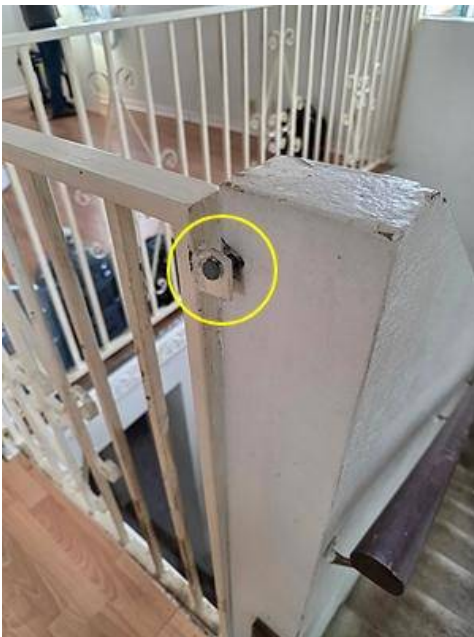
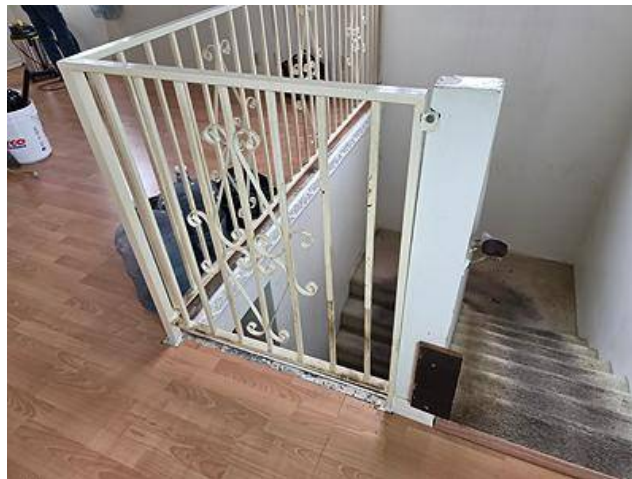
Guardrails at one or more locations with drop-offs higher than 30 inches were loose, and pose a fall hazard. Recommend that a qualified person repair guardrails as necessary.
