## Harmony Inspectors

## Property Inspection Report

Property address: **250 N Monte Vista St # 3  
La Habra CA 90631-4541**

Inspection date: **Tuesday, May 12, 2026**

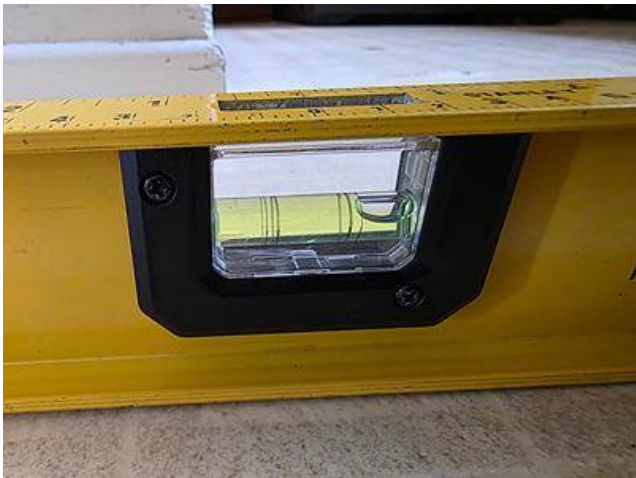
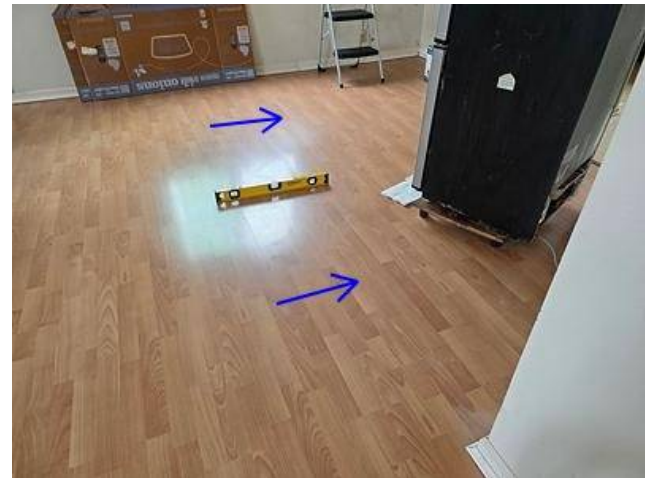
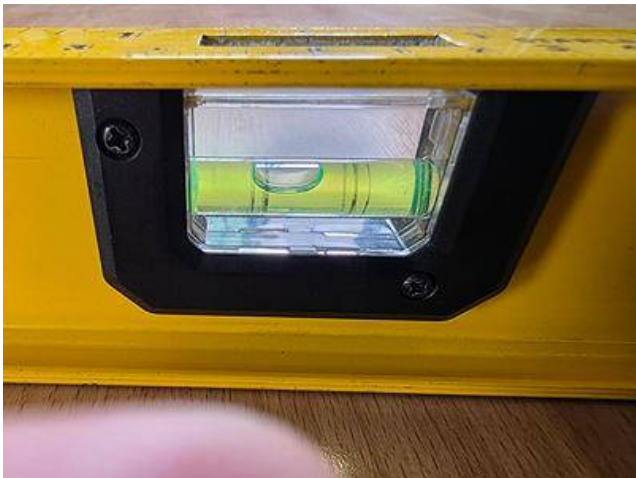
Floors in one or more areas were not level. This can stem from foundation settlement, sagging or damaged floor joists, load-bearing wall issues, moisture-induced wood warping, or poor construction practices. Recommend that a qualified contractor and/or engineer evaluate further. Repairs should be performed by a qualified contractor.

Photo 87-3 Living room

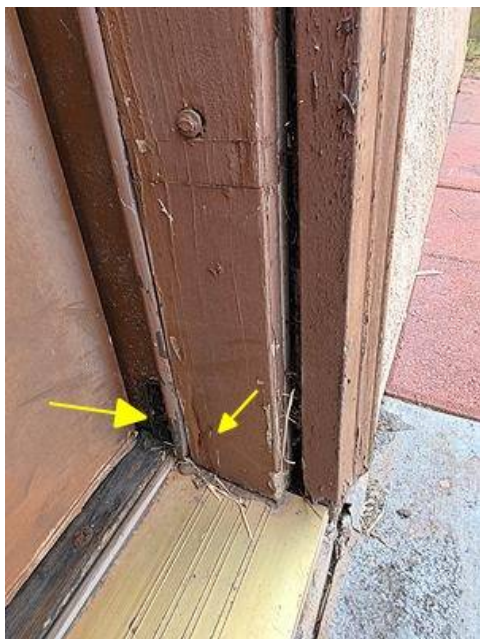
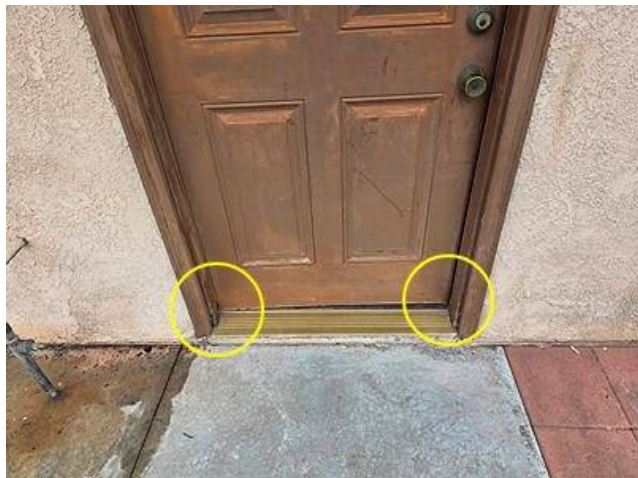
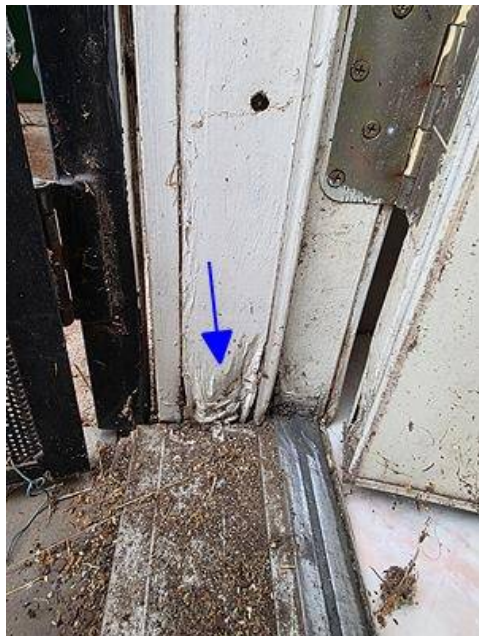
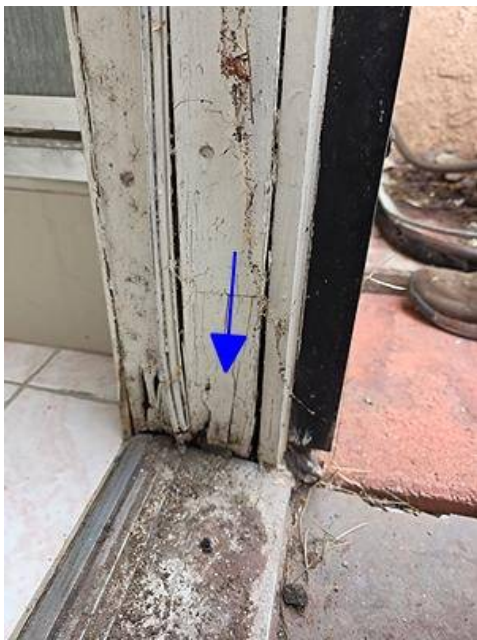
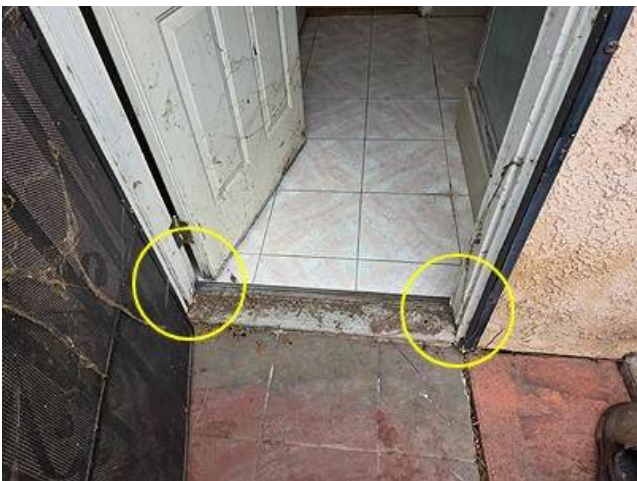
Fungal rot was found at one or more exterior door jambs. Recommend that a qualified person repair as necessary. All rotten wood should be replaced.

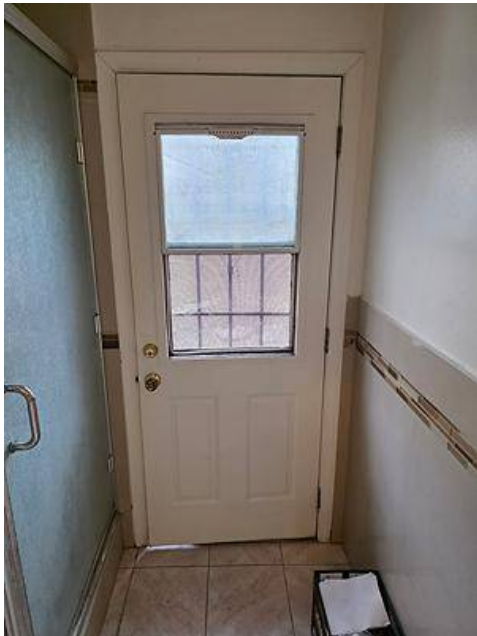
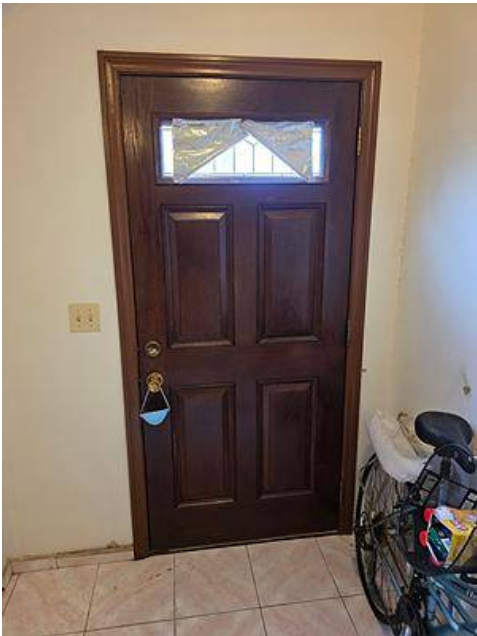
One or more exterior doors were difficult to open or close and/or were sticking. Recommend that a qualified person repair as necessary.

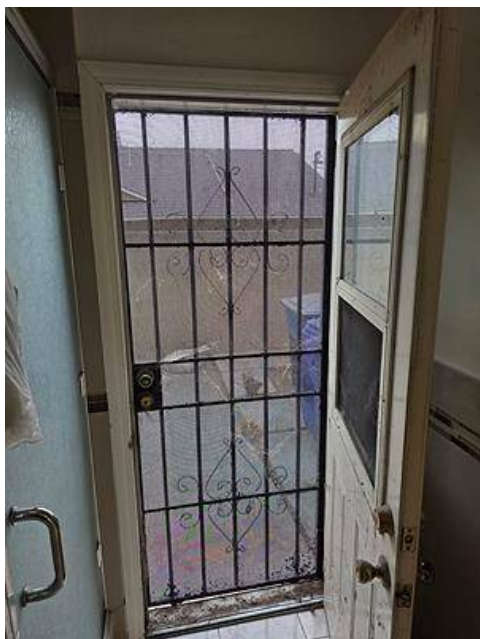
Photo 90-2

Some exterior door hardware, including locksets and and/or deadbolts were difficult to operate. Recommend that a qualified person repair or replace as necessary.

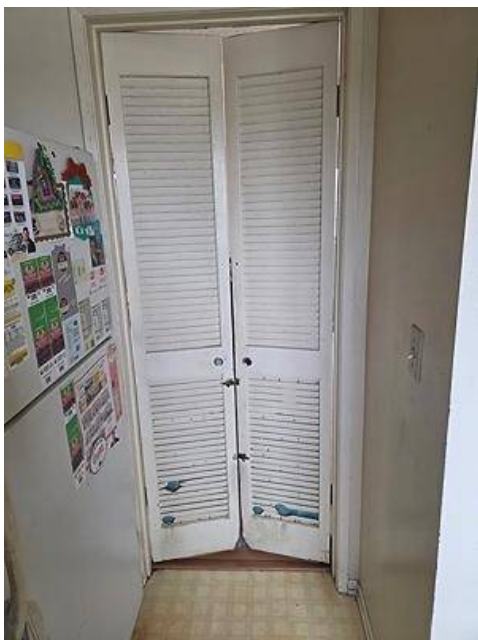
One or more interior doors were damaged. Recommend that a qualified person replace or repair doors as necessary.

Photo 91-2 Kitchen

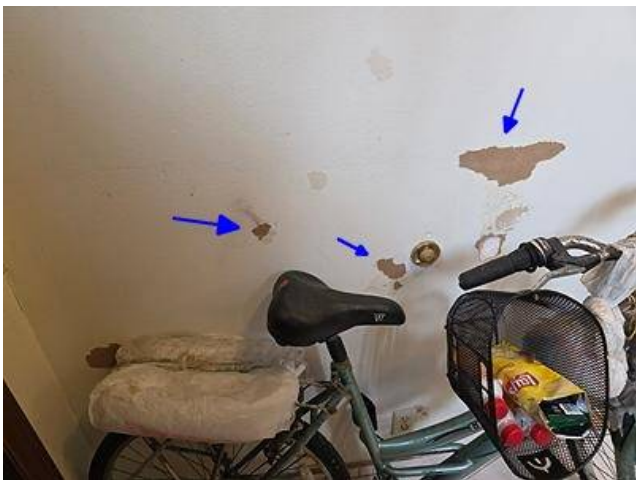
Photo 93-2

One or more walls and/or ceilings were damaged and/or were cracked. Recommend that a qualified person repair as necessary.

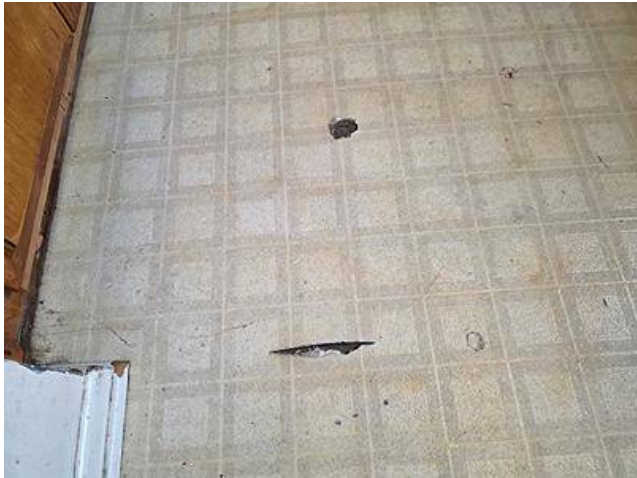
Photo 94-1

Vinyl, linoleum or marmoleum flooring in one or more areas was damaged. If in a wet area, water can damage the sub-floor as a result. Recommend that a qualified contractor replace or repair flooring as necessary.

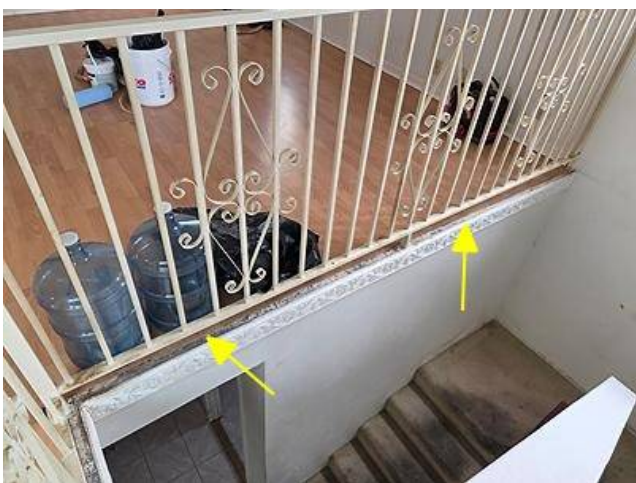
Photo 95-2

The flooring was missing or incomplete in one or more areas. Recommend that a qualified contractor replace or repair flooring as necessary.

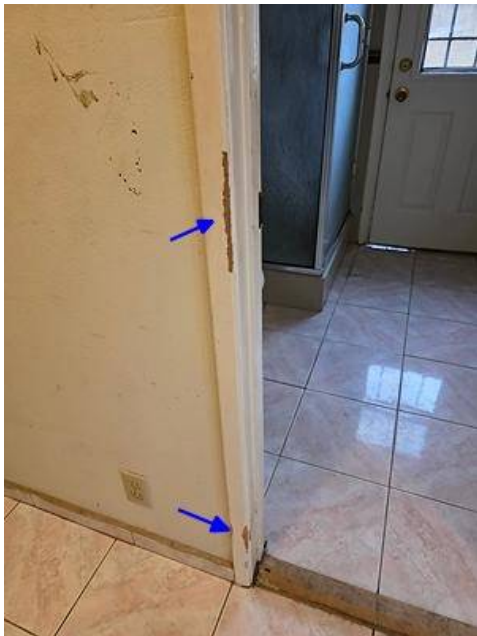
Photo 98-1

98) 🛠 Trim was damaged in one or more areas. Recommend that a qualified person repair as necessary.

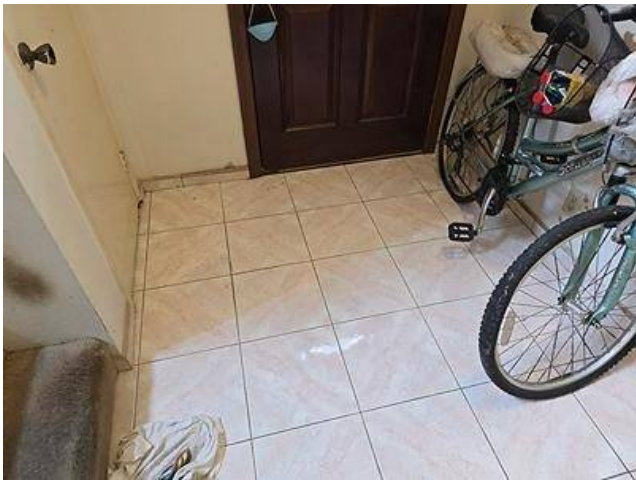
Photo 99-2 Front entry

Tile, stone and/or grout in the flooring in one or more areas was deteriorated (e.g. loose or cracked tiles, missing grout) or substandard. If in a wet area, water can damage the sub-floor. Recommend that a qualified contractor repair as necessary.

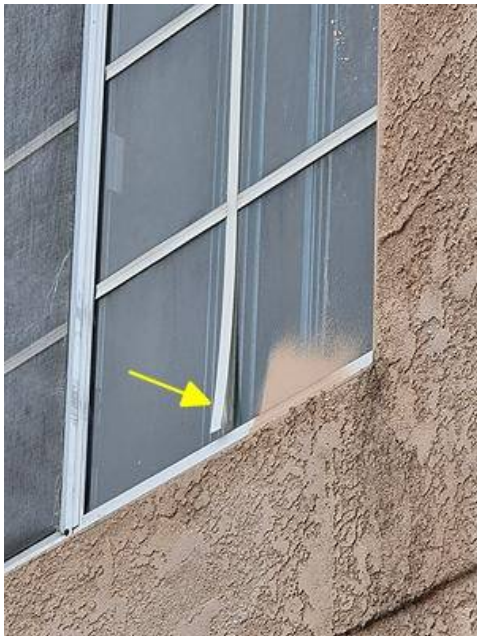
Photo 100-1

The exterior grids at one or more windows were loose and/or missing. Recommend that a qualified person repair as necessary.

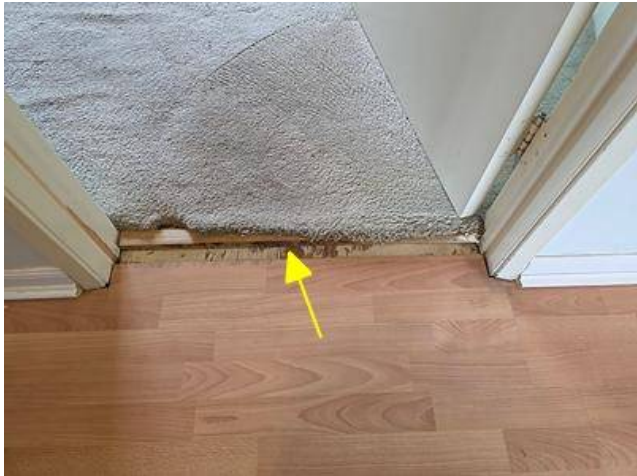
Photo 101-1

101) 🛠️ Transition floor trim was missing in one or more areas. Recommend that a qualified person repair as necessary.

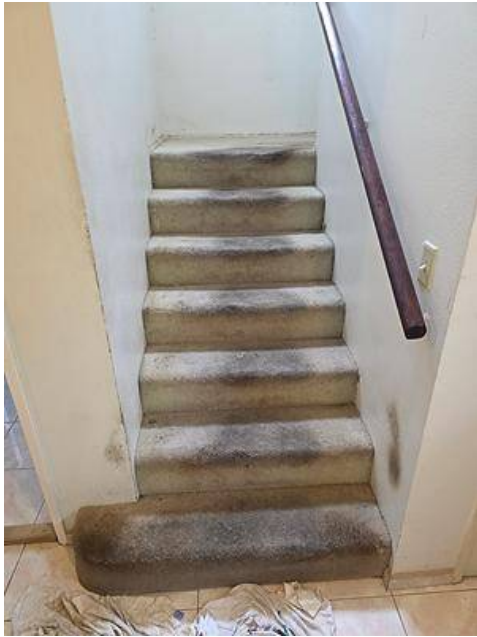
Photo 102-1

102) 🧹 Carpeting in one or more areas was significantly stained or soiled. Recommend having carpeting professionally cleaned as necessary.

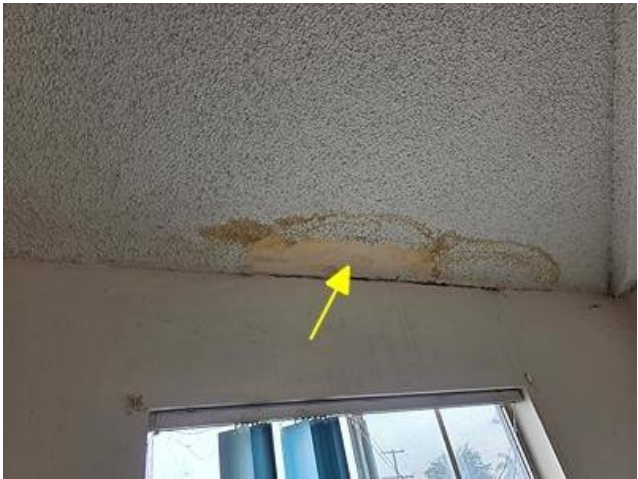
Stains were found in one or more ceiling areas. However, no elevated levels of moisture were found. The stain(s) may be due to past roof and/or plumbing leaks. Consult with the property owner and monitor the stained area(s) in the future, especially after heavy or prolonged rain. If elevated moisture is found in the future, then recommend that a qualified contractor evaluate and repair as necessary.

Photo 103-2 Living room

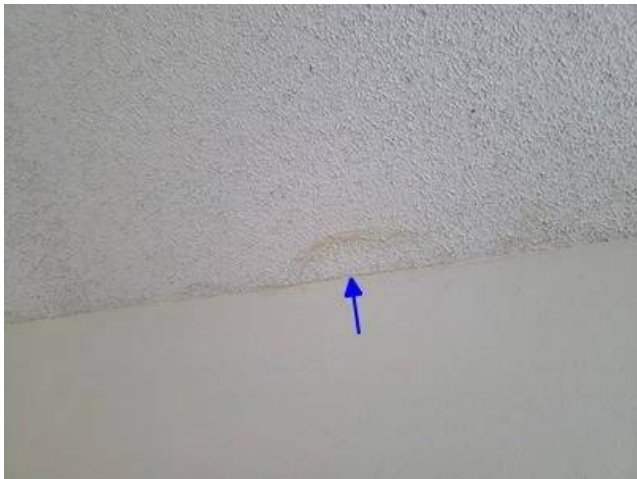
Photo 103-3 Living room

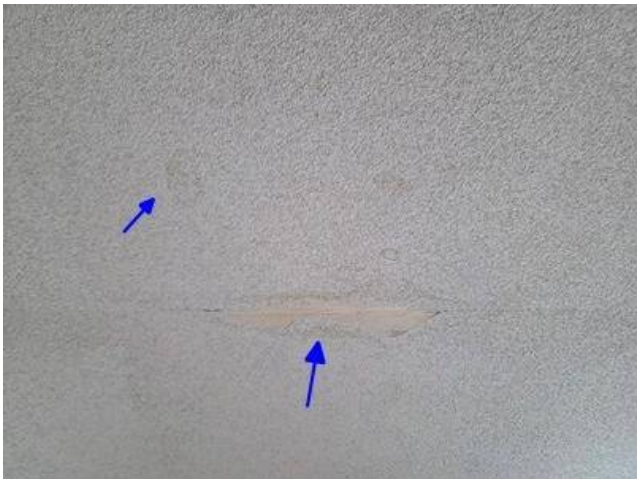
Photo 103-4 Living room

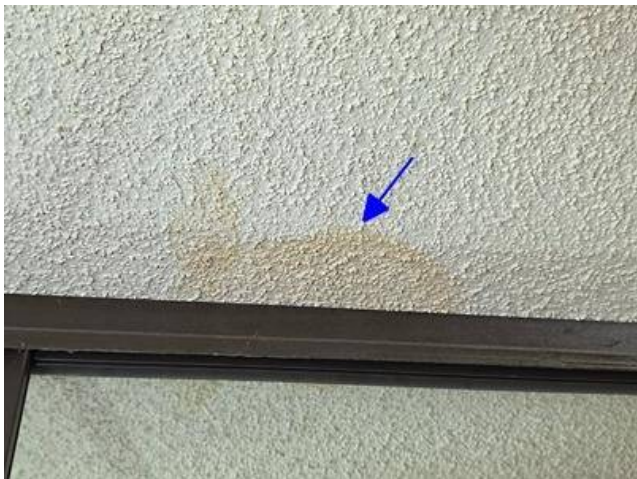
Photo 103-5 Bedroom, 2nd floor

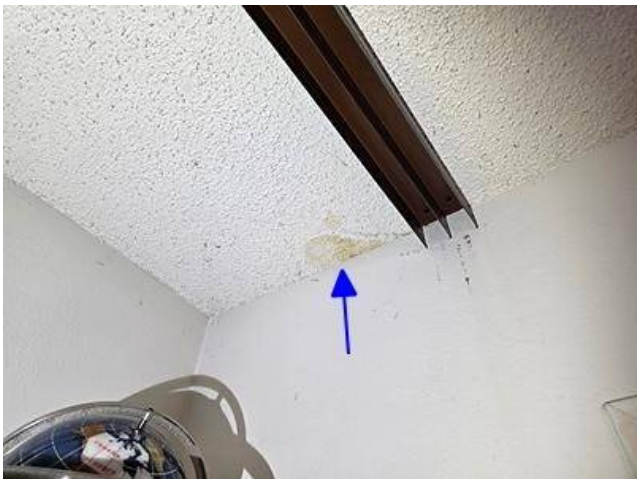
Photo 103-6 Bedroom closet, 2nd floor

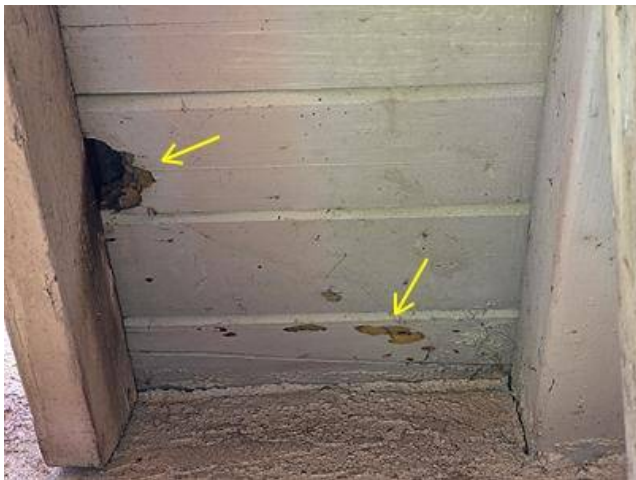
Photo 104-1

Evidence of active infestation of unspecified wood-destroying insects was found at location(s) #A in the form of galleries or holes in wood and/or Mud tubes with visible wood damage. Recommend the following:

- Correct any conducive conditions for wood-destroying organisms mentioned in this report.
- Consult with the property owner about any history of infestation.
- Have a state-licensed pest control operator evaluate further and treat as necessary.

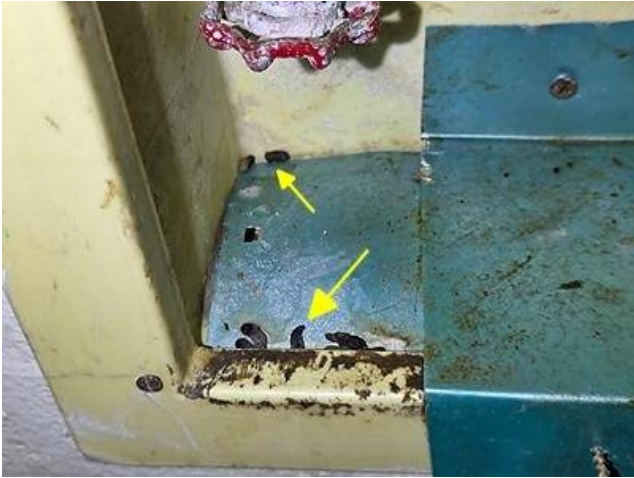
Photo 1-1 Laundry area

Signs of rodent activity were observed in the form of feces, dead rodents and/or damaged trim, walls in the interior rooms. Consult with the property owner about this. A qualified person should make repairs to seal openings in the structure, set traps, and clean rodent waste as necessary. Recommend following guidelines in these Center for Disease Control articles:

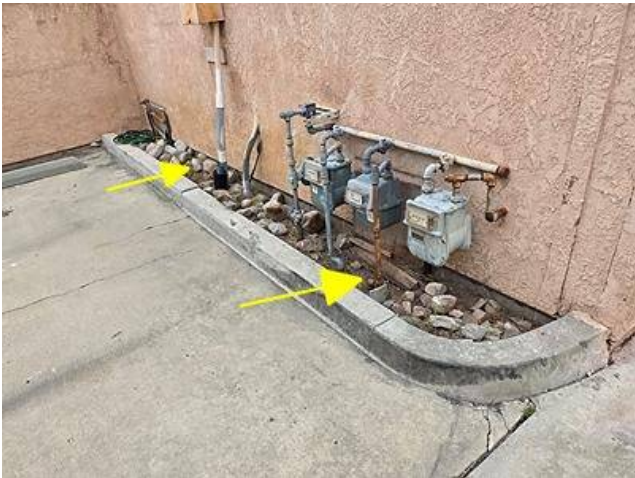
Photo 3-1

Evidence of past accumulated water were found at one or more locations in the yard or landscaped areas, and no drain was visible. If evidence of past water was found (e.g. silt accumulation or staining), monitor these areas in the future during periods of heavy rain. If standing water exists, recommend that a qualified person repair as necessary. For example, installing one or more drains, or grading soil.

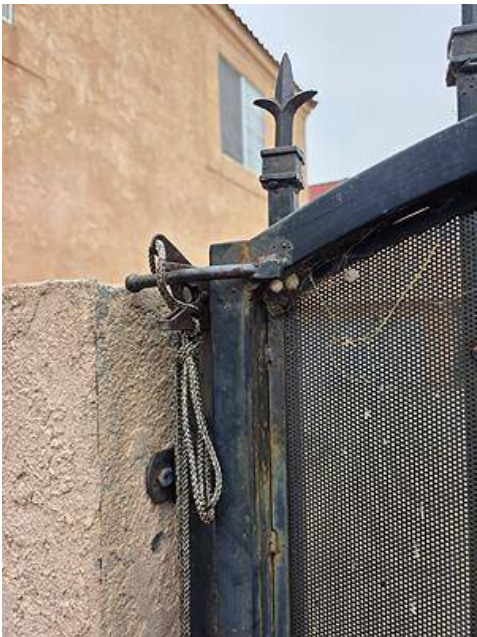
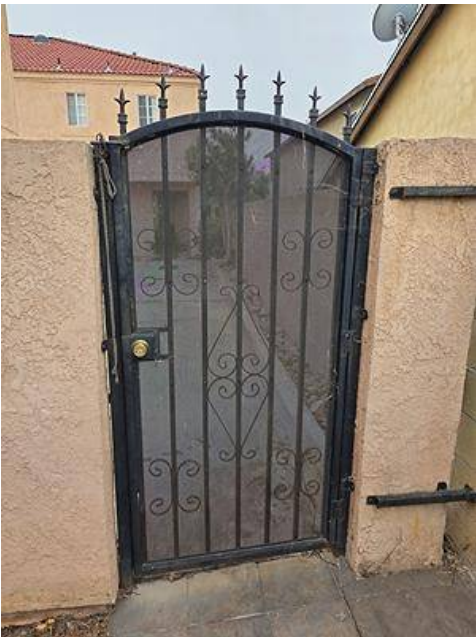
One or more gates were difficult to latch and need repair.

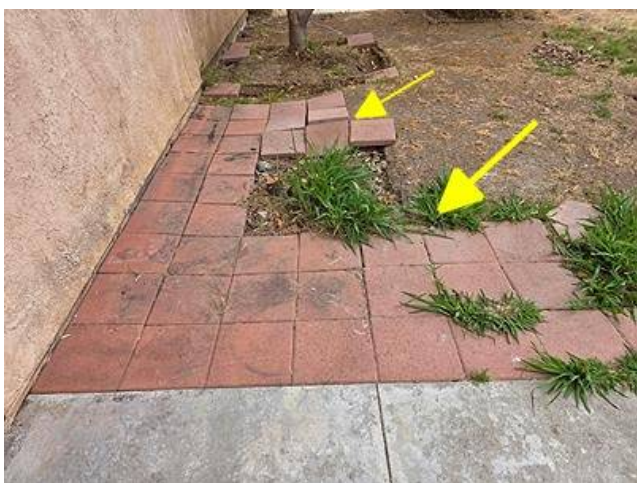
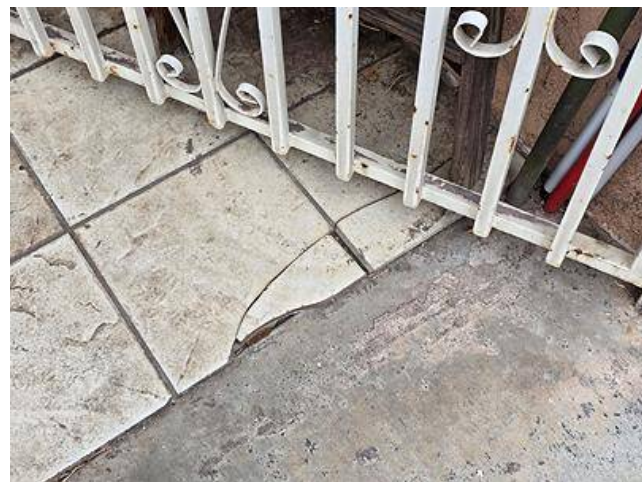
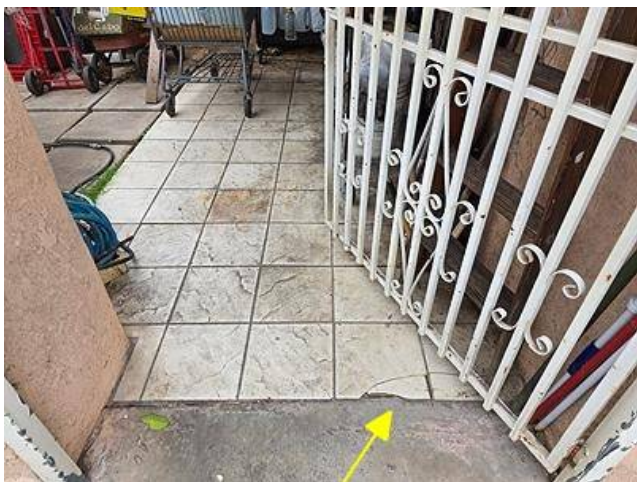
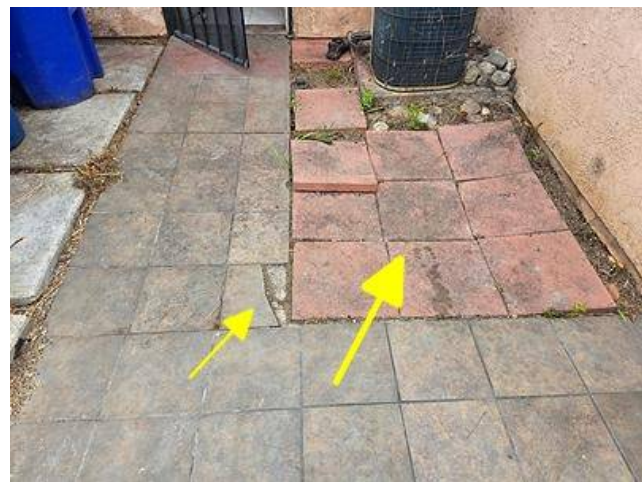
Cracks, holes, settlement, heaving and/or deterioration were found in sidewalks and/or patios. Recommend that qualified contractor repair as necessary.

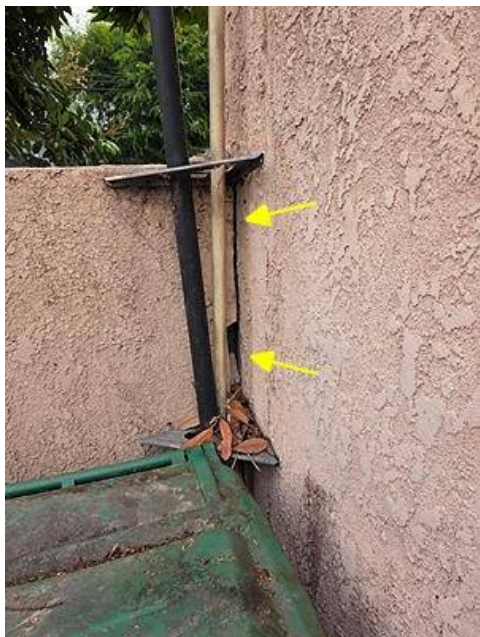
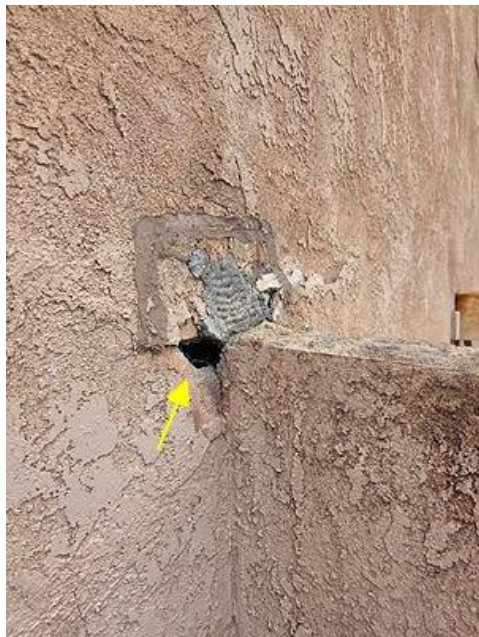
One or more holes or gaps were found in siding or trim. Vermin, insects or water may enter the structure. Recommend that a qualified person repair as necessary.

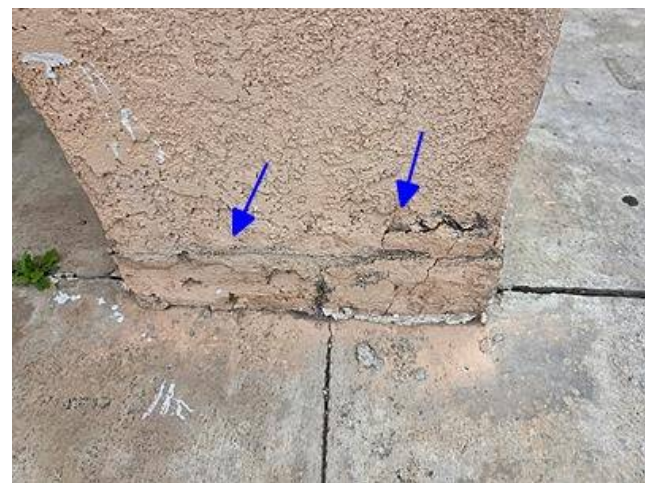
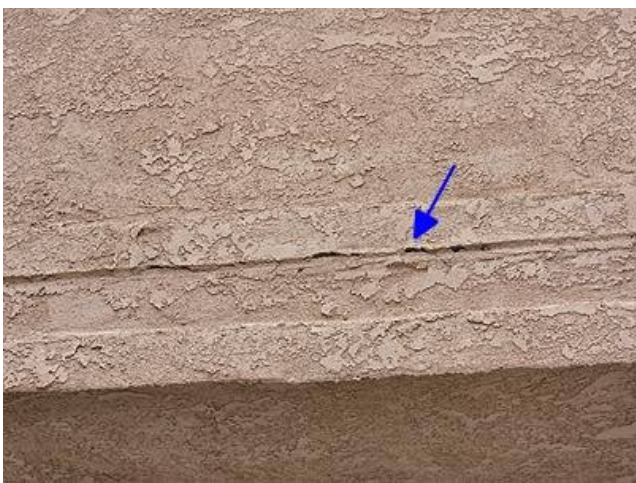
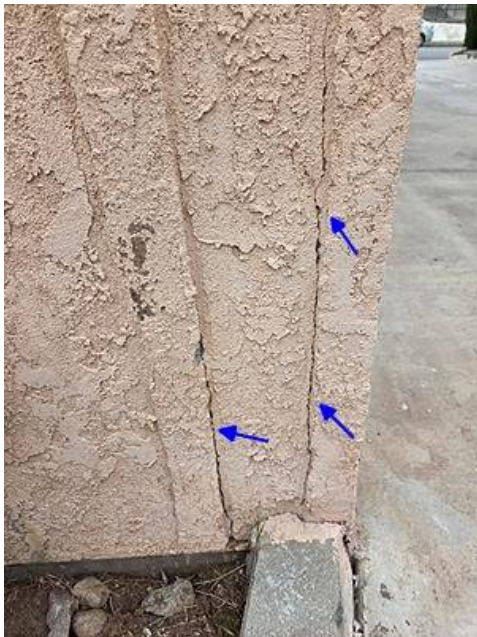
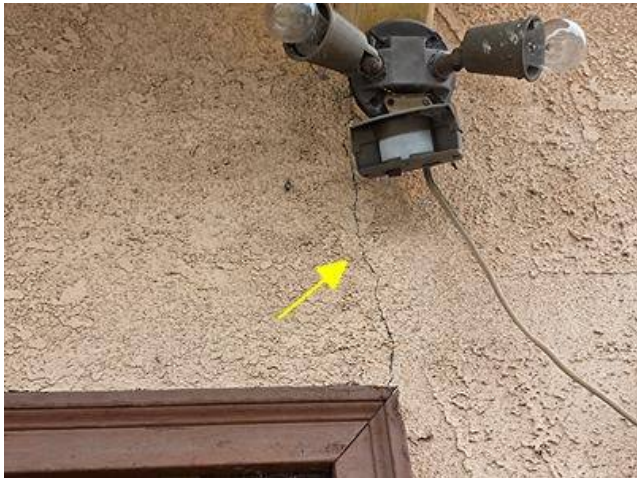
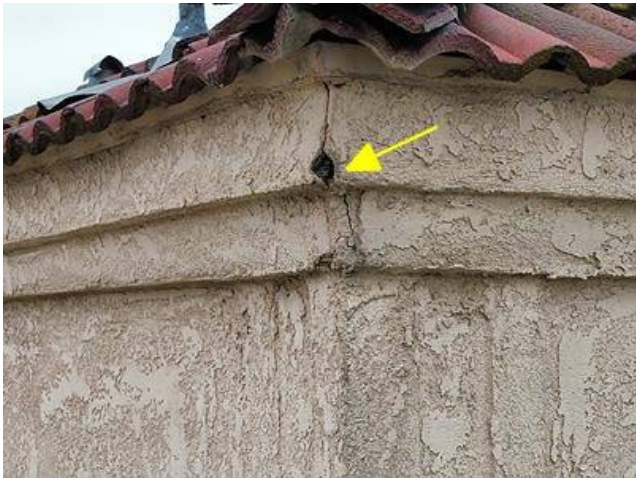
8) 🛠️💧 Cracks, deterioration and/or damage were found in one or more areas of the exterior stucco finish. In damp climates, moisture may enter cracks or damaged areas and further deteriorate the stucco. Also the wall behind the stucco may become damaged from moisture. Note that areas behind the stucco are inaccessible and excluded from this inspection. Recommend that a qualified contractor repair or replace stucco as necessary.

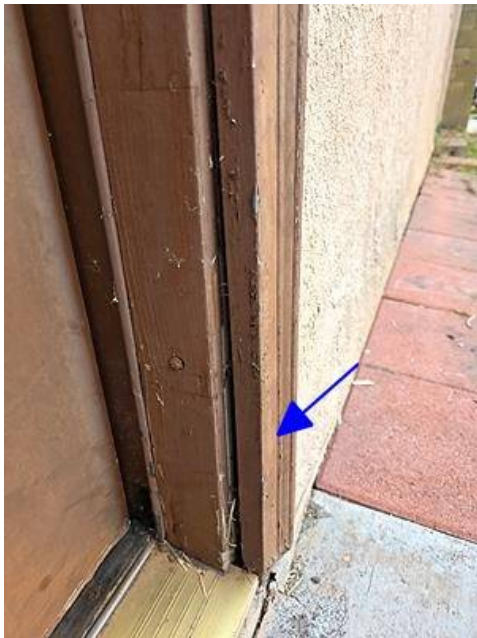
Photo 9-1

Some sections of siding and/or trim were loose. Recommend that a qualified person repair, replace or install siding or trim as necessary.

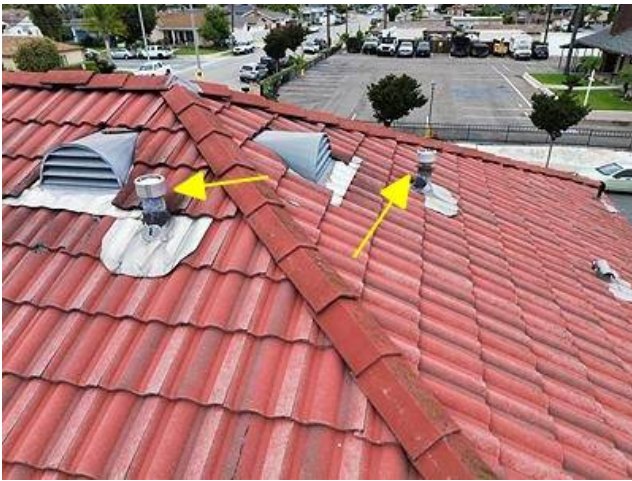
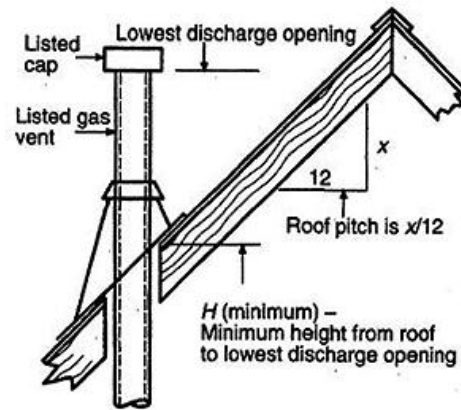
Short flues may not draft properly due to restricted free air movement. This is a potential safety hazard due to the risk of exhaust gases entering living spaces. Recommend having a qualified contractor repair per standard building practices.

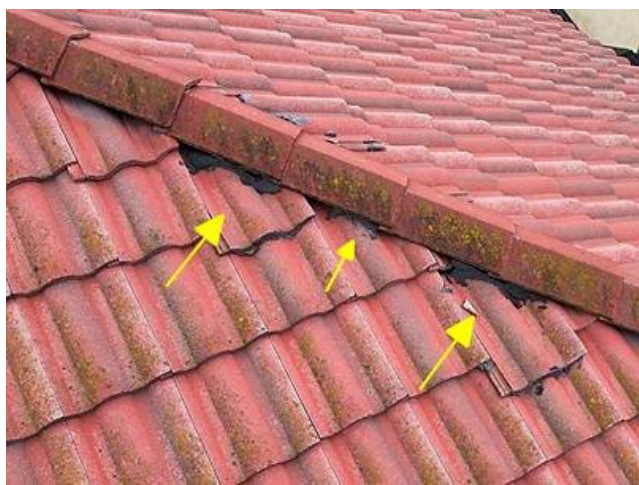
Photo 12-2

12) 🔧🔍 Substandard repairs were found at one or more locations on the concrete tile roof. Sealant was used to repair some sections of the roof and/or around flashing. Sealants may fail to adhere to dirty or wet tiles, trap moisture causing further damage, or degrade under UV exposure, lasting only 5–15 years. For significant damage, replacing tiles is better than sealing, and underlying issues like damaged underlayment must be fixed. Recommend that a qualified contractor evaluate and repair per standard building practices.

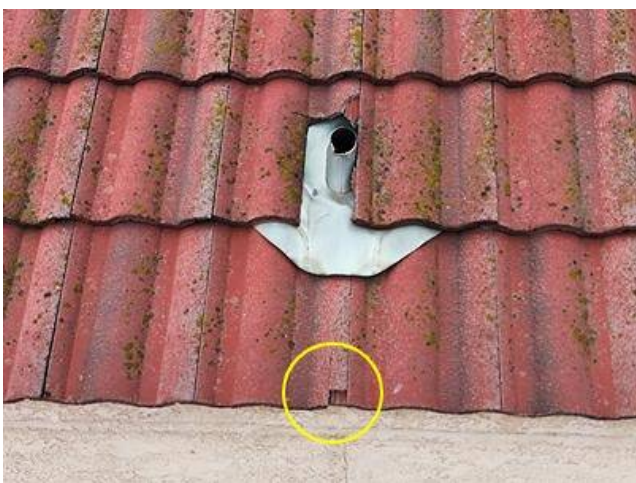
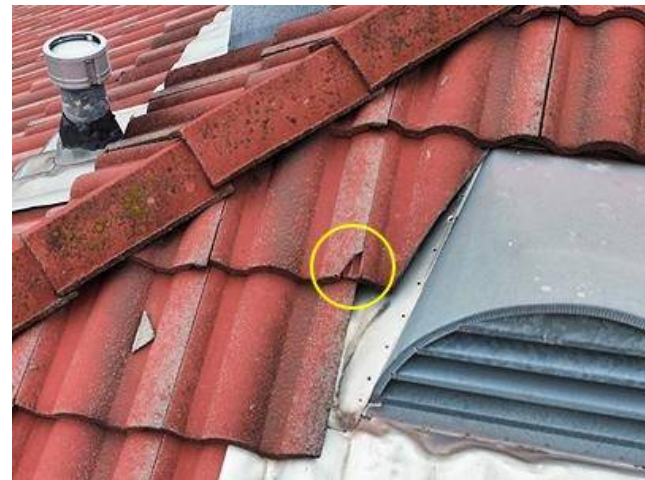
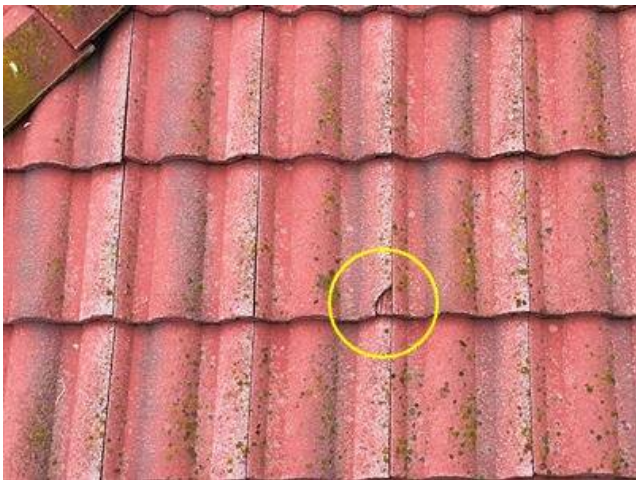
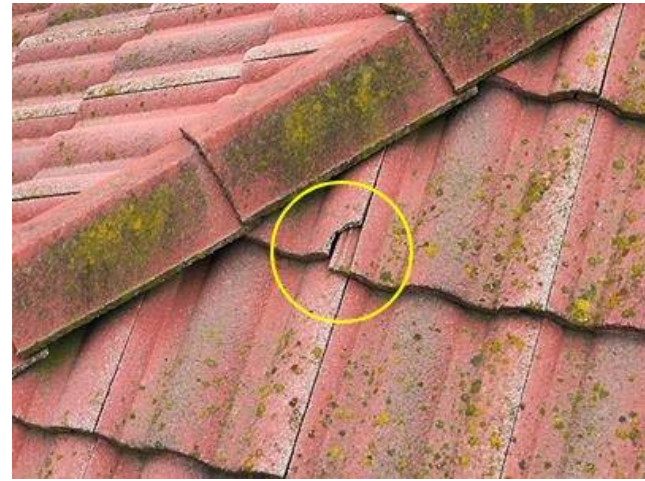
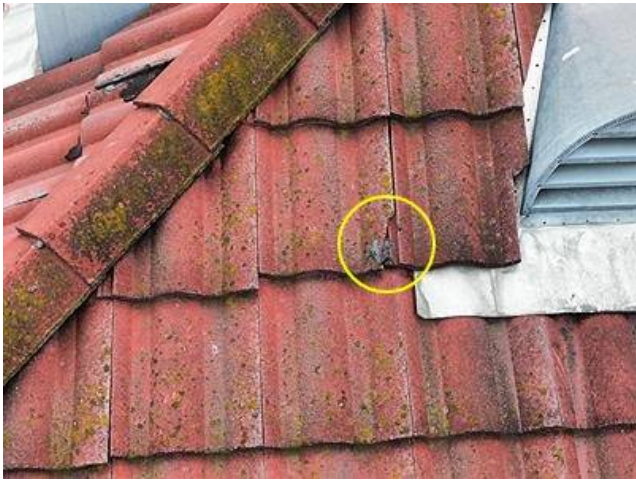
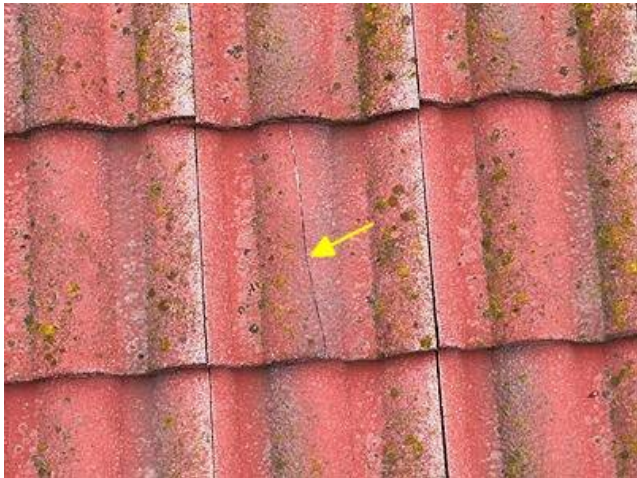
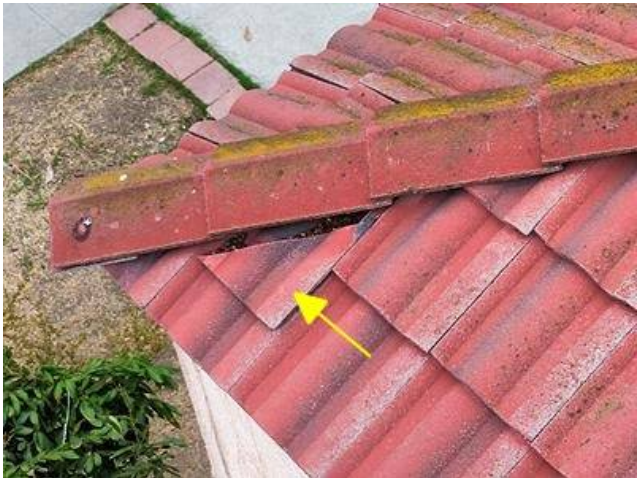
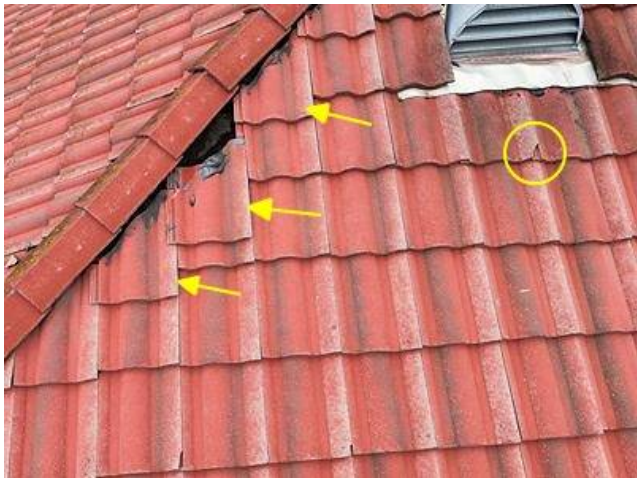
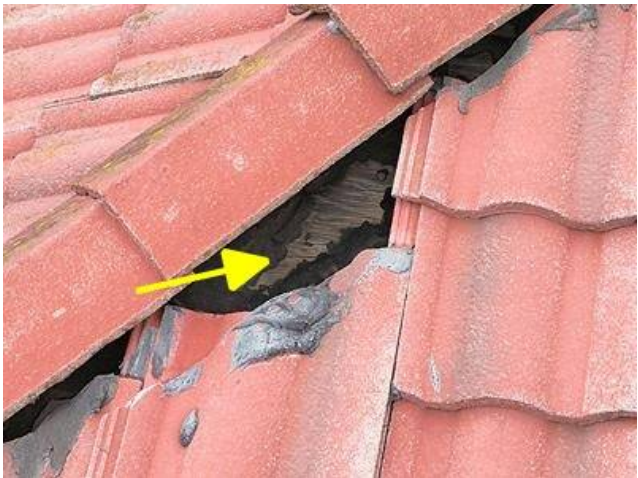
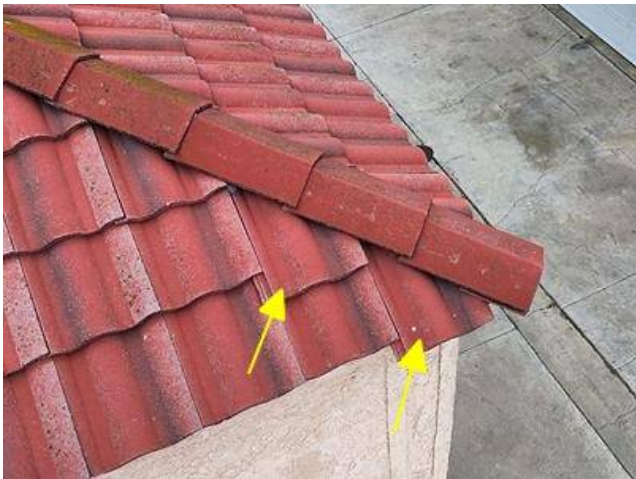
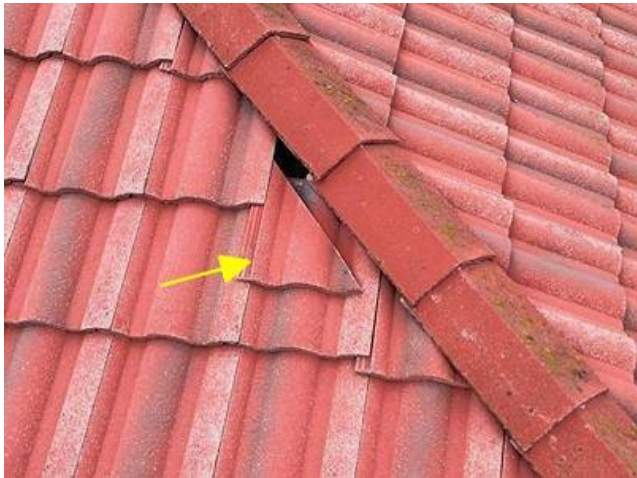
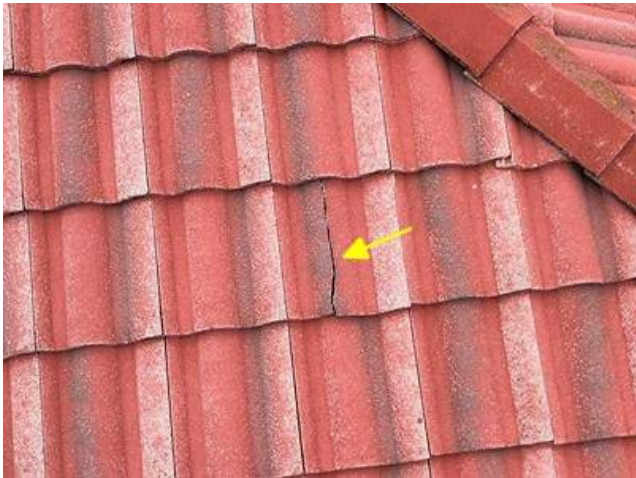
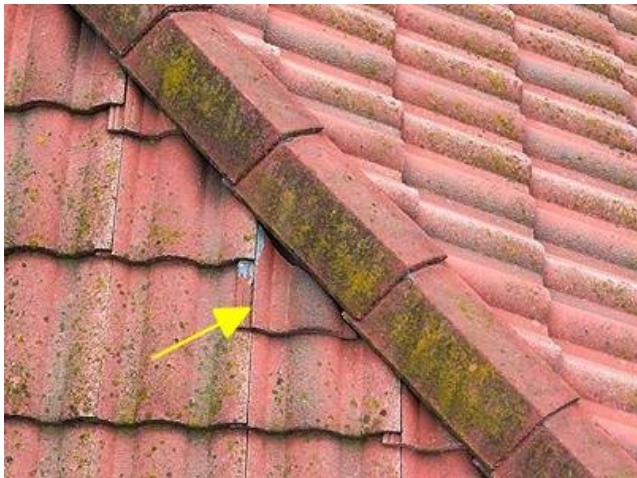
14) 🛠️💧 Many concrete roof tiles were broken, chipped, missing and/or loose. Leaks may occur as a result. This is a conducive condition for wood-destroying organisms. Recommend that a qualified person replace tiles or make repairs as necessary.

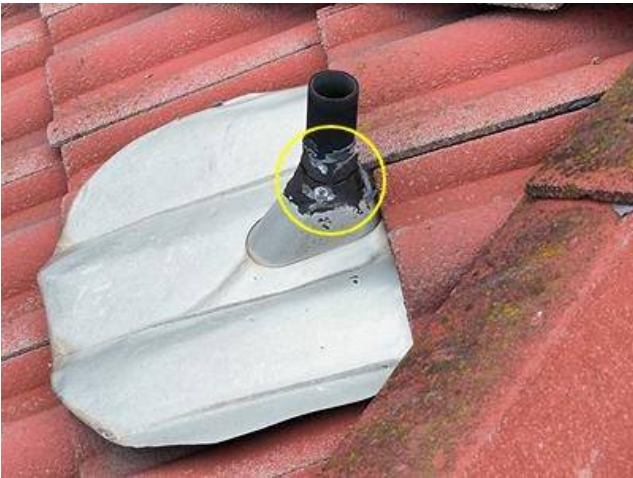
Photo 16-1

The sealant between the flashing and vent pipe was cracked and/or deteriorated. Leaks can occur as a result. This is a conducive condition for wood-destroying organisms. Recommend that a qualified person repair as necessary.

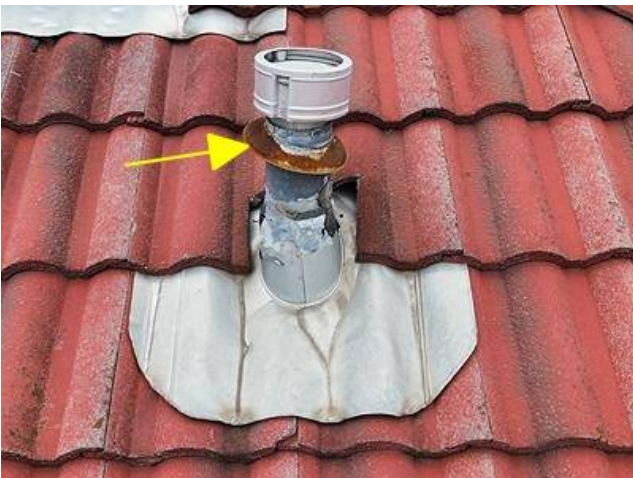
Photo 17-1

One or more flue pipe rain collars were corroded. Leaks can occur as a result. This is a conducive condition for wood-destroying organisms. Recommend that a qualified person repair as necessary.

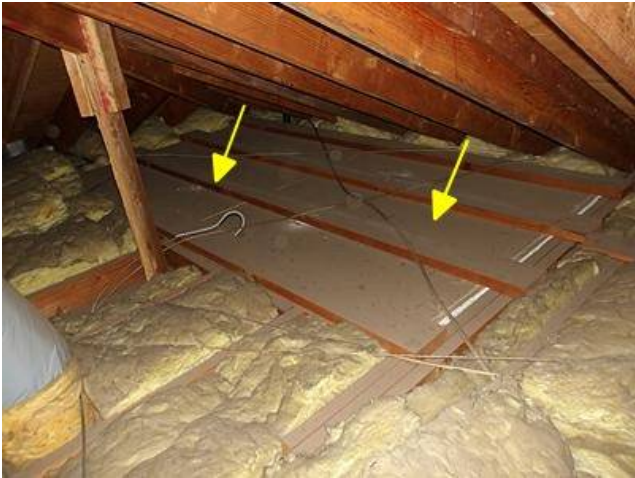
Photo 20-1

The ceiling insulation in one or more areas of the attic was missing. Heating and cooling costs may be higher due to reduced energy efficiency. Recommend that a qualified person repair, replace or install insulation as necessary and per standard building practices (typically R-38).

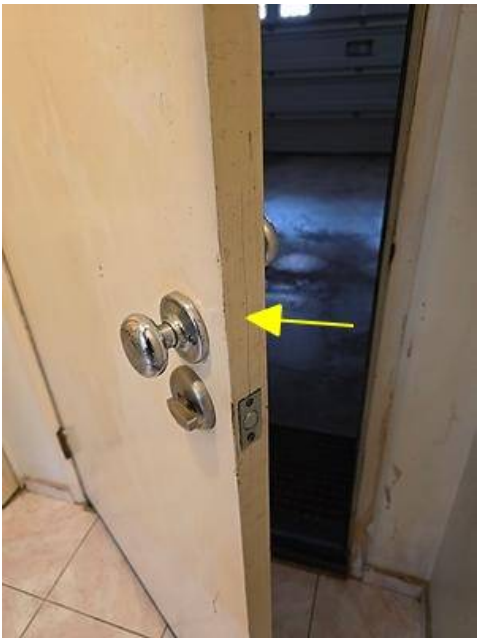
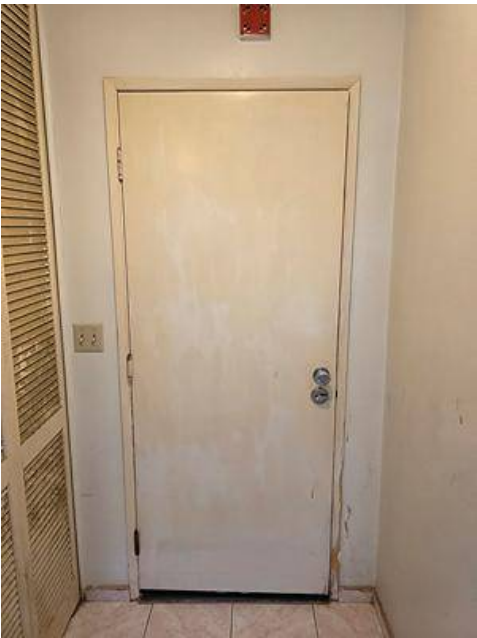
The door between the house and the garage wouldn't latch when closed. This is meant to be a fire-resistant door for safety reasons, and should latch when closed. Recommend that a qualified person repair as necessary.

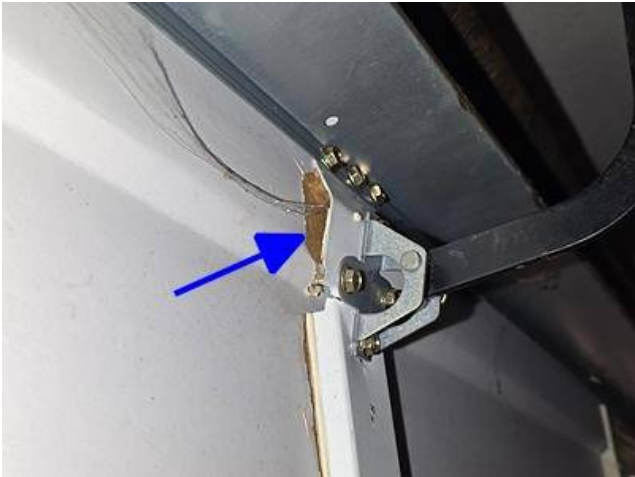
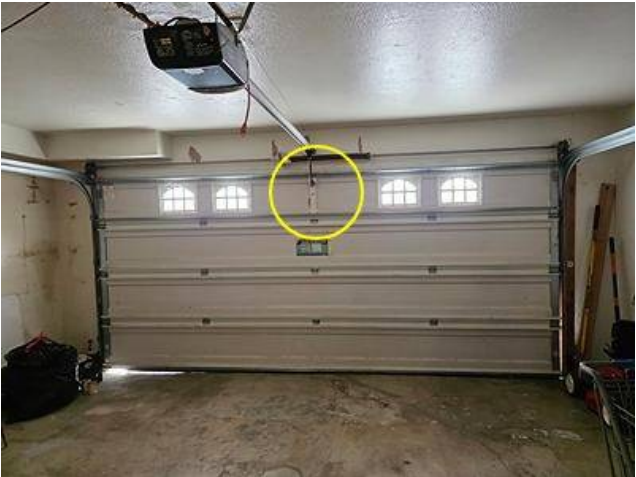
One or more garage vehicle doors were damaged or deteriorated. Recommend that a qualified contractor repair or replace door(s) as necessary.

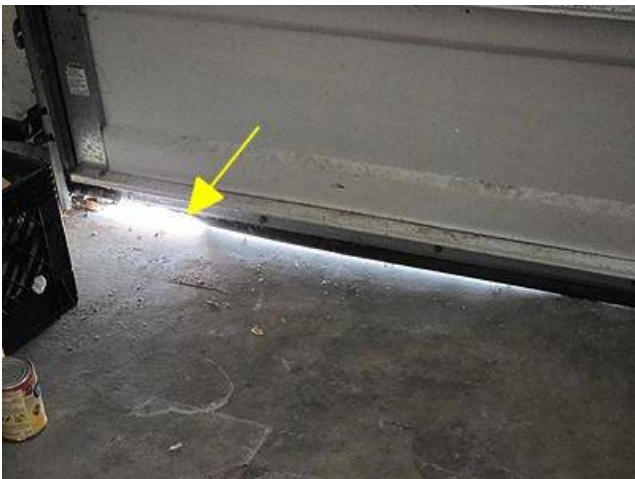
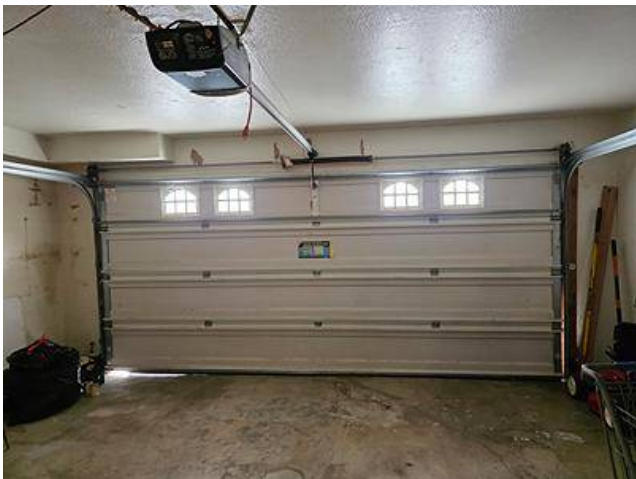
26) 🛠 Weatherstripping sealing one or more garage vehicle doors was damaged. Recommend replacing or installing weatherstripping where necessary to prevent water and/or vermin intrusion.

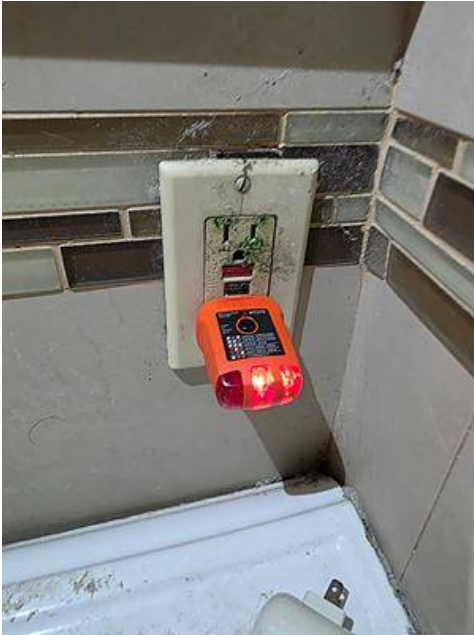
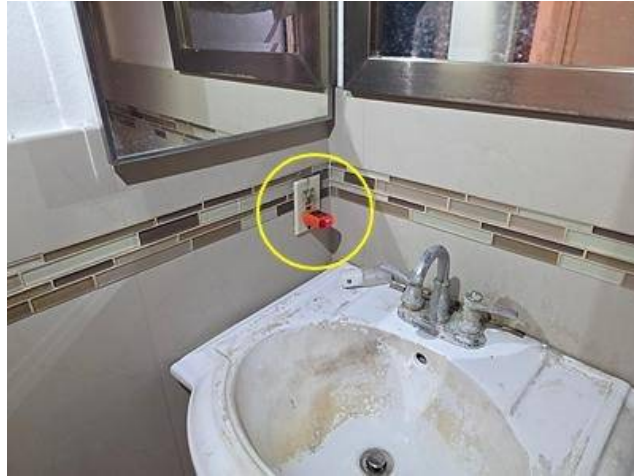
One or more ground fault circuit interrupter (GFCI) devices protecting receptacles at the bathroom(s) wouldn't trip when tested. This is a potential shock hazard. Recommend that a qualified electrician evaluate and repair as necessary.
