## Harmony Inspectors

## Property Inspection Report

Property address: **250 N Monte Vista St # 3  
La Habra CA 90631-4541**

Inspection date: **Tuesday, May 12, 2026**

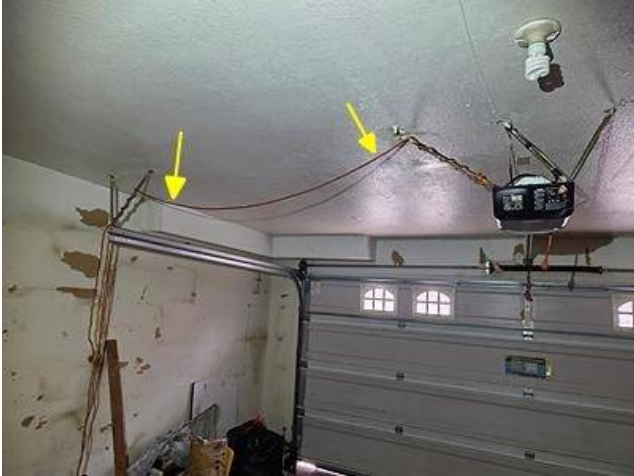
Extension cords were being used as permanent wiring at one or more locations. They should only be used for portable equipment on a temporary basis. Using extension cords as permanent wiring is a potential fire and shock hazard, and indicates that wiring is inadequate and needs updating. Extension cords may be undersized. Connections may not be secure resulting in power fluctuations, damage to equipment, overheating and sparks that could start a fire. Recommend that a qualified electrician repair per standard building practices and eliminate extension cords for permanently installed equipment.

Photo 34-1 Garage

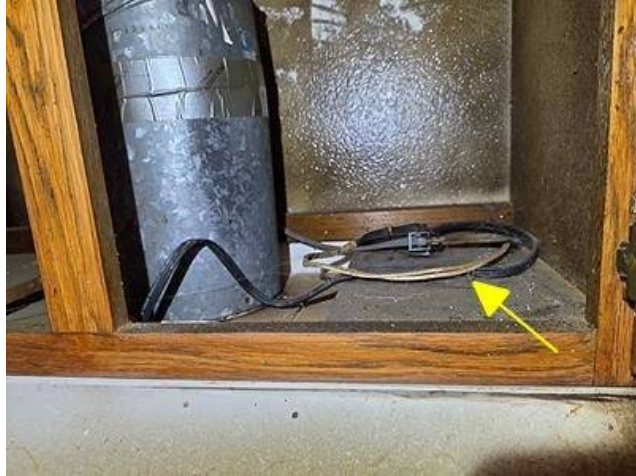
Photo 34-2 Above the range hood

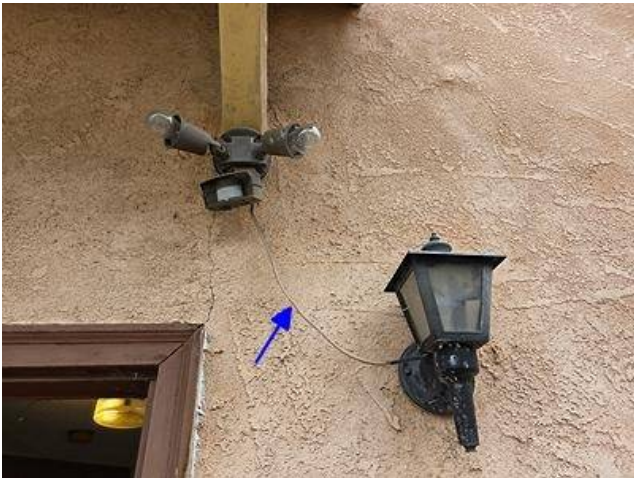
Flexible lamp or appliance cord was being used for permanent wiring at one or more locations. Such wiring is not intended to be used as permanent wiring and poses a safety hazard of shock and fire. Recommend that a qualified electrician repair per standard building practices.

Photo 35-1 Front of unit

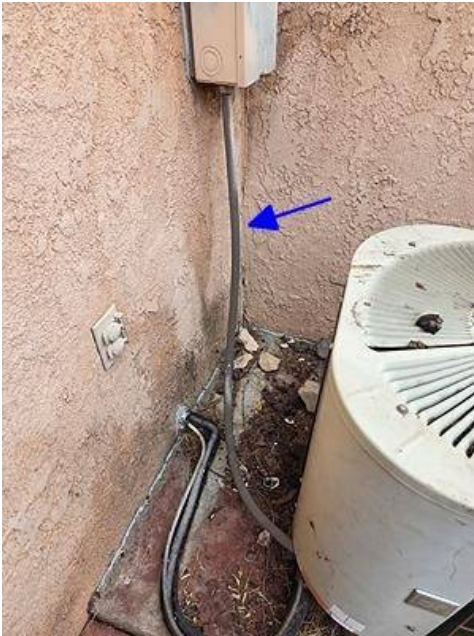
Conduit and/or fittings at one or more locations were loose. This is a potential safety hazard for shock or fire. Recommend that a qualified electrician repair as necessary.

Photo 36-1 At the A/C unit

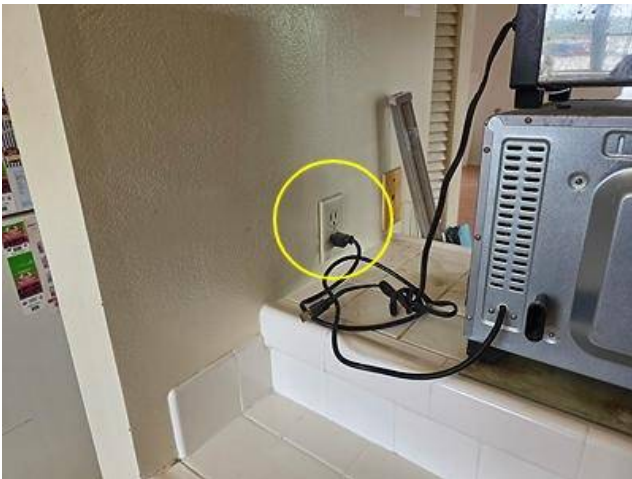
One or more electric receptacles and/or the boxes in which they were installed were loose and/or not securely anchored. Wire conductors can be damaged due to repeated movement and/or tension on wires, or insulation can be damaged. This is a shock and fire hazard. Recommend that a qualified electrician repair as necessary.

Photo 37-1 Kitchen

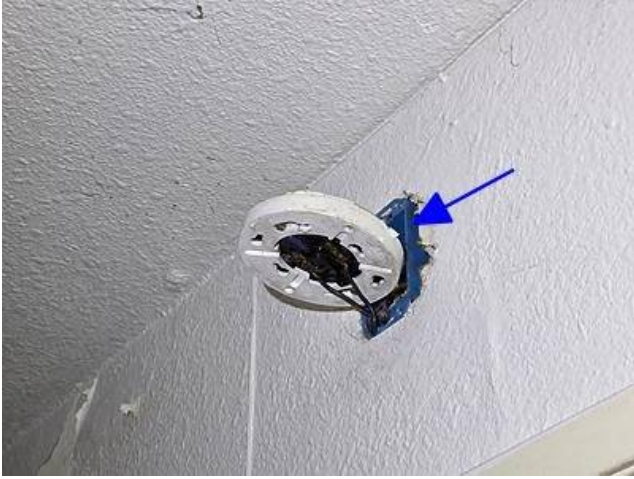
One or more cover plates for switches, receptacles or junction boxes were missing or broken. These plates are intended to contain fire and prevent electric shock from occurring due to exposed wires. Recommend that a qualified person install cover plates where necessary.

Photo 39-1 Garage

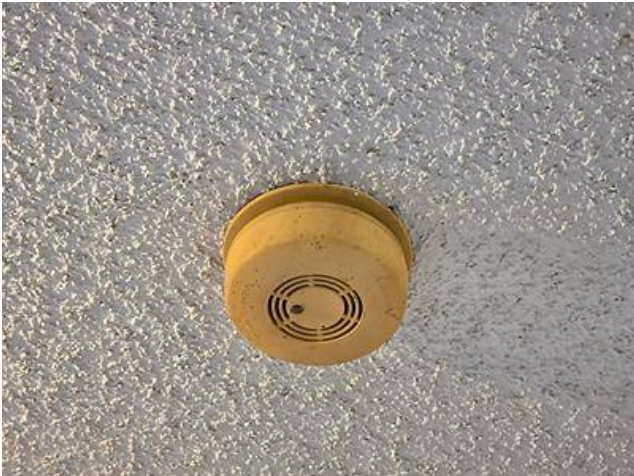
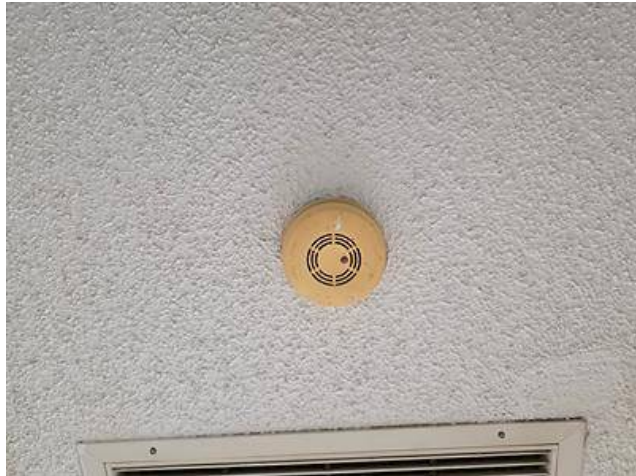
Based on the age of this structure and the appearance of existing smoke alarms, the alarms may have been installed more than 10 years ago. According to [National Fire Protection Association](https://www.nfpa.org), aging smoke alarms don't operate as efficiently and often are the source for nuisance alarms. Older smoke alarms are estimated to have a 30% probability of failure within the first 10 years. Newer smoke alarms do better, but should be replaced after 10 years. Unless you know that the smoke alarms are new, replacing them when moving into a new residence is also recommended by NFPA. For more information, visit: <https://www.reporthost.com/?SMKALRMLS>

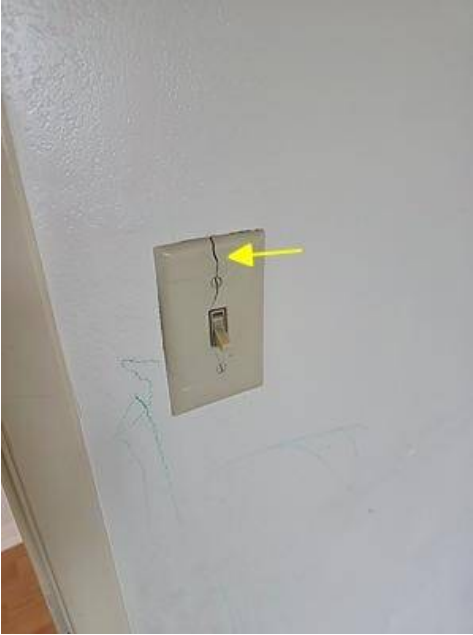
One or more cover plates for switches, receptacles or junction boxes were missing or broken. These plates are intended to contain fire and prevent electric shock from occurring due to exposed wires. Recommend that a qualified person install cover plates where necessary.

Photo 42-1 Master bedroom

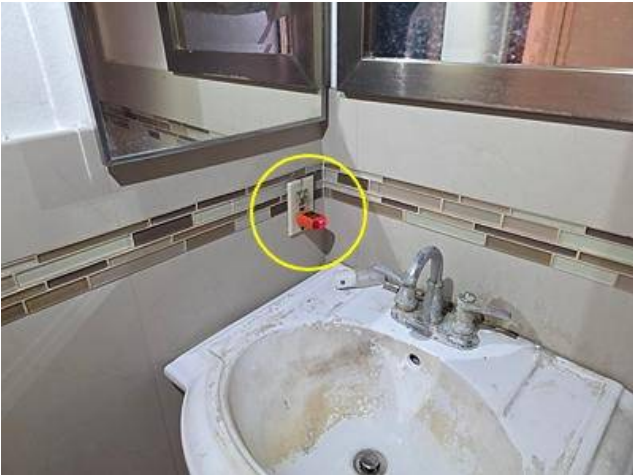
Photo 43-1

One or more ground fault circuit interrupter (GFCI) receptacles or circuit breakers were defective. Because of this, the inspector was unable to determine if all electric receptacles that should be protected by GFCI devices, were protected. After defective GFCI devices have been replaced or repaired, recommend that a qualified electrician verify that receptacles throughout the house have GFCI protection per standard building practices, and make repairs if necessary.

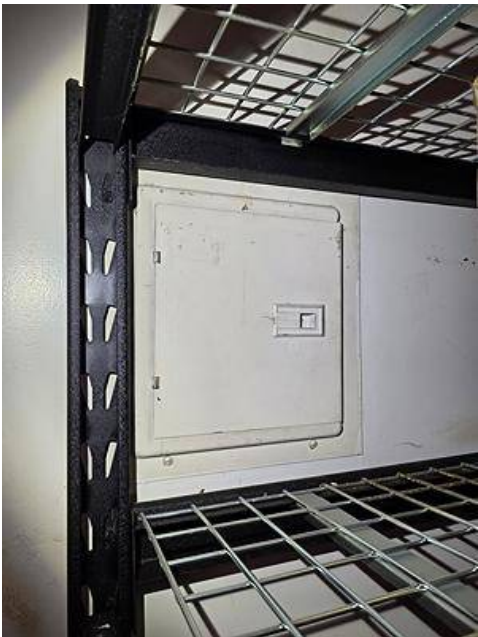
Photo 44-2

The inspector was unable to open and evaluate panel(s) #C because items were blocking access. The condition of these panel(s) is unknown and they are excluded from this inspection. Repairs may be needed. Recommend that a qualified person correct conditions, or that a qualified contractor make repairs if necessary so panels can be opened, and that a qualified person fully evaluate panel(s).

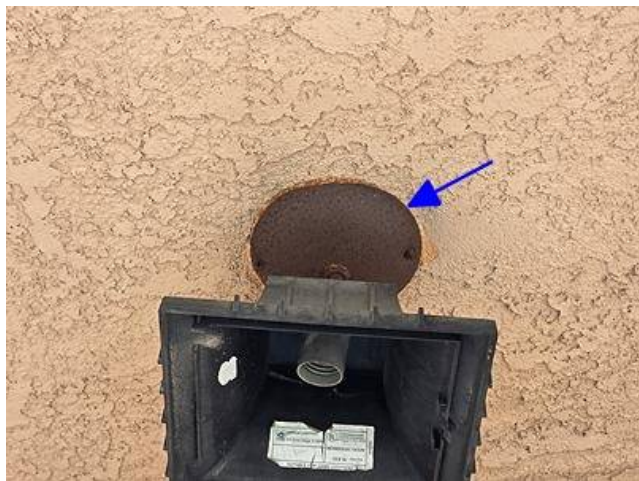
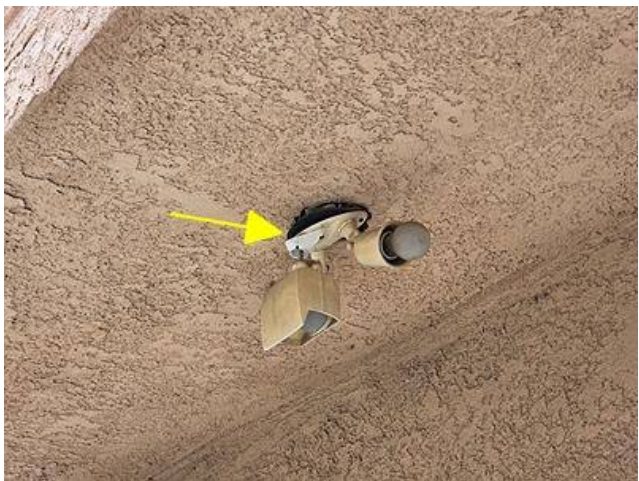
One or more light fixtures were loose and/or corroded. Recommend that a qualified electrician repair or replace light fixtures as necessary.

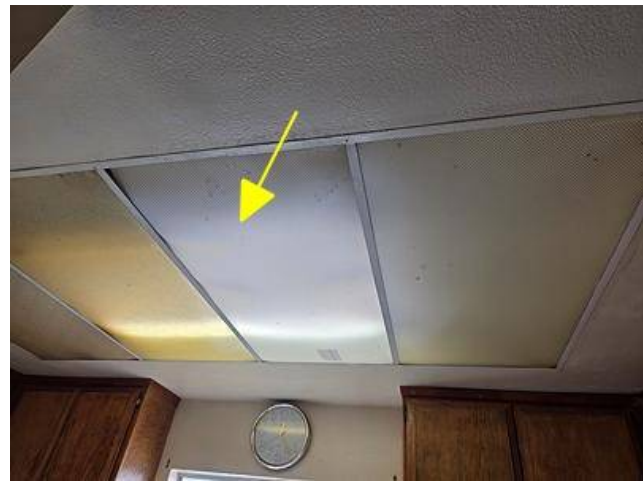
46) 🔧🔍 One or more fluorescent light fixtures were observed to be operating at a significantly dimmed capacity. The condition is typically caused by failing ballast mechanisms, degraded lamps near the end of their operational lifespan, or low voltage supply issues within the circuit. Recommend further evaluation by replacing bulbs and/or consulting with the property owner. If replacing bulbs doesn't work and/or no other switch(es) can be found, then recommend that a qualified electrician evaluate and repair or replace light fixtures as necessary.

Photo 46-1 Kitchen

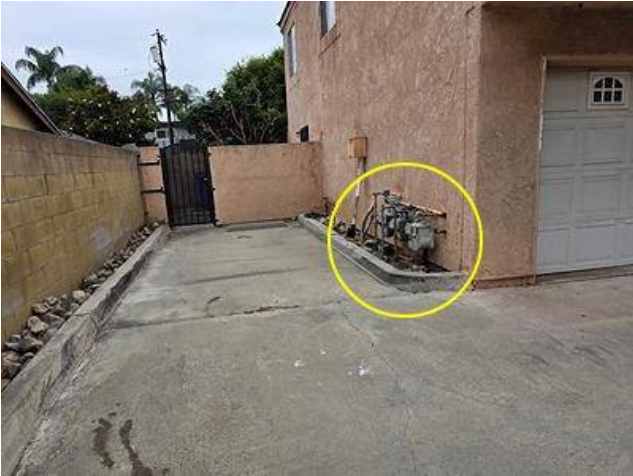
Photo 51-1

The gas meter was located where it was subject to damage from vehicles. This is a potential explosion and fire hazard. Recommend that a qualified contractor install a protective barrier per standard building practices.

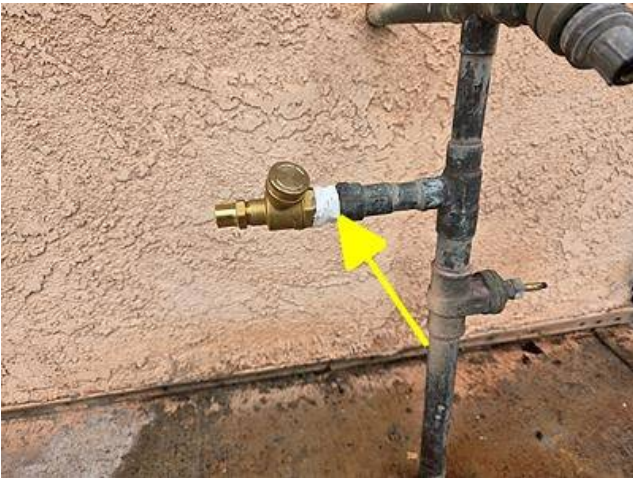
Photo 52-1

One or more leaks were found in water supply pipes or fittings. A qualified plumber should evaluate and repair as necessary.

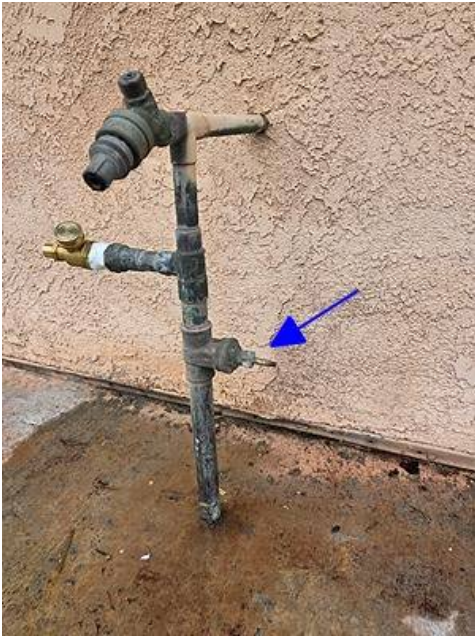
Photo 53-1

The main water shut-off valve handle was missing or damaged. It is especially important to be able to reliably operate the main water shut-off valve in an emergency, such as when a supply pipe bursts. Recommend that a qualified plumber repair as necessary.

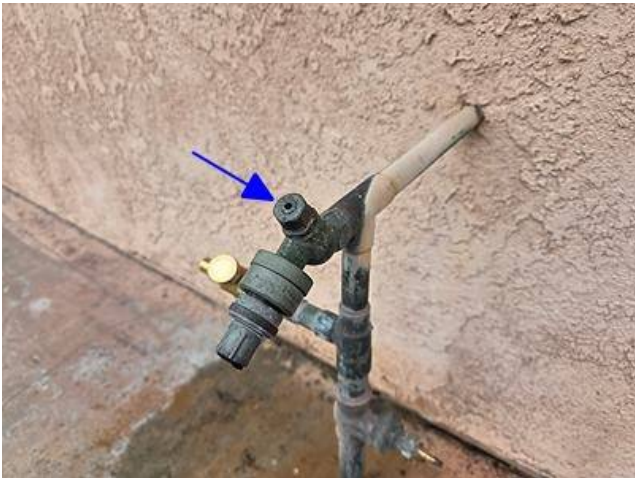
Photo 54-1

One or more hose bib handles were broken. Recommend that a qualified person replace handles or make repairs as necessary.

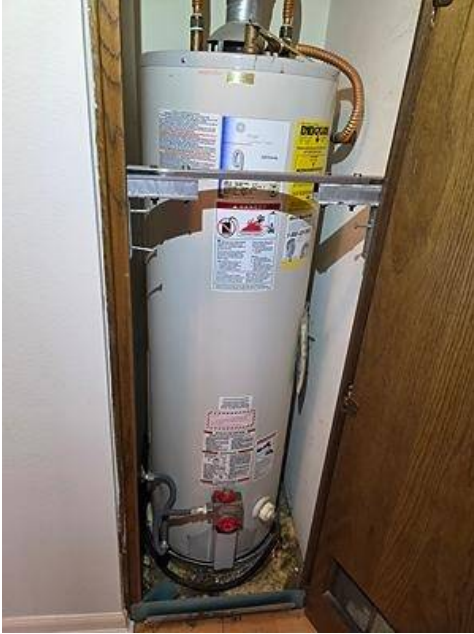
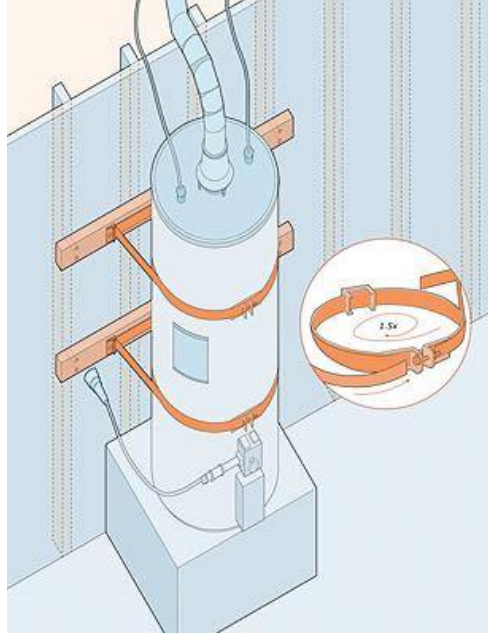
The water heater did not have earthquake straps installed. This is a potential safety hazard in the event of an earthquake due to the risk of the water heater tipping over, gas lines breaking if it's gas-fired, or electric wiring being damaged if powered by electricity. Leaks may also occur in water-supply pipes or fittings. Recommend that a qualified person install earthquake straps per standard building practices.

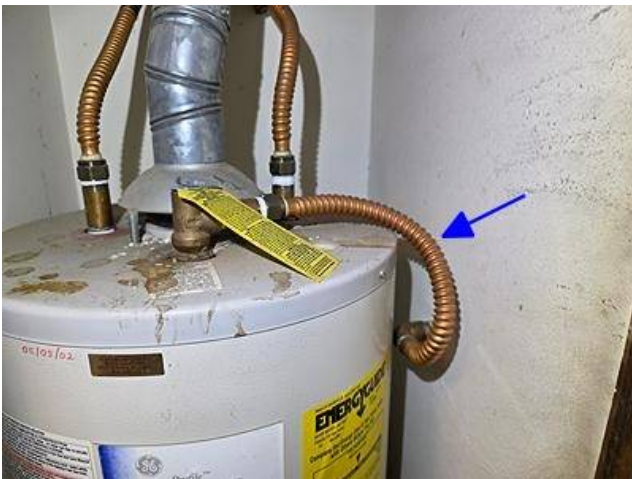
Photo 57-1

One or more flexible connectors were used for the temperature-pressure relief valve drain line. Flex connectors can be bent or kinked so as to restrict the flow of the drain line and impair the operation of the valve. They typically are not rated for the temperature and pressure of water being discharged (potentially 150 psi and 210 degrees F). Flex connectors used this way pose a potential safety hazard for explosion. Recommend that a qualified plumber repair per standard building practices. For example, by installing a drain line made of rigid copper or CPVC plastic pipe.

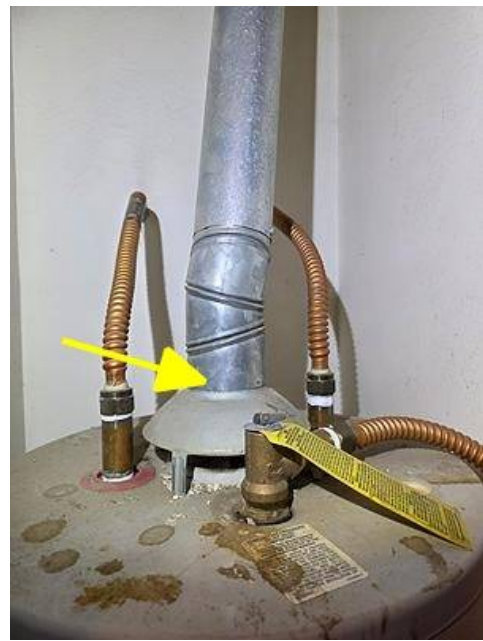
Photo 58-1

Screws were missing from one or more single-wall metal pipe joints. This is a safety hazard due to the risk of the pipe coming apart. Three screws should be installed at each joint and at the draft hood. Recommend that a qualified person repair per standard building practices.

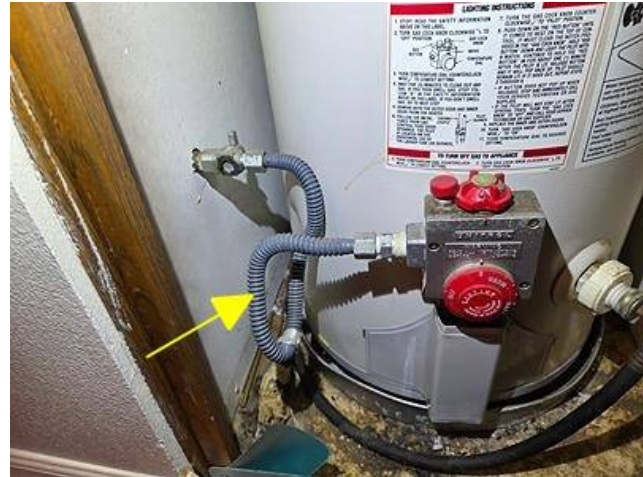
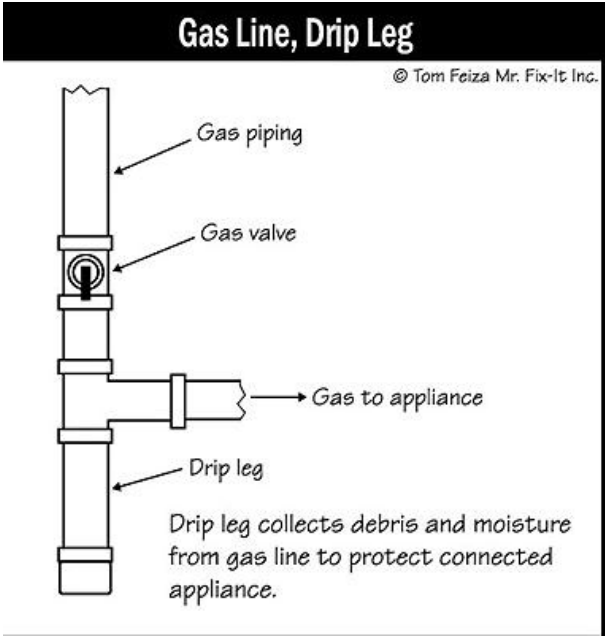
No sediment trap was installed in the gas supply line at the water heater. Sediment traps prevent damage to gas-fired appliances by trapping oil, scale, water condensation and/or debris. Recommend that a qualified contractor install a sediment trap per standard building practices.

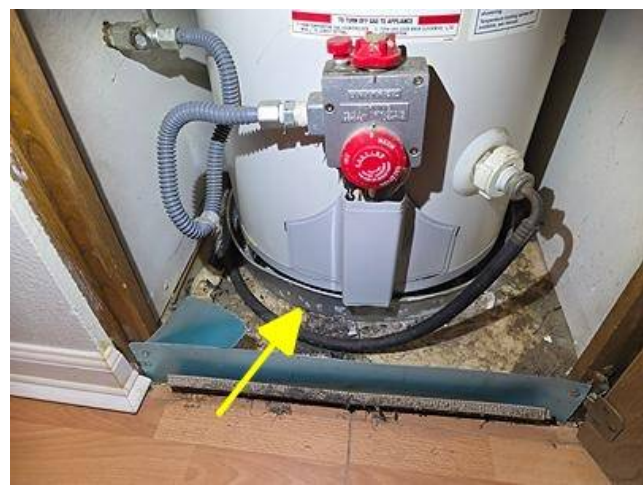
Photo 60-1

A catch pan was installed below the water heater, but no drain line was visible. Typically such catch pans hold only a gallon or two of water. If the water heater fails and leaks significantly, nearby flooring and wall materials, or finished spaces below (if any) may be get water-damaged. Normally, a drain line is installed at the catch pan to route any accumulated water outside the structure. Consider having a qualified contractor install a drain line per standard building practices.

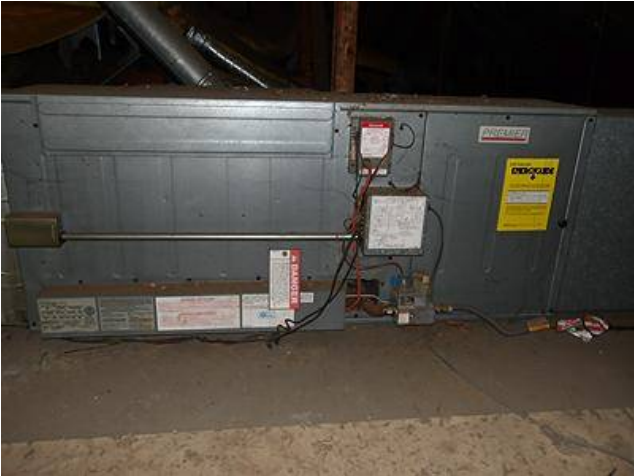
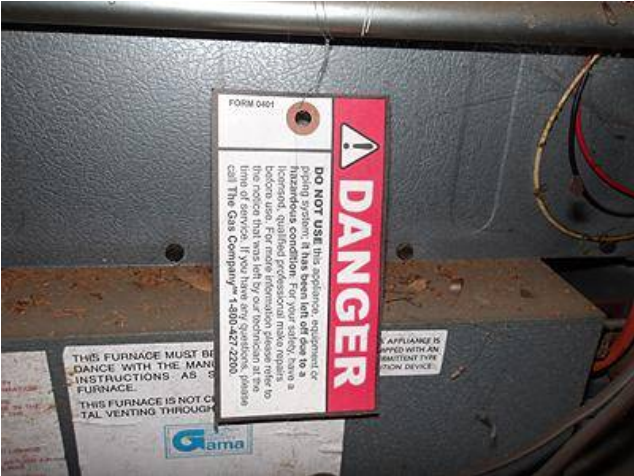
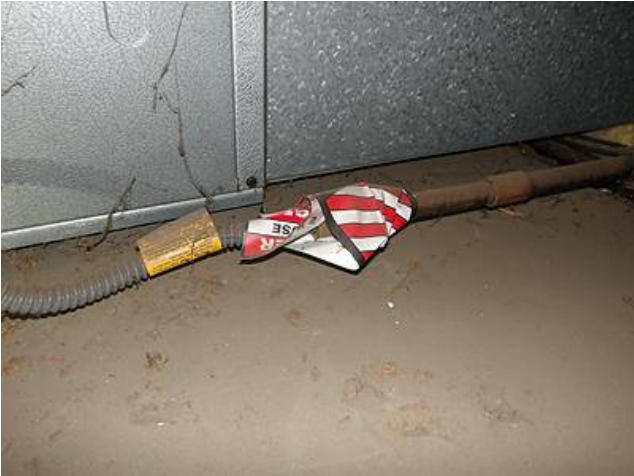
At the time of inspection, a "danger" or "red tag" was observed on the wall furnace, having been placed by the local gas utility company. As a direct result of this safety hazard, the furnace was not operated or tested during the inspection. To ensure safety and restore service, a licensed HVAC contractor or the gas company should evaluate and repair as necessary.

The estimated useful life for most forced air furnaces is 15-20 years. This furnace appeared to be beyond this age and/or its useful lifespan and may need replacing or significant repairs at any time. Recommend budgeting for a replacement in the near future.

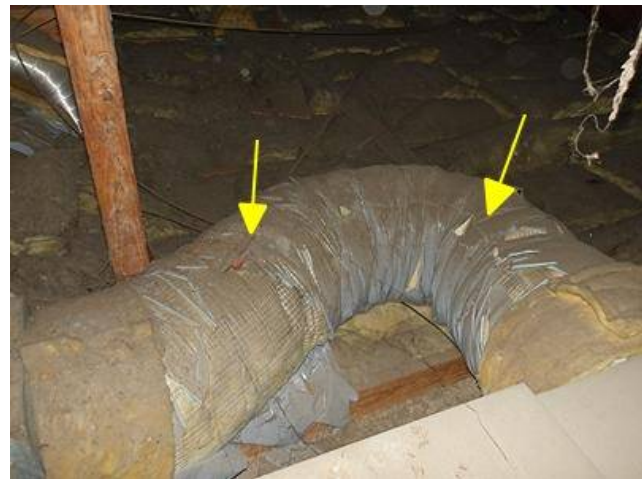
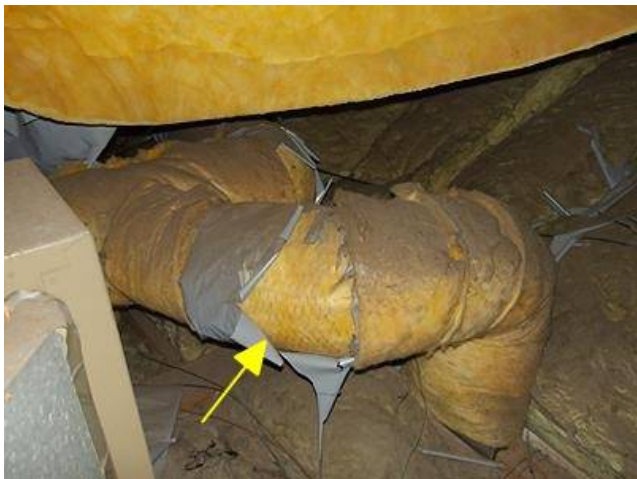
The gray plastic outer layer of many flexible ducts was deteriorated. This can result in air leakage, reduced energy efficiency and higher heating/cooling operating costs. The fiberglass insulation that becomes exposed usually also deteriorates, resulting in further reduced energy efficiency or fiberglass particles entering living spaces. In some cases, air can leak in through the deteriorated ducts or mold can grow due to condensation, both resulting in reduced indoor air quality. Recommend that a qualified contractor evaluate further and replace ducts as necessary.

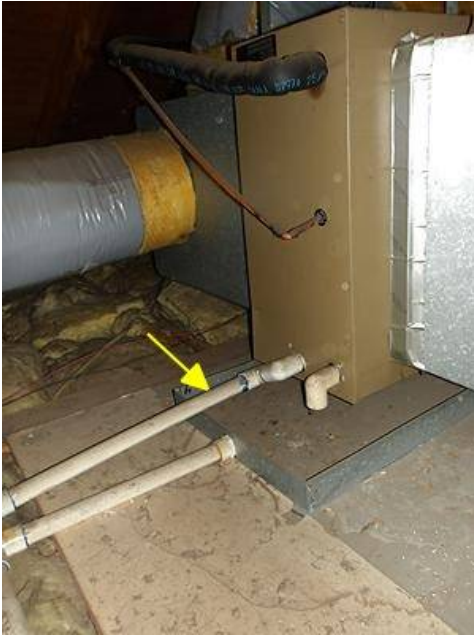
Photo 64-1

The air handler's primary condensate drain line trap was missing. A U-shaped trap with a 2-inch drop should normally be installed to prevent air from moving in or out of the air handler during operation. Without a correctly configured trap, efficiency can be reduced, or condensate water can be pulled into the equipment resulting in wet insulation or components, or microbial growth. Recommend that a qualified HVAC contractor repair per standard building practices.

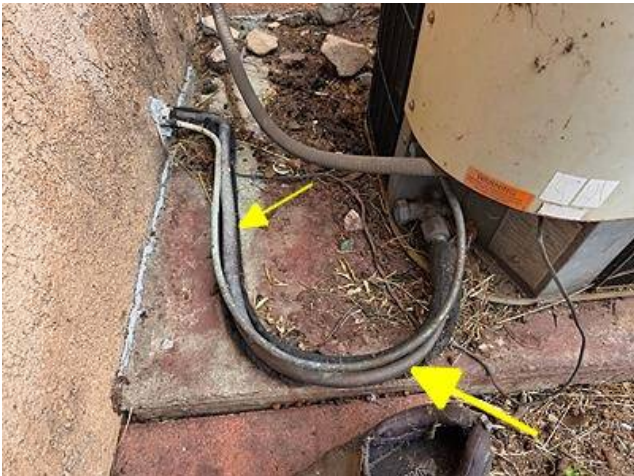
Photo 66-1

Insulation on the heat pump or air conditioning condensing unit's refrigerant lines was deteriorated or missing in some areas. This may result in reduced efficiency and increased energy costs. Recommend that a qualified person replace or install insulation as necessary.

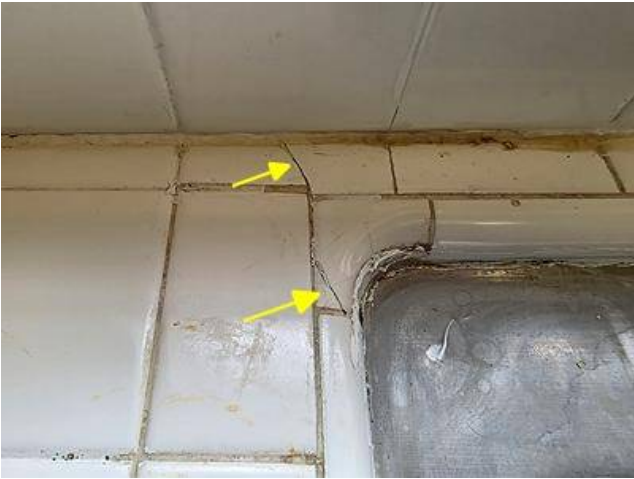
Photo 69-1

Countertops and/or backsplashes were damaged or deteriorated. Recommend repairing or replacing as necessary.

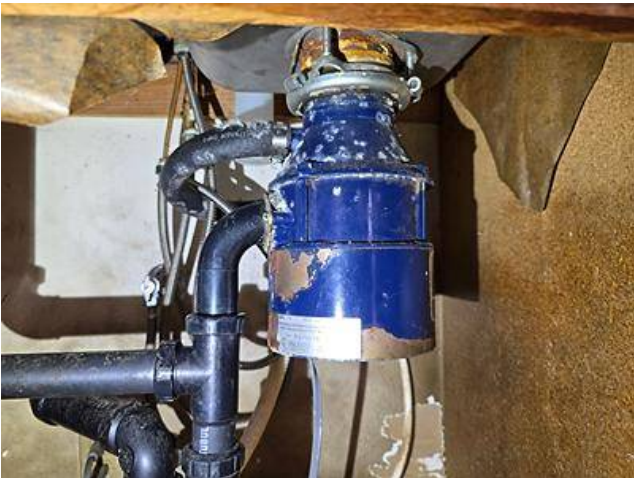
Photo 70-1

The under-sink food disposal was jammed. Recommend that a qualified contractor repair or replace as necessary.

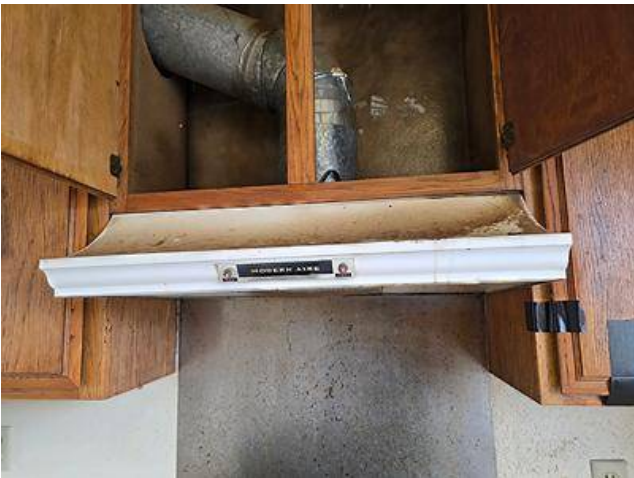
Photo 71-1

The cooktop exhaust fan was noisy or vibrated excessively. Recommend that a qualified person repair or replace as necessary.

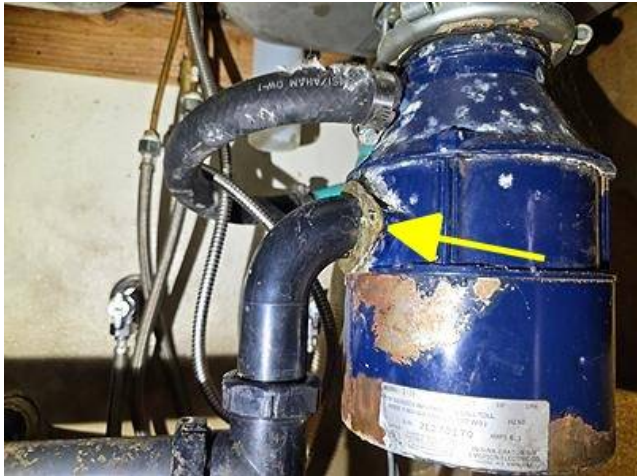
Photo 72-1

One or more sink drains were leaking. A qualified plumber should repair as necessary.

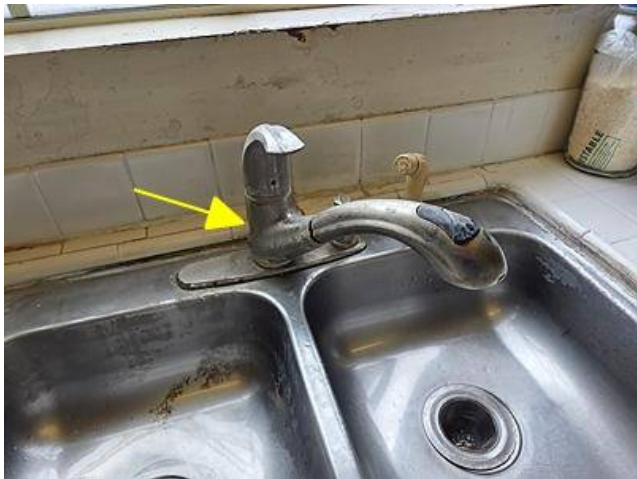
Photo 73-1

The sink faucet was stuck and could not be moved between sink sections. Recommend that a qualified person repair as necessary.

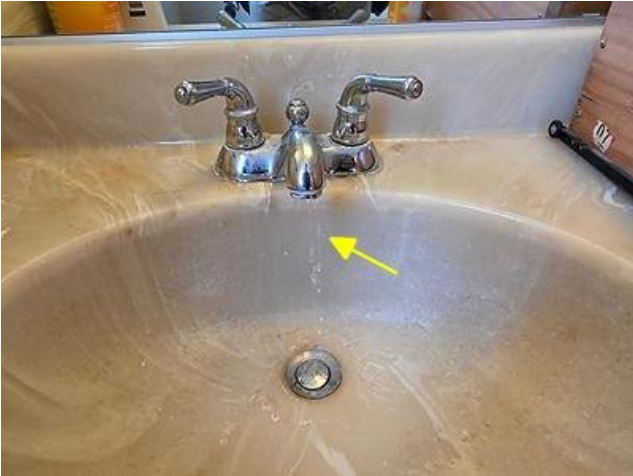
Photo 76-1

The hot and/or cold water supply flow for the sink at location(s) #C was low or inoperable. Recommend that a qualified plumber evaluate and repair as necessary.

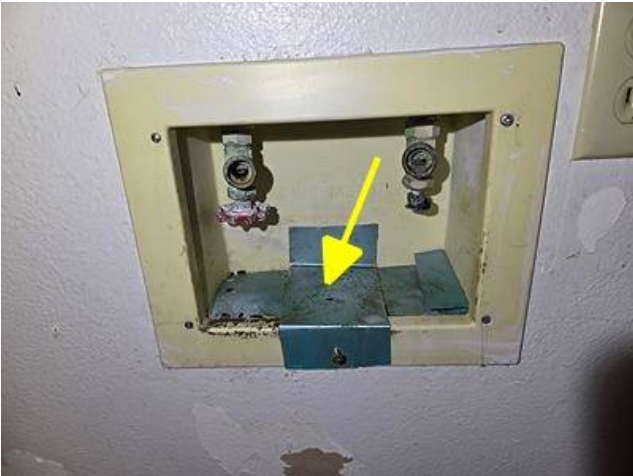
Photo 77-1

The clothes washer drain line located inside the wall outlet box has been purposely blocked. A permanent barrier was intentionally inserted into the standpipe opening, which prevents the attachment or discharge of a washing machine waste hose. A qualified plumber should evaluate and repair as necessary.

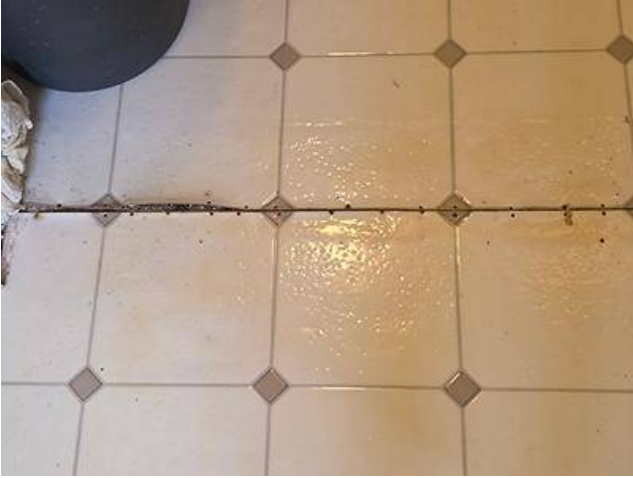
Photo 78-1

78) 🛠️💧 Vinyl flooring in the bathroom at location(s) #C was loose. Water can damage the sub-floor as a result. Recommend that a qualified contractor replace or repair flooring as necessary.

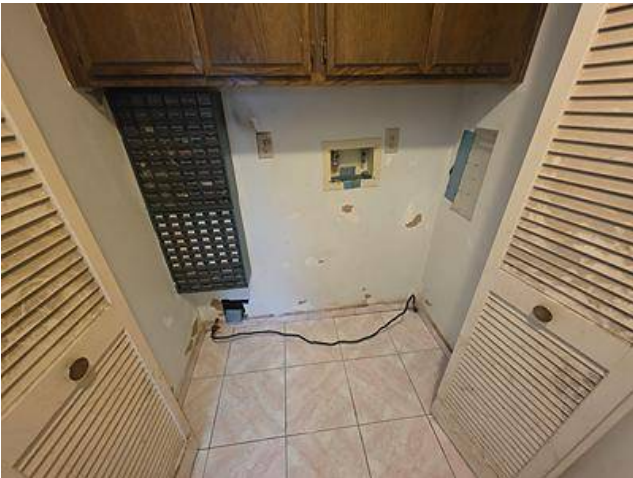
Photo 79-1

79) 🛠️ No exhaust duct was installed for the clothes dryer. Clothes dryers produce large amounts of moisture which should not enter structure interiors. Moisture can accumulate and result in mold, bacteria or fungal growth. A rigid or semi-rigid metal exhaust duct should be installed per standard building practices, and by a qualified contractor if necessary. For information, visit:

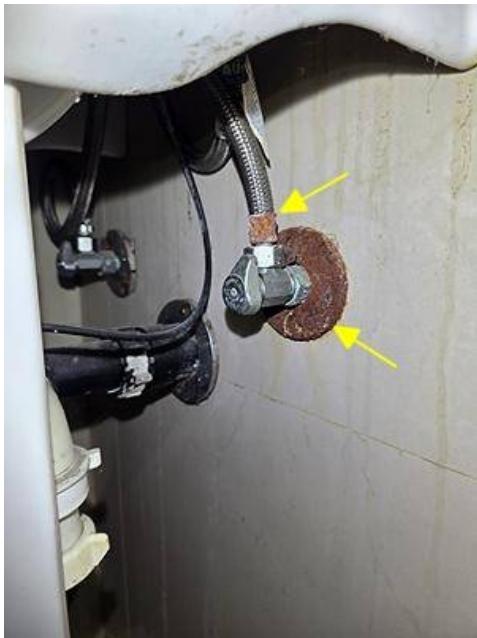
Photo 80-1

One or more water supply lines for the sink at location(s) #A were corroded. This can indicate past leaks, or that leaks are likely to occur in the future. A qualified plumber should replace as necessary.

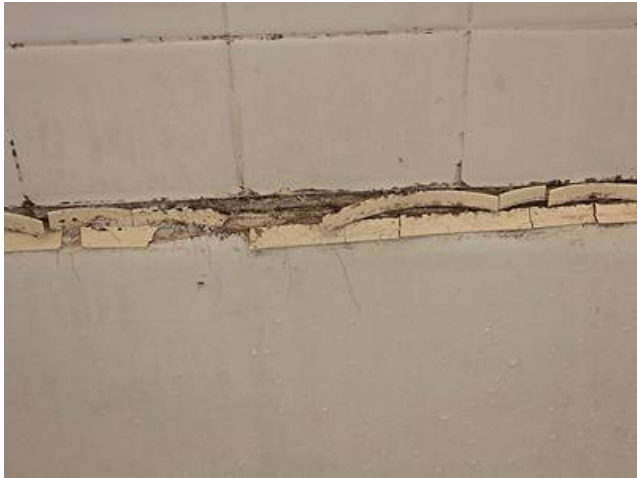
Photo 81-1

81) 🛠️💧 Tile and/or grout in the bathtub surround at location(s) #C was deteriorated (e.g. loose or cracked tiles, missing grout) or substandard. Water can damage the wall structure as a result. Recommend that a qualified contractor repair as necessary.

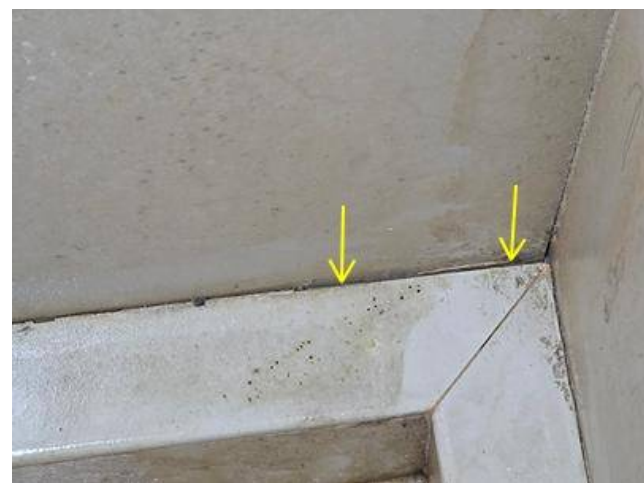
Photo 82-1

82) 🛠️💧 Tile, caulk and/or grout in the shower enclosure at location(s) #A were deteriorated (e.g. loose or cracked tiles, missing grout) or substandard. Water may leak through gaps and damage the wall or floor structure as a result. Recommend that a qualified contractor repair as necessary. Note that the condition of the structure behind and below the shower enclosure is unknown due to it being concealed.

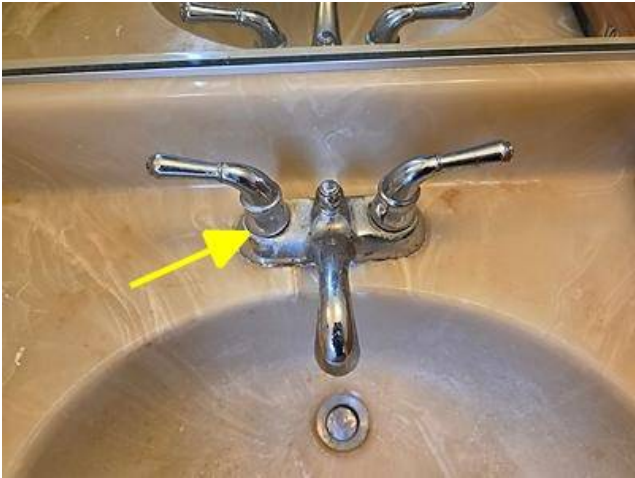
Photo 83-1

Water was leaking at the sink faucet base or handles at location(s) #C. Recommend that a qualified plumber repair as necessary.

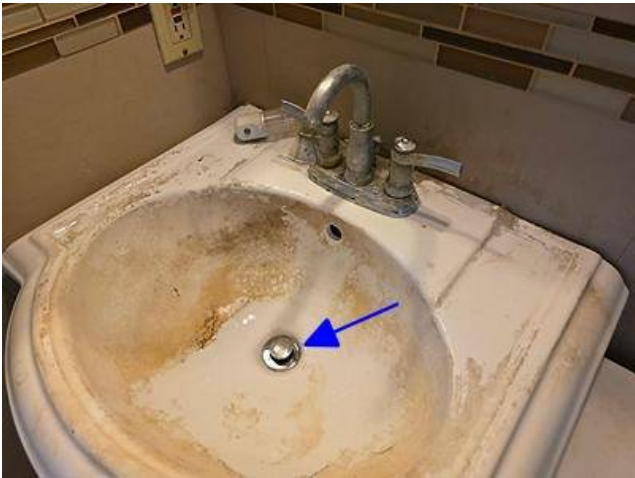
Photo 84-1

The sink drain stopper mechanism at location(s) #A was difficult to operate. Recommend that a qualified person repair or replace as necessary.

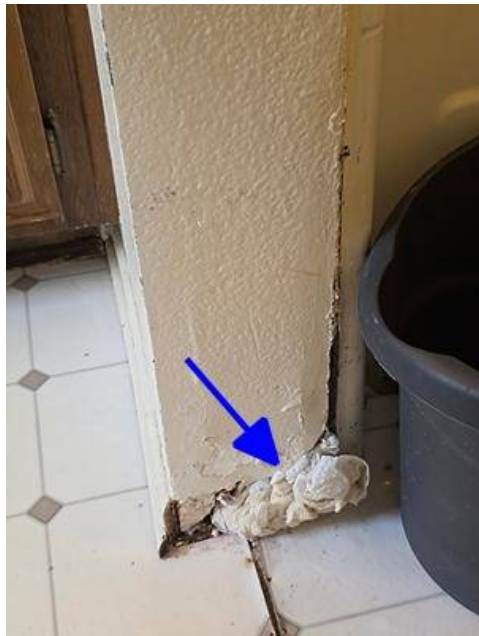
Photo 85-1

The wall by the bathtub at location(s) #C was water-damaged. Recommend that a qualified person repair as necessary.

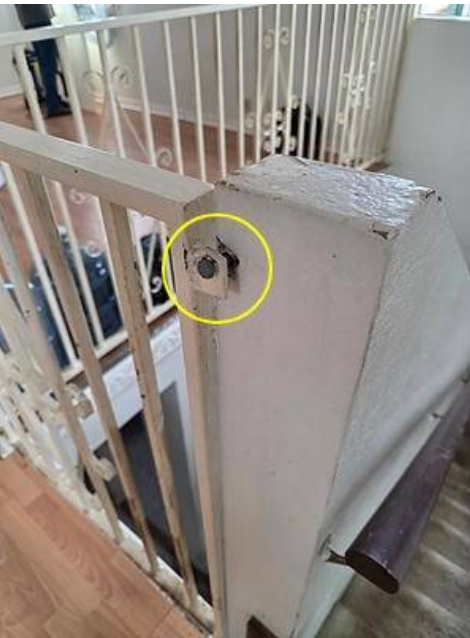
Photo 86-1

Guardrails at one or more locations with drop-offs higher than 30 inches were loose, and pose a fall hazard. Recommend that a qualified person repair guardrails as necessary.

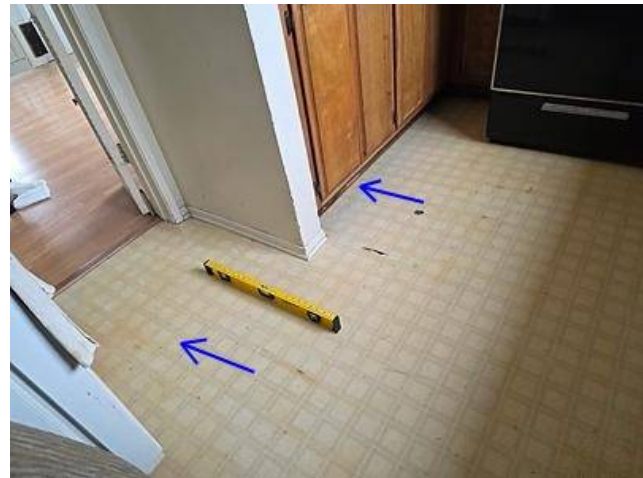
Photo 87-1 Kitchen

Floors in one or more areas were not level. This can stem from foundation settlement, sagging or damaged floor joists, load-bearing wall issues, moisture-induced wood warping, or poor construction practices. Recommend that a qualified contractor and/or engineer evaluate further. Repairs should be performed by a qualified contractor.

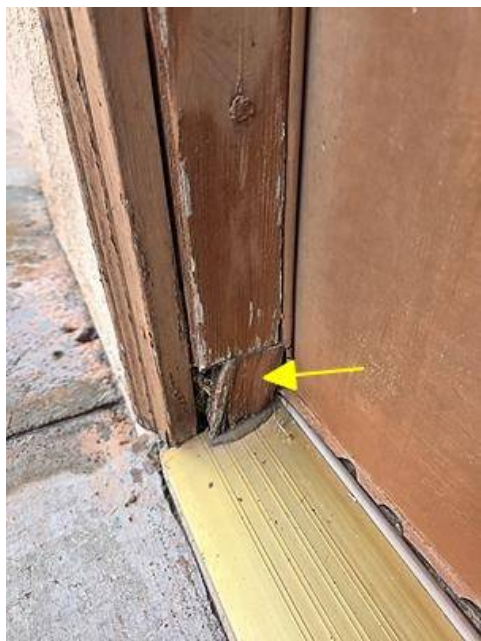
Photo 88-1

Fungal rot was found at one or more exterior door jambs. Recommend that a qualified person repair as necessary. All rotten wood should be replaced.

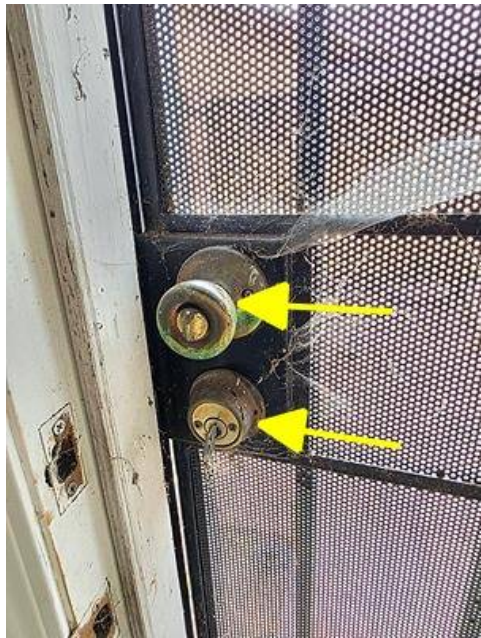
Photo 90-1

Some exterior door hardware, including locksets and/or deadbolts were difficult to operate. Recommend that a qualified person repair or replace as necessary.

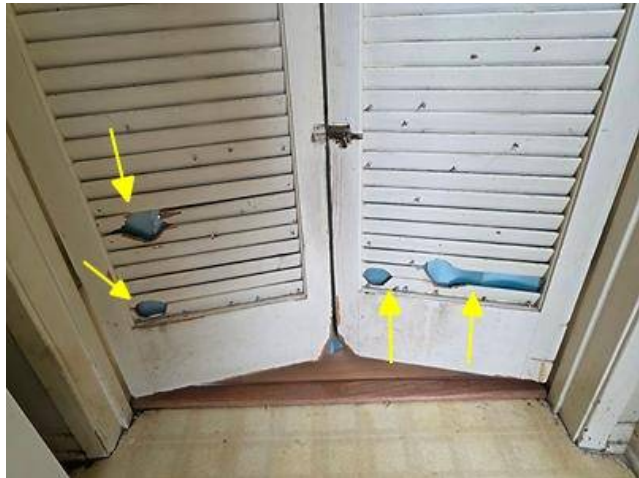
Photo 91-1

One or more interior doors were damaged. Recommend that a qualified person replace or repair doors as necessary.

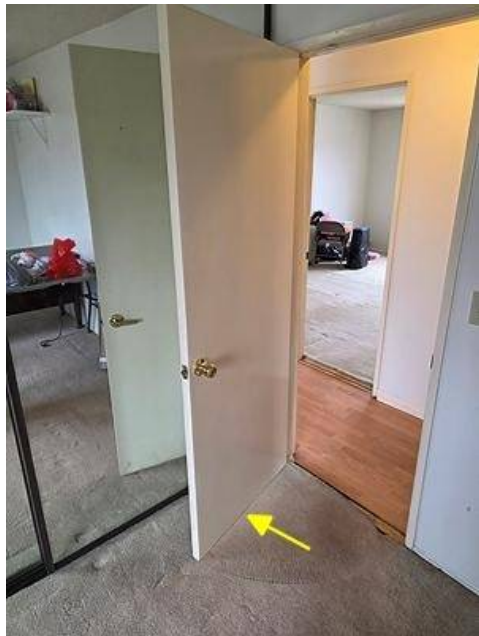
Photo 92-1 Bedroom, 2nd floor

One or more doors dragged on the carpet below and were difficult to open and close. Recommend that a qualified person repair as necessary. For example, by trimming bottoms of doors.
