## Harmony Inspectors

## Property Inspection Report

Property address: **250 N Monte Vista St # 3  
La Habra CA 90631-4541**

Inspection date: **Tuesday, May 12, 2026**

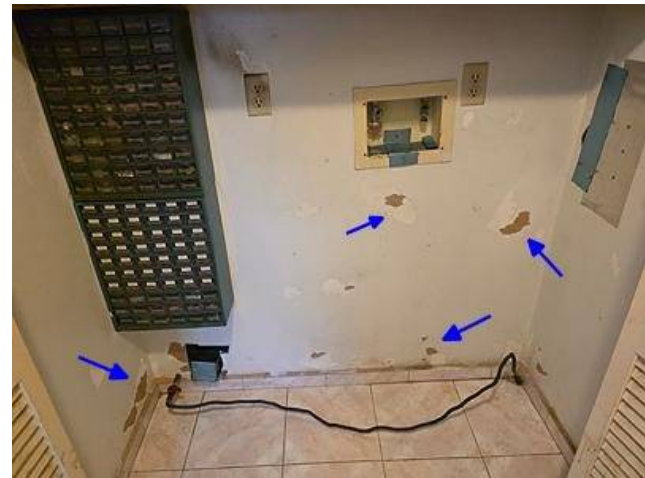
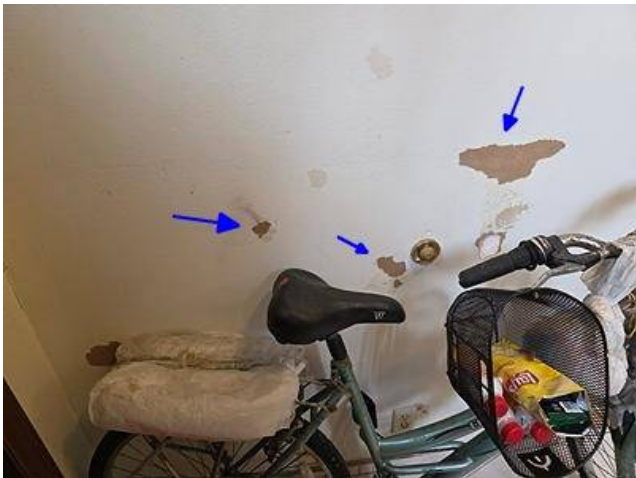
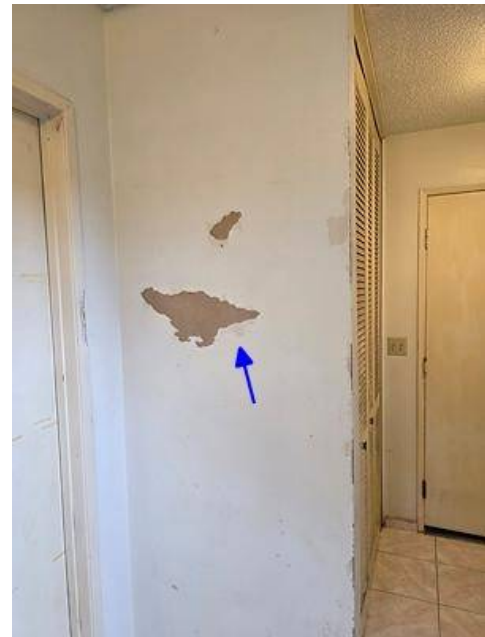
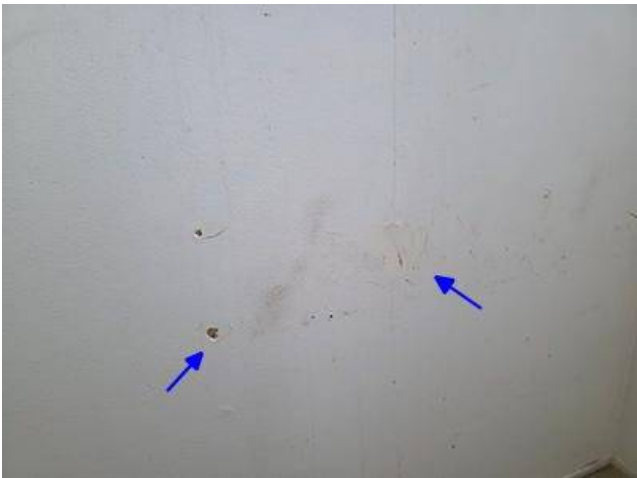
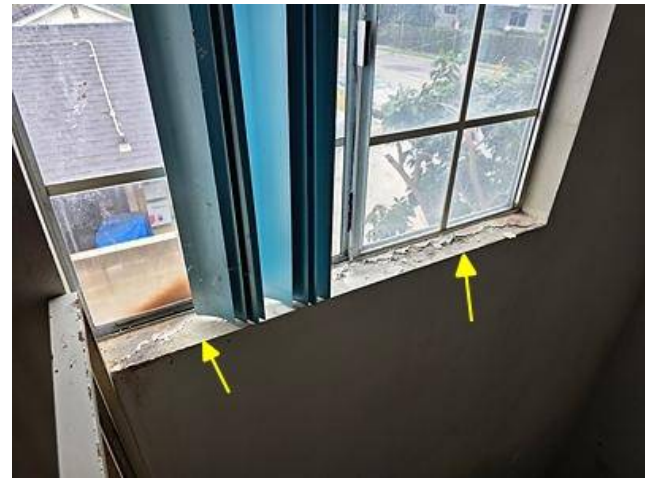
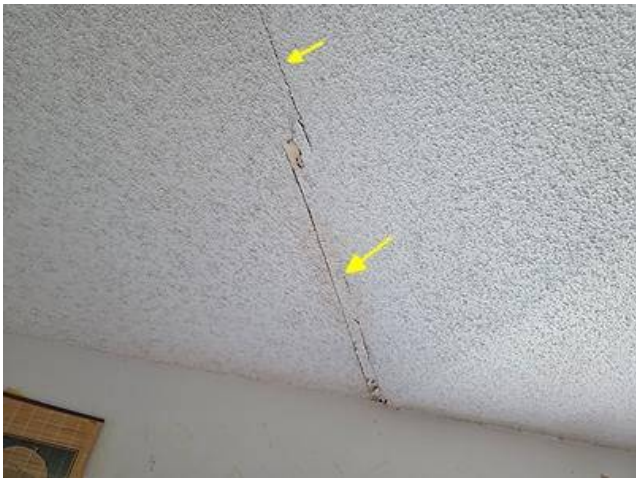
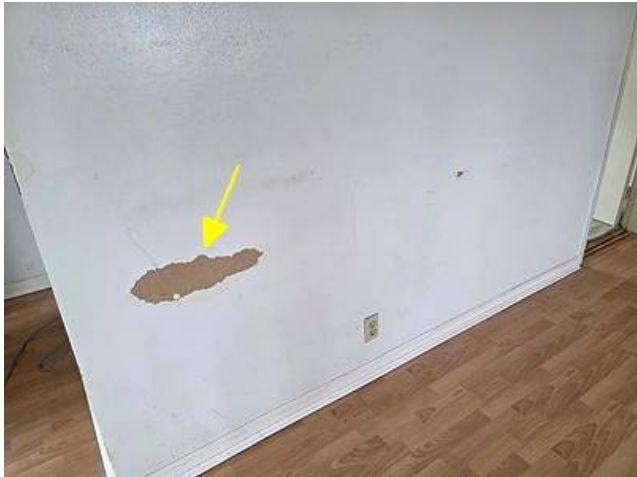
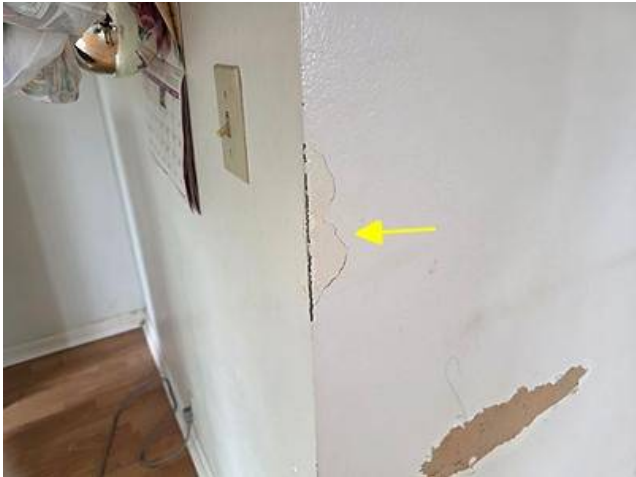
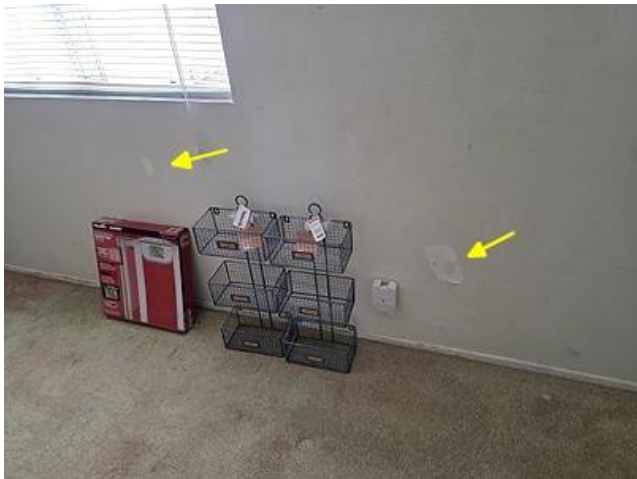
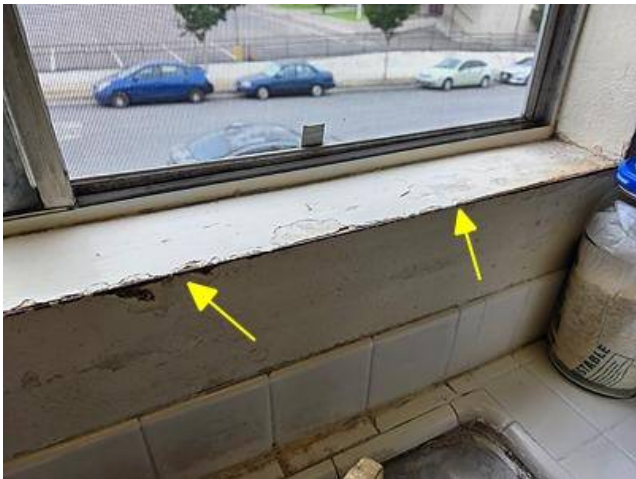
One or more walls and/or ceilings were damaged and/or were cracked. Recommend that a qualified person repair as necessary.

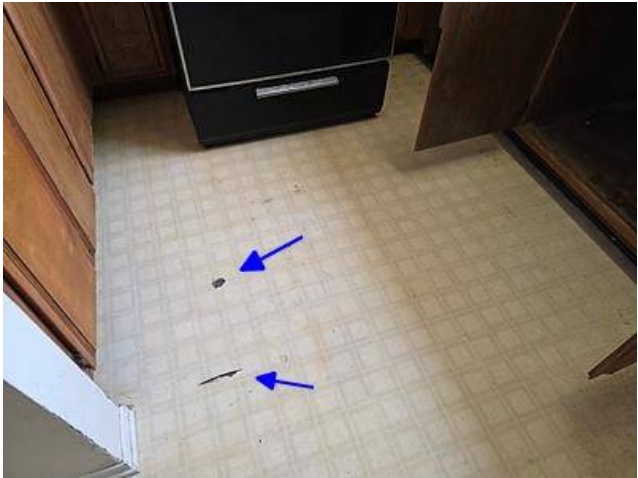
Photo 94-2

Vinyl, linoleum or marmoleum flooring in one or more areas was damaged. If in a wet area, water can damage the sub-floor as a result. Recommend that a qualified contractor replace or repair flooring as necessary.

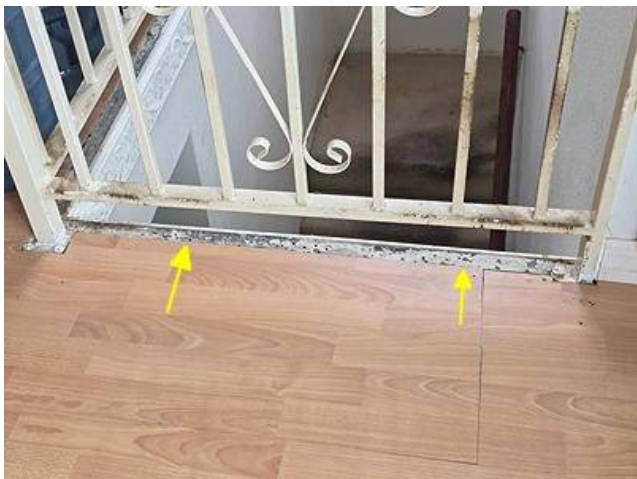
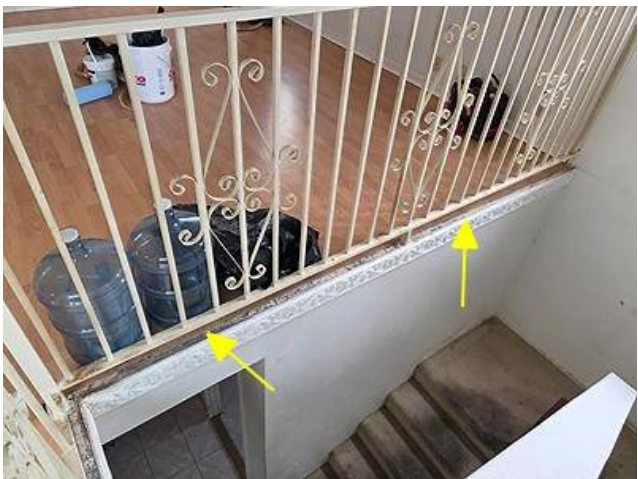
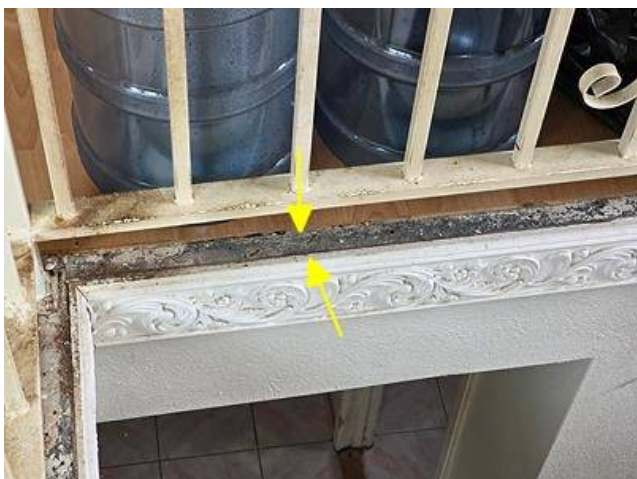
The flooring was missing or incomplete in one or more areas. Recommend that a qualified contractor replace or repair flooring as necessary.

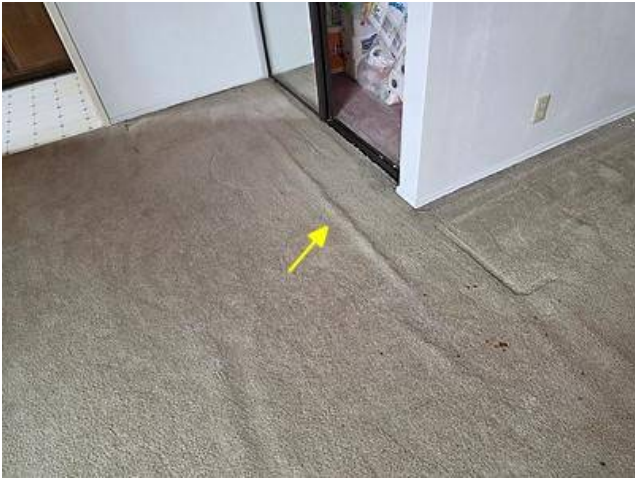
Photo 96-1 Bedroom, 2nd floor

Carpeting in one or more areas was loose. Recommend that a qualified contractor repair as necessary. For example, by stretching or replacing carpeting.

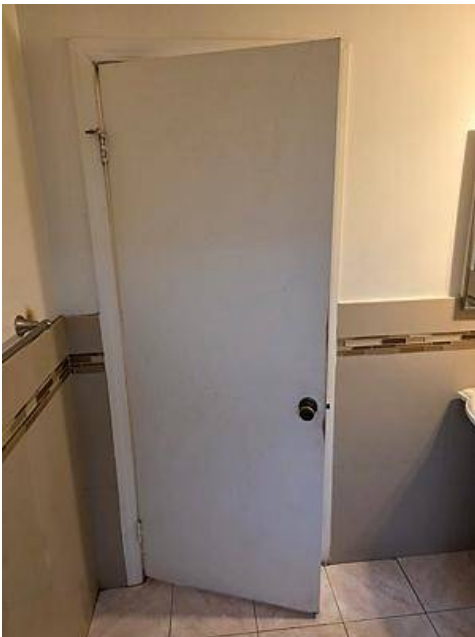
Photo 97-1 Bathroom, 1st floor

The interior door would not remain open and closed by itself. A door may close by itself due to a misalignment in the door or frame, usually caused by loose or improperly installed hinges, an uneven floor, or a slightly tilted door frame, which creates an imbalance causing the door to naturally swing closed due to gravity. Recommend that a qualified contractor repair as necessary.

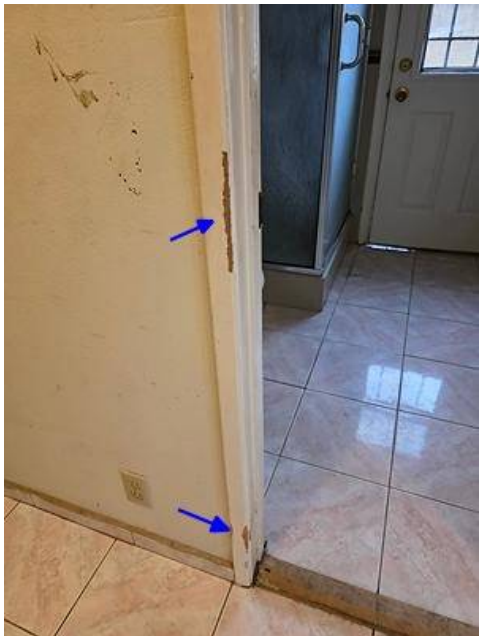
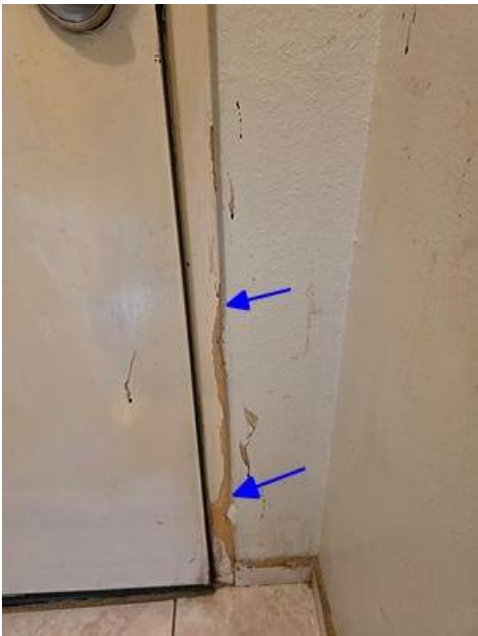
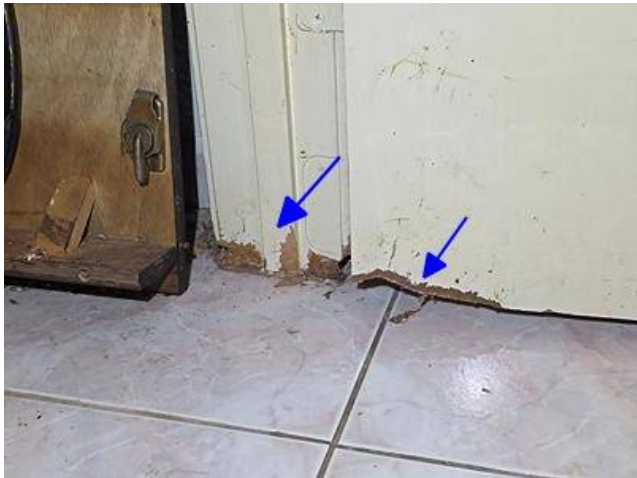
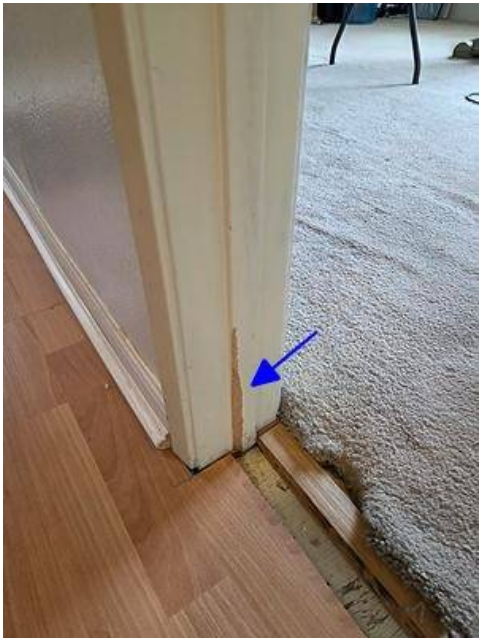
98) 🛠 Trim was damaged in one or more areas. Recommend that a qualified person repair as necessary.

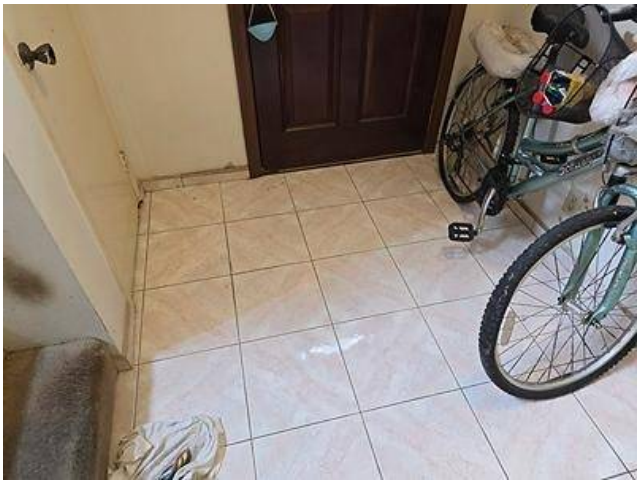
Photo 99-2 Front entry

Tile, stone and/or grout in the flooring in one or more areas was deteriorated (e.g. loose or cracked tiles, missing grout) or substandard. If in a wet area, water can damage the sub-floor. Recommend that a qualified contractor repair as necessary.

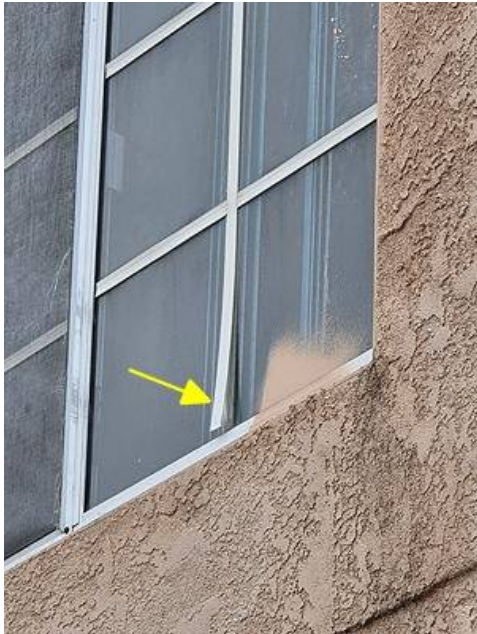
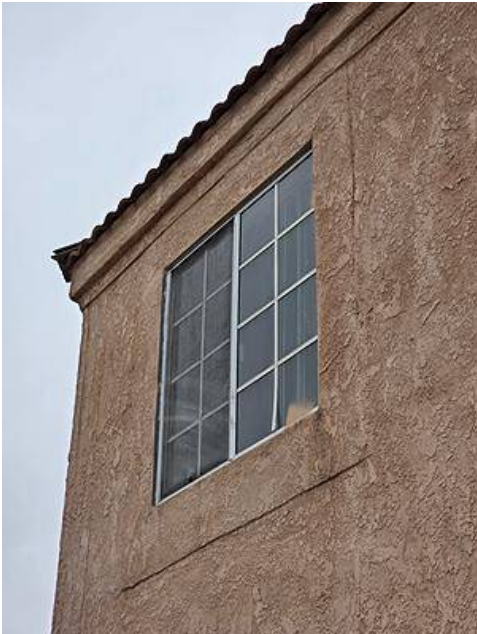
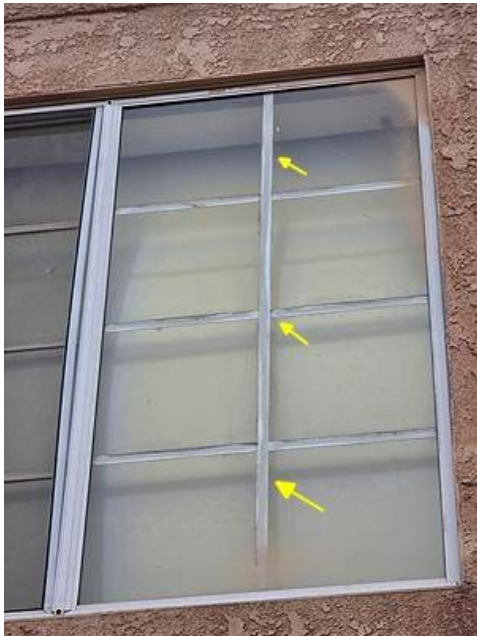
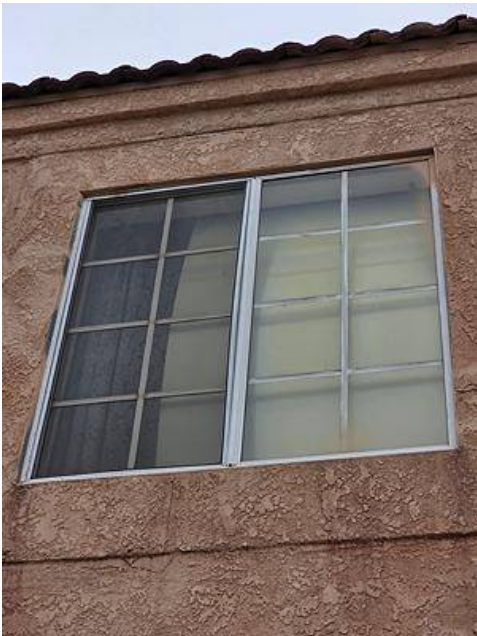
The exterior grids at one or more windows were loose and/or missing. Recommend that a qualified person repair as necessary.

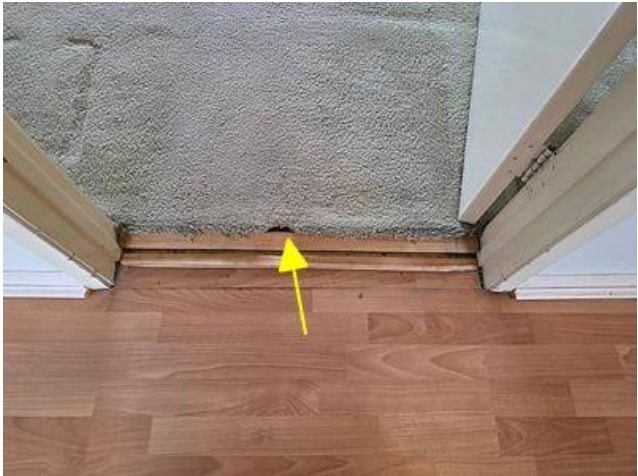
Photo 101-2

101) 🛠️ Transition floor trim was missing in one or more areas. Recommend that a qualified person repair as necessary.
