## ROOF REPORT

| Date | Roof Report No. |
|---|---|
| 04/16/26 | 6599 |

| Project Address |
|---|
| 112 Jimno Ave<br>Pittsburg, CA 94565 |

Roof Inspection Date: April 15th, 2026

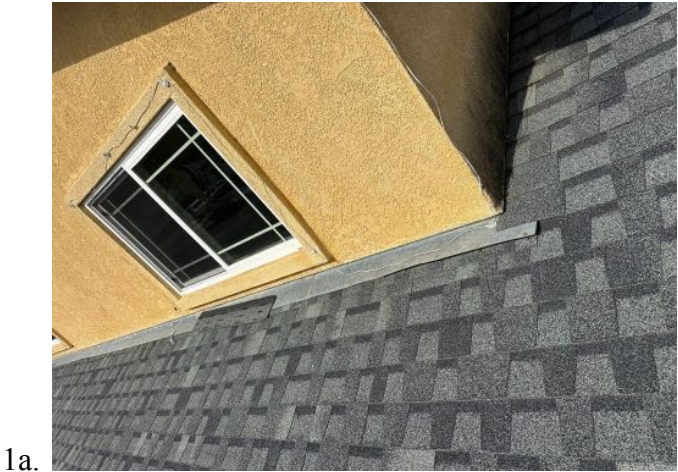
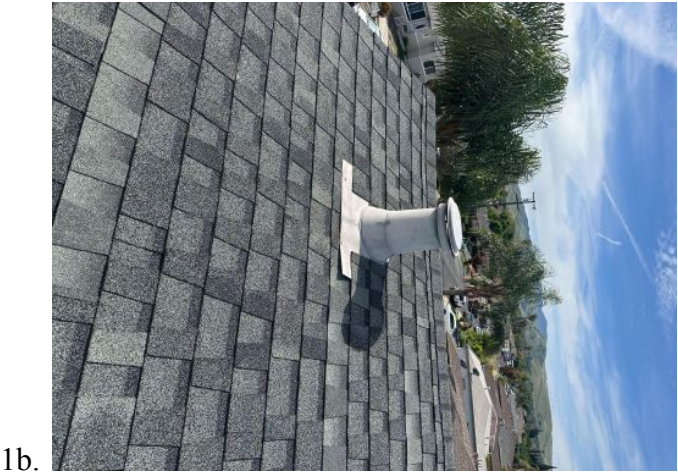
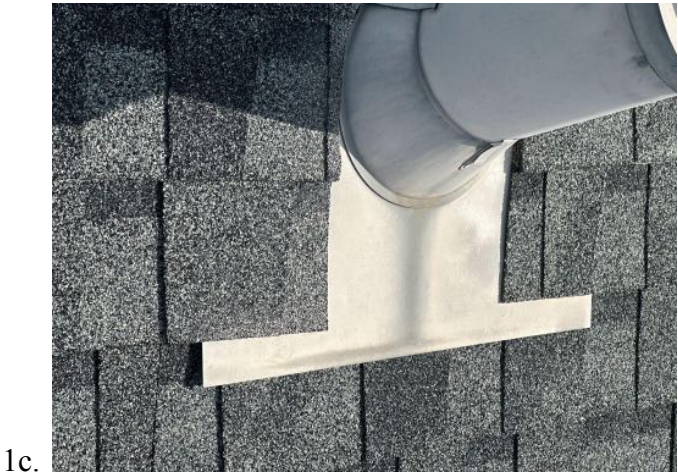
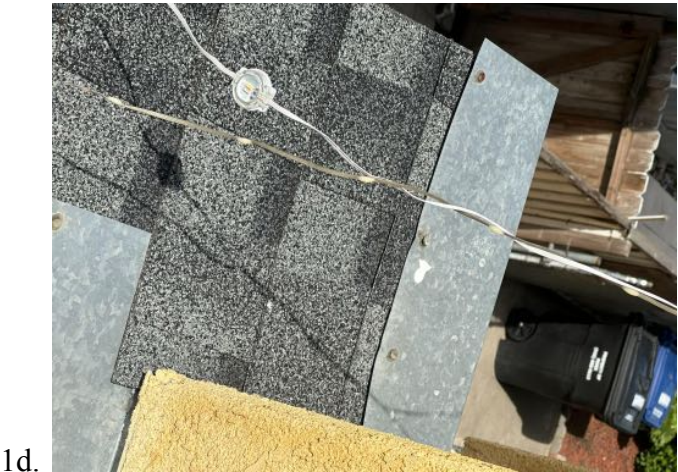
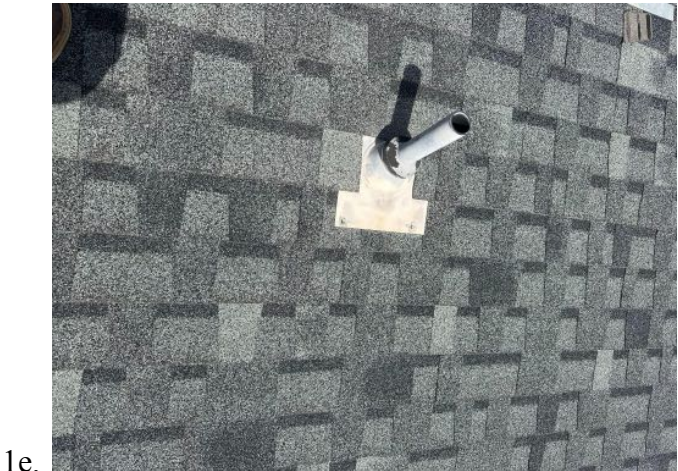
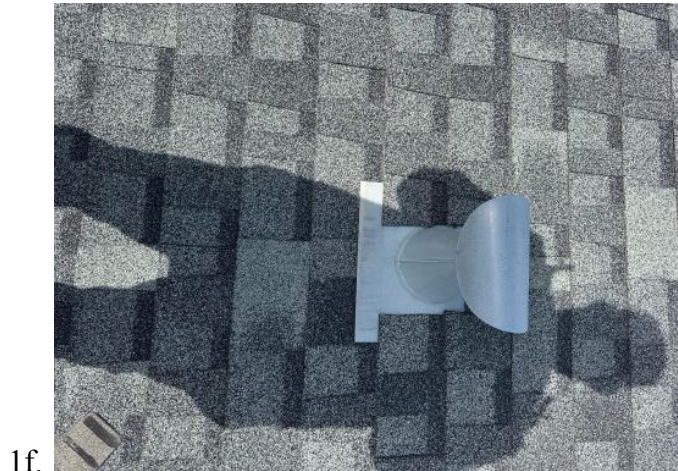
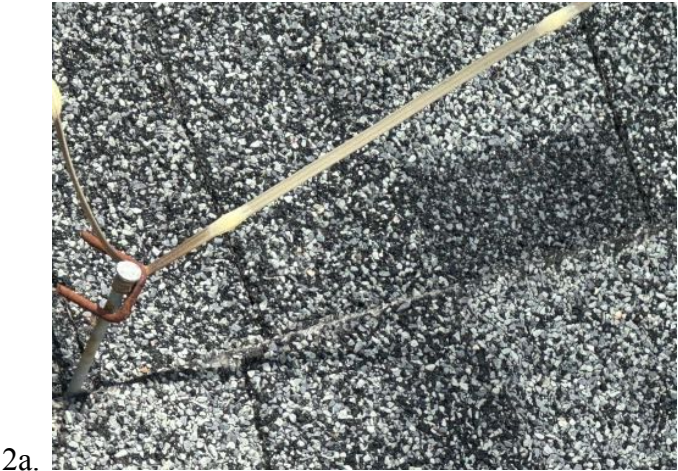
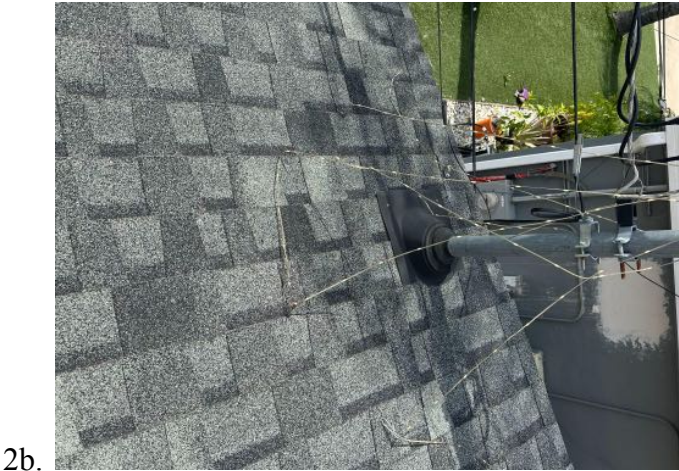
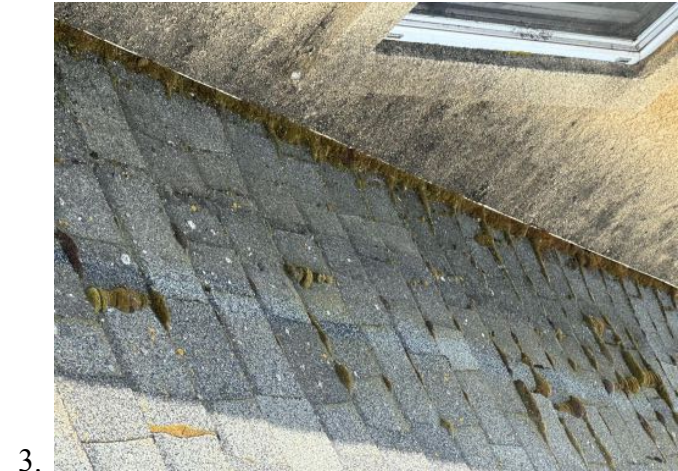
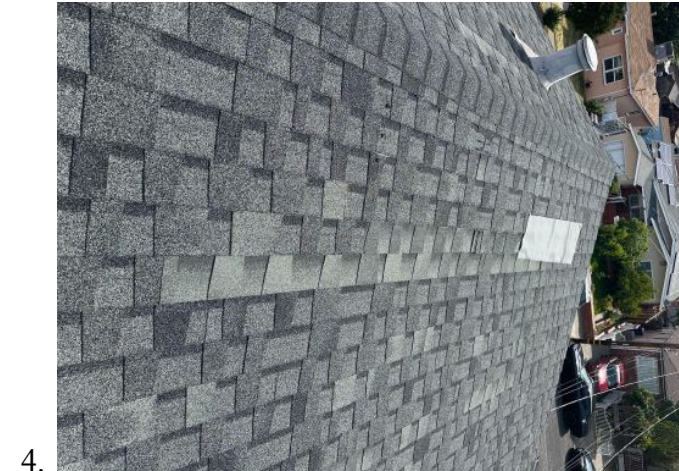
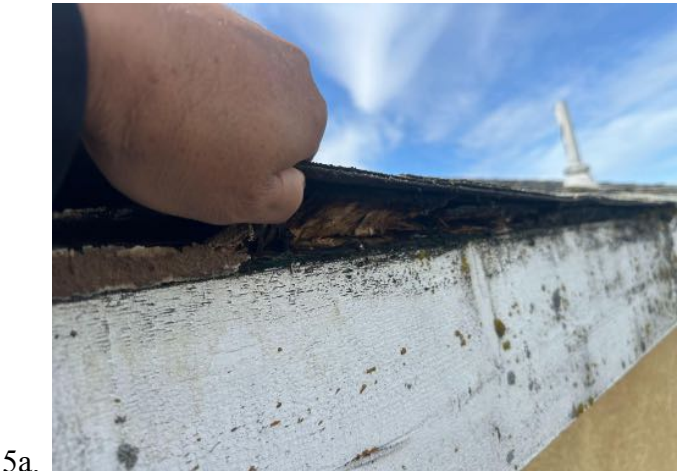
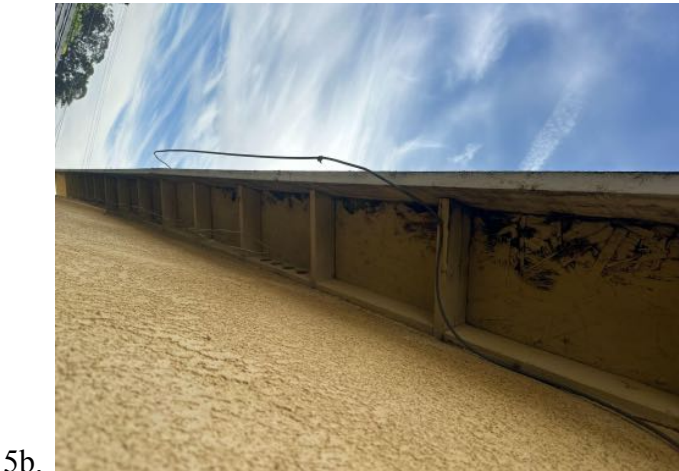
1. It is recommended that lifted flashings be secured with screws, that shiners be sealed with glue to prevent water intrusion, and that all roof flashings be painted.

2. Nails were installed onto the roof for light attachments, creating penetrations that may allow water intrusion. It is recommended that the nails be removed and sealed.

3. Moss buildup was observed on the north side wall of the house. It is recommended that the moss be removed.
4. It is recommended that the temporary patch be removed and shingles be installed in the affected area.

5. There is no drip edge metal or gutters installed at the eaves, which has contributed to dry rot due to unprotected fascia boards. It is recommended that the visibly dry-rotted plywood and fascia along the second-story eaves be repaired or replaced as needed, that any removed shingles be replaced, and that drip edge metal be installed. Alternatively, gutters may be installed in lieu of drip edge; please see Estimate #6600 for details and pricing.
