*Aldis Enterprises*  
Property Inspection Report

6 Nancy Ln, Chico, CA 95926  
Inspection prepared for: Anderson RJ  
Date of Inspection: 8/10/2026 Time: 9AM  
Age of Home: 1978 Size: 1,532 sqft  
Weather: Warm, Dry

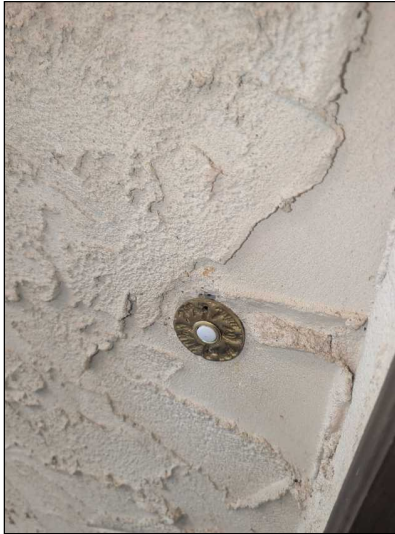
- Did not operate when tested.

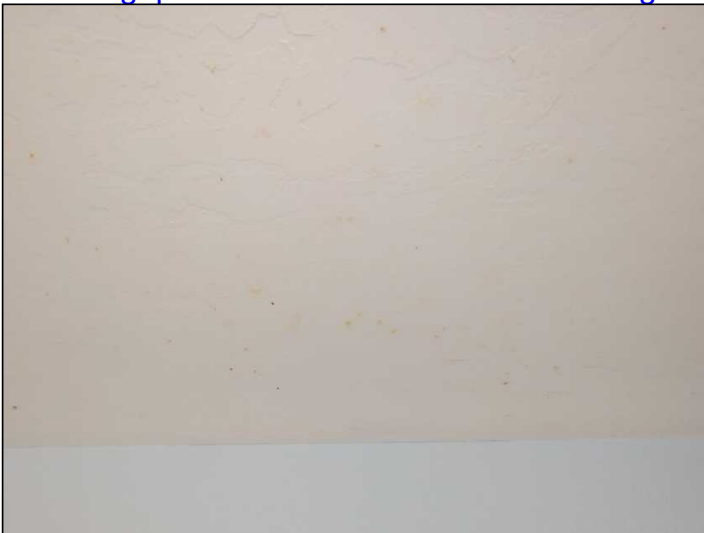
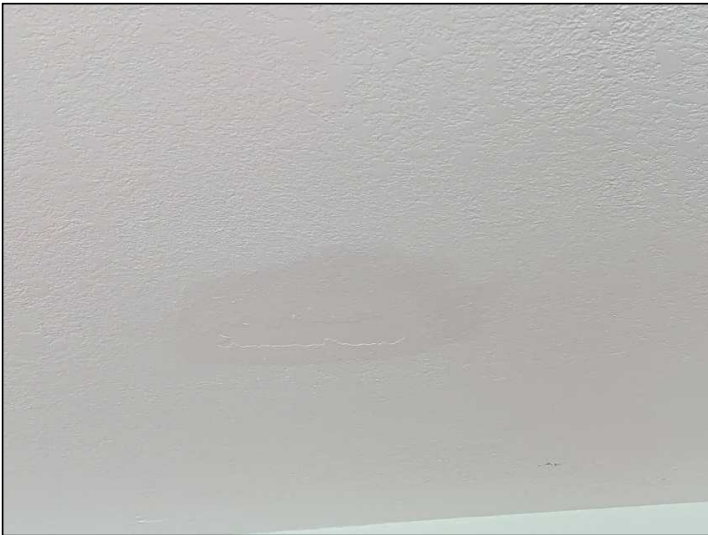
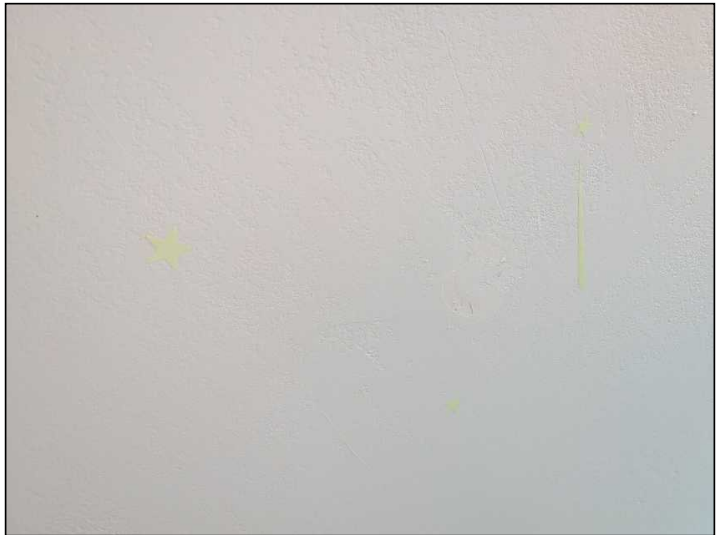
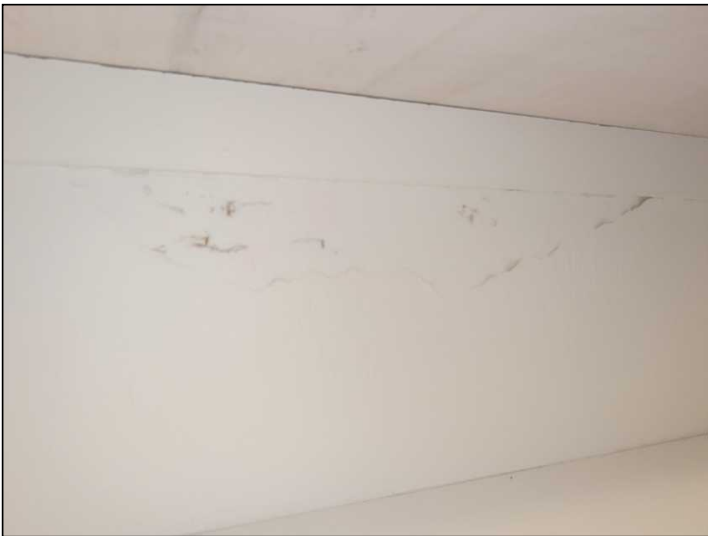
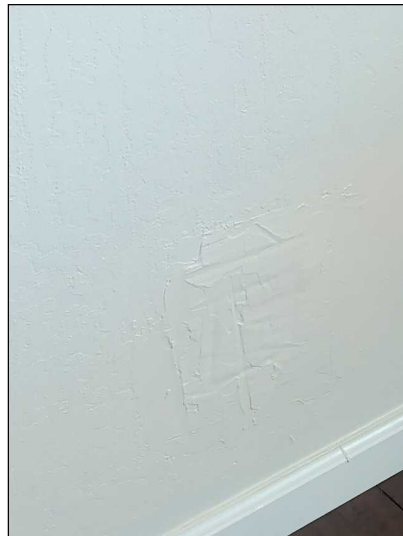
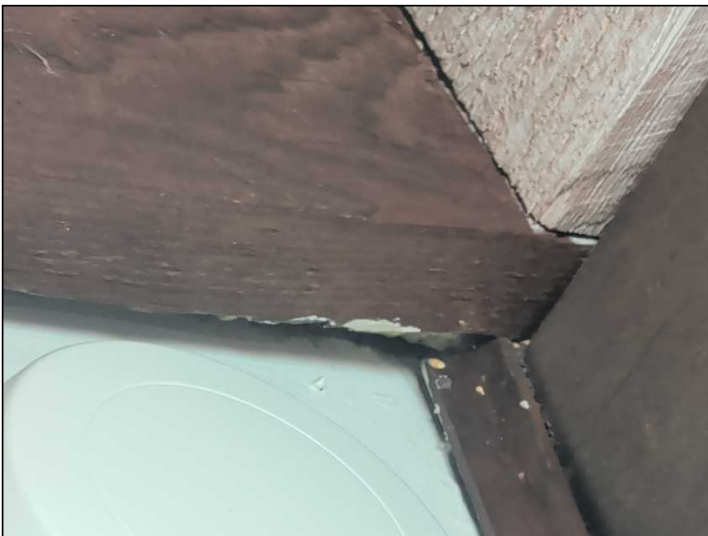
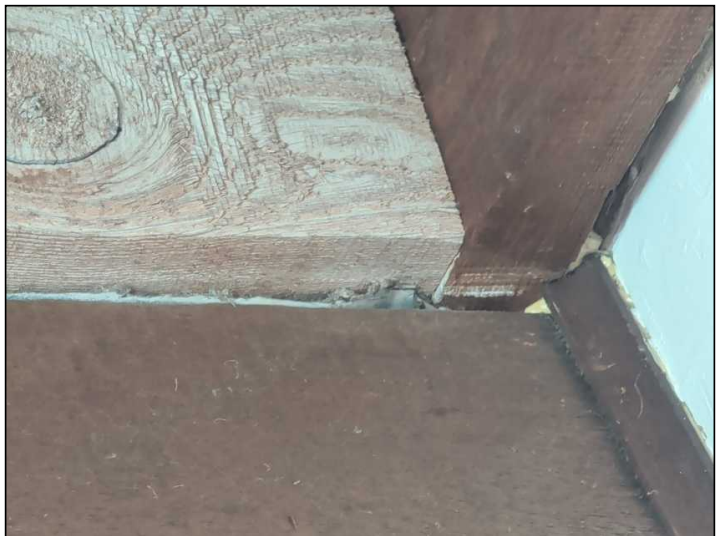
## 2. Walls/Ceilings Condition

- Appeared satisfactory for age and wear.
- Common cosmetic defects/imperfections observed.
- Evidence of some past repairs/modifications noted. Consult seller for any information regarding these areas.
- Some gaps were observed at the main living area beam trim work.

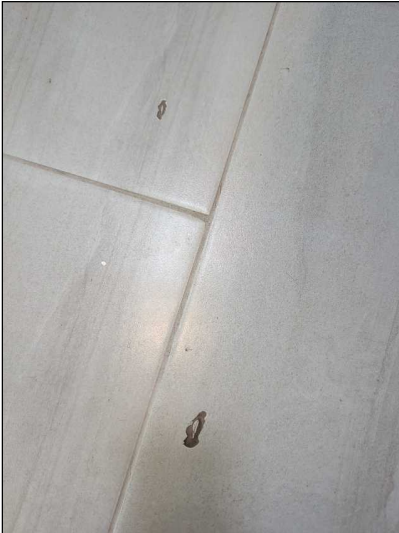
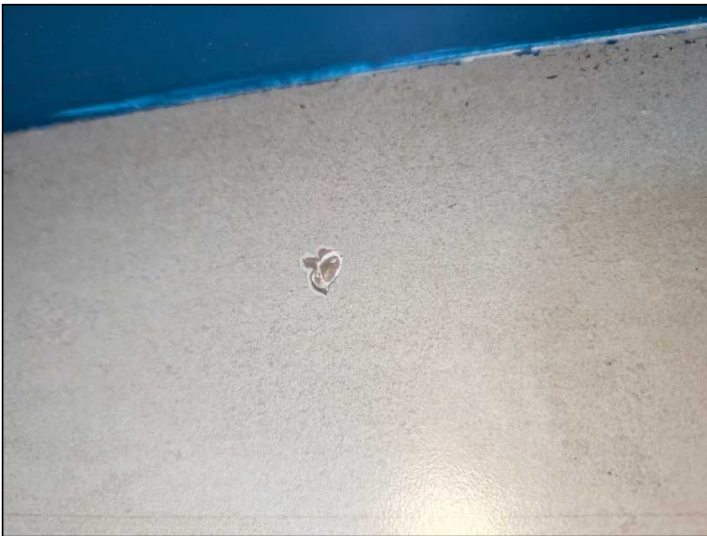
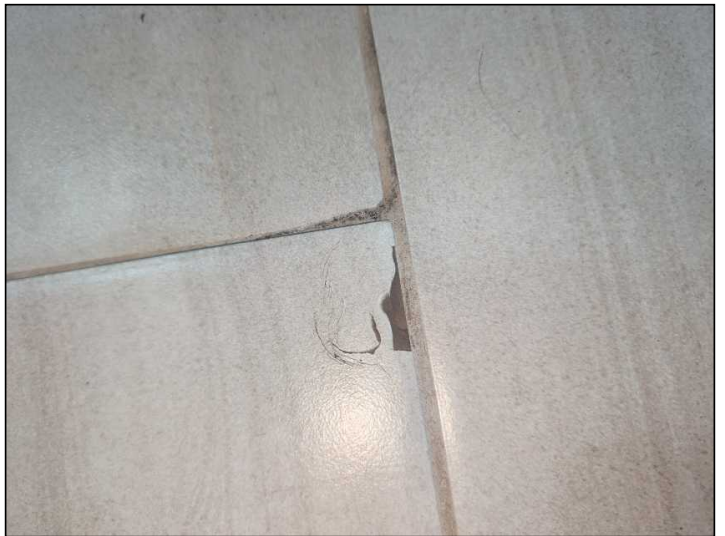
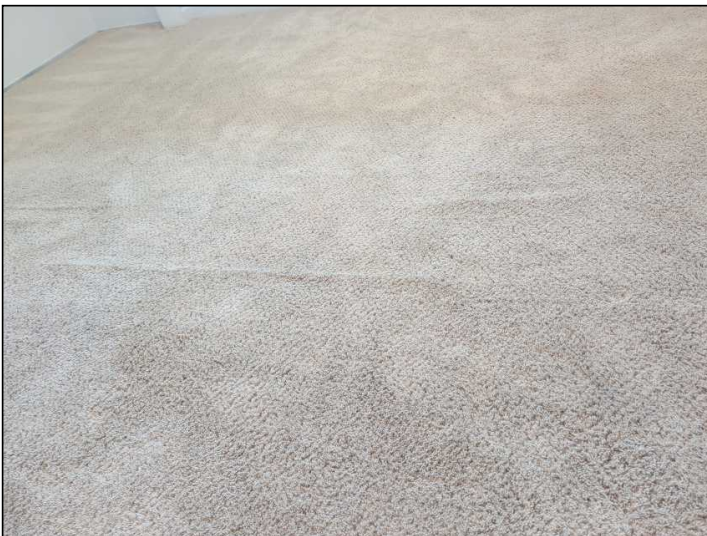
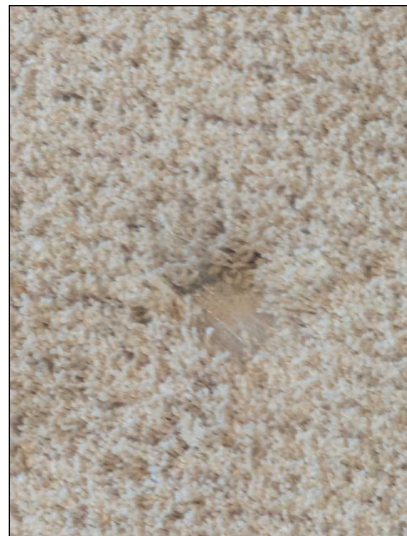
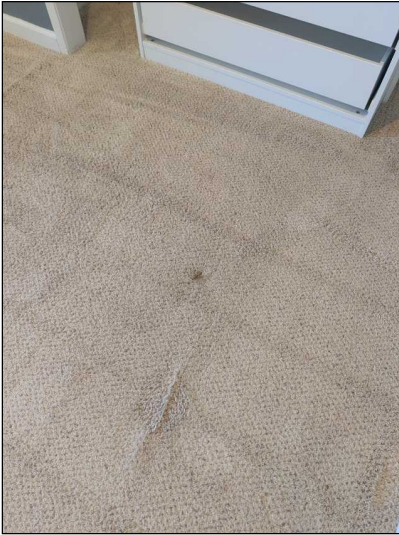
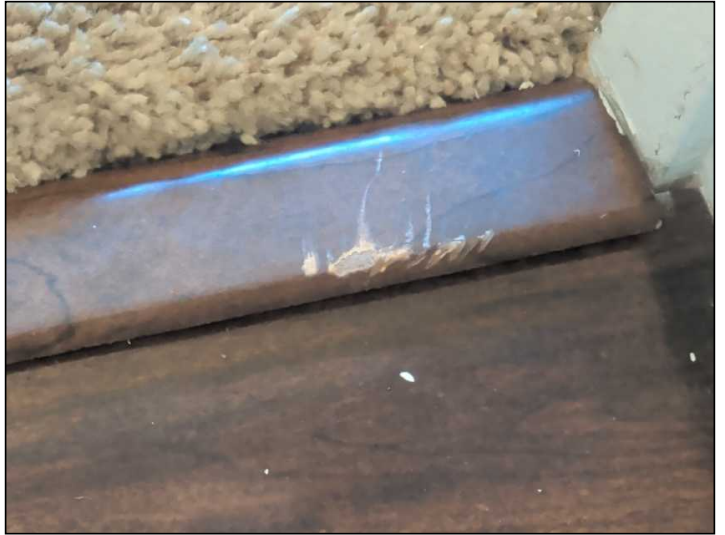
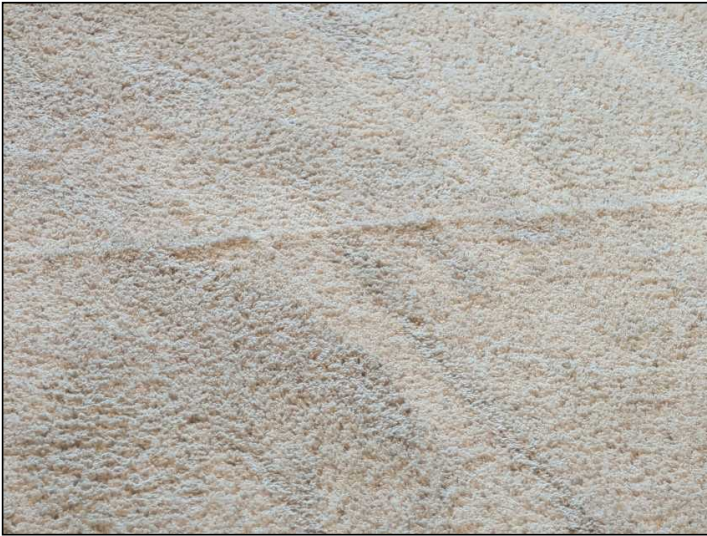
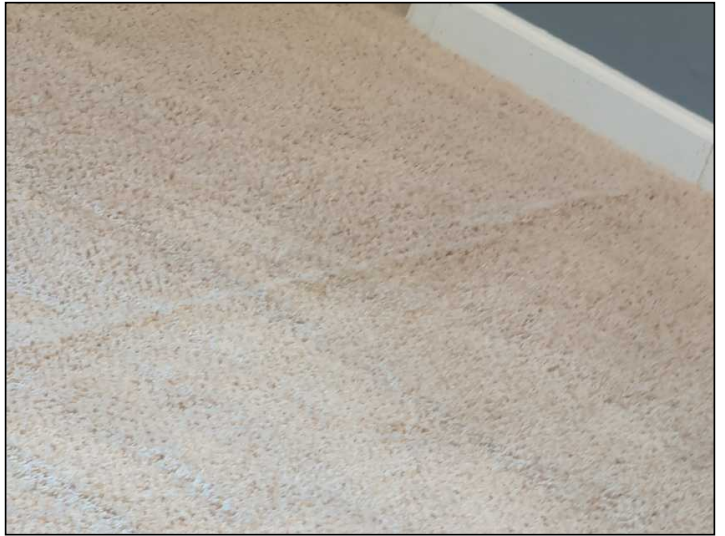
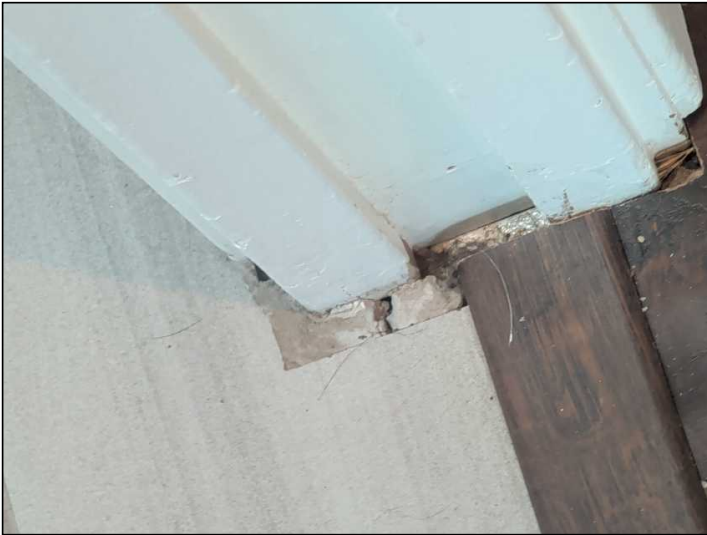
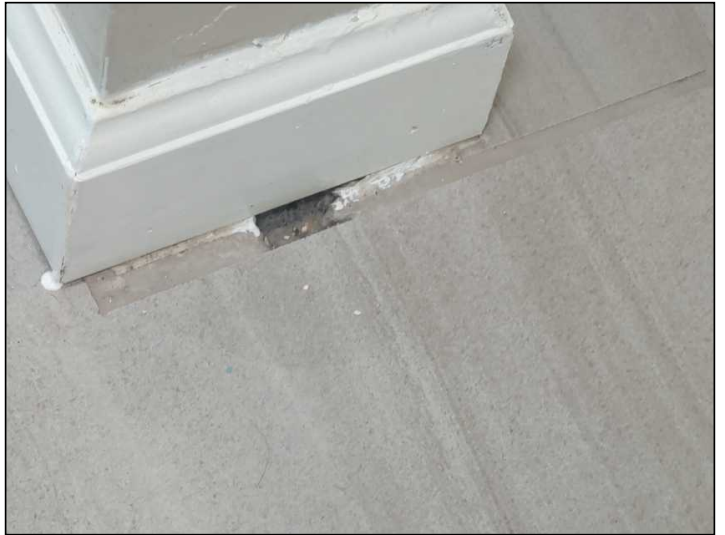
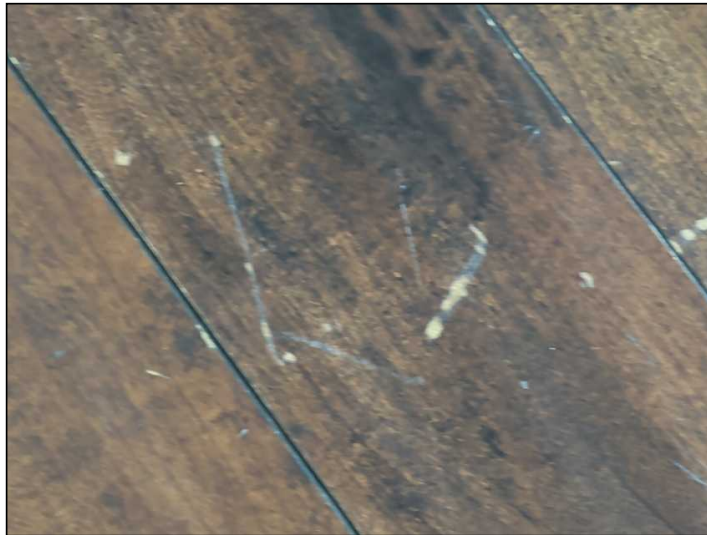
### 3. Flooring Condition

- Appeared satisfactory for age and wear.
- Some damaged flooring observed.
- Recommend having the carpets stretched/repared as needed.

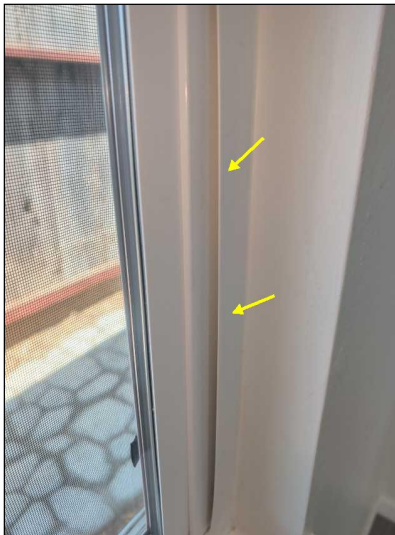
#### 4. Windows/Condition

- Appeared satisfactory for age and wear.
- All accessible windows were functional when tested.
- Some loose interior window trim noted.

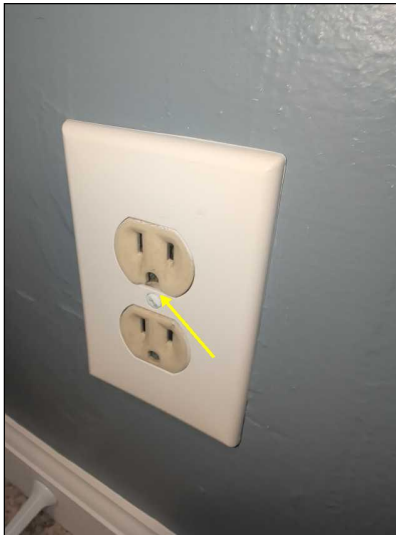
#### 5. Electrical

| Interior Areas | | |
|---|---|---|
| Page 10 Item: 5 | Electrical | • A worn/damaged outlet was noted at the front guest bedroom; these can cause loose connections and potential arcing, should be replaced as needed. |

- All accessible interior electrical outlets/fixtures tested good at inspection.
- A switch near the front entry did not seem to operate anything when tested. Consult seller.
- Current safety standards call for bedroom and living area electrical circuits to be **AFCI** protected. Though not required for this home at the time of construction, it is worth considering this safety upgrade to the home electrical system, and may be required at such time of any major remodeling/addition work on the home involving these electrical circuits.
- A worn/damaged outlet was noted at the front guest bedroom; these can cause loose connections and potential arcing, should be replaced as needed.

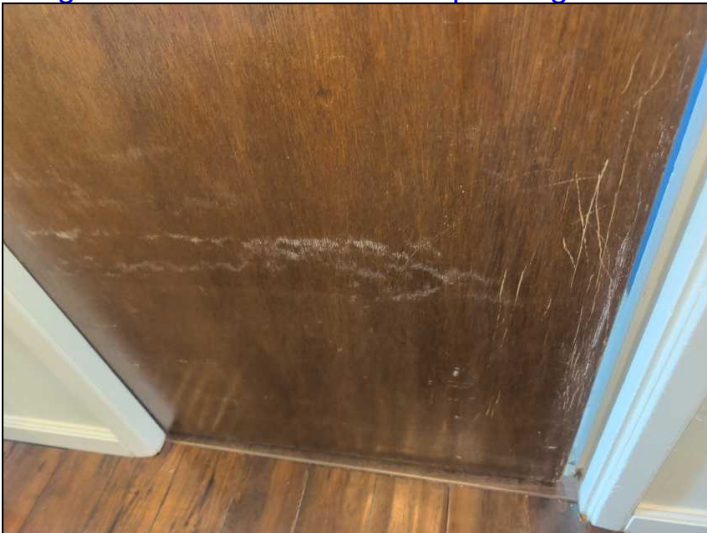
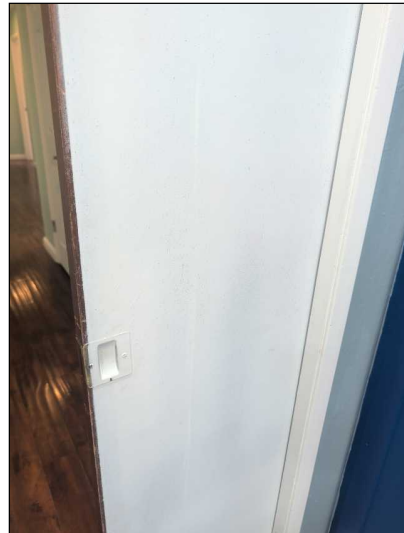
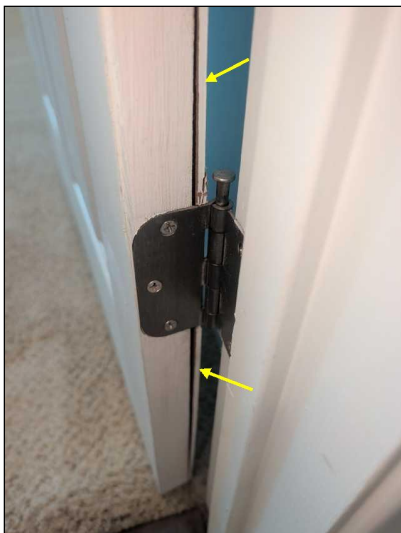
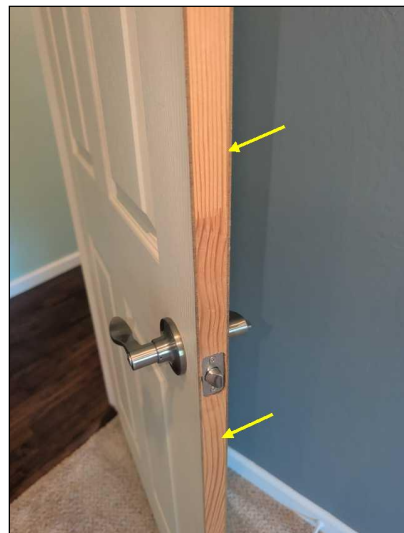
## 6. Interior Doors

- Appeared satisfactory for age and wear.
- All doors were functional at inspection.
- Some cosmetic damage observed.
- A guest bedroom door was separating at the hinged side.

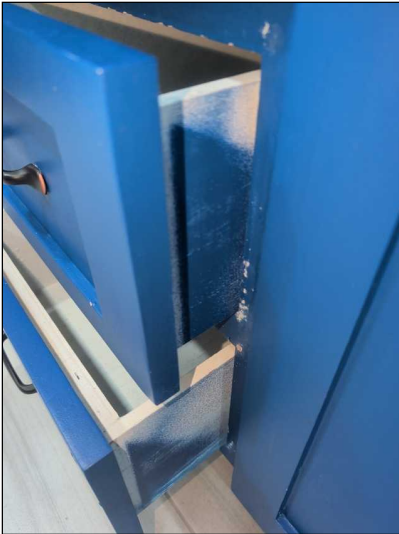
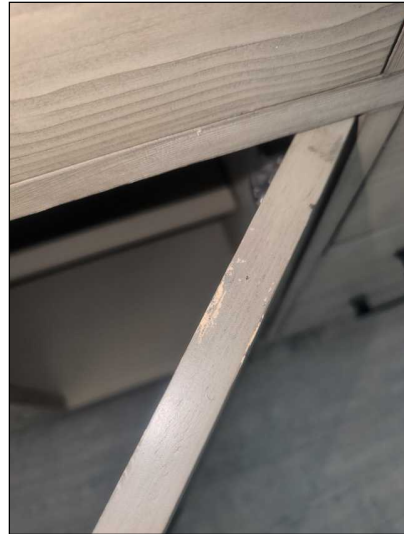
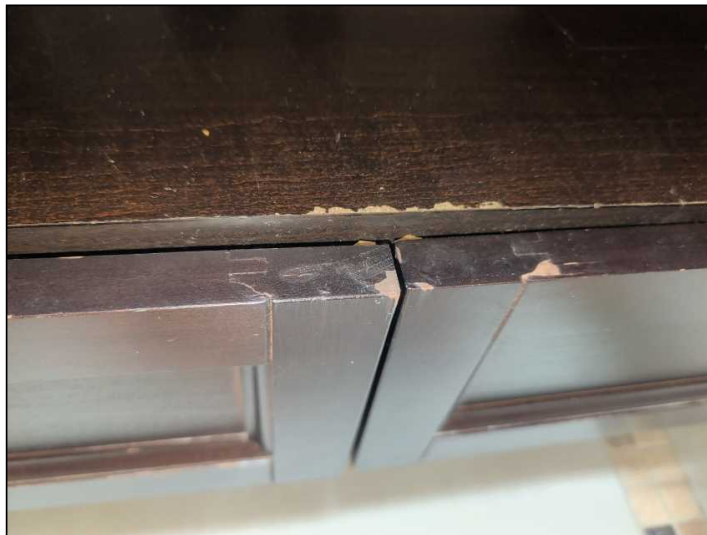
## 7. Cabinets

- Appeared satisfactory for age and wear.
- Cosmetic defects observed.

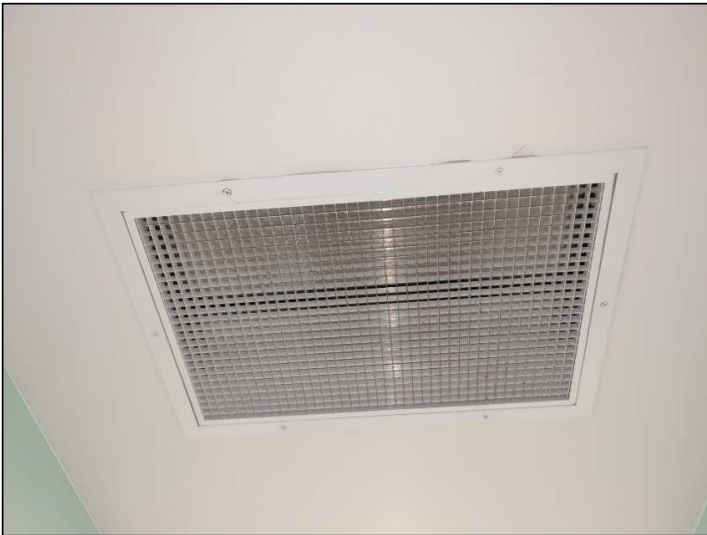
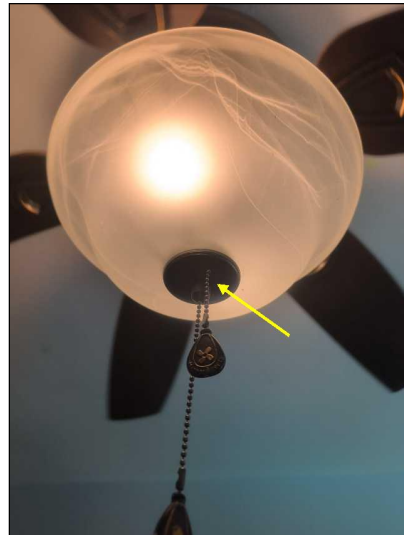
## 8. Ceiling fans

- Appeared satisfactory for age and wear.
- Functional when tested.
- Whole house fan appeared satisfactory for age and wear, functional at inspection.
- The fan pull chain at the rear guest bedroom did not function when tested.

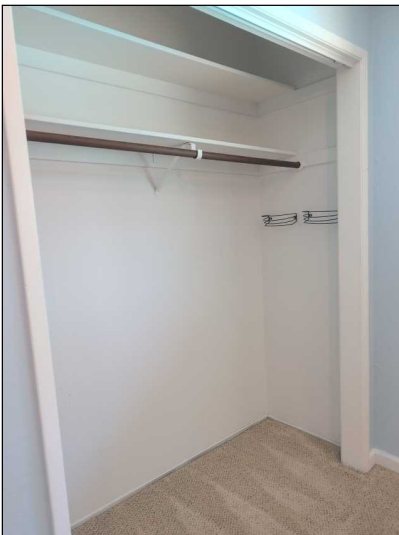
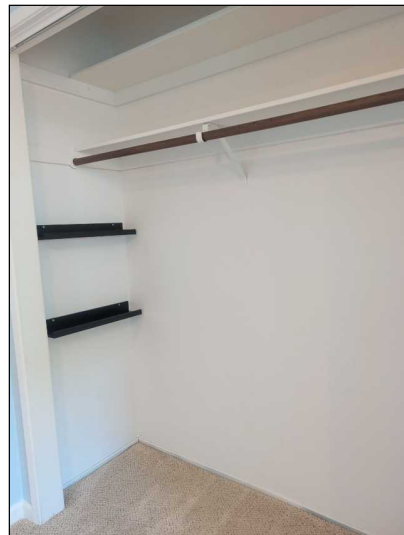
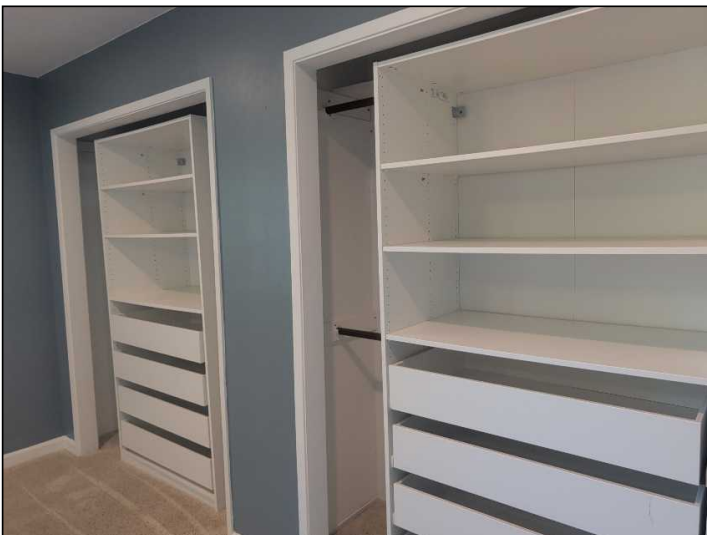
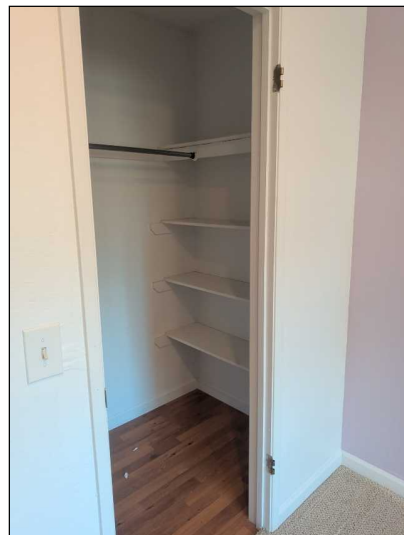
## 9. Closets

- Appeared satisfactory for age and wear.
- Missing/removed closet doors noted.

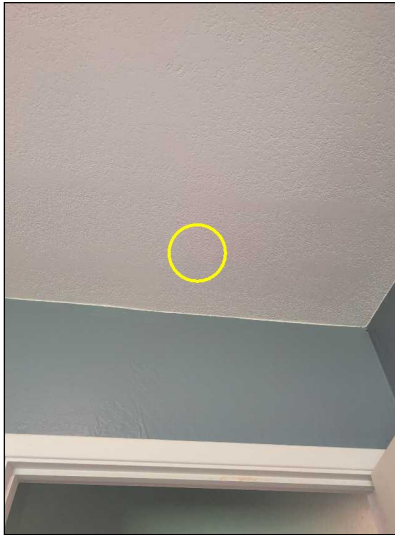
## 10. Smoke/CO Detectors

| Interior Areas | | |
|---|---|---|
| Page 14 Item: 10 | Smoke/CO Detectors | • Recommend adding smoke alarm at the master bedroom where missing. |

- Smoke detectors observed in two of the three bedrooms, smoke and carbon monoxide alarms noted in the common areas outside the sleeping rooms as required.
- All existing alarms were functional at inspection.
- Current safety standards call for Smoke alarms in each sleeping room, each common area outside sleeping rooms, each living area, and each room with a fuel fired heating system. Carbon Monoxide alarms should be installed at each common area outside sleeping rooms, within 15 feet, and in each room with a fuel fired heating device.
- **Recommend adding smoke alarm at the master bedroom where missing.**

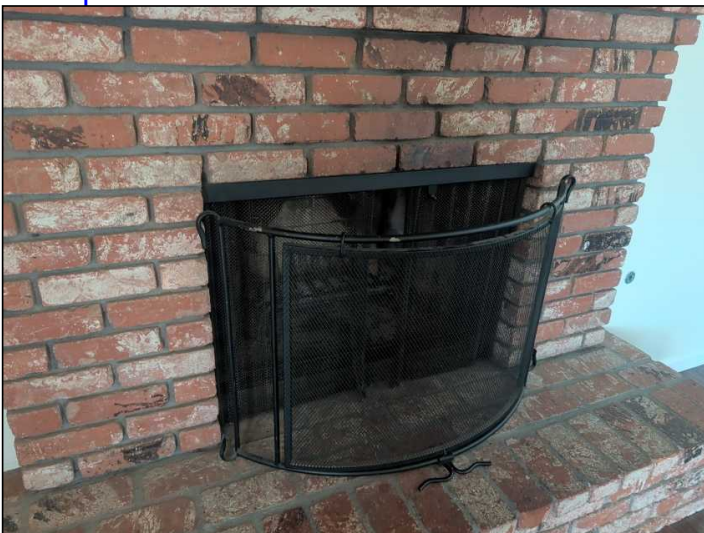
## 11. Fireplace/Stove Condition

- Appeared to be in serviceable condition.
- Fireplaces, stoves, flues and chimneys should always be professionally inspected and serviced as needed by a licensed specialist/chimney sweep, and certified for safety prior to use, and then again every year thereafter for safety and efficiency.
- Recommend further evaluation with corrections as needed by a licensed specialist/chimney sweep.

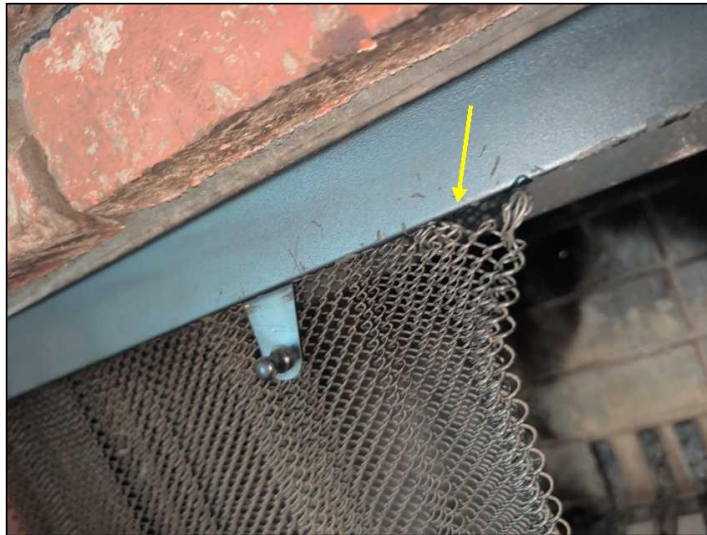
Disconnected screen at the fireplace, left side.

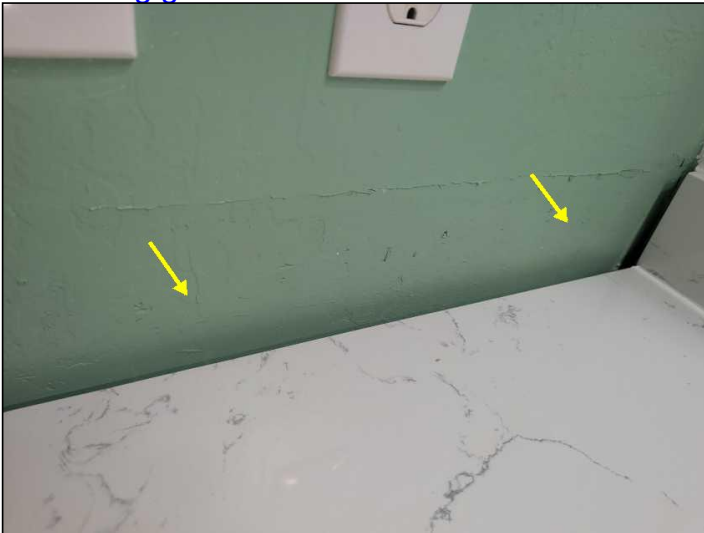
- Appeared satisfactory.
- Consider adding a back splash where missing.
- Caulking/grout maintenance recommended.

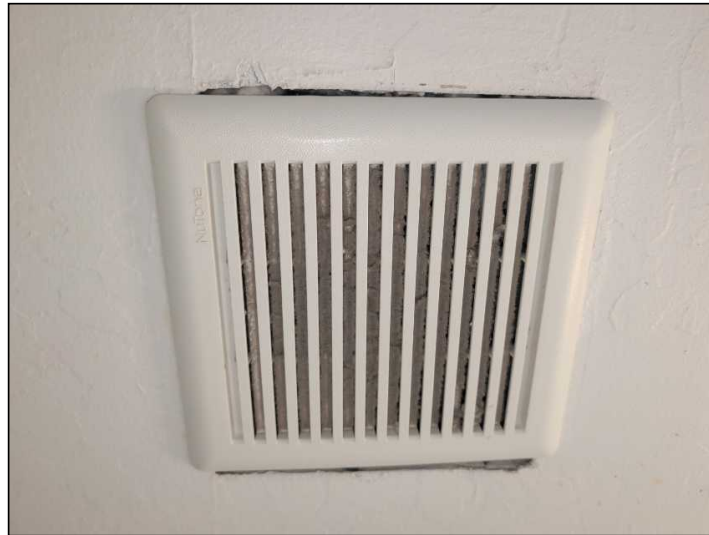
- Appeared satisfactory for age and wear.
- Functional at inspection.
- Bathroom exhaust fans should be cleaned as needed; this should be done periodically.
- Unable to verify if the bathroom exhaust fans terminate to the exterior.

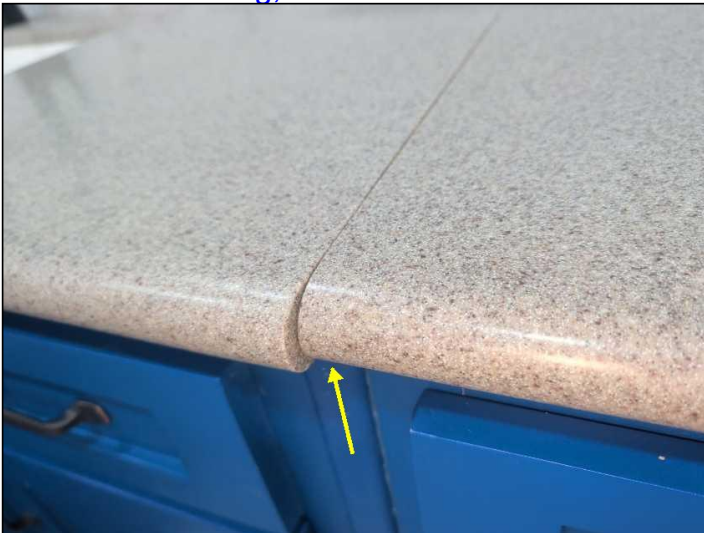
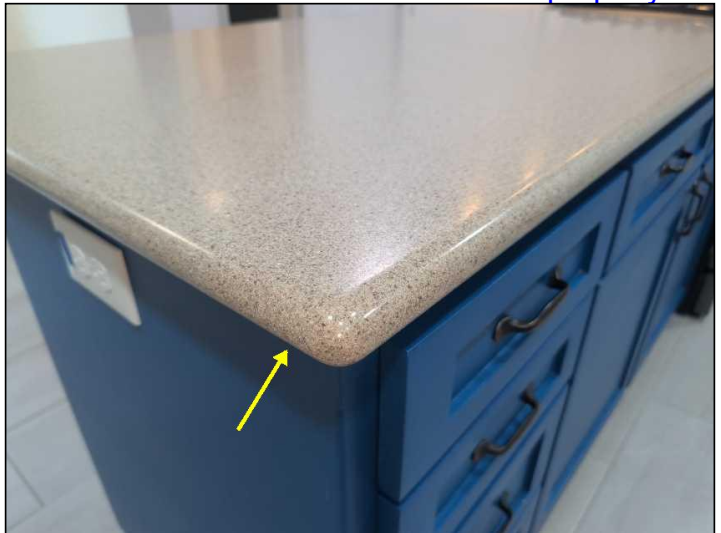
- The counter at right side of sink area appears to have shifted slightly, this section is set in further than the remaining, in a corner of the counter across from the sink area was not secured properly.

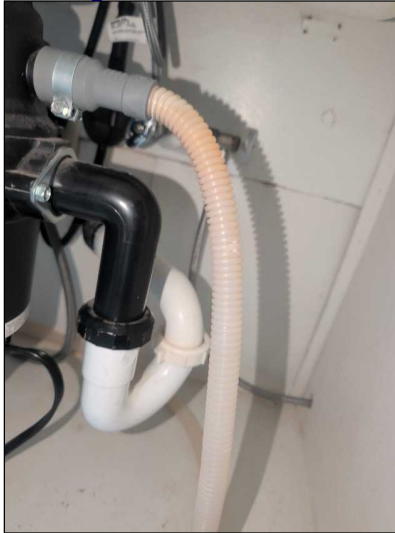
- Functional at inspection, no active leaking detected.

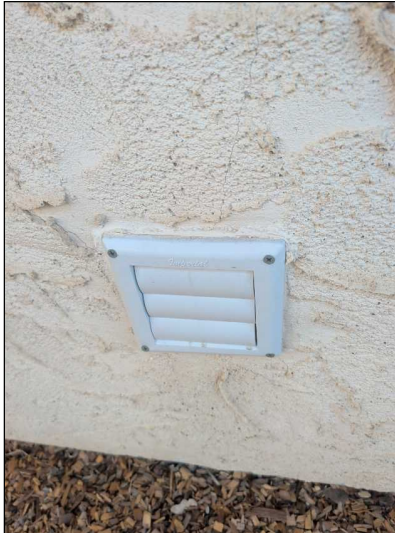
- Appeared satisfactory.
- Dryer vent pipes and hoods should be cleaned periodically to prevent excessive lint buildup and potential fire hazard.

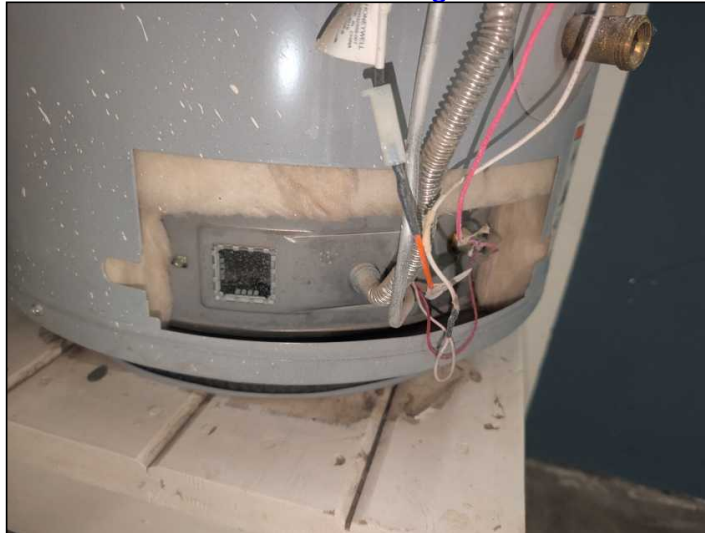
- Appeared satisfactory, but the outer cover was missing.

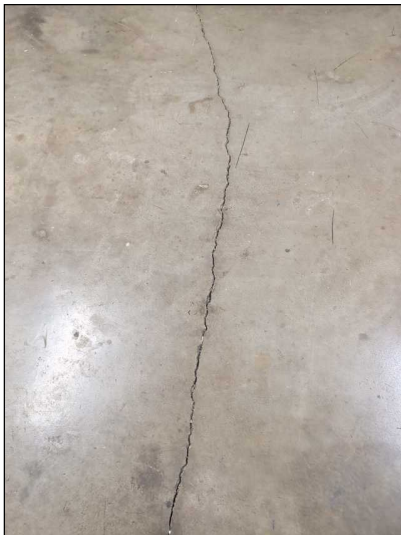
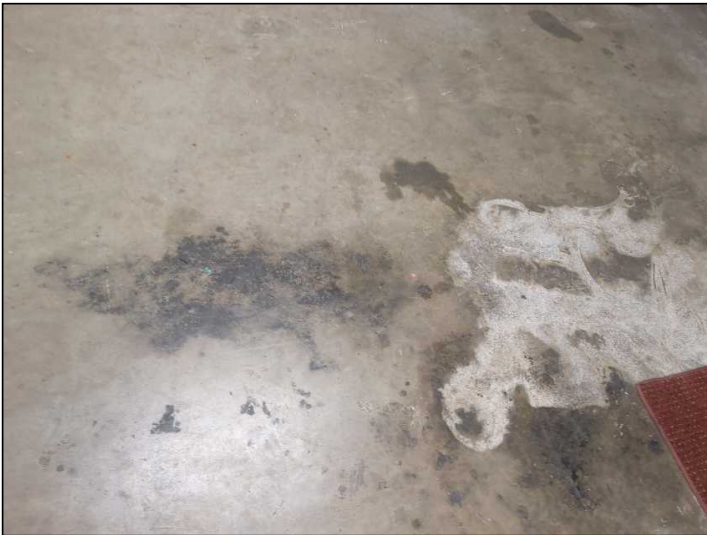
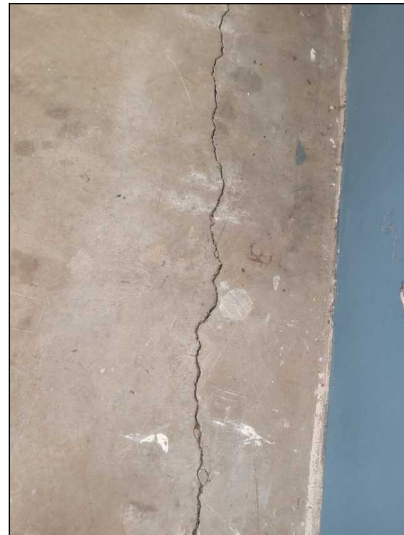
- Concrete cracking noted.
- Common stains and normal wear and tear observed.
- Consider having the garage concrete floor further evaluated and addressed as needed by a licensed concrete contractor.

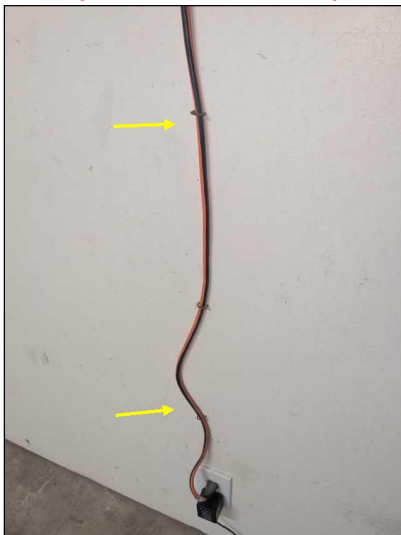
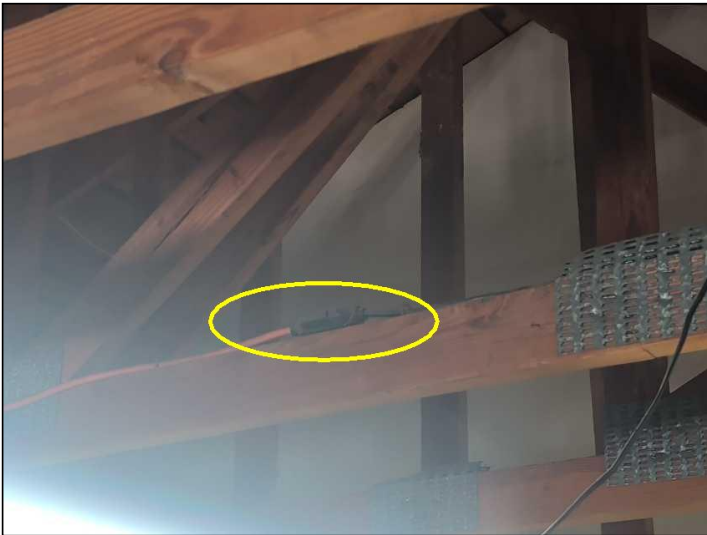
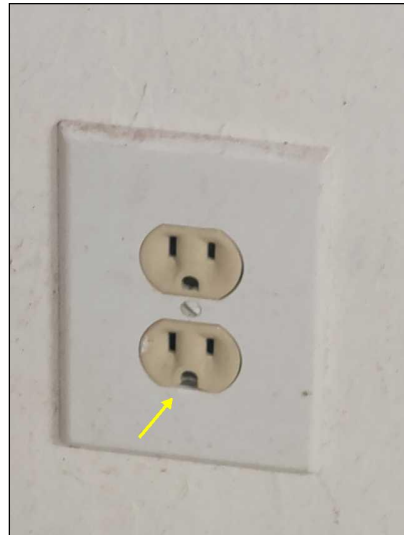
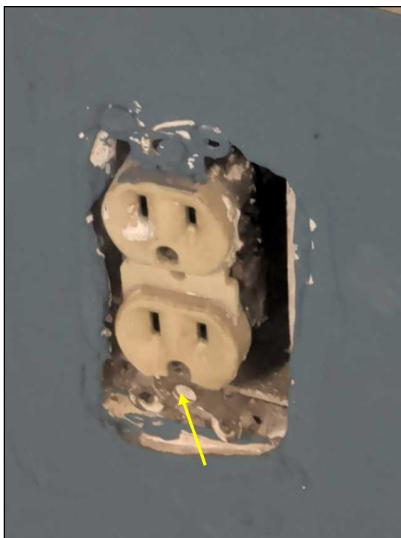
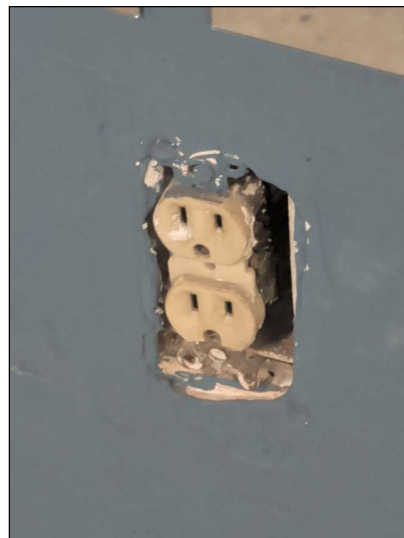
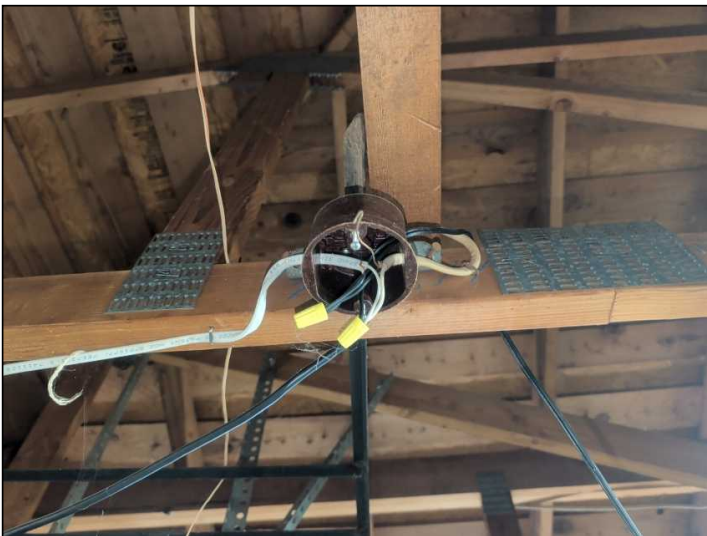
- Improper/unprofessional wiring practices observed.
- Improper use of extension cord observed. Extension cords should not be used as permanent or long term power sources.
- Recommend further evaluation with corrections as needed by a licensed electrical contractor.
- Worn/damaged outlets noted; these can cause loose connections and potential arcing, should be replaced as needed.
- Missing cover plates observed, potential fire/shock hazard, should be installed for safety.

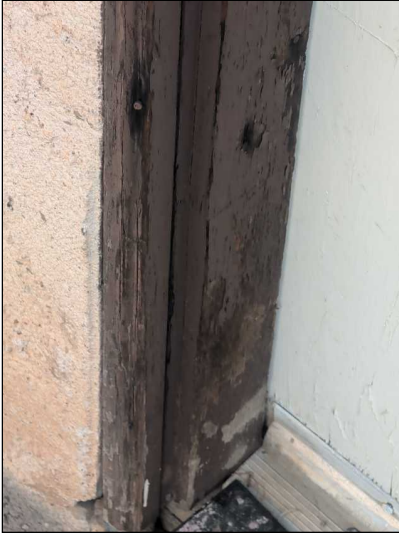
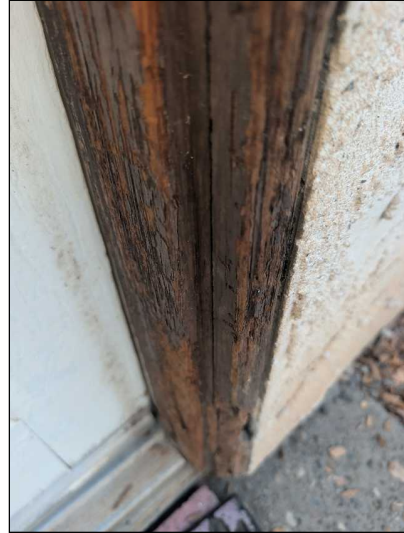
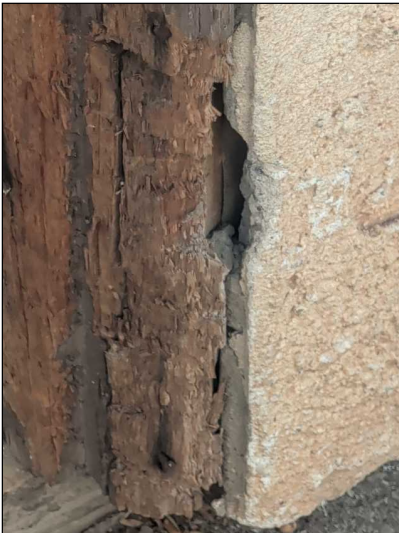
- Functional at inspection.
- Weatherization should be improved at exterior door.
- Damage observed at exterior door frame/jamb.
- Exterior doors/jambs/trim should be kept painted/stained/sealed to protect from elements.
- Consider updating the garage exterior door.

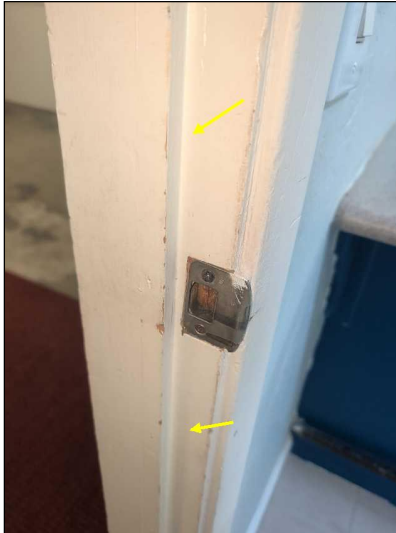
- Appeared satisfactory for age and wear.
- Functional at inspection.
- Weatherization should be improved at fire door.

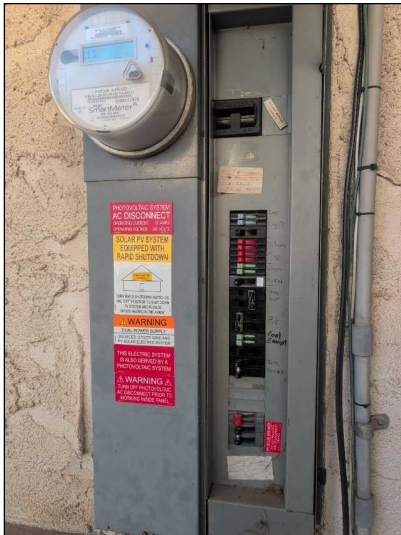
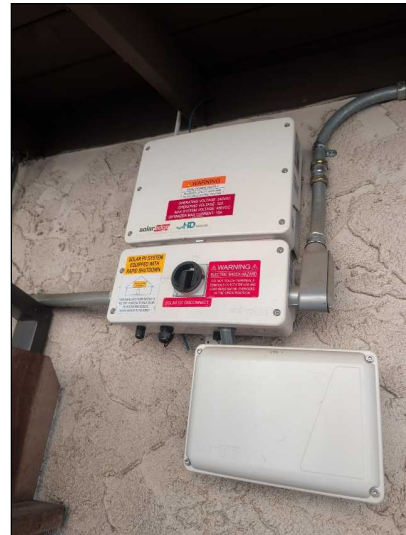
- Modifications to panel noted.
- Home has a solar system installed. Appeared satisfactory and functional at inspection, but fully evaluating these systems is beyond the scope of a general home inspection. Consult seller for operation and maintenance information, and recommend evaluation of system and all components by a licensed solar specialist.
- Home has a Zinsco/GTE Sylvania brand panel. These are widely considered obsolete, unreliable, and potentially unsafe. This panel should be evaluated by a licensed electrical contractor and updated/replaced as needed.

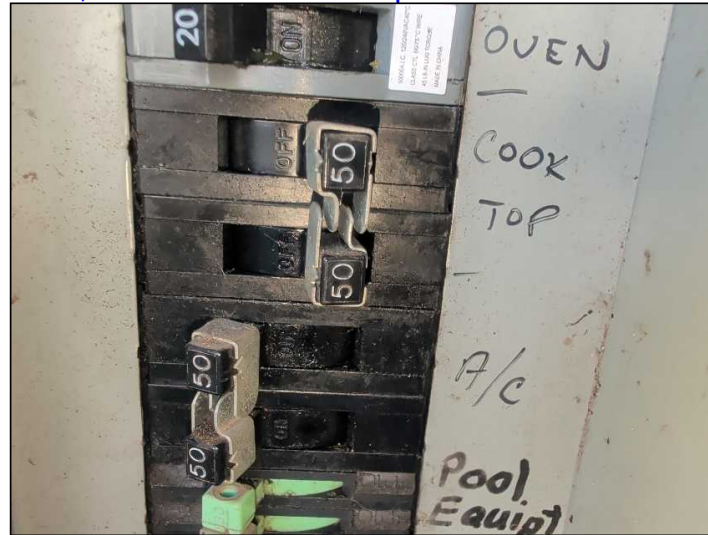
- One 50 amp breaker was off, identified for "cook top".

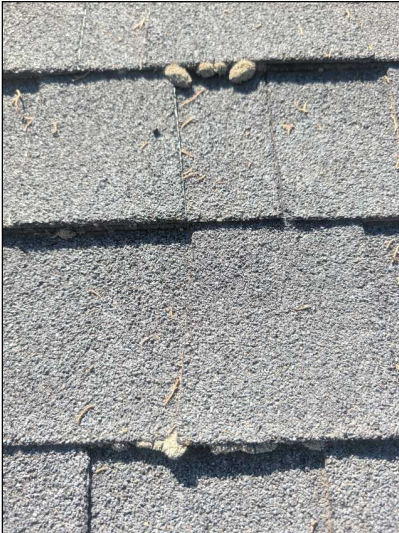
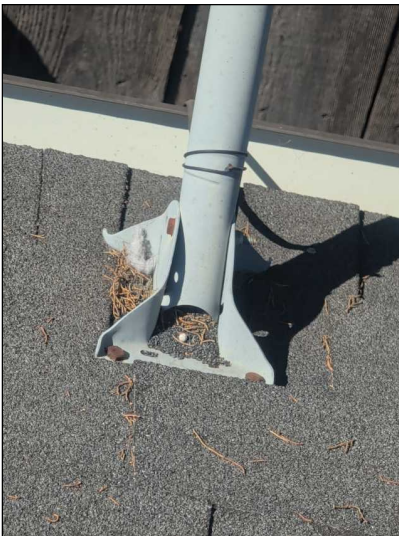
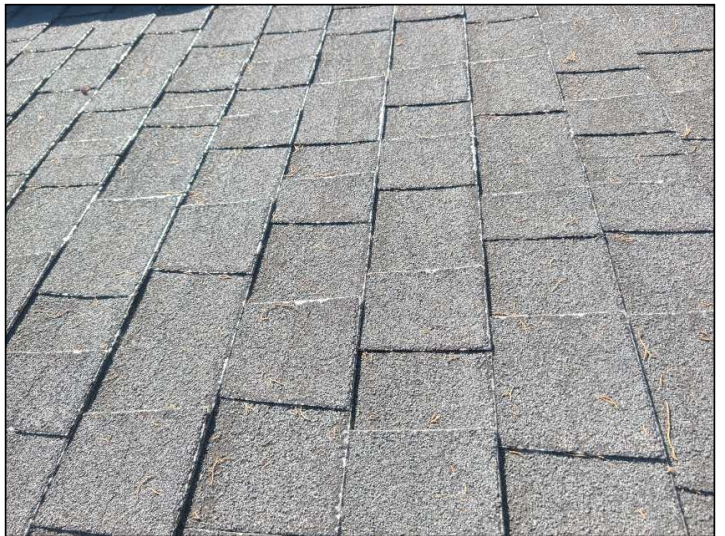
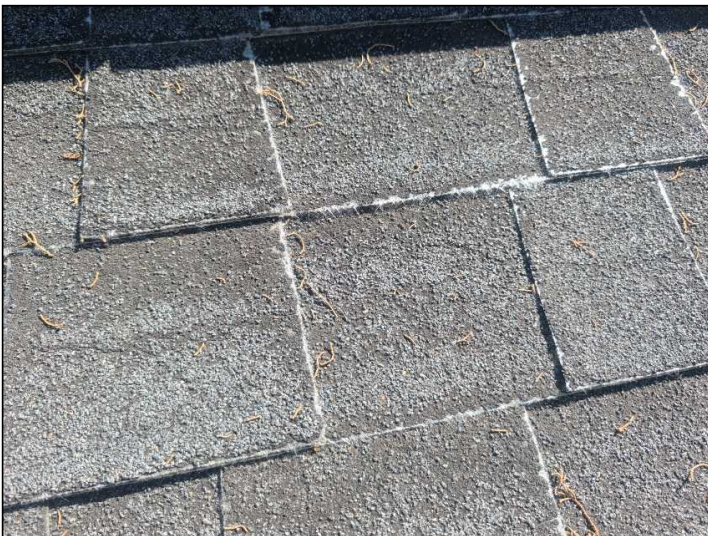
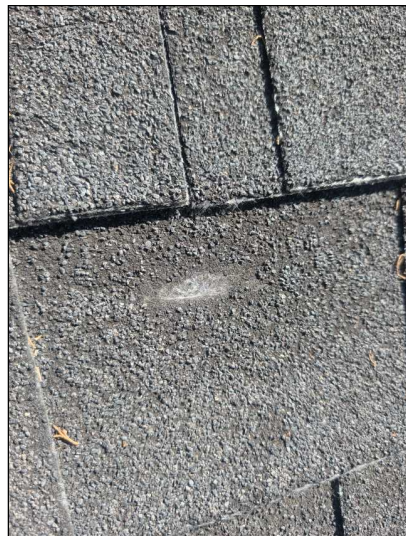
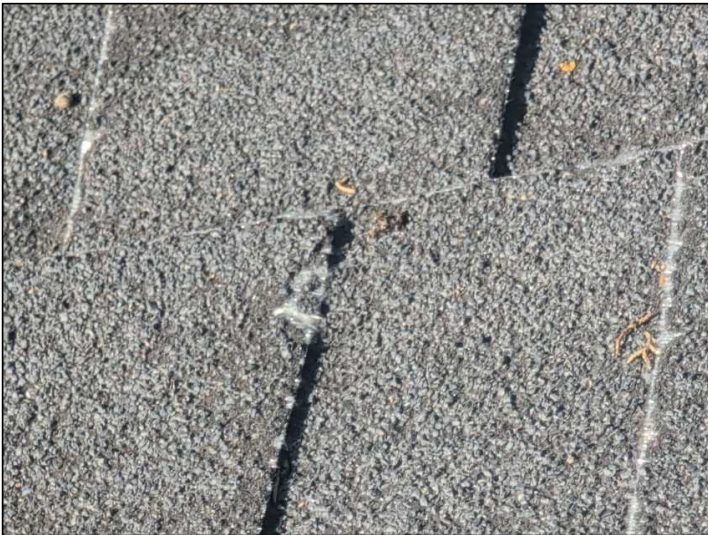
### 1. Roof Condition

- Typical wear and tear noted for an aging roof.
- Organic growth/moss observed on roofing materials.
- Exposed fasteners observed, these should be sealed as needed.
- Damaged shingles observed.
- Evidence of past repairs observed at the rear porch roof. Consult seller.
- Satellite dish/antenna installed directly through roof shingles; these should be checked for leaking periodically and sealed as needed.
- Consult seller for exact age of roof if known.
- Based on the age/overall condition of the roof, it is recommended having the roof fully evaluated with corrections as needed by a licensed roofing contractor, and having the remaining useful life determined, which may be limited.

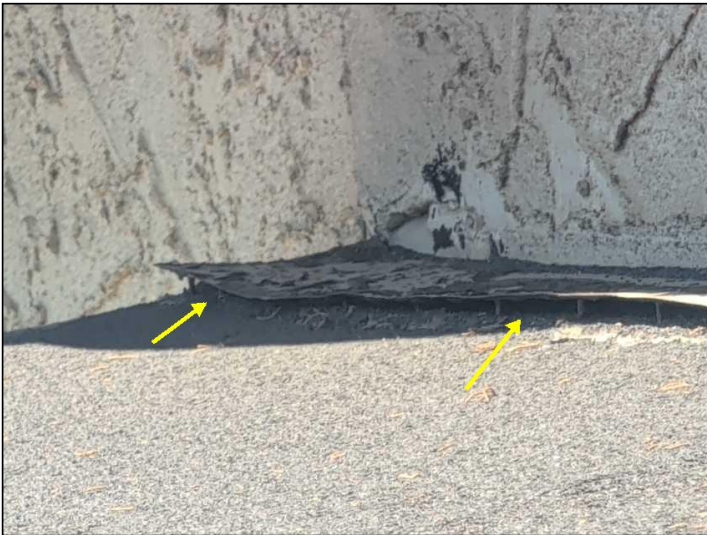
## 2. Flashing

- Loose/lifting flashing observed at the rear porch roof; should be secured properly as needed.

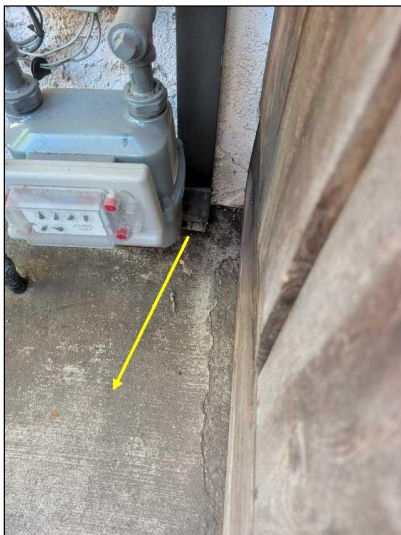
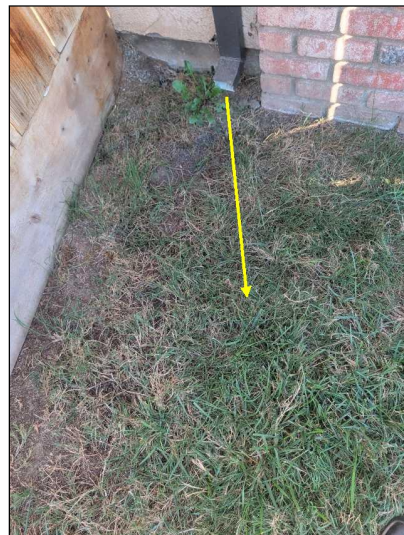
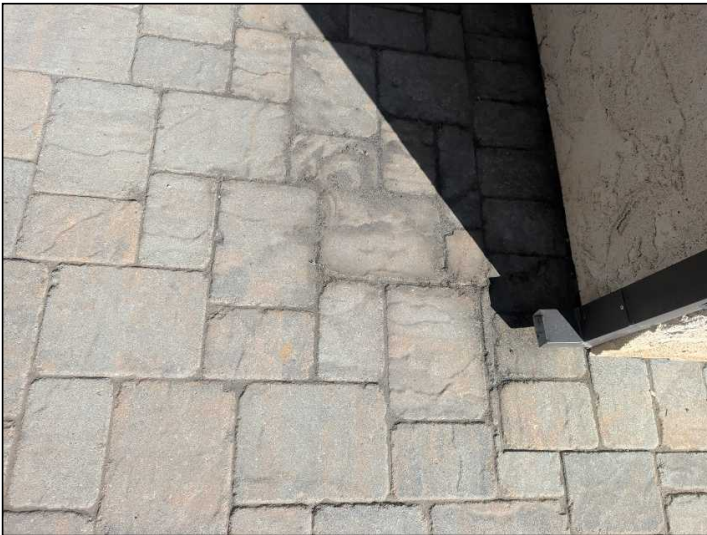
- Appeared satisfactory for age and wear.
- Downspout terminations should be improved as needed to take rain water further away from the foundation perimeter.
- Gutters and downspouts need to be kept clean for proper drainage.
- Gutters and downspouts should be evaluated during heavy rains to determine specific needs for improvement.
