*Aldis Enterprises*  
Property Inspection Report

6 Nancy Ln, Chico, CA 95926  
Inspection prepared for: Anderson RJ  
Date of Inspection: 8/10/2026 Time: 9AM  
Age of Home: 1978 Size: 1,532 sqft  
Weather: Warm, Dry

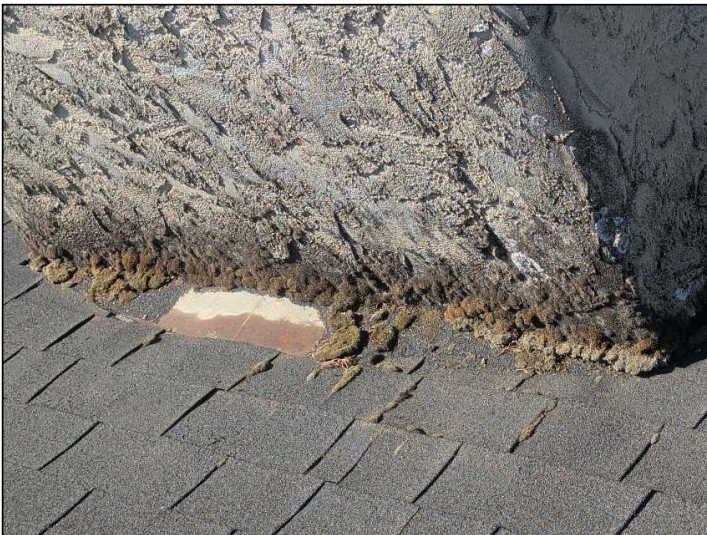
## 5. Chimney

- Maintenance/repairs needed.
- Organic growth observed at the chimney cladding.
- Loose/lifting flashing observed at chimney.
- Additional sealing may be needed at chimney cap.
- Rust observed at the chimney cap metal.
- Chimneys, flues, fireplaces and stoves should always be professionally inspected and serviced as needed by a licensed specialist/chimney sweep, and certified for safety prior to use, and then again every year thereafter for safety and efficiency.
- Recommend further evaluation with corrections as needed by a licensed contractor/chimney specialist.
- **Flashing at chimney base needs to be cleaned and kept clear for proper drainage.**

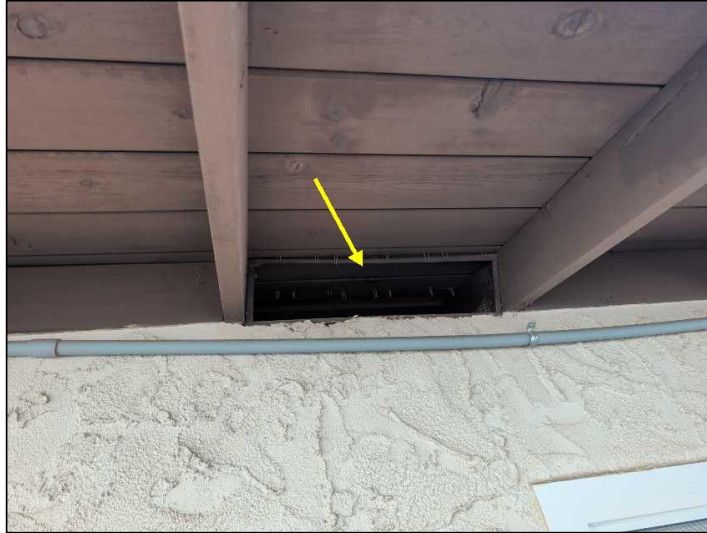
#### 4. Ventilation Condition

- A vent screen at the right side eave was missing; should be installed where missing to prevent pest intrusion.

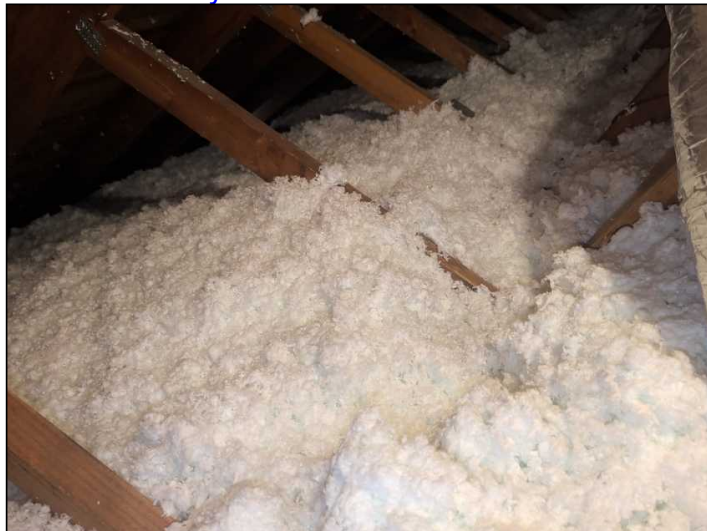
- Visible insulation appeared satisfactory.

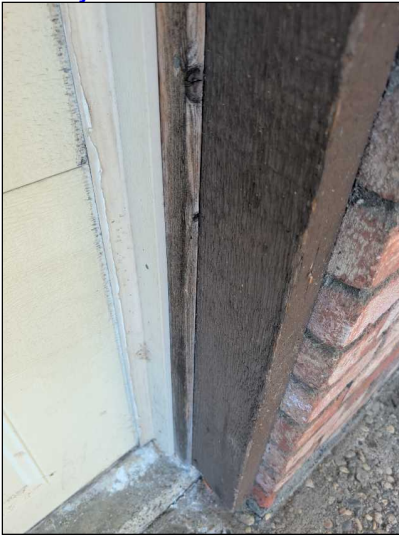
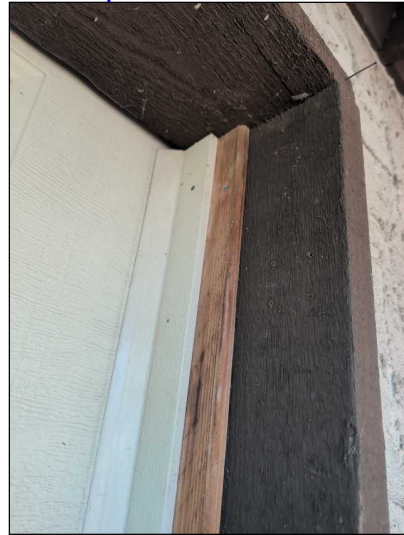
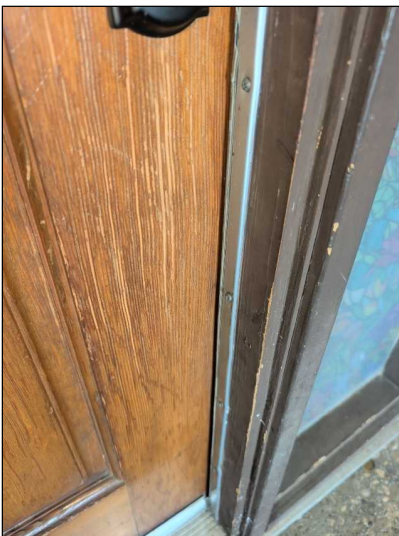
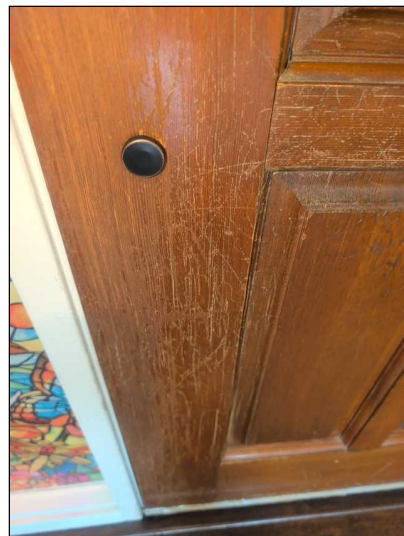
- Appeared satisfactory for age and wear.
- Exterior doors were functional at inspection.
- Exterior doors/jambs/trim should be kept painted/stained/sealed to protect from elements.

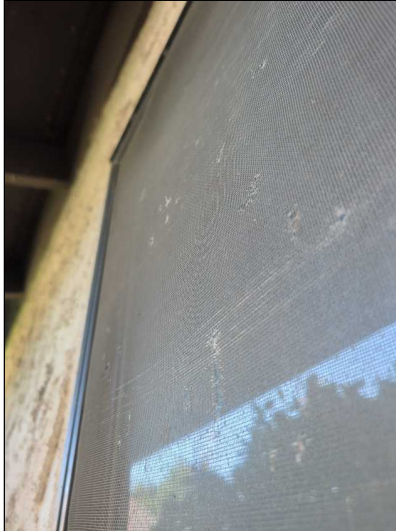
- Appeared satisfactory for age and wear.
- Damaged window screens observed; should be repaired/replaced as needed by a qualified person.

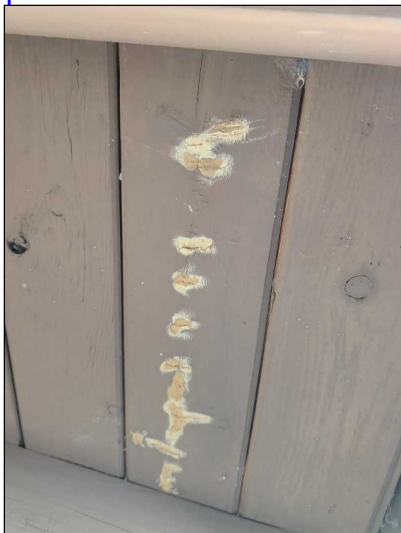
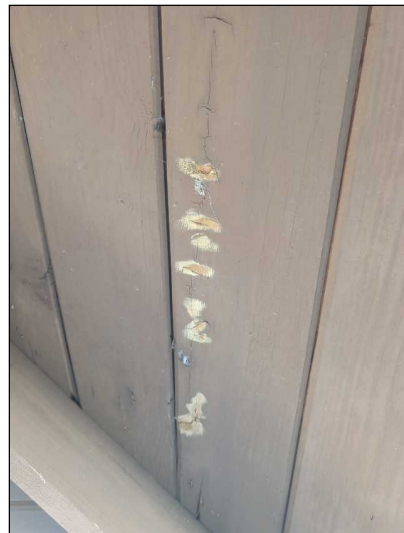
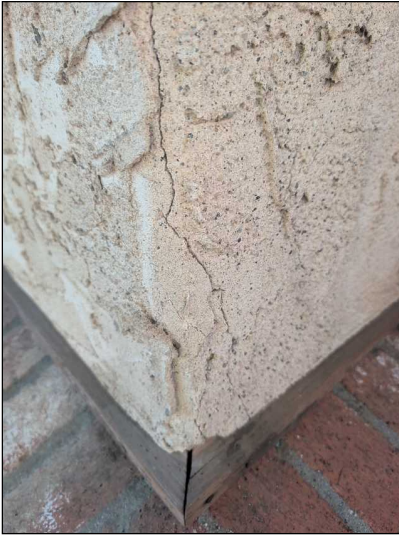
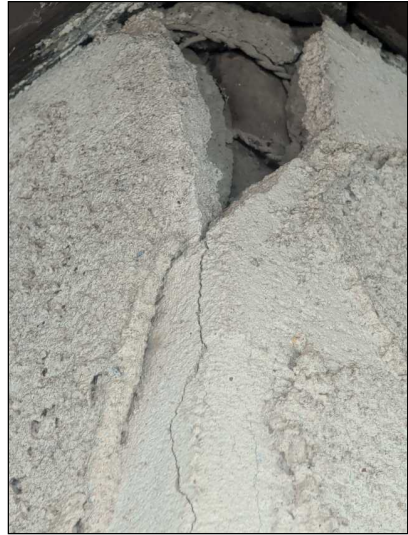
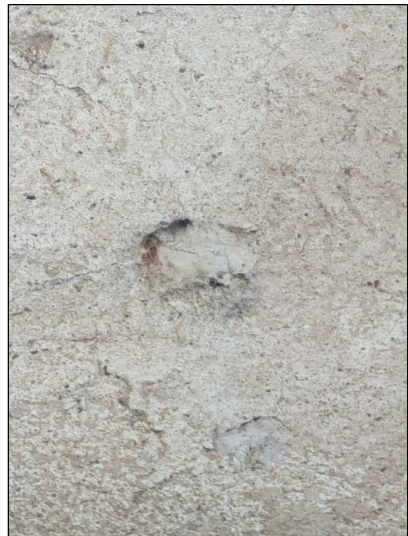
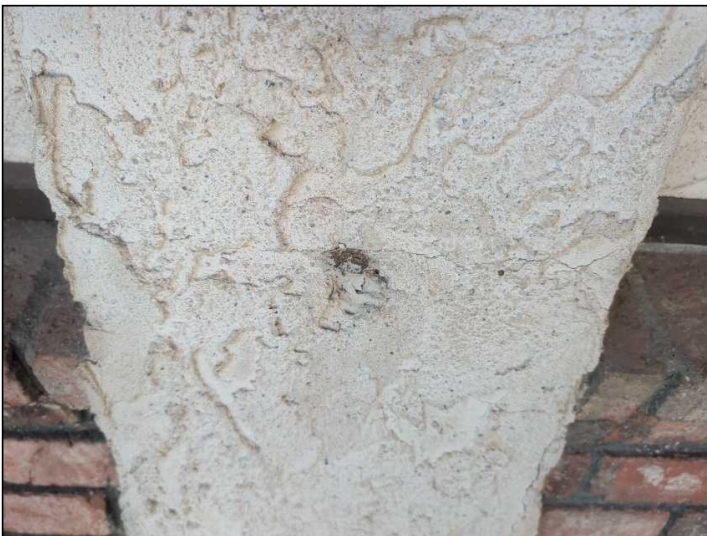
- Maintenance/repairs needed at sections.
- Evidence of past repairs/modifications noted. Consult seller for any information regarding these areas.
- Cracked/chipped stucco observed.
- All gaps/cracks/openings at siding should be repaired/sealed to prevent moisture/pest intrusion.
- Wasp/bee nests observed, these should be removed as needed.
- Recommend further evaluation of siding/eaves with corrections as needed by a licensed contractor/pest control.

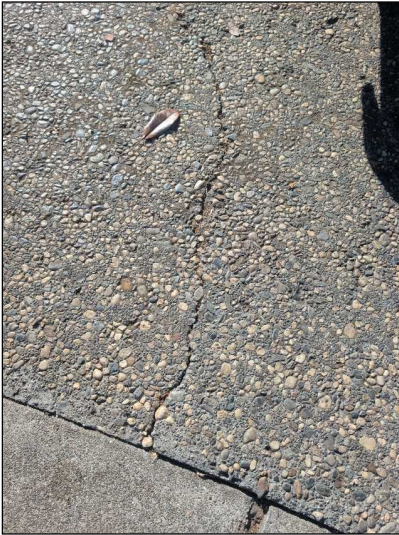
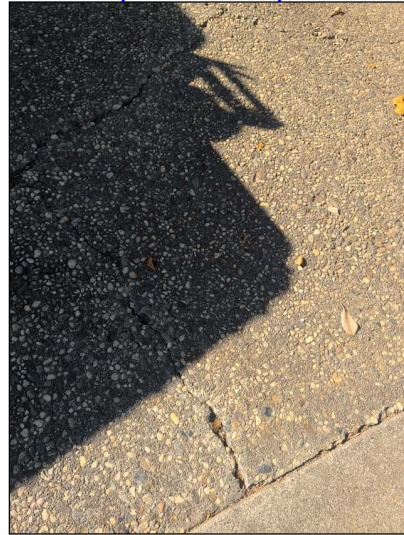
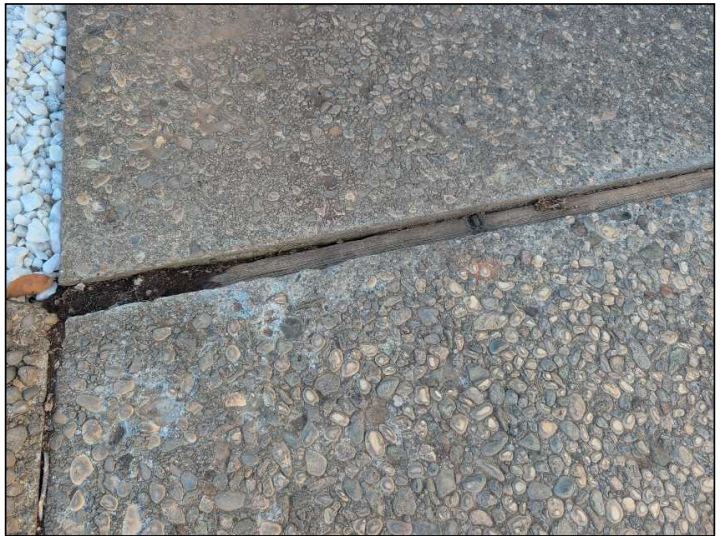
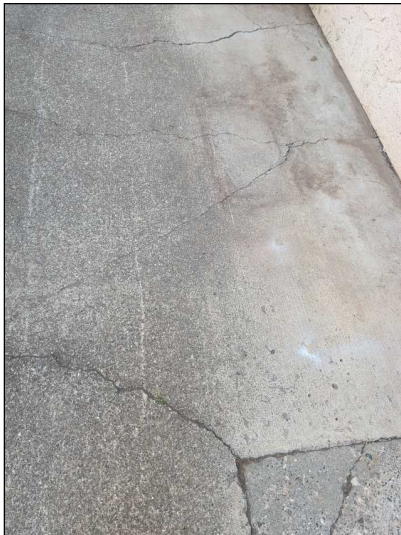
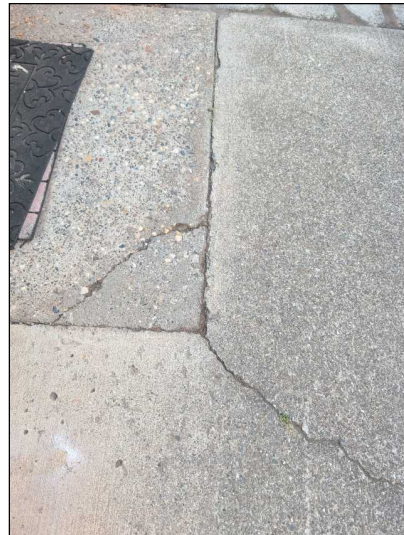
- Cracked concrete observed.
- Uneven surfaces around the home should be improved to eliminate potential trip hazards.

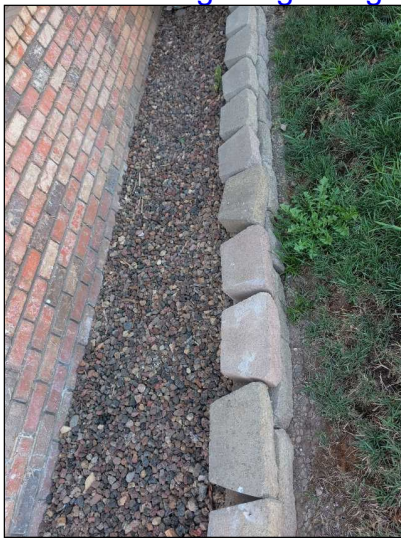
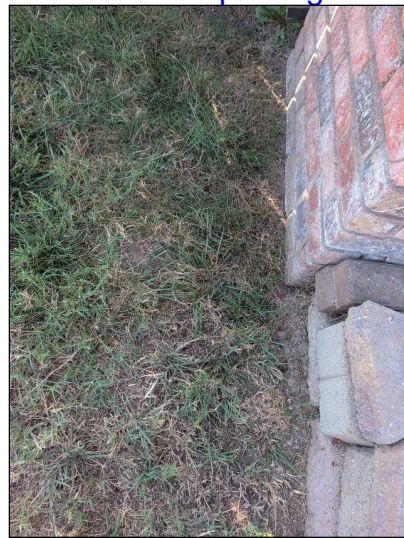
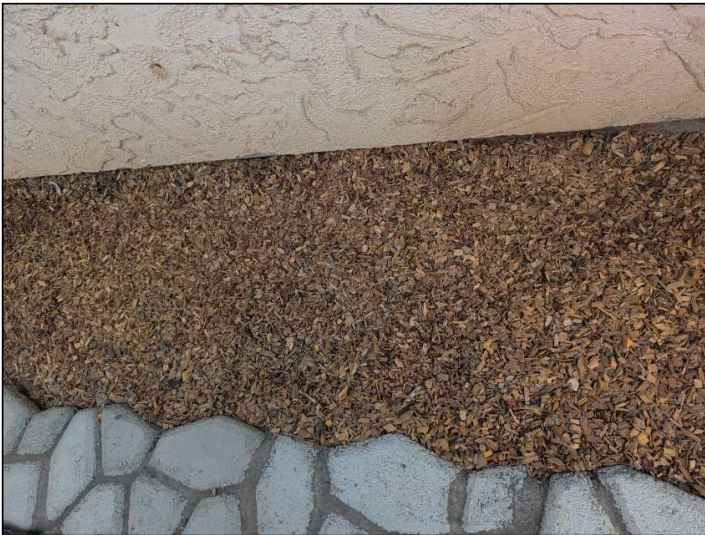
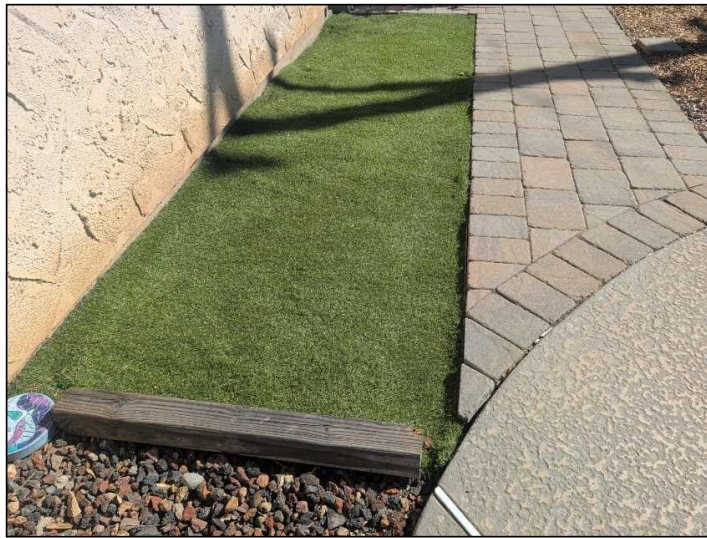
- Some negative grade observed at rear of home. Grading should slope away from structure.
- Planters next to home foundations are not ideal as they can potentially trap excessive moisture next to the foundation perimeter.
- Recommend adding landscape rock at bare soil around home perimeter as needed to help control drainage and erosion.
- Landscape rock is preferable to mulch/bark at home perimeter for better drainage and erosion control. Mulch and bark may also attract pests to the home perimeter.
- Recommend monitoring the grading/drainage at structure perimeter and improving as needed.

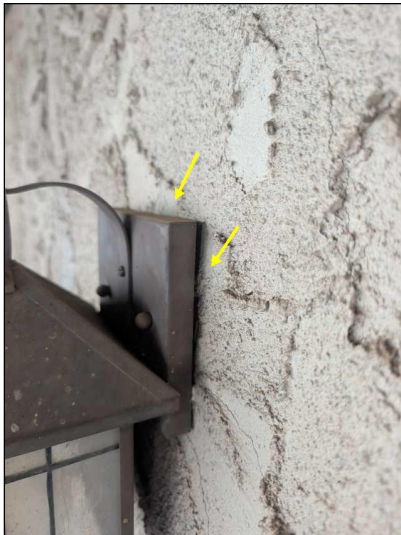
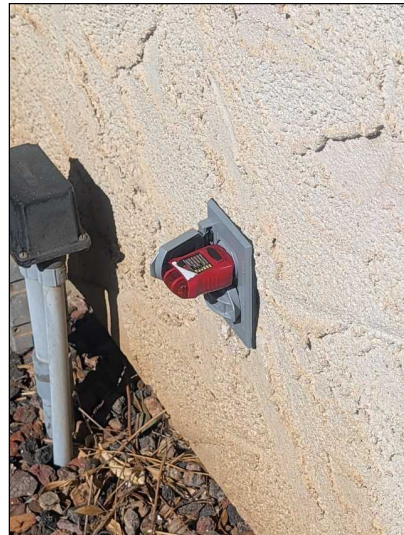
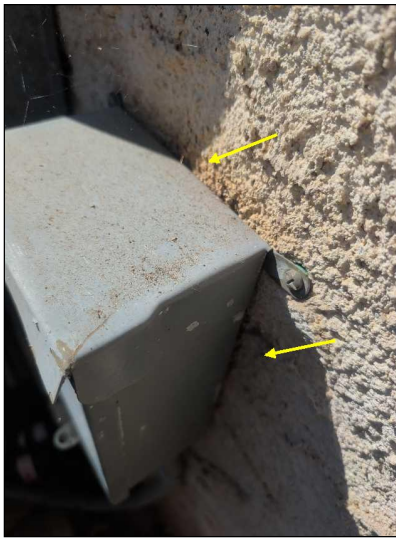
- Exterior light fixtures/electrical boxes/panels with should be caulked/sealed as needed to prevent water intrusion.
- A rear electrical outlet tested for open ground, indicating no equipment ground. Recommend further evaluation with corrections as needed by a licensed electrical contractor.

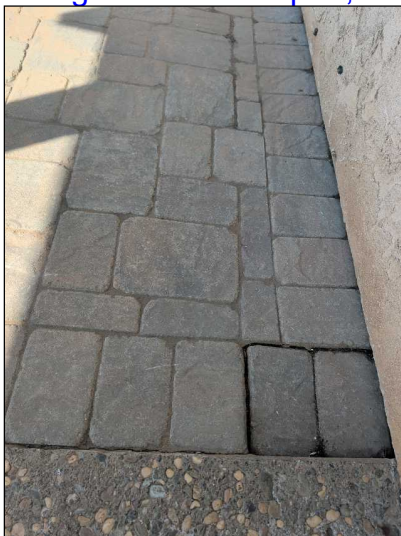
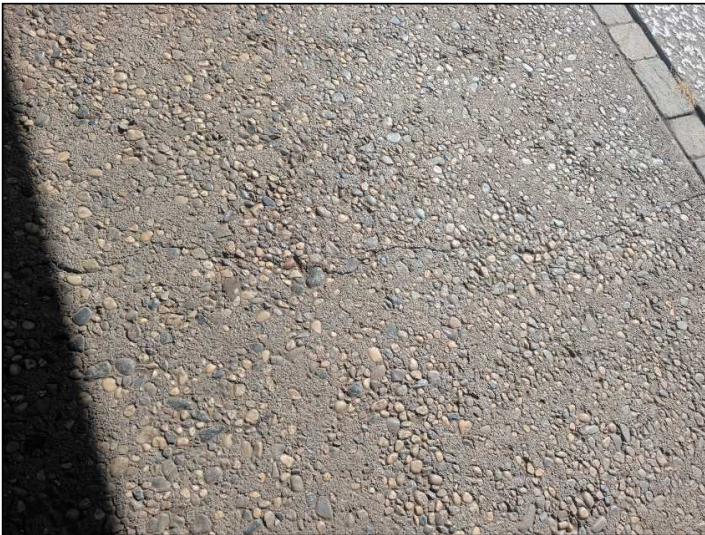
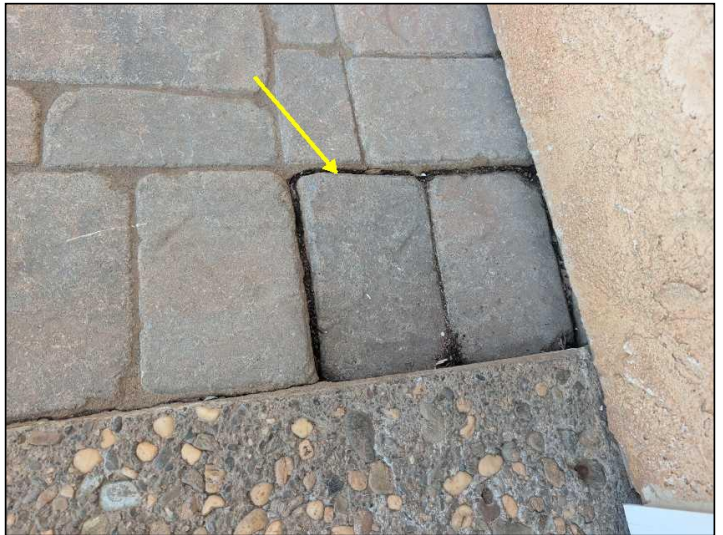
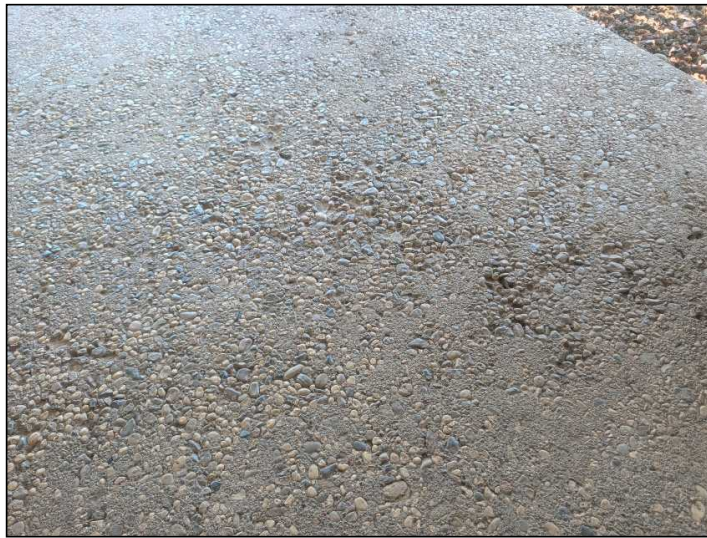
- Appeared satisfactory for age and wear.
- Cracked concrete noted.
- A couple of the rear pavers have sunken creating a pocket where water can collect. See also Grading/Drainage section of report, as there is a slight negative slope in this area.

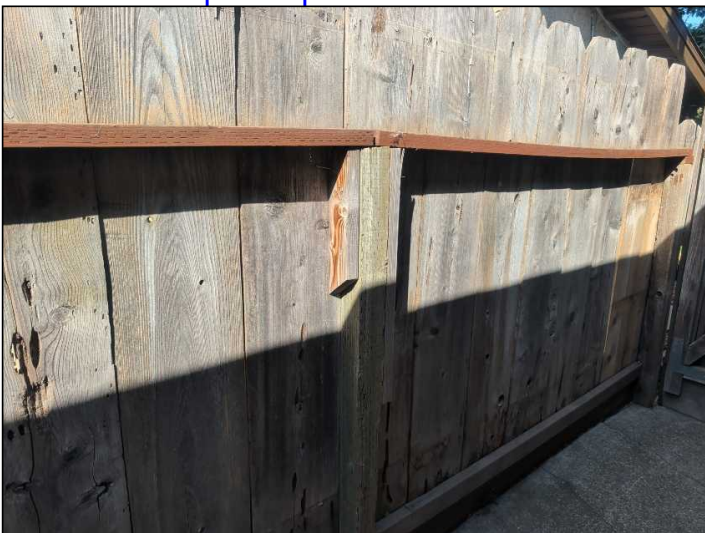
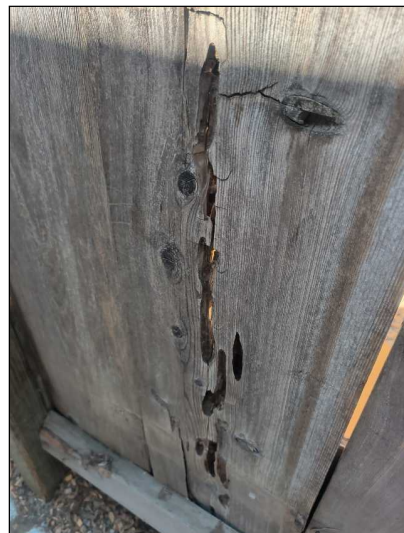
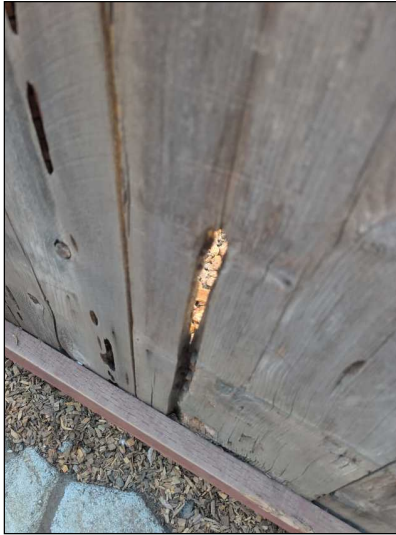
- Deteriorated wood observed.
- Evidence of past repairs noted.

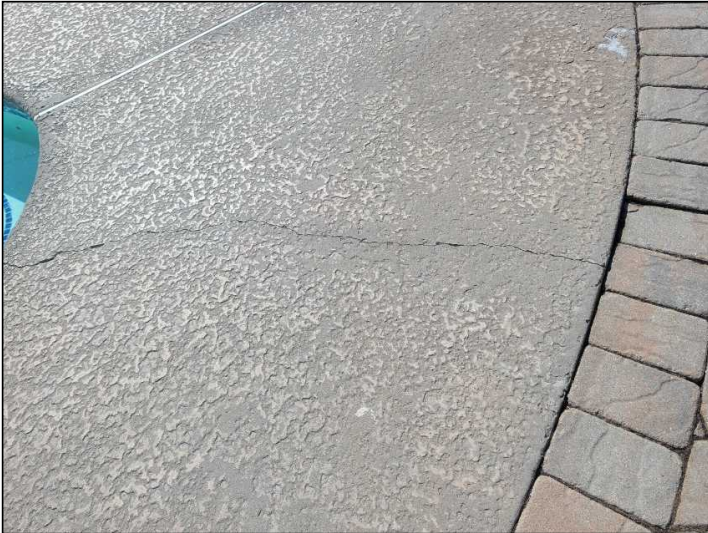
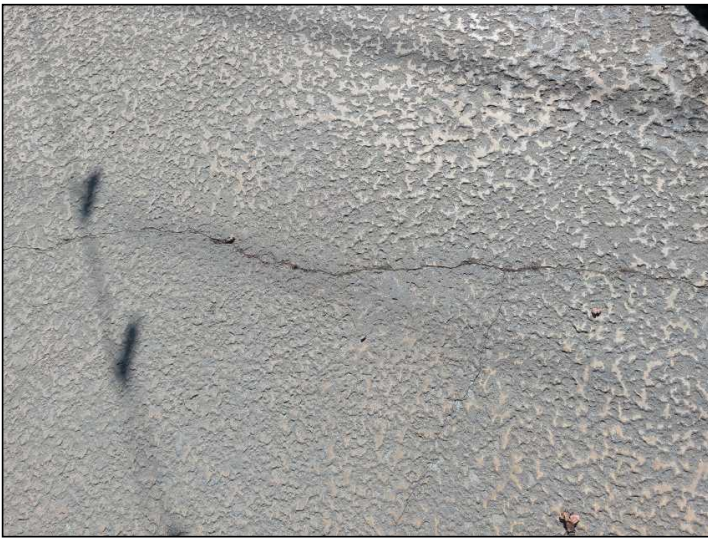
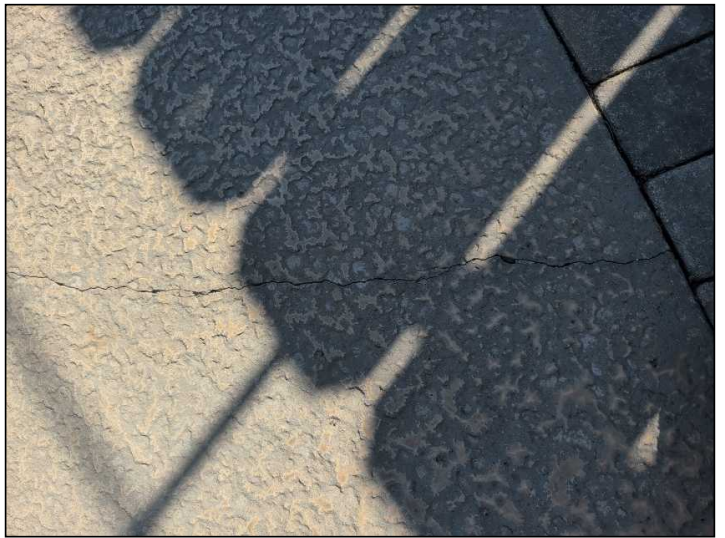
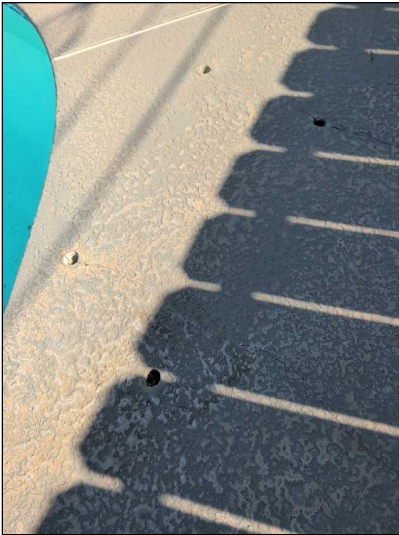
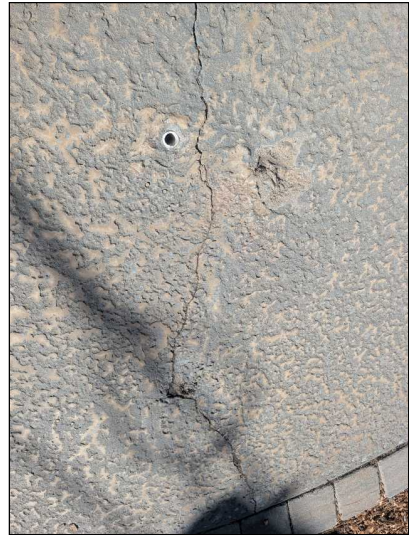
- Concrete cracking noted.

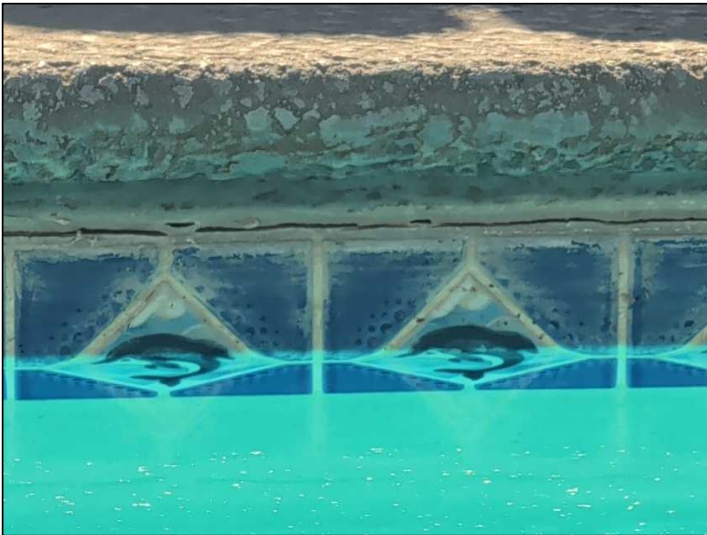
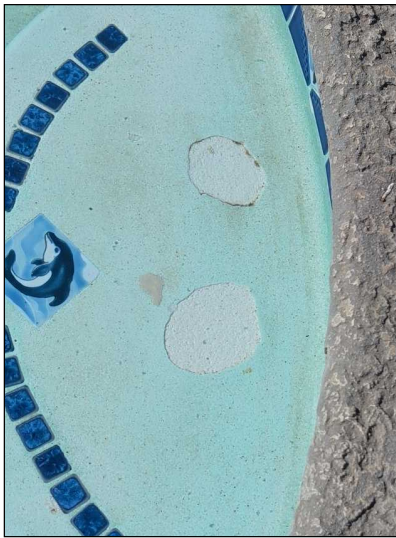
## 3. Structure Condition

- Satisfactory condition for age and wear.
- Some surface chipping observed.
- General maintenance needed at the tile.

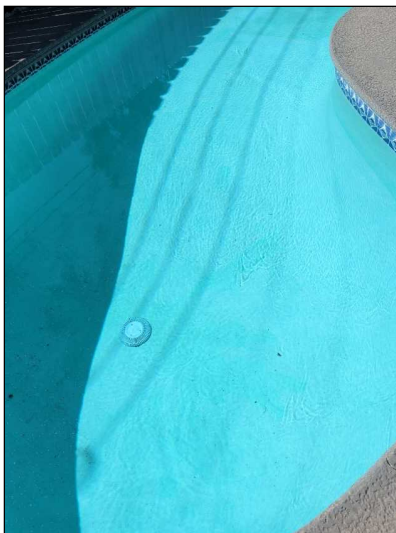
#### 4. Water Condition

- Clear, appears to be properly maintained.

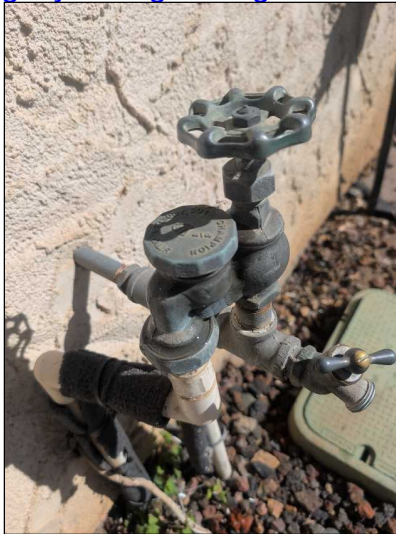
### 5. Water Fill Unit

- Satisfactory condition for age and wear.
- Functional at inspection, leaked slightly during testing.

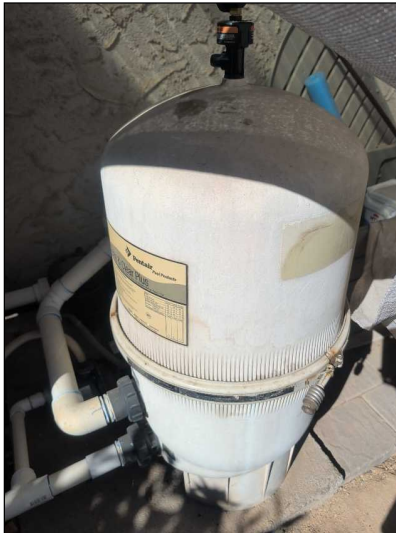
### 6. Filter Condition

- Satisfactory condition for age and wear.

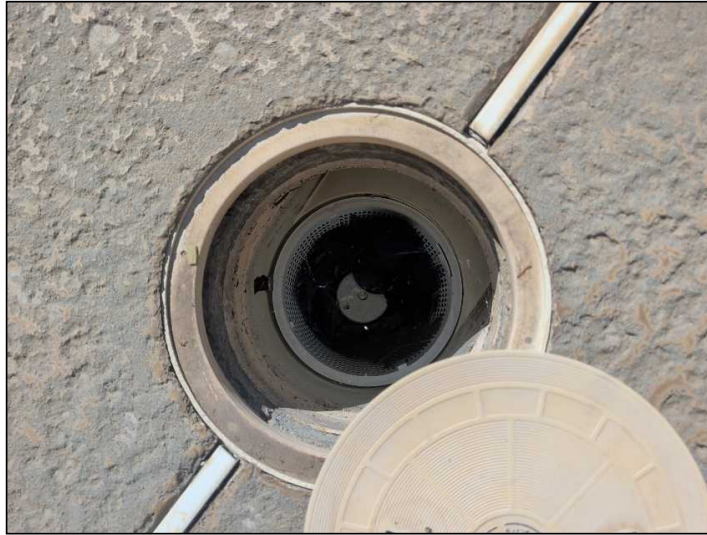
### 7. Skimmer/Weir/Basket

- Appeared satisfactory for age and wear.
- Appeared to be operating as designed.
- Skimmer baskets need to be checked and cleaned regularly for optimum performance.

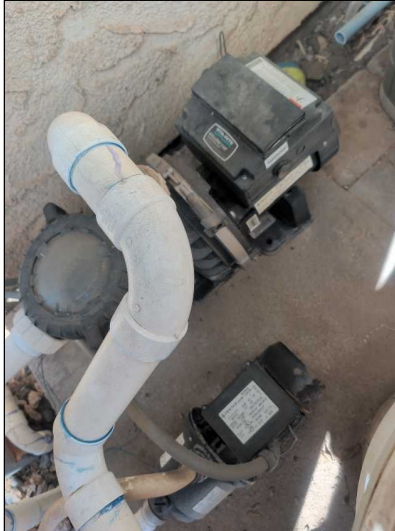
## 8. Pumps

- Appeared satisfactory for age and wear.

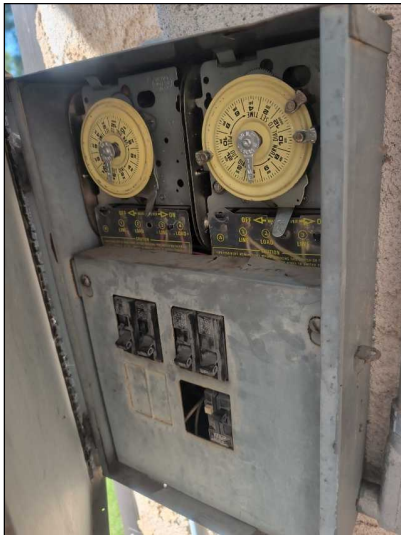
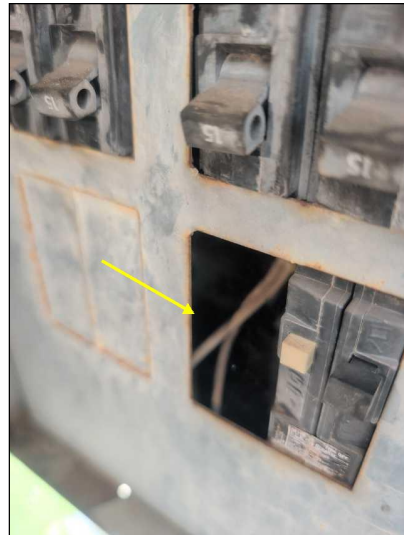
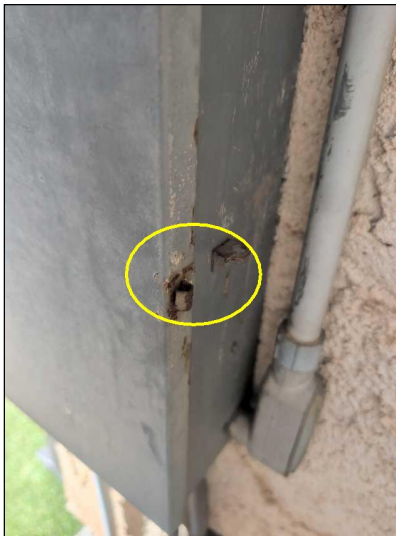
## 9. Electrical

- Functional at inspection.
- An open space was observed where a breaker has been removed/relocated. Recommend further evaluation with corrections as needed by a licensed electrical contractor. Consider updating the pool electrical panel. Electrical panels should be updated every 25 to 40 years depending on condition.

No functional latch at the panel door.

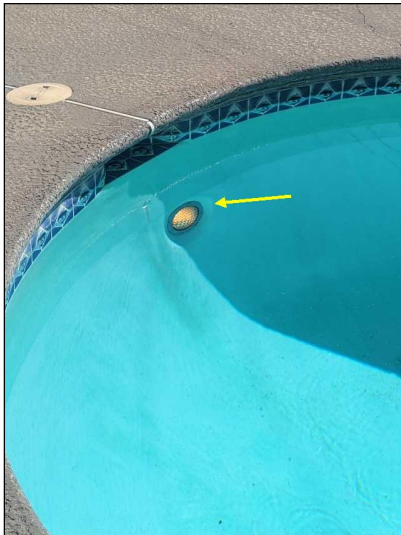
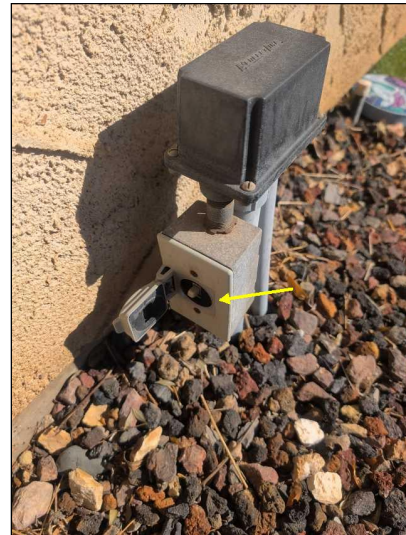
- Appeared satisfactory for age and wear.
- Functional at inspection.

Switch for pool light.

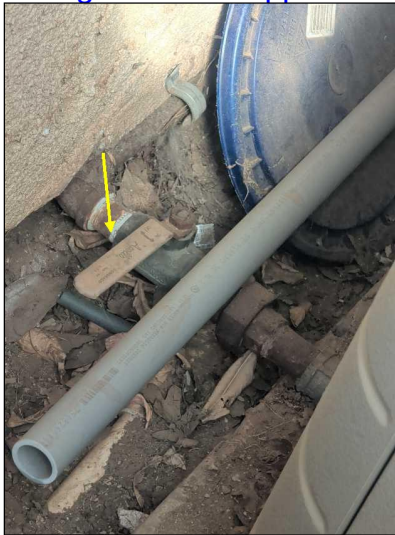
## 12. Pool Heater Condition

- No pool heater is currently installed but gas service appears to be available.
