# Confidential Inspection Report

LOCATED AT:  
7642 Hampton  
West Hollywood, California

INSPECTED ON:  
Wednesday, August 19, 2026

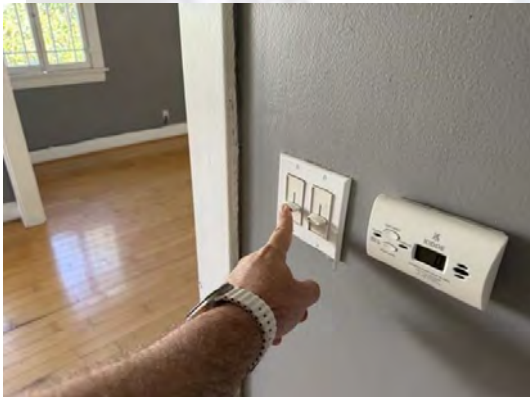
**NDSA** There are some mystery switches in the building and it is not known what exactly they operate. Such as in the hallway.

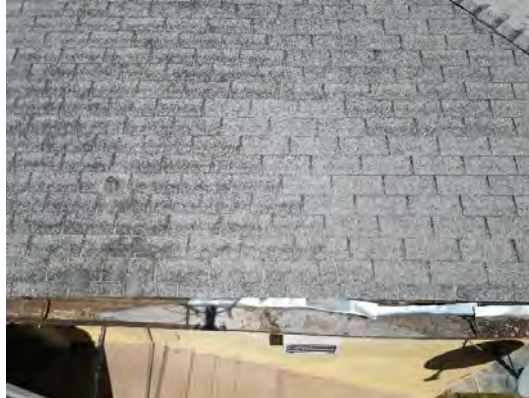
**NDSA** Needs attention, the roof is worn more in areas and sections will need to be replaced in the near future. It is recommended to consult a roofer.

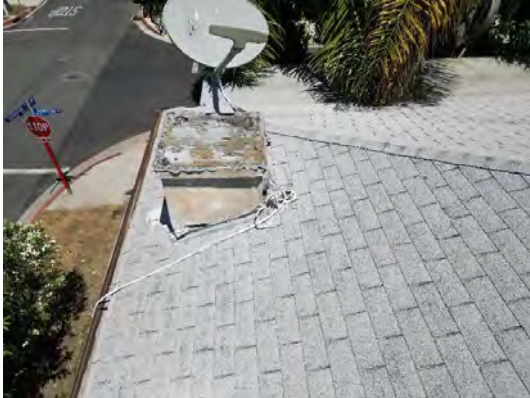
**NDSA** Needs Attention, the chimney has been capped off and now the cap is deteriorated and should be re-done.

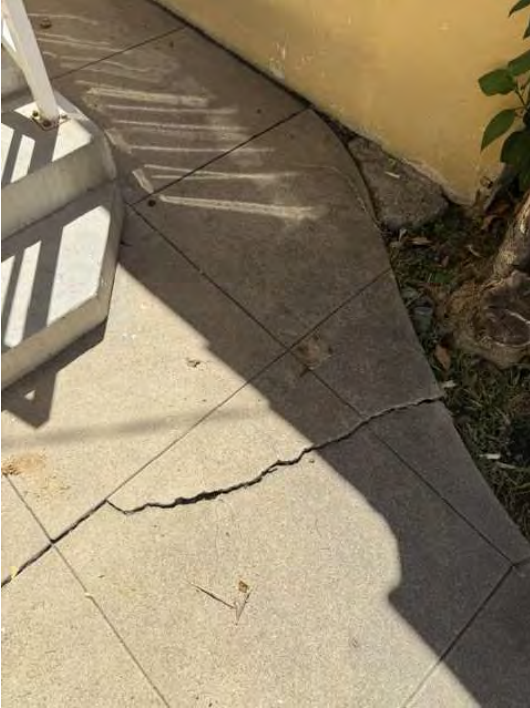
**ACPT** There are cracked areas of the walkways that are typical for the age and style of construction.

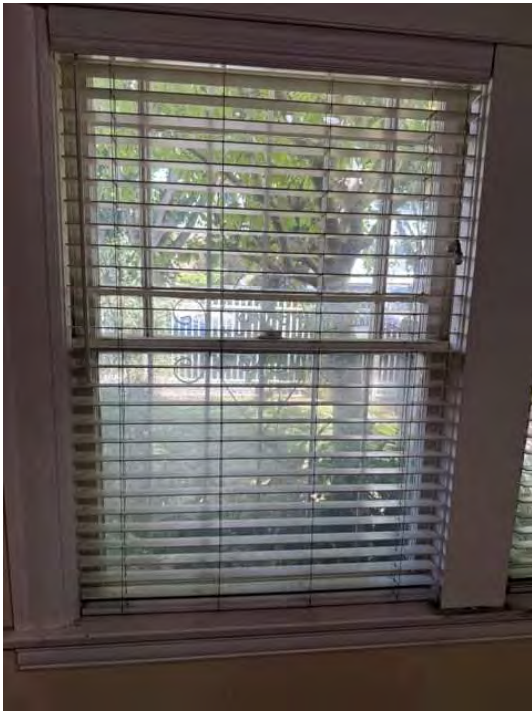
The security bars on the windows have release latches in case of fire. These bars are not tested as a part of this property inspection. It is advised to have the owner demonstrate how these releases work.

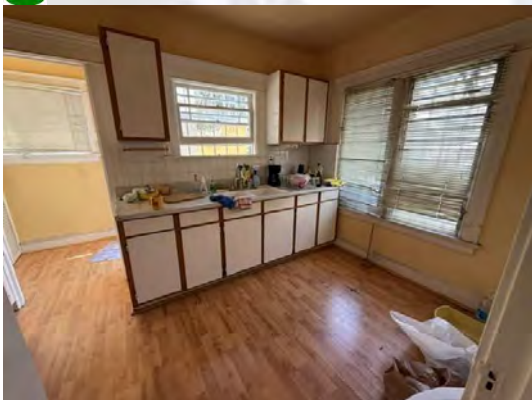
## FLOORING

**NDSA** The kitchen linoleum flooring is worn and peeling in areas.

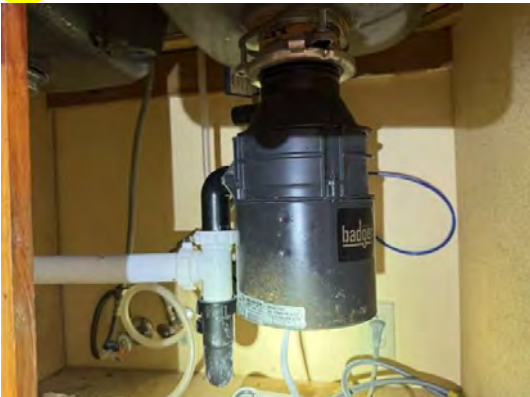
### GARBAGE DISPOSAL

**NDSA** The disposal did not work. It may need repair/replacement.

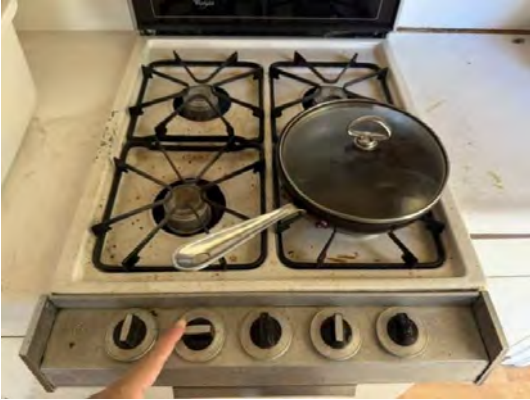
**NDSA** The electronic ignition for the gas burners was not working and lighting the burners.

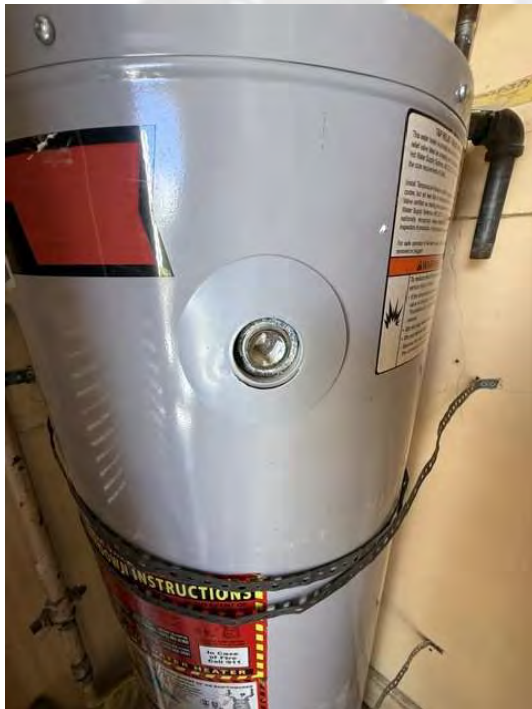
## TEMPERATURE/PRESSURE RELIEF VALVE

**NOTA** There is no temperature/pressure relief valve installed on the hot water tank. This is a valve that releases if the pressure or temperature is too high and it is advised that one be installed per manufacturer's specifications.

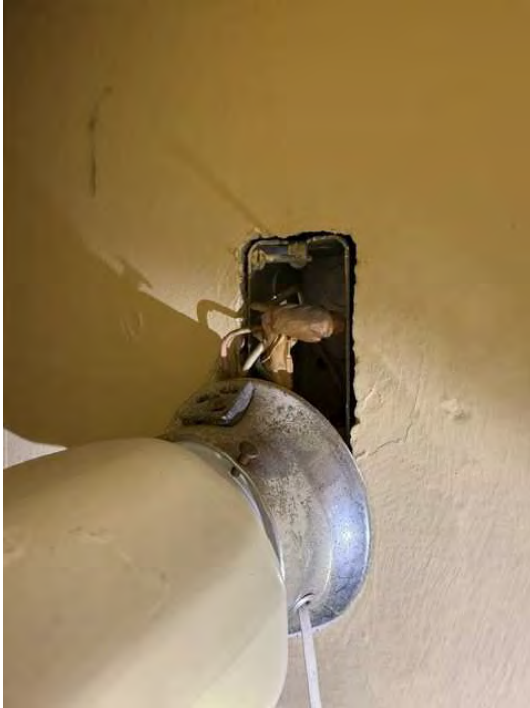
### FIXTURES

Needs attention, there is a light in the second bedroom closet that is hanging by its wires and needs to be properly covered and attached to the wall.

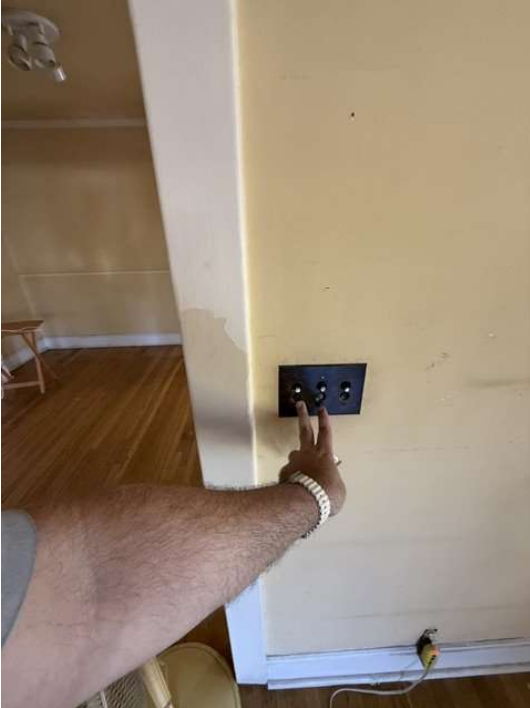
## SWITCHES

Needs attention, there are switches that do not appear to do anything, such as in the living room
