**ELITE GROUP**  
INSPECTION PROFESSIONALS

PROPERTY LOCATION: 207 W Buffalo Ave Santa Ana, CA 92706

# INSPECTIONREPORT

Date of Inspection: 7/31/2026 at 10:00 AM

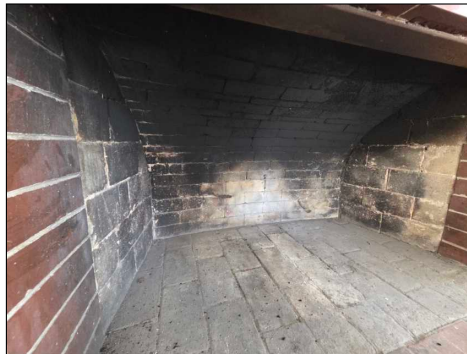
**No gas present/visible**

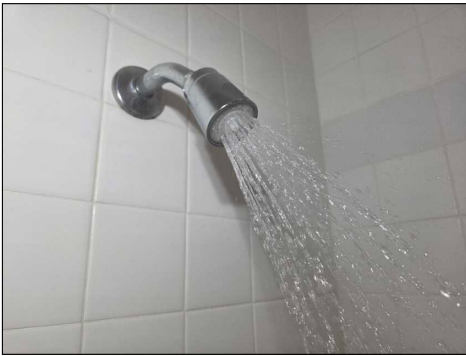
**Shower fixture(s) tested and operated**

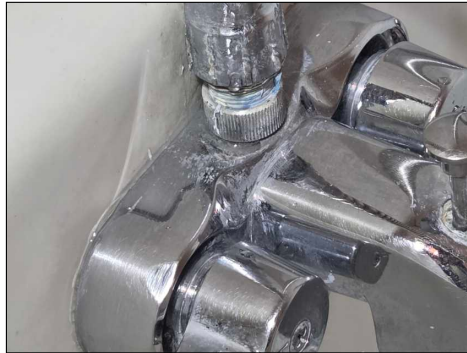
**Leak at shower line connection - needs to be serviced @ 207**

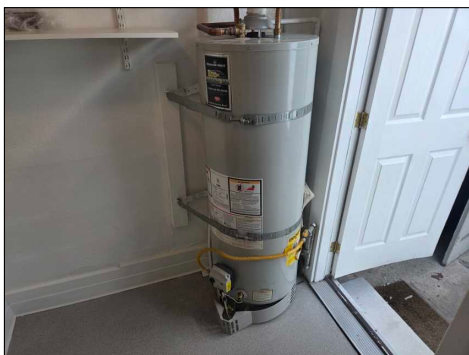
- Operated at the time of the inspection - Gas unit
- No major visible defects at the time of the inspection
- Older water heater present - recommend annual seasonal maintenance to extend the life of the unit
- The water heater is visually inspected only, the combustion/pilot doors are not removed for flame or burner condition inspection due to the potential for draft to burn out the pilot flame - the Inspector does not estimate the age and cannot predict the remaining life of the unit.
- It is recommended that water heaters are flushed annually to remove sediment buildup
- **"Sediment knock" in tank noted; may decrease efficiency of the water heater - needs to be serviced**

Water heater tested and operated

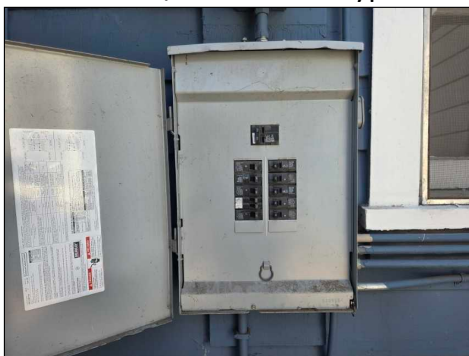
- No major visible defects at the time of the inspection
- Main panel is worn/weathered - typical for age/weather exposure

General view - main panel

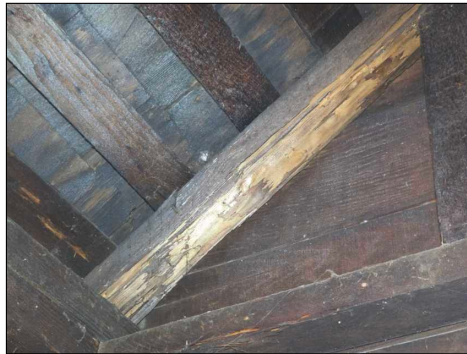
- Exposed wood rafters/joists - consult termite report for all wood
- Worn/stained/deteriorated wood members - needs to be serviced/further evaluated - consult the termite report
- New lumber/patched areas - consult seller for past repairs
- **Deteriorated wood members - needs to be serviced**

**Deteriorated wood members - needs to be serviced**

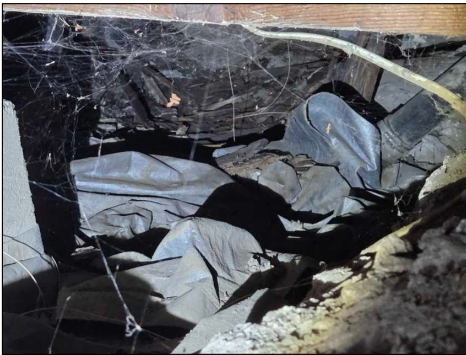
Debris/soil obstructing access in areas - confined areas in crawl space - very limited access

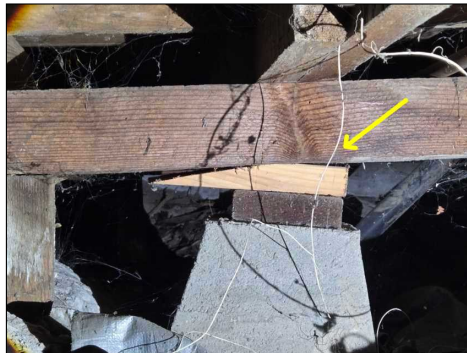
**Irregularly shimmed posts - needs to be serviced**

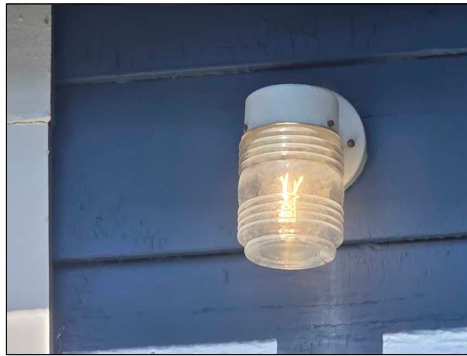
- No major visible defects at the time of the inspection
- Accessible lights/switches/outlets were tested on the day of the inspection
- Exterior electrical is in a worn/older condition - recommend routine maintenance to maintain weathertight seals

Exterior light(s) tested and operated

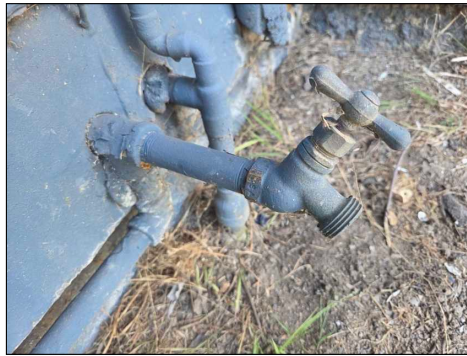
Bibb(s) not functional at one or more locations - needs to be serviced (**galvanized**)
