ROB BOWLEN HOME INSPECTION INC.

## RESIDENTIAL REPORT

4537 Montara Dr  
Antioch, CA 94531

08/24/2026

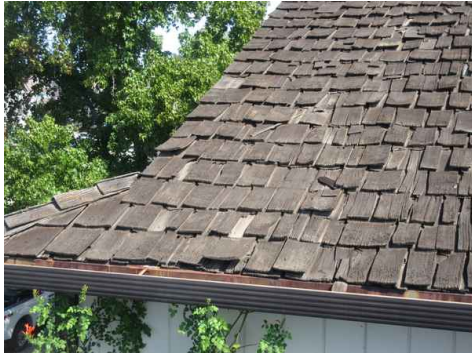
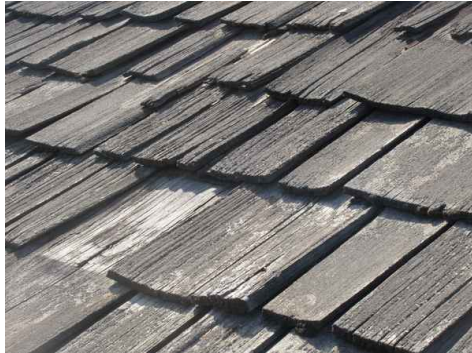
**WOOD SHAKE ROOF END OF LIFE**

The wood shake roof covering has reached the end of its serviceable life and requires replacement. Wood shake roofs typically last 20-40 years depending on climate, maintenance, and exposure. Continued use of an end-of-life roof risks water infiltration, interior damage, and potential structural compromise. A roofing professional should evaluate the roof and provide a replacement estimate and timeline.

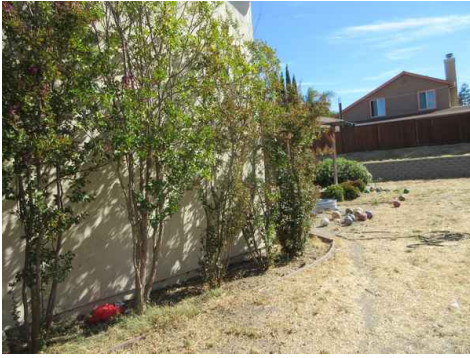
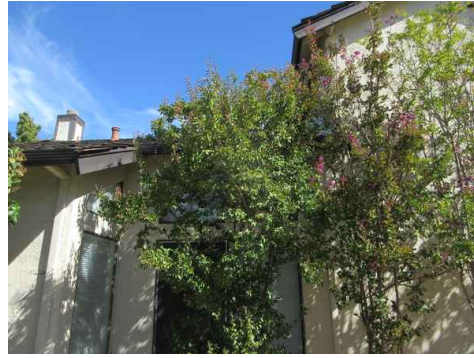
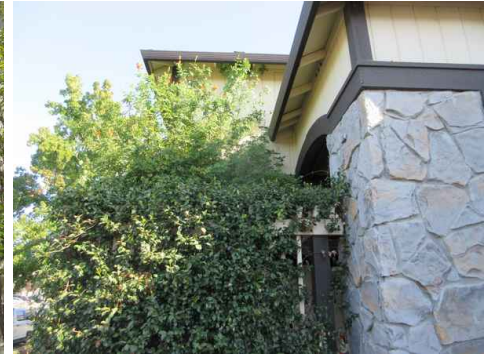
### EXTERIOR PORTIONS IA STORAGE/VEGETATION

Portions of the exterior of the home were restricted due to vegetation and/or stored items or debris.

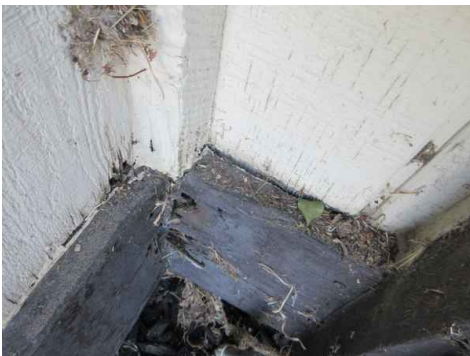
#### WATER DAMAGE TO SIDING AND TRIM

Water damage observed on the exterior siding and trim during inspection. This indicates moisture intrusion that can lead to rot, structural deterioration, and mold growth if not addressed. A qualified contractor should evaluate the extent of damage and identify the moisture source to prevent further deterioration.

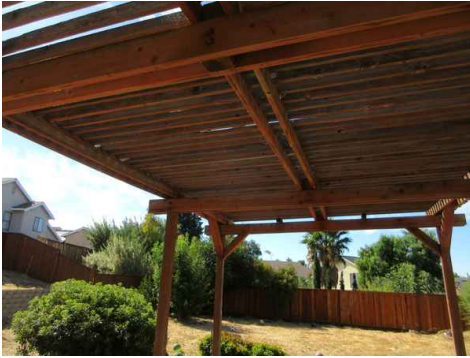
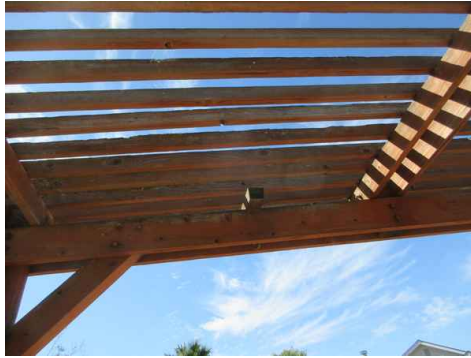
The rear patio cover exhibits significant deterioration with rusted brackets that are poorly secured to the concrete floor. This compromised structural integrity creates a potential safety hazard, as the cover could fail. A qualified contractor should evaluate the extent of rust damage, assess structural stability, and either reinforce or replace the cover and fastening system as needed.

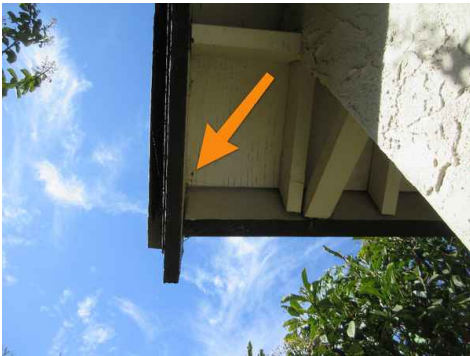
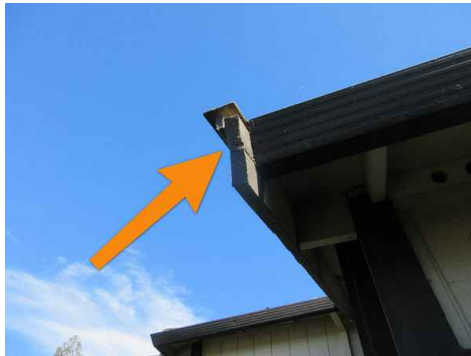
#### 4.5.1 Eaves, Soffits & Fascia

### **BARGE RAFTER DAMAGE**

One or more of the roof line barge rafters and portion of the roof eave sheathing are water damaged, warped and poorly secured. Contact a qualified contractor to evaluate the entire roof line eave system and repair as needed.

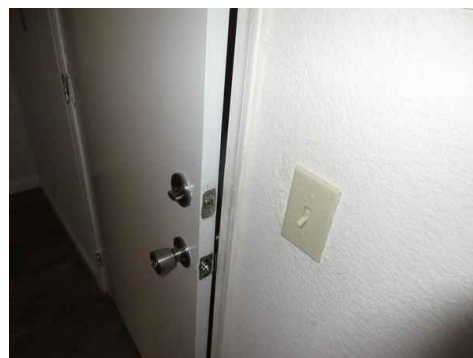
### AUTO CLOSE NEEDED ON MAN DOOR

The door between the house and garage should be fitted with an automatic closer that closes the door all the way from any open position. This will reduce the potential of toxic automobile gases entering the house.

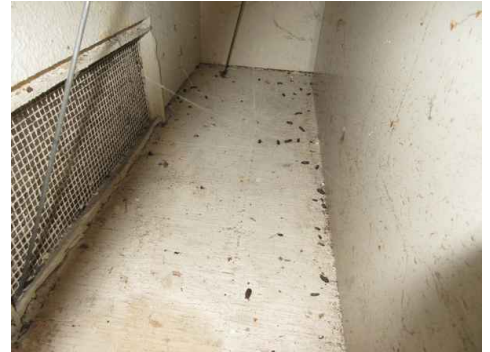
Vermin droppings were observed in the furnace closet during inspection. This indicates pest activity near the heating equipment and may pose health and sanitation concerns. A pest control professional should inspect the area, identify the pest type, and implement appropriate treatment and exclusion measures to prevent further infestation.

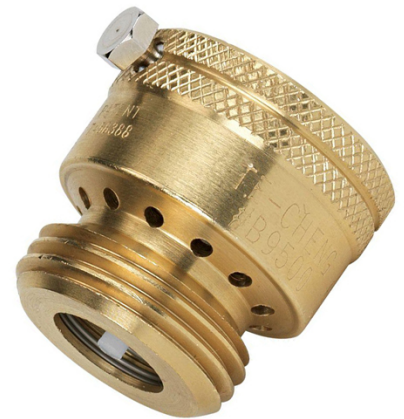
To reduce the risk of contamination of supply water, installation of anti-siphon devices on exterior hose bibbs would be wise.

Backflow prevention devices are now required on exterior hose bibbs to prevent contamination of the domestic water supply. These devices are inexpensive and available at most hardware stores. Consider upgrading the hose bibbs by installing backflow devices.

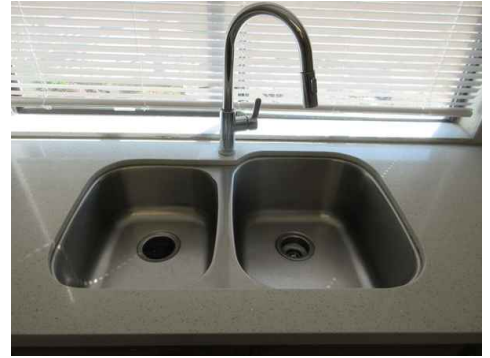
### 12.1.2 Dishwasher

#### **DISHWASHER NEED AIRGAP**

The dishwasher lacks an airgap device. Air gaps are now standard equipment to assure a separation between supply and waste water. It is advised that one be installed.
