# - INSPECTION REPORT -

**CHRIS RIPPY INSPECTIONS**

**3541 Goldenrod Cir Seal Beach, CA 90740**  
**Inspection prepared for: Rod & Susan Morales**  
**Real Estate Agent: Lisa Broder - Think Boutiq Real Estate**

**Date of Inspection: 8-9-2026**

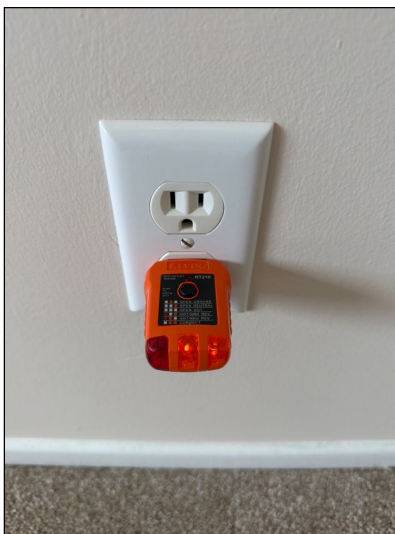
8.2. Worn outlets noted.

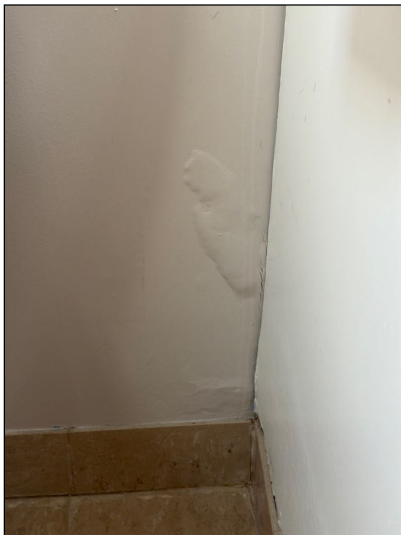
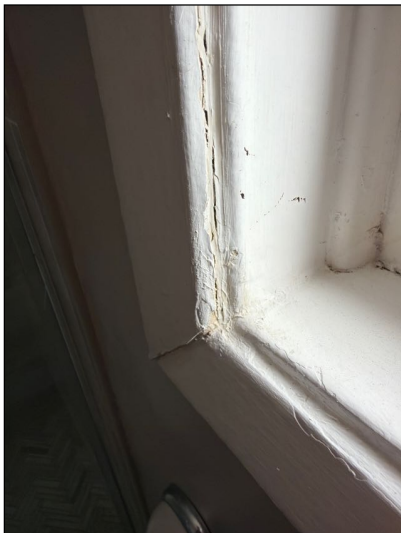
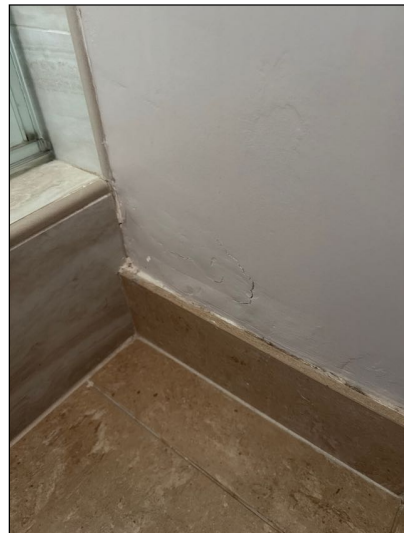
| Page 20 Item: 2 | Wall Condition | 2.2. Blistering paint observed. Unknown cause. Recommend further evaluation by a licensed professional. |

2.2. Blistering paint observed. Unknown cause. Recommend further evaluation by a licensed professional.

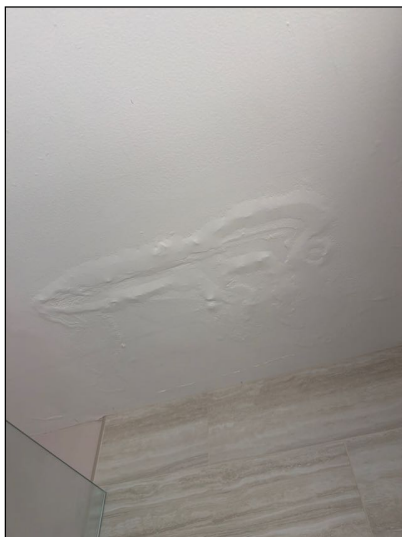
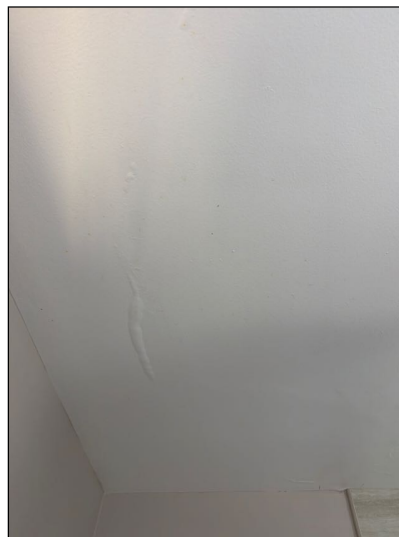
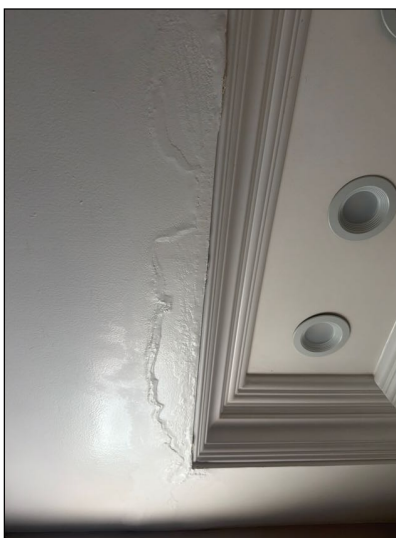
| Page 21 Item: 3 | Ceiling Condition | 3.1. Blistering paint observed. Southwest Bathroom |

#### 3.1. Blistering paint observed. Southwest Bathroom

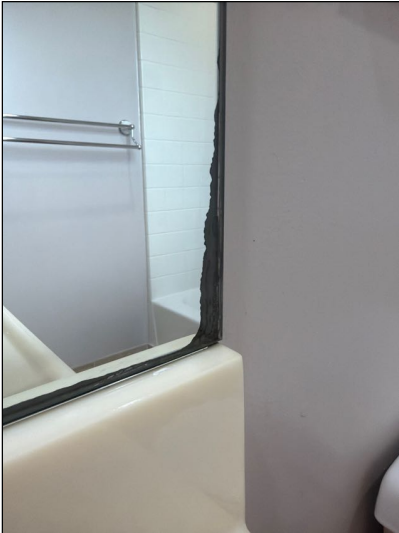
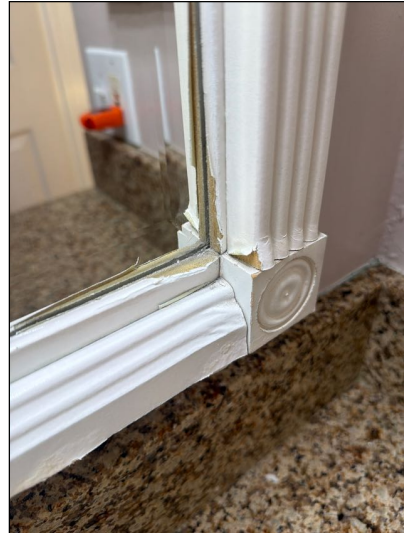
6.3. Delamination observed at various mirrors.

6.4. Minor moisture-related deterioration, including peeling paint, was observed around the wood-framed mirror. Recommend repairs as needed and maintaining adequate ventilation within the bathroom to help reduce moisture accumulation.

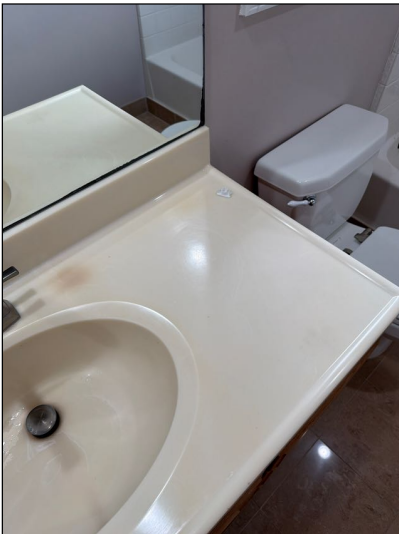
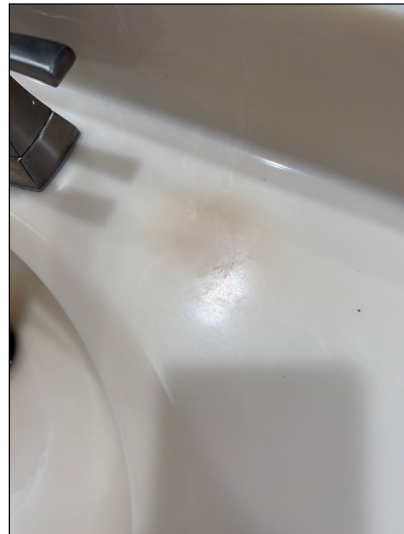
9.2. Minor discoloration observed. This appears to be cosmetic. Upstairs

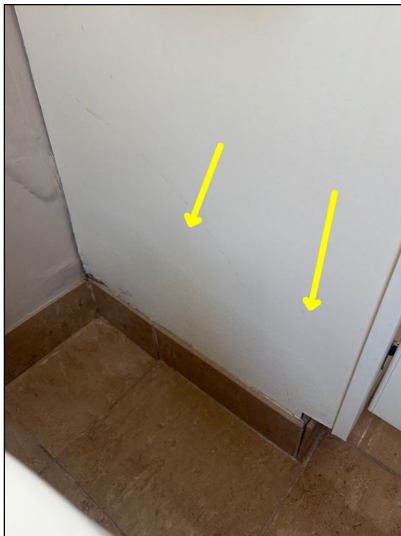
| Page 25 Item: 10 | Cabinets | <p>10.2. <b>Cabinet Water Damage:</b> Evidence of water damage was observed to the cabinet. The exact source and whether this condition is active or the result of a past event could not be determined during this visual inspection. Recommend further evaluation by a qualified, state-licensed professional to determine the source, verify whether the condition is ongoing, and perform any necessary repairs. Downstairs hallway</p> <p>10.3. <b>Moisture Damage:</b> Swelling or deterioration of the cabinet material was observed, consistent with previous moisture exposure. Recommend further evaluation and repair or replacement as appropriate. Downstairs hallway</p> |

10.2. **Cabinet Water Damage:** Evidence of water damage was observed to the cabinet. The exact source and whether this condition is active or the result of a past event could not be determined during this visual inspection. Recommend further evaluation by a qualified, state-licensed professional to determine the source, verify whether the condition is ongoing, and perform any necessary repairs. Downstairs hallway

10.3. **Moisture Damage:** Swelling or deterioration of the cabinet material was observed, consistent with previous moisture exposure. Recommend further evaluation and repair or replacement as appropriate. Downstairs hallway

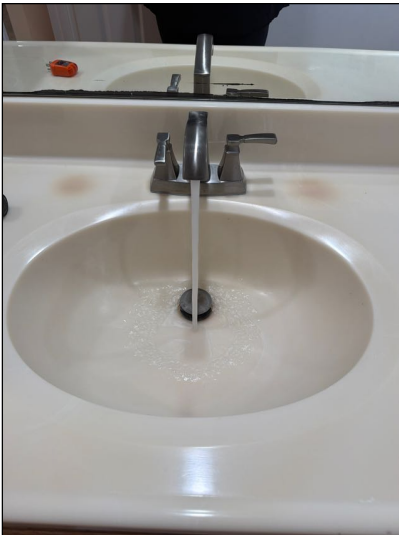
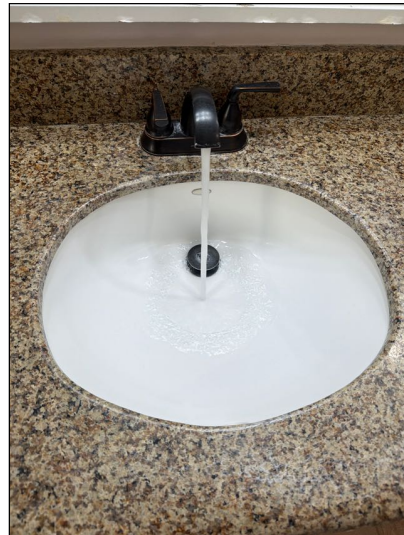
| Page 25 Item: 11 | Sinks | 11.2. Recommend re-caulking sink. Downstairs Hallway Bathroom |

11.2. Recommend re-caulking sink. Downstairs Hallway Bathroom

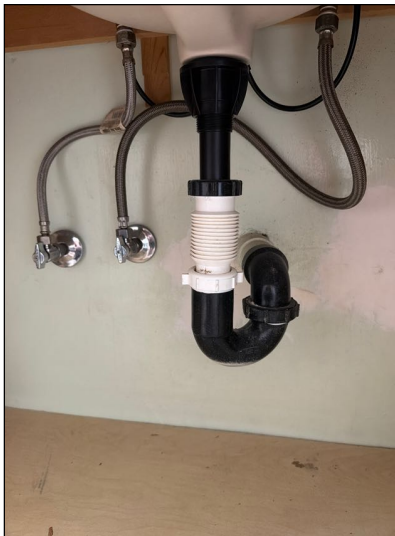
12.2. Flex drain observed, these are subject to frequent clogging.

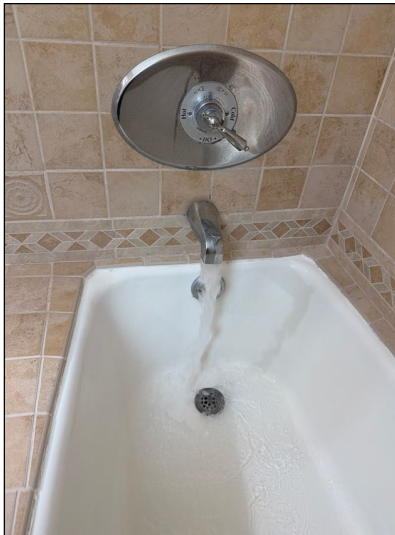
| Page 27 Item: 13 | Bath Tubs | 13.2. The bathtub overflow assembly was observed to be loose. This condition may allow water to leak behind or beneath the tub during use. Recommend securing and repairing the overflow assembly as needed to help prevent moisture intrusion. Upstairs bathroom. |

13.2. The bathtub overflow assembly was observed to be loose. This condition may allow water to leak behind or beneath the tub during use. Recommend securing and repairing the overflow assembly as needed to help prevent moisture intrusion. Upstairs bathroom.

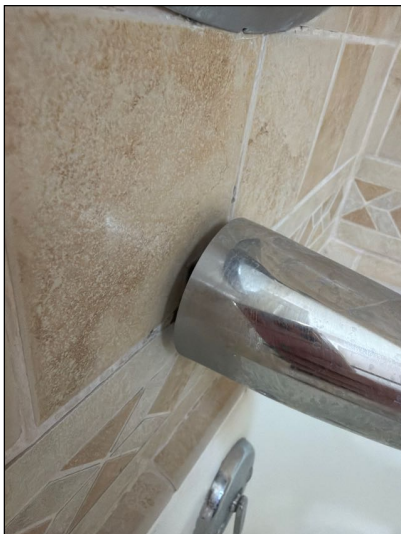
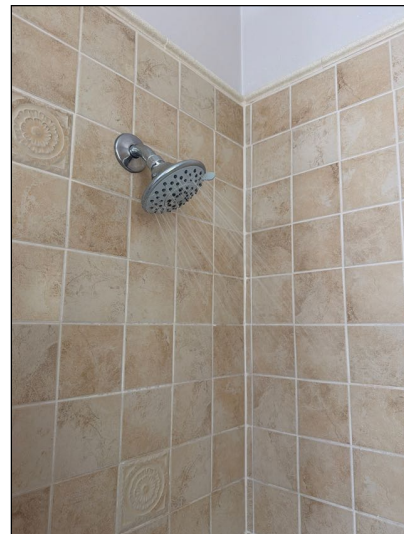
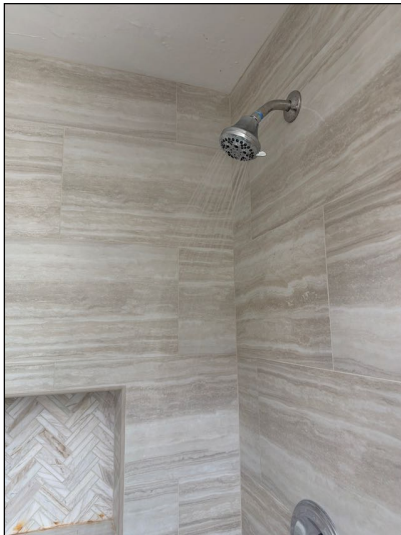
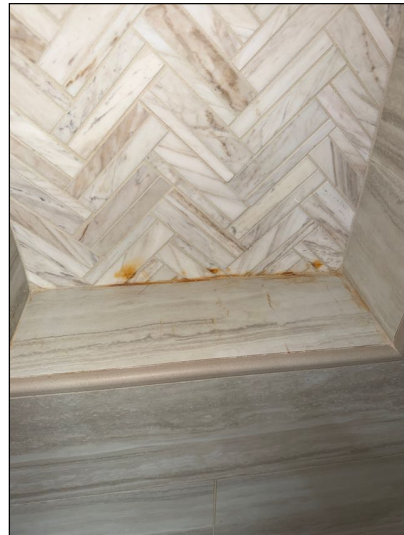
| Page 28 Item: 14 | Showers | 14.3. Rust-colored staining was observed within the shower niche/shadow box. The source of the staining could not be determined, and it could not be confirmed whether it is related to previous moisture conditions in the area. Recommend further evaluation and monitoring for any continued staining or signs of moisture intrusion. |

14.2. Visible gaps observed at the tub spout/wall area. These areas should be sealed to prevent water intrusion.

14.3. Rust-colored staining was observed within the shower niche/shadow box. The source of the staining could not be determined, and it could not be confirmed whether it is related to previous moisture conditions in the area. Recommend further evaluation and monitoring for any continued staining or signs of moisture intrusion.

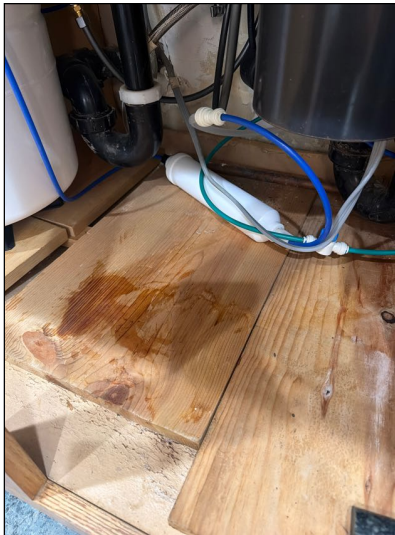
1.2. **Cabinet Water Damage:** Evidence of water damage was observed to the cabinet. The exact source and whether this condition is active or the result of a past event could not be determined during this visual inspection. Recommend further evaluation by a qualified, state-licensed professional to determine the source, verify whether the condition is ongoing, and perform any necessary repairs.

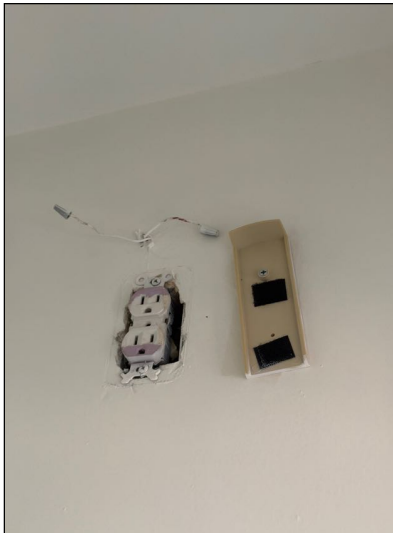
3.2. Wiring was observed extending from the wall above an electrical receptacle. The purpose and status of this wiring could not be determined and may be associated with a previous low-voltage device or other equipment. Recommend consulting with the seller for additional information and having any unused wiring properly terminated or removed as needed.

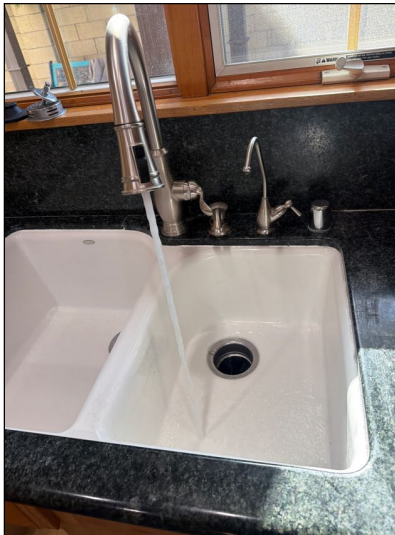
5.1. The sink was operated using normal user controls and drained properly at the time of the inspection.

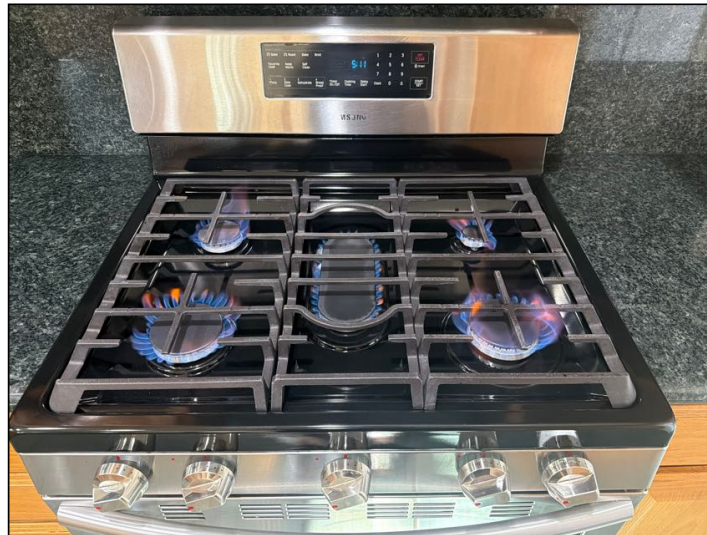
10.2. Gas cook top noted.

10.3. All heating elements operated when tested.

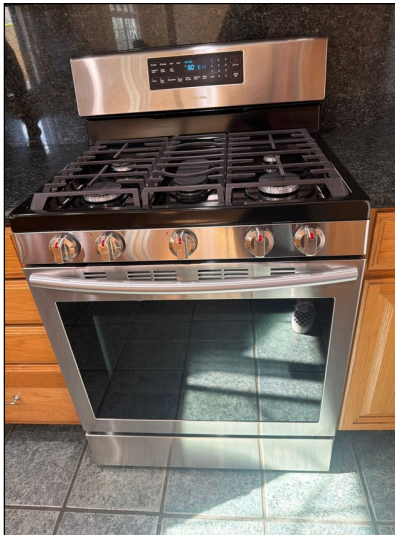
11.2. Oven(s): Gas burners

11.3. Oven(s) operated when tested.

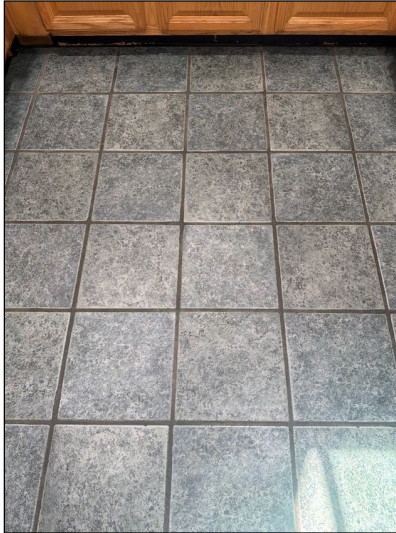
15.1. Cosmetic irregularities/imperfections noted.

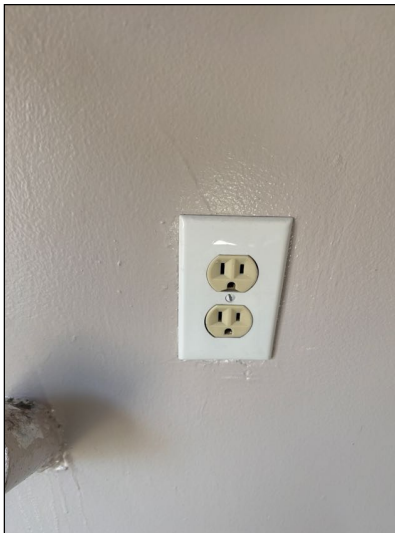
2.1. **Receptacle Not Protected:** The receptacle was not GFCI protected where protection is typically recommended. Recommend upgrading the circuit.

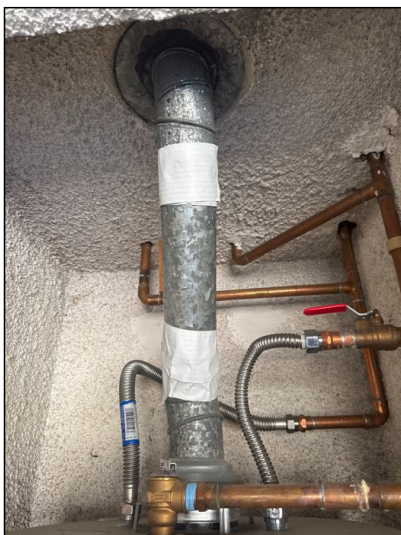
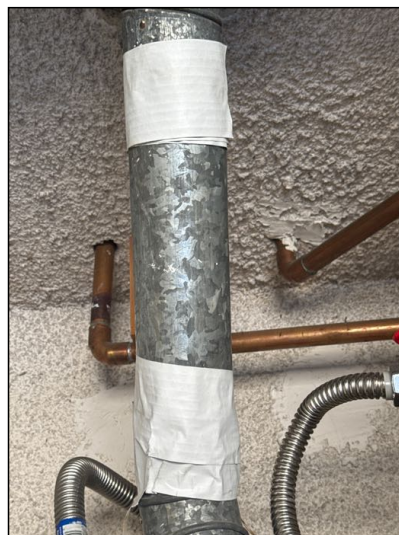
3.2. Improper tape was observed at the venting connection. The tape may not be rated for use with the venting system and could present a potential combustible-material concern. Recommend evaluation and correction by a state licensed professional using materials approved for the specific venting system.

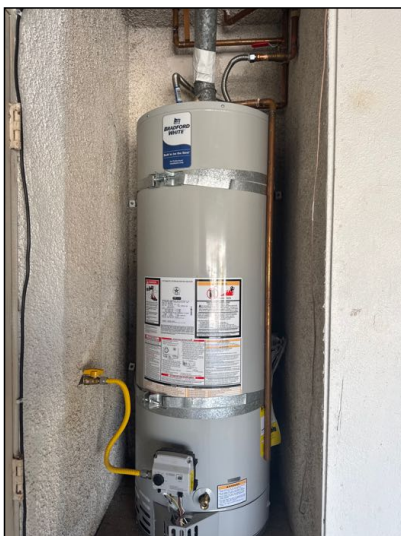
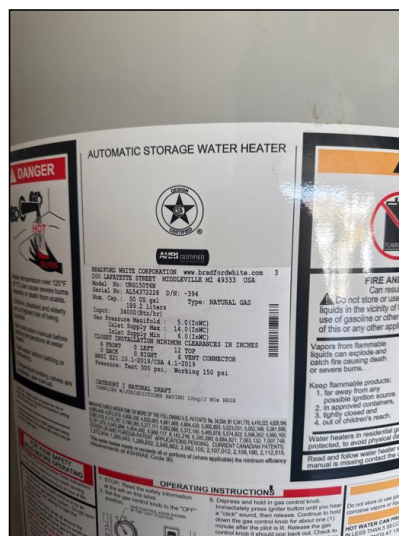
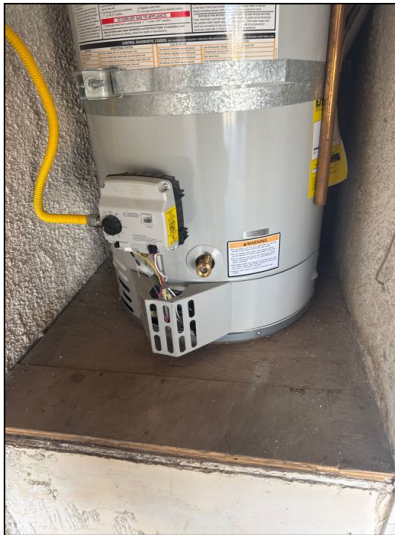
4.5. No Catch Pan and Drain. Consider installation.

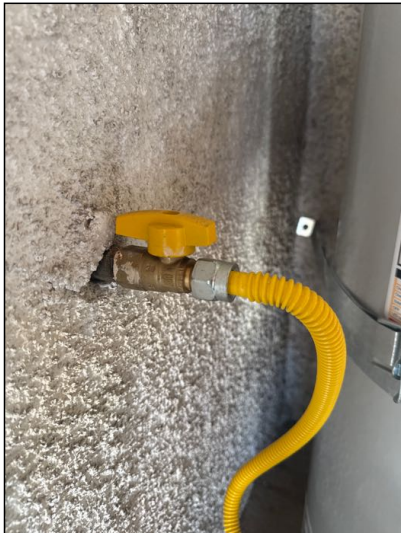
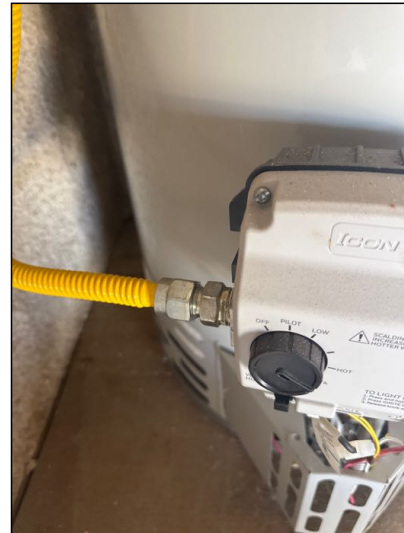
8.1. No sediment trap was observed at the time of inspection. Recommend checking local codes for requirement, and evaluation by a licensed plumber for installation as needed.

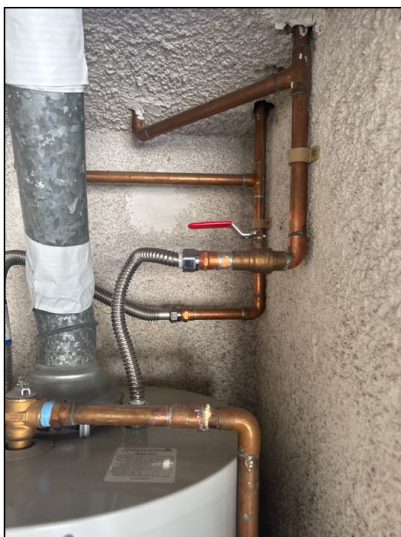
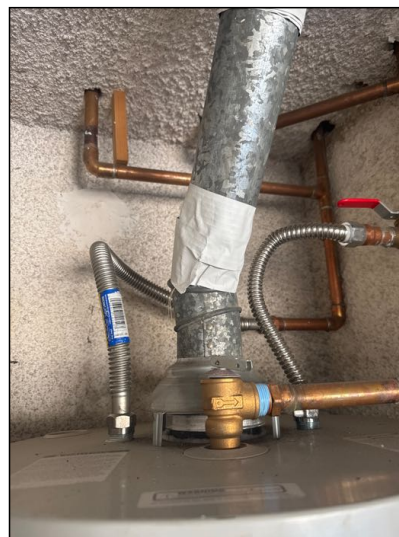
9.2. No expansion tank was observed at the time of inspection. Recommend checking local codes for requirement, and evaluation by a licensed plumber for installation as needed.

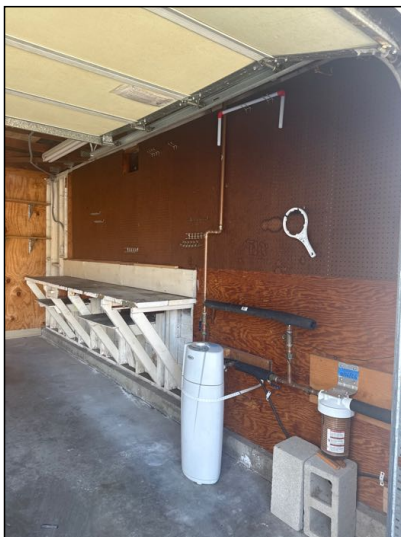
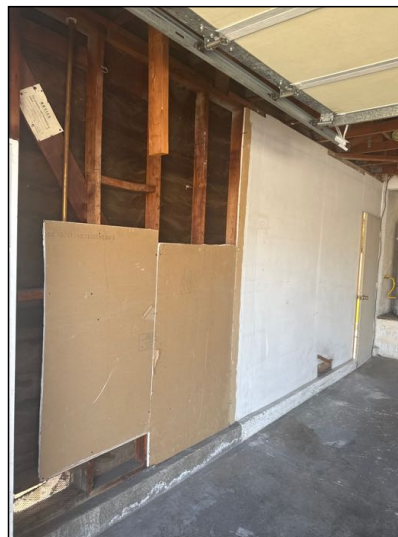
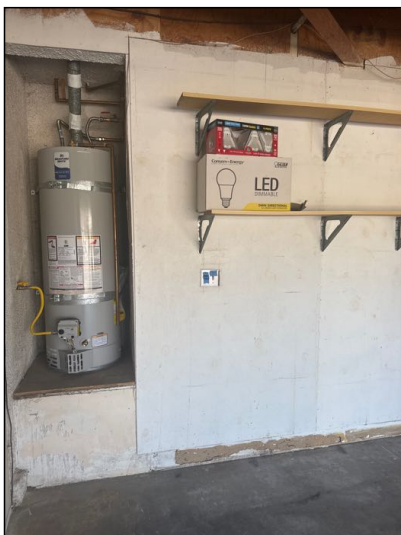
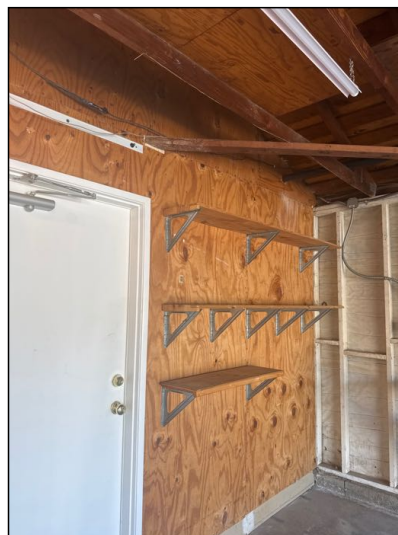
2.2. **Firewall:** Garage Firewall/Fire Separation: Plywood sheathing was installed on the garage wall where a required fire-resistive separation may be present. Type X gypsum board was visible at the lower portion of the wall; however, the extent and continuity of the fire-resistive assembly could not be determined due to the plywood covering. Because plywood is a combustible material and may not provide the required fire-resistance rating, the adequacy of the garage-to-dwelling fire separation could not be confirmed at the time of inspection. Recommend further evaluation by a state licensed professional to verify the existing assembly and make corrections as needed to meet applicable fire-separation requirements.

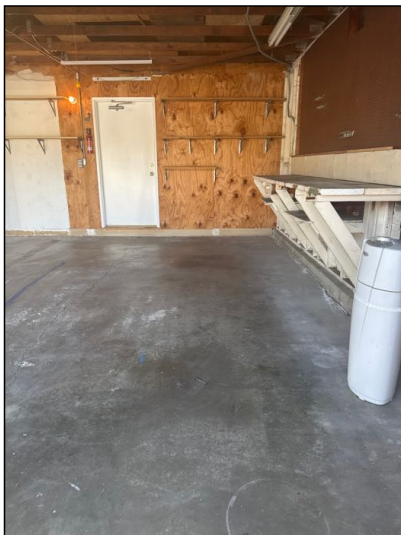
3.2. **Garage Floor:** Common cracks were observed in the garage floor. These appear consistent with normal shrinkage or settling and do not indicate a structural concern at this time. Monitoring for expansion or movement is recommended.

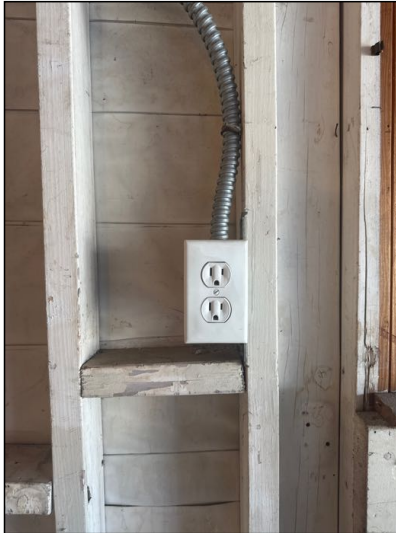
**6.3. Missing GFCI Protection:** GFCI outlets were not installed in one or more areas where required, such as the garage, bathrooms, kitchen, or exterior. Installation of GFCI protection by a qualified electrician is recommended for safety.

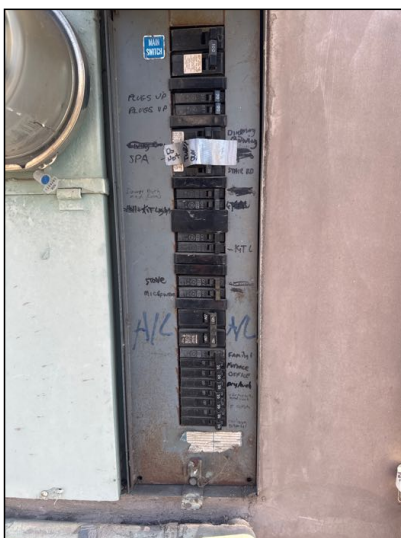
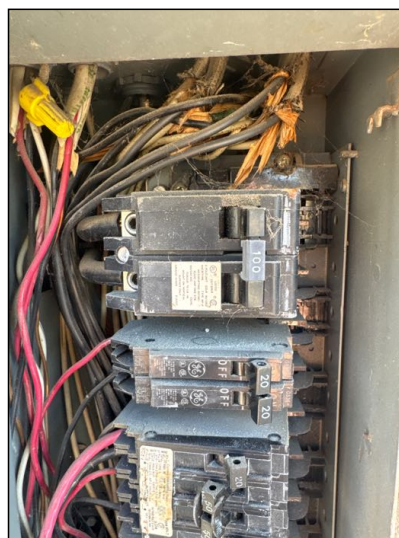
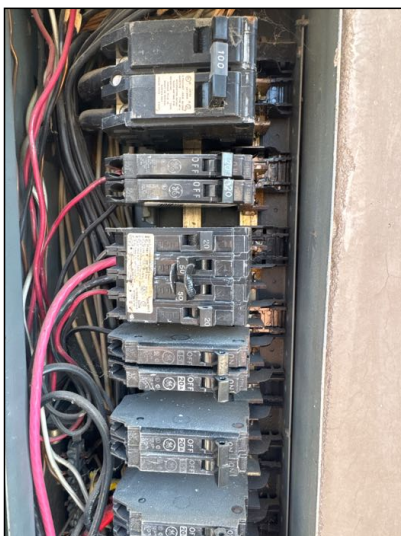
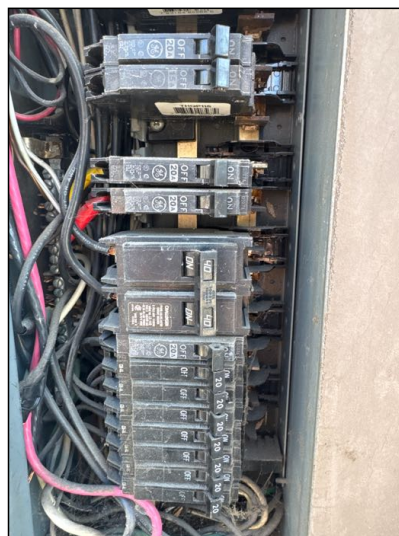
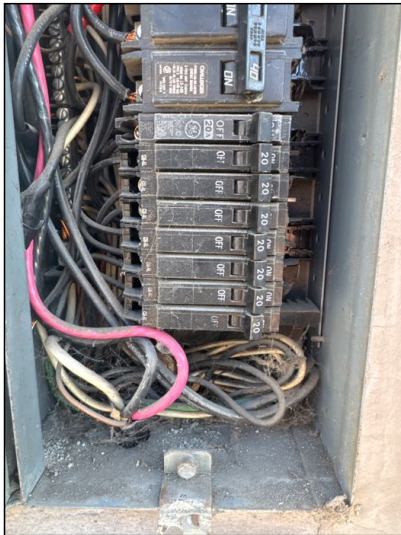
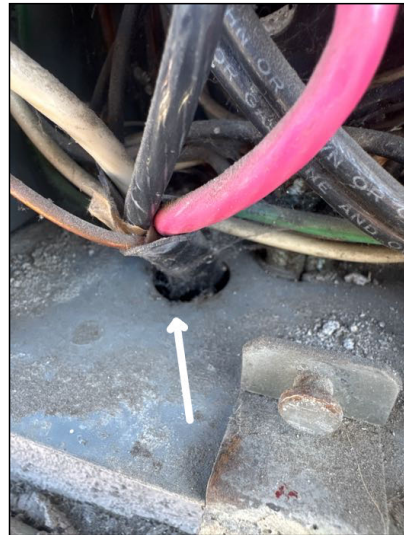
2.1. No bonding bushing was installed at the electrical service panel. Bonding bushings are required where electric raceway/panel connections are made through concentric knockouts. Bonding bushings should be installed where required by a state licensed professional.

2.2. Bare, unterminated wires were observed inside the electrical service panel. The wires were not connected to the bus bar or other terminals and were not energized at the time of inspection. The purpose and disposition of these wires could not be determined. Recommend evaluation by a state licensed electrician and proper termination, removal, or securing of the conductors as appropriate.

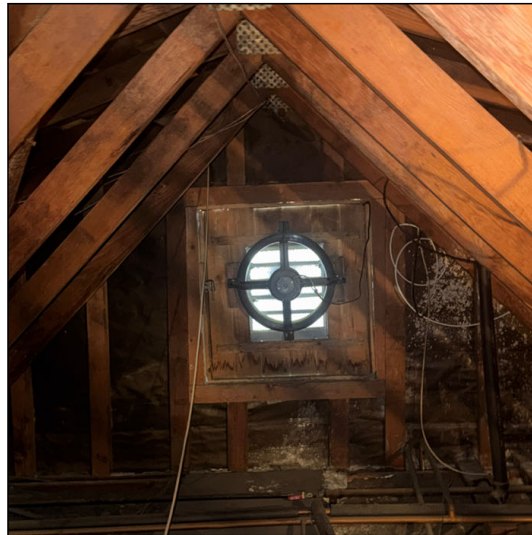
3.2. Electrically powered fan vent observed. These need to be inspected, tested and maintained annually.

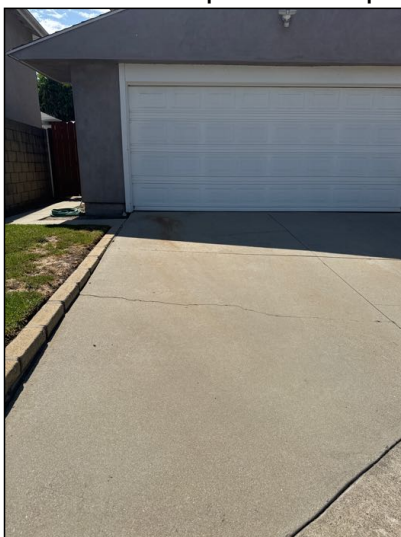
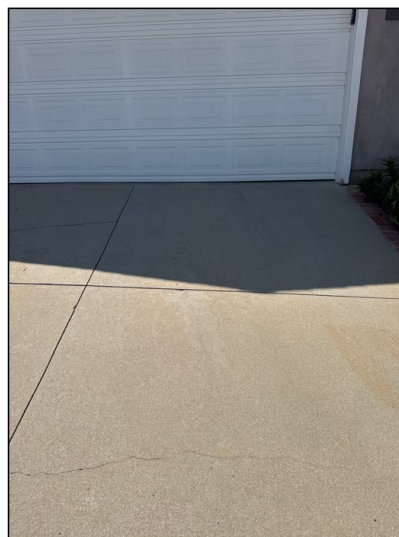
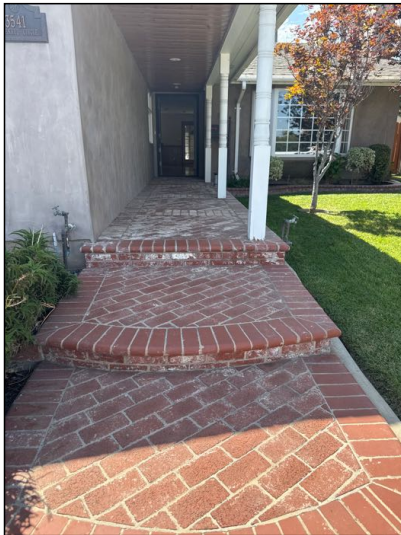
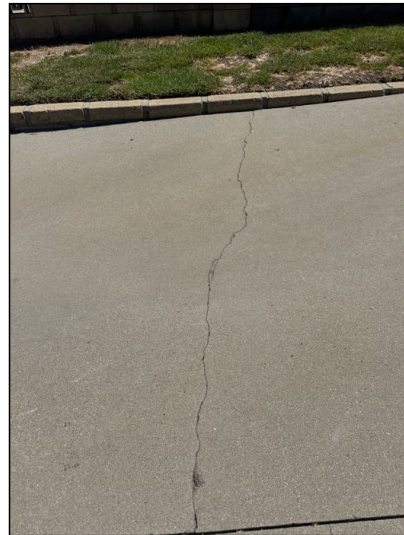
1.5. Monitor: Surface deterioration observed at the concrete surface.

1.6. Moderate cracks in sidewalk. Repair and / or monitor for expansion and development of trip hazards.

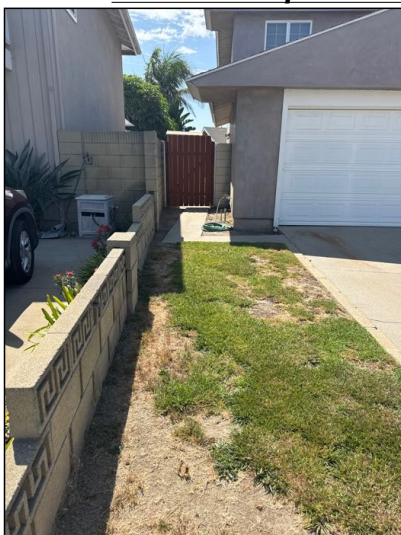
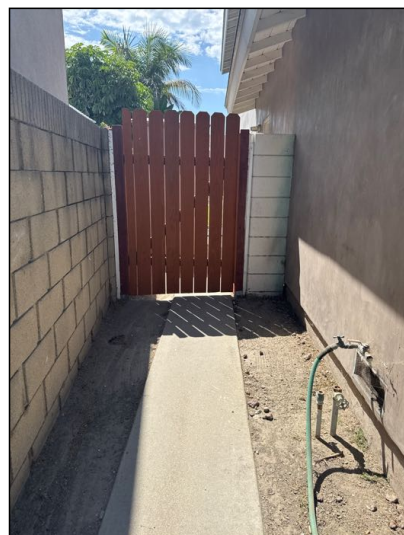
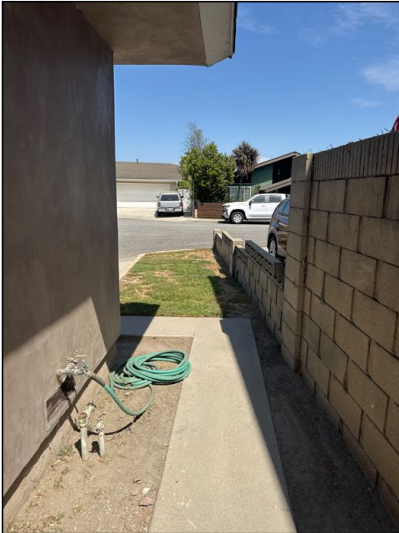
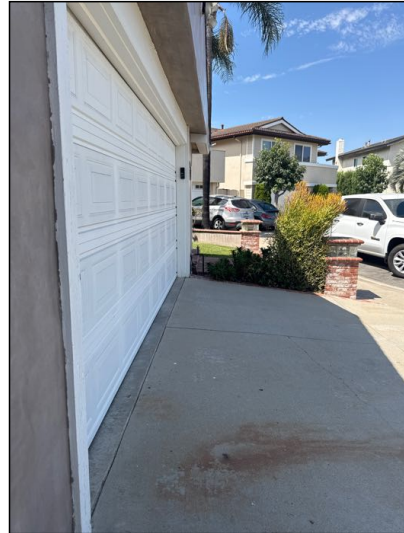
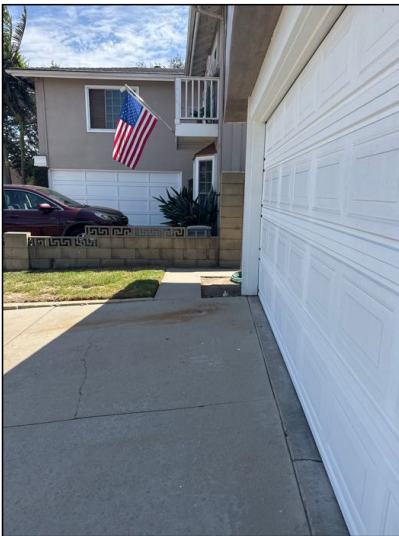
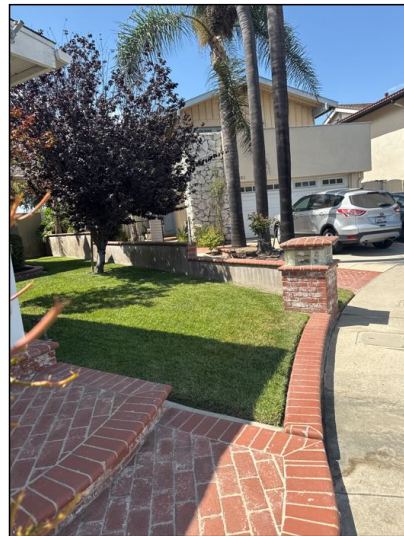
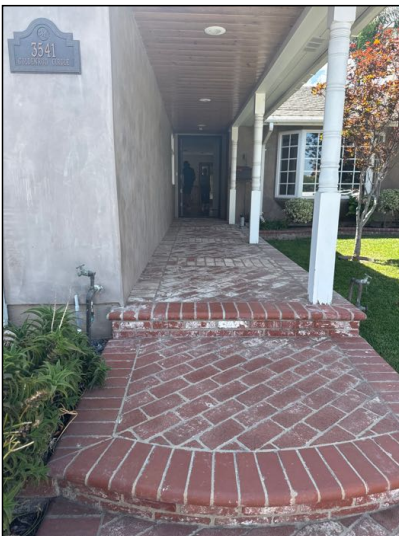
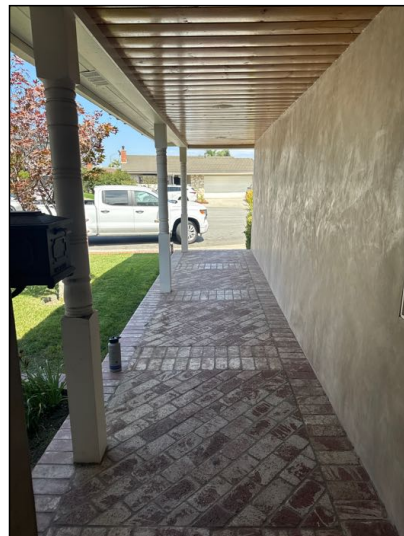
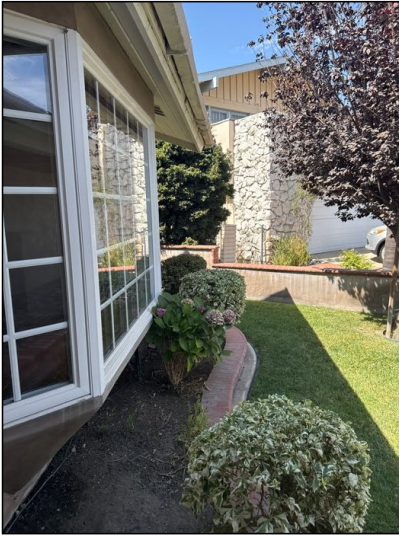
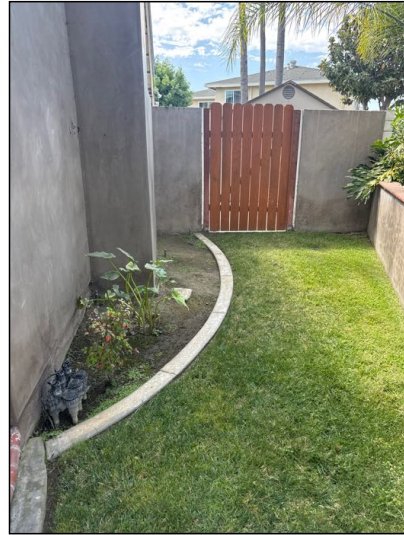
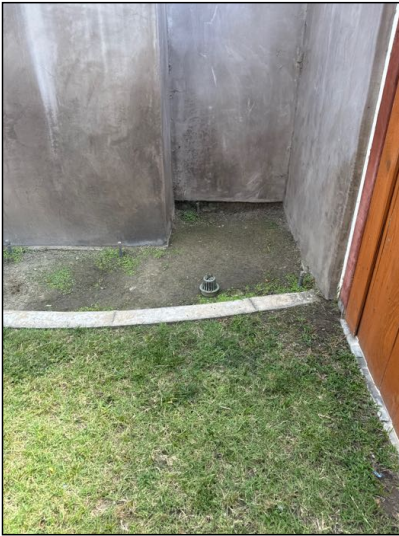
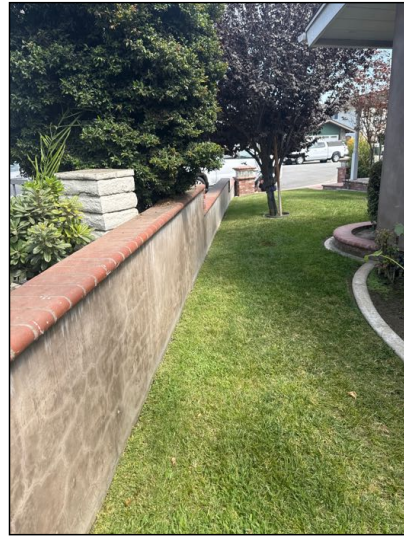
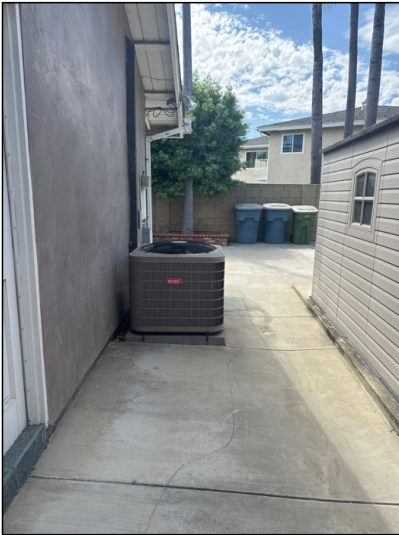
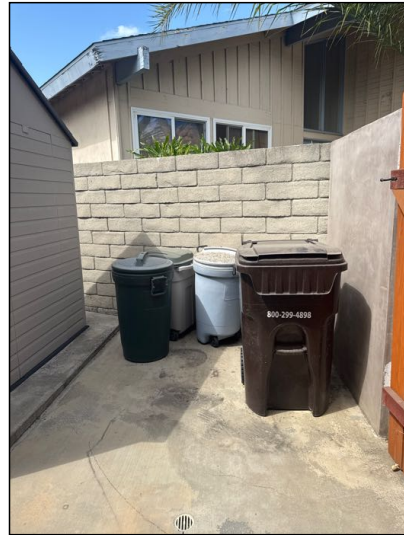
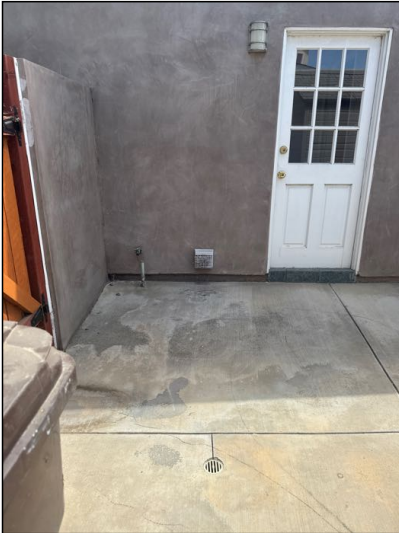
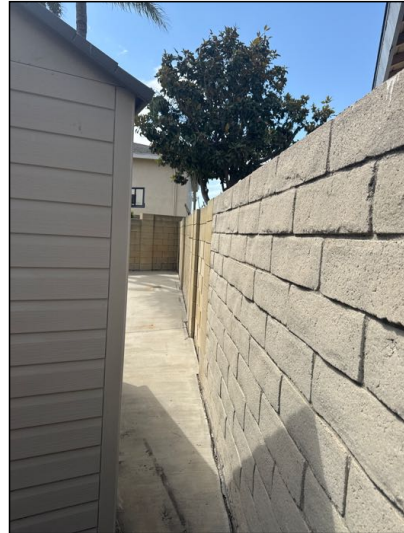
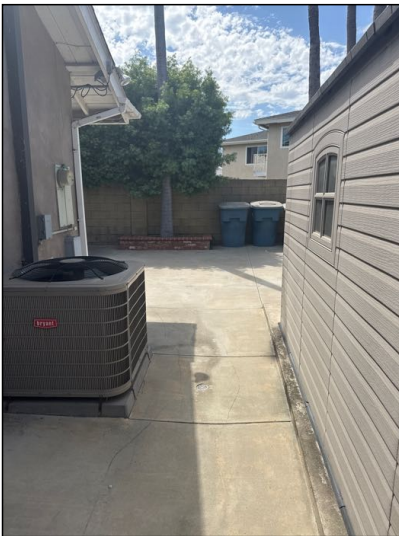
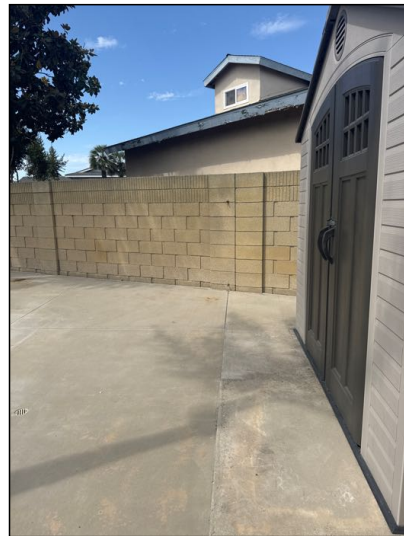
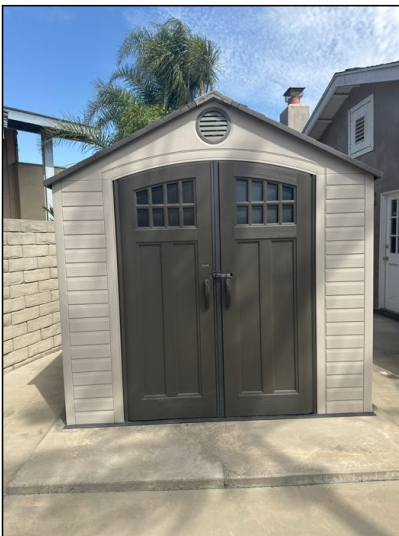
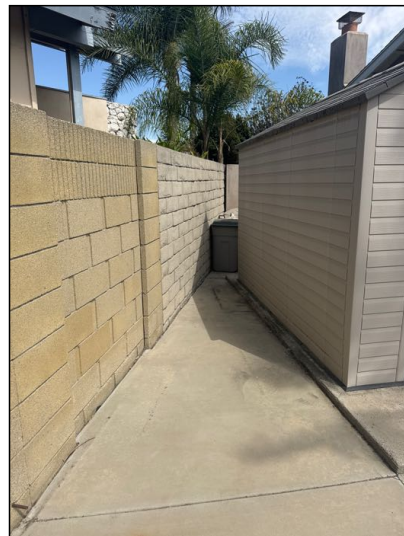
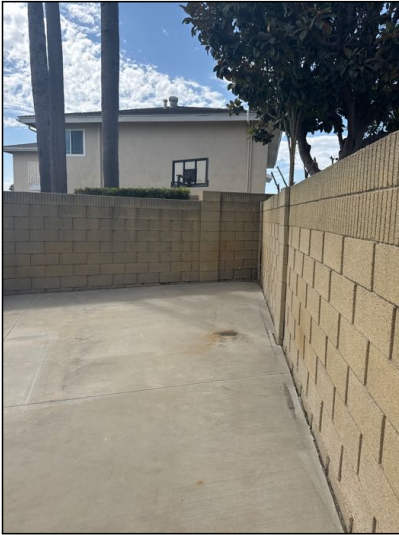
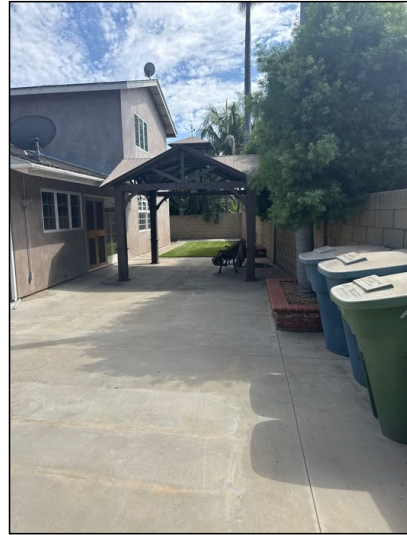
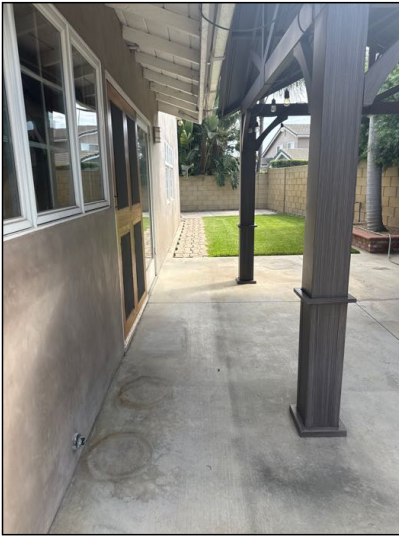
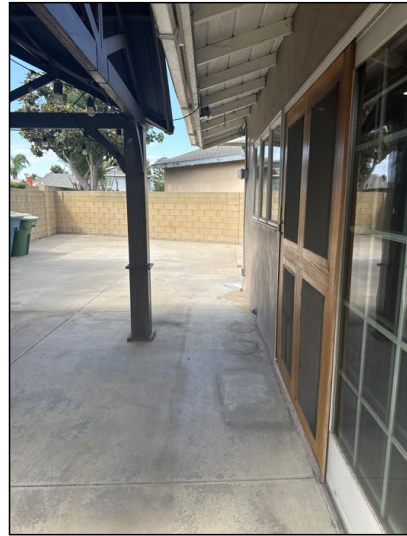
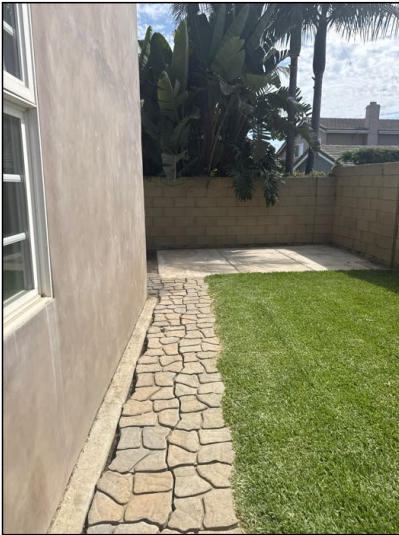
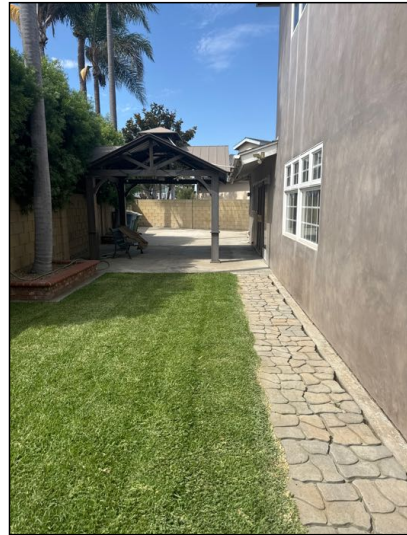
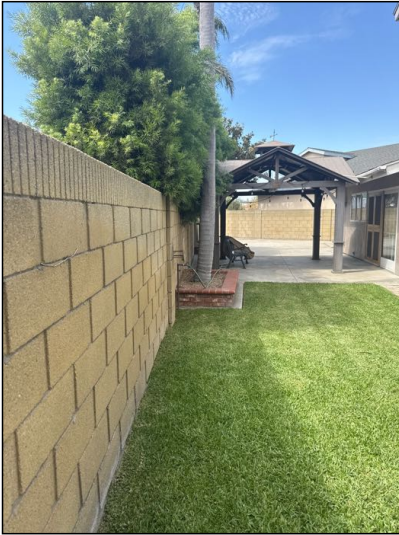
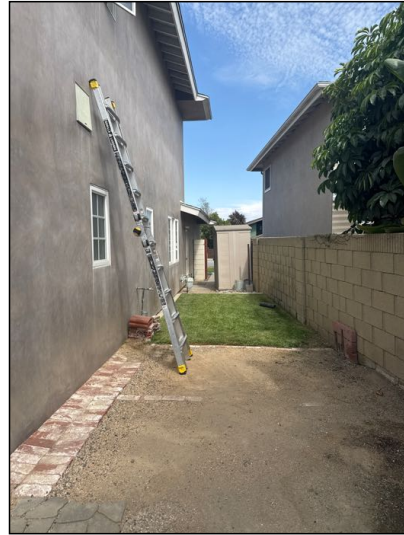
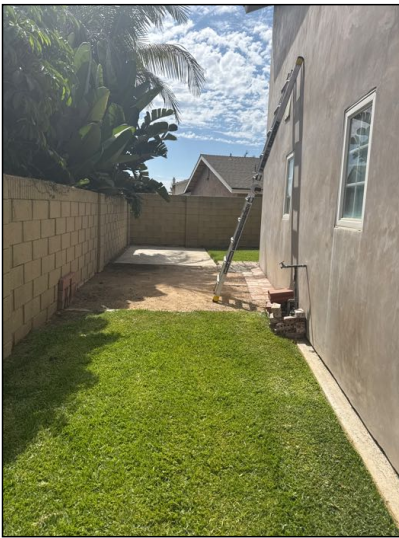
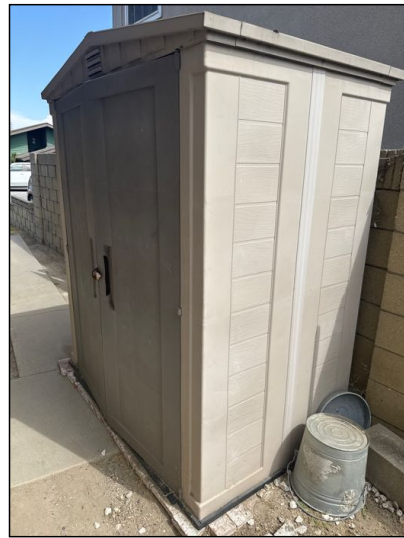
1.1. Common cracks were observed at the concrete surfaces. Further deterioration will occur as water expands and contracts due to temperature changes. Recommend sealing the cracks to prolong the life of the concrete.

1.3. Some oil staining. Clean and seal to extend life.

1.4. Moderate cracks in driveway. Repair and / or monitor for expansion and development of trip hazards.

1.2. Recommend sealing areas to extend life.

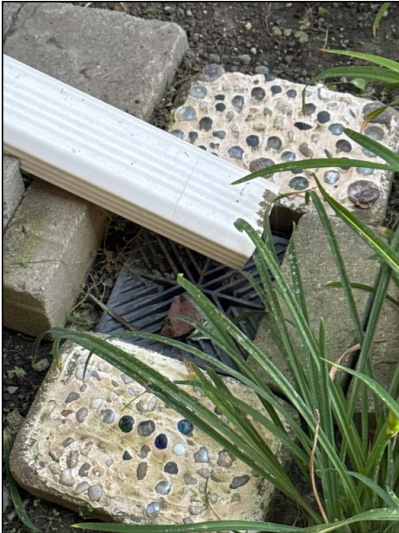
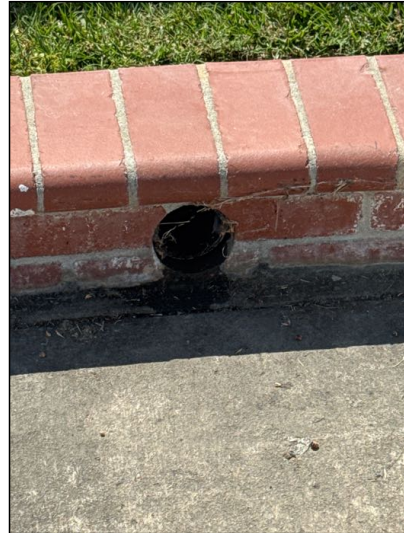
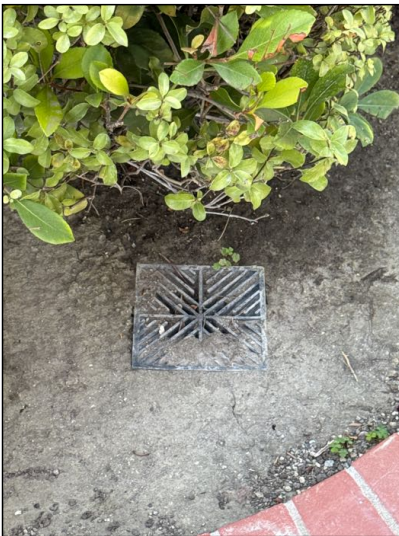
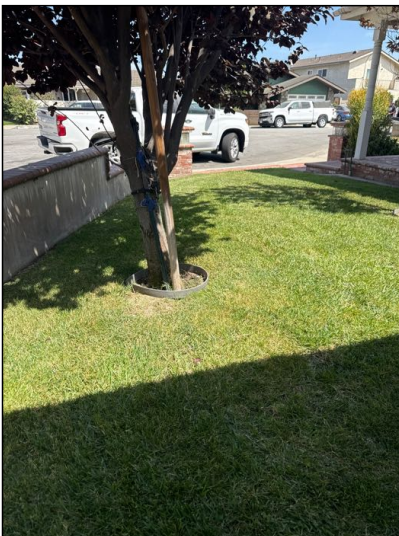
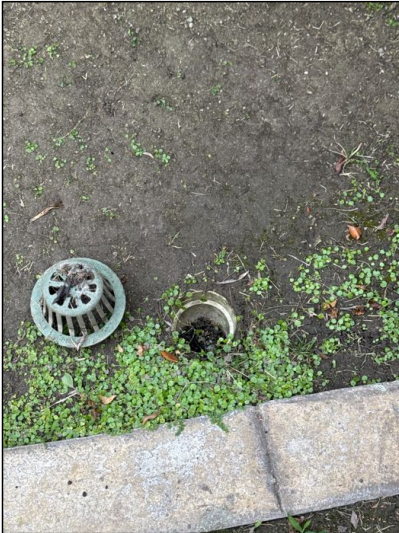
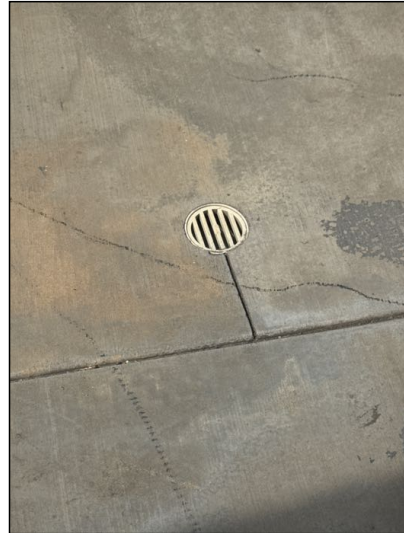
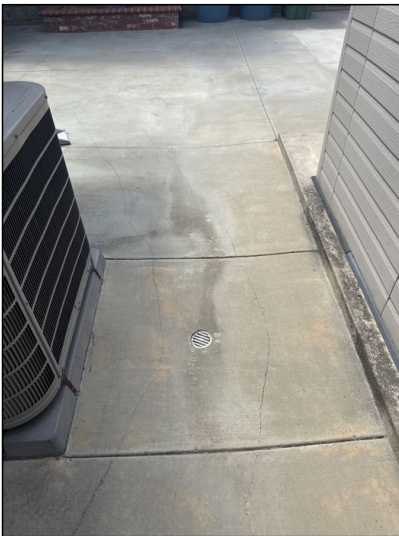
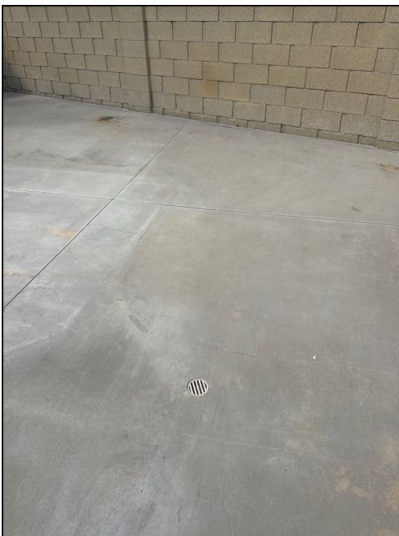
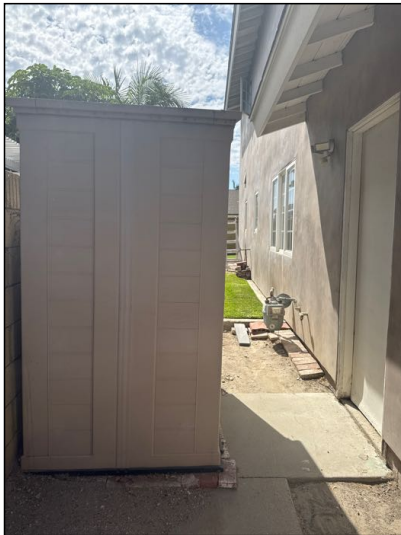
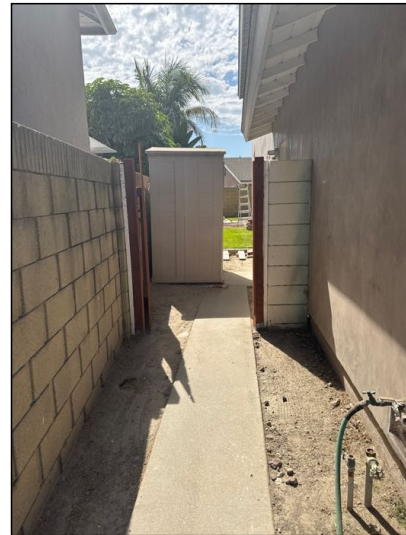
3.1. Drainage grates were observed on the property. Recommend further exploration to determine the extent of the system. Also recommend ongoing maintenance (cleaning, removing debris, etc.) to facilitate optimal performance of the system.

3.2. Significant debris observed. Recommend clearing.
