# - INSPECTION REPORT -

**CHRIS RIPPY INSPECTIONS**

**3541 Goldenrod Cir Seal Beach, CA 90740**  
**Inspection prepared for: Rod & Susan Morales**  
**Real Estate Agent: Lisa Broder - Think Boutiq Real Estate**

**Date of Inspection: 8-9-2026**

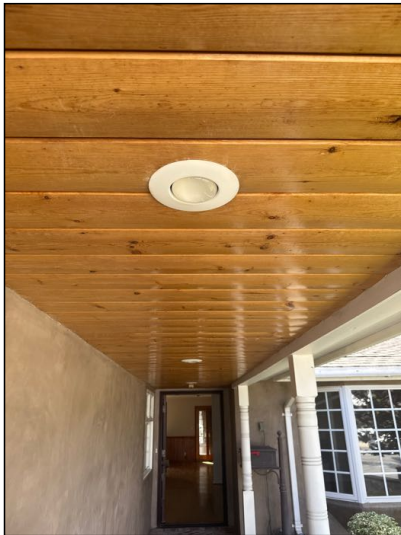
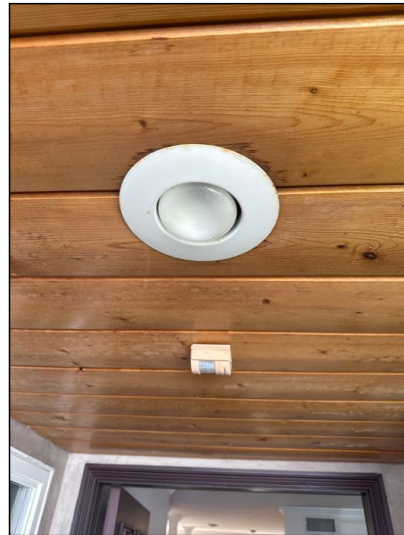
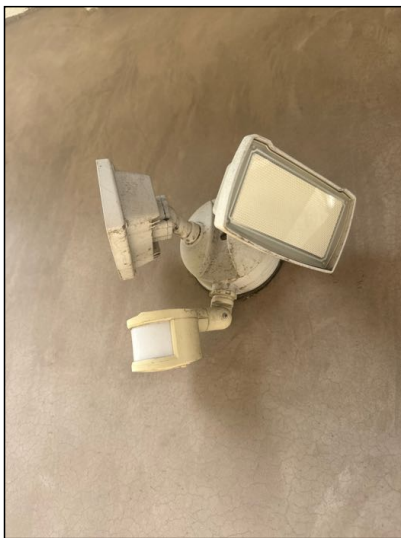
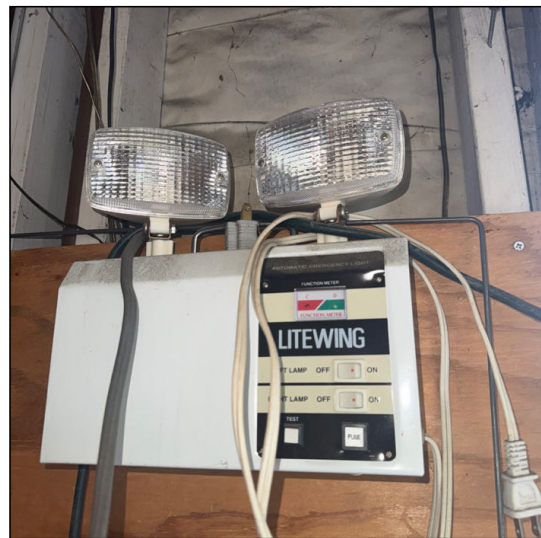
6.1. The exterior motion-activated lights could not be tested at the time of inspection. The control for the motion detectors was found unplugged in the garage, preventing testing of the lights and motion-sensor function. Recommend restoring power to the controls and testing the system for proper operation.

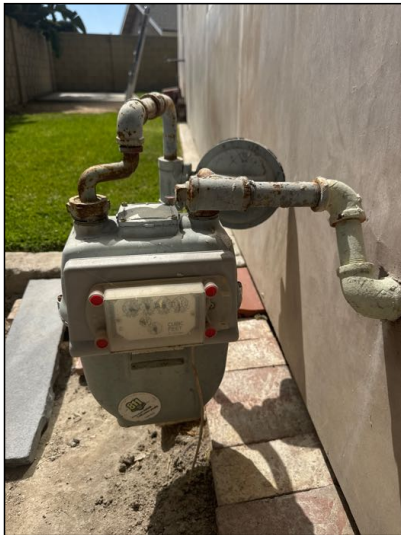
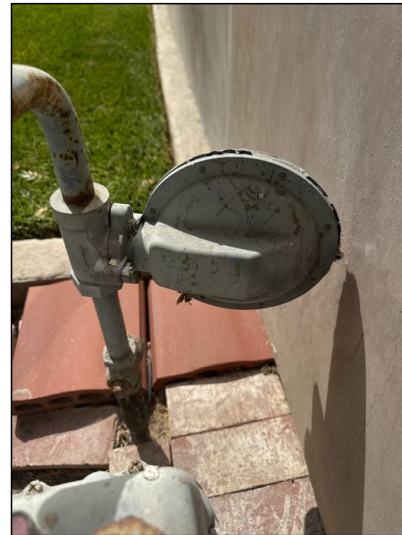
8.3. No seismic shut off valve present. Consult local codes.

8.1. **Recommend keeping a gas valve shutoff wrench close to the meter in case of an emergency.**

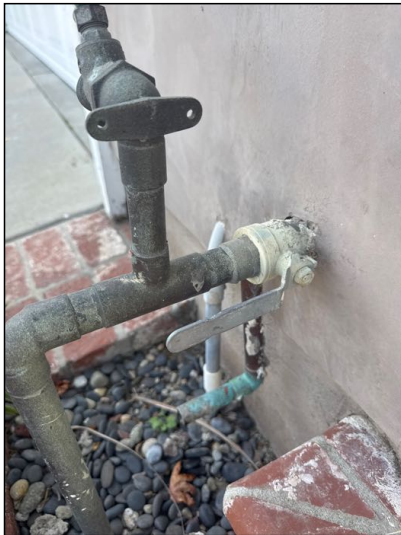
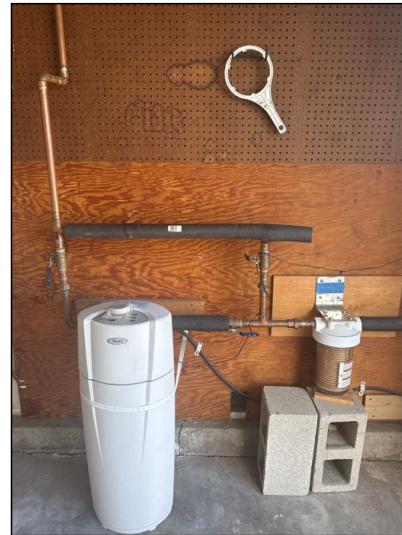
9.2. The inspector was unable to locate a clean-out for the main sewer line. To facilitate clearing blockages, a full-size clean-out should be located within 5 feet of the foundation in line with the building drain and sewer. This condition may complicate the clearing of any blockages that might develop. Recommend consulting with a state licensed professional for more information.

9.3. Sprinkler system noted; client is advised to seek advice of a specialist in evaluating this system before use. The inspector recommends also consulting with seller for operation instructions if needed. Sprinkler systems are beyond the scope of a Home Inspection, due to most of its parts/piping not visible.

9.4. A whole house water filtration system was noted at the time of inspection. This system is beyond the scope of a general home inspection, and the internal components, filter condition, and function were not evaluated. Recommend obtaining service records and evaluation by a state licensed professional to verify proper operation and maintenance status.

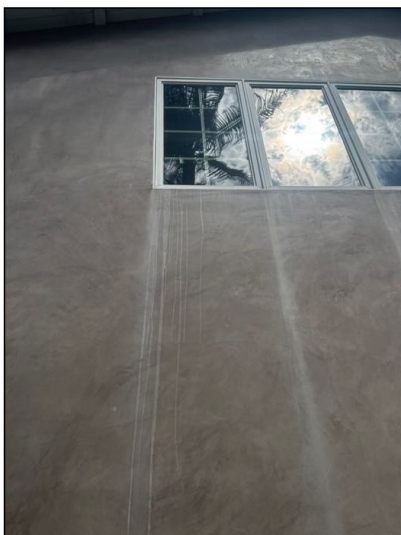
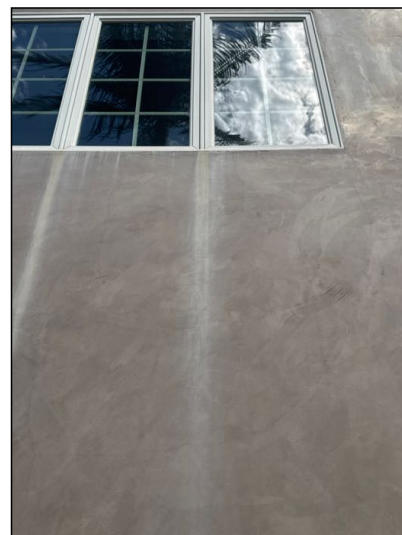
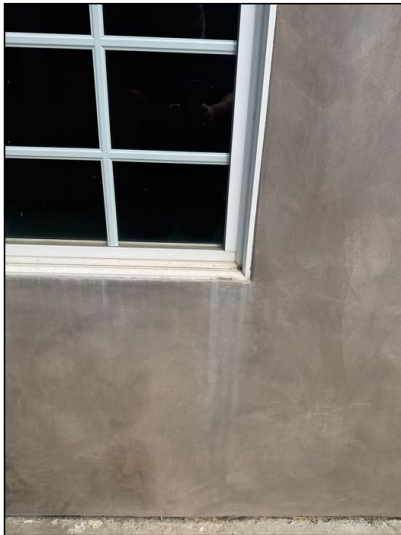
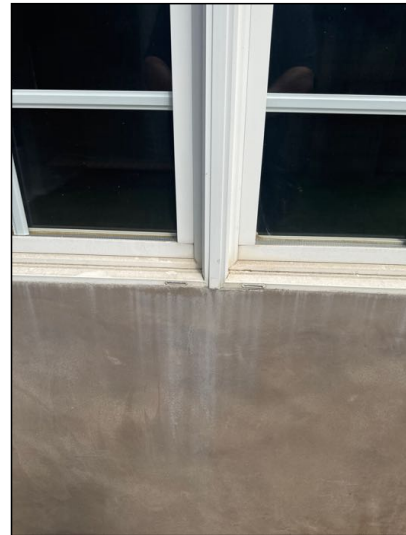
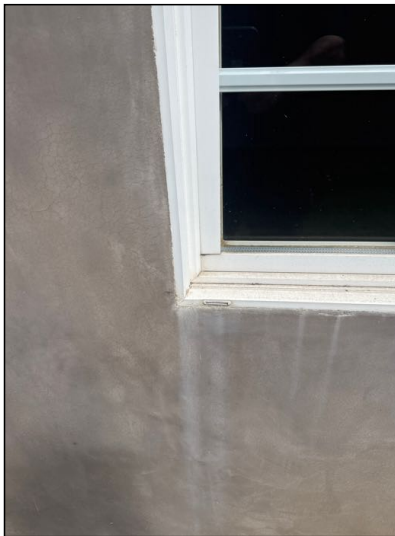
**12.3. Cracks in Stucco:** Cracks were observed in the stucco surface. These can allow moisture intrusion and should be sealed or repaired.

**12.4. Staining and streaking were observed on the stucco below the windows, consistent with possible water runoff or moisture exposure. Recommend evaluation and repair as needed to determine the source and prevent further staining or potential moisture intrusion.**

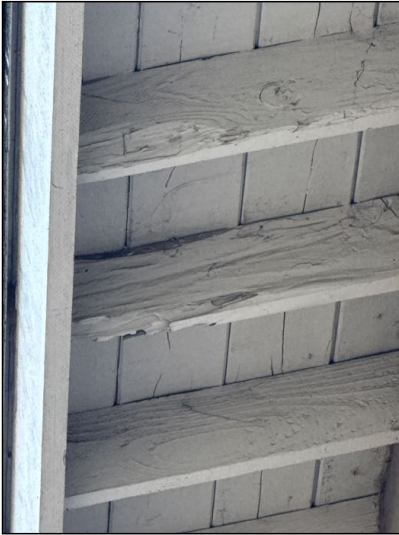
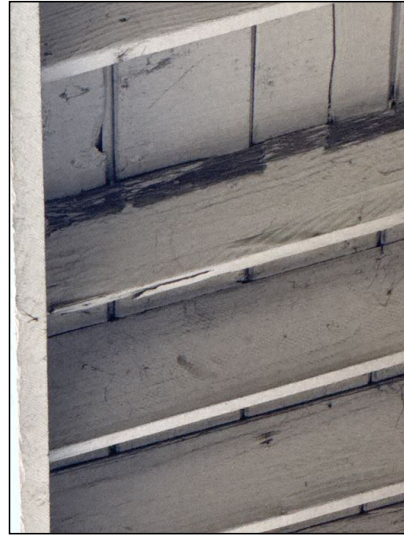
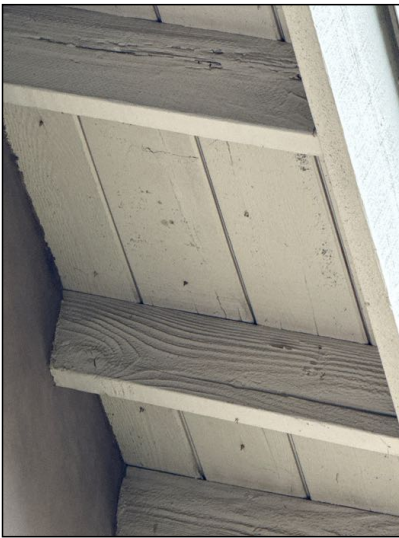
**13.1. Deteriorated or Rotted Wood:** Areas of rot or deterioration were observed at the eaves, soffits, or rafter tails. This condition is typically caused by prolonged moisture exposure and should be repaired or replaced as needed.

**13.2. Peeling or Failing Paint:** Peeling or deteriorated paint was noted on the eaves or soffits. This exposes the underlying material to moisture and UV damage. Repainting is recommended to maintain protection.

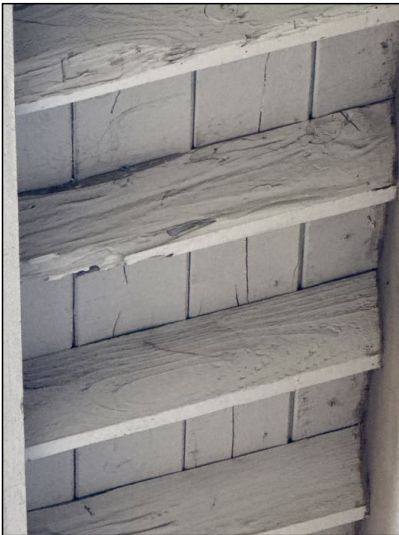
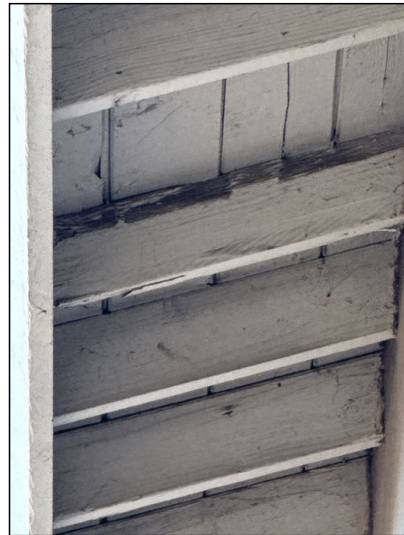
**14.1. Peeling or Flaking Paint:** Areas of peeling or flaking exterior paint were observed. This condition exposes underlying materials to moisture and may lead to deterioration. Scraping, priming, and repainting are recommended.

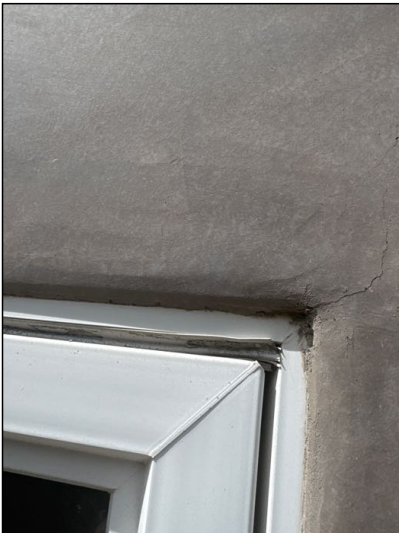
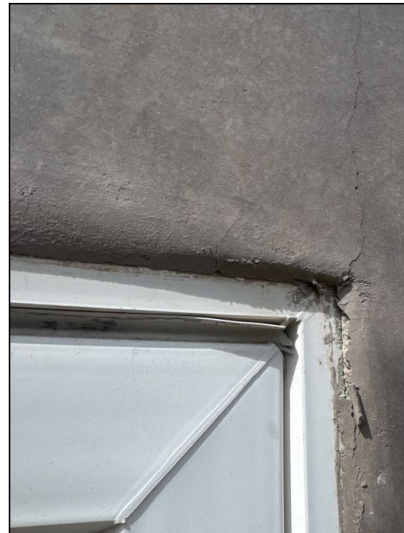
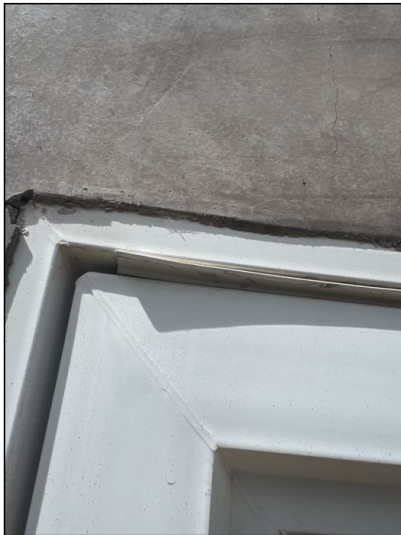
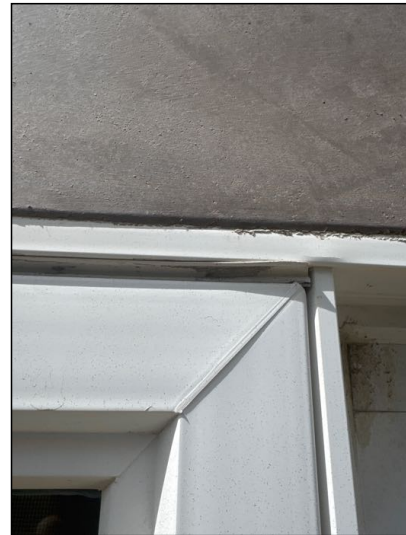
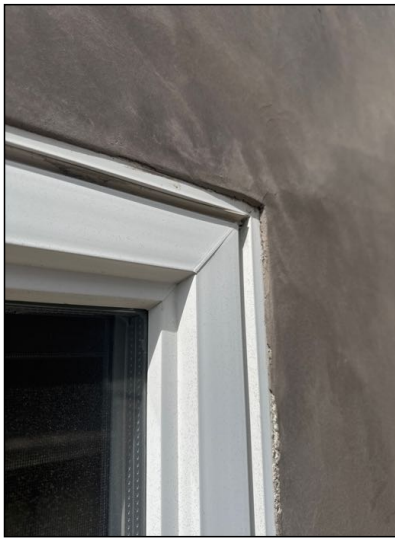
15.1. **Deteriorated or Loose Weatherstripping:** Weatherstripping at one or more windows is worn, loose, or missing. Replacement is recommended to improve energy efficiency and reduce drafts.

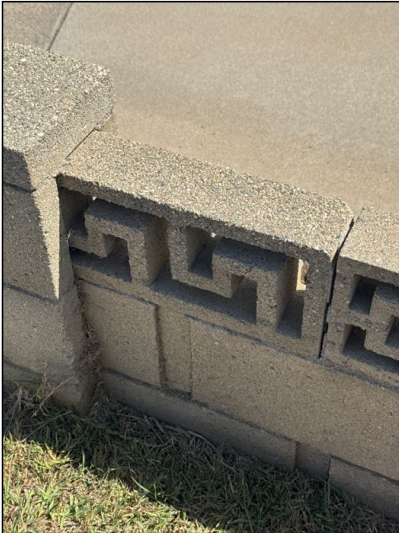
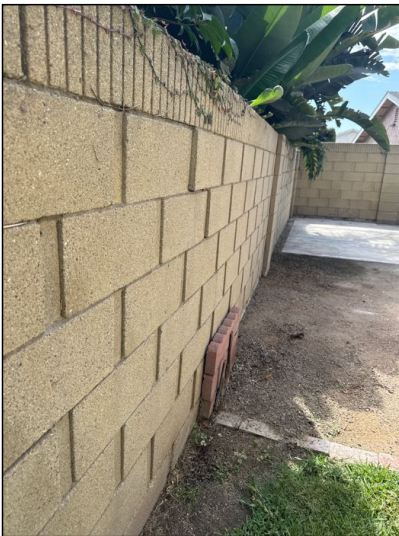
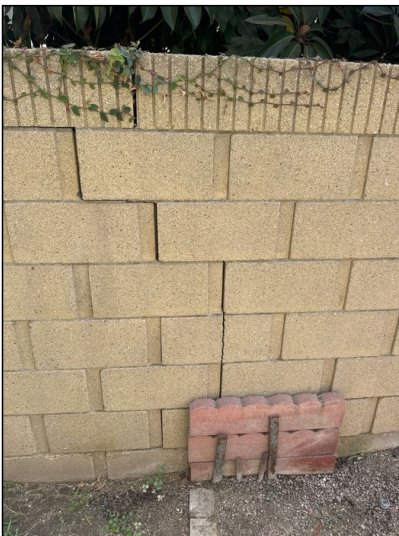
17.2. Loose top blocks observed. This is a safety concern. Suggest maintenance/repairs as needed to ensure safety.(Located at the north block wall in backyard)

17.3. The south-side block wall appeared to be leaning, with cracked mortar joints and visible separations between blocks. The wall has been reinforced in one area with stakes and brick material; however, the adequacy and effectiveness of this reinforcement could not be determined at the time of inspection. Recommend evaluation by a state licensed professional to assess the condition of the wall and recommend repairs or stabilization as needed.
