## SUMMARY

26401 Oak Crossing Rd, Santa Clarita,  
CA 91321

Ina Ray Simpson  
07/30/2026

Mike Ortiz  
CMI Certified Master Inspector, ICC  
Certified  
Home-Front Inspection Services LLC  
3103478945

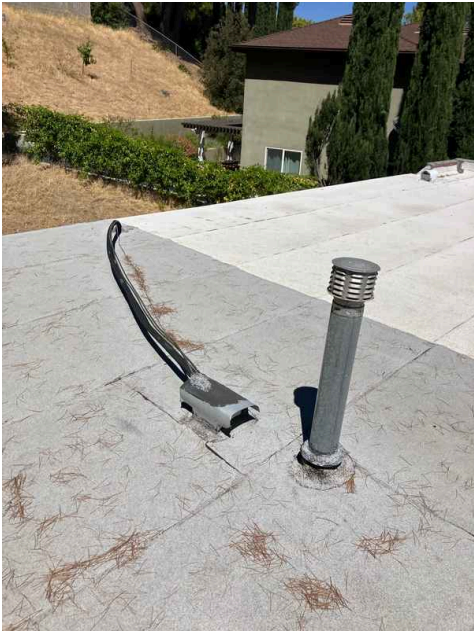
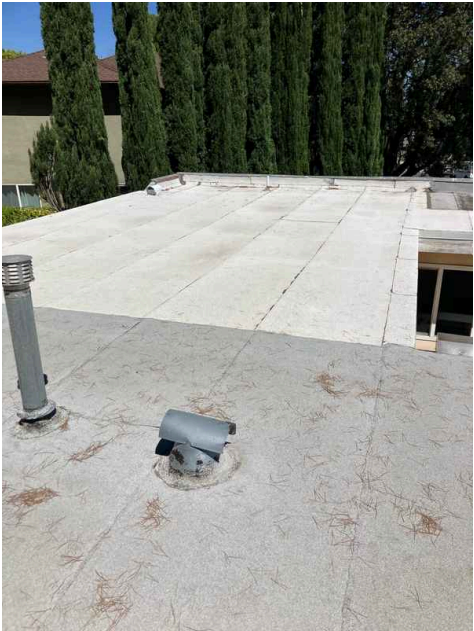
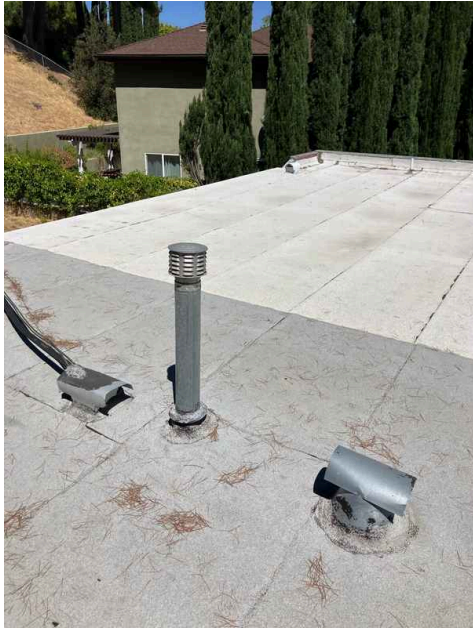
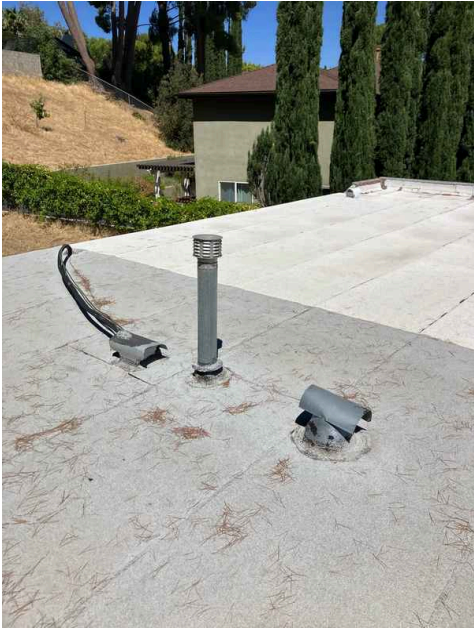
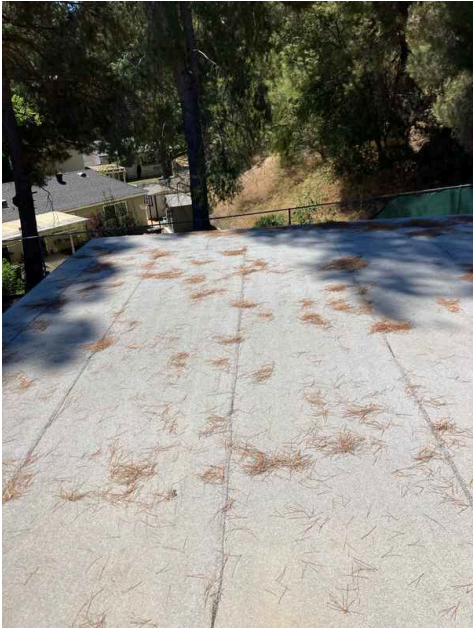
### 7.1.1 Condition DEFECTS

- \* **Roof Covering:** The rolled composition roofing exhibited visible wear and deterioration consistent with an aging roof covering. Overall conditions indicate that repairs and possible replacement should be anticipated.

- \* **Debris:** Moderate to heavy debris accumulation was observed across multiple roof areas. Debris can retain moisture, obstruct drainage, and accelerate deterioration of roofing materials.

- \* **Ponding Evidence:** Staining and evidence of previous ponding water were observed in multiple areas, indicating that portions of the roof may not be draining effectively.

- \* **Roof Penetrations:** Multiple vent flashings and vent boots exhibited gaps, loose components, and signs of deterioration. These conditions can allow water intrusion and should be evaluated for appropriate repair or replacement as needed.

- \* **Flashing/Drip Edge:** Sections of the perimeter flashing and drip edge appeared loose, deteriorated, or inadequately sealed in areas. Repairs are recommended to help maintain a weather-resistant roof assembly.

- \* **Areas of Greatest Concern:** The most significant deterioration was observed at the front of the property, particularly near the garage and front roof sections. These areas should receive priority during further evaluation and repairs.

- \* **Previous Repairs:** Portions of the rear roof appeared to have been repaired more recently; however, the quality and extent of those repairs could not be fully determined during this inspection.

- \* **Recommendation:** Based on the observed conditions, a qualified roofing contractor should perform a comprehensive evaluation of the entire roof system and provide recommendations for any necessary repairs or replacement.
