## R.B.Inspections

### Property Inspection Report

Property address: **11605 Garfield Ave, South Gate, CA 90280**

Inspection date: **Tuesday, September 22, 2026**

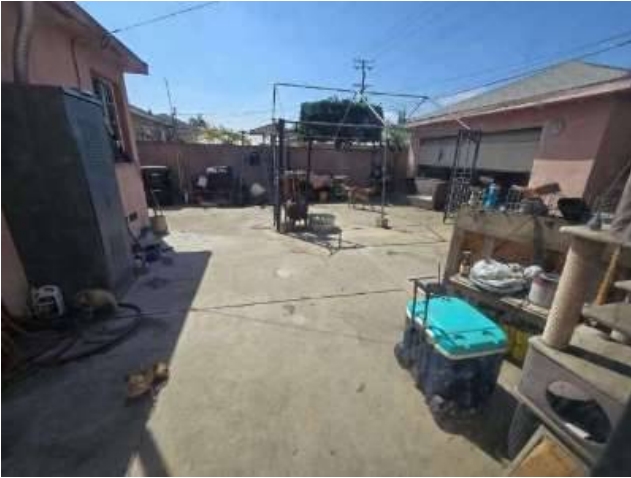
Photo 3-1

Due to the presence of dogs on the property, the inspector was unable to safely access and fully evaluate certain areas, including portions of the grounds, exterior areas, detached garage, main electrical panel, water heater, and air conditioning condenser. These areas were not fully inspected at the time of the inspection. Further evaluation is recommended once safe access is provided and the animals are properly secured.

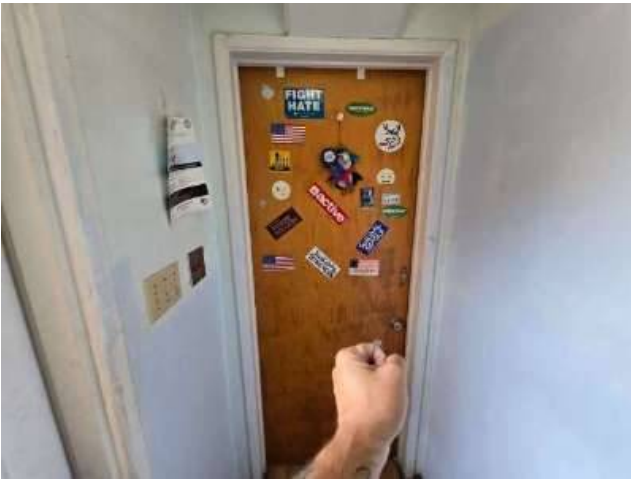
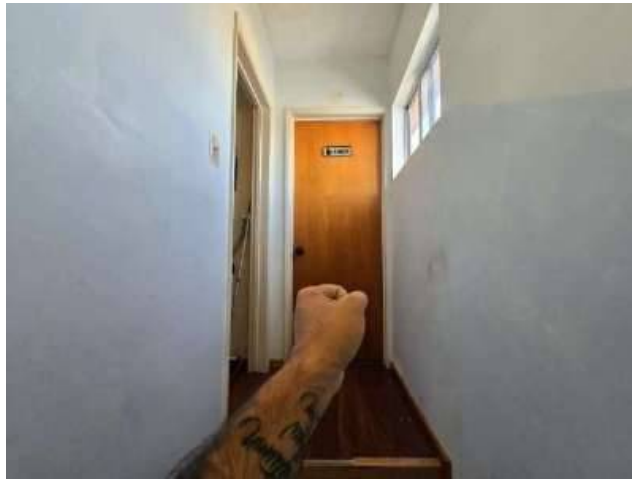
Several interior rooms were locked and were not accessible at the time of inspection. These areas and their components could not be fully evaluated. Recommend verifying access and condition prior to closing.

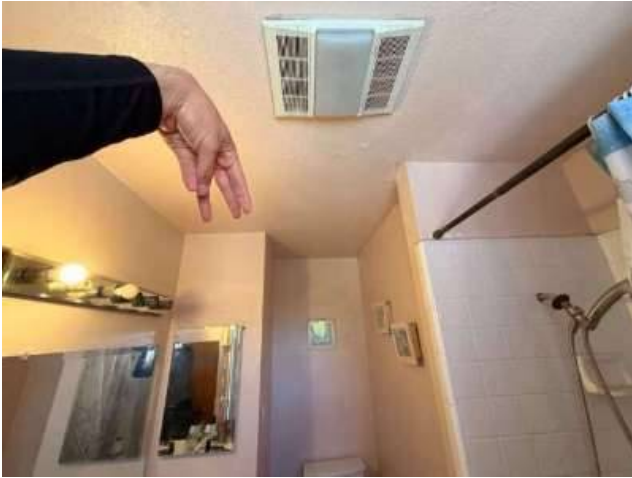
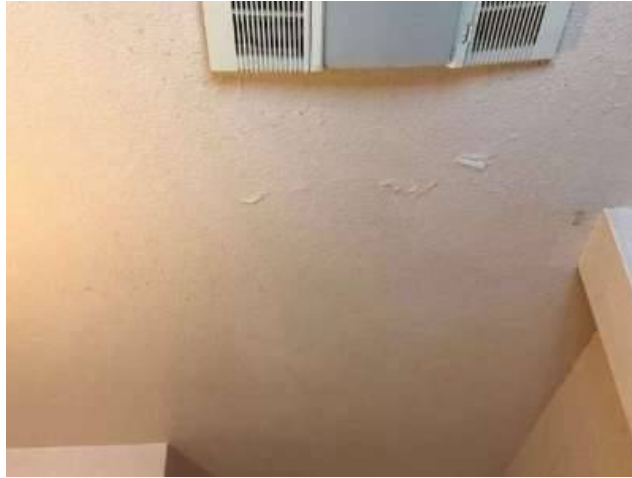
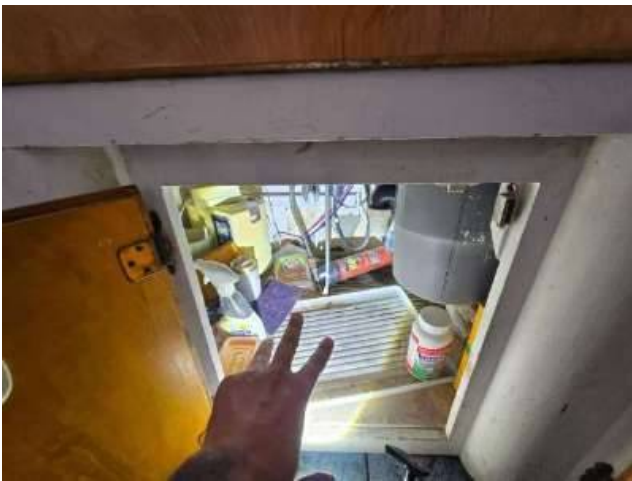
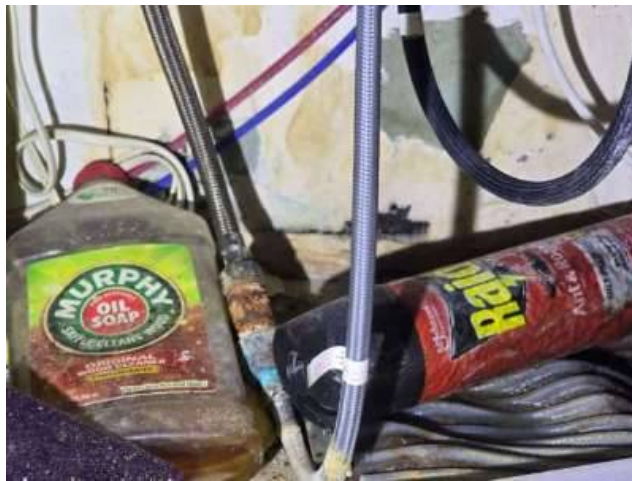
Microbial growths were found at one or more locations in interior rooms and/or bathroom #B. It is beyond the scope of this inspection to identify what substance or organism this staining is. However such staining is normally caused by excessively moist conditions, which in turn can be caused by plumbing or building envelope leaks and/or substandard ventilation. These conducive conditions should be corrected before making any attempts to remove or correct the staining. Normally affected materials such as drywall are removed, enclosed affected spaces are allowed to dry thoroughly, a mildewcide may be applied, and only then is drywall reinstalled. For evaluation and possible mitigation, consult with a qualified industrial hygienist or mold/moisture mitigation specialist. For more information, visit:

\*under kitchen sink

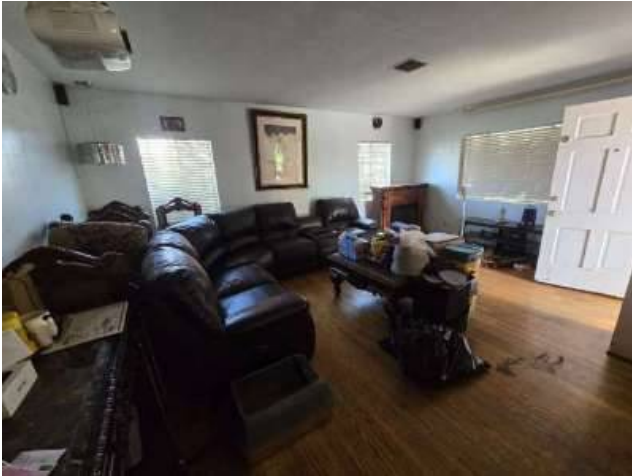
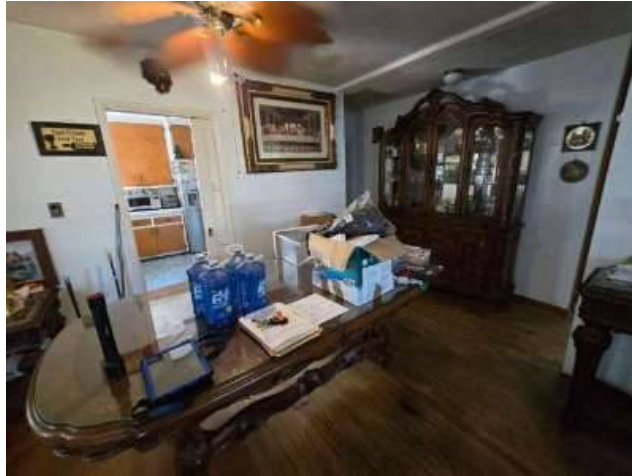
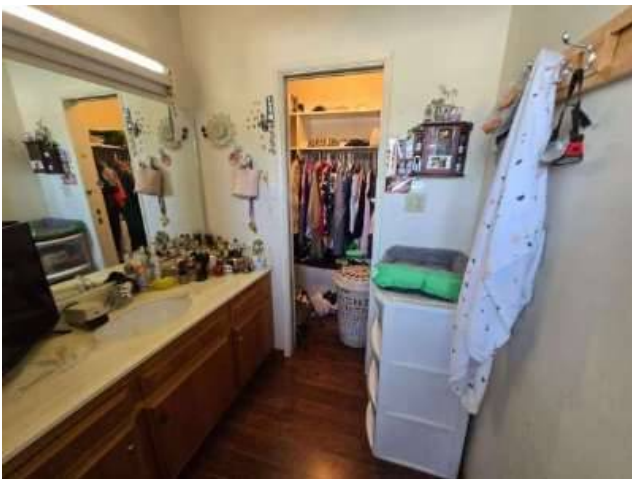
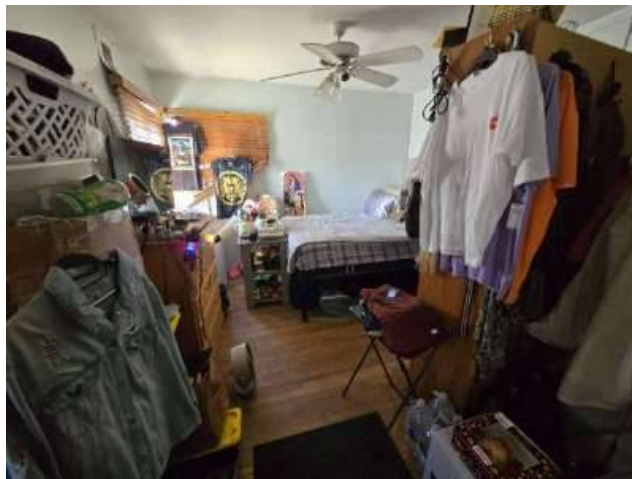
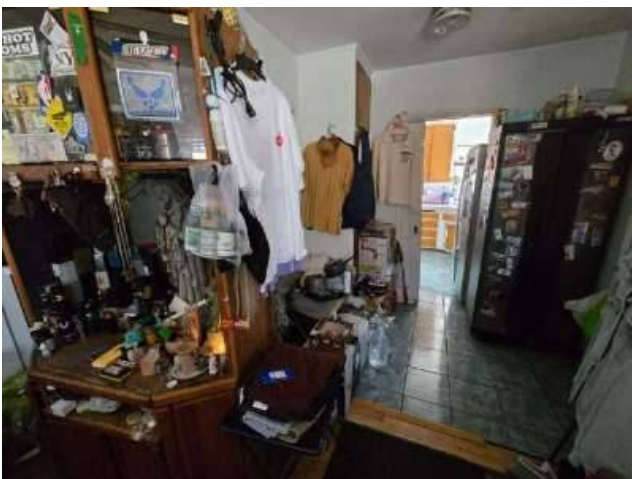
Many areas and items at this property were obscured by furniture and/or stored items. This often includes but is not limited to walls, floors, windows, inside and under cabinets, under sinks, on counter tops, in closets, behind window coverings, under rugs or carpets, and under or behind furniture. Areas around the exterior, under the structure, in the garage and in the attic may also be obscured by stored items. The inspector in general does not move personal belongings, furnishings, carpets or appliances. When furnishings, stored items or debris are present, all areas or items that are obscured, concealed or not readily accessible are excluded from the inspection. The client should be aware that when furnishings, stored items or debris are eventually moved, damage or problems that were not noted during the inspection may be found.

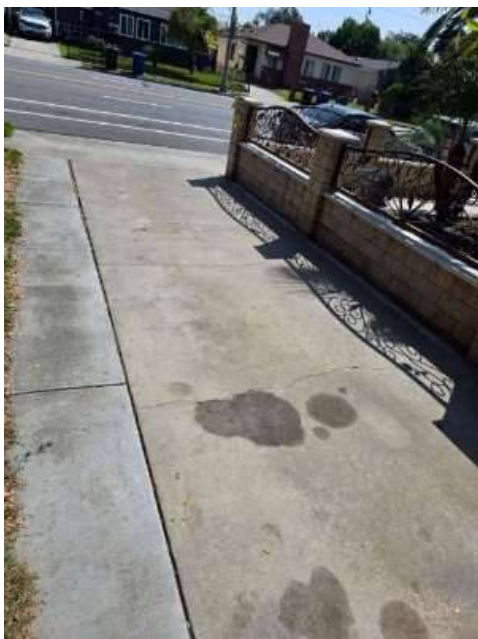
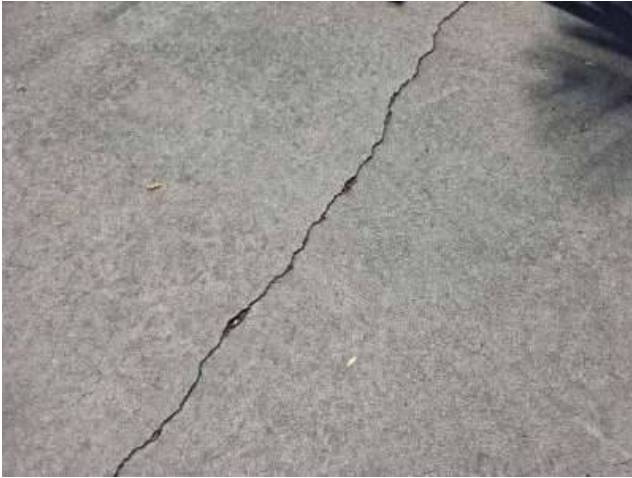
9) 🛠️ Minor deterioration (e.g. cracks, holes, settlement, heaving) was found in the driveway, but no trip hazards were found. The client may wish to have repairs made for cosmetic reasons.

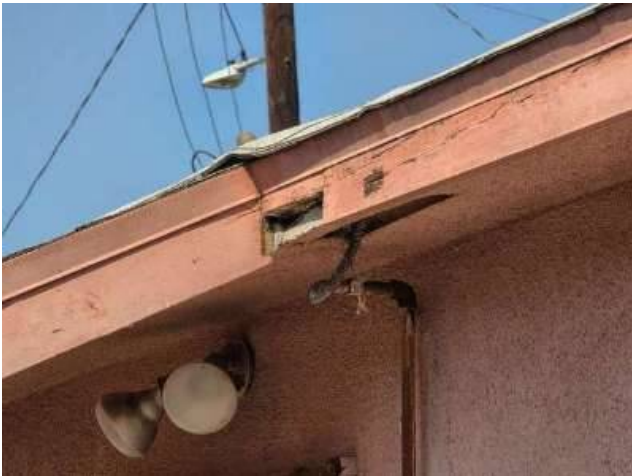
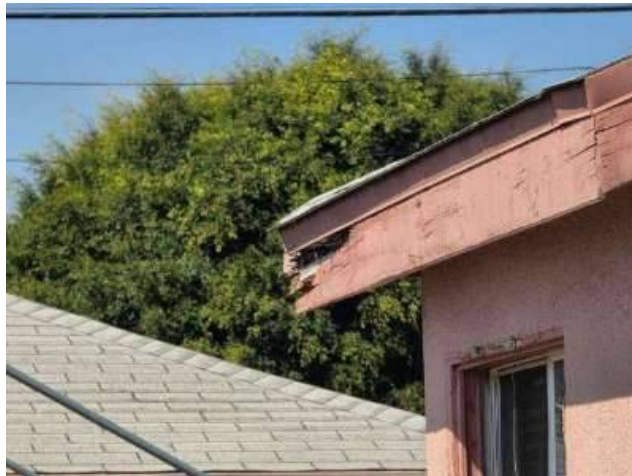
Some sections of siding and/or trim were deteriorated and/or damaged. Recommend that a qualified person repair, replace or install siding or trim as necessary.

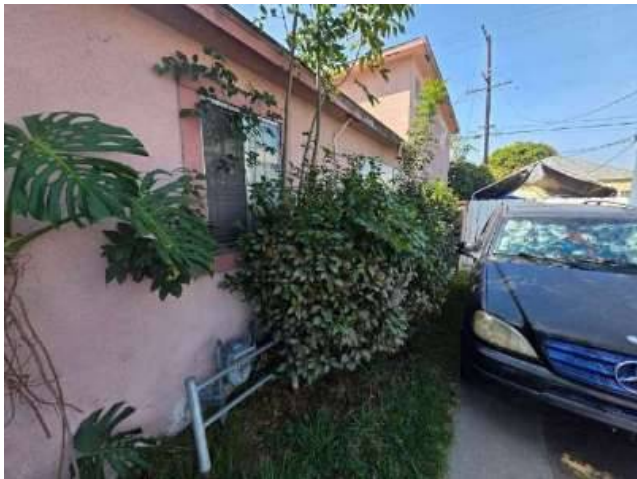
Photo 15-1

Some exterior wall sections were obscured by vegetation and couldn't be fully evaluated. They are excluded from this inspection.

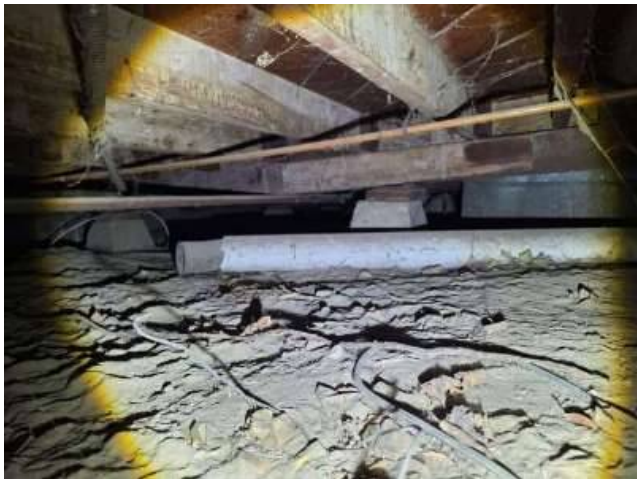
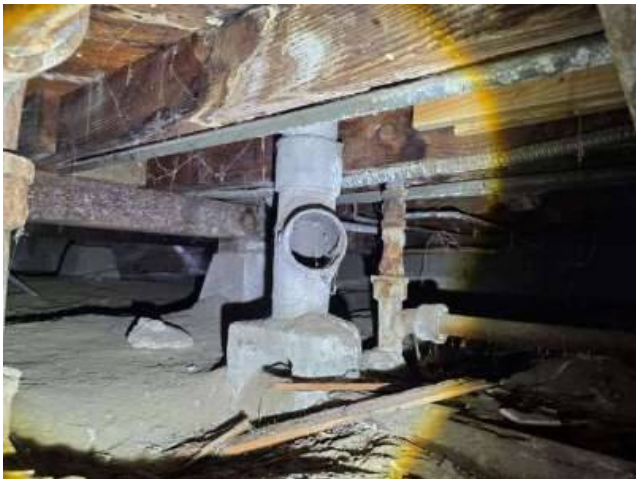
Note that evaluating for the presence of asbestos is beyond the scope of this inspection. Any mention in this report of these materials is made as a courtesy only, and is meant to refer the client to a specialist.

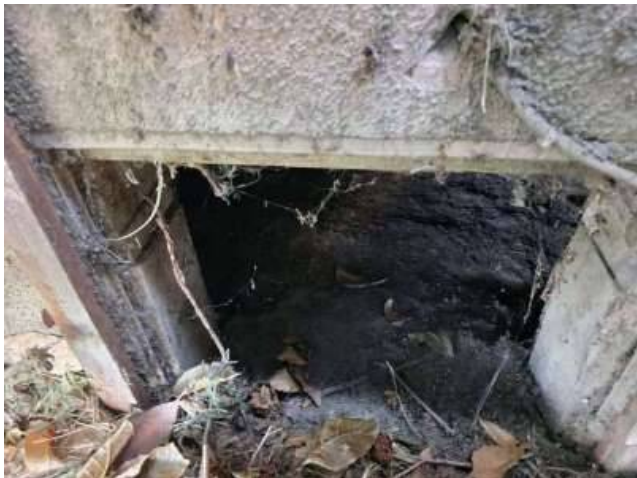
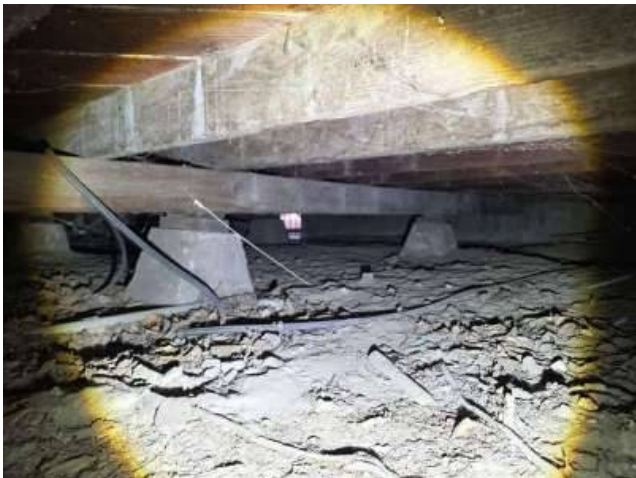
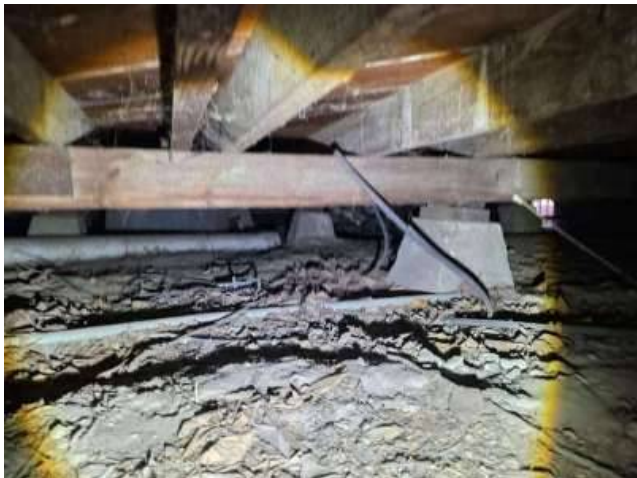
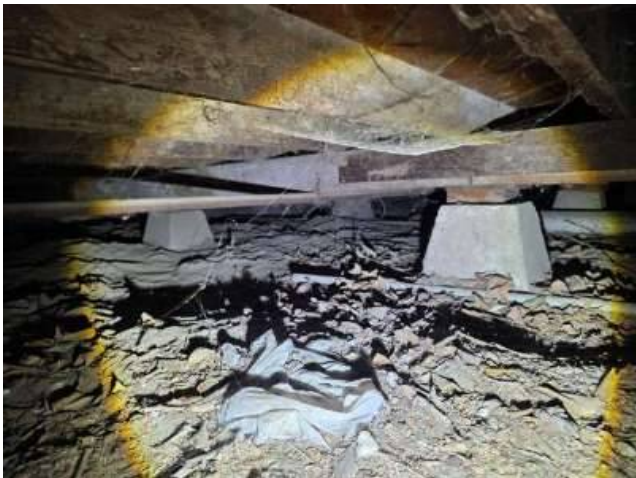
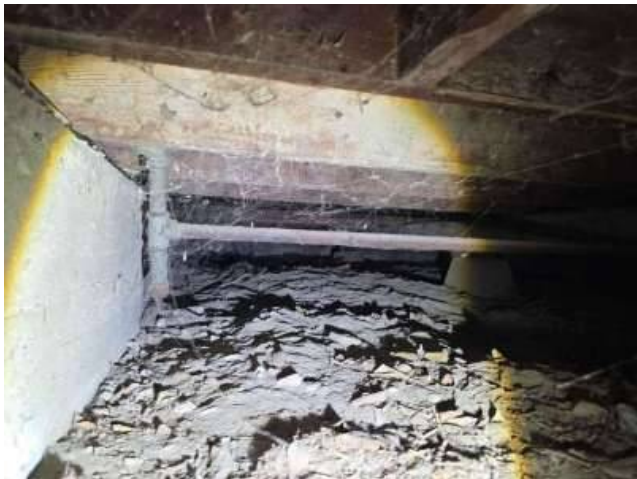
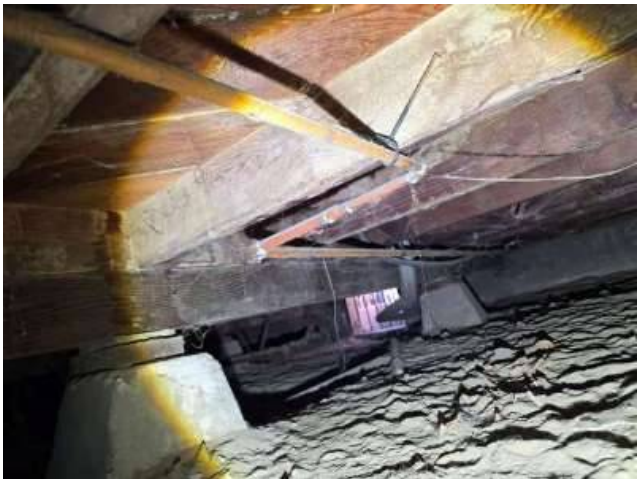
19) ✓ Crawl space overview.

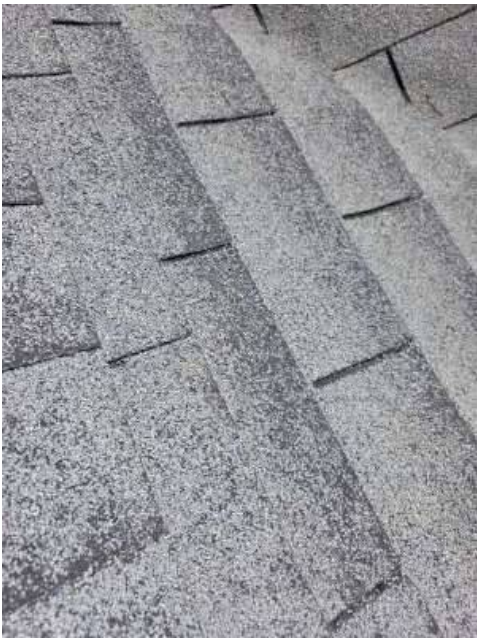
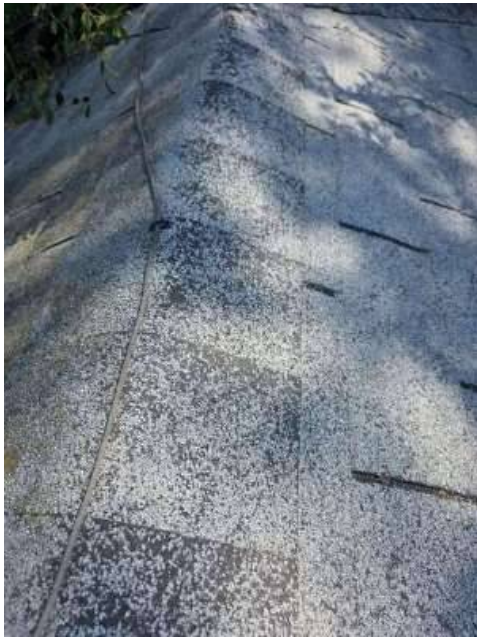
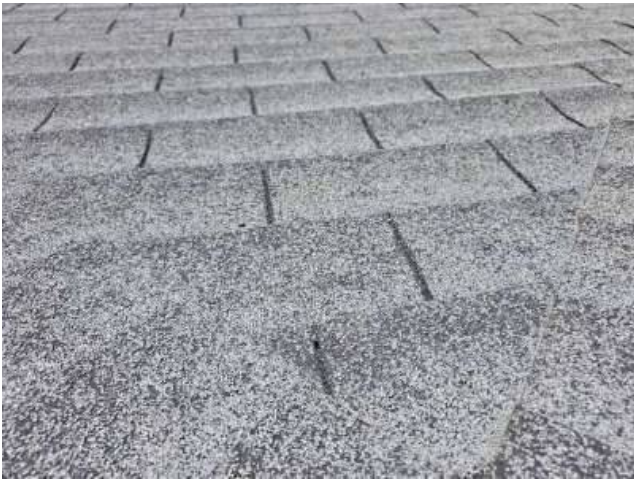
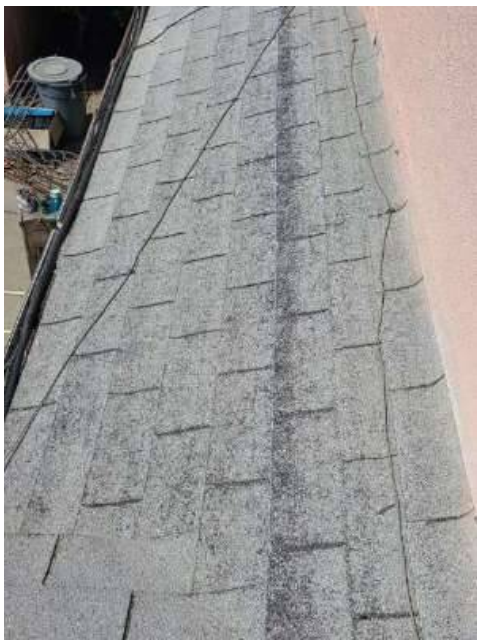
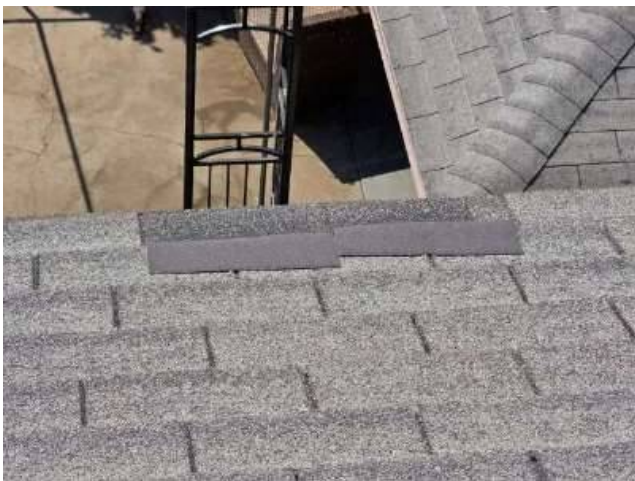
Many composition shingles were damaged and/or deteriorated. Leaks can occur as a result. This is a conducive condition for wood-destroying organisms. Recommend that a qualified contractor repair as necessary. For example, by replacing shingles.

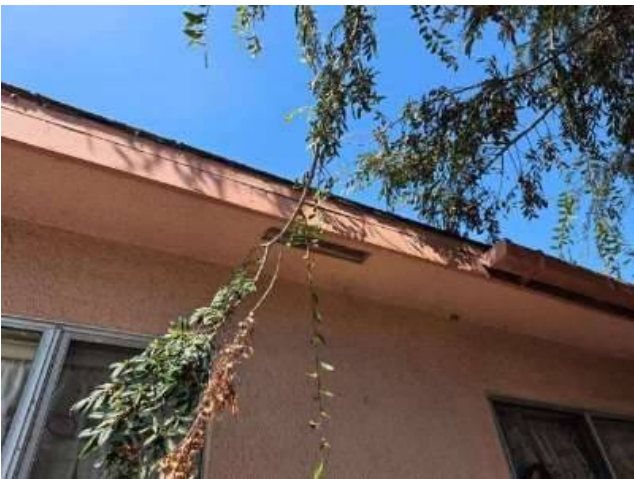
Photo 21-1

The roof drainage system was incomplete. Gutters, downspouts and extensions were missing from one or more roof sections. Rainwater may come in contact with the building exterior or accumulate around the building foundation as a result. This can be a conducive condition for wood-destroying organisms. Recommend that a qualified contractor install roof drainage components where missing per standard building practices.

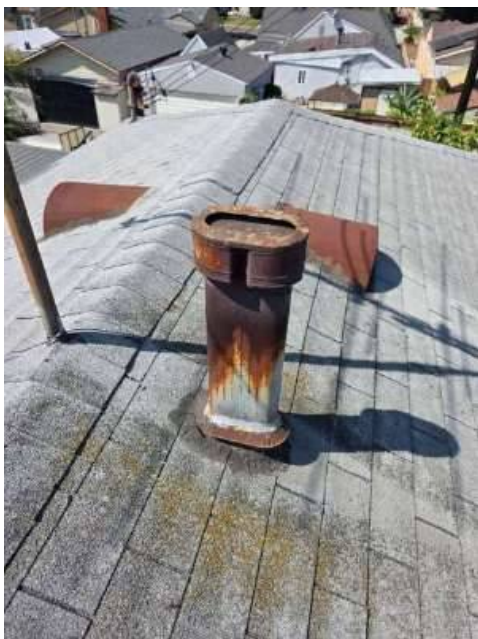
Photo 22-1

22) One or more roof-top appurtenances such as vents, sheet metal on chimney structures, masts, pipes, etc. were rusty or corroded. Metal may deteriorate to the point of needing replacement. Leaks can occur around such items if flashing or sealant doesn't form a waterproof seal with the corroded metal. This can be a conducive condition for wood-destroying organisms. Recommend that a qualified person repair as necessary. For example, by cleaning rust and repainting with a rust-inhibiting paint.

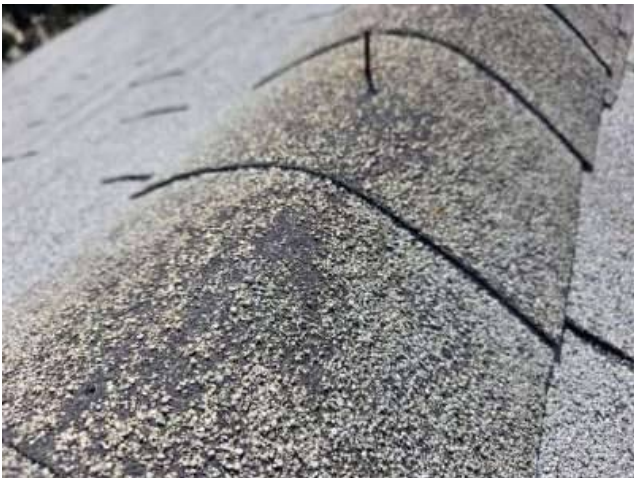
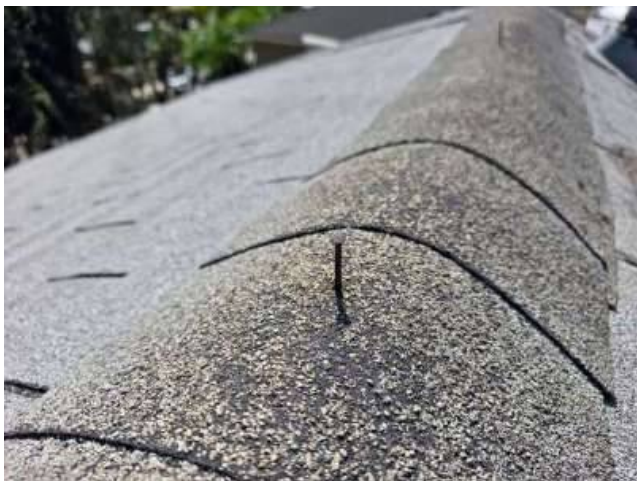
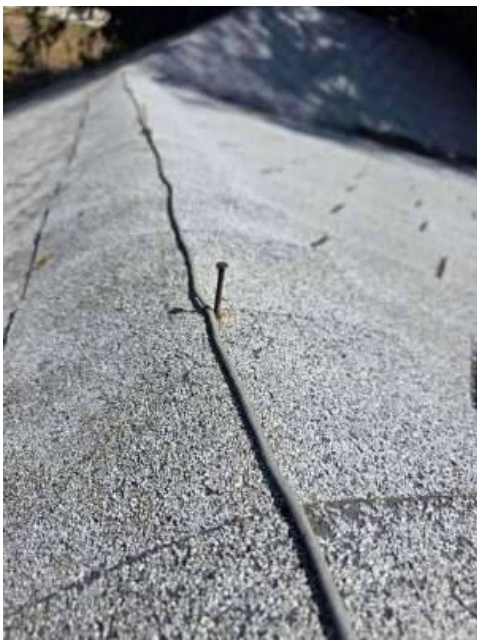
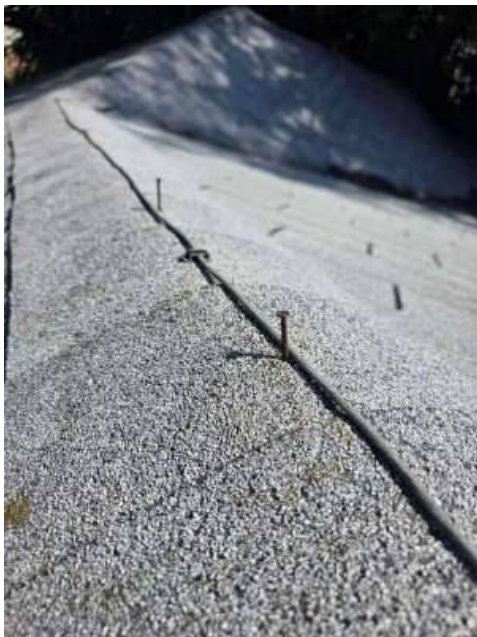
23) One or more roofing nails weren't fully seated and shingles were lifting or nail heads were protruding through shingle surfaces. The nails may have loosened, or were not pounded in fully when installed. Shingles are likely to be wind damaged, and leaks can occur as a result. This is a conducive condition for wood-destroying organisms. Recommend that a qualified contractor repair as necessary. For example, by replacing shingles.

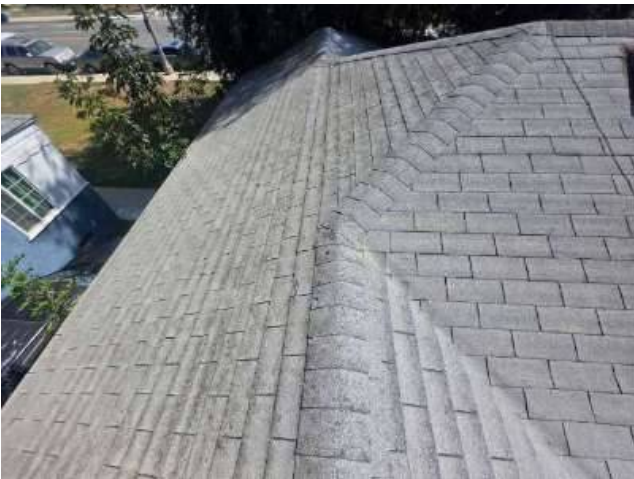
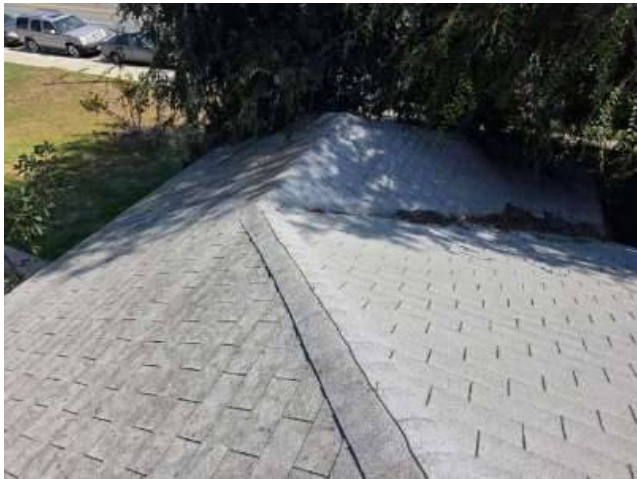
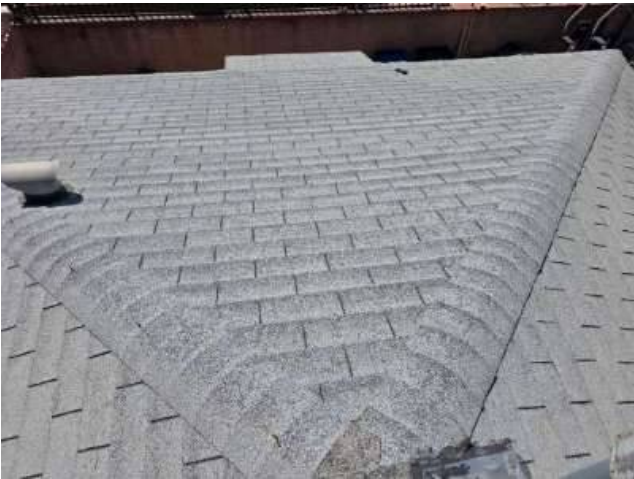
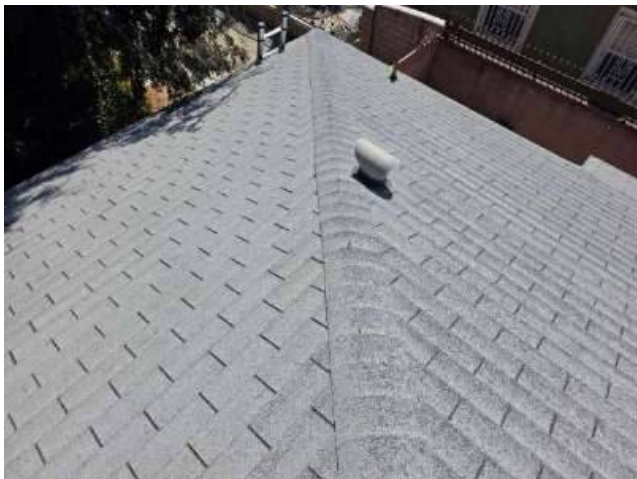
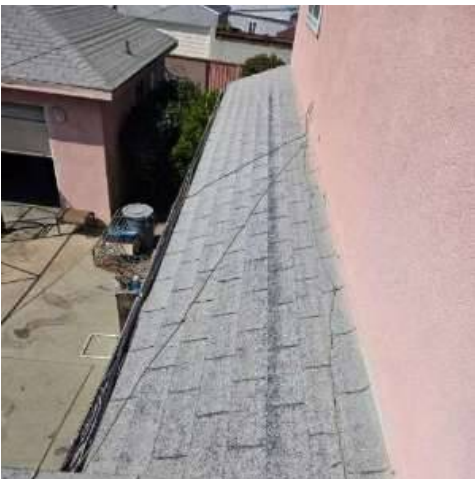
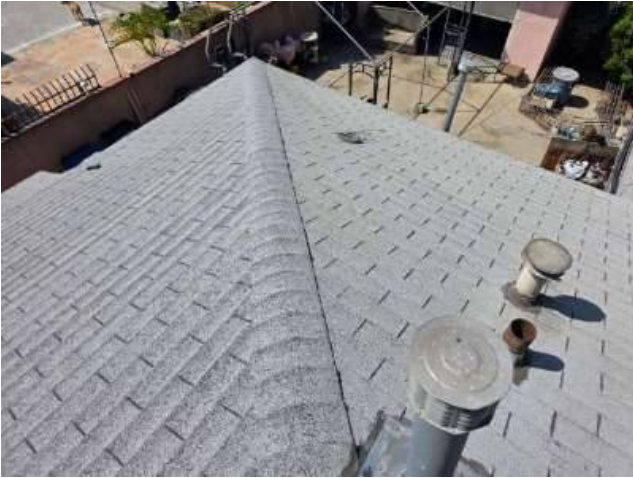
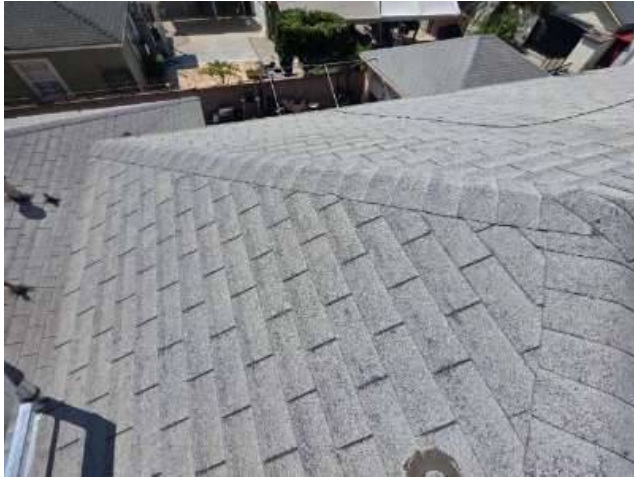
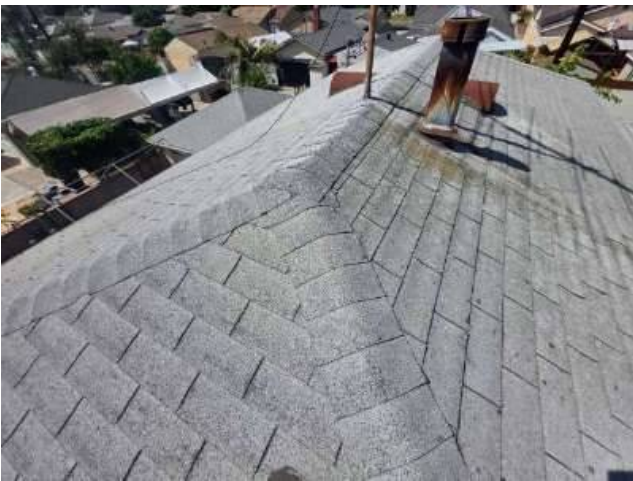
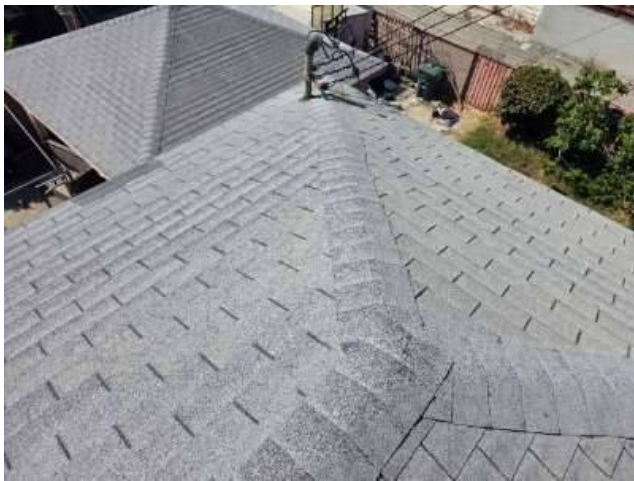
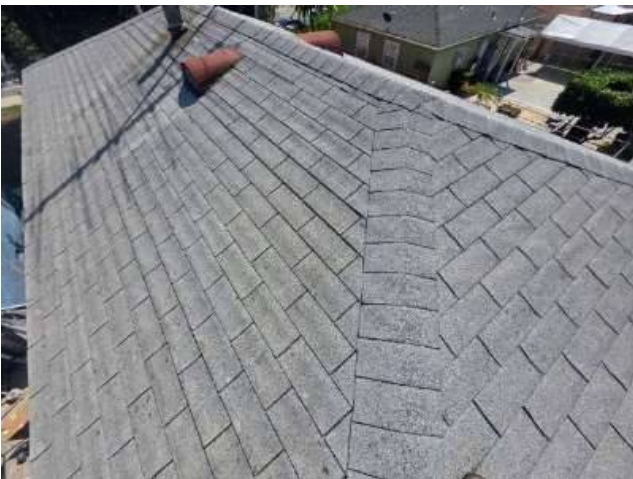
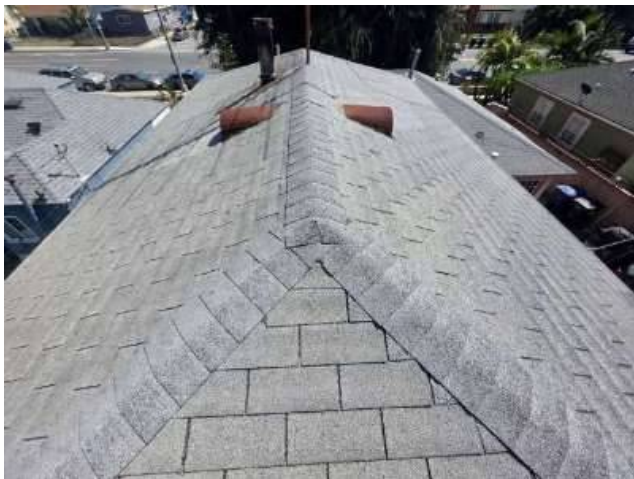
The roof surface appeared to be near the end of its service life and will likely need replacing in the near future even if repairs are made now. Recommend discussing replacement options with a qualified contractor, and budgeting for a replacement roof surface in the near future. The client may also wish to consider having a qualified contractor attempt to issue a "5 year roof certificate."

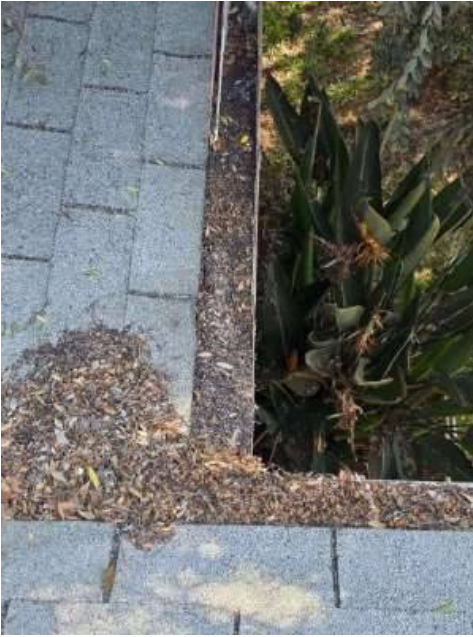
Photo 25-1

Significant amounts of debris have accumulated in one or more gutters or downspouts. Gutters can overflow and cause water to come in contact with the building exterior, or water can accumulate around the foundation. This is a conducive condition for wood-destroying organisms. Recommend cleaning gutters and downspouts now and as necessary in the future.

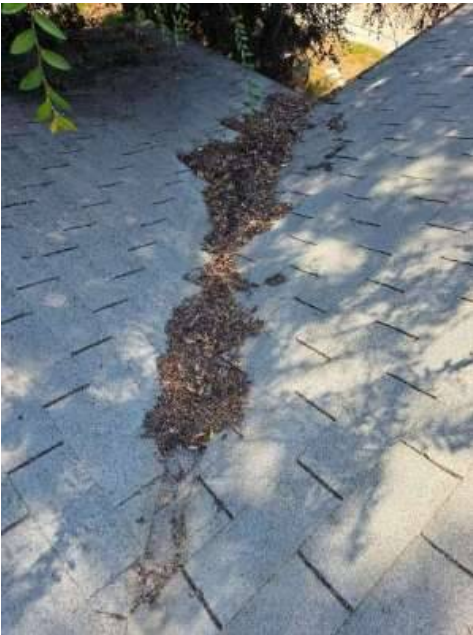
Photo 26-1

Significant amounts of debris such as leaves, needles, seeds, etc. have accumulated on the roof surface. Water may not flow easily off the roof, and can enter gaps in the roof surface. Leaks can occur as a result. This is a conducive condition for wood-destroying organisms. Recommend cleaning debris from the roof surface now and as necessary in the future.

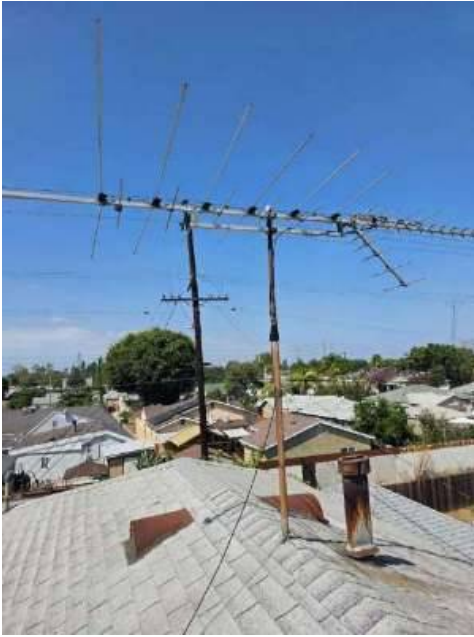
**Photo 29-1**

29) 🛠️ At the time of inspection there appeared to be a TV antenna that was strapped to the roof. This means of bracing the antenna is undesirable because repeated twisting action on the antenna can cause potential leaks at penetrations or bracing areas. Recommend removing the TV antenna and sealing bracing areas upon taking possession of the property.

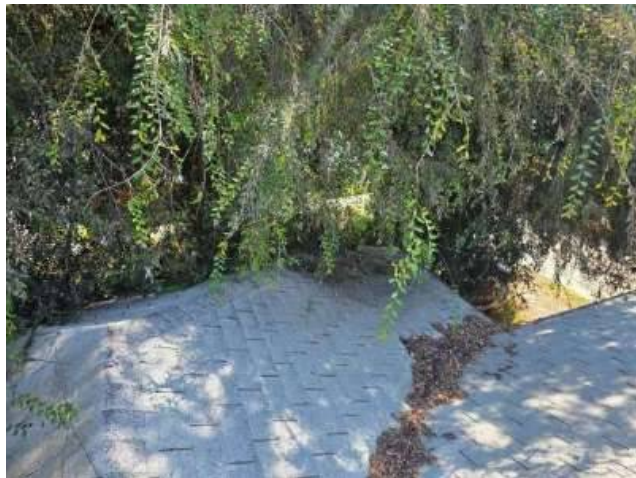
**Photo 30-2**

Vegetation such as trees, shrubs, and/or vines overhung the roof surface or were in contact with the roof edge. Organic debris such as leaves or needles are likely to accumulate in gutters and on the roof surface. Gutters can overflow and cause water to come in contact with the building exterior or water can accumulate around the foundation. This is a conducive condition for wood-destroying organisms. Vegetation in contact with the roof can damage the roof surface and/or the roof drainage system. Recommend pruning vegetation so as to not be in contact with the roof and to not overhang the roof surface. If vegetation is too tall then it should be pruned at least 10 feet above the roof surface.

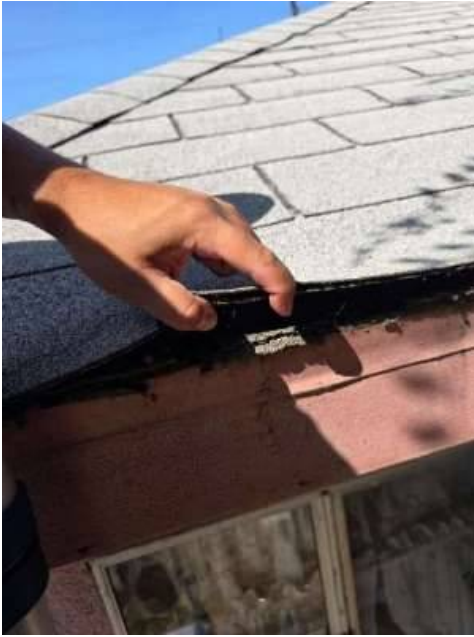
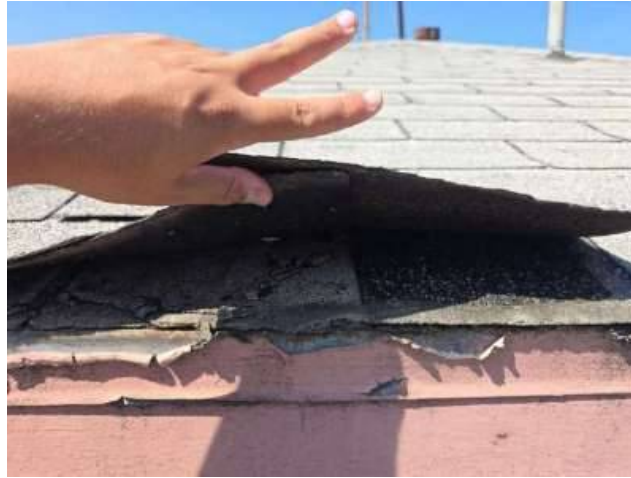
This asphalt or fiberglass composition roof surface appeared to have two or more layers of shingles. Additional layers of composition shingles typically last only 80% of their rated life, and the shingle manufacturer's warranty may be voided. The client should be aware that all layers of roofing will need to be removed when this roof surface needs replacing.

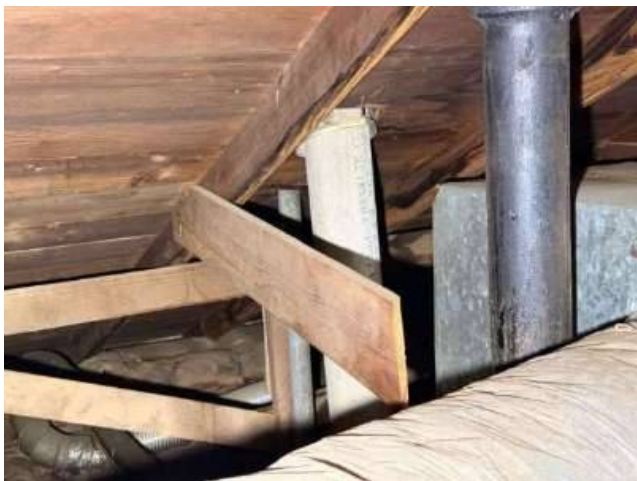
Photo 32-1

** Possible asbestos wrap was found at one or more exhaust duct or vents in the attic. However, it appeared to be intact and not significantly deteriorated. Asbestos may pose a health hazard when airborne. If this is asbestos, in some cases, no action is needed except to leave this material undisturbed. The client may wish to have this material tested by a qualified specialist to determine if it is asbestos, and if it should be removed or encapsulated. For information on asbestos hazards in the home, visit:

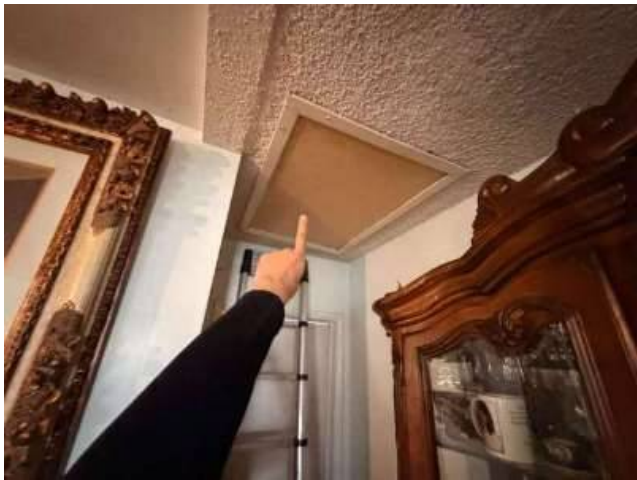
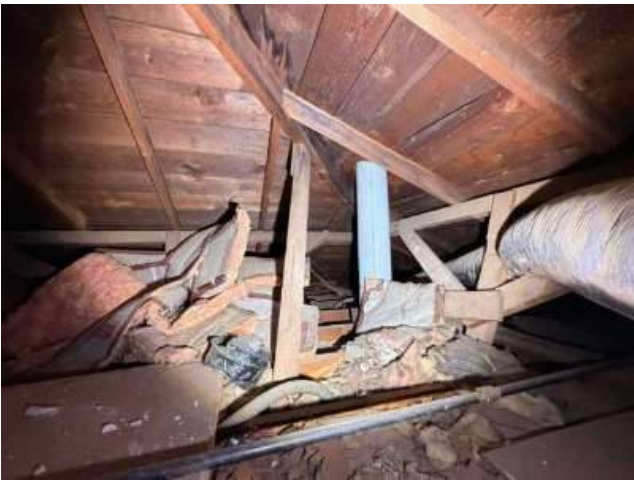
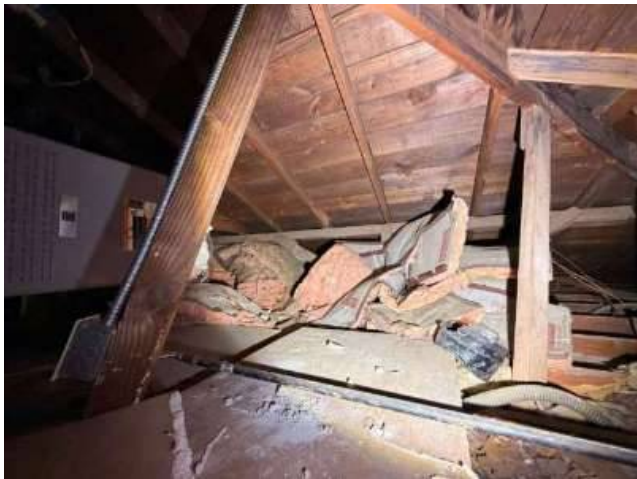
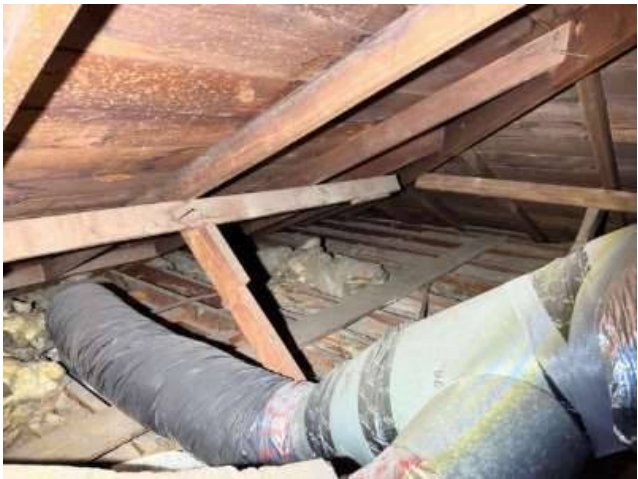
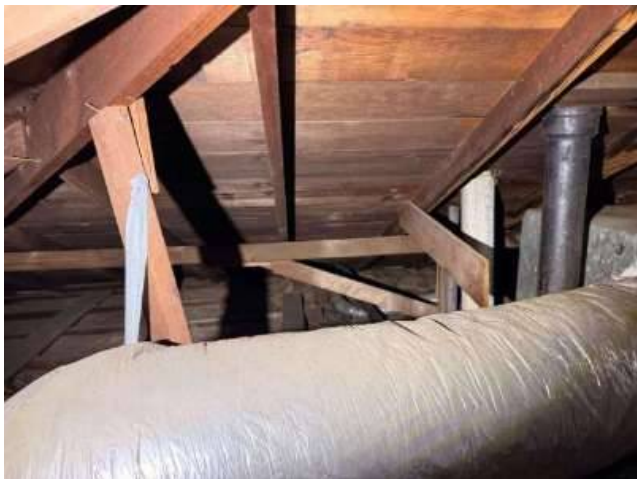
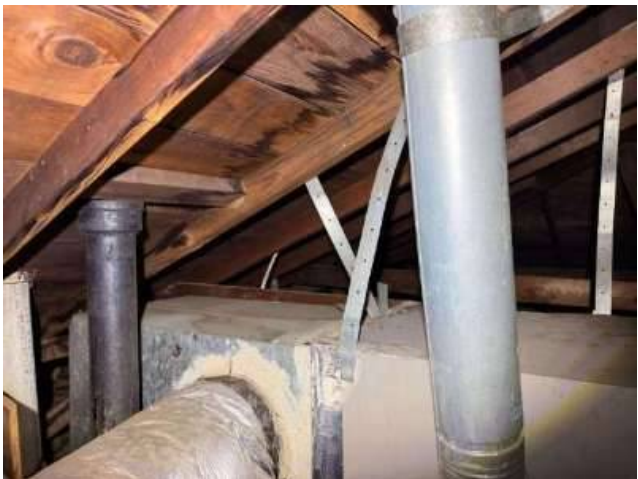
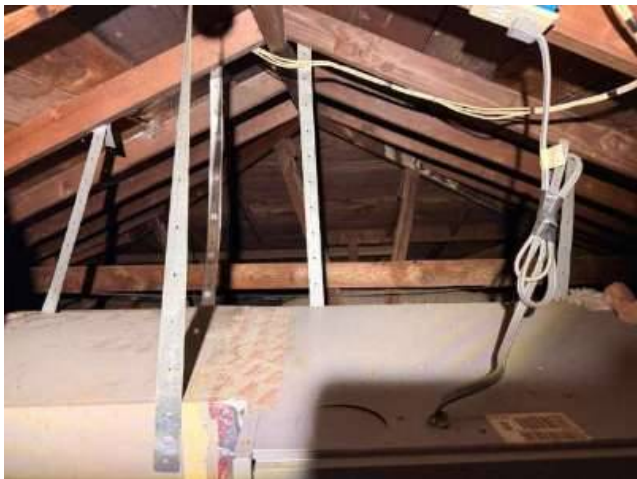
Attic overview.

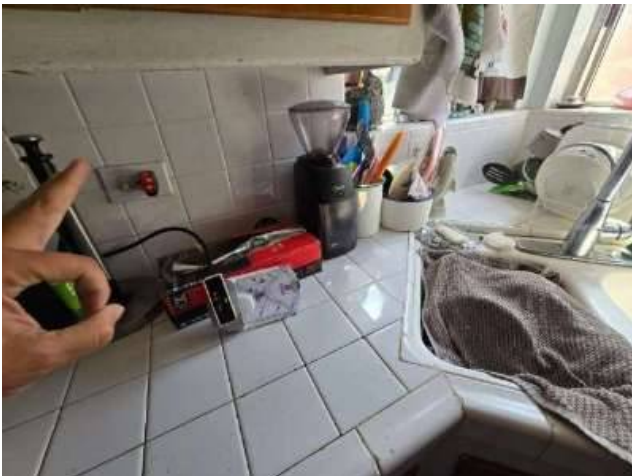
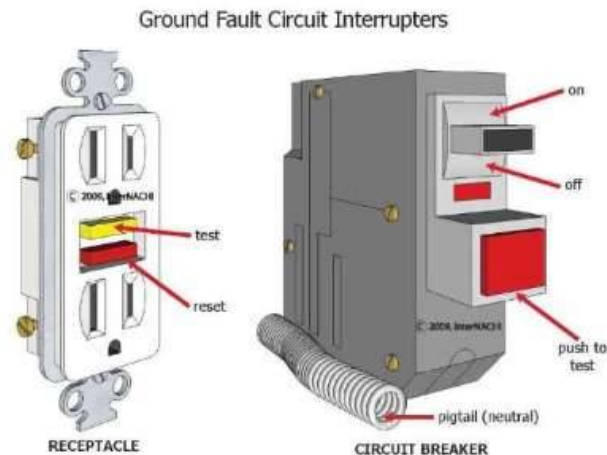
**37) 🔧🔍** One or more electric receptacles at the kitchen and/or bathroom(s) had no visible ground fault circuit interrupter (GFCI) protection, or the inspector was unable to determine if GFCI protection was present. If not GFCI-protected, receptacles in wet areas pose a shock hazard. Recommend that a qualified electrician evaluate and install GFCI protection if necessary and per standard building practices. General guidelines for GFCI-protected receptacles include the following locations:

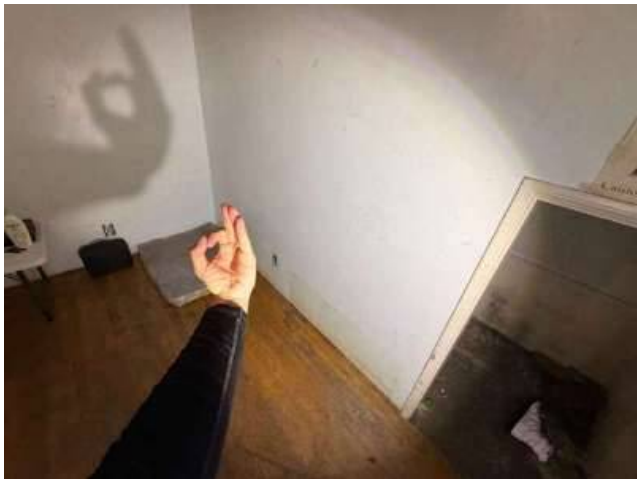
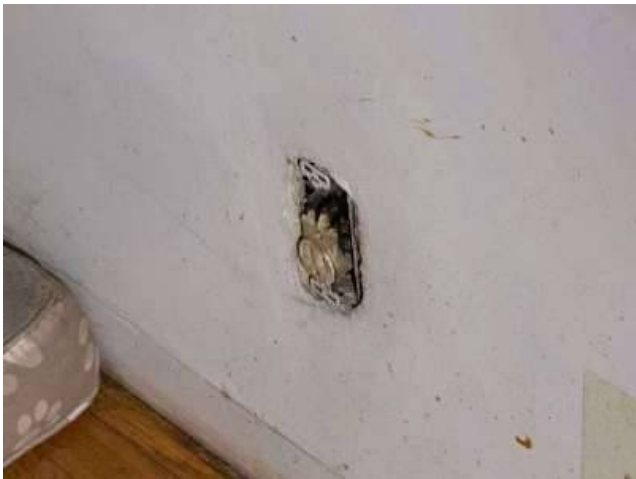
**38) 🔧🔍** One or more receptacles were broken or damaged. This is a potential shock or fire hazard. Recommend that a qualified electrician replace such receptacles as necessary.

\*interior

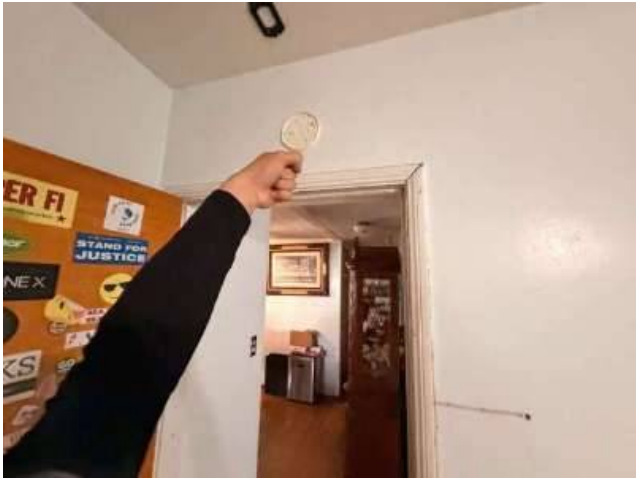
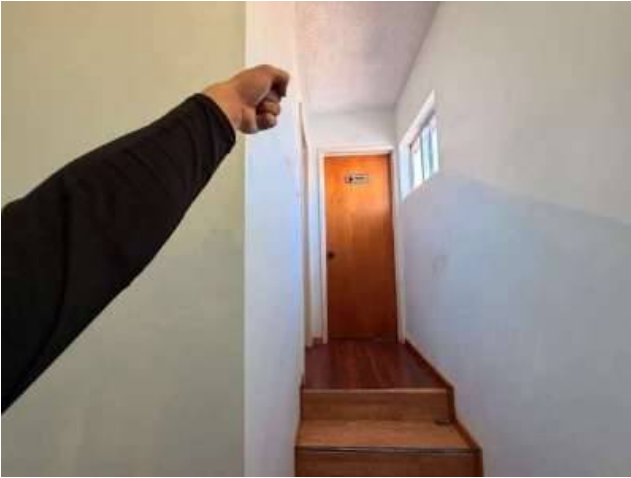
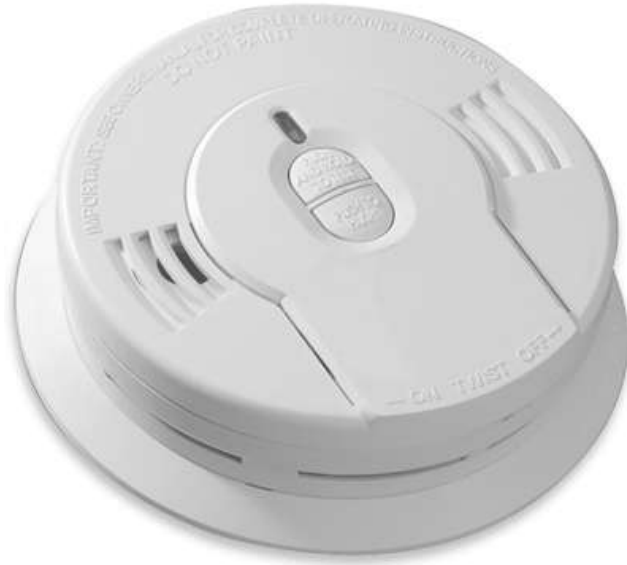
39) 🚒 No permanently installed smoke alarms were found. This is a potential safety hazard. A qualified electrician should install smoke alarms per standard building practices (e.g. in hallways leading to bedrooms, in each bedroom, on each floor and in attached garages). For more information, visit: <https://www.reporthost.com/?SMKALRM>
