## R.B.Inspections

### Property Inspection Report

Property address: **11605 Garfield Ave, South Gate, CA 90280**

Inspection date: **Tuesday, September 22, 2026**

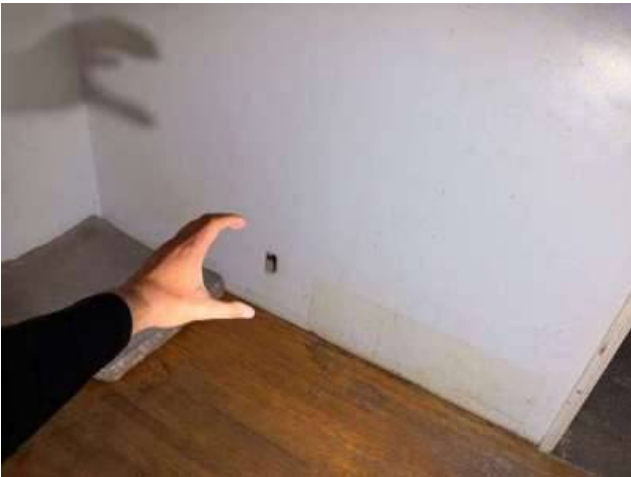
One or more cover plates for switches, receptacles or junction boxes were missing or broken. These plates are intended to contain fire and prevent electric shock from occurring due to exposed wires. Recommend that a qualified person install cover plates where necessary.

\*interior

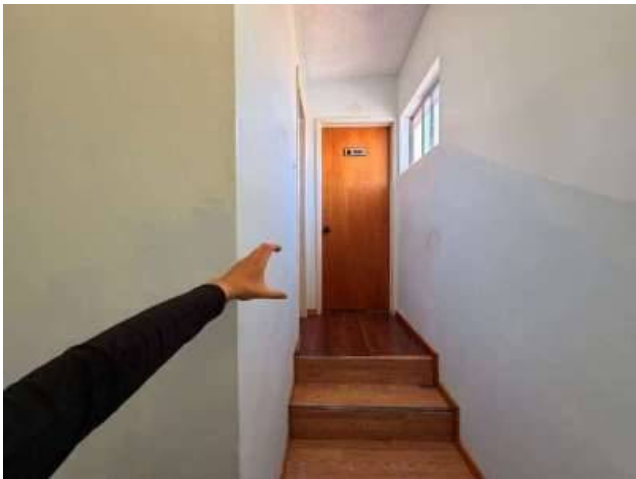
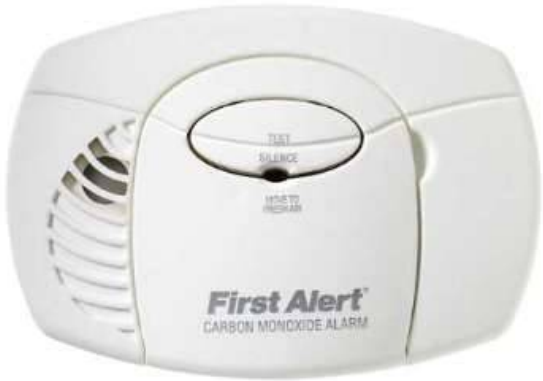
No permanently installed carbon monoxide alarms were found. This is a potential safety hazard. Some states and/or municipalities require CO alarms to be installed for new construction and/or for homes being sold. Recommend installing approved CO alarms outside of each separate sleeping area in the immediate vicinity of the bedrooms on each level and in accordance with the manufacturer's recommendations. For more information, visit: <https://www.reporthost.com/?COALRM>

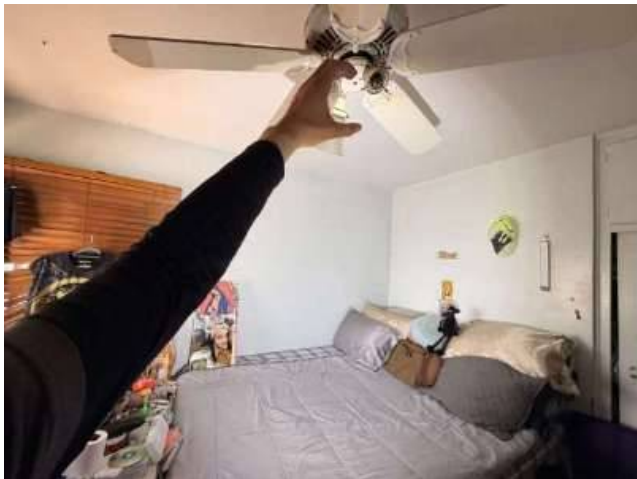
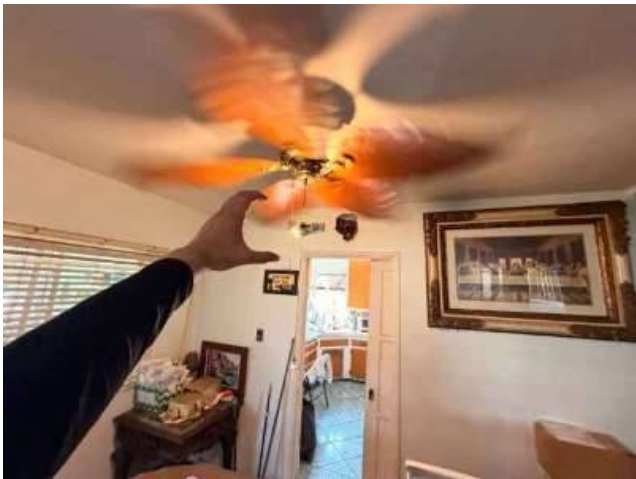
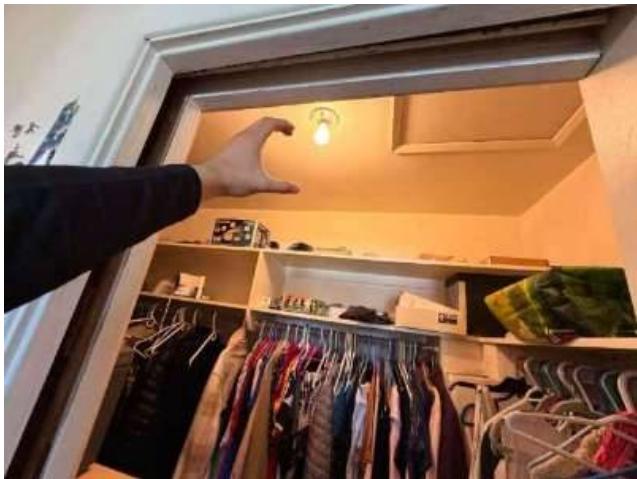
42) One or more globes or covers for light fixtures were missing or damaged. Recommend replacing as necessary to avoid exposed bulbs. With closet lighting or where flammable stored objects are near light fixtures, missing or broken covers can be a fire hazard.

\*interior

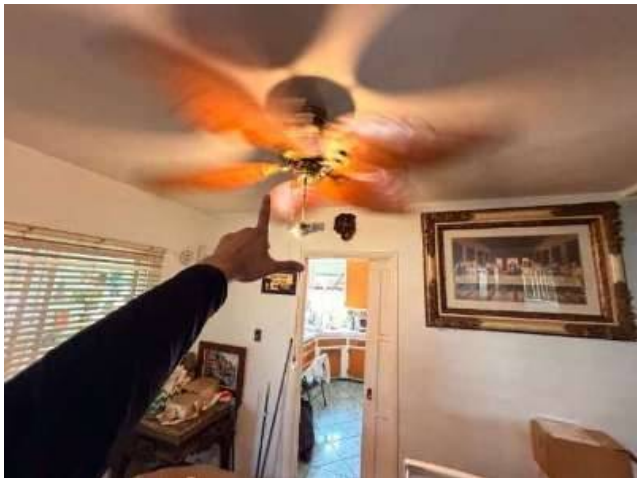
One or more light fixtures were loose. Recommend that a qualified electrician repair or replace light fixtures as necessary.

\*interior

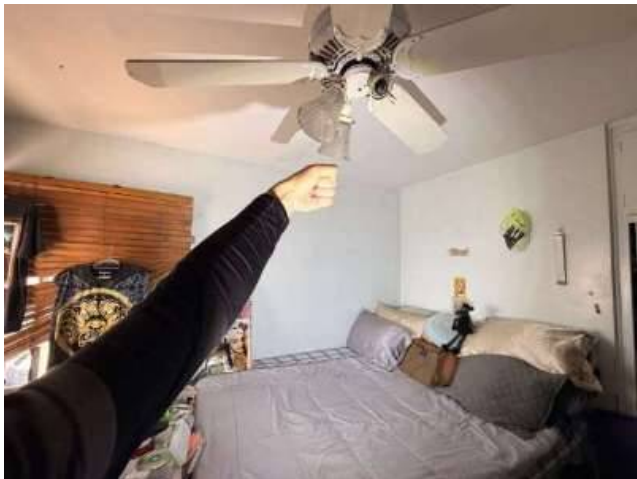
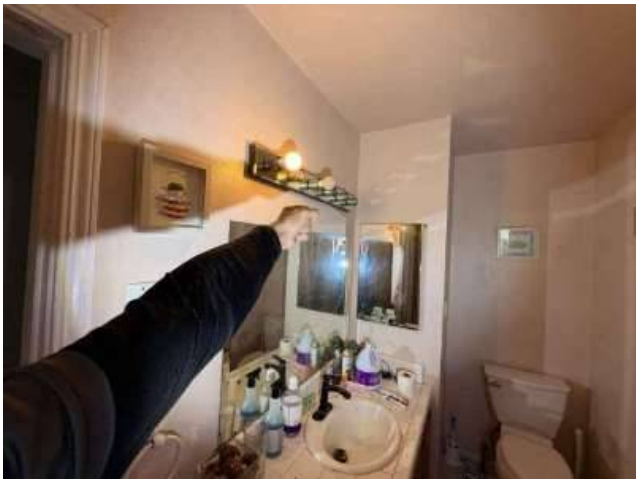
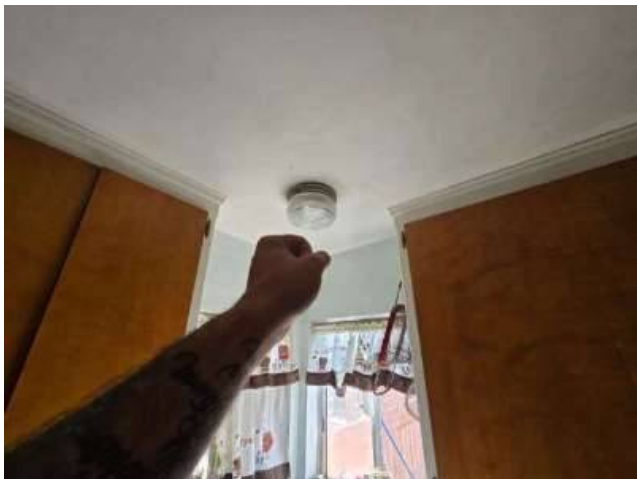
Bulbs in one or more light fixtures were missing or broken. These light fixtures couldn't be fully evaluated. If replacement bulbs are inoperable, then recommend that a qualified electrician evaluate and repair or replace light fixtures as necessary.

\*interior

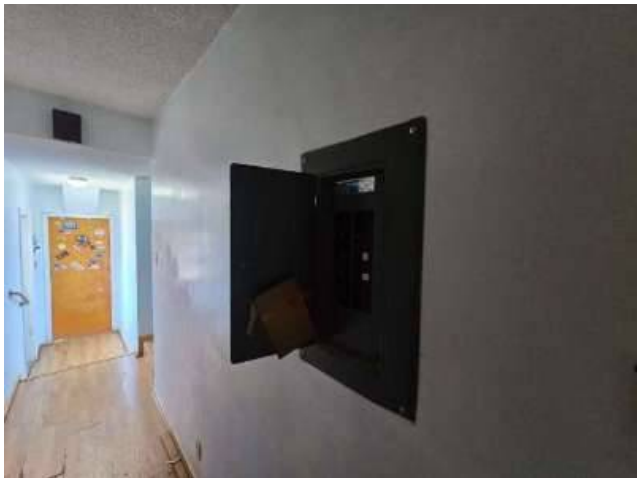
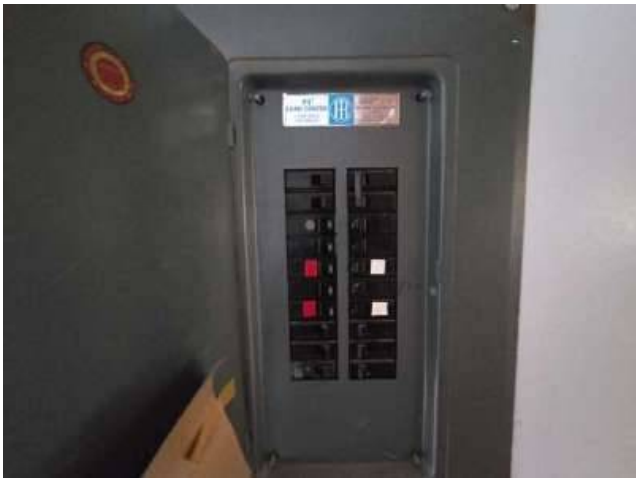
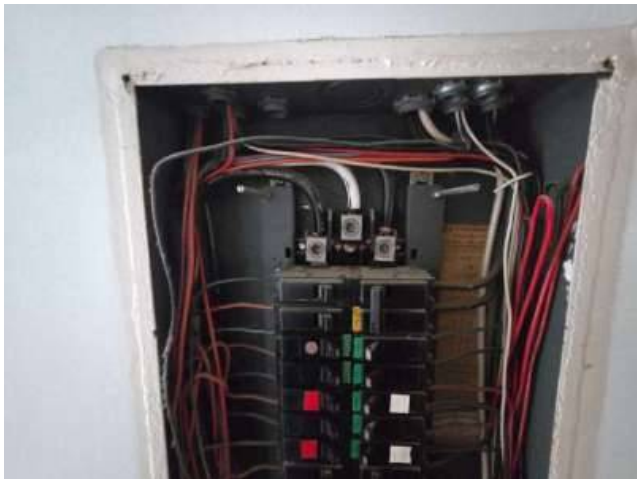
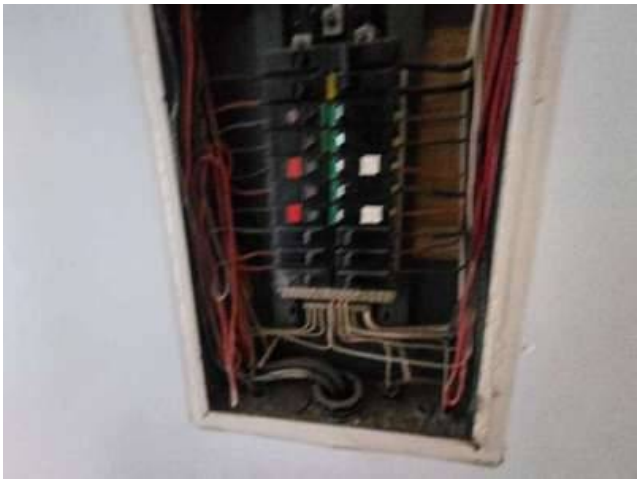
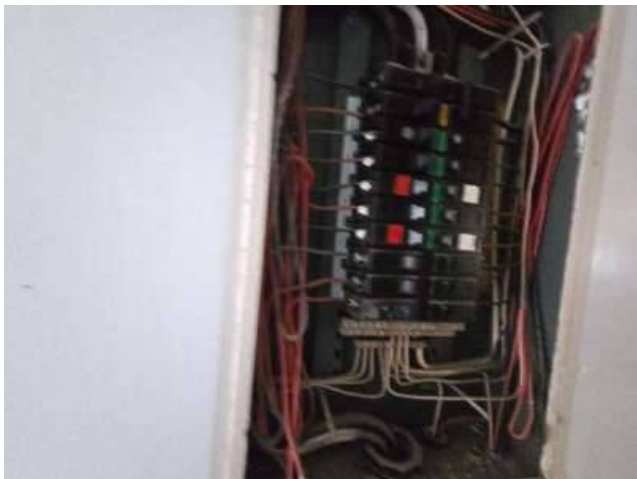
45) ✓ Location of sub-panel #C: Hallway.

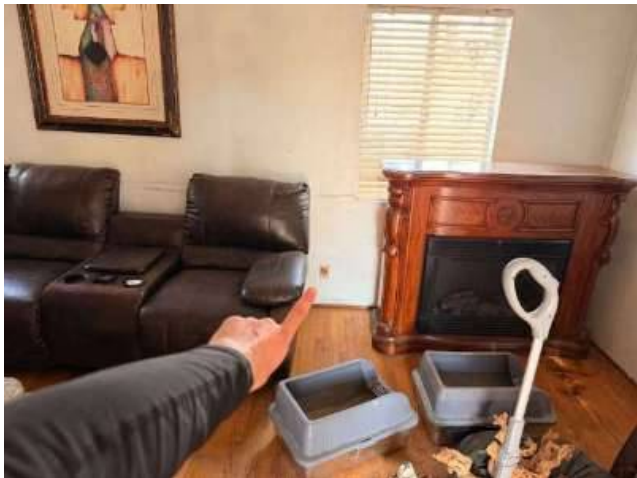
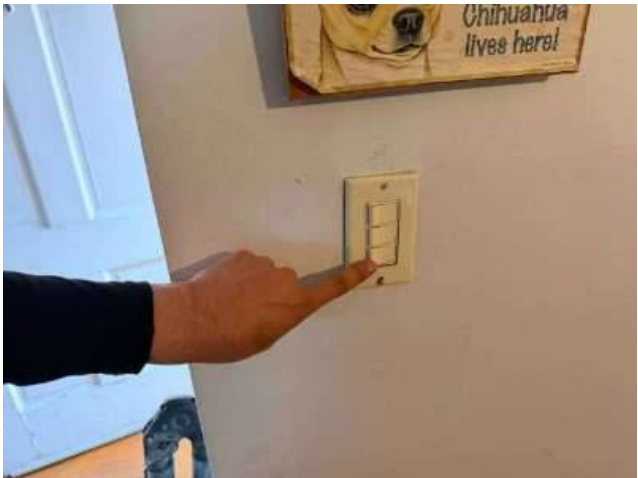
46) ⓘ One or more interior rooms were equipped with a lamp switch.

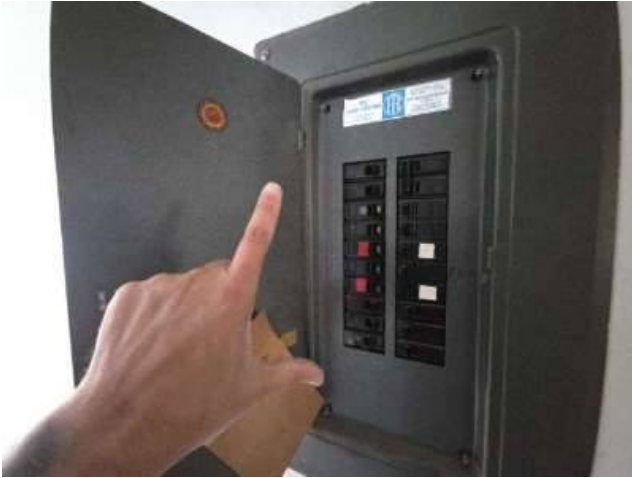
47) ⓘ Recommend labeling panel with shut off location(s).

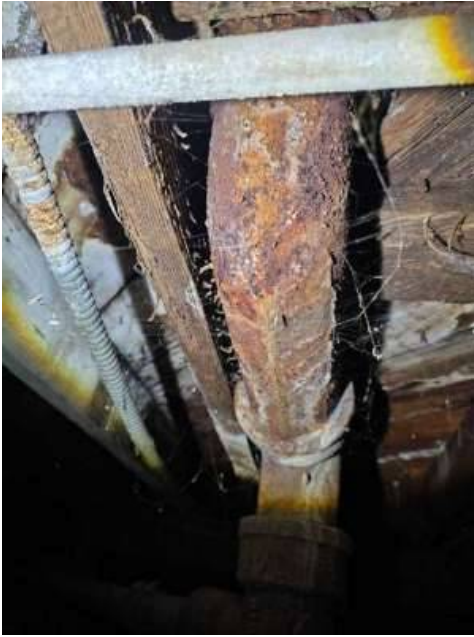
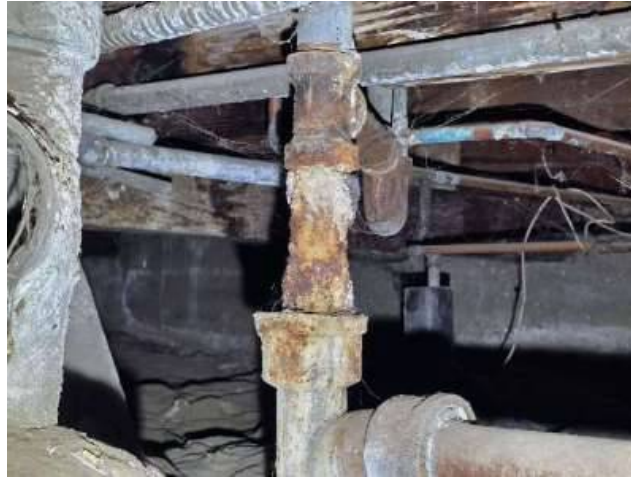
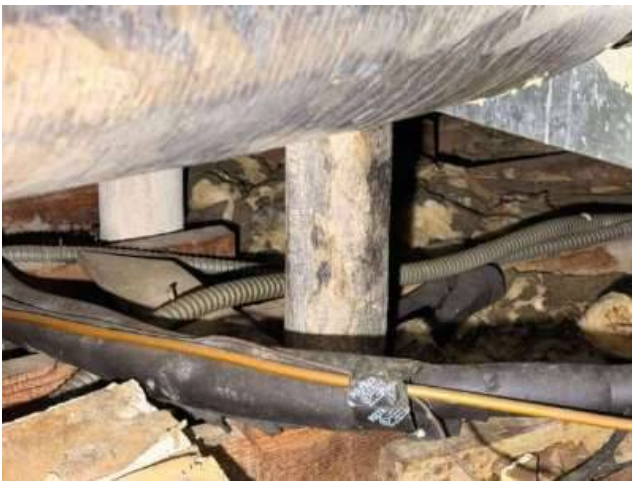
Rust or corrosion was found in some drain and/or waste pipes or fittings. This can indicate past leaks, or that leaks are likely to occur in the future. Recommend that a qualified plumber evaluate and repair as necessary.

\*crawl space

\*attic

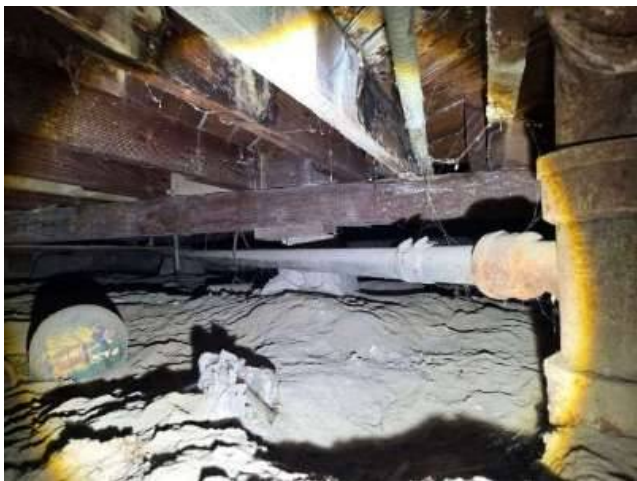
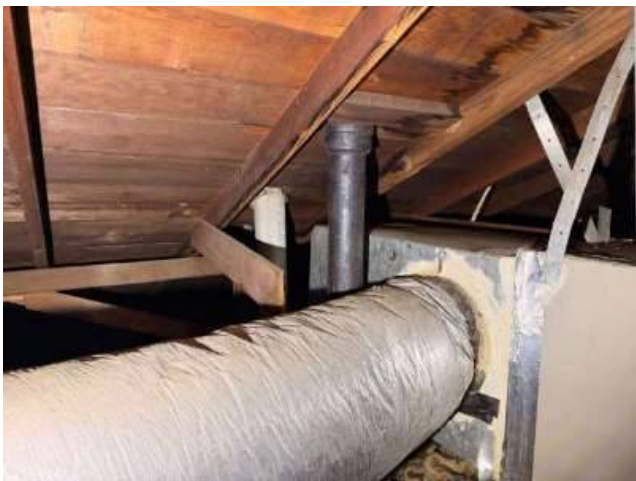
Galvanized steel water supply and drain or vent pipes were found. Based on the age of this structure and the 40-60 year useful life of this piping, it will likely need replacing in the future. Leaks can develop, flooding and/or water damage may occur, flow can be restricted due to scale accumulating inside the piping, and water may be rusty. Note that it is beyond the scope of this inspection to determine what percentage of the piping is older, galvanized steel, as much of it is concealed in wall, floor and/or ceiling cavities. Recommend the following:

- That a qualified plumber evaluate to better understand or estimate the remaining life
- Consulting with a qualified plumber about replacement options and costs
- Budget for replacement in the future
- Monitor these pipes for leaks and decreased flow in the future
- Consider replacing old, galvanized steel piping proactively

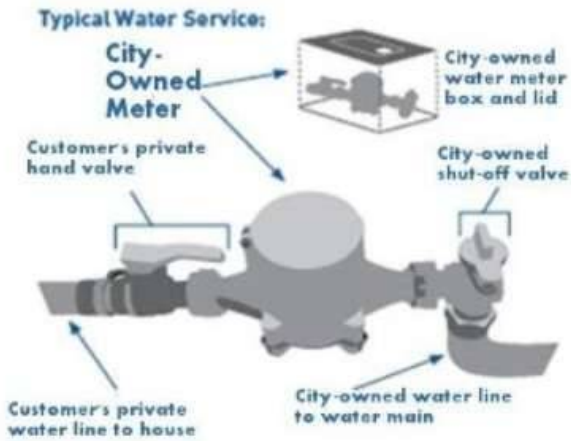
50) The inspector did not determine the location of the water meter. Recommend consulting with the property owner to determine the meter location, that you locate it yourself, or consult with the local water municipality if necessary. It is especially important to find the meter if no main shut-off valve is found because the meter may be the only way to turn off the water supply in the event of an emergency, such as when a supply pipe bursts.

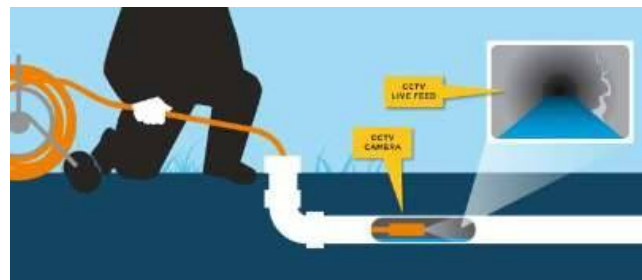
52) Based on the age of this structure, recommend that a qualified plumber inspect the waste lines using a video scope device to determine if they need repair or replacement. Property owners are usually responsible for repairs to the side sewer and publicly owned lateral lines. Such repairs can be expensive.

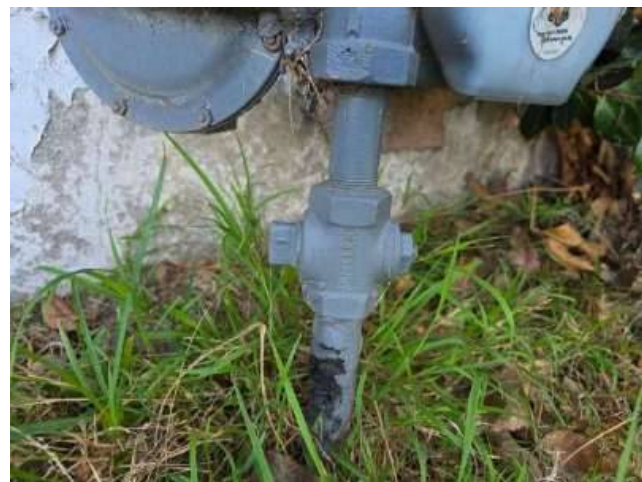
53) Location of main fuel shut-off valve: At gas meter.

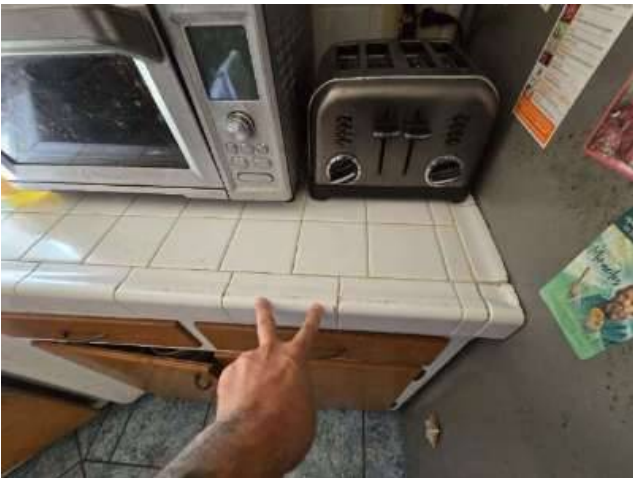
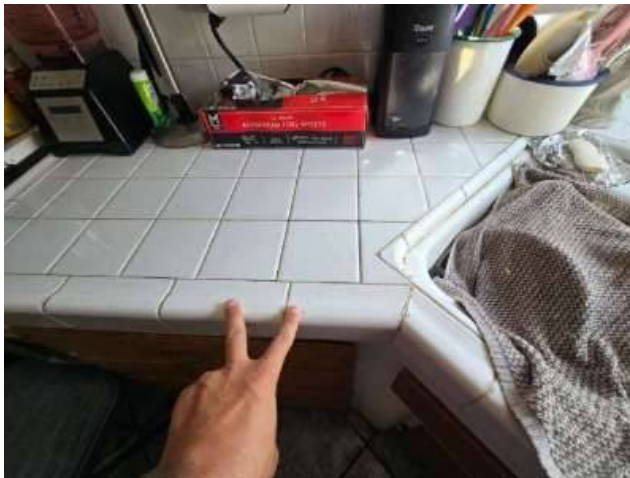
Countertops and/or backsplashes were damaged or deteriorated. Recommend repairing or replacing as necessary.

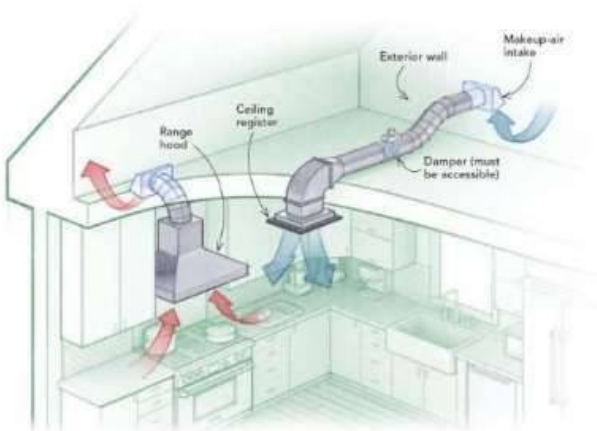
Photo 59-2

59) The cooktop exhaust fan was inoperable. Recommend that a qualified person repair or replace as necessary.

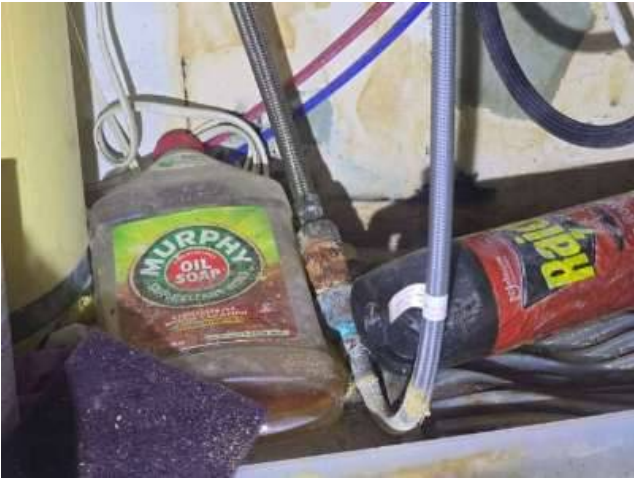
Photo 60-2

60) Rust and corrosion was found at water supply lines and drain lines under the sink. Recommend having a qualified person repair as well.

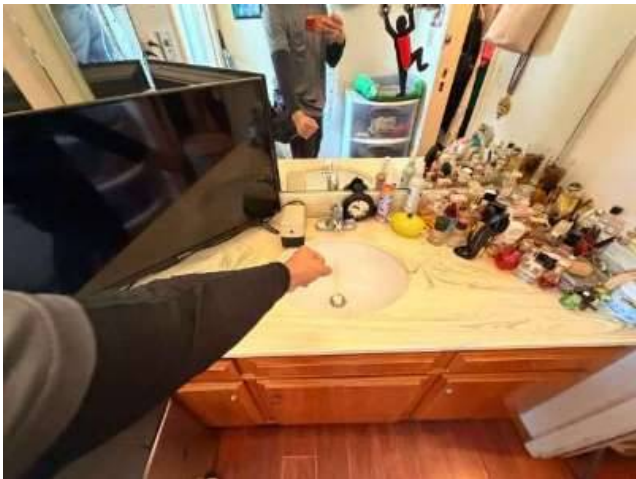
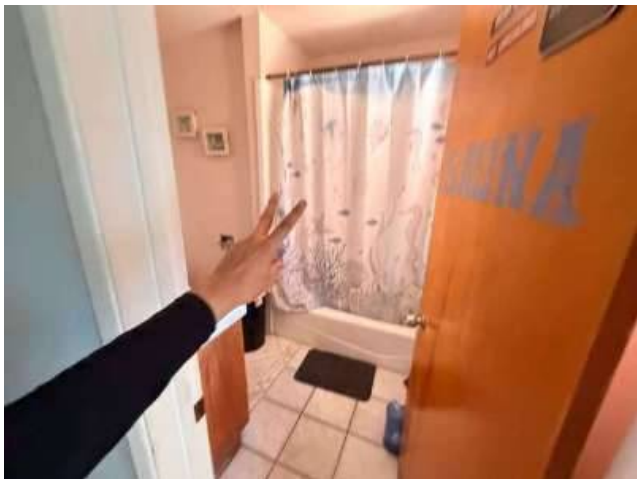
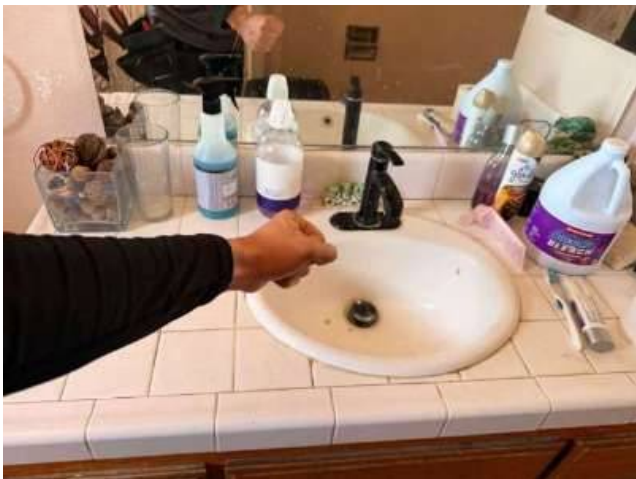
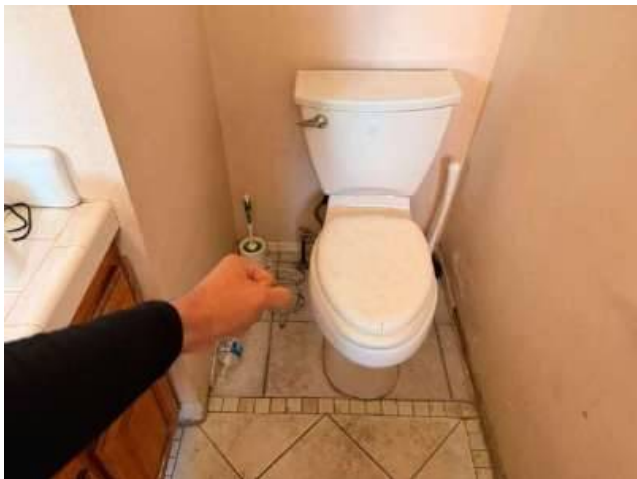
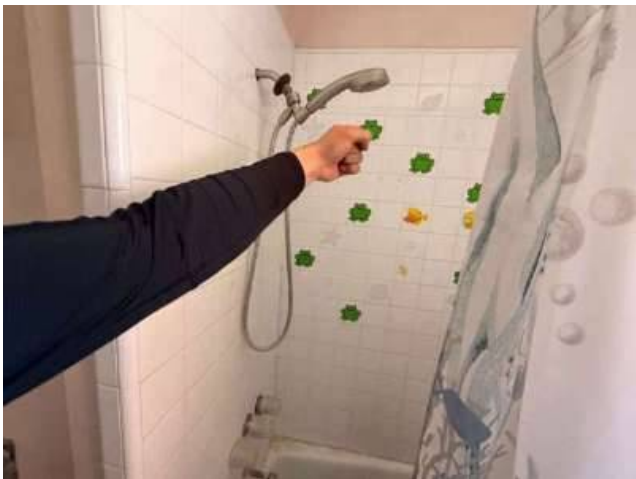
**62)** The water supply was inoperable or there was no water flow at the sink, toilet, bathtub and/or shower at location(s) #A and B. As a result the inspector was unable to fully evaluate. Shut-off valve(s) may be turned off, or repairs may be needed. Recommend asking the property owner about this if possible, and that a qualified plumber evaluate and repair if necessary.

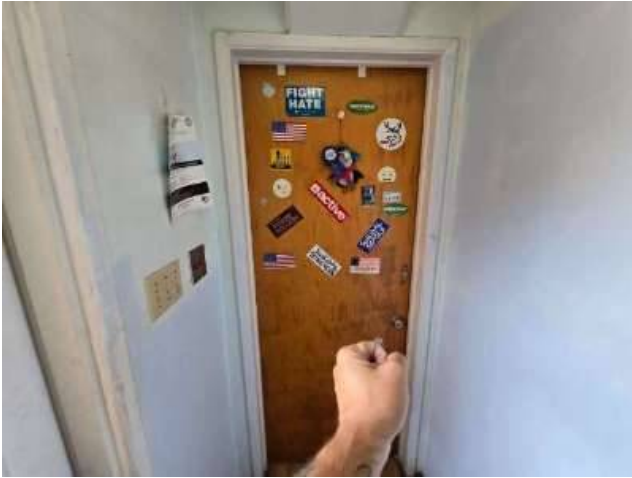
Photo 69-1

69) 🔍 ⓘ Bathroom #C was located in 1st floor master bedroom, however the door was locked and couldn't be fully evaluated. Recommend having a qualified person further evaluate once conditions have been corrected.

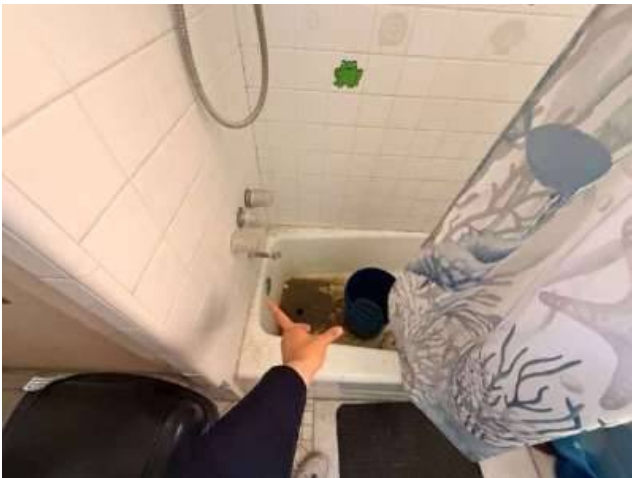
Photo 70-1

The bathtub at location(s) #B was worn, blemished or deteriorated.

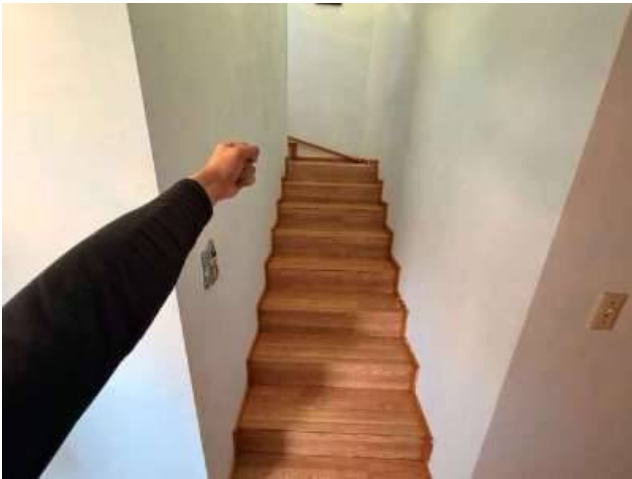
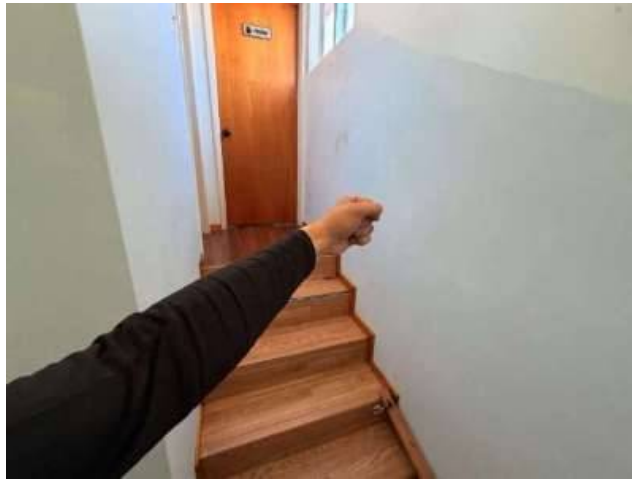
Handrails at one or more flights of stairs were missing. This is a potential fall hazard. Handrails should be installed at stairs with four or more risers or where stairs are greater than 30 inches high. Recommend that a qualified contractor install handrails where missing and per standard building practices.

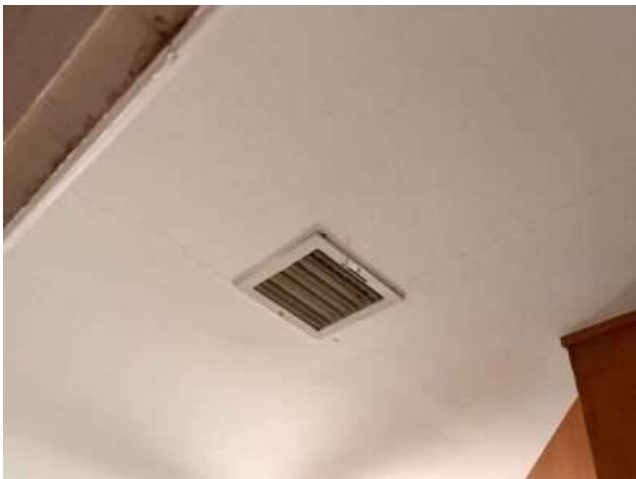
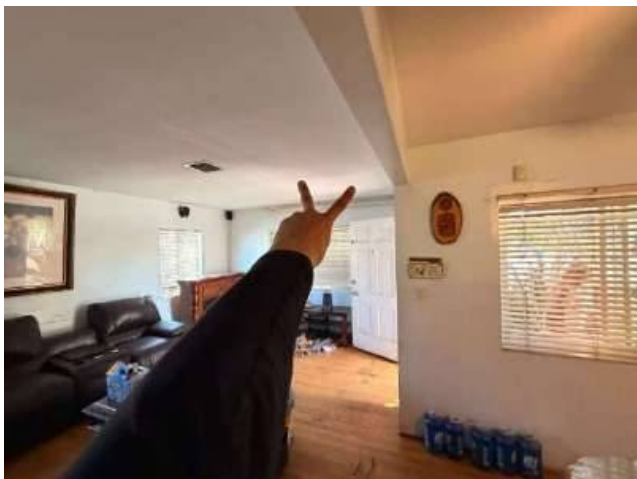
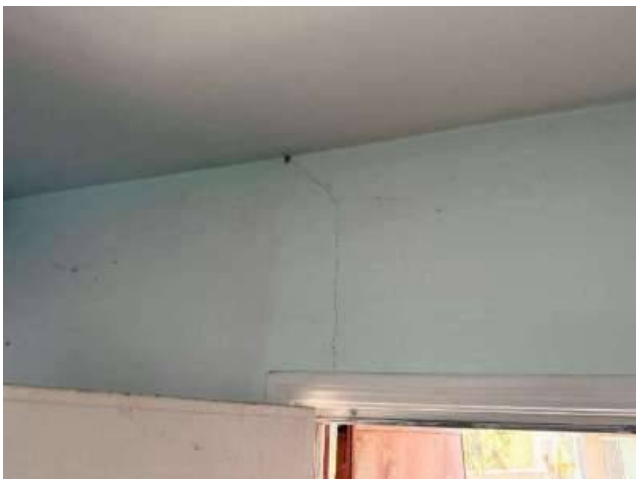
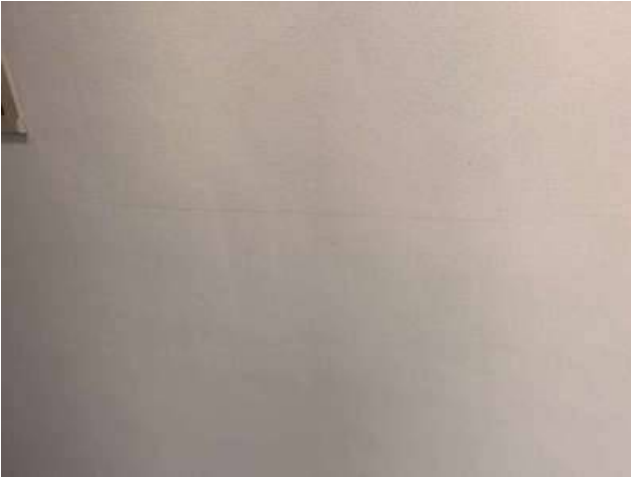
74) This structure appears to have settled, based on the presence of cracks in walls, ceilings. Recommend that a qualified contractor and/or engineer evaluate further. Significant repairs may be needed. If so, a qualified contractor should make repairs.

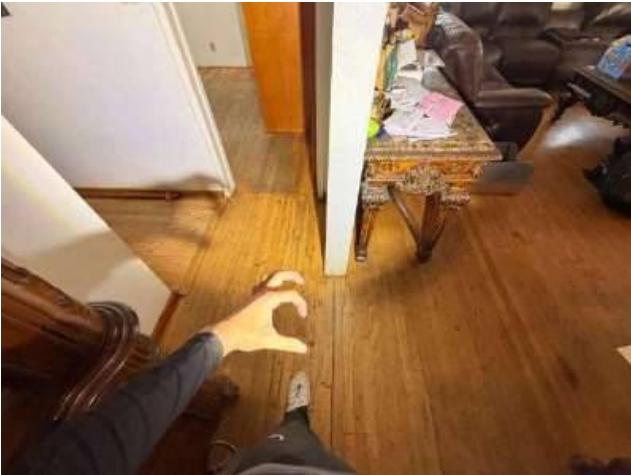
**Photo 75-1**

75) 🔧🔍 Squeaking or creaking noises occur when walking on one or more sections of flooring. This is usually caused by substandard construction practices where the sub-floor decking is not adequately fastened to the framing below. For example, not enough glue was used and/or nails were used rather than screws. In most cases, this is only an annoyance rather than a structural problem. Various solutions such as [Squeeeeeek No More and Counter Snap fasteners](https://www.reporhost.com/?SQUEAK) exist to correct this. Repairs to eliminate the squeaks or creaks may be more or less difficult depending on the floor covering and the access to the underside of the sub-floor. Recommend that a qualified contractor evaluate and repair as necessary. For more information, visit: <https://www.reporhost.com/?SQUEAK>

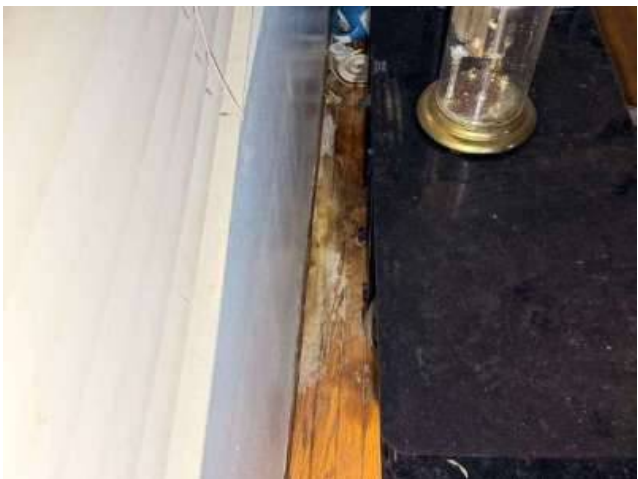
Photo 76-2

76) 🔧🔍 Fungal rot was found at one or more locations. Conductive conditions for rot should be corrected (e.g. wood-soil contact, reverse perimeter slope). Recommend that a qualified contractor repair as necessary. All rotten wood should be replaced.

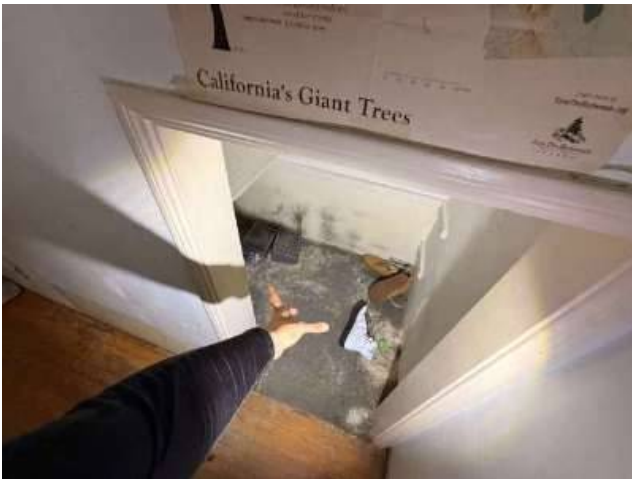
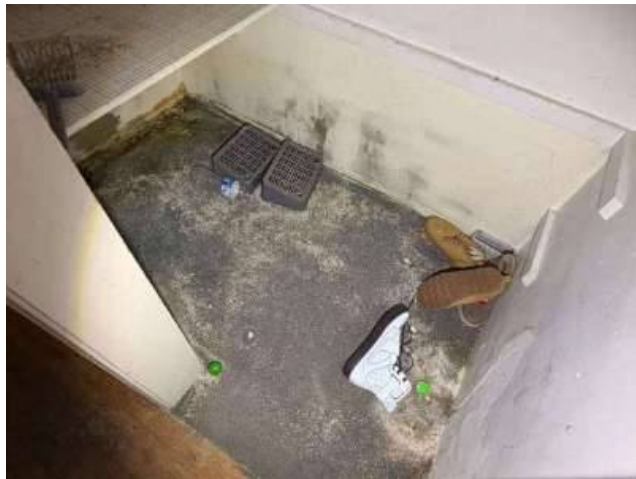
Carpeting in one or more areas was damaged or deteriorated. Recommend that a qualified contractor replace as necessary.

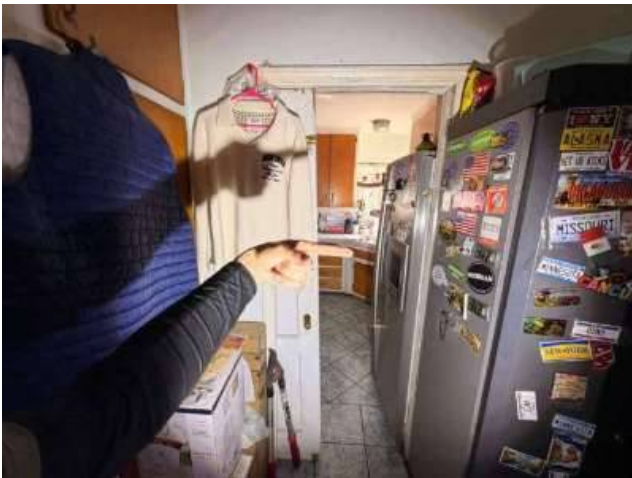
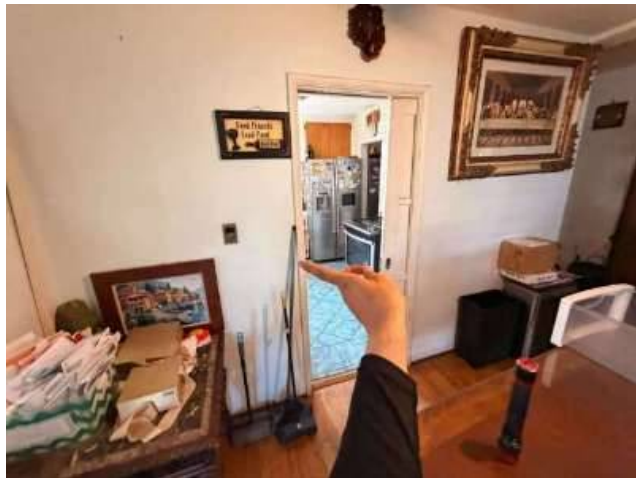
86) 🛠️ One or more "pocket" doors were stuck or difficult to operate. Recommend that a qualified person repair as necessary.

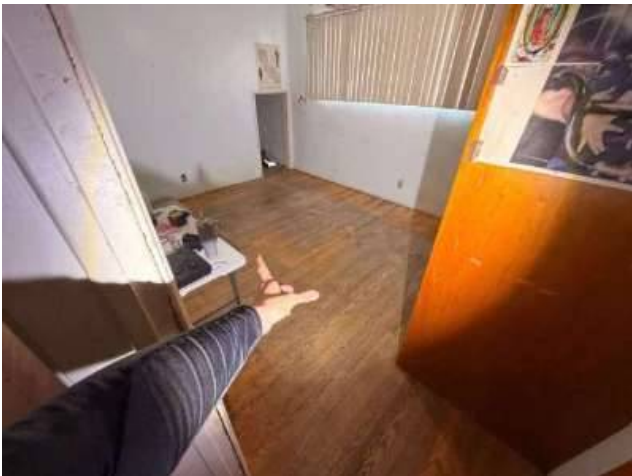
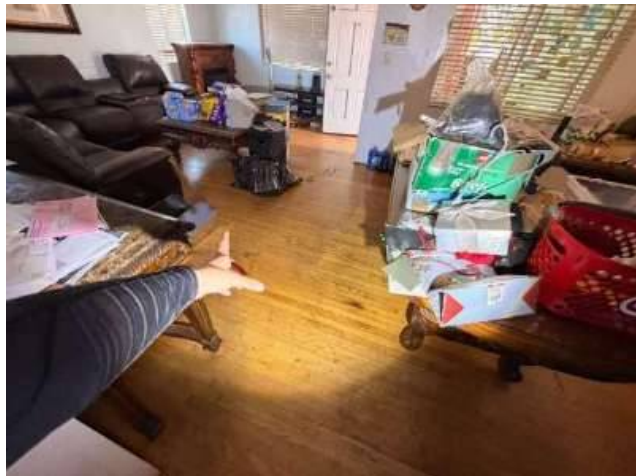
87) 🛠️ Wood flooring in one or more areas was significantly worn, deteriorated or damaged. Recommend that a qualified contractor refinish wood flooring as necessary.

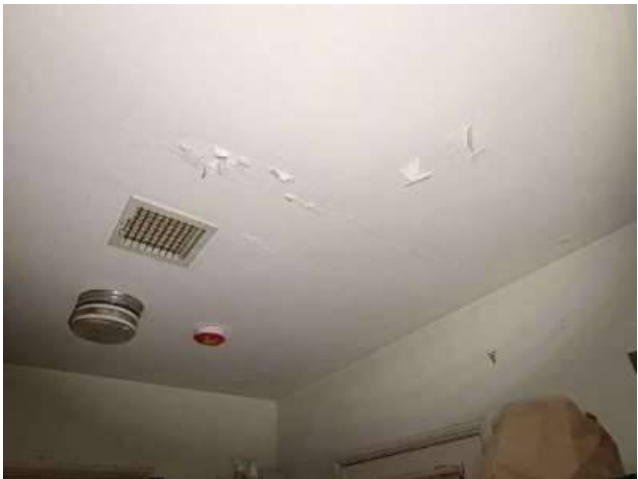
Photo 88-2

88) 🛠️ Paint was chipping, bubbling or peeling at one or more areas. Recommend having a qualified person repair as necessary.

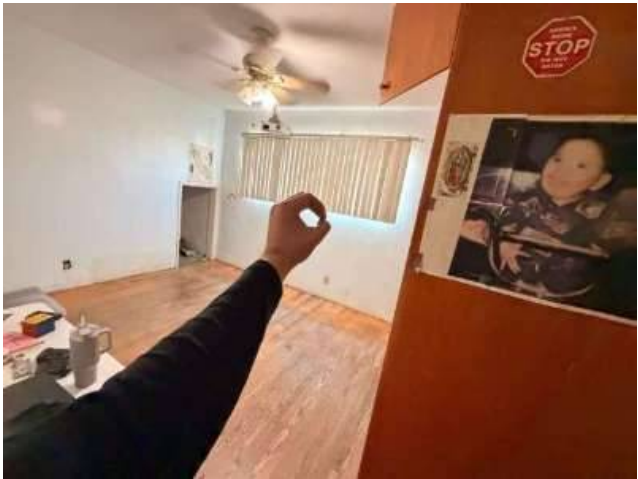
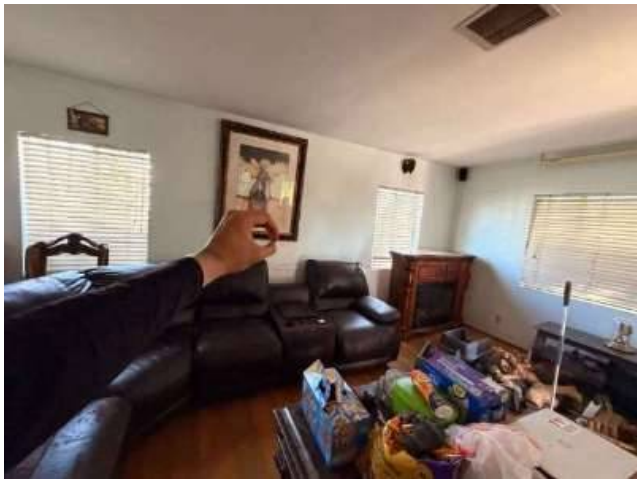
Photo 89-2

Many windows used single-pane glass. Single-pane windows are prone to sweating and are one of the largest sources of heat loss in winter and heat gain in the summer due to their low insulating ability and high air leakage rates. Consider replacing single-pane windows with multi-pane windows.

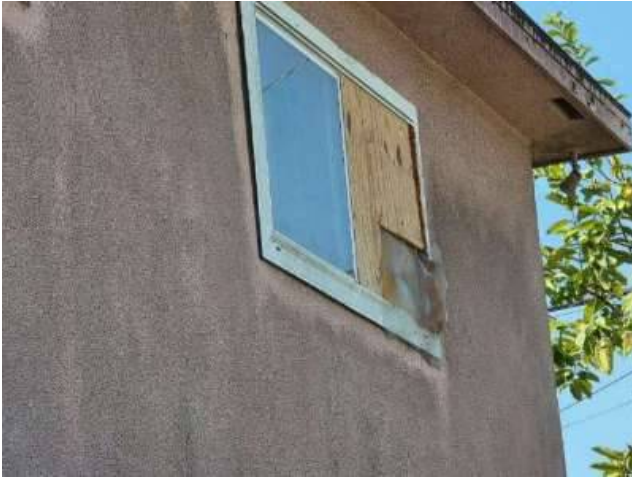
Photo 90-1

Screens were missing from some windows. These windows may not provide ventilation during months when insects are active.
