# ***Cornerstone Inspection***

## **Property Inspection Report**

***7255 Navajoa Ave, Atascadero, CA 93422***

***Date of Inspection: 9/8/2026 Time: 1:00 PM***

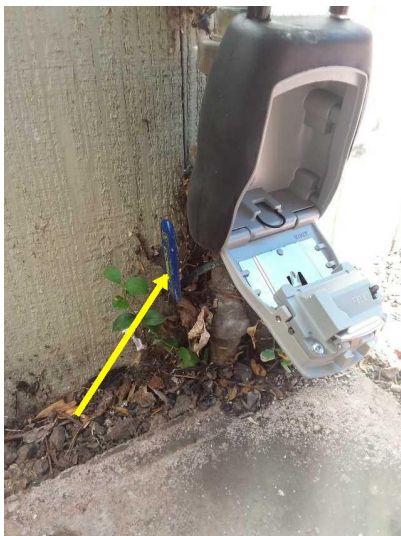
1.4. The pressure inside the residence is above 80 PSI and will stress components of the system. A licensed plumber should reduce the pressure at the regulator to sixty pounds per square inch, which is optimum. However, the regulator may have failed and would need to be replaced.

The main water shut-off valve is located at the right side of the house.

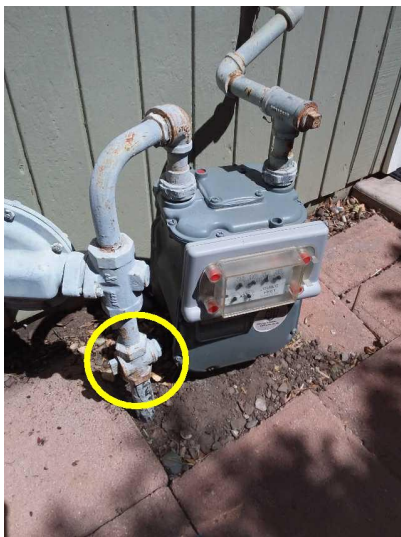
2.4. Some of the gas lines at the meter are rusted and should be painted to prevent further corrosion.

The gas main shut-off is located on right side of the home, unit or building.

2.3. We recommend that a wrench, designed to fit the gas shut off valve, be located on or adjacent to the gas meter to facilitate an emergency shut off.
