# PROPERTY INSPECTION REPORT

**FOUR POINT**  
HOME INSPECTION INC.

**5950 Forked Horn Pl**  
**Inspection Prepared For: Candy Wiedemann**  
**Agent: -**

**Date of Inspection: 9/3/2026**

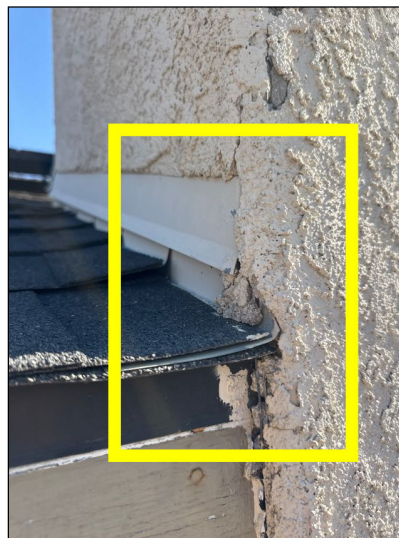
The home had no kick-out flashing installed where walls extended past roof edges.

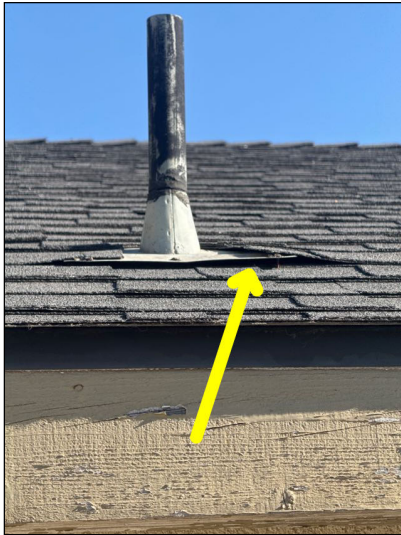
Flashing protecting the point at which one or more exhaust vents penetrated the roof was lifting

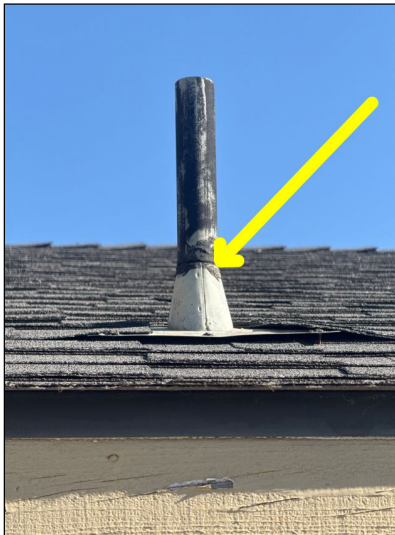
***Maintenance Needed:*** Plumbing vent flashings are mastic covered and some are *showing signs of cracked mastic/mastic deterioration* from sun exposure. Recommend re-sealing all through the roof vents and projections as a part of routine maintenance to prevent unwanted moisture intrusion.

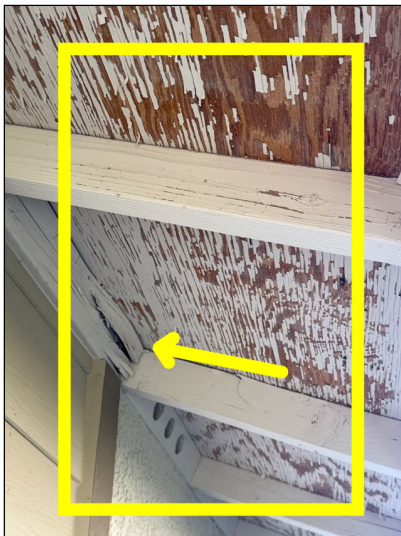
**Maintenance Needed:** Soffits had peeling paint and needed maintenance.

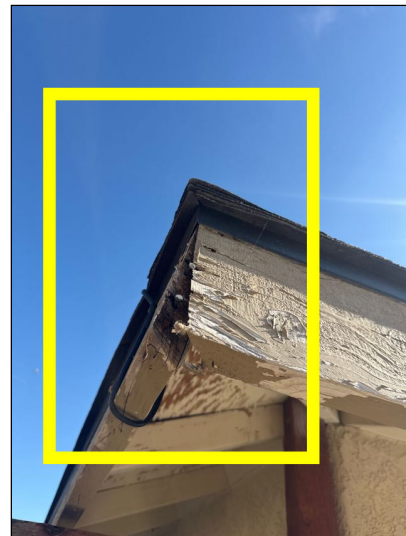
**Monitor:** Home fascia had opened at corners and splices.

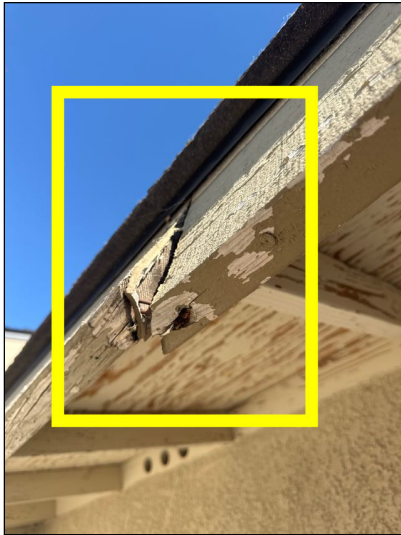
**Monitor:** Home fascia had opened at corners and splices.

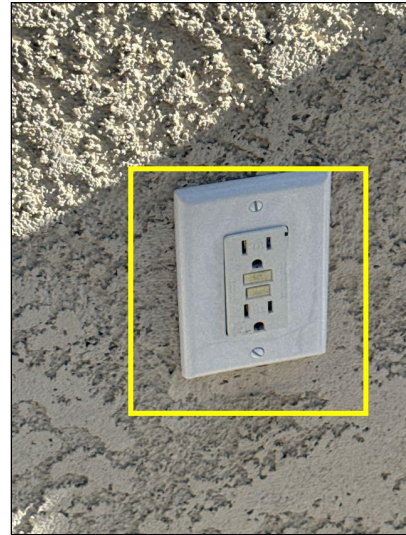
A ground fault circuit interrupter (GFCI) was inoperable and not properly installed

Exterior outlet at the home were not protected from weather. rear of the home

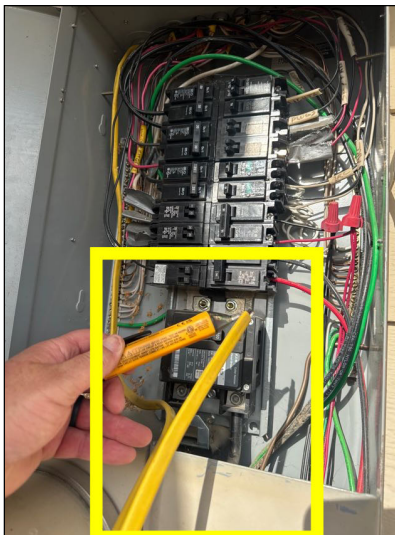
| | Page 30 Item: 4 | Panel Wiring | <p>Electrical wires visible inside the electrical panel were improperly terminated. Although they were not energized at the time of the inspection, these wires may have the potential to become energized and should be correctly terminated by a qualified contractor.</p> |

Electrical wires visible inside the electrical panel were improperly terminated. Although they were not energized at the time of the inspection, these wires may have the potential to become energized and should be correctly terminated by a qualified contractor.

Electrical wires visible inside the electrical panel were improperly terminated. Although they were not energized

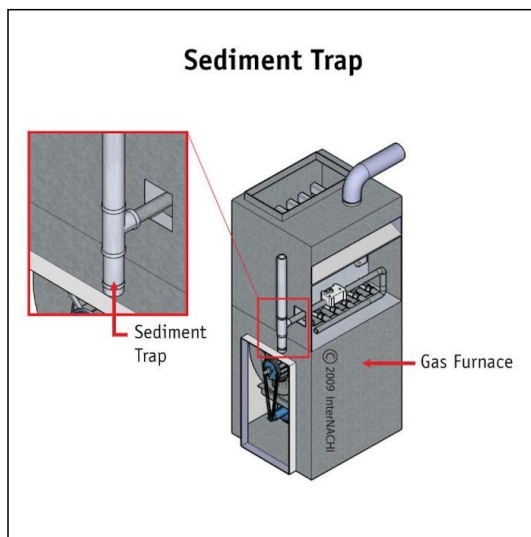
**Improvement:** The gas supply pipe contained no sediment trap.

The purpose of a sediment trap is to prevent sediment or debris particulates from entering and clogging the heaters gas valve.

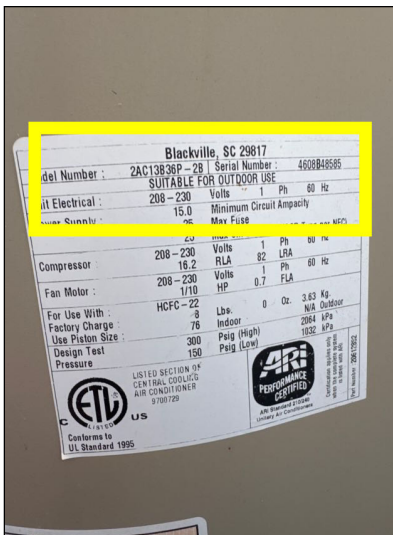
AC model and serial number

| | Page 36 Item: 13 | AC Compress Condition | <p>The air-conditioning system did not respond to the controls and should be serviced by a qualified HVAC technician.</p> |

The air-conditioning system did not respond to the controls and should be serviced by a qualified HVAC technician.

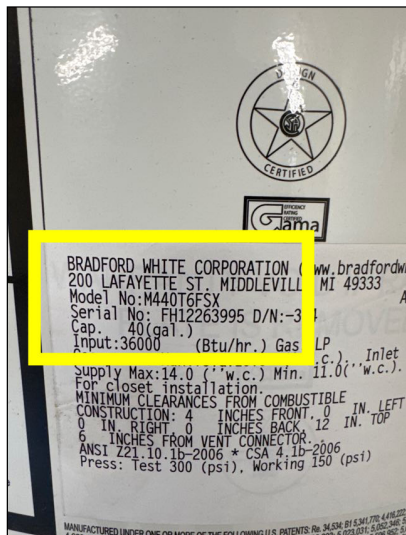
Water heater model and serial number

| | Page 37 Item: 1 | Water Heater Condition | <p>This water heater appeared to have be leaking at the time of the inspection and should be shut off, drained immediately and an an evaluation and any necessary work be performed by a qualified HVAC or plumbing contractor.</p> |

This water heater appeared to have be leaking at the time of the inspection and should be shut off, drained immediately and an an evaluation and any necessary work be performed by a qualified HVAC or plumbing contractor.

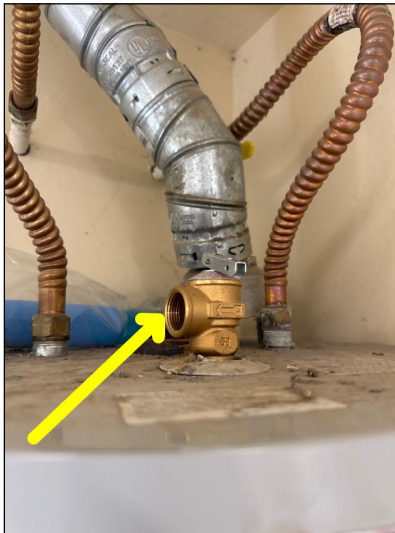
Unit #1

| | Page 38 Item: 5 | TPR Discharge Line Condition | <p>The discharge line for the water heater relief valve (TPRV) is missing. This is a potential scalding concern as water can discharge improperly. Recommend installing the proper <b>TPR valve</b> discharge tube that must be made of copper, iron, or CPVC (NOT regular <b>PVC</b>). It must terminate within 6" above the floor--the end cannot be threaded or have a fitting. We recommend that the discharge line extend to the exterior of the home if possible.</p> |

The discharge line for the water heater relief valve (TPRV) is missing. This is a potential scalding concern as water can discharge improperly. Recommend installing the proper **TPR valve** discharge tube that must be made of copper, iron, or CPVC (NOT regular **PVC**). It must terminate within 6" above the floor--the end cannot be threaded or have a fitting. We recommend that the discharge line extend to the exterior of the home if possible.

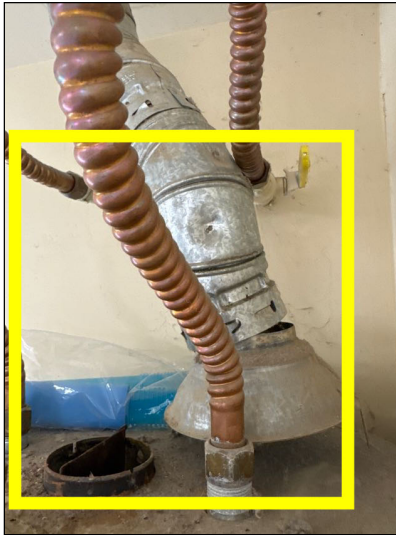
| | Page 39 Item: 7 | Combustion Vent/Air Supply | <p>The combustion exhaust vent of this gas-fired water heater was separated. This hazardous condition may allow the invisible, odorless, tasteless, toxic products of combustion (such as carbon monoxide) to enter the living space. Exposure to these gases may result in injury or death. The Inspector recommends that this water heater be shut down immediately and remain shut down until the problem has been corrected by a qualified HVAC contractor.</p> |

The combustion exhaust vent of this gas-fired water heater was separated. This hazardous condition may allow the invisible, odorless, tasteless, toxic products of combustion (such as carbon monoxide) to enter the living space. Exposure to these gases may result in injury or death. The Inspector recommends that this water heater be shut down immediately and remain shut down until the problem has been corrected by a qualified HVAC contractor.

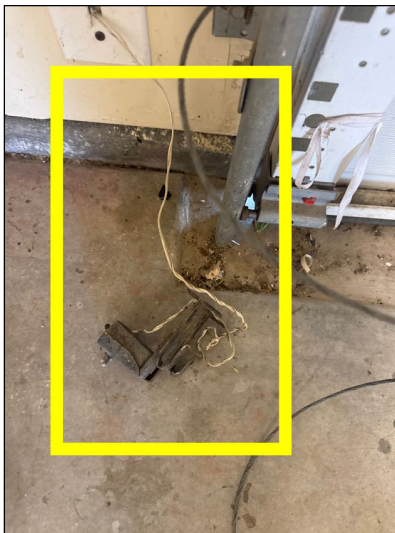
| Garage | | | |
|---|---|---|---|
| | Page 41 Item: 3 | Garage Door's Reverse Status | <b>Safety:</b> The automatic-reverse photoelectric sensors at an overhead garage door was inoperable. This usually means that the sensors are misaligned and need maintenance. The Inspector recommends repair/replacement of a photo sensor by a qualified garage door contractor. |

**Safety:** The automatic-reverse photoelectric sensors at an overhead garage door was inoperable. This usually means that the sensors are misaligned and need maintenance. The Inspector recommends repair/replacement of a photo sensor by a qualified garage door contractor.

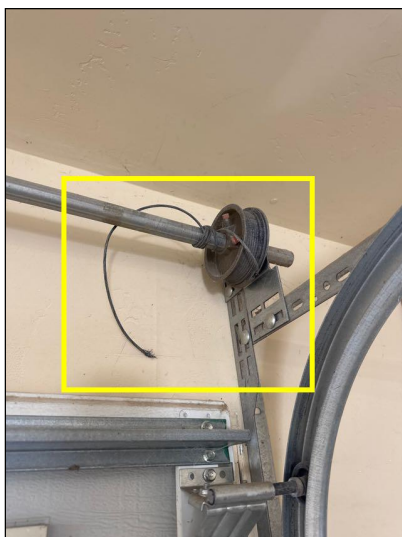
| Garage | | | |
|---|---|---|---|
| | Page 42 Item: 4 | Garage Door Parts | <p><b>-TRACKS</b><br/>The track was damaged and needed repair. All work should be performed by a qualified contractor.</p> <p><b>-DOOR SPRINGS/CABLE</b><br/>Door cabled supporting an overhead garage door were disconnected. The Inspector recommends correction by a qualified contractor.</p> <p>Springs supporting an overhead garage door were broken and needed replacement. This operation can be dangerous. The Inspector recommends all work be performed by a qualified contractor.</p> |

Door cabled supporting an overhead garage door were disconnected.

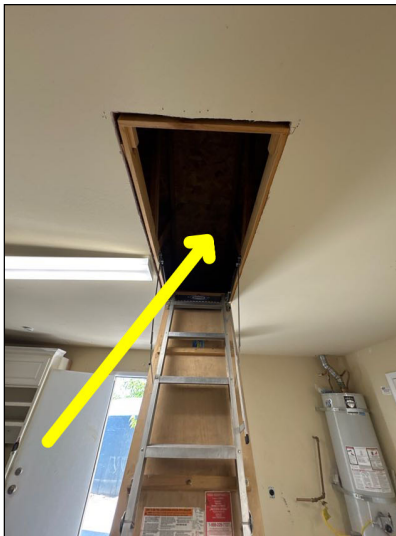
Attic access in garage is considered a breach in the fire wall. Fire walls are fundamental to the integrity of fire barriers which provide resistance to the spread of fire, smoke, and toxic gasses. This means that should a fire occur in the garage, this door does not afford protection until fire-rescue people arrive. A fire rated access panel should be installed to complete the fire wall.

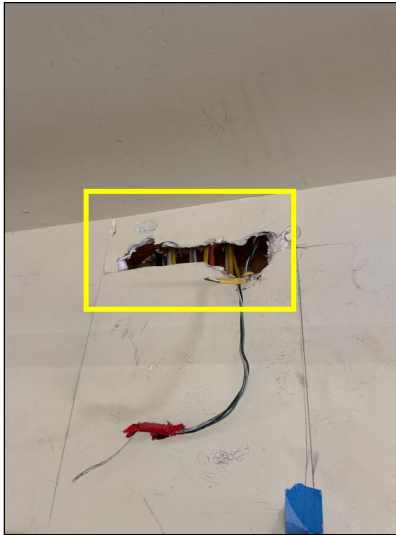
The garage walls had minor damage visible at the time of the inspection. The Inspector recommends that before the expiration of your Inspection Objection Deadline you consult with a qualified contractor to discuss options and costs for repair or replacement.

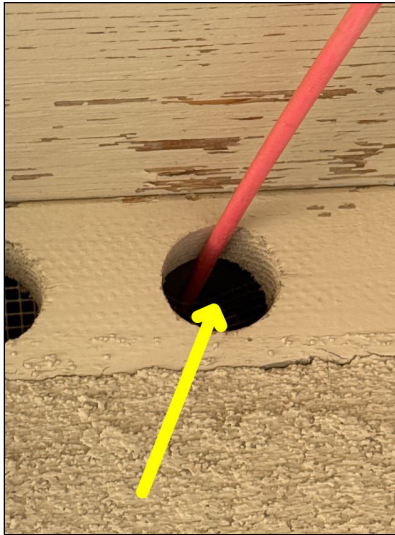
**Maintenance Needed:** Vent screens are damaged or missing, suggest repairing or replacing screens as necessary to prevent entry of unwanted pests.

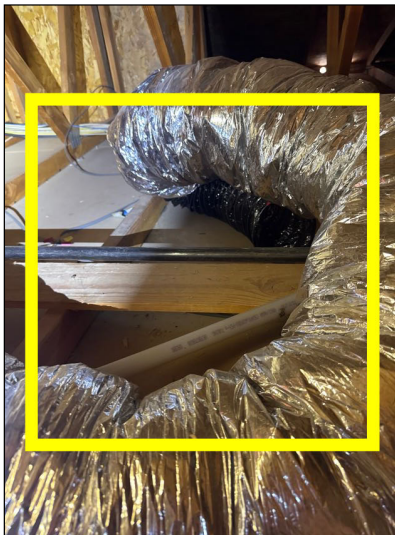
Disconnected ducts were visible in the garage attic. The inspector recommends reconnection by a qualified HVAC contractor.

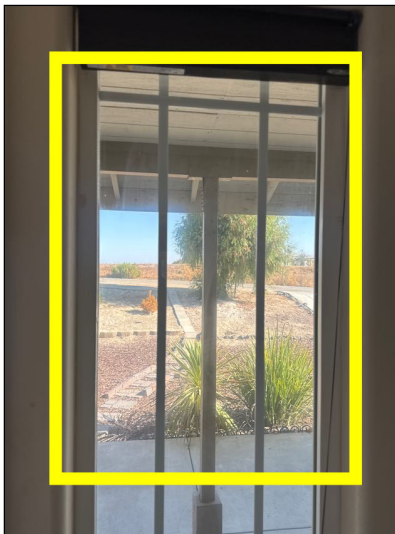
Although no condensation was visible at the time of the inspection, staining and etching of the glass at a window in the Living Room, Front Entry indicated a loss of thermal integrity. Etching of the glass from long-term exposure to condensation constitutes permanent damage. The Inspector recommends that before the expiration of your Inspection Objection Deadline you consult with a qualified contractor to discuss options and costs for replacement.

Staining and etching of the glass at the window indicated a loss of thermal integrity.

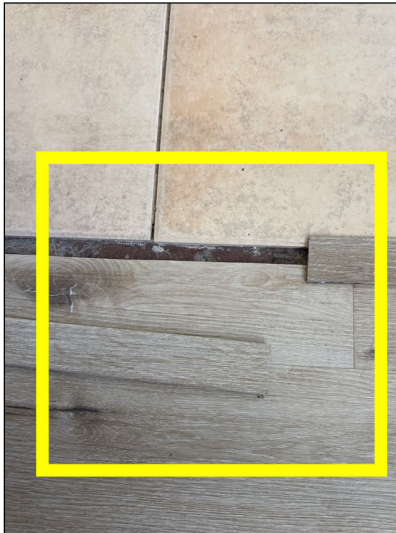
**Monitor:** The plank flooring had minor damage and was poorly installed. The Inspector recommends that before the expiration of your Inspection Objection Deadline you consult with a qualified contractor to discuss options and costs for repair or replacement.

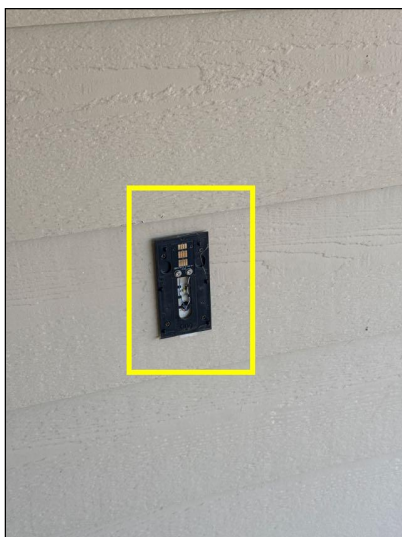
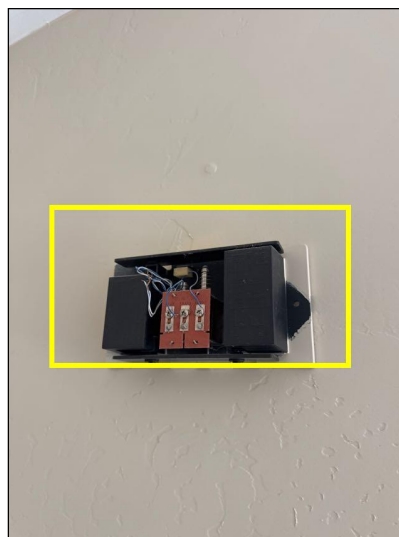
- **Maintenance Needed:** The interior door chime is missing it's decorative cover exposing the working parts. Consult with the seller for replacement.

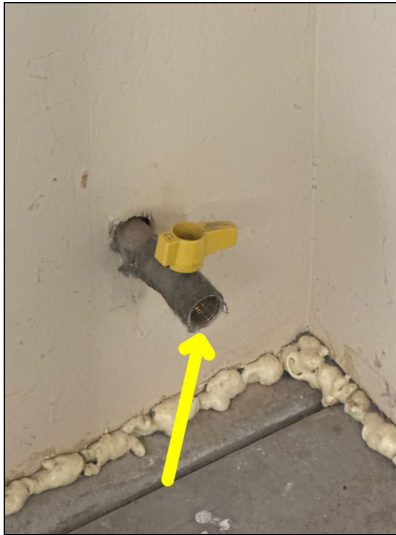
- **Safety:** A gas valve is present and in the off position. Recommend the valve is capped until valve is properly connected to an approved gas appliance. This will insure there is no accidental discharge of gas if the valve is accidentally opened.

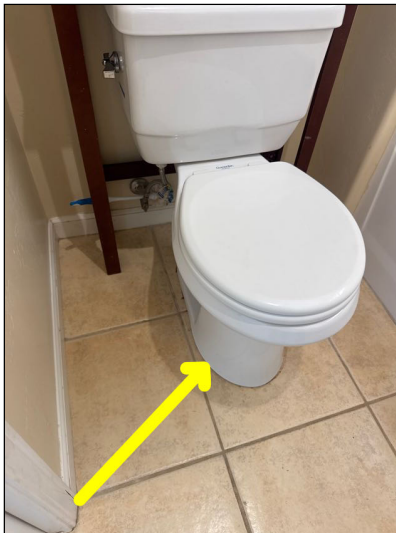
**In the bathroom, the toilet was loose at the floor and should be re-attached by a qualified plumbing contractor.**

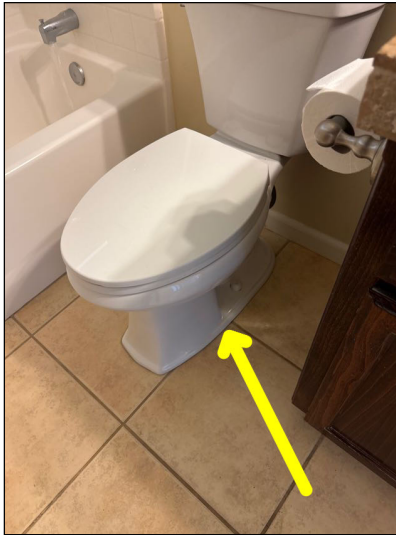
**In this bathroom, the toilet was loose at the floor and should be re-attached by a qualified plumbing contractor.**

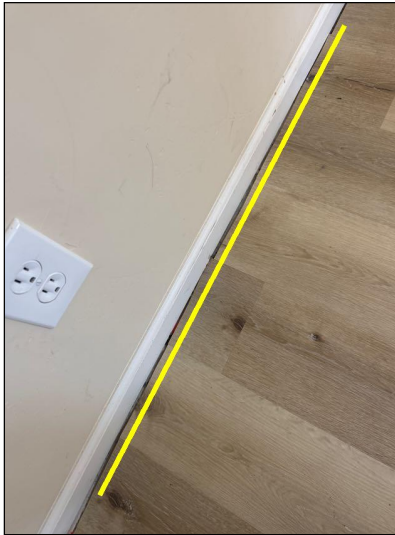
- The Inspector observed few deficiencies in the condition of floors. Notable exceptions are listed.
  - Vinyl floor coverings in this bedroom exhibited evidence of poor installation practices. The Inspector recommends that before the expiration of your Inspection Objection Deadline you consult with a qualified contractor to discuss options and costs for repair or replacement.

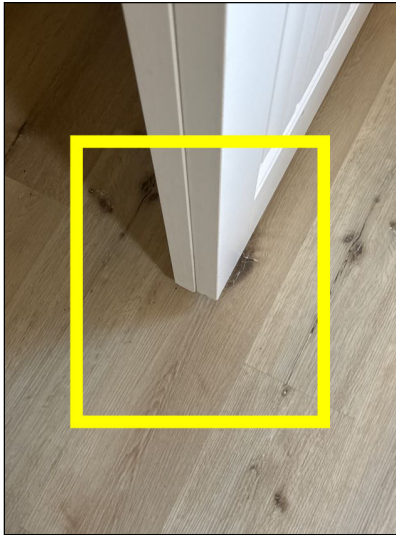
• **Safety:** The closet door has no door stop to keep doors from swinging in and out. This could allow the doors to fall off the track and injure a person. The inspector recommends that the proper hardware is installed by qualified contractor.

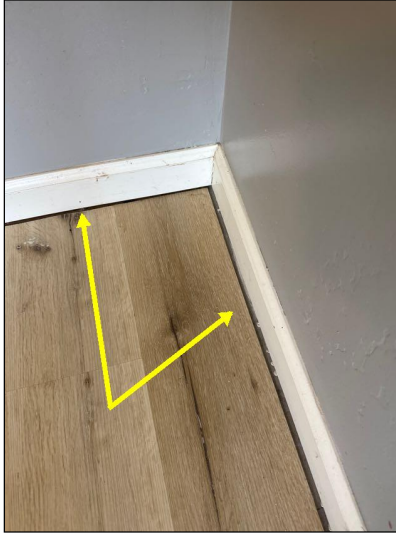
- The Inspector observed few deficiencies in the condition of floors. Notable exceptions are listed.
- Vinyl floor coverings in this bedroom exhibited evidence of poor installation practices. The Inspector recommends that before the expiration of your Inspection Objection Deadline you consult with a qualified contractor to discuss options and costs for repair or replacement.

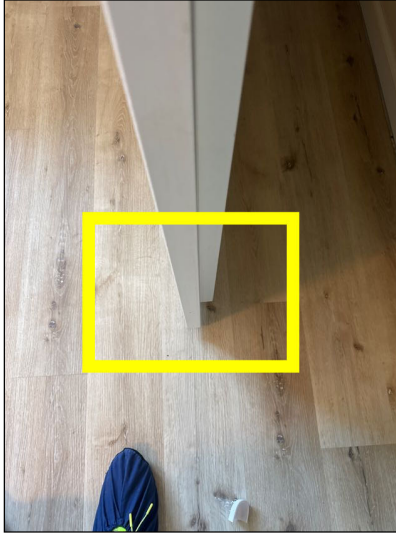
- The closet is in serviceable condition.
- **Safety:** The closet door has no door stop to keep doors from swinging in and out. This could allow the doors to fall off the track and injure a person. The inspector recommends that the proper hardware is installed by qualified contractor.

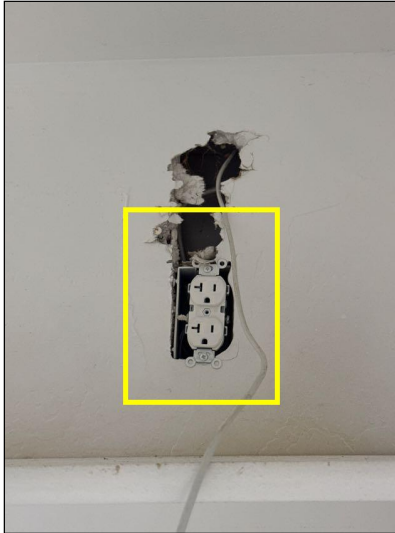
An electrical receptacle in this bedroom was missing a cover plate. This condition left energized electrical components exposed to touch. This shock/electrocution hazard should be corrected by a qualified electrical contractor.

An electrical receptacle in this bedroom was missing a cover plate.

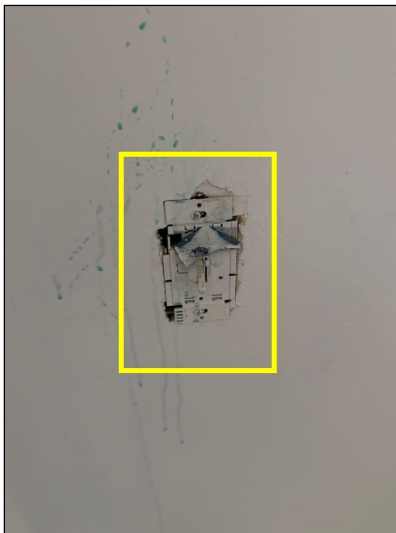
- A switch cover plate was missing in this bedroom. This condition left energized electrical components exposed to touch, a shock/electrocution hazard. The Inspector recommends that a listed cover plate be installed by a qualified electrical contractor.
- A light fixture was missing the globe cover leaving the light bulb exposed.

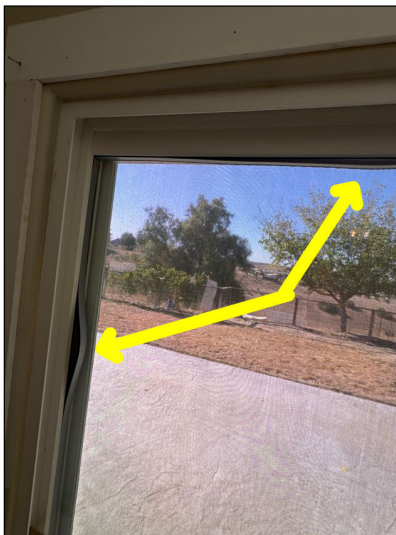
• Although no condensation/staining was visible at the time of the inspection, pulled seals in the glass sliding door indicated a loss of thermal integrity. As the argon gas leaks out it causes a vacuum that pulls the seal out. The Inspector recommends that before the expiration of your Inspection Objection Deadline you consult with a qualified contractor to discuss options and costs for replacement.
