### *Inspection Report*

**Address: 2630 La Mirada Los Osos, CA**

**09/08/2026**

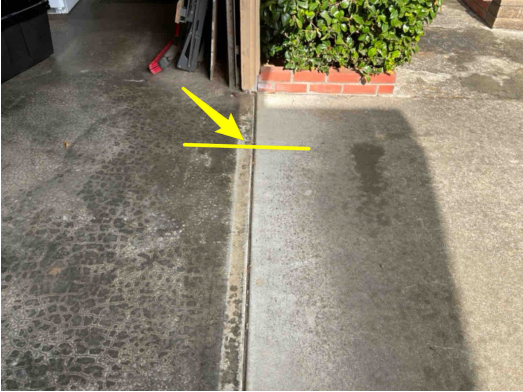
**DS 20: Disclosure:** Due to the slope and height of the driveway at the garage connection, some water intrusion into the garage may occur during certain weather.

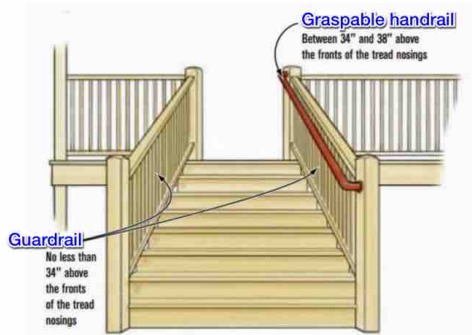
**SC 37:** Missing the proper / required graspable handrail at the exterior stairway OFF THE FRONT ENTRY.

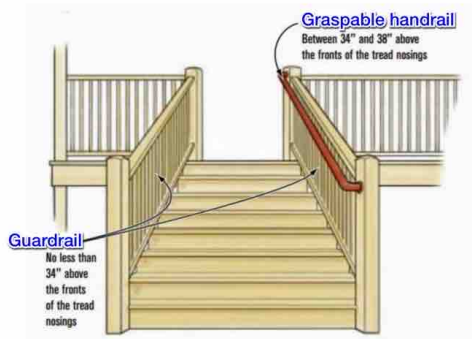
**SC 39:** Missing the proper / required graspable handrail at the exterior stairway OFF THE DRIVEWAY PARKING AREA.

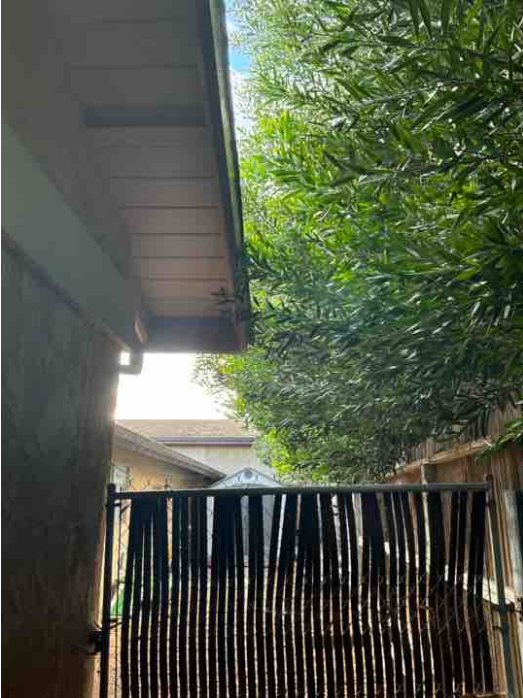
**MR 44:** Plants and/or Trees touch the buildings exterior and/or the roof. Proper landscape maintenance needed.

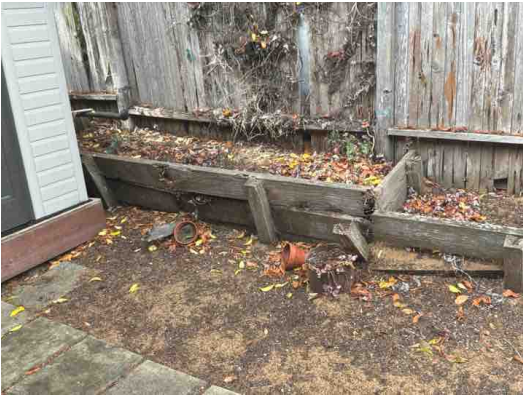
**E&C 50: Some heavy moisture damage, with leaning of the wood retaining wall(s).** Sections of the wood, retaining walls appear to be nearing the end of its structural life. *Be aware that wood retaining walls have a limited lifespan and will warrant eventual replacement. Monitor, replace or repair the wood retaining walls as needed.*

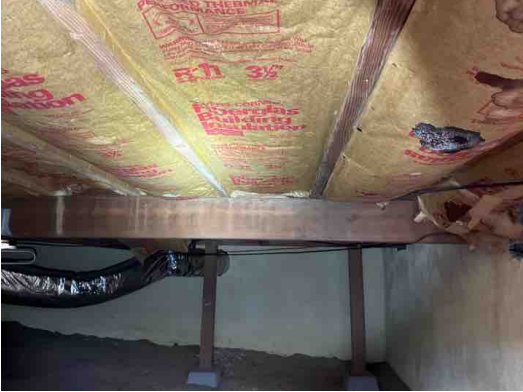
**SU 62:** The Insulation that is installed in the crawlspace was found to be installed upside-down. The paper on the insulation should be towards the living space.

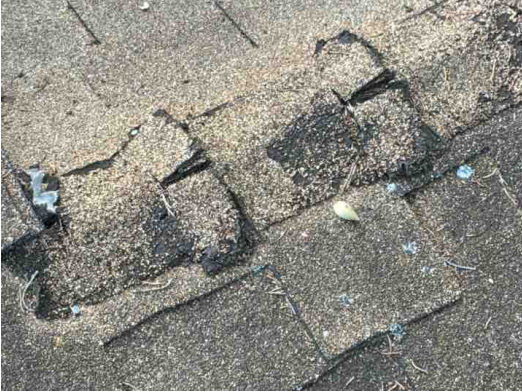
**E&C 67:** Some damaged and missing roof ridge shingles at areas of the roof. Corrections are needed. Contact a qualified roofer to evaluate the roof and make the appropriate recommendations and repairs as needed.

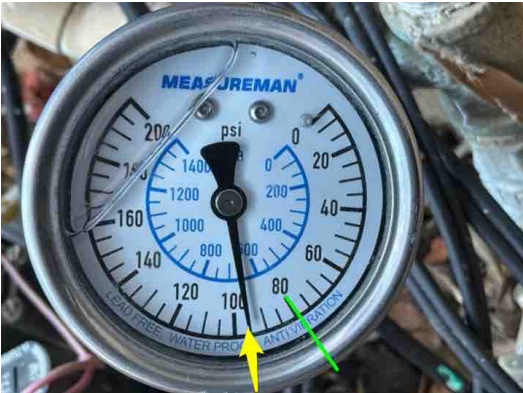
**E&C 82: Excessive water pressure** (above the maximum of 80-psi, **currently at: 95-psi** ). Recommend the installation of a pressure regulator.

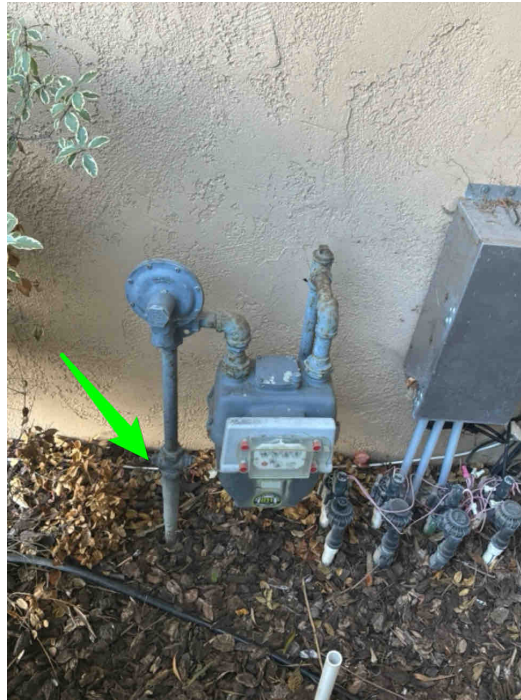
Main gas shut off valve

**91: Gas shut-off appears serviceable.**

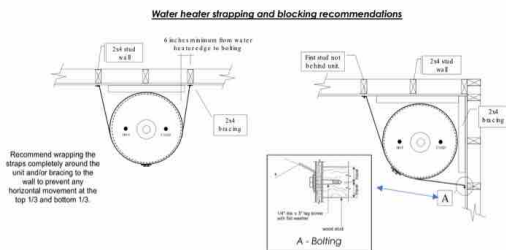
**E&C 95:** The Water heater is loosely strapped & not secured well - moves when pushed . Recommend adding BRACING OR BLOCKING to the wall to properly secure the tank per Uniform Plumbing Code and State Architect Requirements.

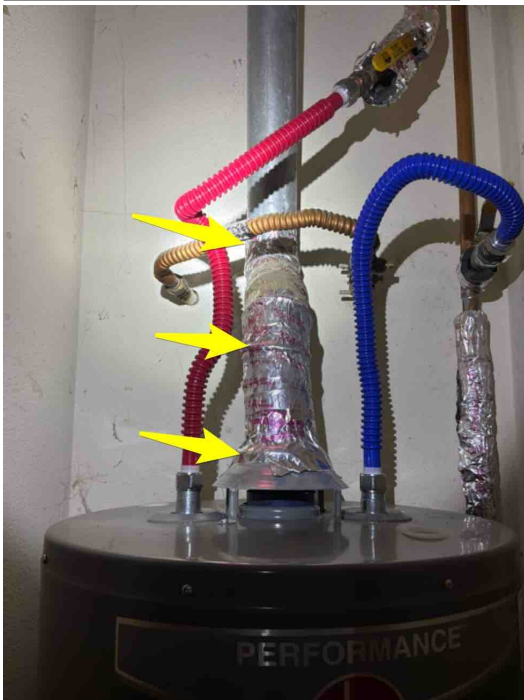
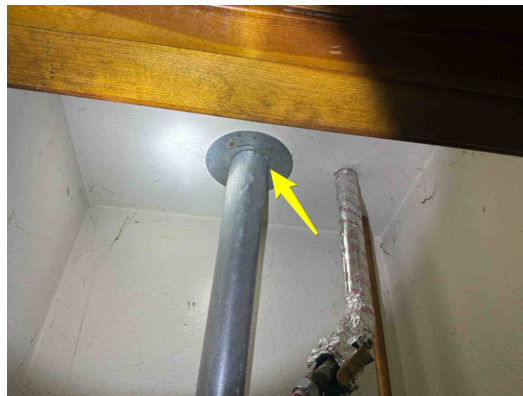
**SC 98:** Water heater vent connector pipe (single wall) is not properly fastened at all connections with the required 3 fasteners at each connection, including the draft hood per standards. The use of Aluminum tape is not an acceptable alternative to using screws.

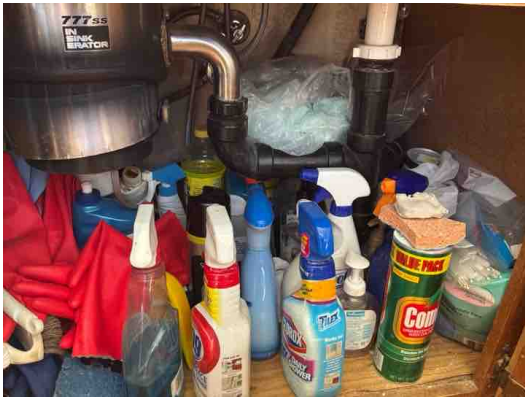
**DS 107: Disclosure:** *Restricted view below kitchen sink (areas not fully visible). Do a secondary check carefully once kitchen cabinets are empty.*

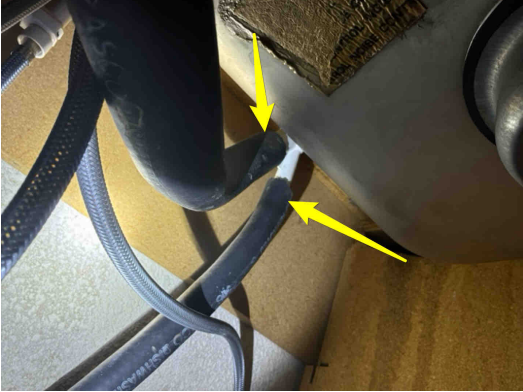
**E&C 113:** Missing the required hose clamp at the dishwasher air gap / drain hose connection under the kitchen sink. This can allow the drain hose to dislodge and cause flooding.

The air gap under the kitchen sink

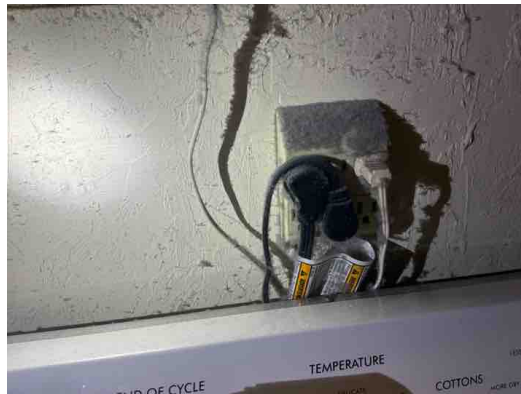
**SC 130:** The current laundry dryer vent pipe is leaking lint and exhaust air into the areas behind the laundry dryer. Additional review and correction is needed.

**MR 129:** Recommend cleaning and servicing the laundry dryer vent system, pipe and cap, for safety as part of typical ongoing maintenance.

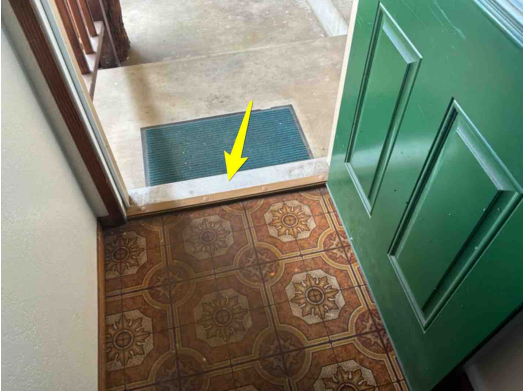
**MR UPG 151:** Loose exterior door threshold found at the KITCHEN HALLWAY EXTERIOR DOOR TO THE GARAGE BREEZEWAY. This could damage the threshold and/or create a water leak.

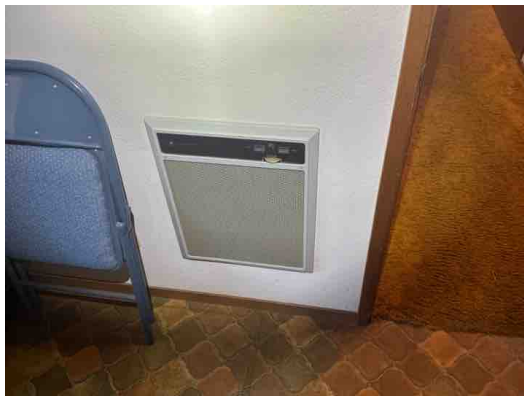
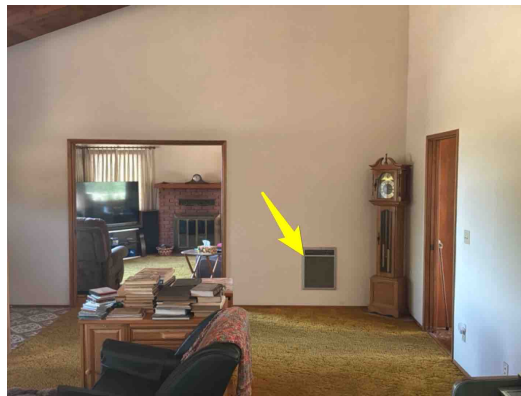
**177: Heater Type: Electric Wall Heater did not operate:**

1. BEDROOM-3
2. ENTRY HALLWAY
3. BEDROOM-2

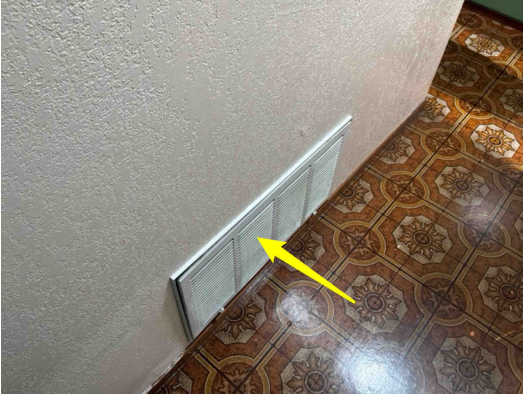
**MR 184:** Dirty Heating air filter found in the return air grill(s). Recommend cleaning or changing the furnace air filters as part of ongoing maintenance.

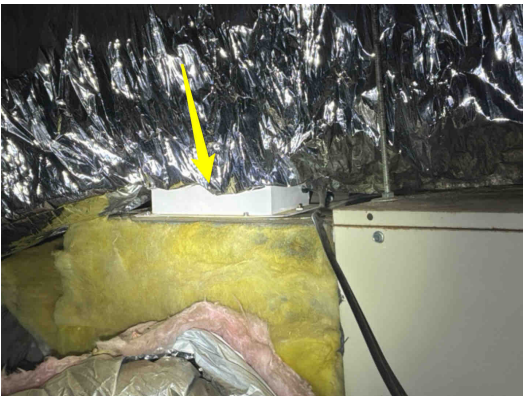
**MR DS 185:** An ultraviolet light air purification system is installed at the furnace plenum. Unable to determine if the UV light is currently functioning due to the type of system installed. Recommend additional review and certification of proper and safe operation by a licensed HVAC contractor.

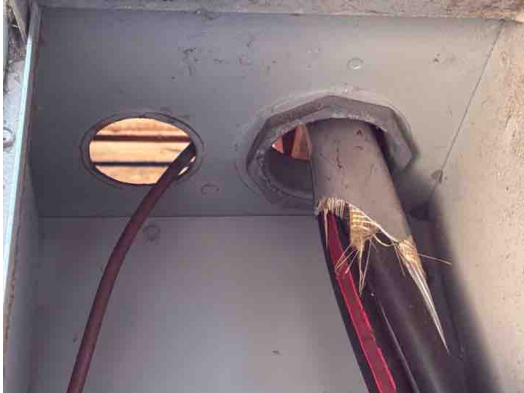
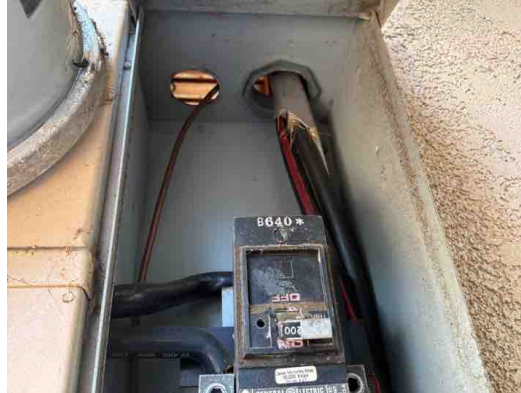
**SC 191:** Missing and Oversized bushing clamp as wires are passing into the TOP of the MAIN ELECTRICAL PANEL. Wires are improperly rubbing on the sharp metal edge of the electrical panel as they pass through. Proper bushing clamps are needed to help stabilize wires and prevent critter intrusion..

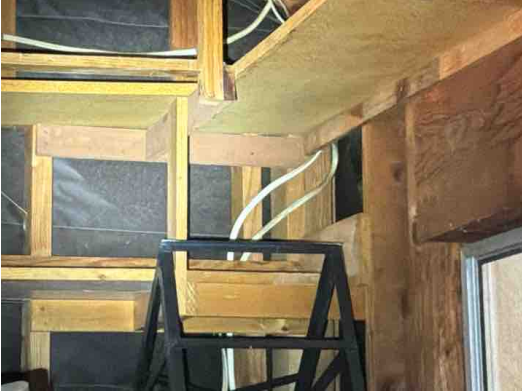
**SC 195:** Improper exposed electrical wiring, "Romex" improperly installed subject to physical damage, not in a conduit or raceway per standards: IN AREAS OF THE GARAGE

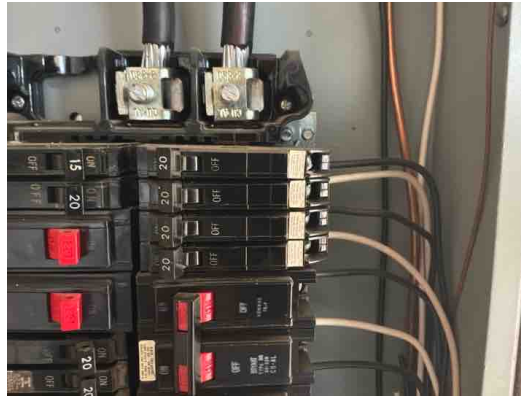
**SC 200:** Missing the required split-branch coupler at a 240-volt breaker in the: ELECTRICAL SUB PANEL.

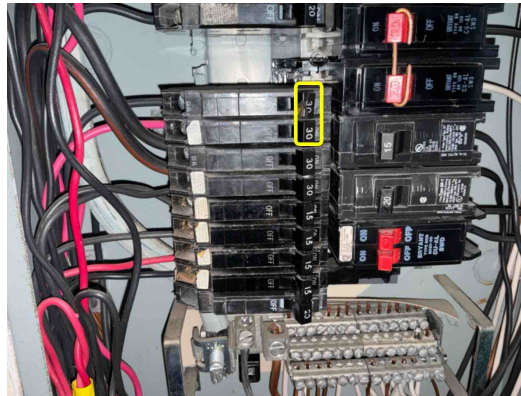
**SC 201:** Missing / BROKEN split-branch coupler at a 240-volt breaker in the: ELECTRICAL SUB PANEL.

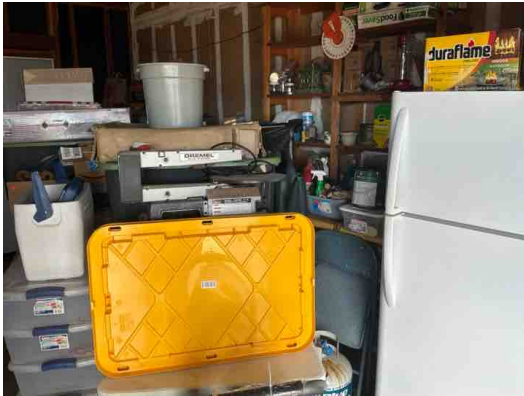
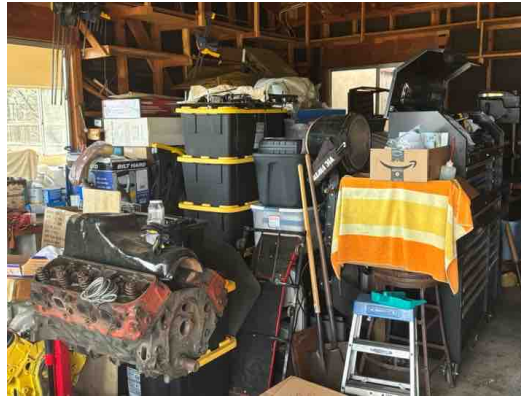
**DS 206:** The garage floor and walls are not fully visible due to occupants' belongings and/or cabinetry. *Areas of the garage is not accessible, visible nor inspected. A re-inspection is recommended once full access is made available.*

**DS 207:** *Due to an excessive amount of stored items and/or cabinetry in the garage, the majority of the garage walls and/or floor, is not accessible, not visible, nor inspected. A re-inspection is recommended once access is made available.*

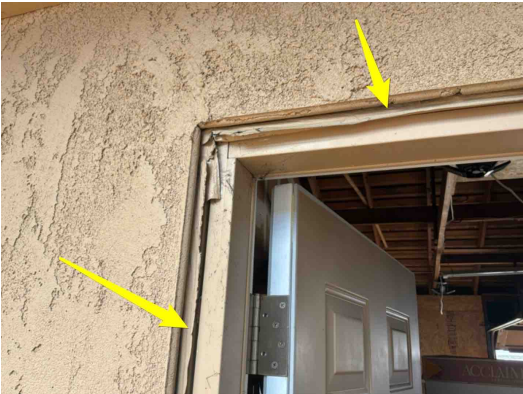
**E&C 213:** Missing the exterior trim and waterproofing around the garage exterior pedestrian door to the backyard. Contact a qualified contractor to review and correct.

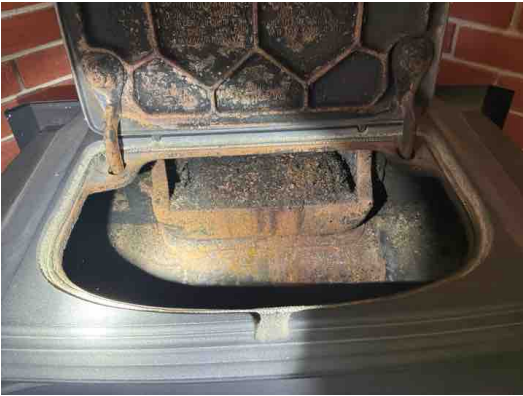
**MR UPG 225:** Evidence of water intrusion with stains and rust at and around the flue pipe and inside the freestanding fireplace. Additional review and corrections are needed by a qualified fireplace professional prior to use.

**223:** Cleaning and sweeping the DINING AREA freestanding fireplace metal chimney pipe by a qualified and licensed chimney sweep.

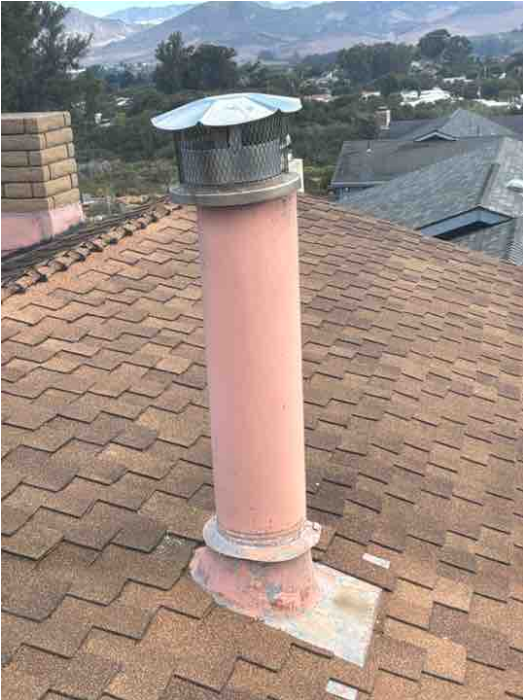
**226:** The DINING AREA fireplace chimney.

**227:** The DINING AREA Metal fireplace chimney is needing servicing or repair. The inner pipe at the metal fireplace Chimney appears to be loose, possibly disconnected and offset. Contact a qualified fireplace and chimney sweep to perform appropriate repairs, upgrades or needed maintenance.

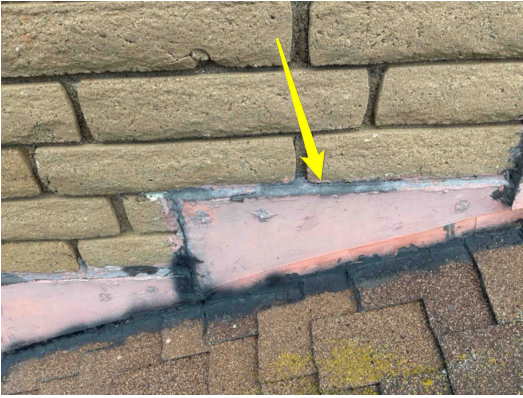
**MR 247:** Deteriorated caulking, cracks and/or separations noted at the LIVING ROOM masonry chimney at its roof flashings. General maintenance such as caulking and resealing the fireplace roof flashings is needed. Contact a qualified roofer for maintenance recommendations.
