# **Inspection Report**

**Property Address:  
11422 Edmonson Ave  
Moreno Valley CA 92555**

| <b>Date:</b> 9/18/2026 | <b>Time:</b> 11:00 AM | <b>Report ID:</b> 091826-02MC |

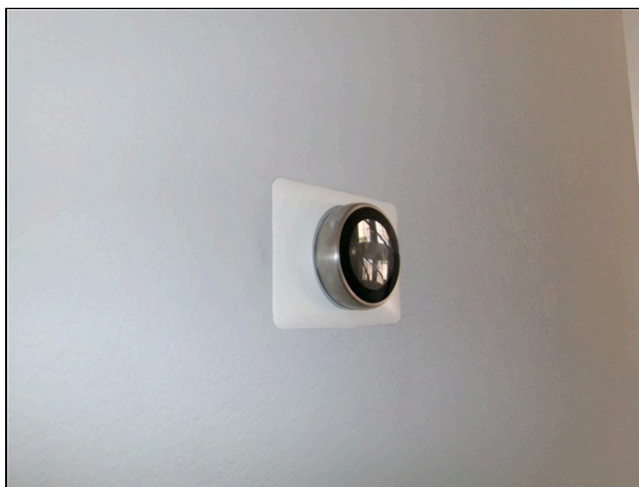
3.0 Item 1(Picture) General View

**3.0 Heat/ Cold air wall thermostat control was responsive and in working order at time of inspection. Note: Removal of old batteries and installing new is suggested.**

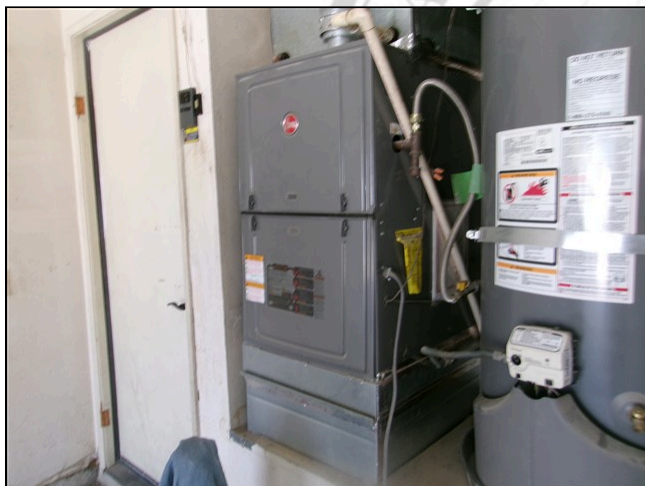
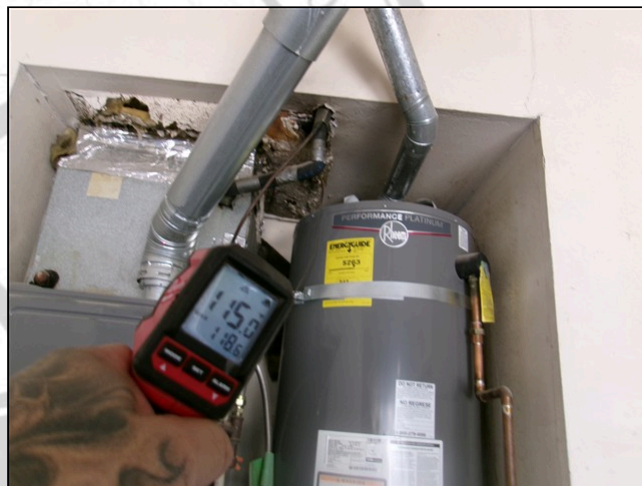
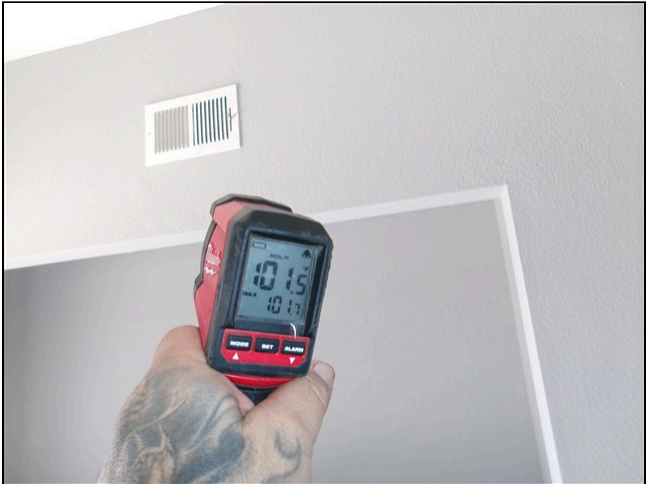
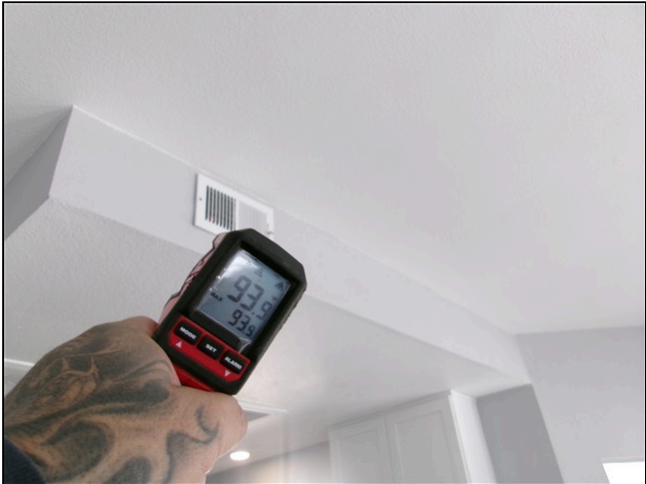
**3.1 Heat Unit system was in working order at time of inspection. Adequate hot air flow was present and recorded from all registers. ( Thermal reading shown. ) Note: Gas Shutoff Valve was present at Unit. Due to age a safety check should be required by your local Gas Company. Cover was not removed.**

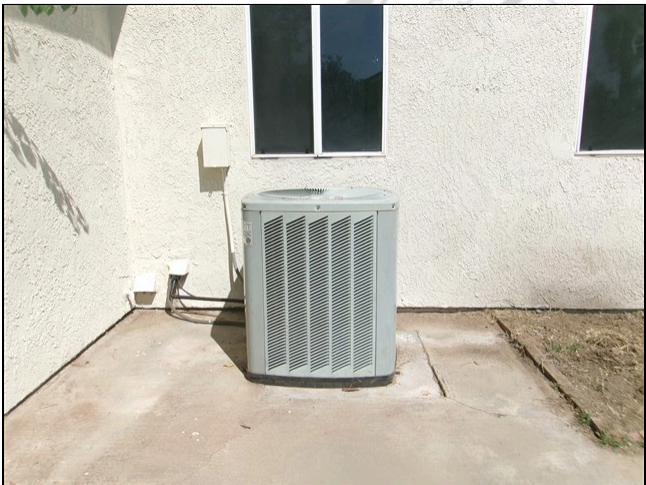
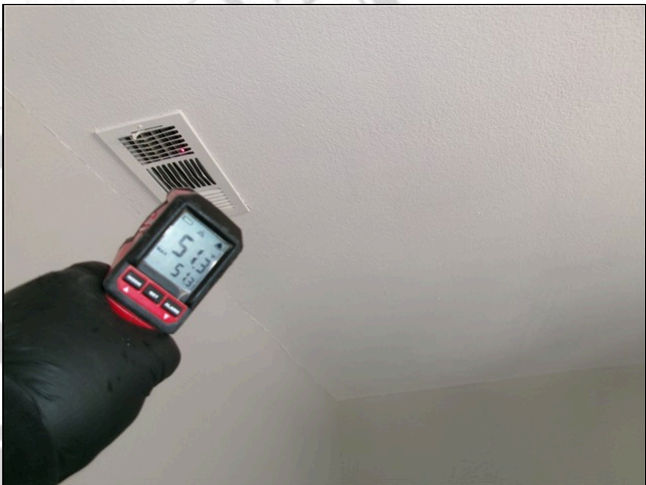
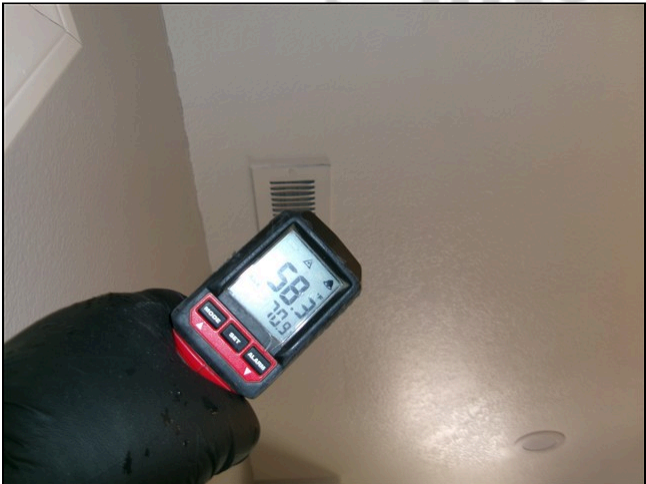
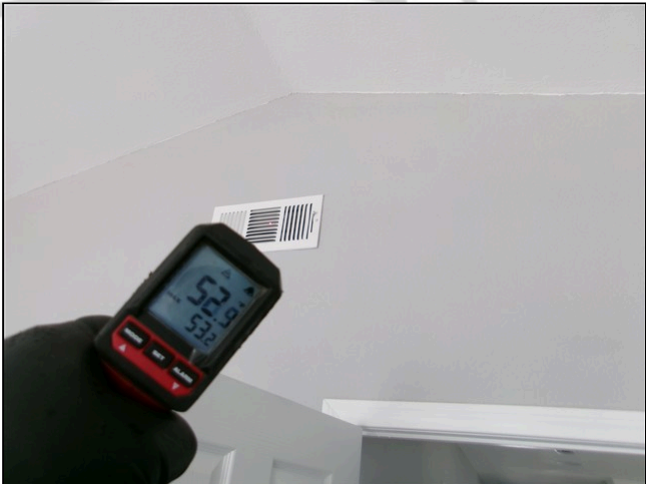
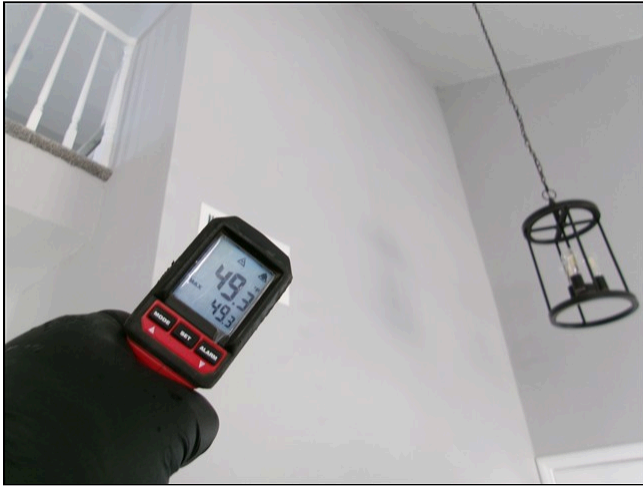
**3.3 (1) The A/C unit was operable at time of inspection. Adequate cold air flow was tested and recorded from all registers within home. (Thermal reading shown). Note: Client should be aware Unit was an older Model. Discussing with an HVAC technician if Unit is still serviceable to recharge is suggested.**

**3.3 (2) Recommend removing existing foam cover and installing new at A/C unit. Complete foam cover helps out with more energy-efficient on home cooling. Work can be done by a qualified or licensed HVAC technician.**

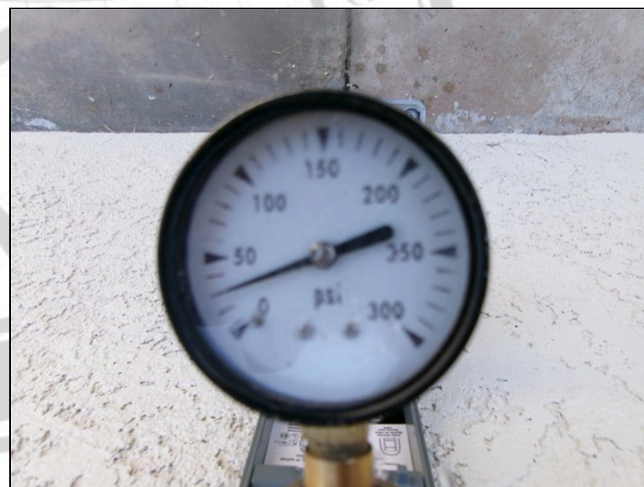
4.2 Item 4(Picture) General View

**4.2 (2) The client should be aware that the water supply pressure was less than 50 pounds per square inch (PSI) at time of inspection. 40-80 PSI is considered the normal range for water pressure in a home and most plumbers recommend 50-60 PSI. Recommend re-evaluation by a qualified or licensed plumber. Note: Pressure regulator was present.**

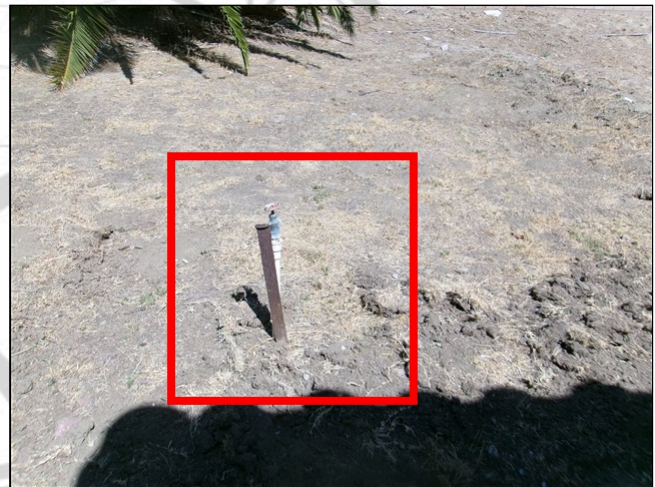
4.2 Item 7(Picture) General View

**4.2 (3) Water supply has been discontinued, not in working order at exterior walkways. Recommend discussing reevaluation and repair back to it's original design. Work can be done by a qualified or licensed plumber.**

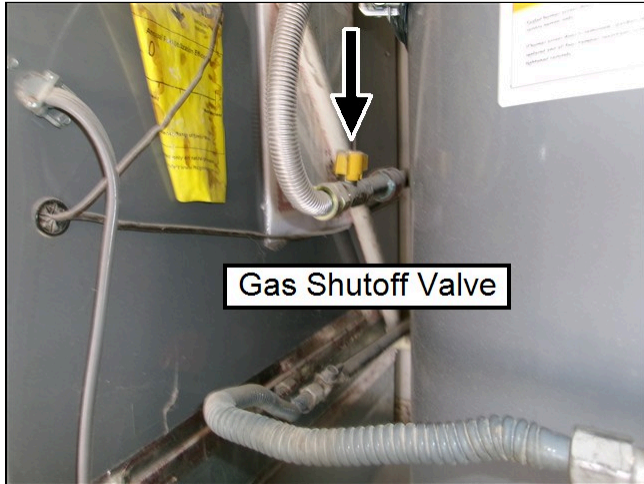
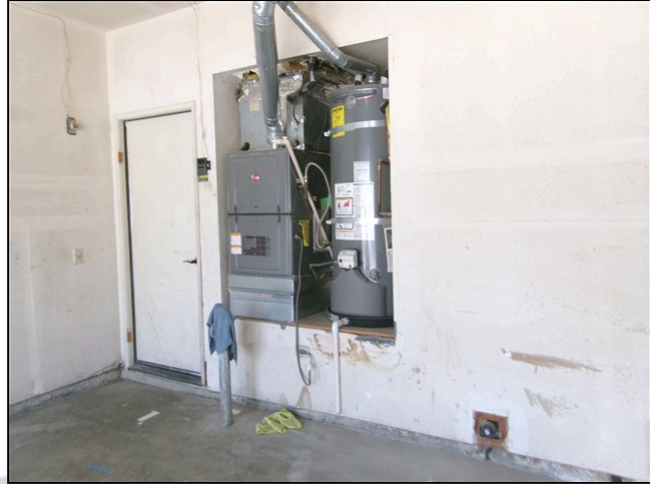
**4.3 Water heater tank was in working order at time of inspection. Client should be aware emergency Gas shutoff Valve was present.**

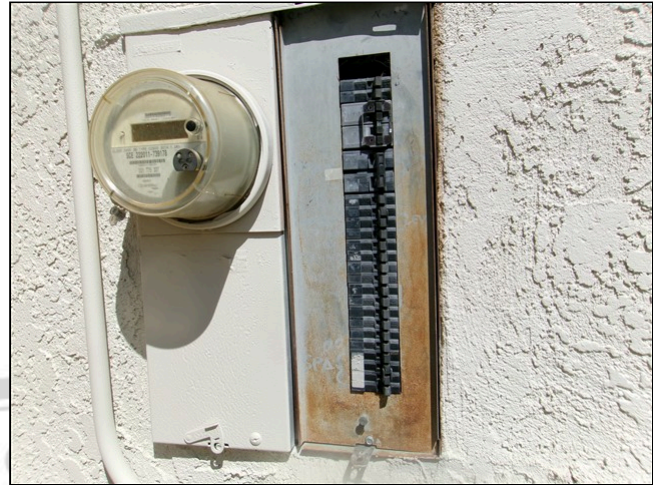
5.0 Item 2(Picture) General View

**5.0 Main distribution panel was in working order at time of inspection. Recommend installing adequate legends at dead front cover for improved ease of station location. Work should be done by a qualified or licensed electrician.**

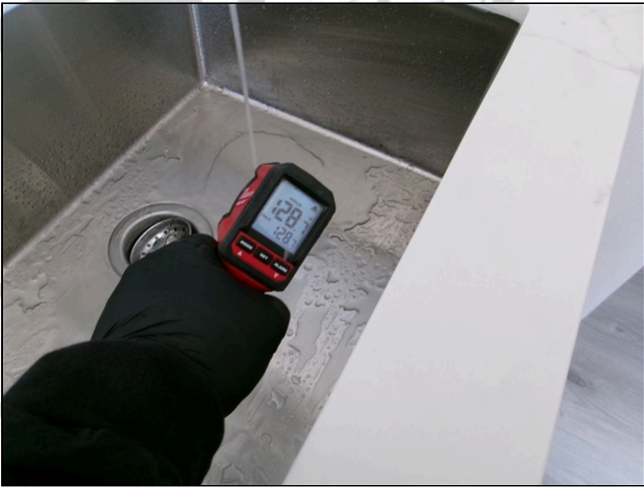
7.0 Item 1(Picture) General View

**7.0 Sink/ Fixtures water supply were in working order at time of inspection. Note: Hot/ Cold water test was performed.**

***Note: Client should be aware standard water temperature should be no greater then 120 degrees fahrenheit. Adjustment on lowering degree can be done accordingly at water heater temperature dial.***

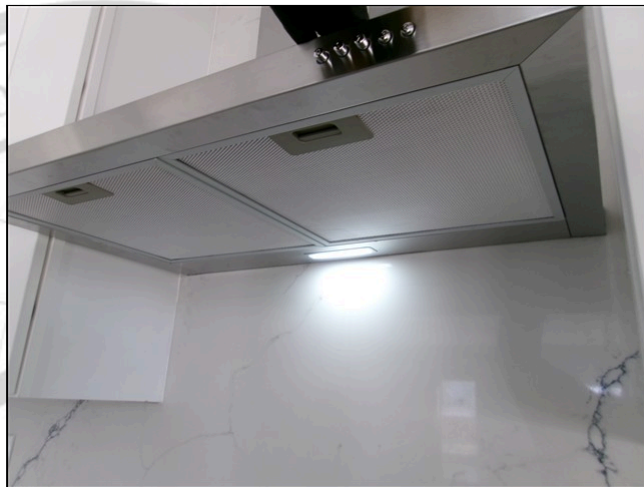
7.3 Item 1(Picture) General View

**7.3 Kitchen Vent was tested  
and in working order at time of  
inspection.**

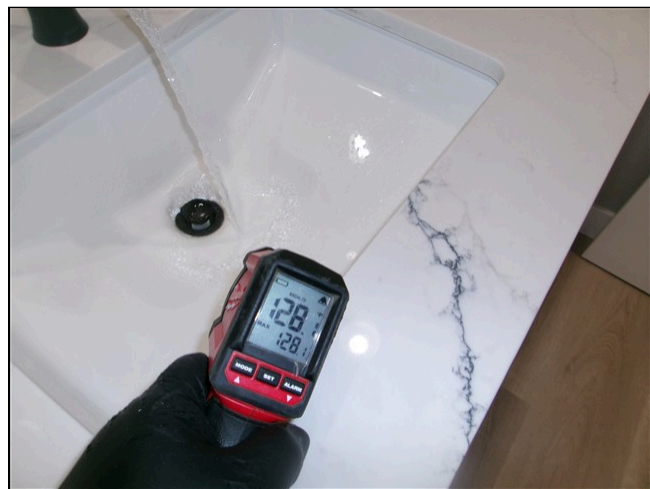
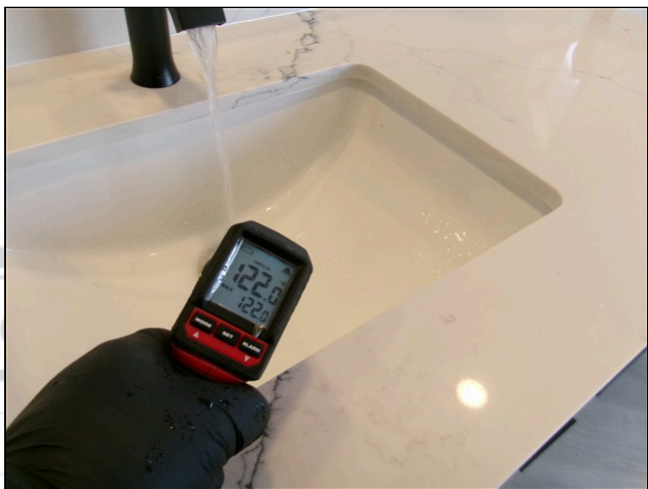
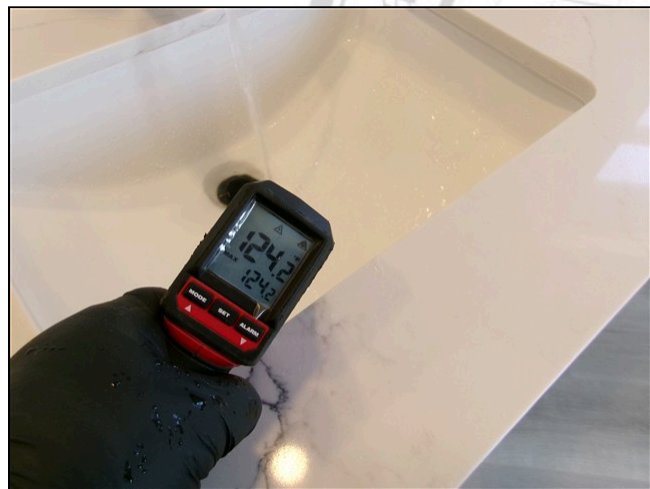
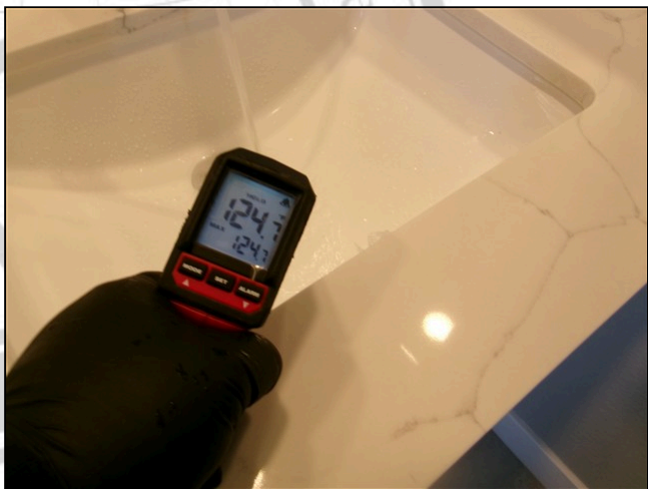
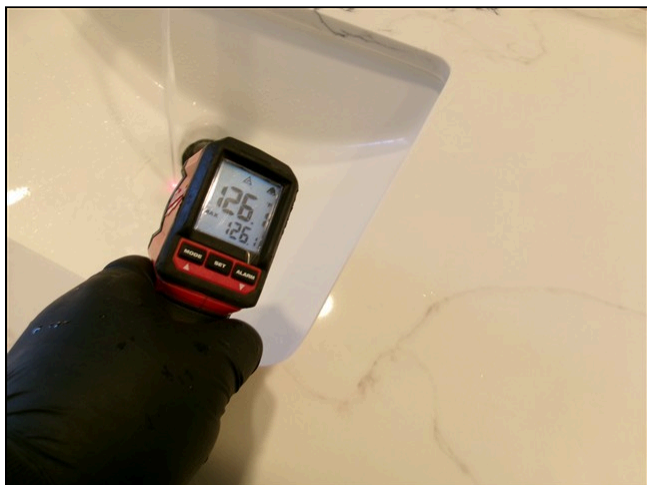
8.0 Sink/ Fixtures water supply were in working order at time of inspection. Note Hot/ Cold water test was performed.

*Client should be aware standard water temperature should be no greater then 120 degrees fahrenheit. Adjustment on lowering degree can be done accordingly at water heater temperature dial.*

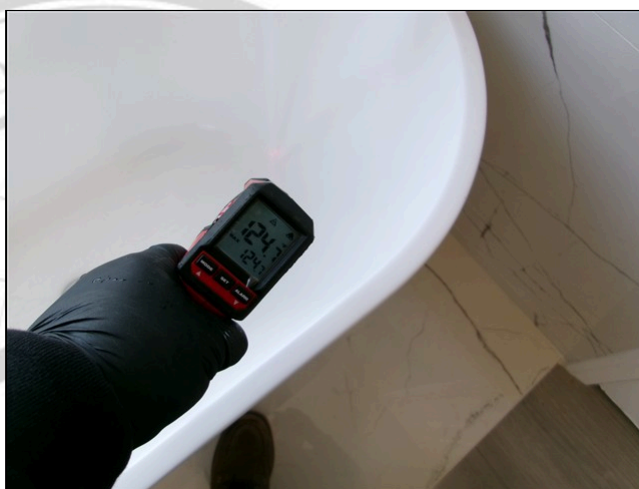
8.1 Item 1(Picture) General View

**8.1 Shower/ Tub fixtures water supply were in working order at time of inspection. Note: Hot/ Cold water test was performed.**

***Client should be aware standard water temperature should be no greater then 120 degrees fahrenheit. Adjustment on lowering degree can be done accordingly at water heater temperature dial.***

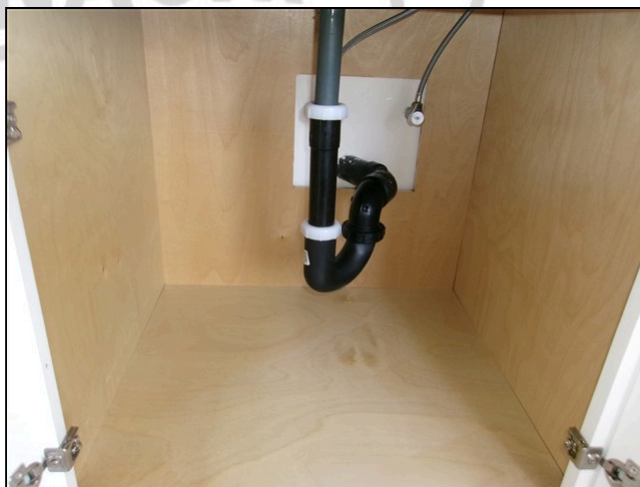
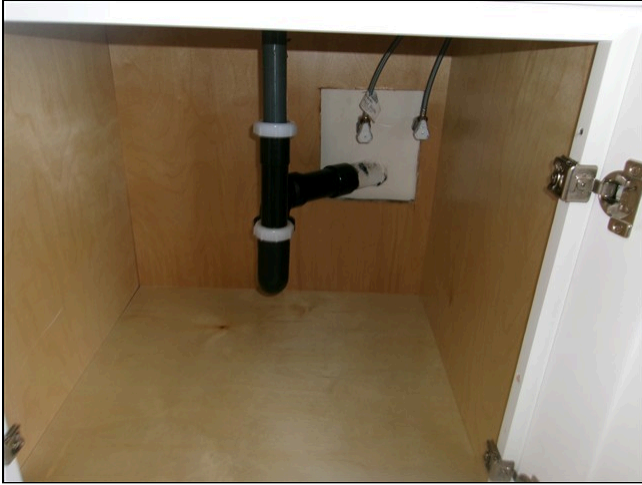
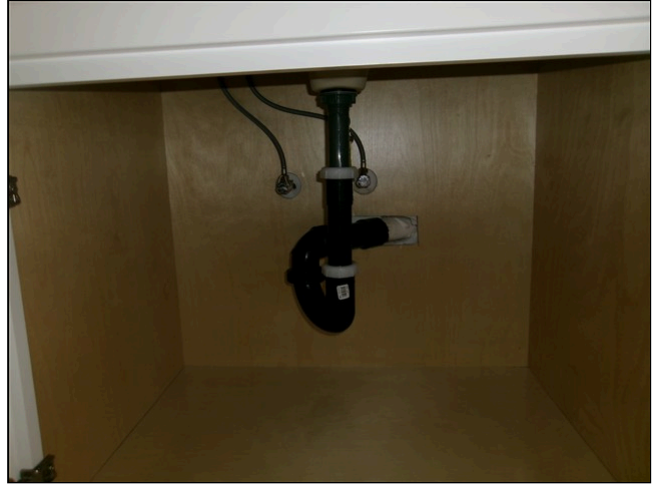
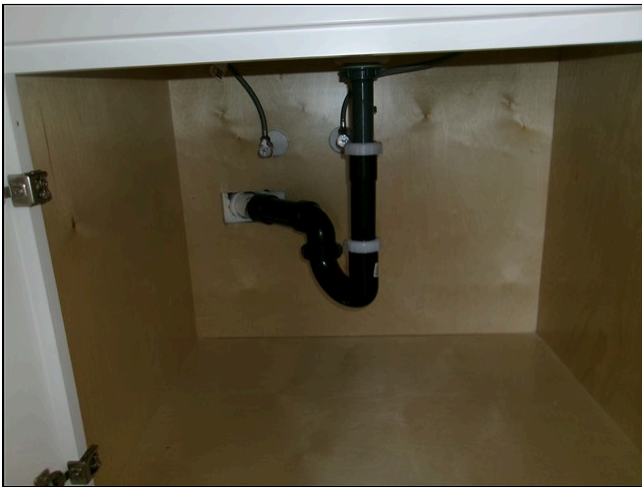
**8.2 Under sink plumbing observed satisfactory and no leaks/ clogging at time of inspection. Angle stops were movable and in working order.**

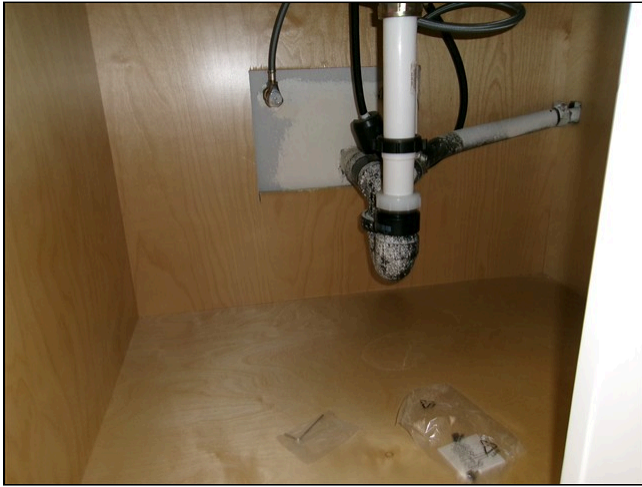
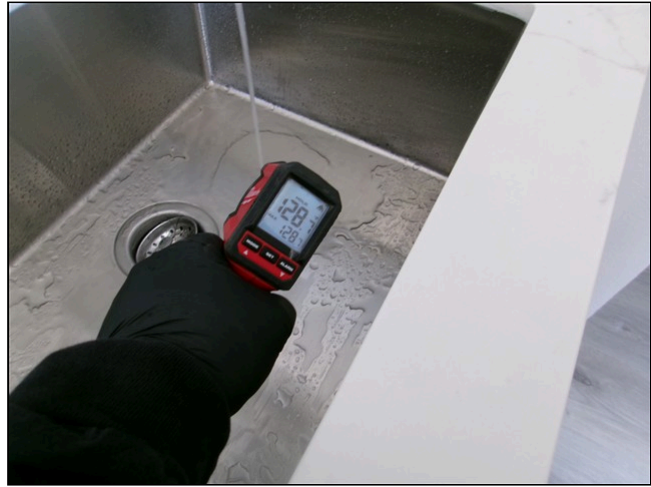
**8.9 Laundry sink cold/ hot water was in good working order at time of inspection. Plumbing**

observed no leaks/ clogging during water testing.

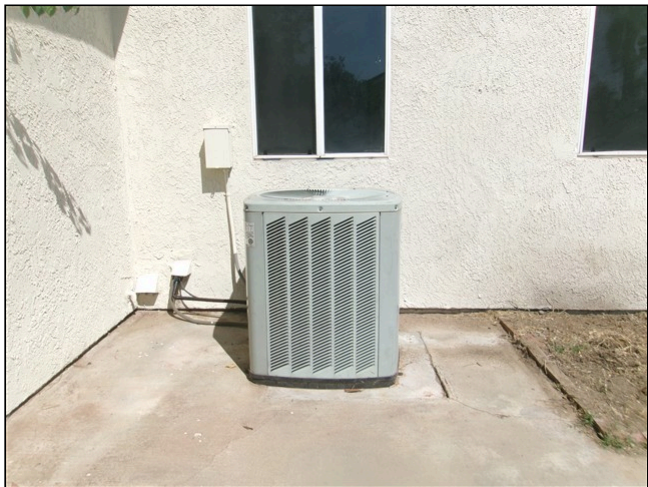
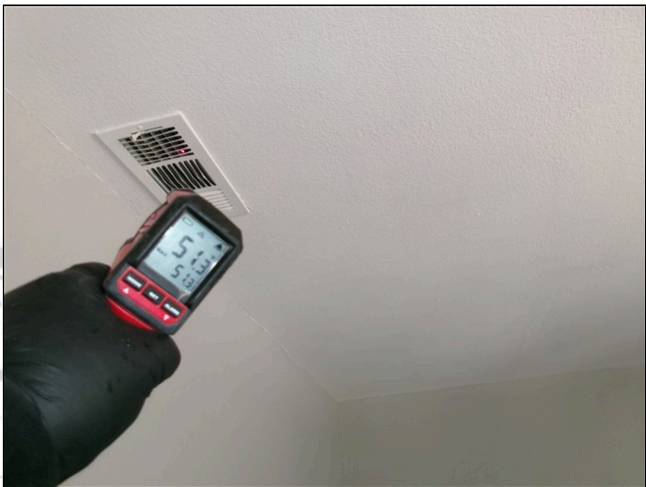
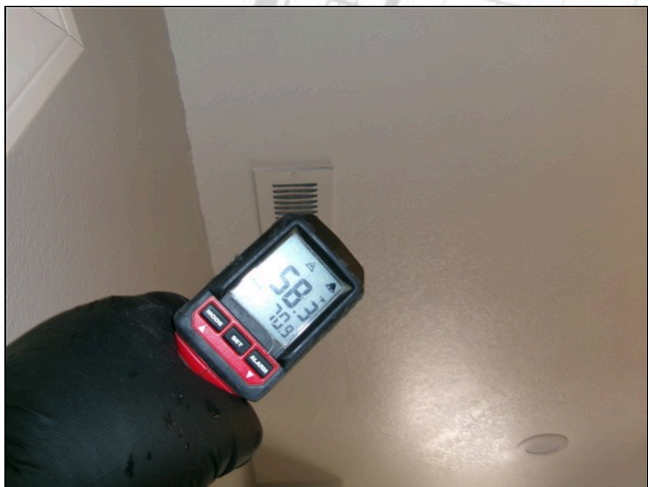
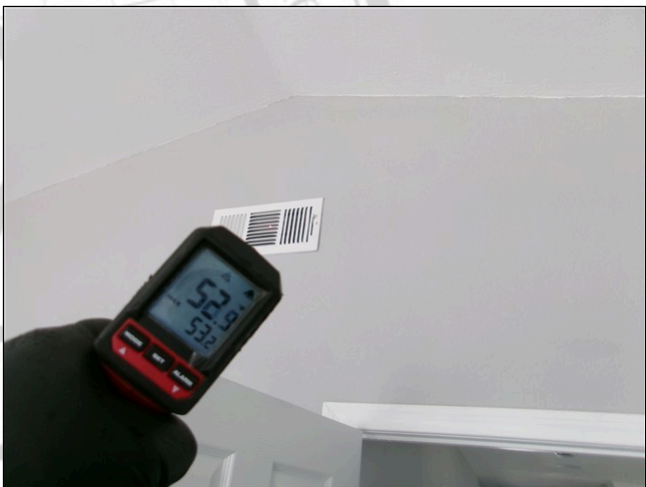
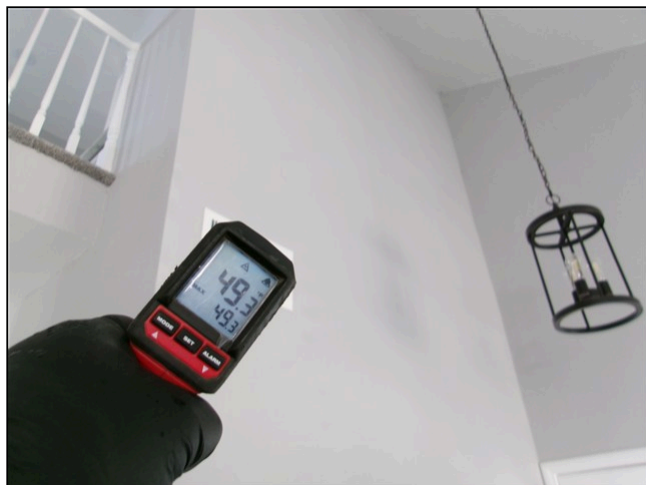
(1) The A/C unit was operable at time of inspection. Adequate cold air flow was tested and recorded from all registers within home. (Thermal reading shown). Note: Client should be aware Unit was an older Model. Discussing with an HVAC technician if Unit is still serviceable to recharge is suggested.

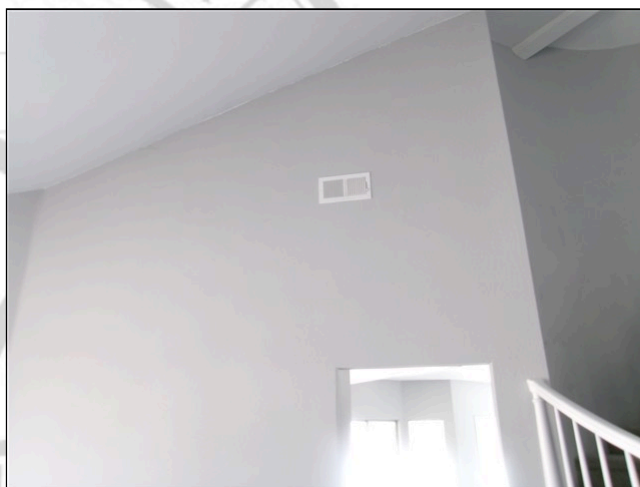
3.5 Item 2(Picture) General View

Minor or no air degree flow was present when tested at wall vent, Vent can be clogged, disconnected. torn at ductwork system within your attic. Recommend further evaluation and repair by a qualified or licensed HVAC Technician.

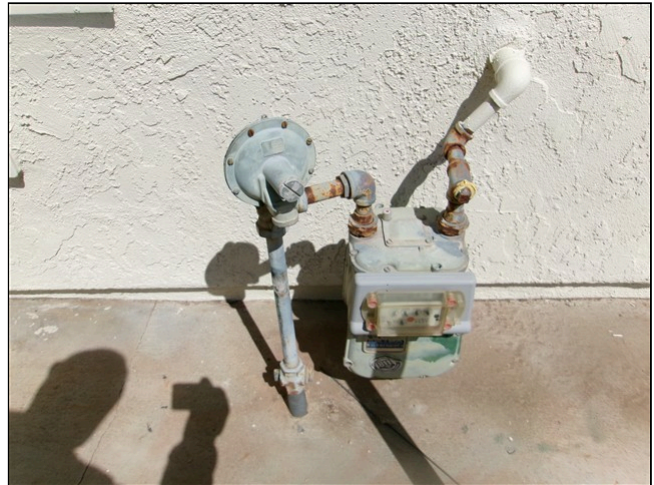
4.0 Item 2(Picture) General View

The Main fuel shut off is at gas meter outside located at the South walkway. Client should be aware surface rust was present on fuel Meter and lines, condition is typical but knowing Meter has not been serviced. Recommend your local Gas Company to perform a full safety check inspection prior to occupancy. Note: Maintenance with a rust prohibiting paint on Meter should be followed with Gas Company slip of inspection.

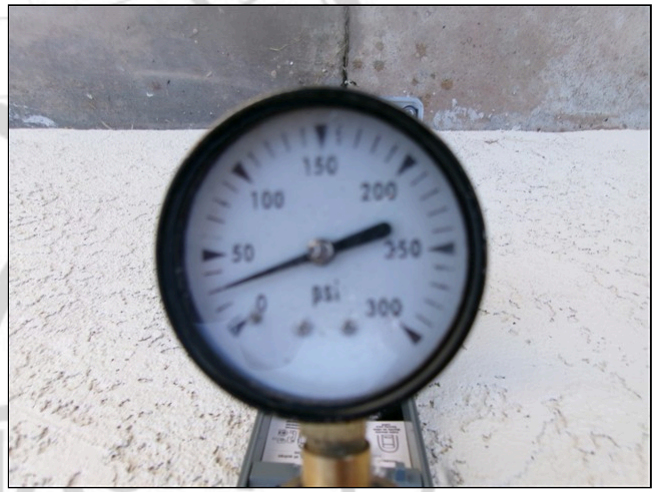
4.2 Item 4(Picture) General View

(2) **The client should be aware that the water supply pressure was less than 50 pounds per square inch (PSI) at time of inspection. 40-80 PSI is considered the normal range for water pressure in a home and most plumbers recommend 50-60 PSI. Recommend re-evaluation by a qualified or licensed plumber. Note: Pressure regulator was present.**

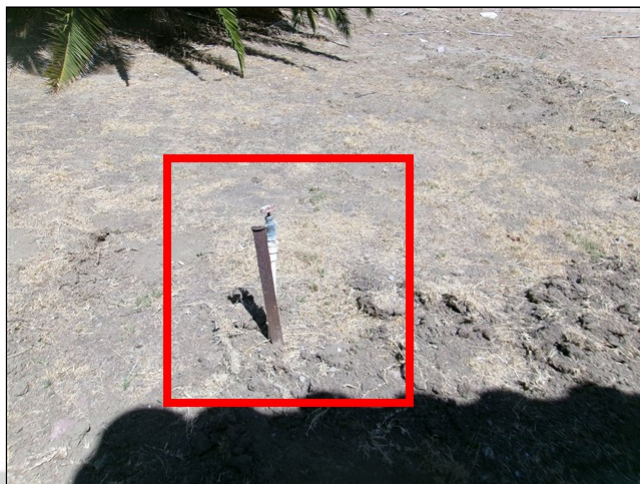
4.2 Item 7(Picture) General View

(3) **Water supply has been discontinued, not in working order at exterior walkways. Recommend discussing reevaluation and repair back to it's original design. Work can be done by a qualified or licensed plumber.**

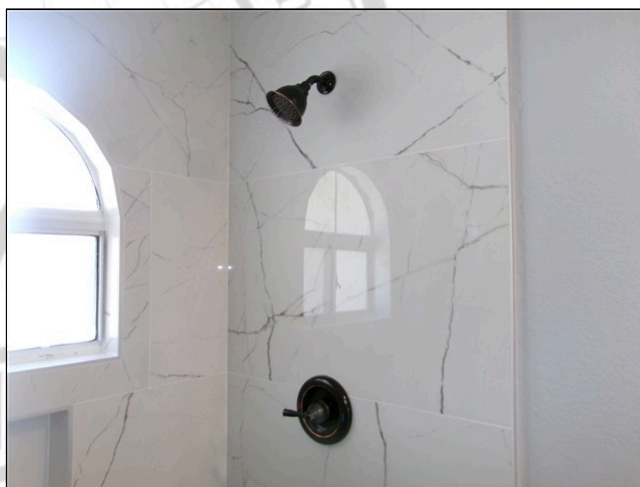
4.10 Item 2(Picture) General View

**Client should beware air in plumbing line was present at time of water testing. Temporary loss of water pressure can be caused by recent plumbing repairs, pressure regulator, water leaks. Recommend further evaluation and repair by a qualified or licensed plumber.**

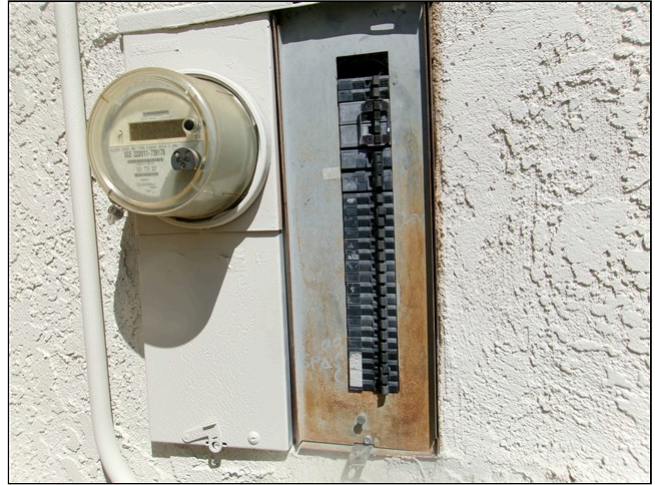
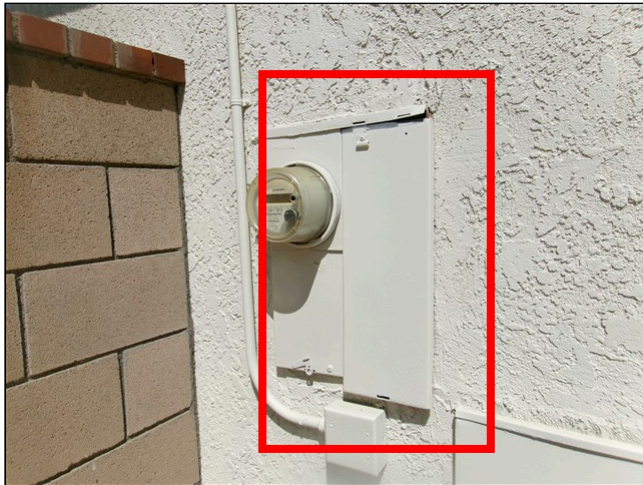
**Main distribution panel was in working order at time of inspection. Recommend installing adequate legends at dead front cover for improved ease of station location. Work should be done by a qualified or licensed electrician.**

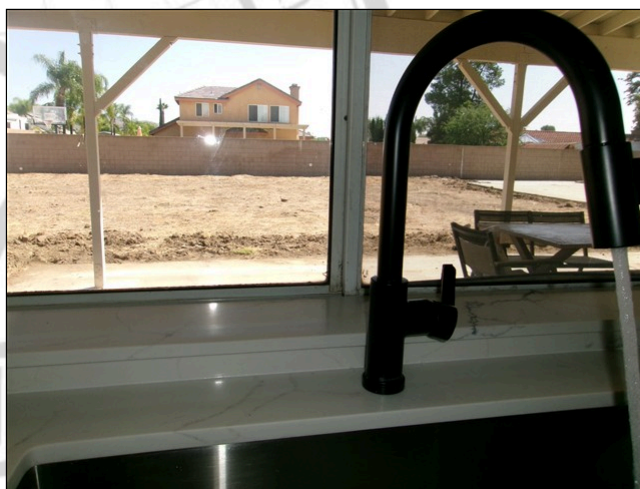
6.0 Item 2(Picture) General View

**Cracked window pane were observed at kitchen at time of inspection. This poses a safety hazard as crack may worsen, recommend a qualified or licensed contractor evaluate and replace window pane as necessary.**

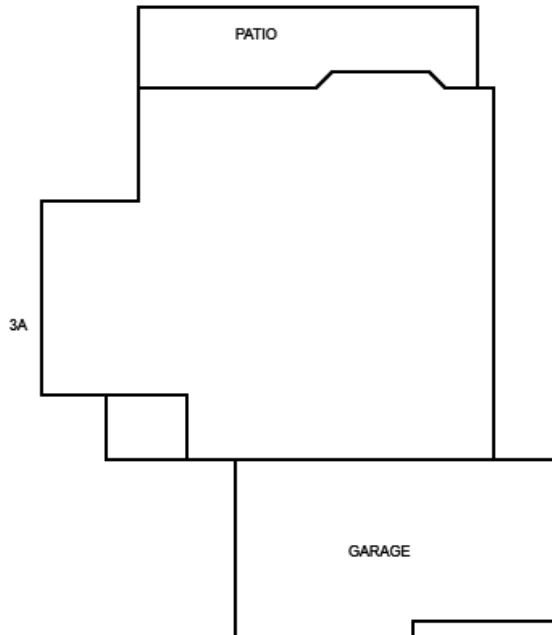
**Diagram Not To Scale**

FINDING - Dry rot damaged noted at exterior fascia and fascia trim.
