File Number: **0926-204-650**  
Address of Inspection: **3018 Jolley Drive**  
Date of Inspection: **9/10/26**

## **HOME VIEW INSPECTION SERVICE**

### **REAL ESTATE INSPECTION REPORT**

3018 JOLLEY DRIVE  
BURBANK, CA 91504

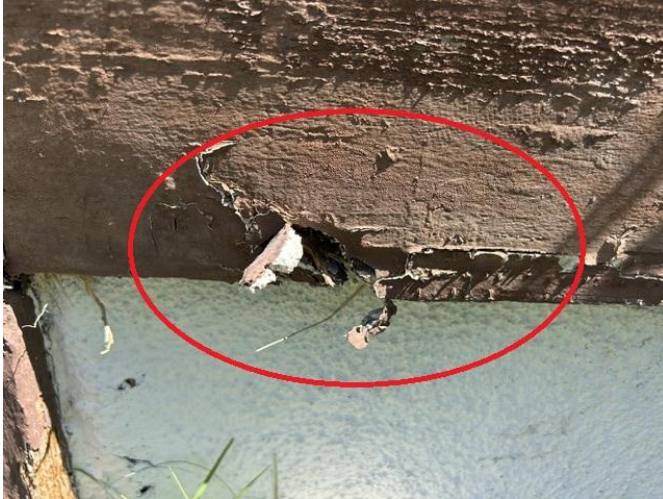
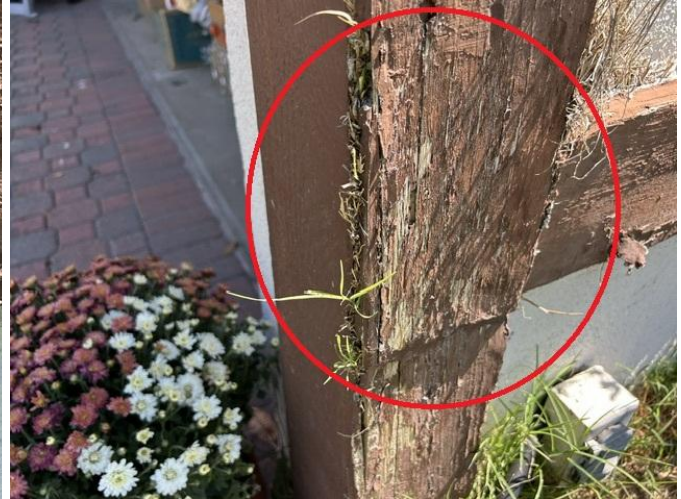
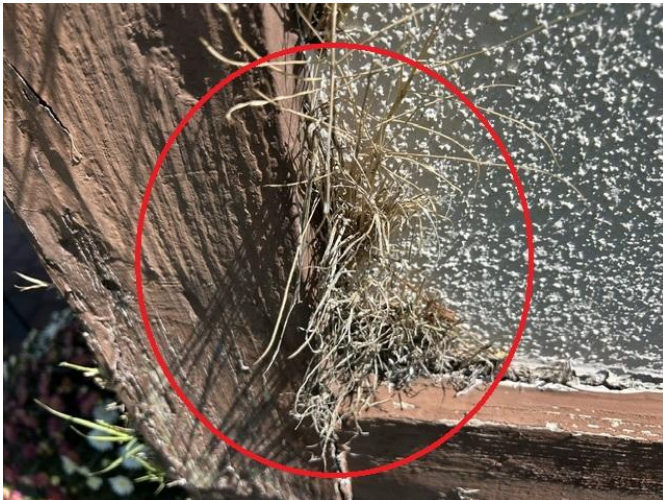
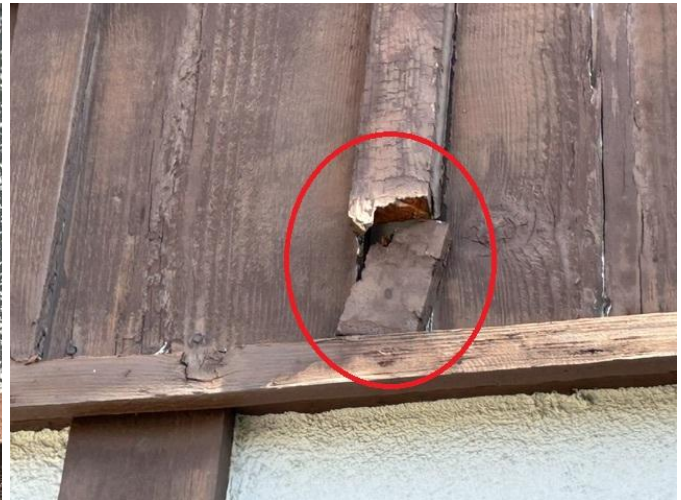
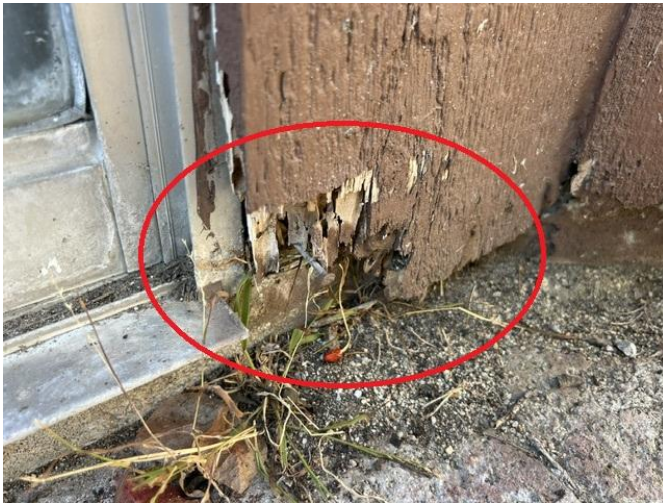
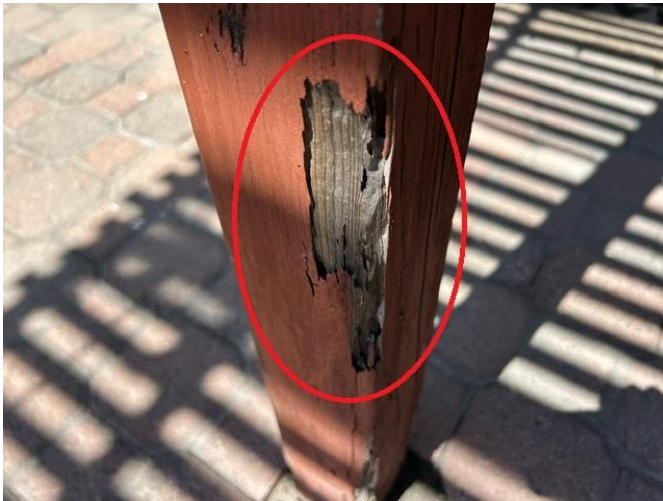
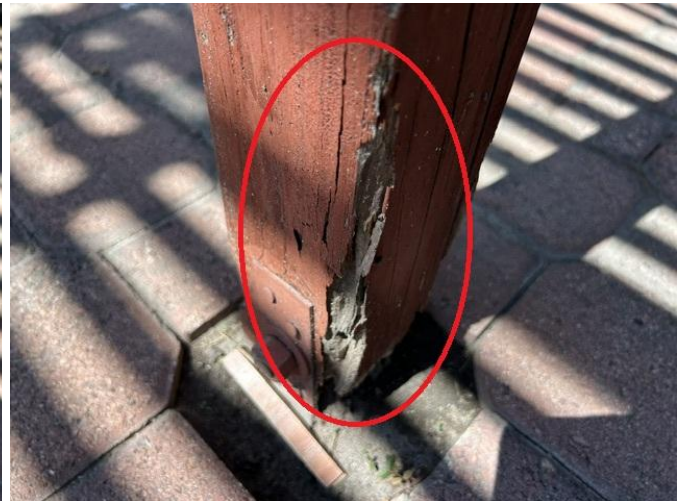
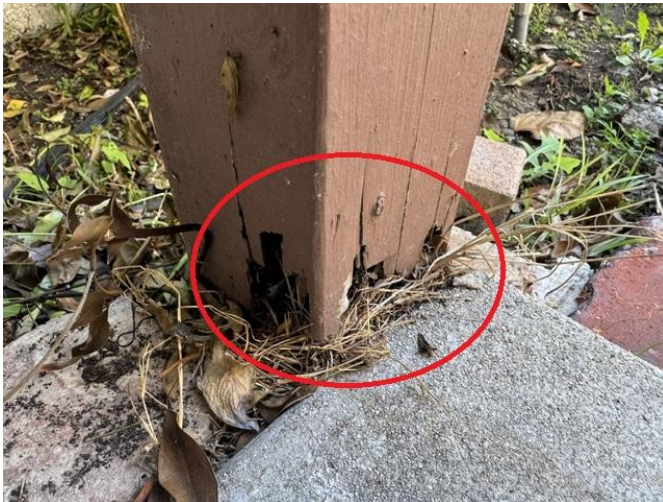
4. Rot and damages were visible on sections of the exterior wood surfaces. All wood surfaces should receive periodic water proofing and paint in order to avoid wood deterioration and rot. For further information regarding the condition of the wood materials, please refer to the termite inspection report.

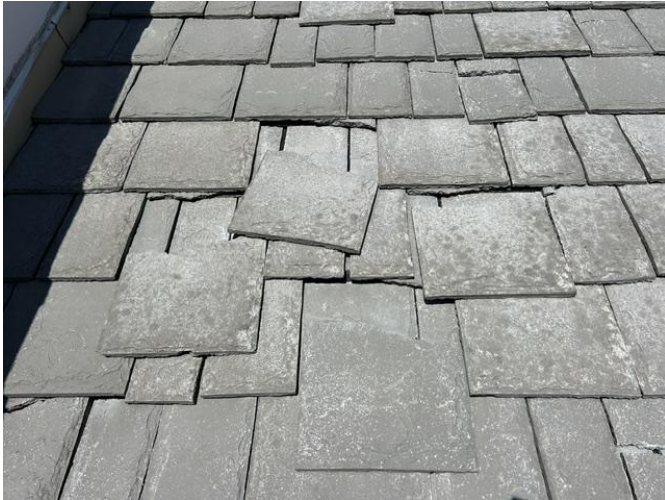
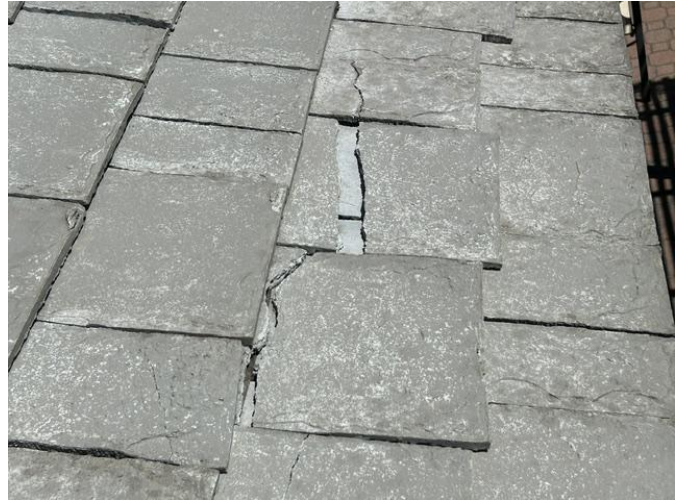
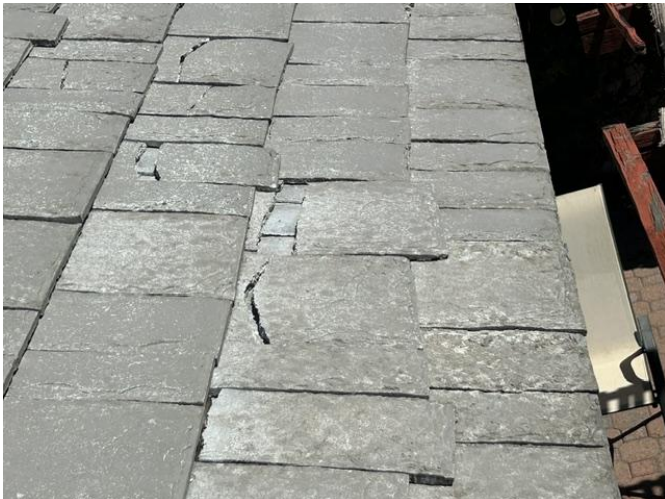
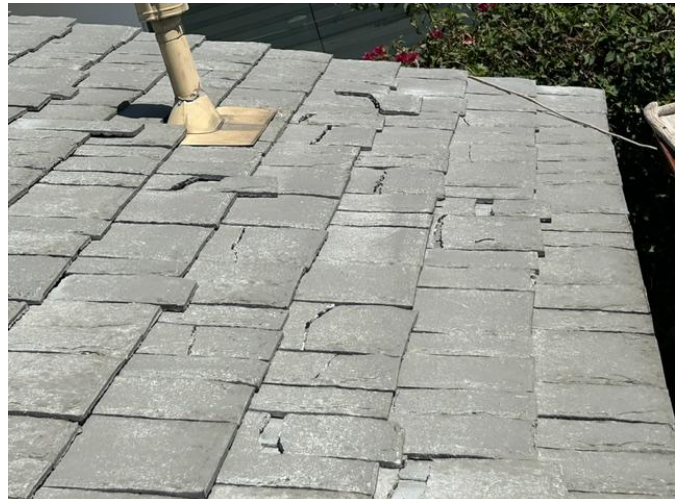
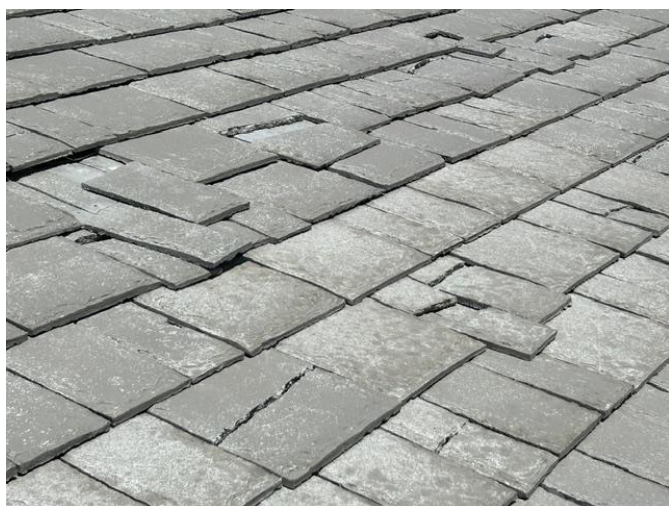
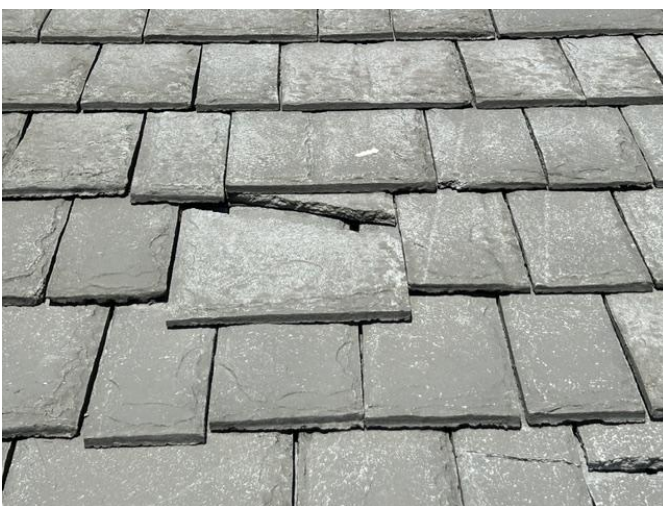
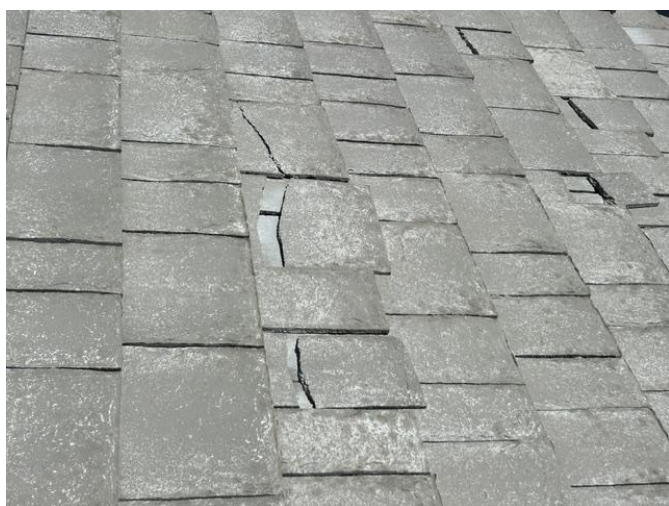
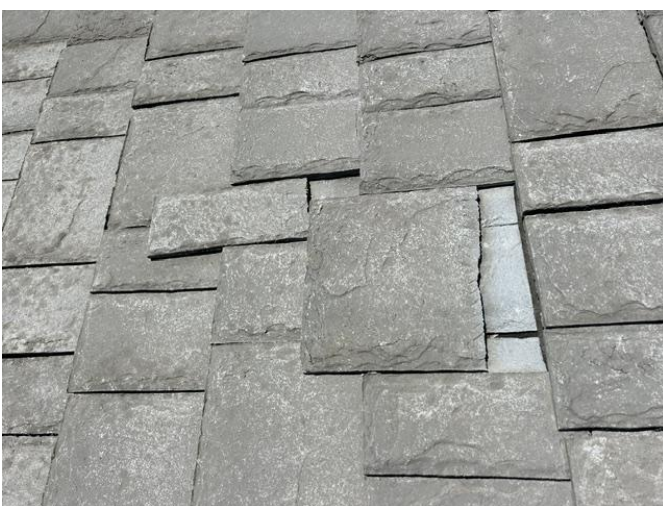
1. Cracked, damaged, and shifted tiles were observed throughout the roof. The roof covering material was at the end of its useful life.

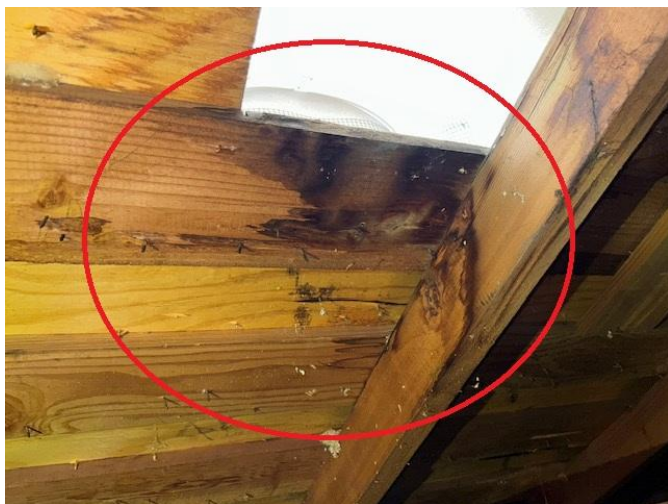
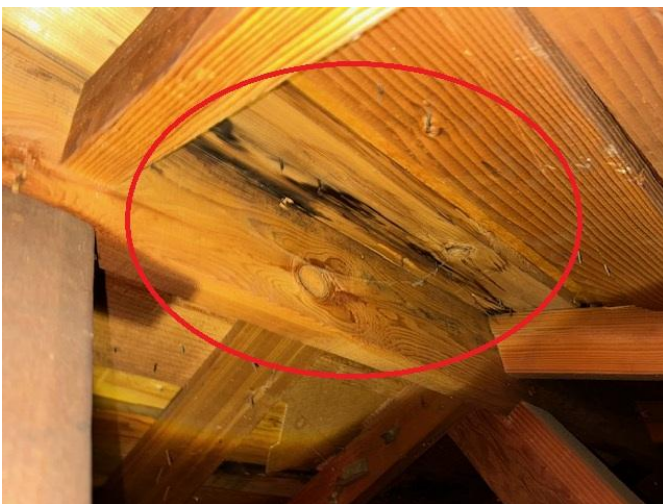
1. Home View recommends that the interior of the attic be inspected periodically during heavy rains to ensure that the roof is free of leaks.
2. Water staining was visible on portions of the roof structure as viewed from the attic space. This indicates rainwater penetration.

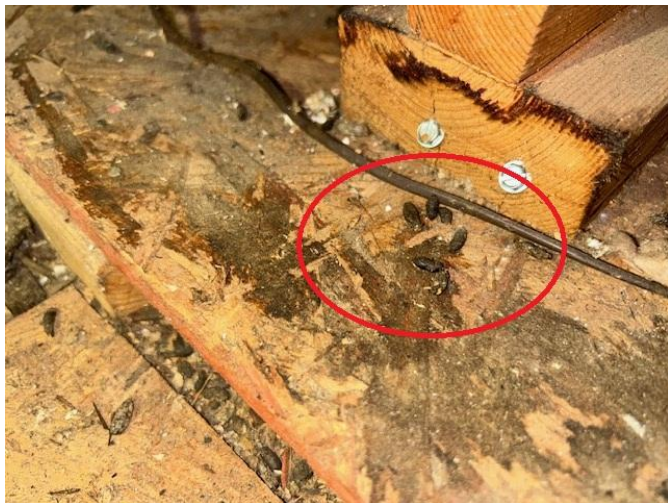
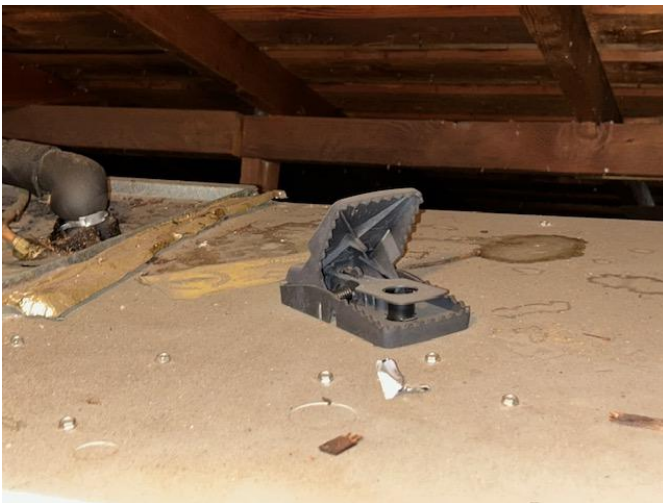
3. Rodent droppings and traps were visible in the attic space.

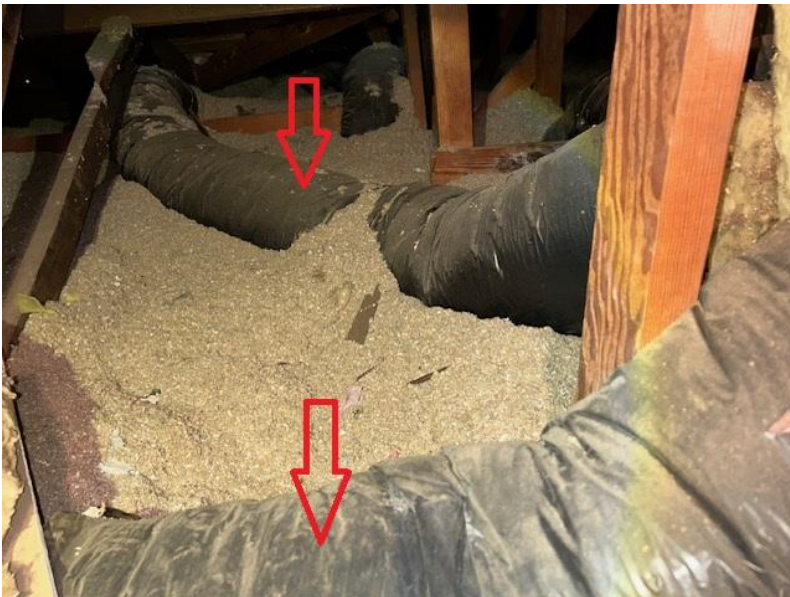
4. Air ducts in the attic were placed on the floor. Attic located air ducts must be suspended.

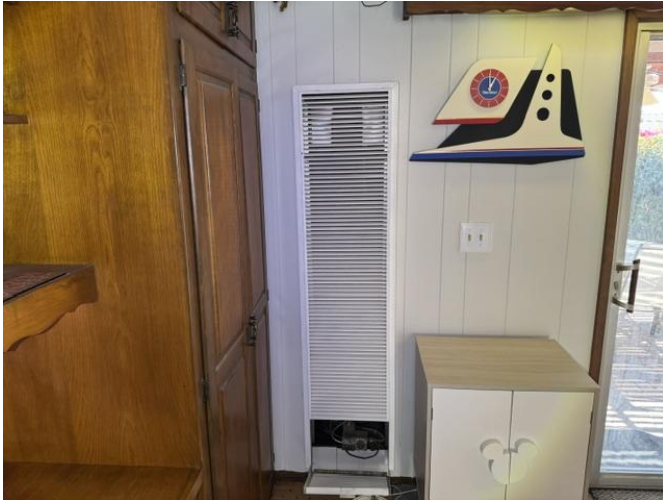
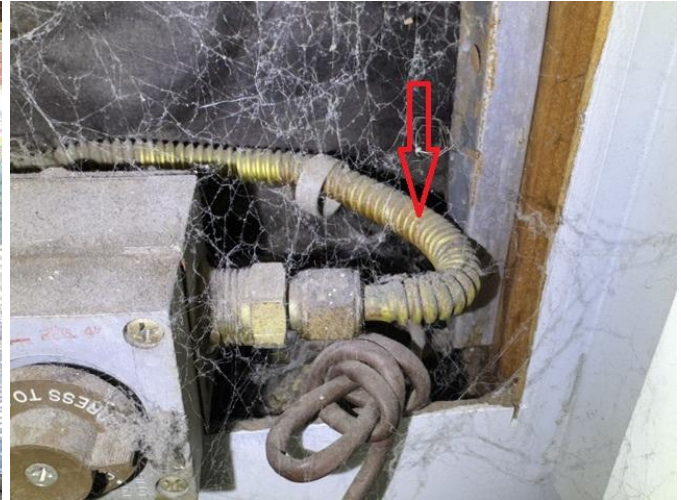
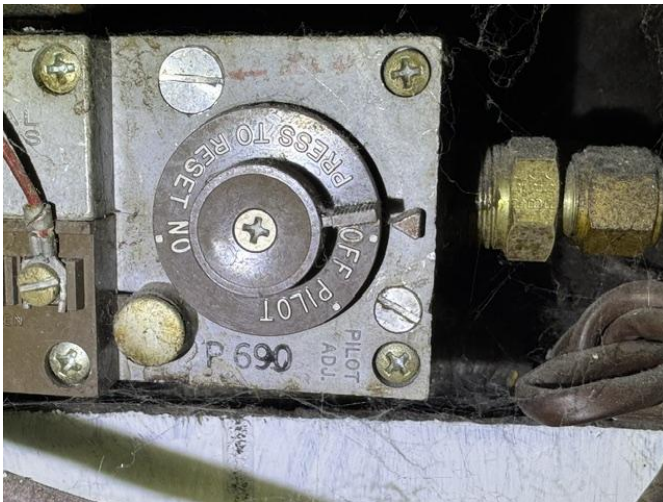
7. Wall furnace in the family room was not in operational state, as the pilot light was in the off position. In addition, flexible portion of the gas pipe consisted of obsolete brass type material. As this material ages, it would be prone to cracks and gas leaks.

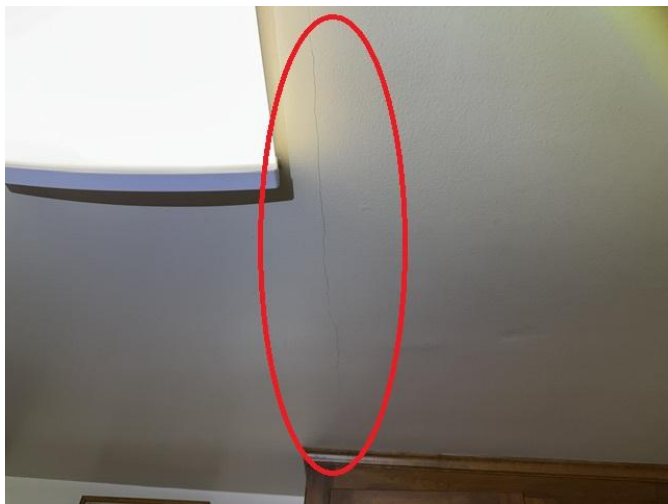
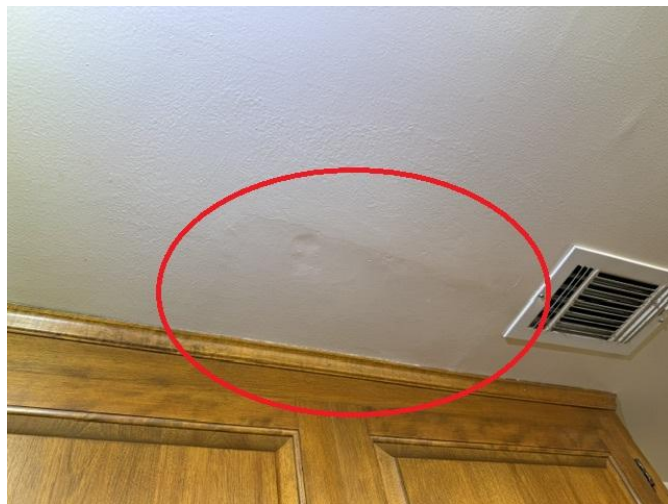
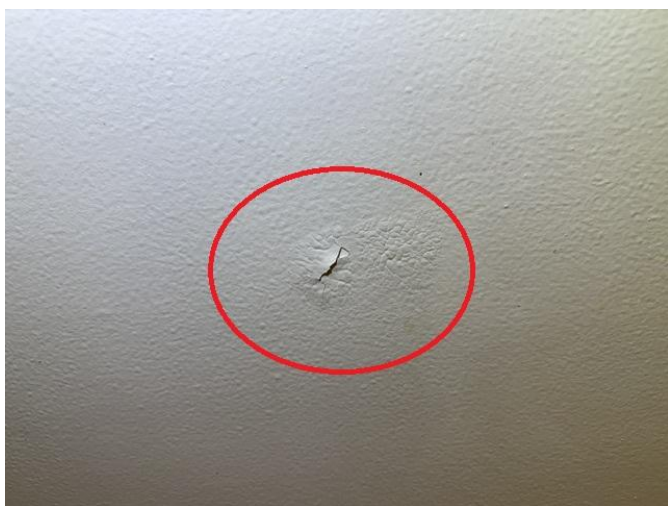
1. Due to the quantity and location of the occupant's belongings, the floors, walls and wall fixtures in the interior, closets, or cabinets could not be thoroughly viewed or inspected.
2. Crack, patchwork and paint peel/bubbling were visible on the ceiling of the kitchen.

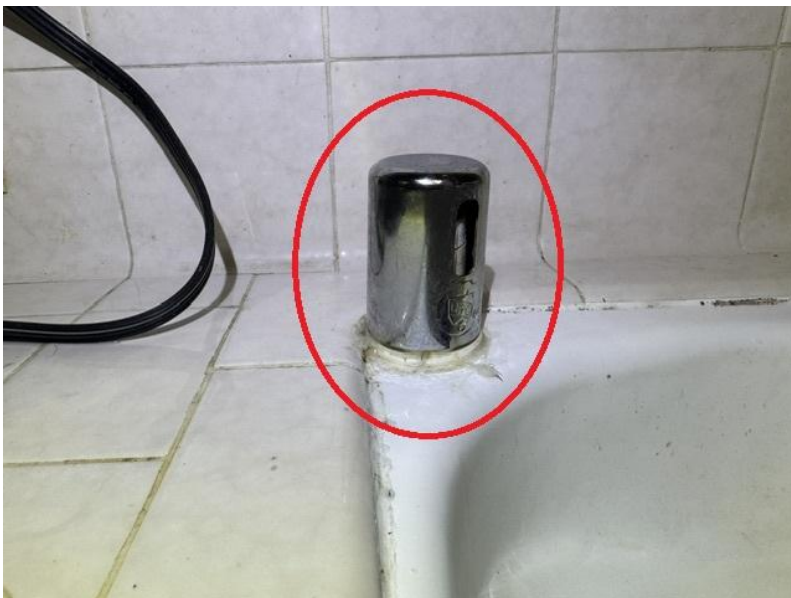
3. The dishwasher drained from the air gap, indicating a clog in the primary drain (garbage disposal).

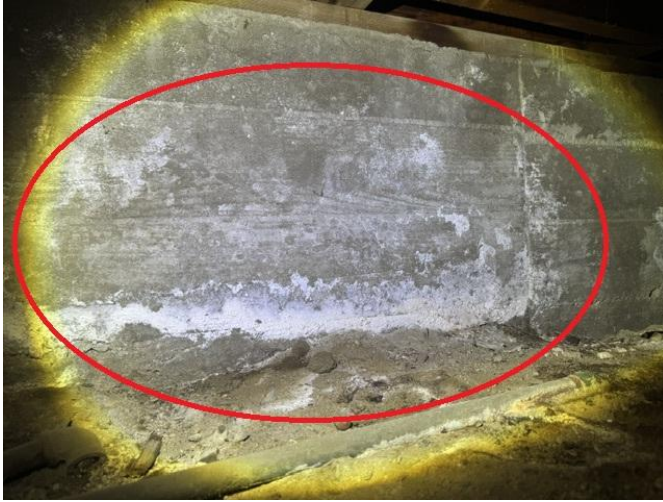
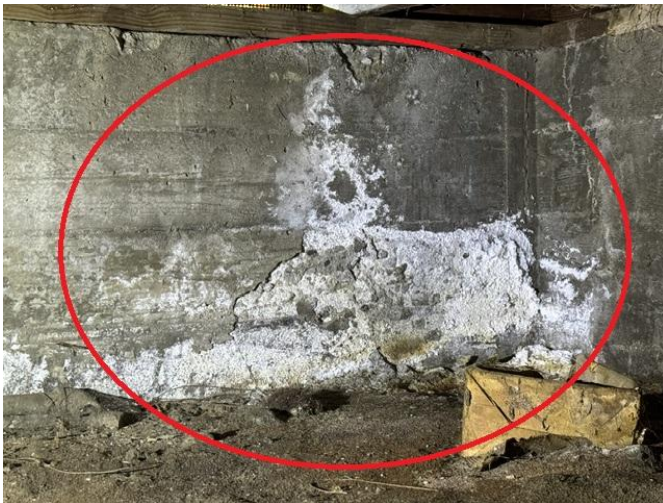
4. Efflorescence buildup and spalling was visible on portions of the foundation walls, indicating water penetration.

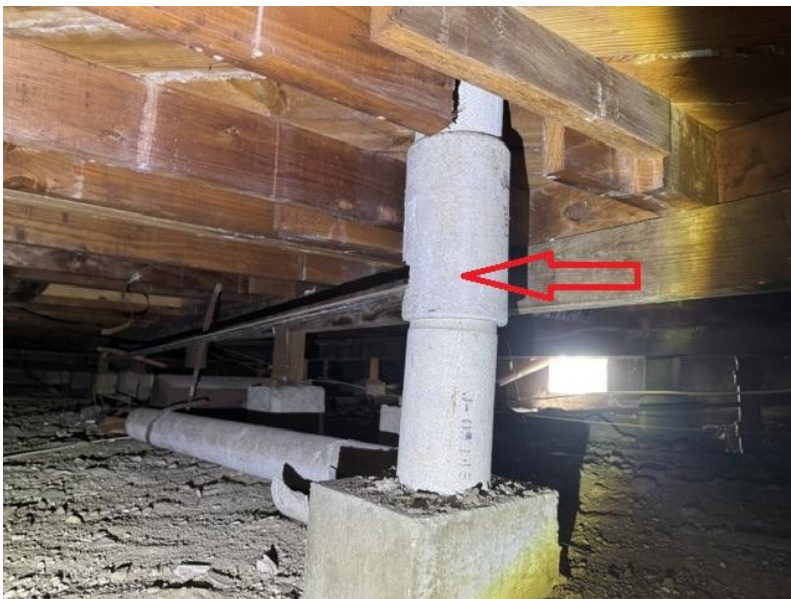
6. Abandoned exhaust pipe in the crawl space consisted of possible asbestos type material.

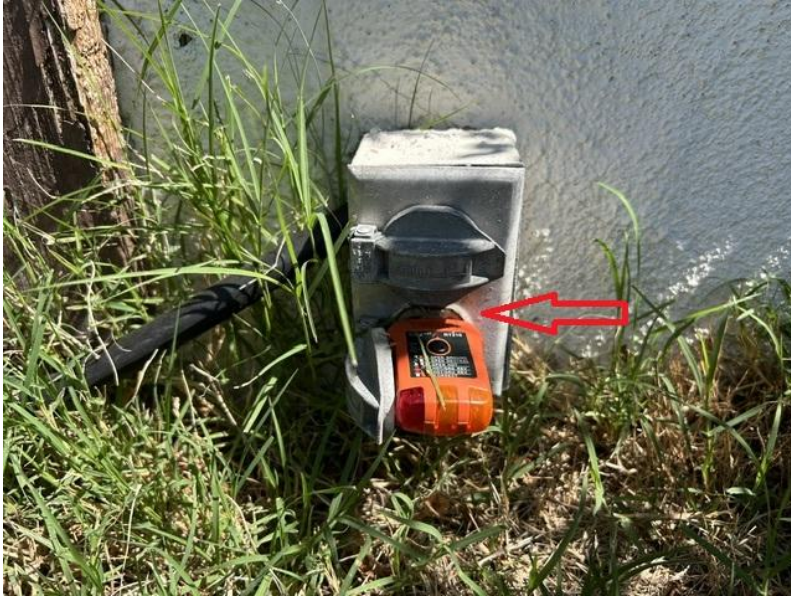
1. Receptacle on the front exterior wall of the garage was not GFCI type and was without power.

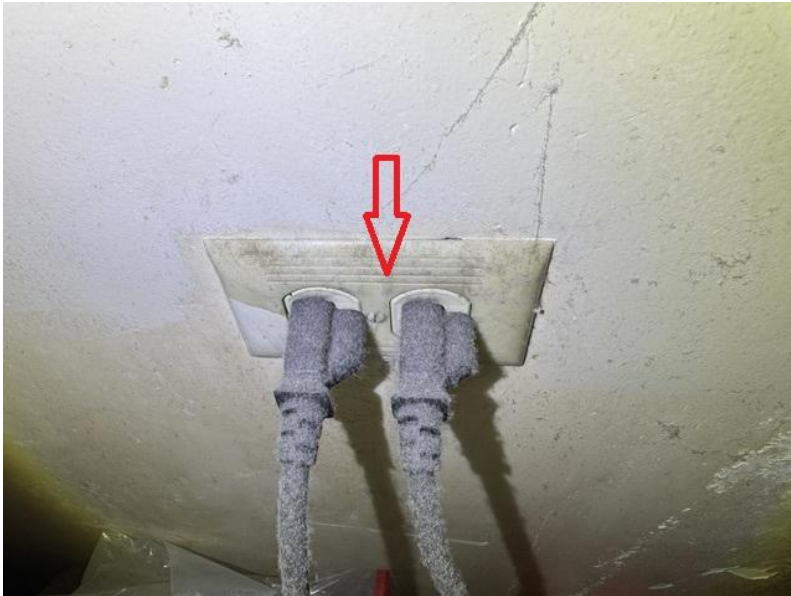
7. Kitchen wall receptacles were not GFCI type.
8. Receptacle powering the washing machine was not GFCI type.

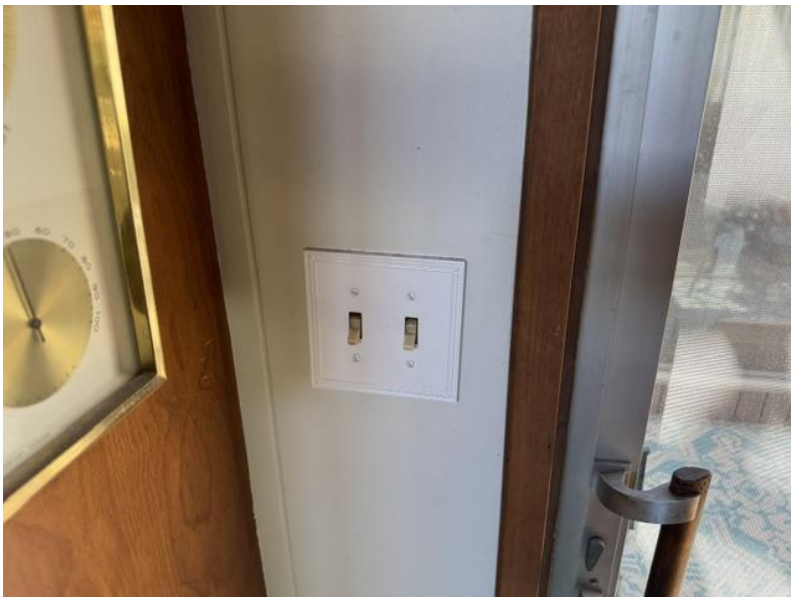
9. Purpose of two switches on the family room wall adjacent to the deck sliding glass door was not known.

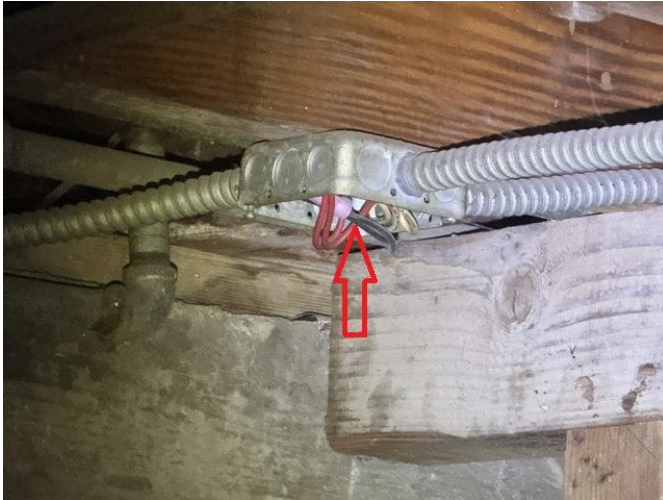
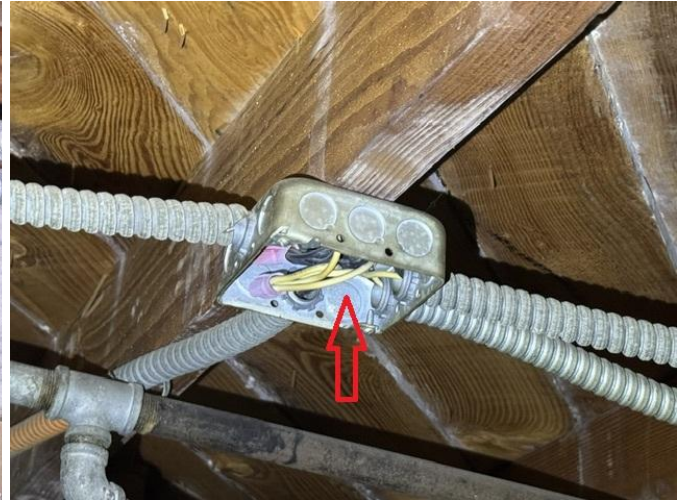
17. Junction boxes in the crawl space were missing cover plates, exposing the wires.

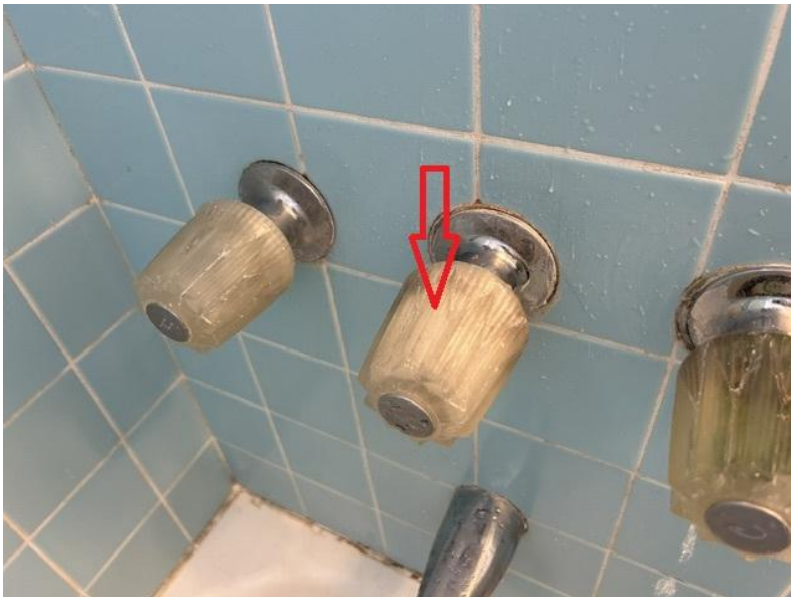
7. Diverter of the full bathroom tub was not functioning properly. Water was simultaneously running from the spout and shower.

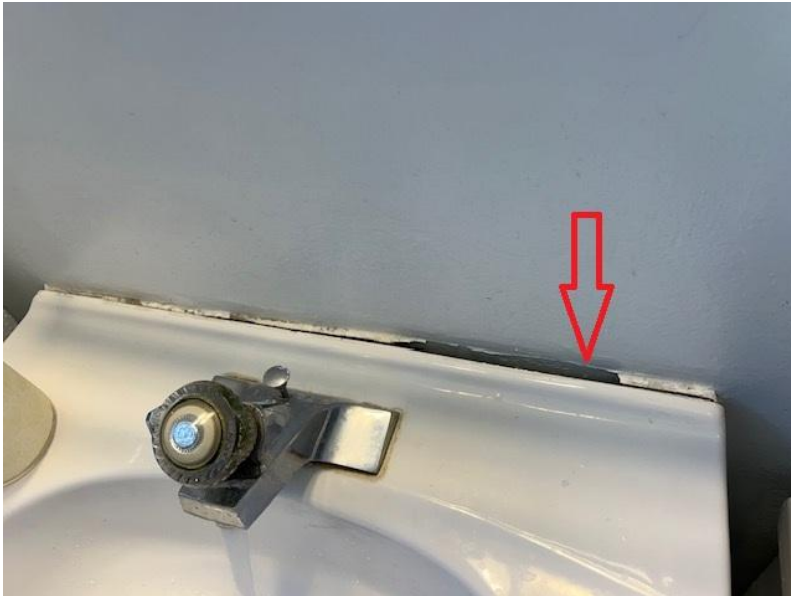
8. Full bathroom sink was detached from the wall. In addition, it did not contain a backsplash.

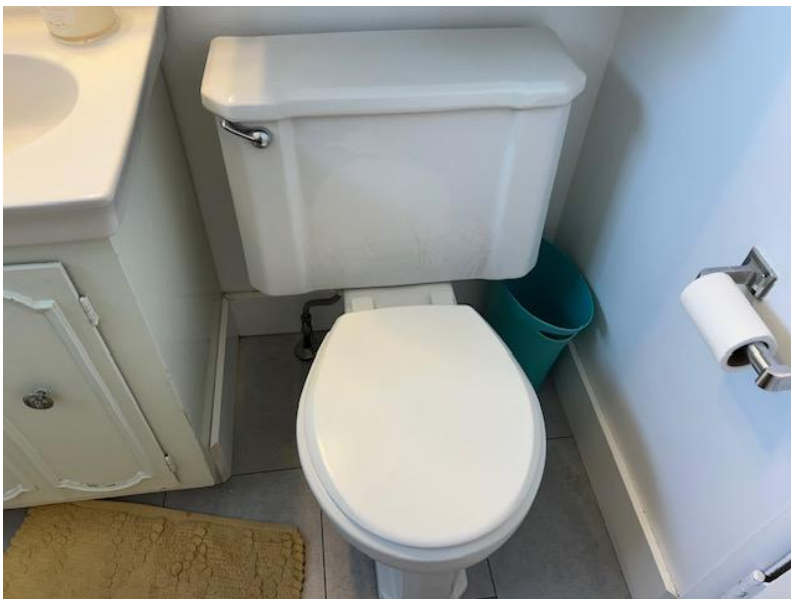
9. Toilets in both bathrooms were not low flushing type.

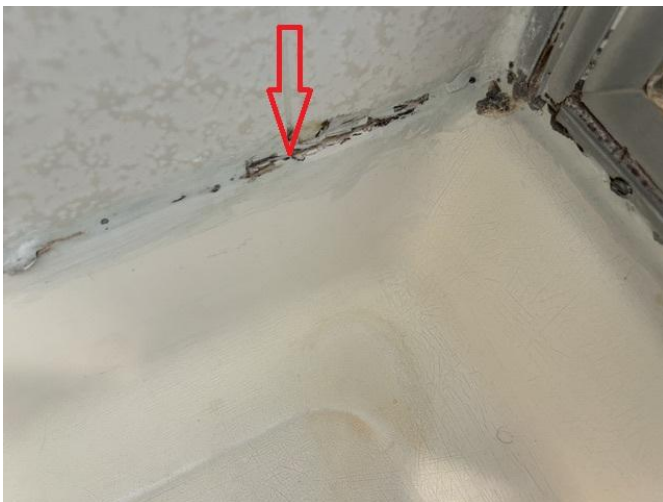
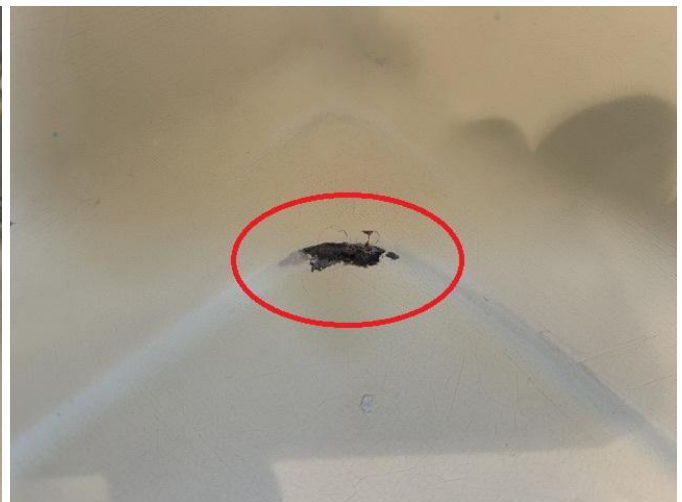
11. Perimeter of the three-quarter bathroom shower floor pan was heavily sealed, and chips were observed on the surface.

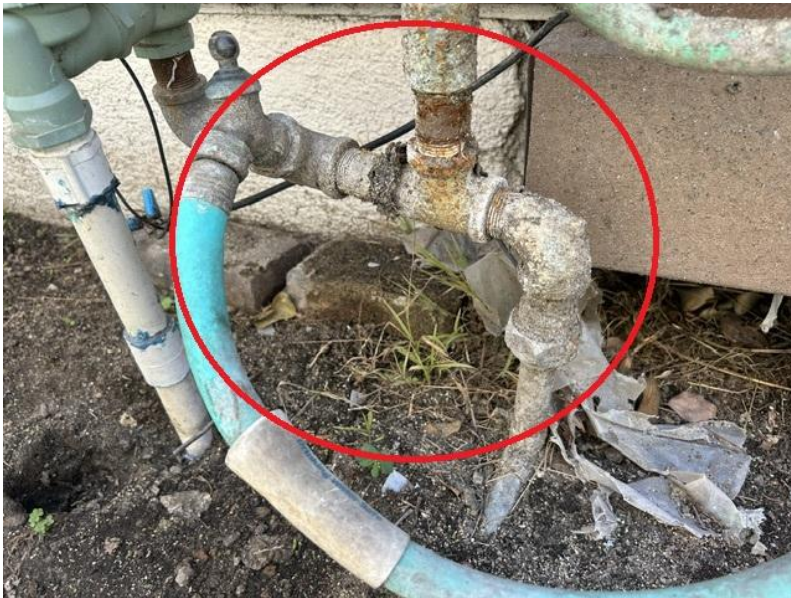
13. Sections of the water supply pipes, as viewed from the exterior, consisted of aged galvanized type.

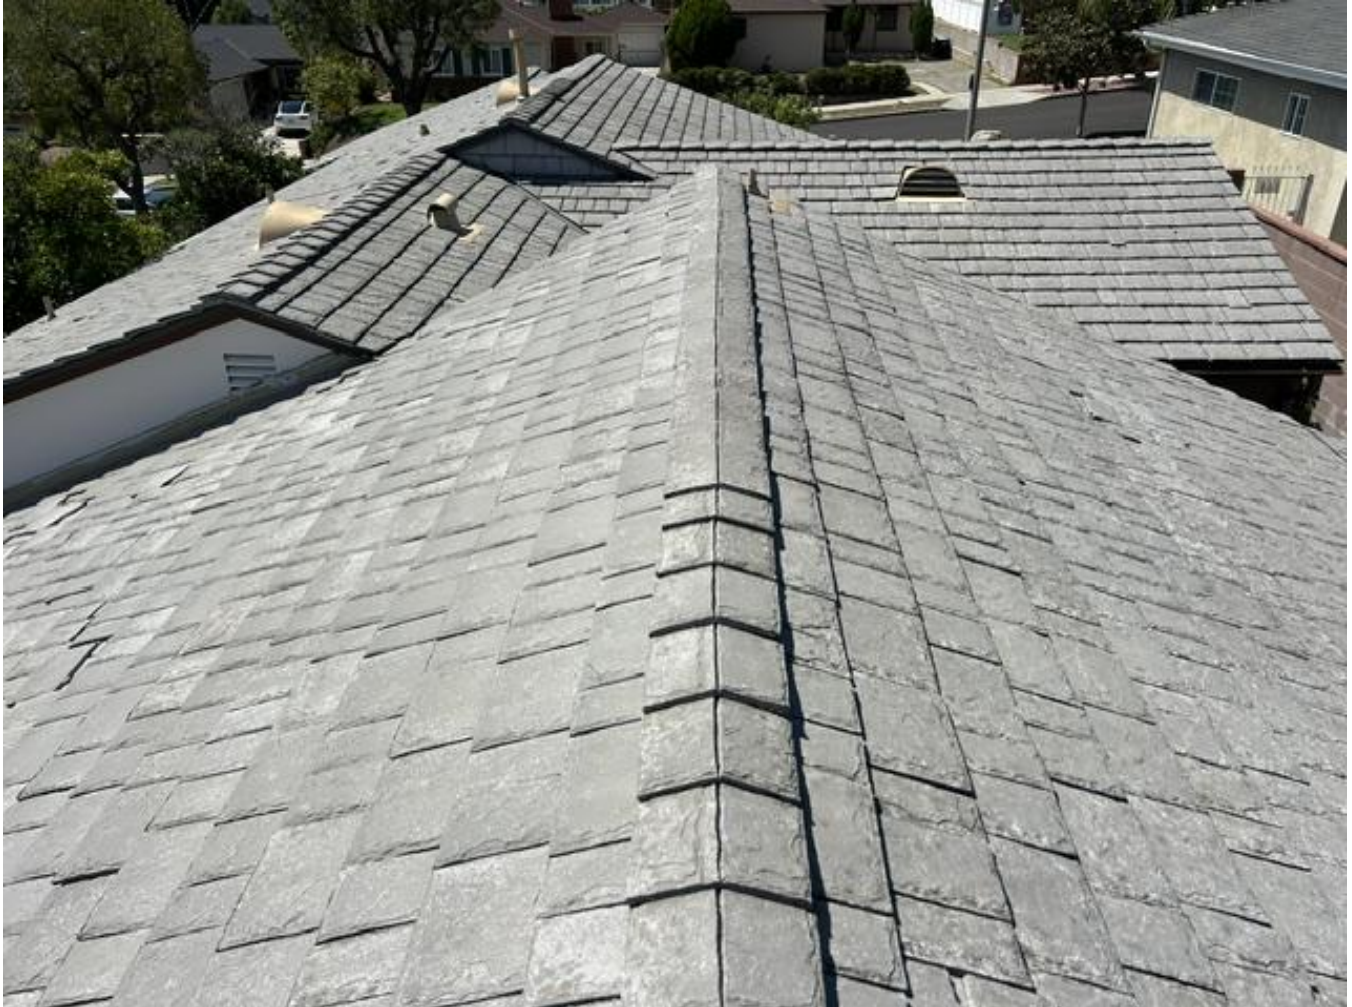
The roof was a gable and valley design covered with composite tiles. Observation of the roof surfaces and flashing was performed from the roof. The age of the roof covering was not known. Several damaged, cracked, and shifted tiles were found on the roof. These conditions indicate the roof tiles were at the end of their useful life.

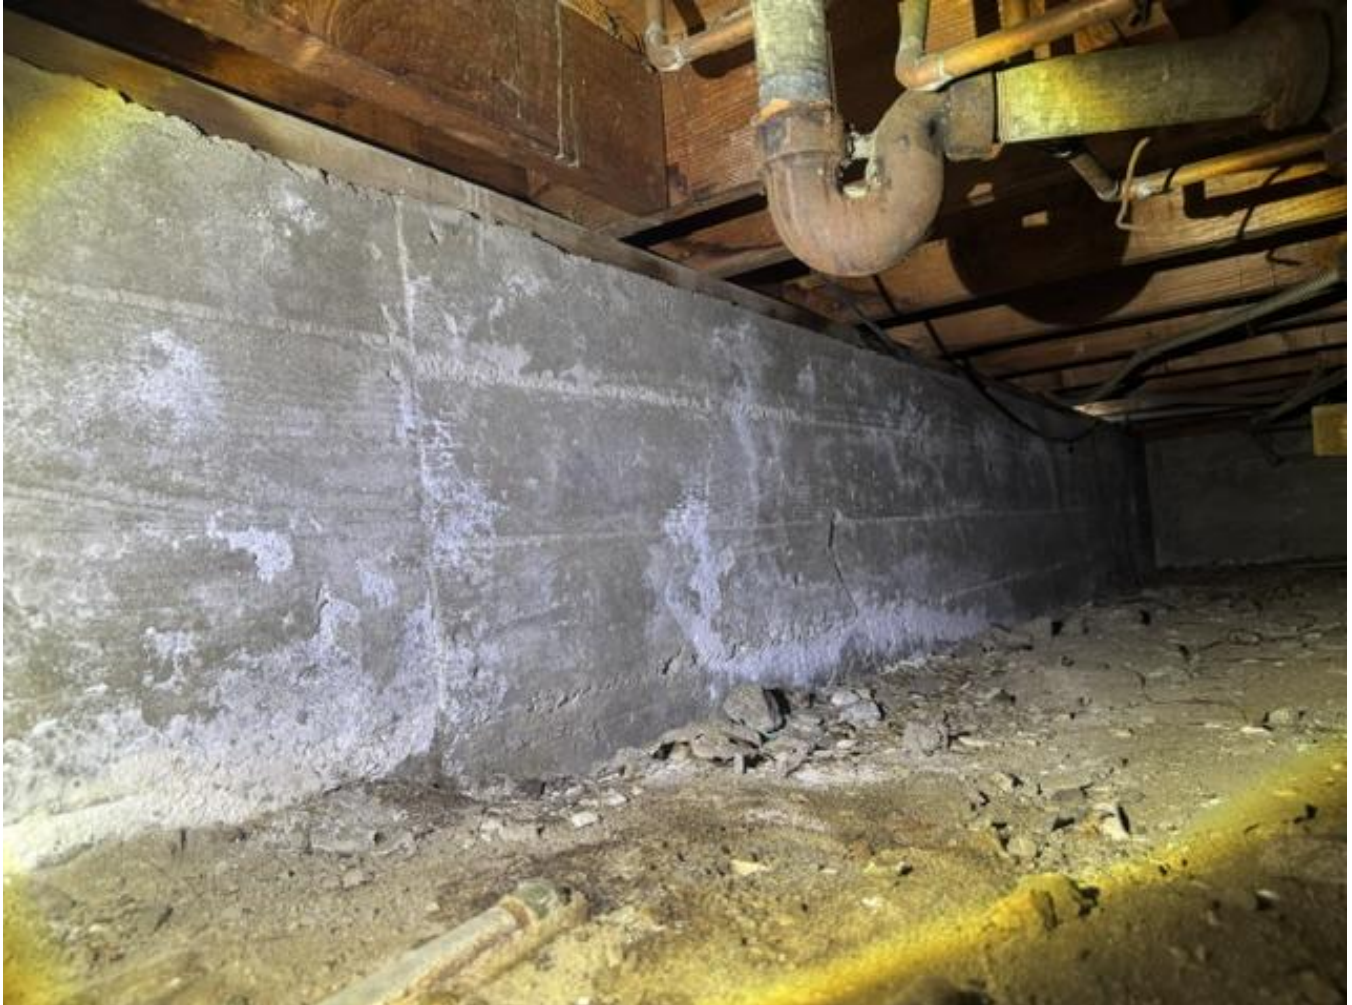
The foundation was constructed of poured concrete and slab on grade. The home was anchored to the foundation walls. A single inspection cannot determine whether movement of a foundation has ceased. Any cracks should be monitored regularly.

Spalling was visible on sections of the foundation walls.

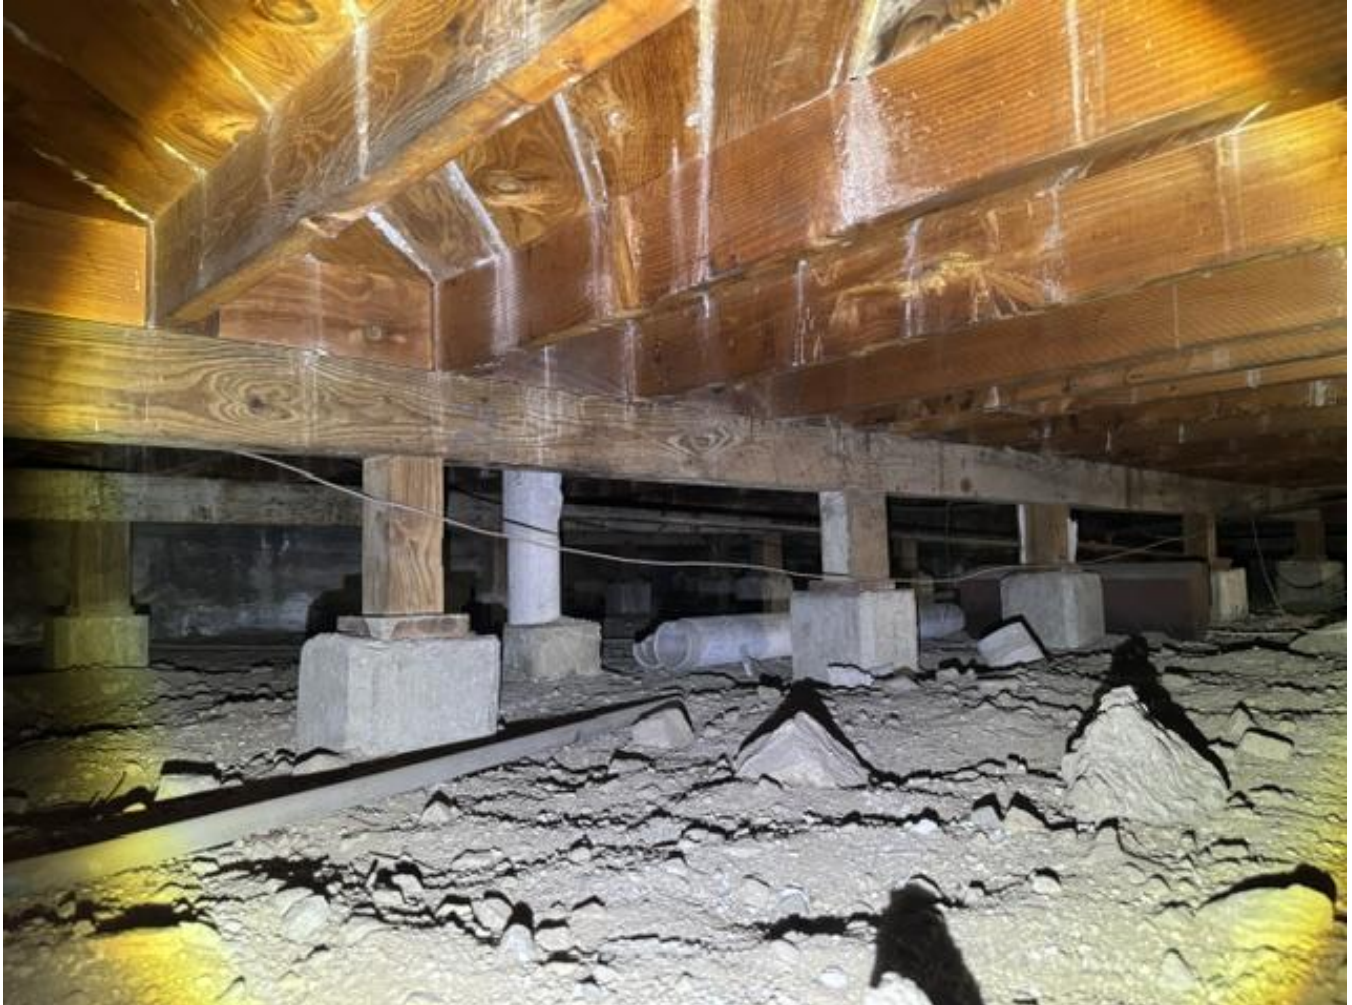
The crawl space was accessible at the time of the inspection, and was dry. Evidence of water penetration was visible. Because of its configuration, it was not possible to inspect all areas of the crawl space. A crawl space should be adequately vented at all times. There were no major visual defects observed in the crawl space.

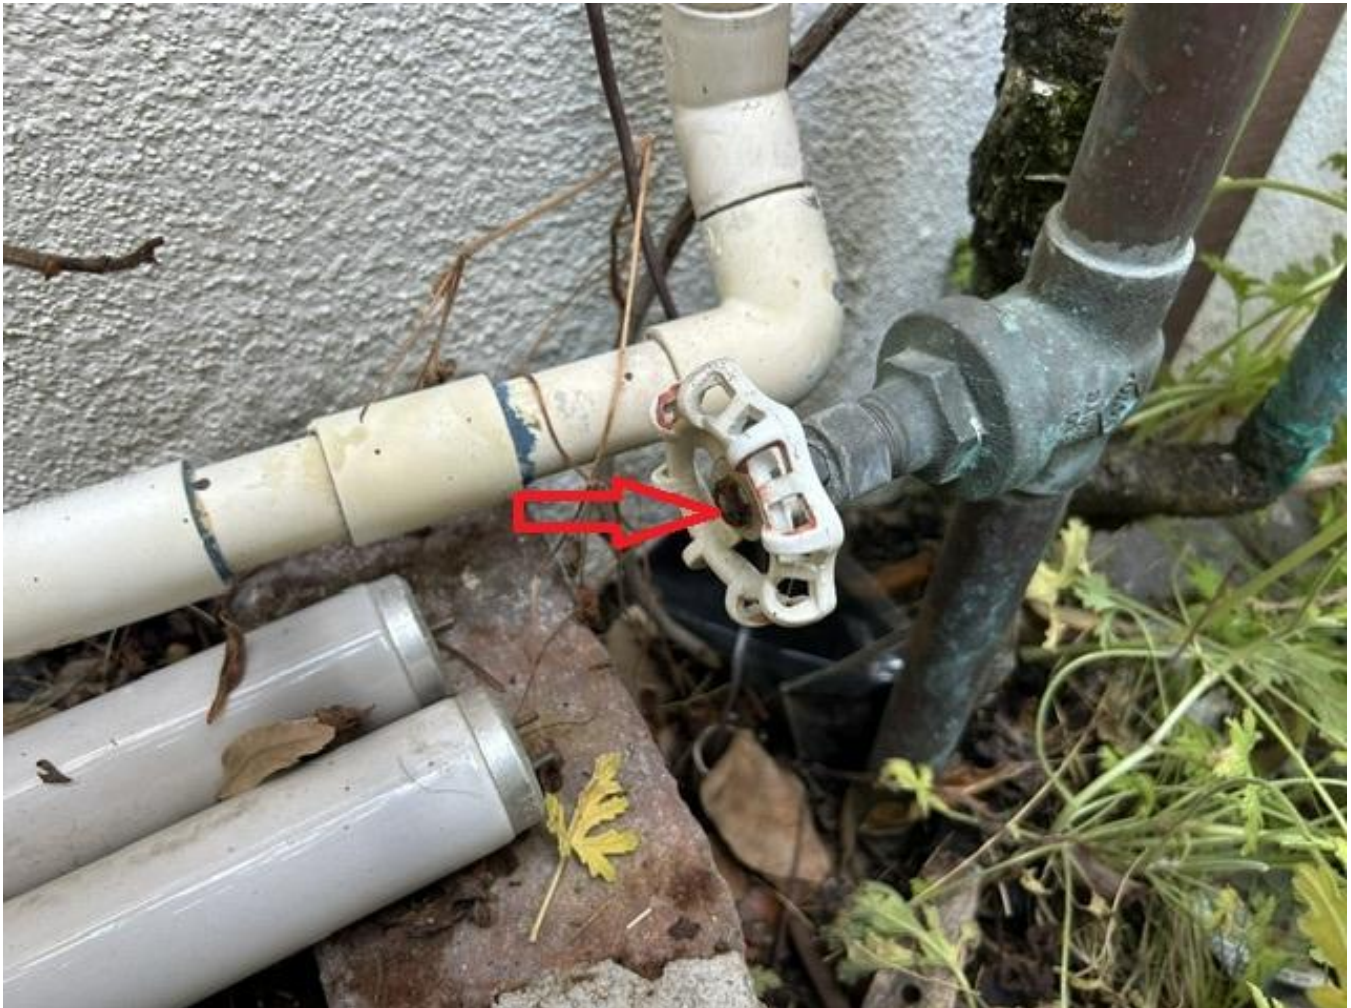
The water meter was located in the front sidewalk. The main water shutoff valve for the home was located adjacent to the water service entry point on the front exterior wall.
