File Number: **0926-204-650**  
Address of Inspection: **3018 Jolley Drive**  
Date of Inspection: **9/10/26**

## **HOME VIEW INSPECTION SERVICE**

### **REAL ESTATE INSPECTION REPORT**

3018 JOLLEY DRIVE  
BURBANK, CA 91504

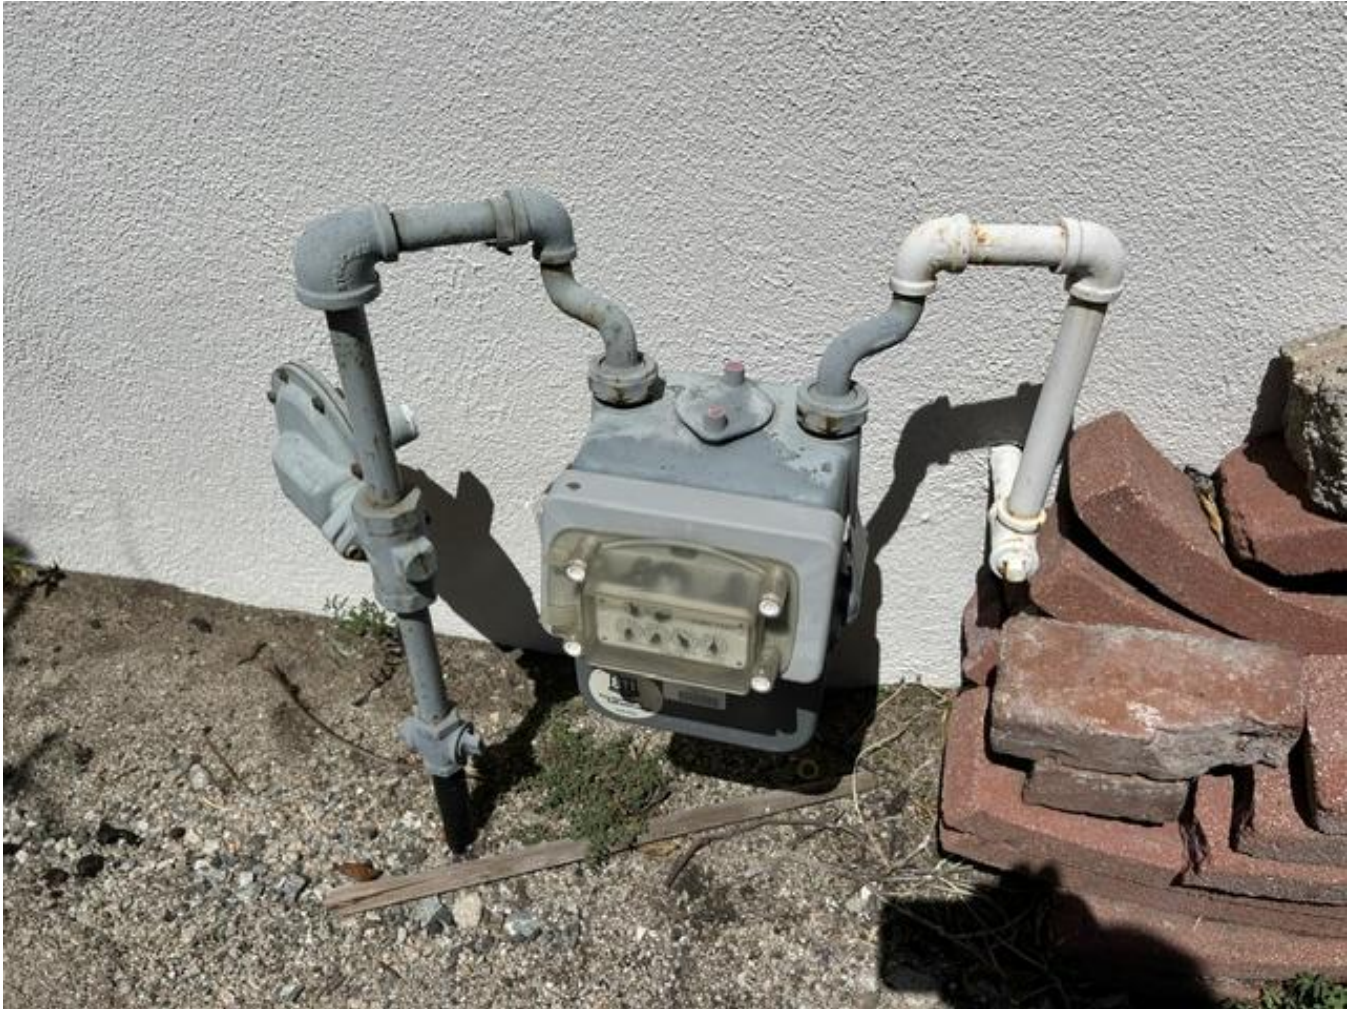
The gas meter was located on the right exterior wall. Although no actual testing was performed to detect the presence of gas fumes, there was no noticeable odor of gas detected at the time of the inspection. Seismic gas shutoff valve was not present.

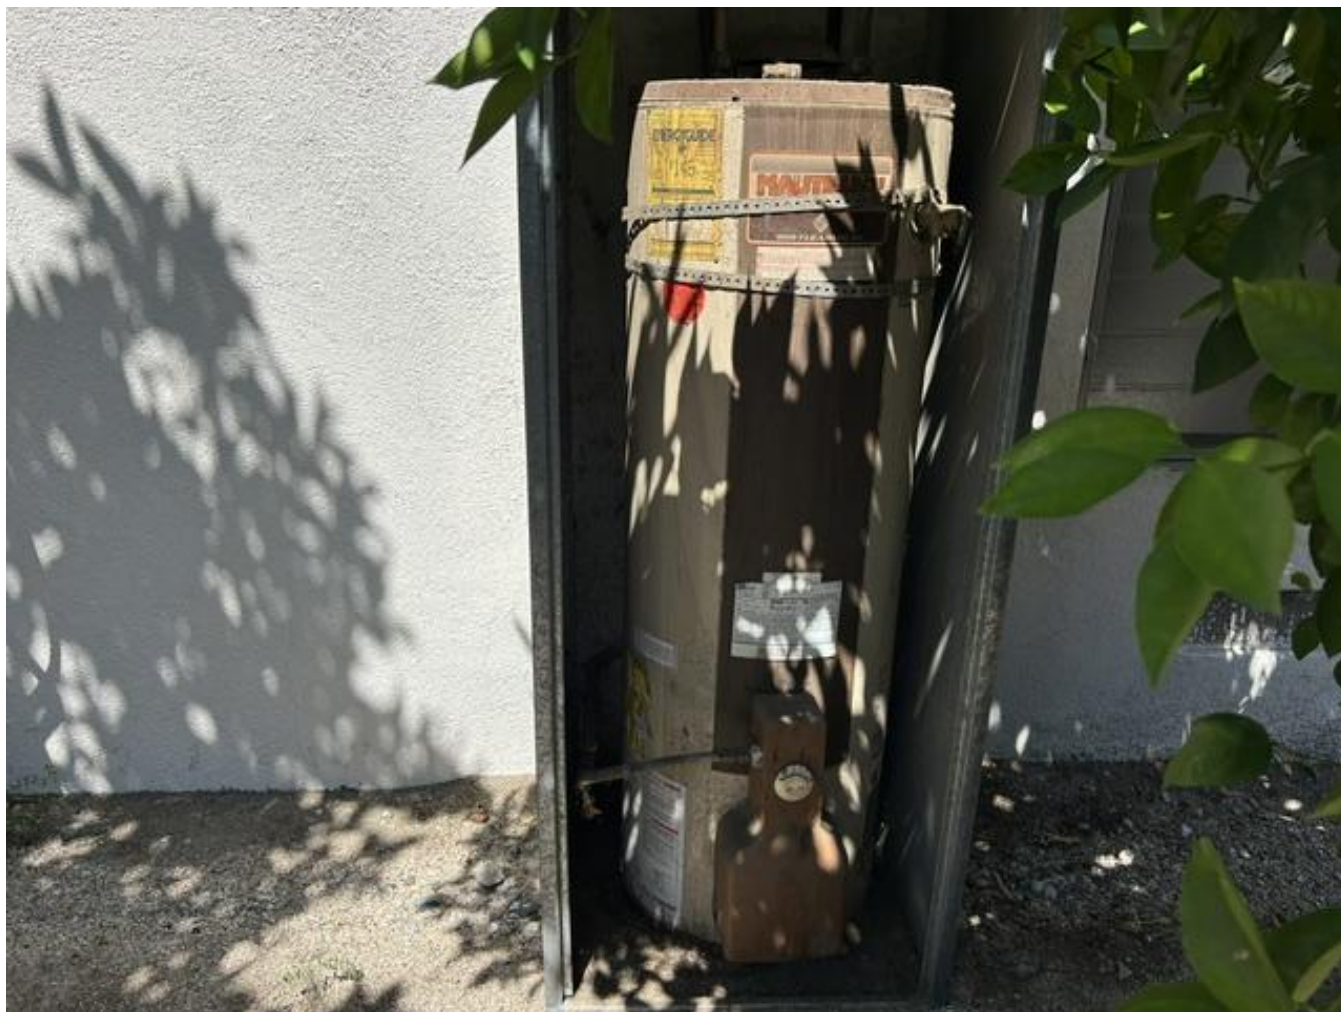
There was a 40-gallon capacity, natural gas water heater located in the exterior metal enclosure. The water heater was manufactured by Nautilus. Information on the water heater indicated that it was manufactured 34 years ago. A temperature and pressure relief valve (T & P) was present. Because of the lime build-up typical of T & P valves, we do not test them. An overflow leg was not present. Your safety depends on the presence of a T & P valve and an overflow leg terminating close to the floor. The required seismic restraints were missing. The water heater was functional.

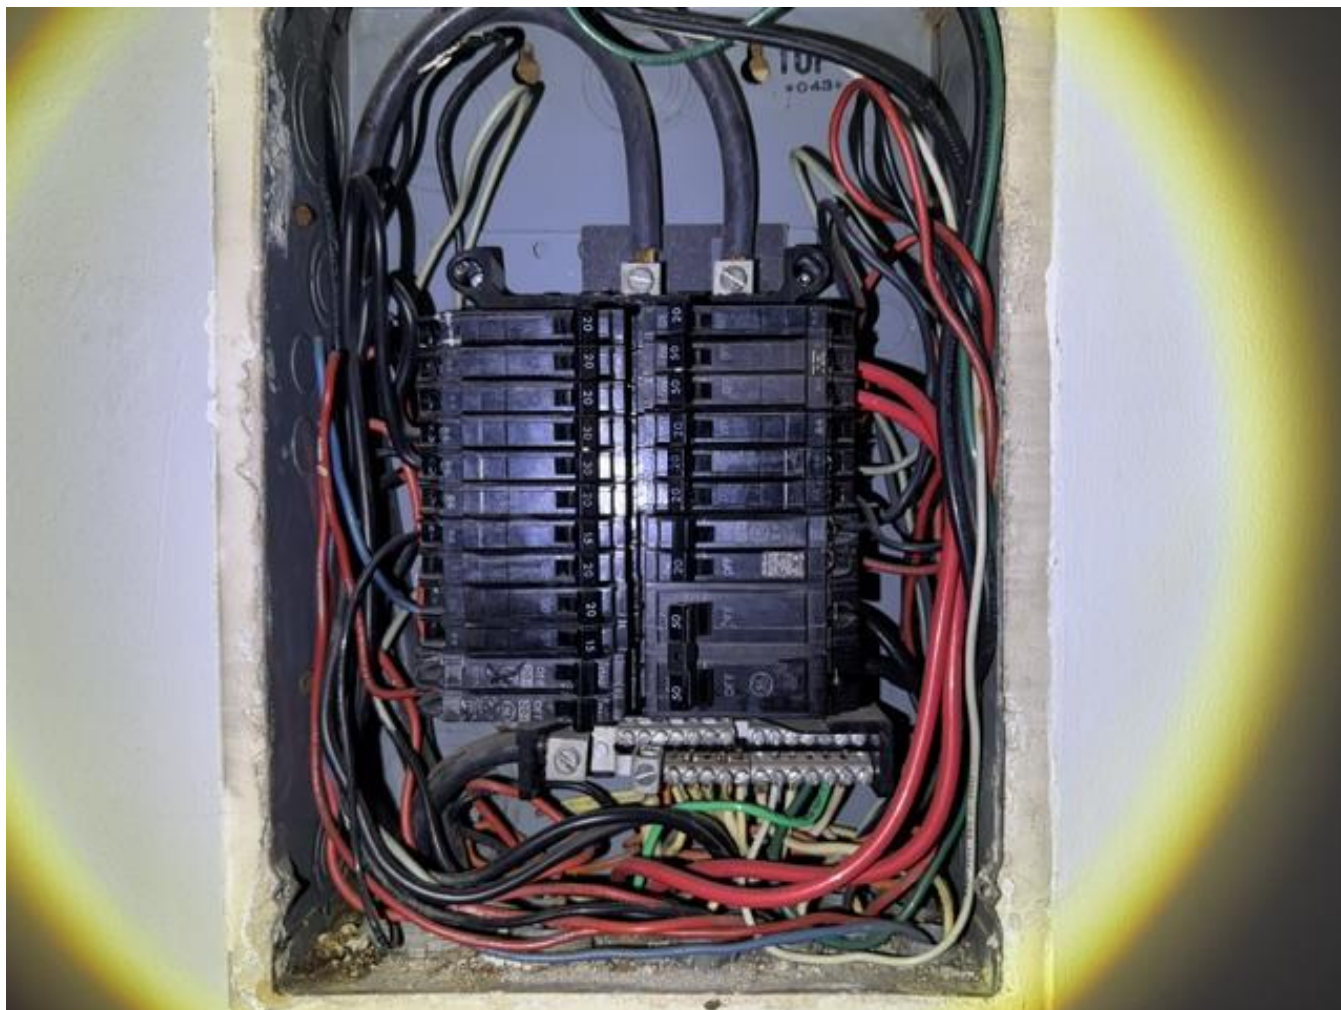
The overhead electric service wire entered the home on the left side. The electric meter was located on the exterior. The service wire entered a GE service panel, located on the family room wall with 100 amps and 120/240 volt rated capacity. The branch circuits within the panel were copper. These branch circuits and the circuit breakers to which they were attached appeared to be appropriately matched. The visible house wiring consisted primarily of the flexible conduit, romex and possible obsolete cloth type.

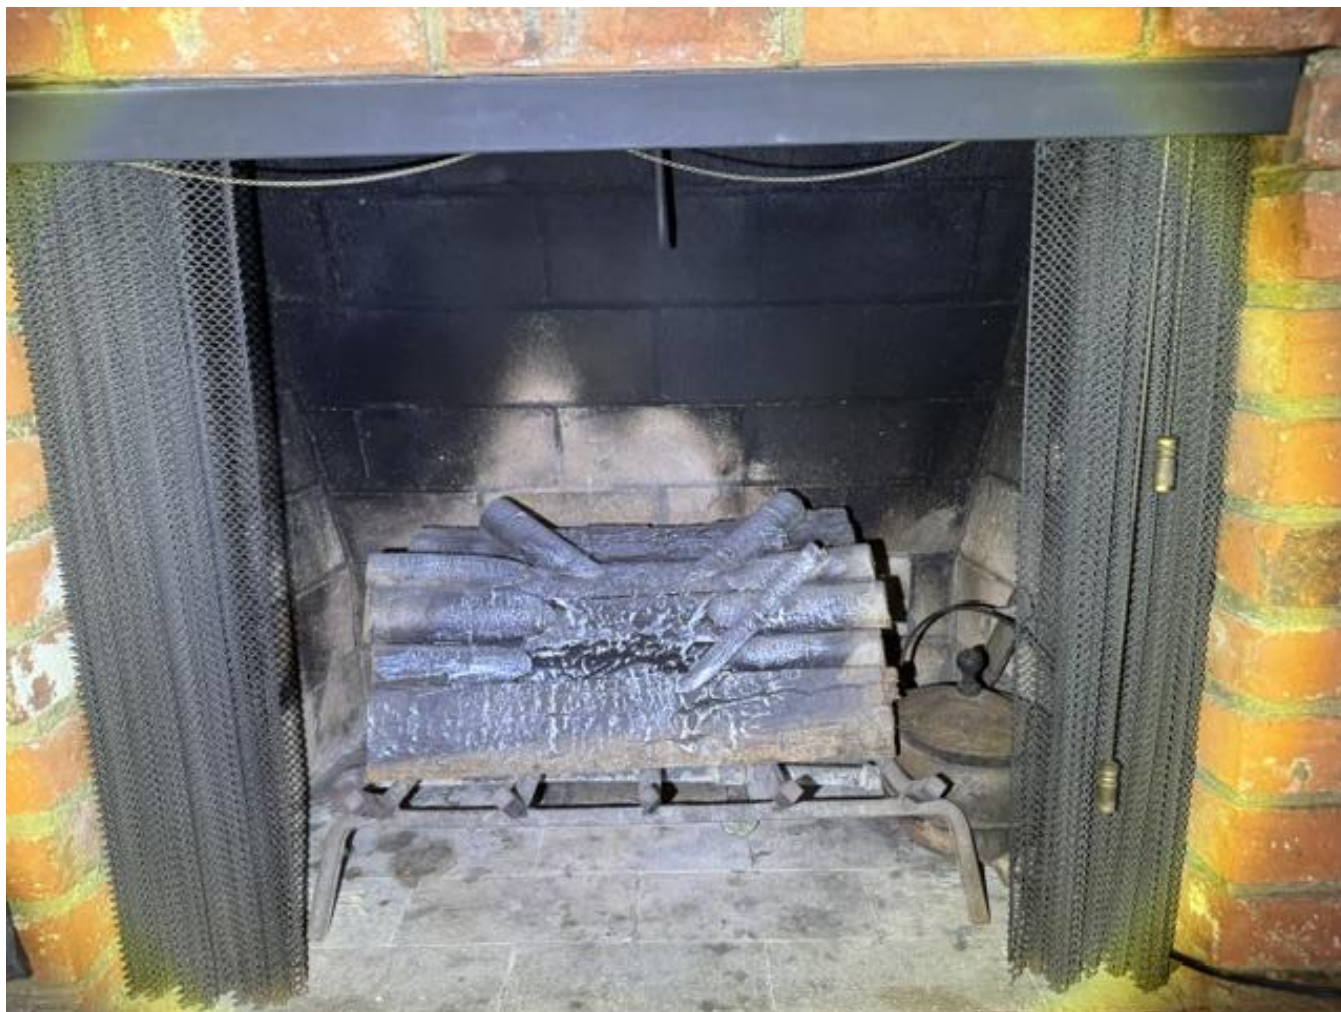
A gas-log fireplace was located in the family room. The damper was functional. There was visual evidence of creosote buildup in the firebox. There were no cracks observed in the firebox or visible portions of the chimney.

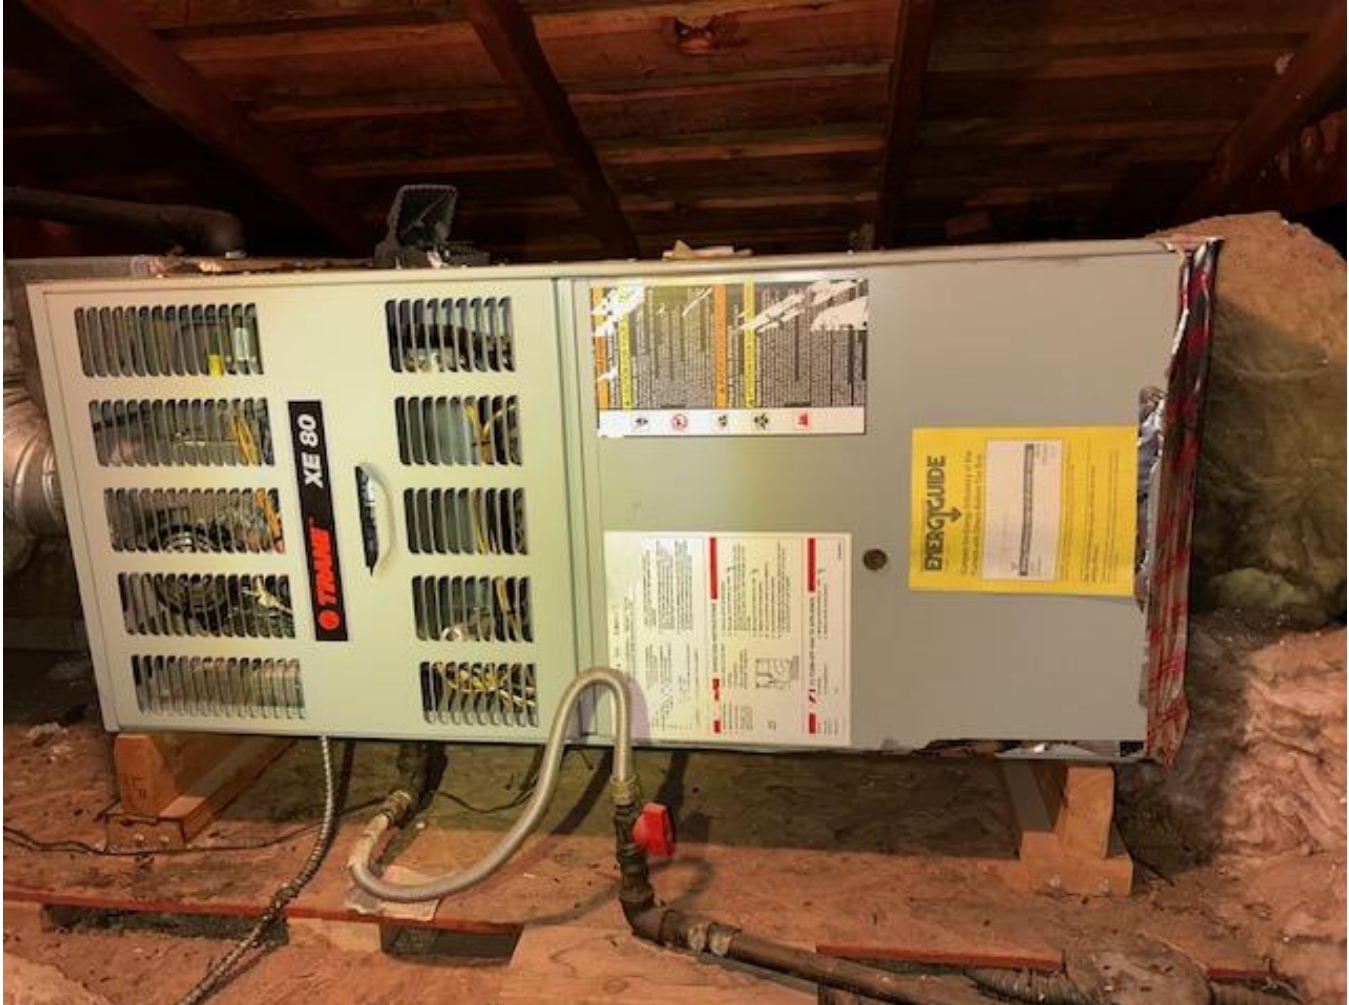
The home was heated by a Trane natural gas forced air furnace, which was 30 years old. The unit was located in the attic of the home. It has an approximate net heating capacity of 80,000 BTUH.

The heating system was found to be non-functional.

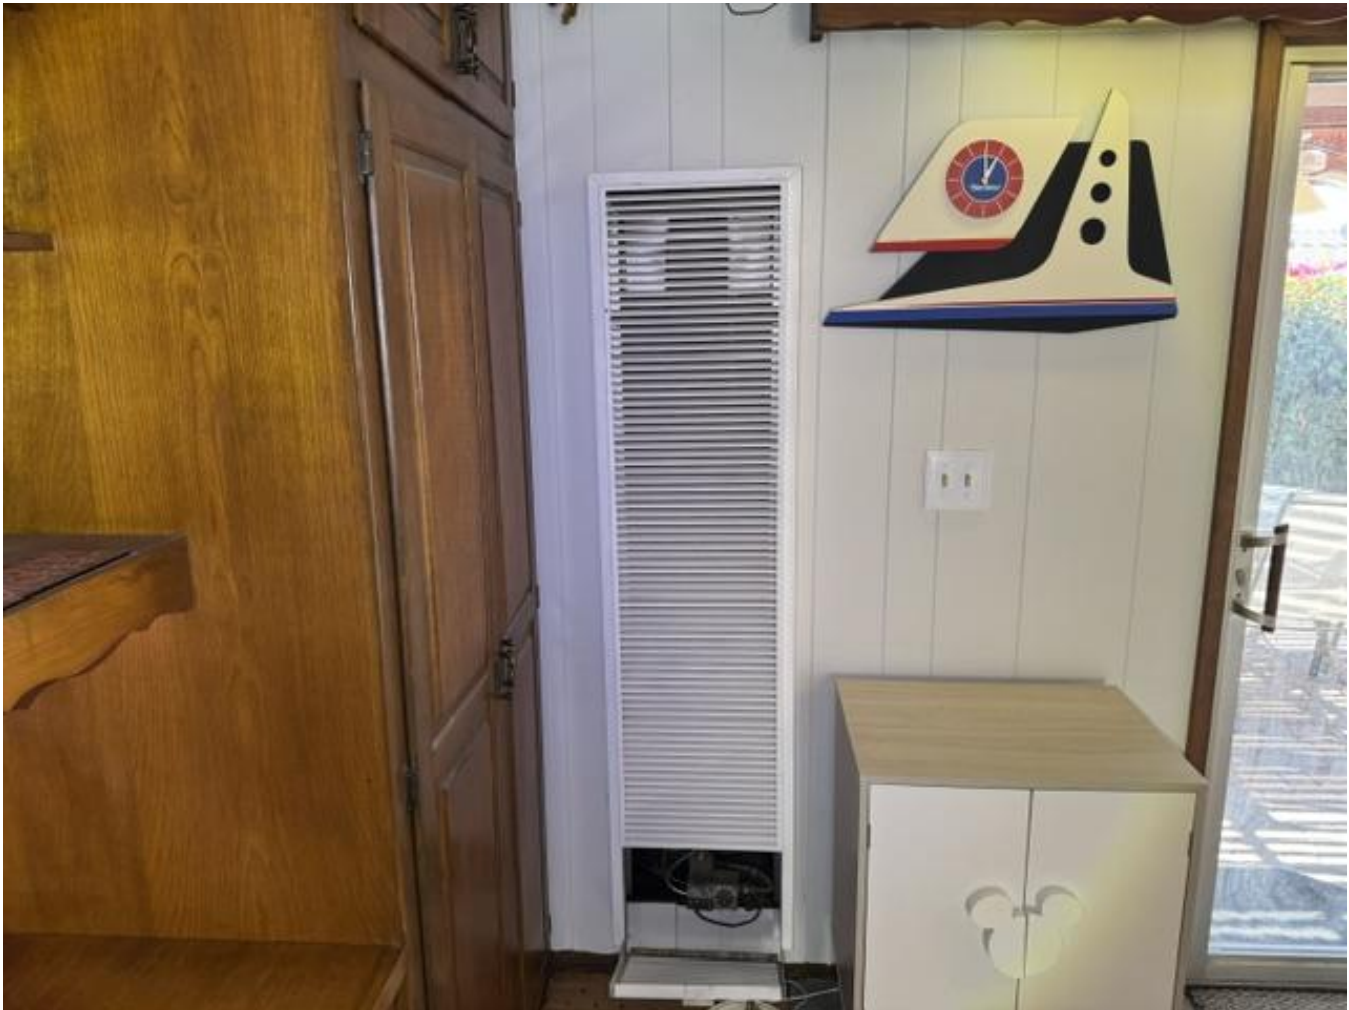
The natural gas wall heater in the family room was not operational.
