# Professional

### *Inspection Report*

Address: 345 N 4th St Grover Beach, CA 93433

08/20/2026

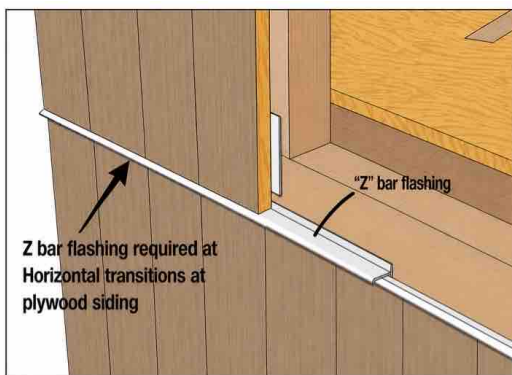
'Z' Weather Strip Flashing

**FI 27: Disclosure:** No visible water shed / "Z" bar flashing at areas of some past exterior plywood wood siding repairs. Areas will need to be sealed and maintained regularly or removed and replaced with appropriate Z-bar flashing to help ensure water tightness.

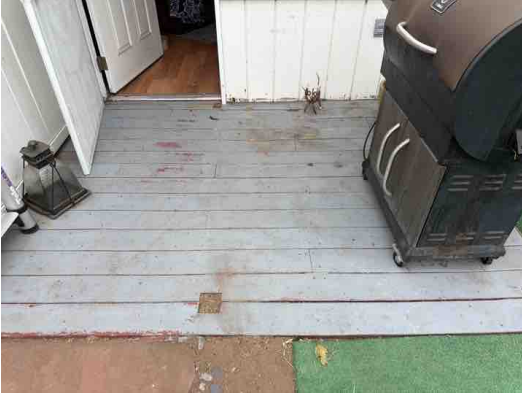
37: DECK LOCATION: **FRONT ENTRY DECK**

**DS 38:** *The underside of the FRONT ENTRY DECK deck was not visible or accessible due to at-grade construction. As a result, the condition of the deck framing and components could not be determined in concealed areas. Decks constructed at or near grade typically have reduced service life due to limited airflow, which can promote moisture retention and wood deterioration. Inspection was limited to visible surfaces only. Recommend further evaluation by a qualified licensed contractor.*

**E&C 39:** The FRONT ENTRY DECK does not meet minimum construction standards, has moderate moisture damage, and appears to be at the end of serviceable life. Contact a qualified contractor for evaluation and repairs or replacement.

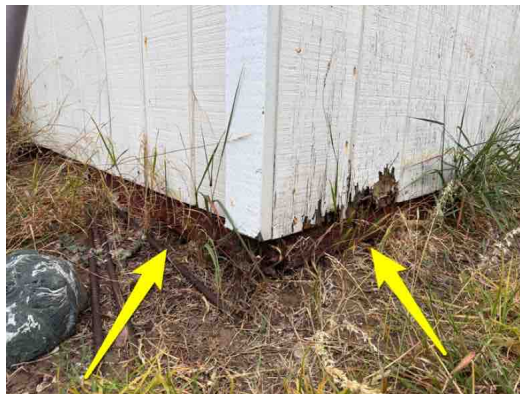
**49:** The entry area lean-to structure appears to have no foundation and may consist of direct wood framing-on-dirt style construction. Moderate leaning and settlement of the small addition is visible and warrants further evaluation by a qualified foundation professional or engineer.

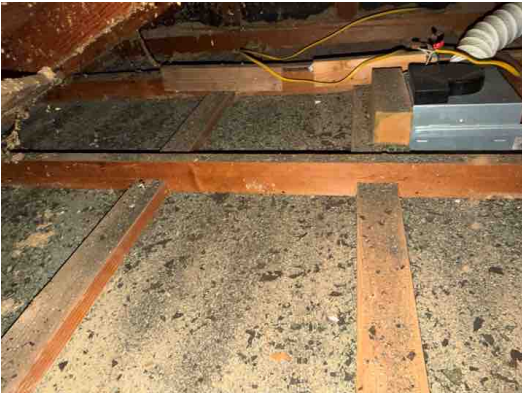
**E&C 72:** Missing insulation in the areas attic. Some of the attic Insulation in has been moved, displaced or was not originally installed for reasons unknown.

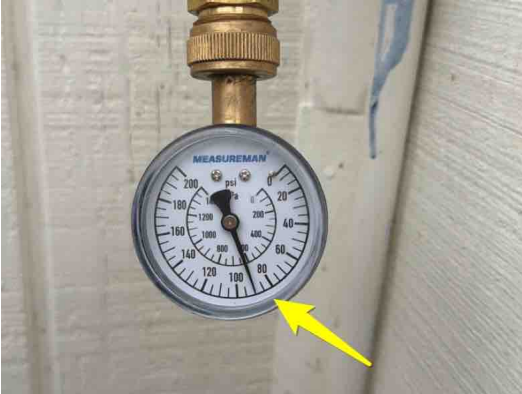
**E&C 78: Excessive water pressure** (above the maximum of 80-psi, **currently at: 90-psi** ). Recommend the installation of a pressure regulator.

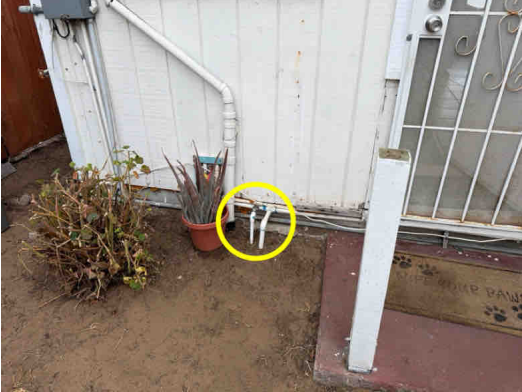
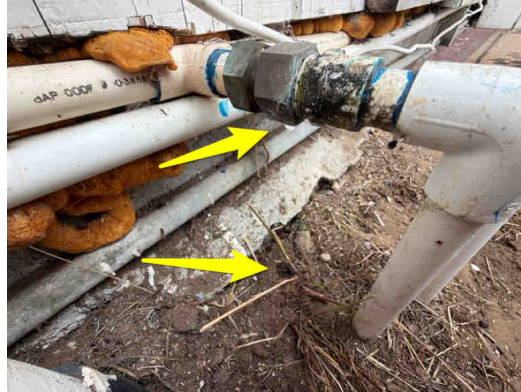
**E&C 86:** Active water leak found at NORTHWEST EXTERIOR HOT WATER SUPPLY LINE OUTSIDE THE KITCHEN. Recommend further evaluation and repairs by qualified plumbing professional.

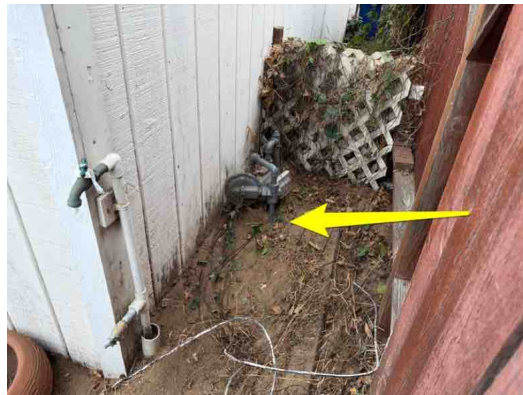
**E&C SC** 97: Gas meter main shut off found buried or partially buried in the soil. Corrections warranted.

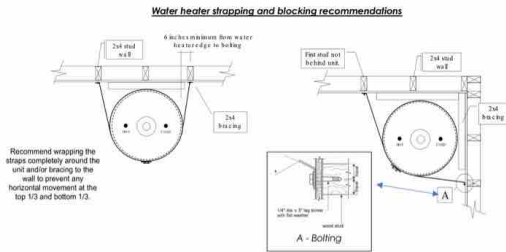
**E&C 103:** The Water heater is loosely strapped & not secured well - moves when pushed . Recommend adding BRACING OR BLOCKING to the wall to properly secure the tank per Uniform Plumbing Code and State Architect Requirements.

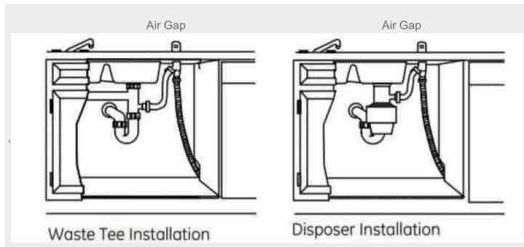
**SU 121:** Improper installation of the dishwasher drain hose. Missing the Air Gap Device at the dishwasher drain per minimum codes and standards (California does not allow for high-loop methods or direct waste connections). {CPC 801.2}

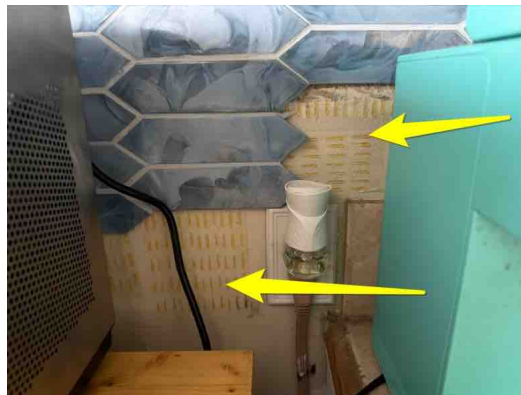
**126:** The kitchen appears to have incomplete finish work, including areas of missing backsplash tile, missing kick-plates, and unfinished countertop/backsplash components, Etc. Recommend buyer awareness that additional work and repairs will be needed to complete the kitchen finishes.

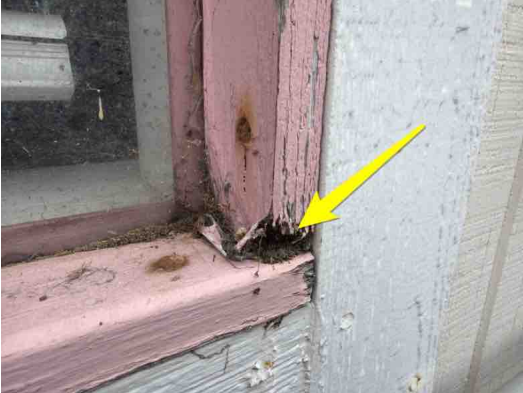
**E&C 155:** Moisture and bug type damage noted at wood windows. Refer to termite report for extent and location.

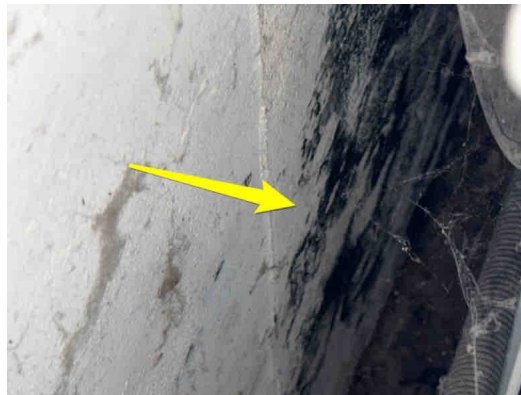
**SC FI 167:** Evidence of past moisture stains & damage with some visible mold growth on areas of the drywall: LAUNDRY ROOM. Recommend additional review by a qualified remediation professional. Recommend further review to determine if stains are current or old and if repairs are needed.

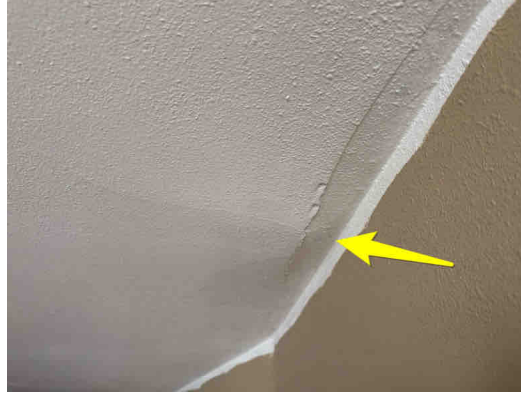
**FI 169:** The ceiling in the LIVING ROOM NEAR THE HEATER found sagging. Cause and condition is unknown. Client may wish to investigate further until satisfied as to cause and current condition.

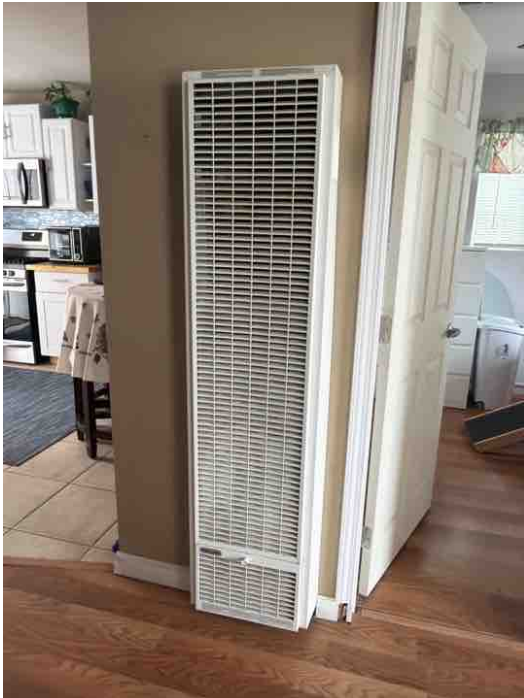
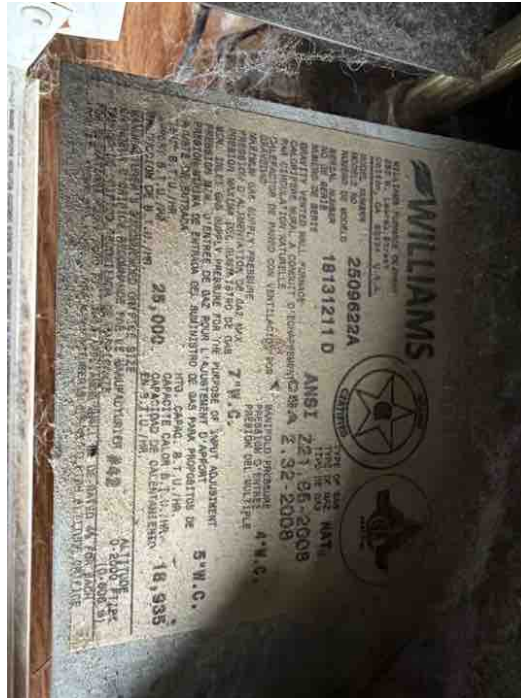
**FI** **172: FURNACE CONDITION:** **The Furnace did not respond to normal controls.** Recommend further review, cleaning, servicing and certification by a licensed HVAC contractor.

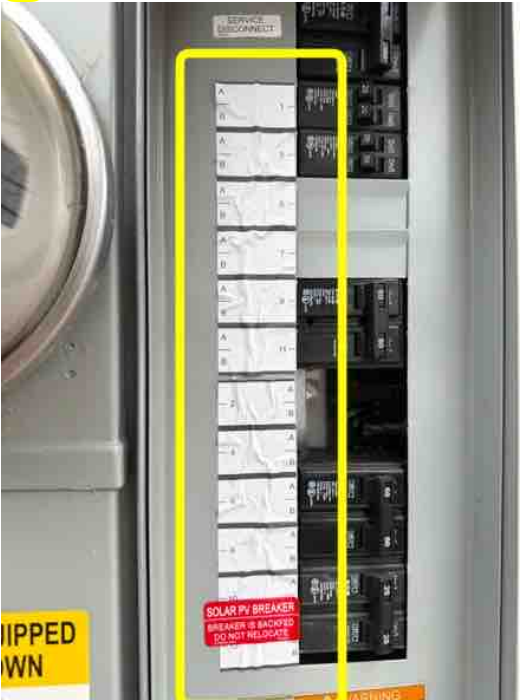
**SU 180:** Breaker panel is not fully or properly labeled per standards: MAIN ELECTRICAL PANEL.

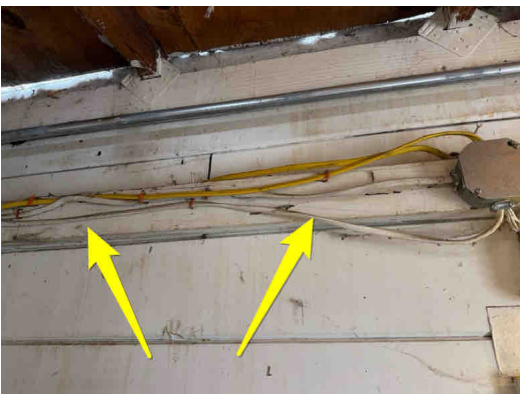
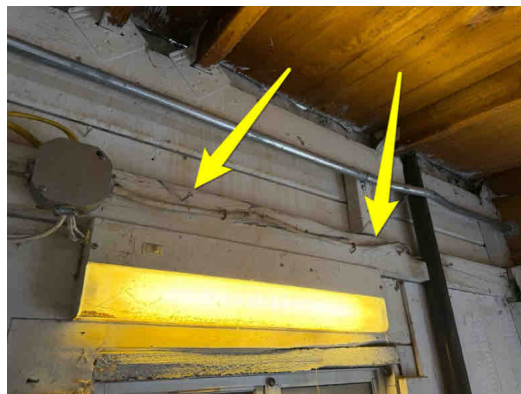
**SC 183:** Improper exposed electrical wiring, "Romex" improperly installed subject to physical damage, not in a conduit or raceway per standards: THROUGHOUT THE LAUNDRY AREA  
NEC 334.15(B)  
NEC 300.4

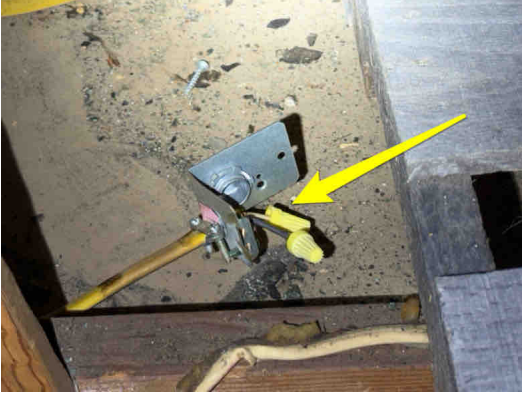
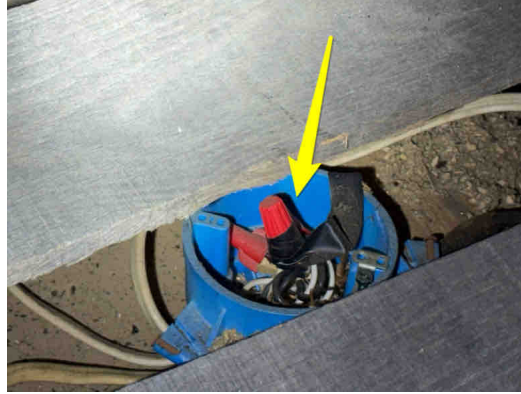
**SC 184:** Improper electrical wiring. Exposed electrical wires and/or splices not protected in a box with a cover:  
MULTIPLE THROUGHOUT THE ATTIC

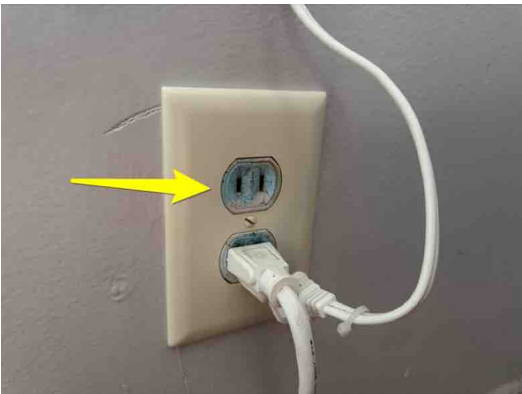
**SC UPG 185:** Some electrical circuits and outlets throughout the home are ungrounded with 2-prong outlets installed. This type of wiring is considered outdated and unsafe by today's standards due to specific requirements of today's newer appliances. Recommend review and safety upgrades to all ungrounded circuits, outlets and lights by a licensed electrical contractor.

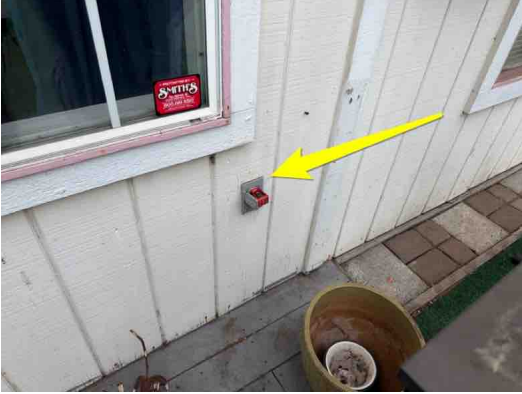
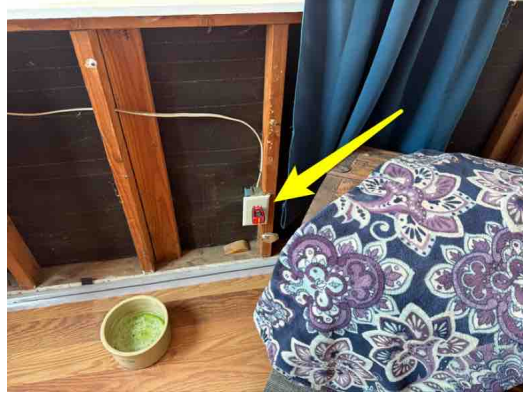
**SC 186:** Miswired electrical outlet (Reverse polarity) found at the EXTERIOR AND INTERIOR AT THE ENTRY AREA. Have electrician check all outlets and correct as needed.

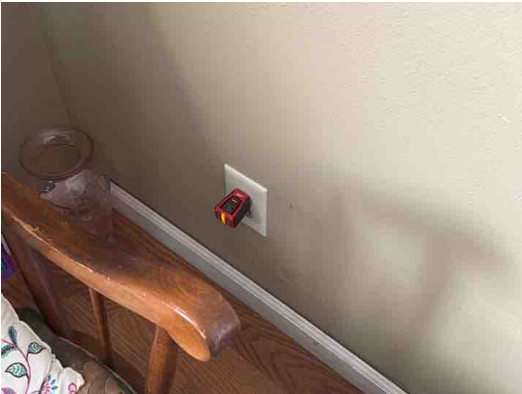
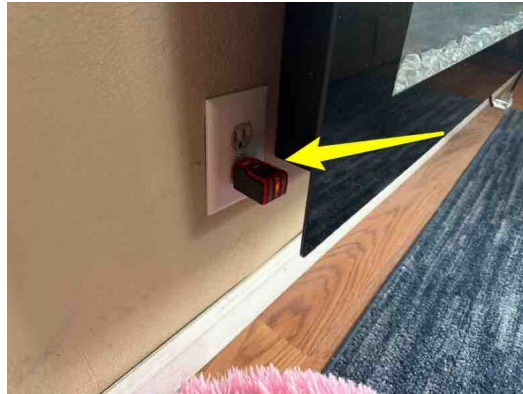
**SC 187:** Some three-prong electrical outlets did not test properly grounded. Recommended further review and repair or upgrade of all defective outlets once furnishings and occupant's belongings have been removed by a certified or licensed electrical professional.
