## **Property Inspection Report**

***412 Penelope Ln, Santa Maria, CA 93455***

***Date of Inspection: 8/12/2026 Time: 1:30 PM***

***Inspector: Peter Ruiz***

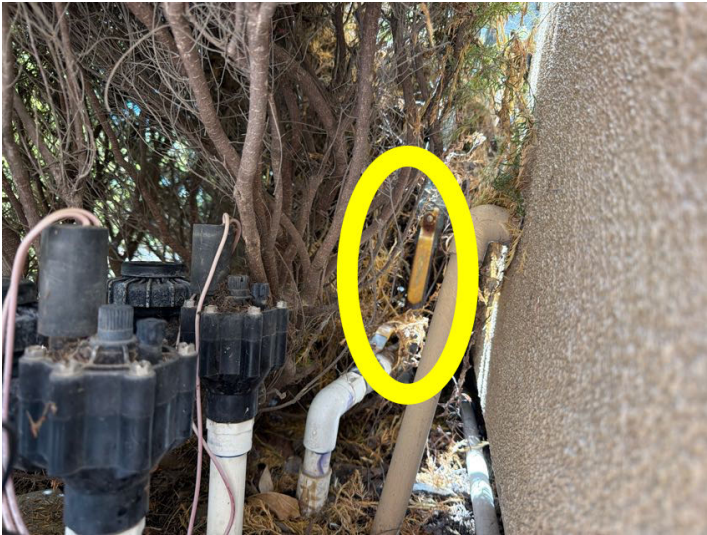
The main water shut-off valve is located at the right side of the home, unit, or building.

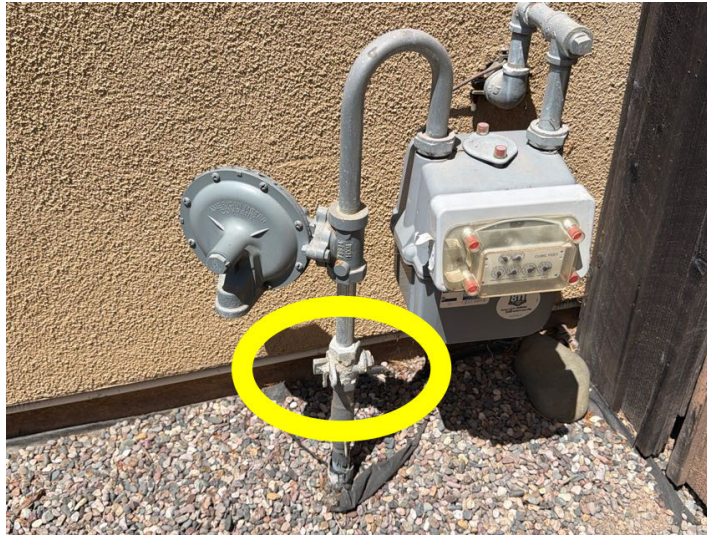
The gas main shut-off is located on the right side of the home, unit or building.

3.4. We recommend that a wrench, designed to fit the gas shut-off valve, be located on or adjacent to the gas meter to facilitate an emergency shut off.

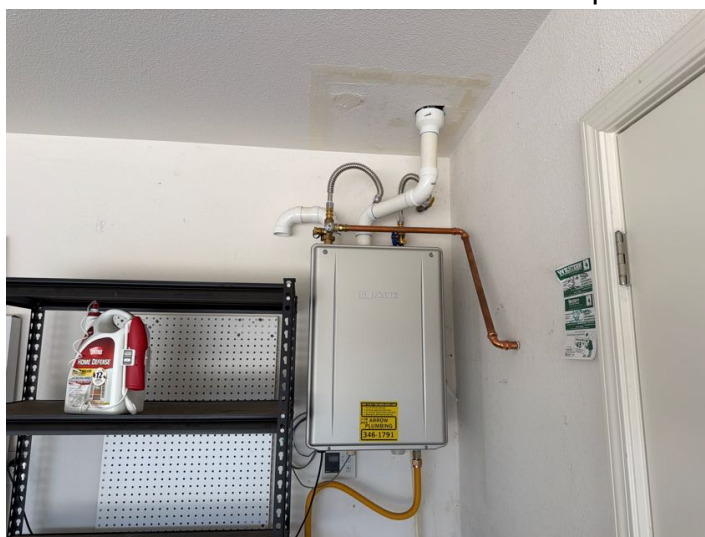
The residence is served by a tankless water heater located in the garage.

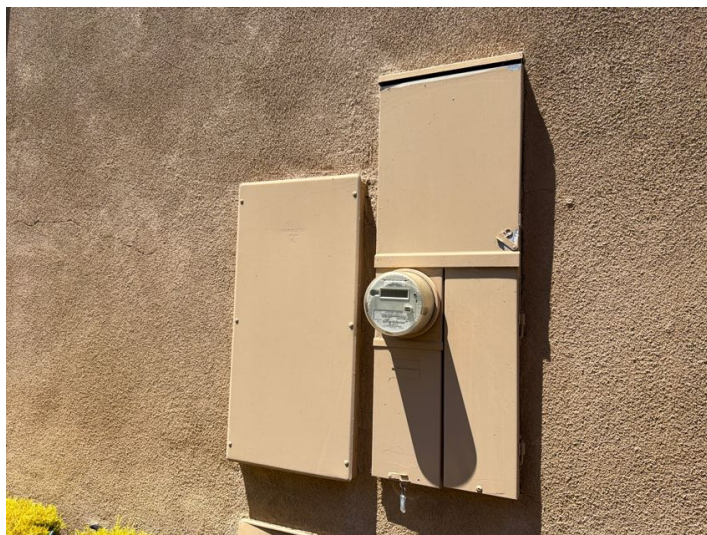
1.10. The main electrical panel is double-grounded to a foundation steel known as a UFER and to a water pipe.

The residence is served by a 200 amp main electrical panel, located at the right side of the home or unit.

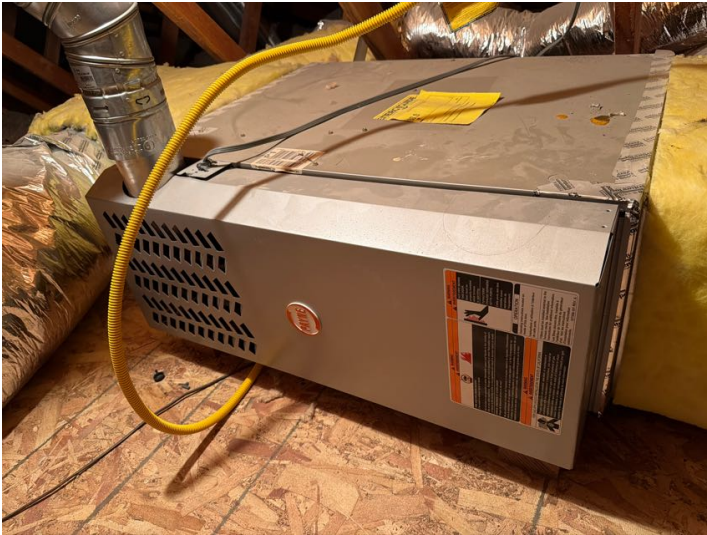
1.14. There is no drip pan beneath the evaporator coil at the horizontal furnace. Although such an installation is not mandated, it is a sensible feature and one that is commonly recommended.

Central heat is provided by a forced-air furnace that is located in the attic.

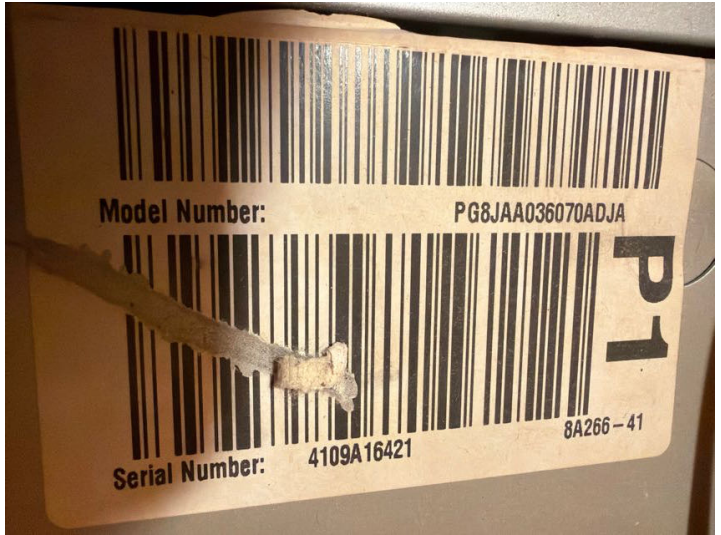
Serial Number 4109A 16421 - Manufactured 2009
