### *Inspection Report*

Address: 920 Walnut Dr Paso Robles, CA 93446

07/18/2026

Inspector: Keith Vreeken, MCI, FCI  
P.O. Box 415 Templeton, CA 93465 O: 805.462.1978 C: 805.440.5050

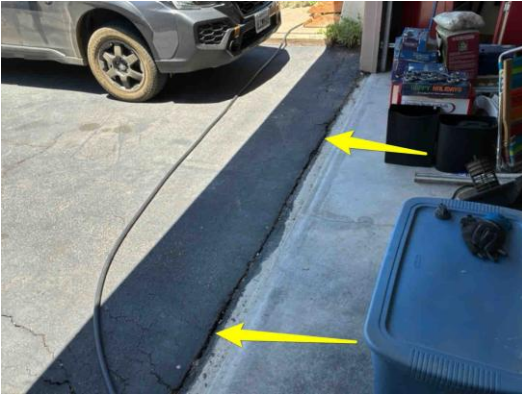
Example location

**FI DS** 16: The asphalt driveway appears to be lifted slightly at the garage connection. This may allow water to collect against the garage vehicle door and considered a potential trip hazard.

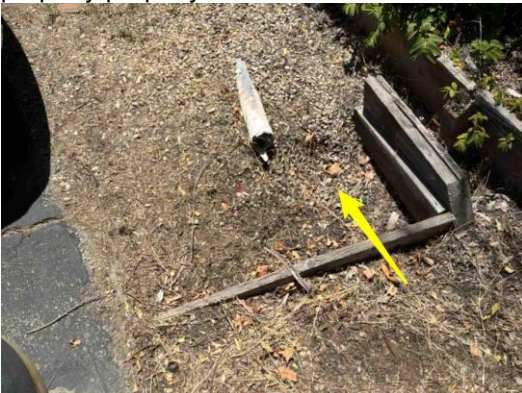
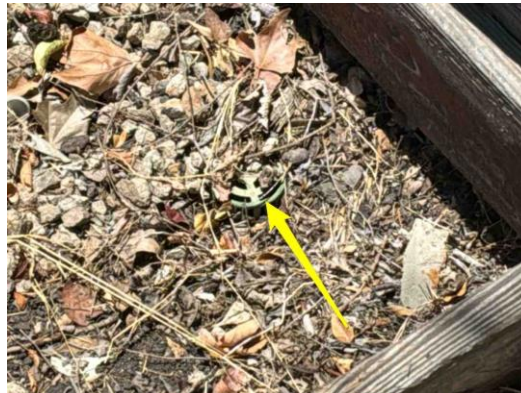
**F 17:** The drain inlet provided for the driveway rain and water runoff appears to be undersized partially blocked. Recommend contacting a civil engineer to evaluate and to help ensure that water flows off the driveway and off the property properly.

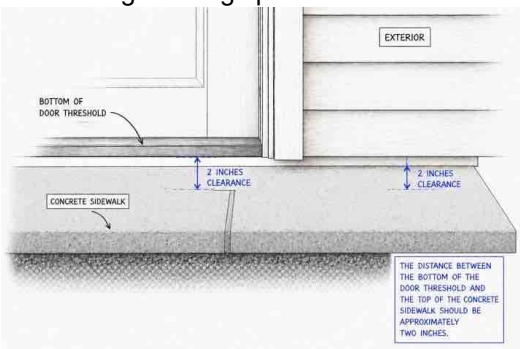
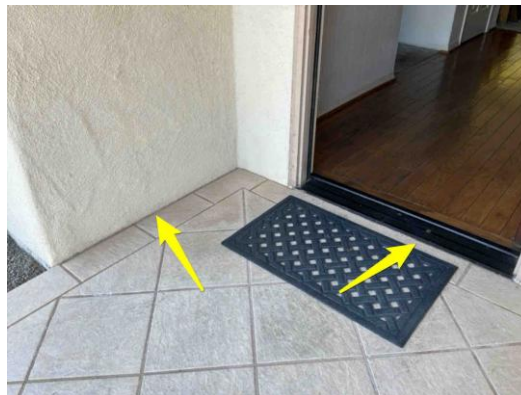
**UPG DS 21:** Areas of the exterior walkways found to be improperly installed high, at or above the exterior siding and/or the door threshold. This can allow for moisture or water to buildup and collect behind the exterior siding and trim and can potentially wick water into the wall framing and living spaces. This can also allow water to intrude into the framing or living spaces from under the door thresholds.

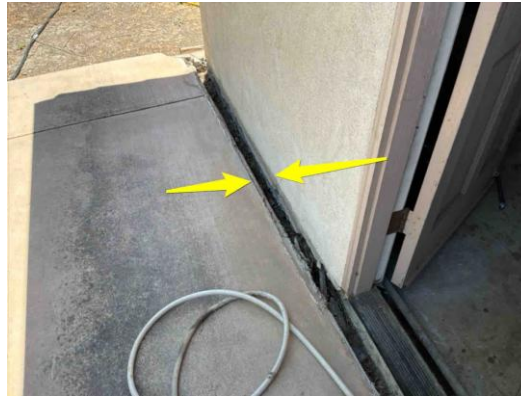
Example location

**FI 22:** Areas of the sidewalks appear to be settling and pulling away from the building. Client should investigate further until satisfied as to the cause, condition and potential future issues.

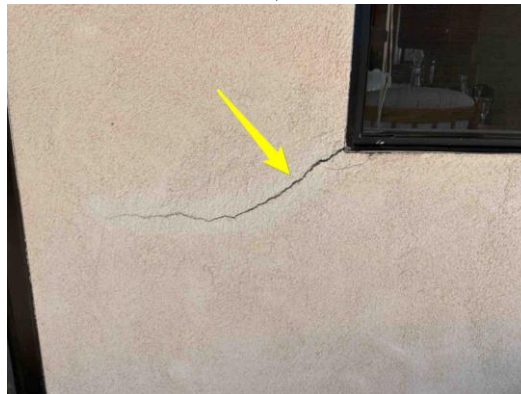
**FI** 36: Some unusual visible cracks found in the exterior stucco siding along areas OUTSIDE THE DINING AREA WINDOWS which are open greater than 3/32", (thickness of a nickel). These cracks are open / separated more than normal indicate some unusual settlement or movement of the foundation or wall. framing.

Separations in the exterior stucco that are open / separated, (greater than 3/32"), are a potential concern for water intrusion as the underlayment, Tar Paper or Tyvek, can tear allowing moisture or water intrusion into the wall cavities. Buyer or seller should consult an appropriate Civil engineer to evaluate the cause, the current conditions, and the potential future issues that may arise if not addressed. Afterwards, they also should contact a stucco professional to evaluate and to address any concerns as to potential of water intrusion, and correct as needed.

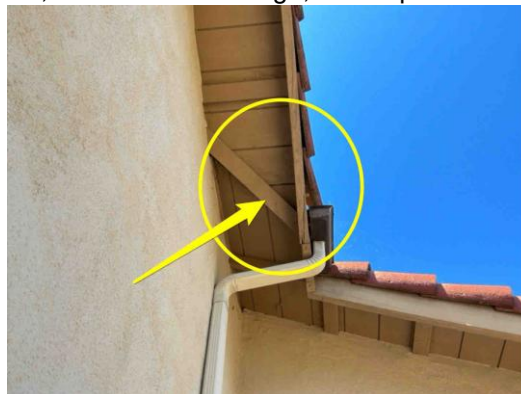
**58:** Evidence of past roof leakage was observed at the roof overhang area, including visible moisture staining and/or damage: **Example - at the Roof valley termination off the back of the laundry room .** These conditions indicate a failure of roofing components and possible concealed damage. Recommend further evaluation by a qualified roofing contractor to determine the source, full extent of damage, and to perform necessary repairs.

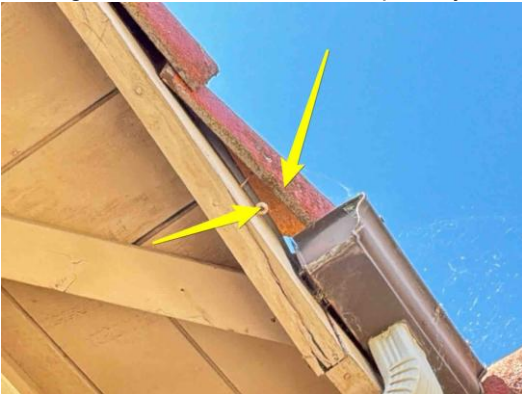
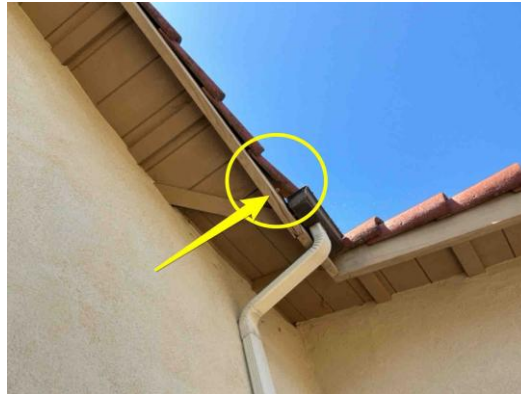
**E&C MR 59:** Some loose roof tiles needing repair or maintenance found missing the required approved fastener, nail, or batten extender at areas of the tile roof. Recommend further review of the roof by a qualified / licensed roofing contractor to determine quantity of repair or maintenance needed.

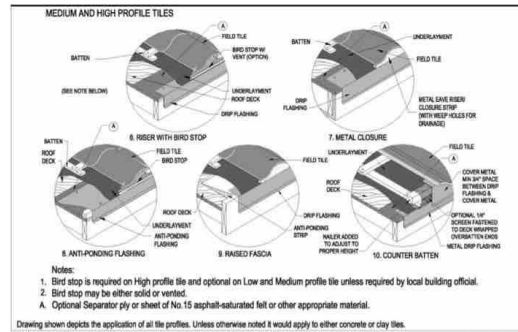
Example

**E&C MR 61:** Improper or poor installation of the tar paper along the roof lower edges. Some deteriorated and damage tar paper. Recommend the installation of a proper metal roof drip edge flashings, a proper tile lifter, chamfer strip and the proper extension of the tar paper. See installation requirements in the photos below. Current condition can/is causing puddling of water on the back side of the fascia board and does not allow the roof to properly drain.

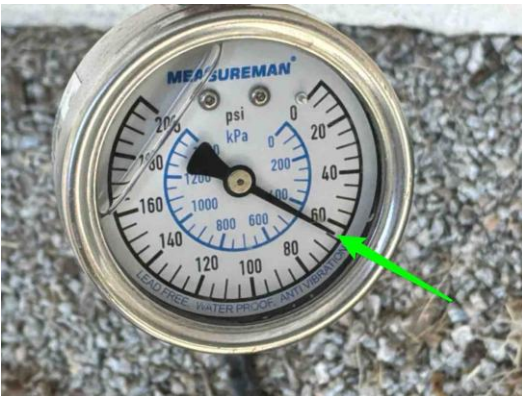
**Water Pressure** - Is At Approx. **65 +/- PSI**. Optimal water pressure is between 40 and 80 PSI.

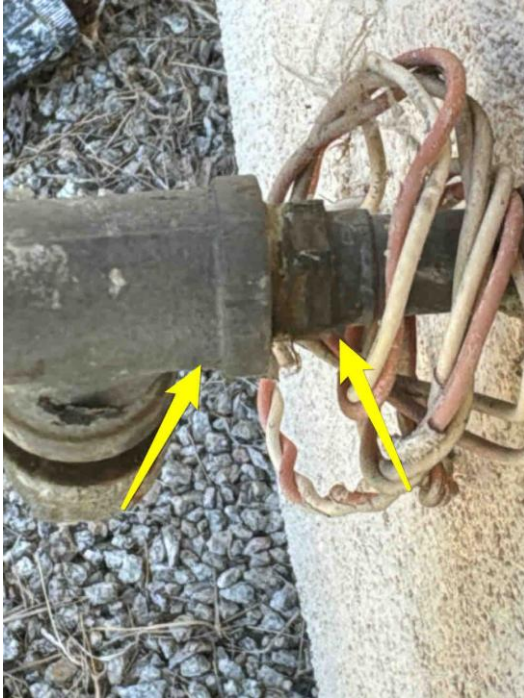
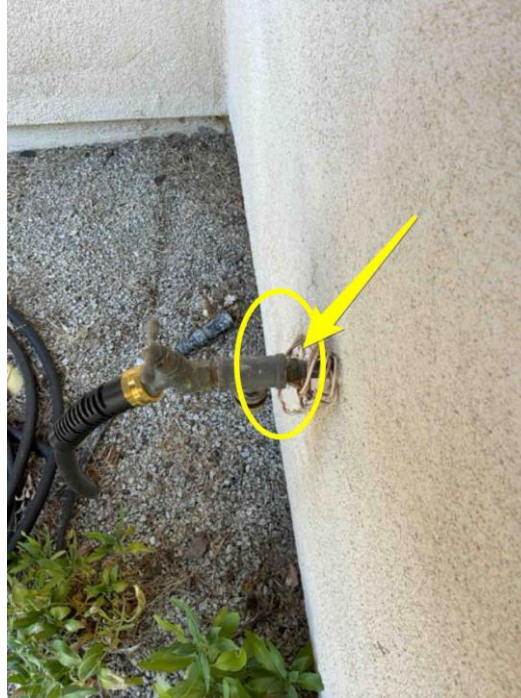
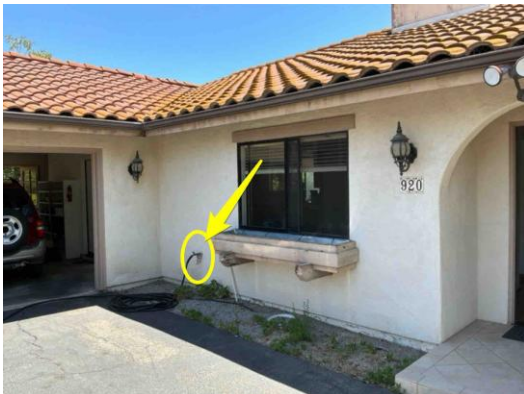
1. AT MUTUAL EXTERIOR HOSE FAUCETS.

**80:** An improper copper to galvanized pipe cross connection. This can cause electrolysis and damage the piping. Recommend repairs by a certified or licensed plumbing professional familiar with minimum standards.

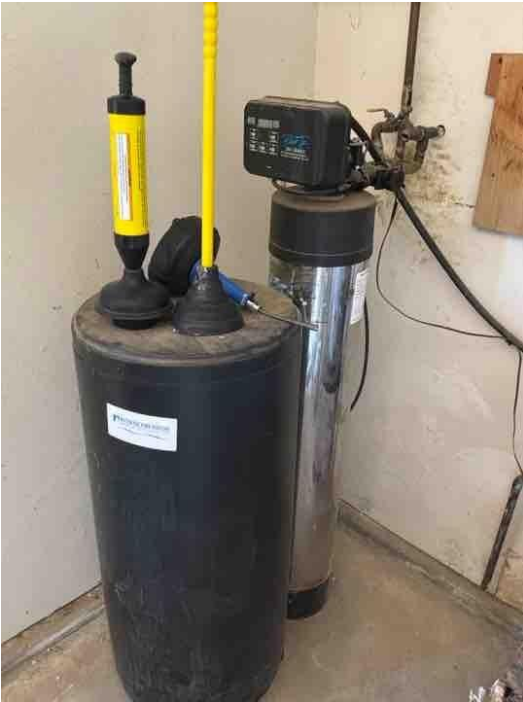
**81:** Water softener installed in the Garage. **Power is off unit NOT in Bypass mode**

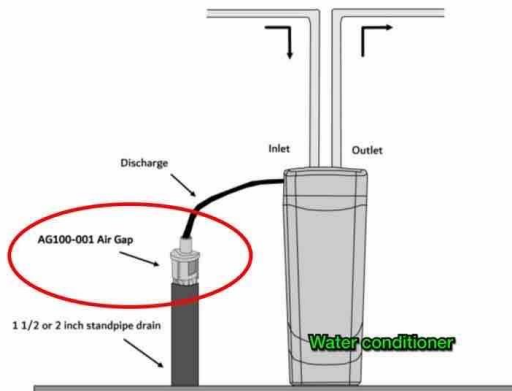
**SC 84:** Improper installation of the water softener drain hose. Missing the required air gap at water softener drain hose at waste connection. Refer to the manufacturer's installation requirements and plumbing code. California Plumbing Code (CPC) §801.2.1

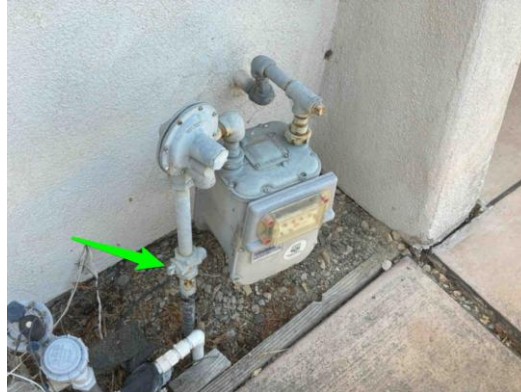
Main gas shut off valve

**90:** Gas shut-off appears serviceable.

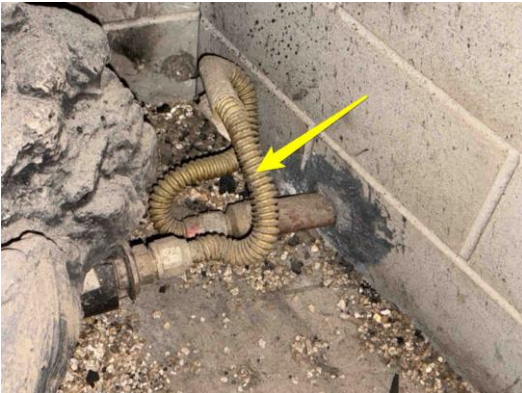
**SC 91:** The GAS CO. has determined that an uncoated brass gas flex connector needs to be replaced for safety at the: FAMILY ROOM GAS FIREPLACE ARTIFICIAL LOG APPLIANCE.

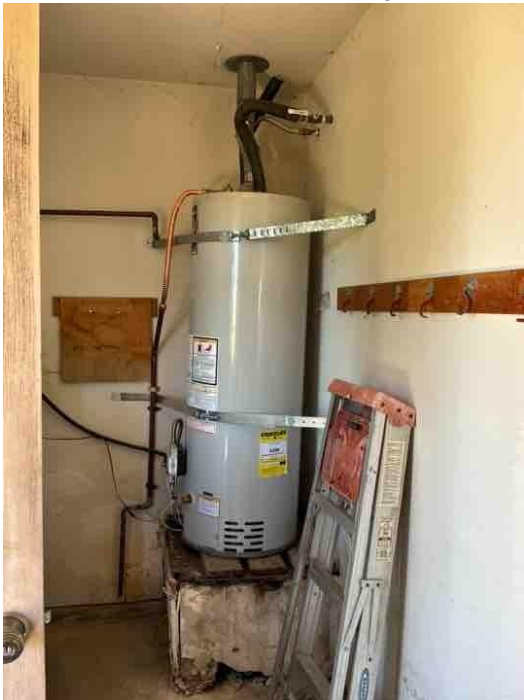
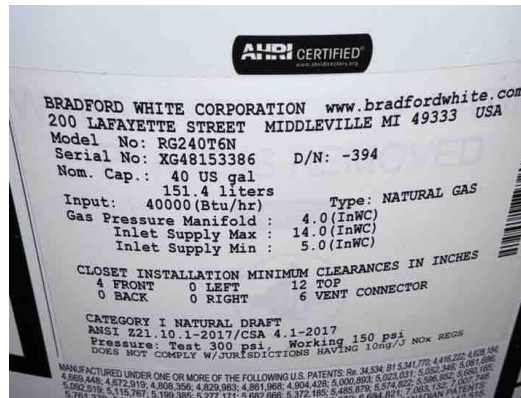
**Date: 2021:** The average lifespan of this type of water heater is approximately 10 years. This water heater is approximately 5 years old. Water heaters can fail without warning and should be monitored and inspected regularly for leaks, corrosion, and other signs of deterioration.

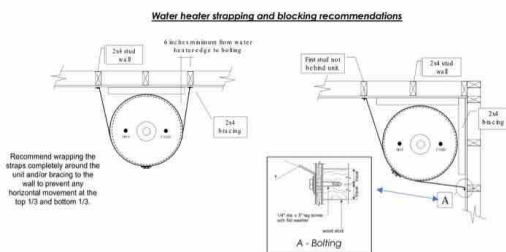
**E&C 95:** Water heater is improperly and loosely strapped & not secured well - moves when pushed . Recommend adding the proper STRAPPING which wraps at least once completely around the tank and/or adding BRACING OR BLOCKING to the wall to properly secure the tank per Uniform Plumbing Code and State Architect Requirements. Recommend further review and repairs by a certified or licensed professional familiar with the minimum installation requirements.

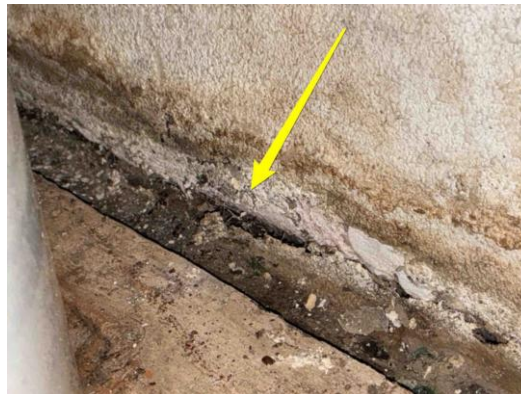
**SC FI** 98: Moisture stains and damage at the drywall areas of the water heater platform and/or enclosure. Some visible mold growth noted on areas of the drywall. Recommend additional review and clean up by a qualified mold remediation professional. Refer to Termite report for additional comments and recommendations.

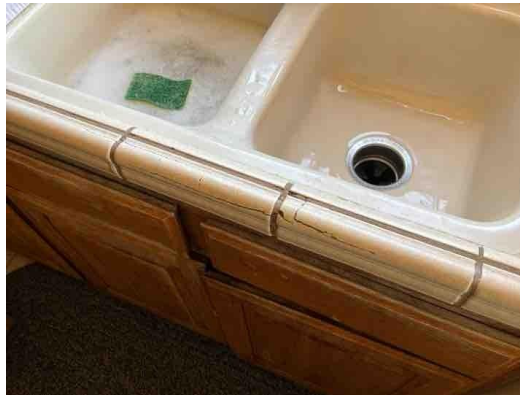
**MR 110: Disclosure:** Some cracked tiles noted at the kitchen counter.

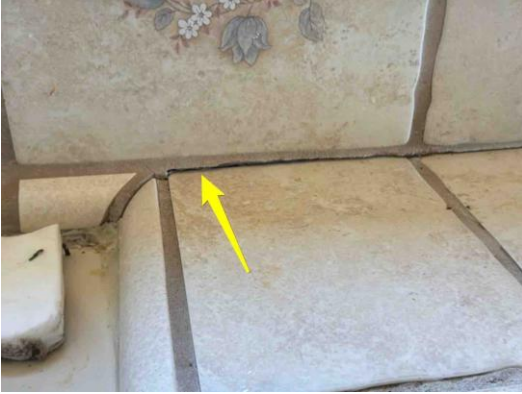
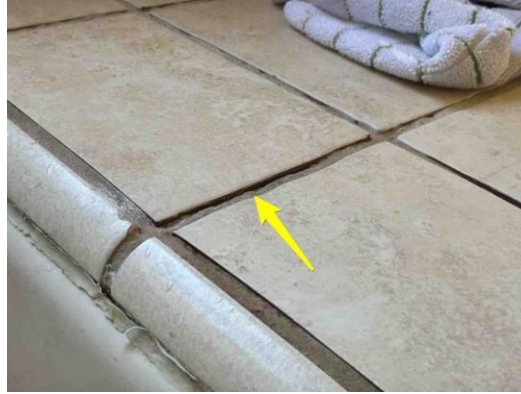
**E&C 111:** Deteriorated, cracked and damaged grout founded areas of the kitchen tiled countertops.

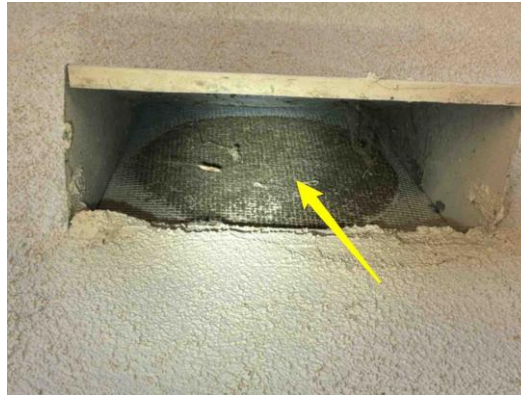
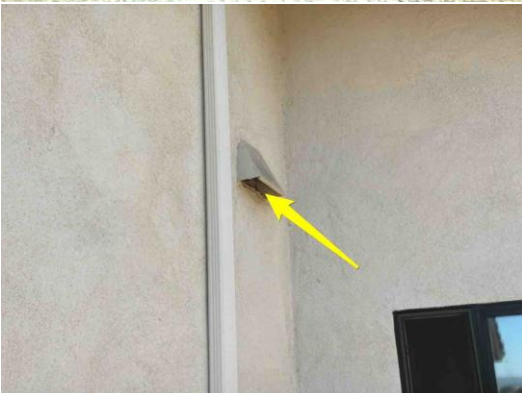
**SC 113:** The kitchen cooktop hood exhaust vent pipe termination found to have its screen clogged or partially blocked. Proper cleaning, maintenance is needed.

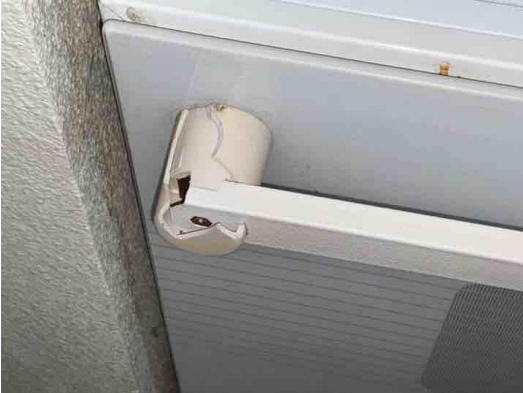
**E&C 118:** The lower oven door handle is broken.

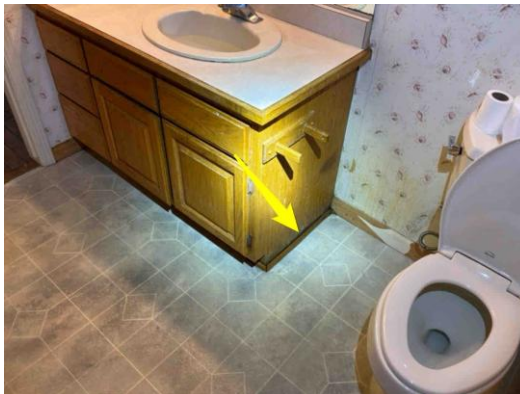
**FI** 133: Some dry moisture stains and damage found at the bathroom cabinet in the: HALLWAY BATHROOM

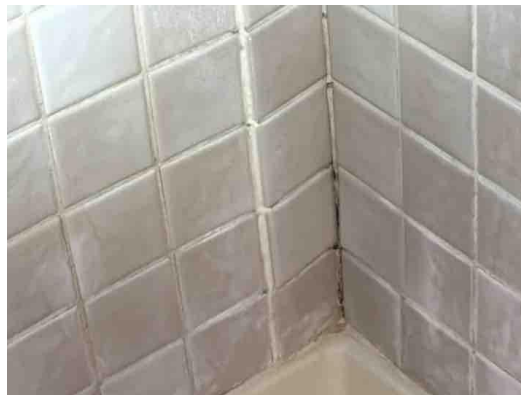
**UPG** 142: Deteriorated and or moldy grout found in the PRIMARY BEDROOM BATHROOM shower enclosure. Some general maintenance and/or upgrades are recommended.

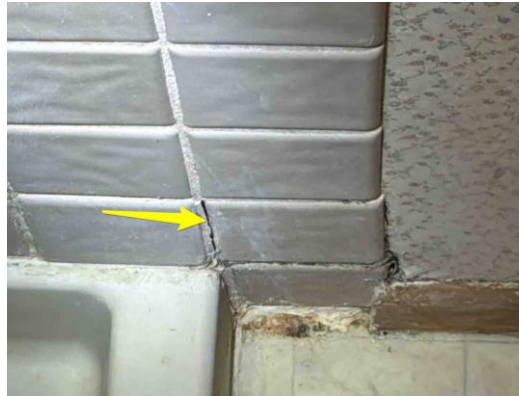
**FI 144:** Some loose, separated and uneven tiles found PRIMARY BEDROOM BATHROOM SHOWER.

Damaged grout

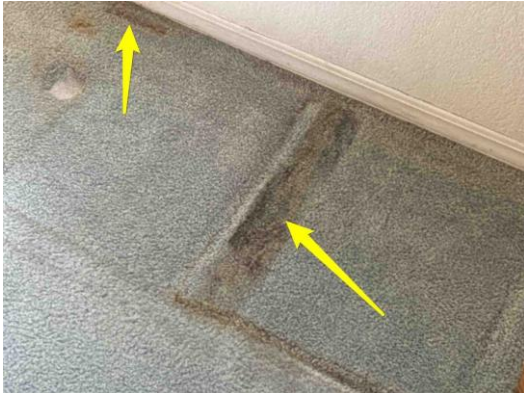
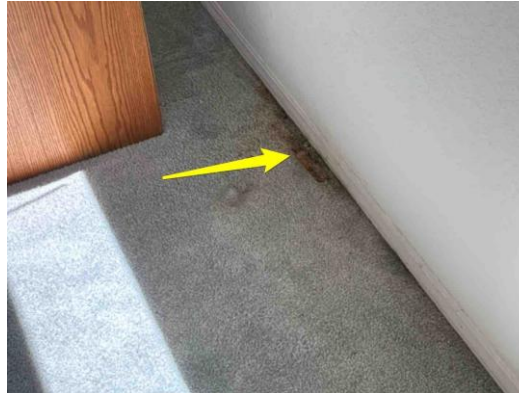
**167:** Some significant water stains and damage to the flooring and wall found in areas of BEDROOM-2 along the exterior walls. Client is advised to have a licensed contractor removed the baseboards, flooring and drywall to determine the cause and conditions inside the wall cavity. **Suspected mold growth** in confined areas of the wall.

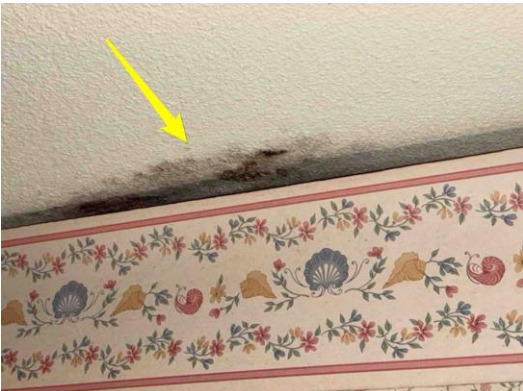
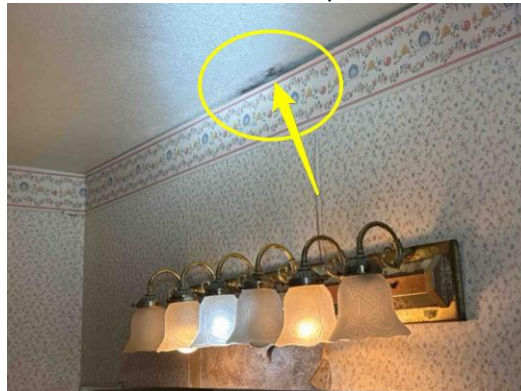
**SC 177:** Evidence of past moisture stains & damage with some visible mold growth on areas of the drywall: PRIMARY BEDROOM BATHROOM. Recommend additional review by a qualified remediation professional. Recommend further review to determine if stains are current or old and if repairs are needed.

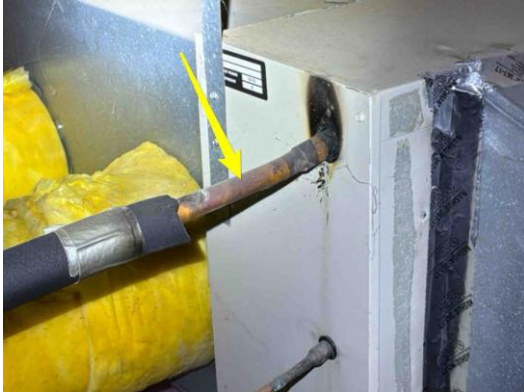
Example

**E&C 191:** Insulation damaged or missing at areas of the Air Conditioner refrigerant piping in the attic at multiple locations. This allows water to condensate and drip causing water stains and/or damage. Repairs or additional insulation needed.
