### *Inspection Report*

Address: 1345 Cecelia Ct San Luis Obispo, CA 93401

06/05/2026

Inspector: Taylor Vreeken, CCI

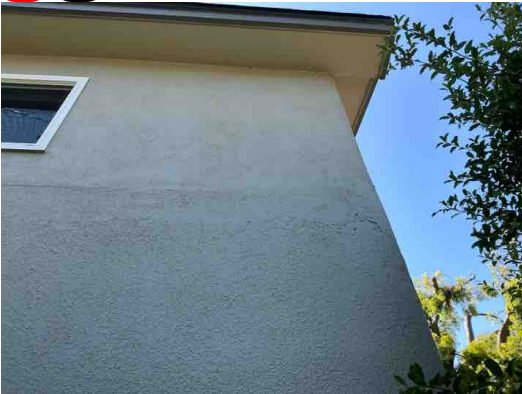
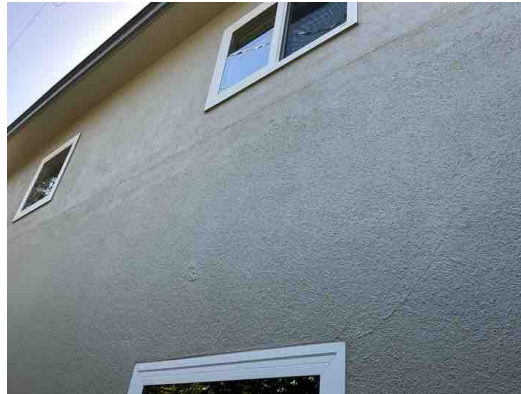
**FI DS 39:** Multiple past stucco crack repairs noted throughout. Ask seller for details.

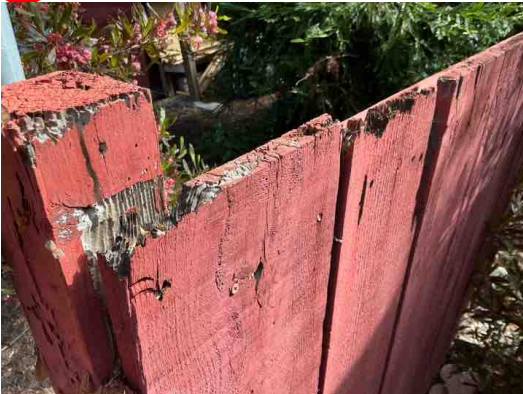
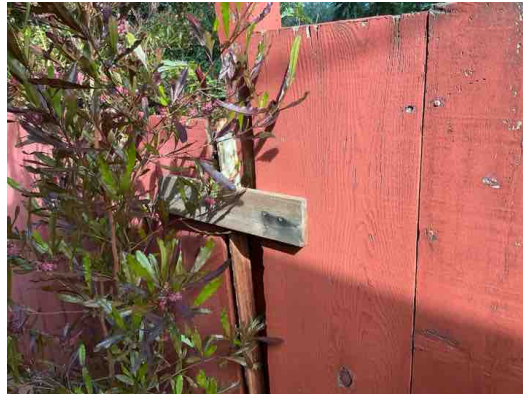
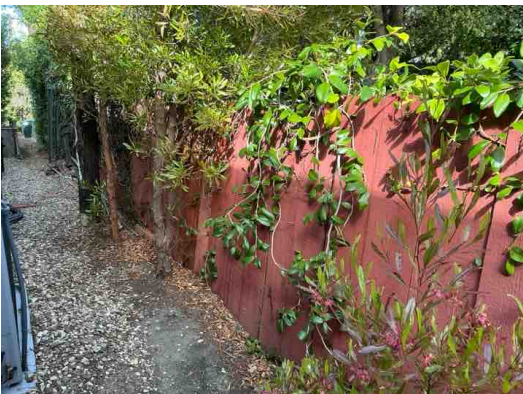
**E&C 48:** Areas of the fencing and gates are in a generally poor condition. Recommend servicing and/or repair.

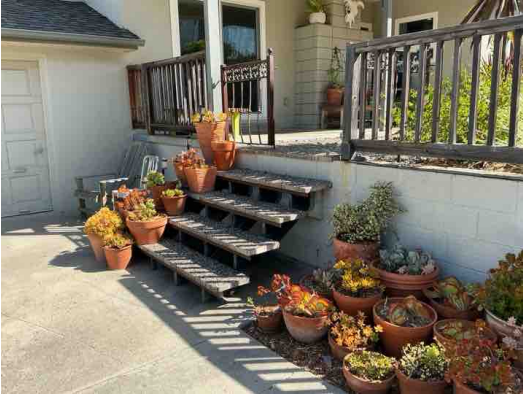
#### 51: OFF THE BACKYARD PATIO

**E&C 52:** Moisture and/or bug type damage & deterioration found at exterior wood stairs, steps and/or landings: OFF THE BACKYARD PATIO. Refer to the Termite report for additional details and recommendations.

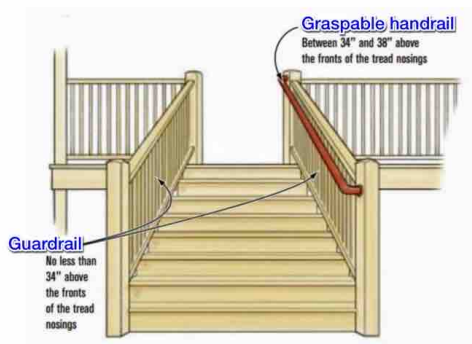
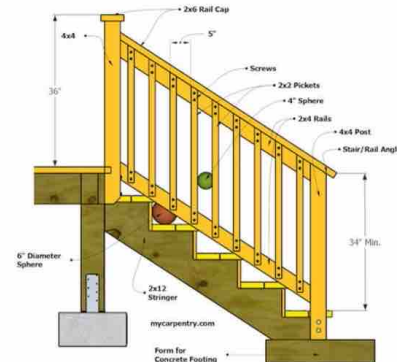
**SC 53:** Missing the proper guardrails and graspable handrail at the exterior stairway: OFF THE BACKYARD PATIO. A proper guardrail and graspable handrail is required on all exterior stairs where the potential fall from the stairway is greater than 30 inches.

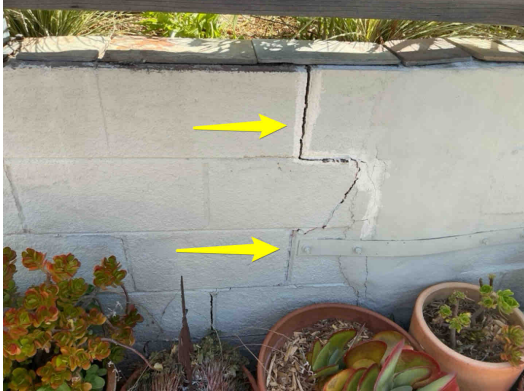
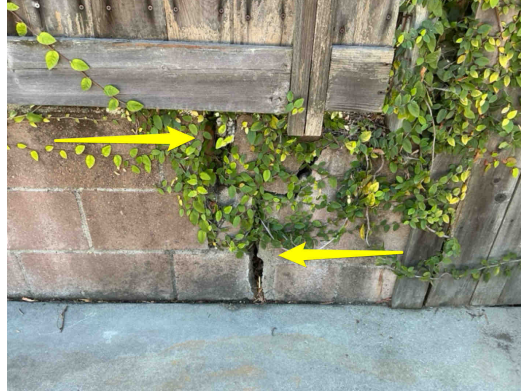
**FI 58:** Moderate, Major cracks with some displacement visible in the retaining walls.

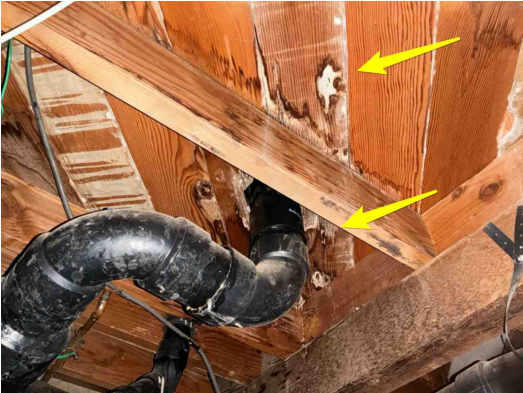
**FI 62:** Some water stains noted on the underside of the wood framing in areas of the crawlspace under some exterior doors, bathrooms and/or kitchen. Refer to the Termite report for additional comments and recommendations as to the exact location, extent, and if repairs are needed.

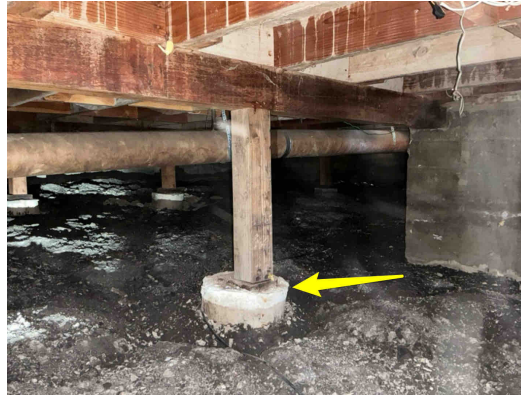
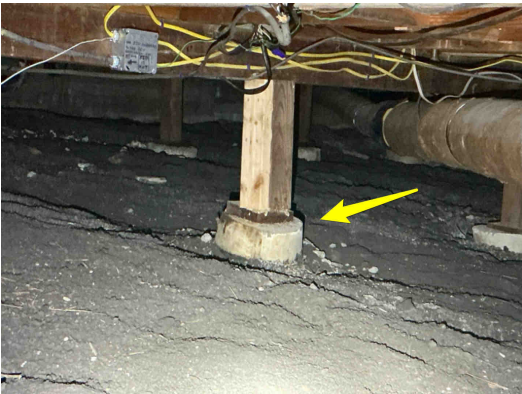
**E&C 72:** Some support posts in the crawlspace show signs of minor settlement with uneven framing and interior floors. Recommend further review and repairs by qualified foundation professional.

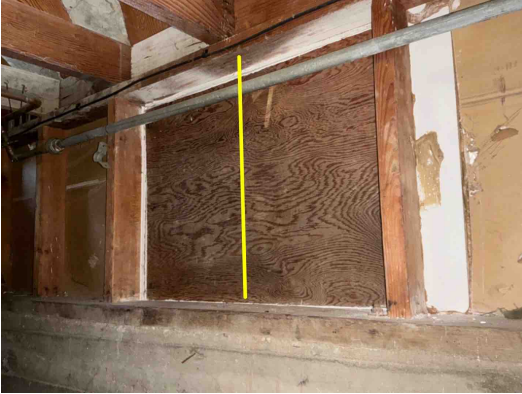
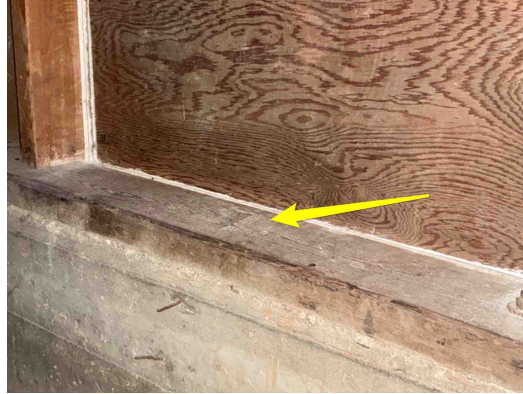
**74:** An access from the Garage to the CRAWLSPACE was added without proper framing support. Contact a licensed professional for repairs.

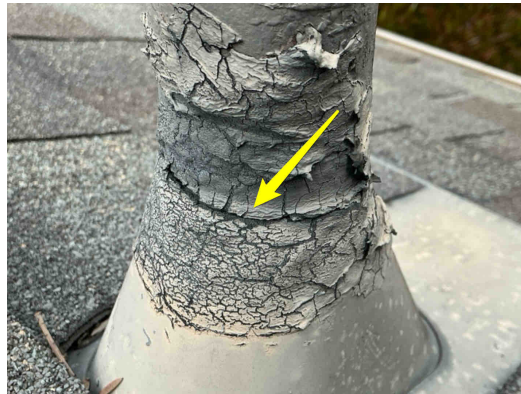
**MR 82:** Deteriorated sealant at some roof flashings, around the roof penetrations. Maintenance recommended to help prevent water intrusion into areas of the attic. Have roofer evaluate the roof flashings and correct as needed.

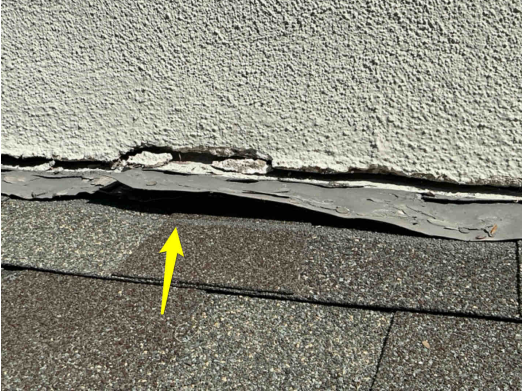
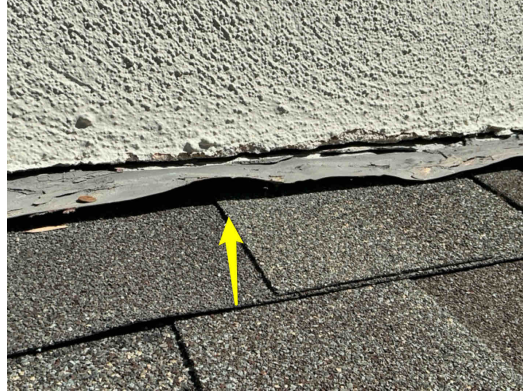
**E&C** **MR** **83:** Some lifting roof flashings. Corrections, maintenance or repairs are recommended to help prevent water intrusion and/or roof leakage from windy, wet weather.

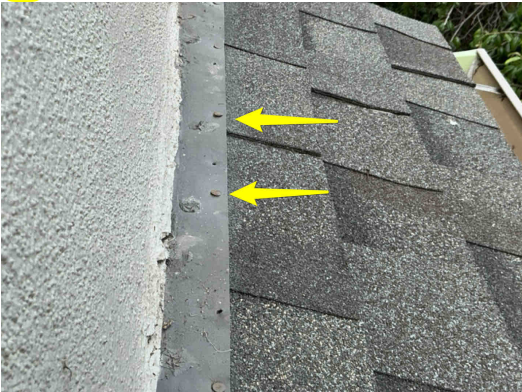
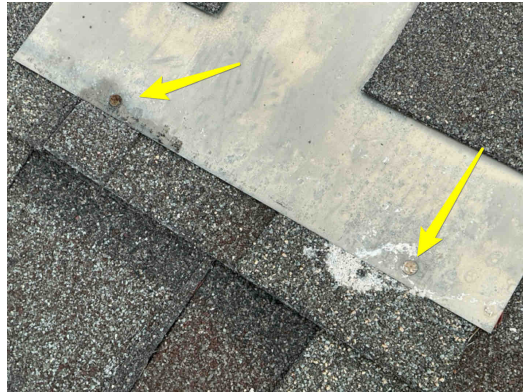
**MR** **85:** Recommending resealing fasteners at the roof flashing as part of typical maintenance.

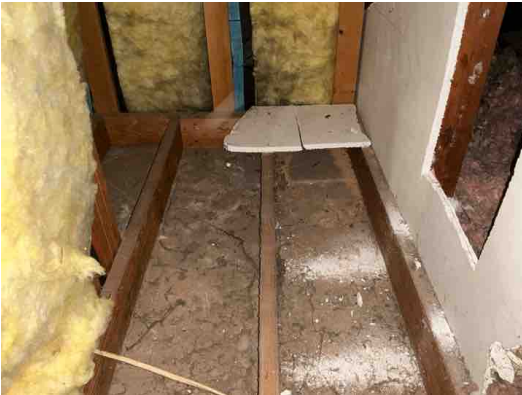
**E&C 94:** Missing insulation in the areas attic. Some of the attic Insulation in has been moved, displaced or was not originally installed for reasons unknown.

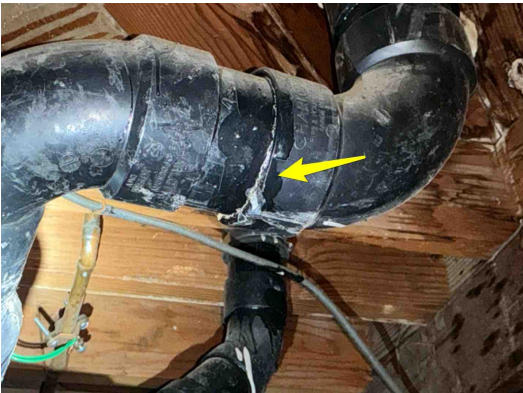
**FI 112:** Corrosion with evidence of past leaking noted on areas of the waste piping and fittings in areas of the crawlspace. Recommend further review of the waste piping throughout the crawlspace with cleanup and correction by qualified plumbing professional to help prevent additional future leakage.

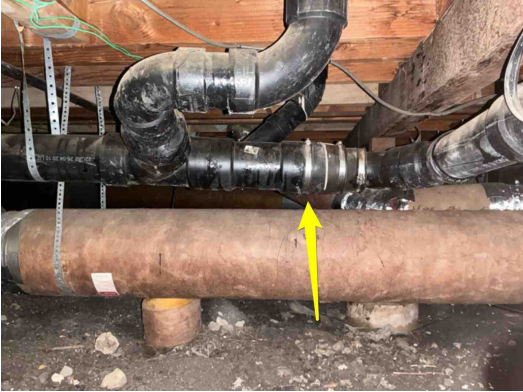
**E&C 113:** Areas of insufficient fall for drainage at some waste piping in areas of the crawlspace. Recommend further review of all the waste piping in the crawlspace by a qualified plumbing professional and repair as needed.

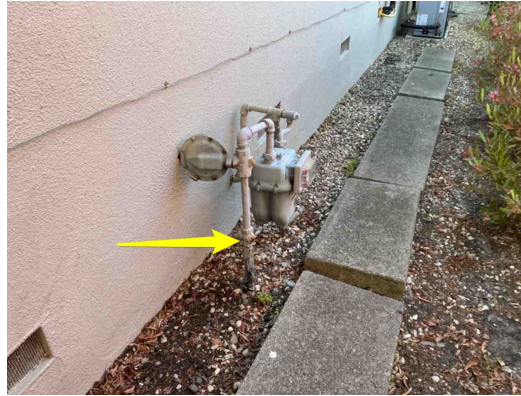
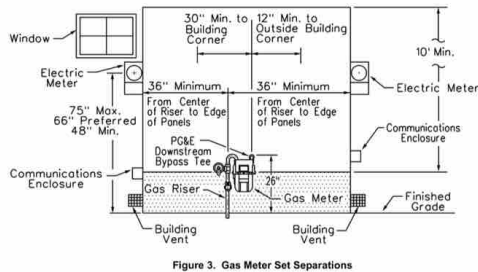
**SU 118:** Disclosure: The Gas meter found to be improperly installed too close to a crawlspace or garage vent opening per standards. Contact the Gas Company to evaluate and make recommendations for upgrades for safety. Generally the Gas Company repairs or upgrades at No cost.

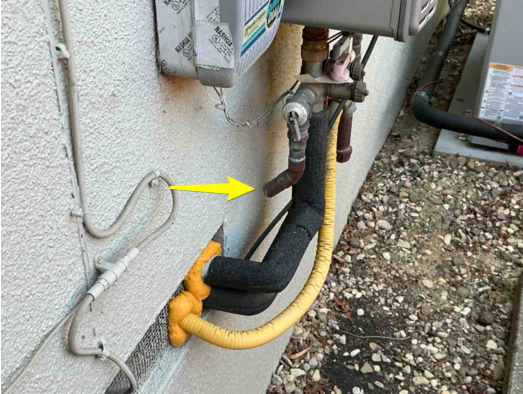
**SC 125:** The Water heater pressure relief pipe improperly terminates. Must terminate downward at the exterior at **6 to 24 inches from the ground.**

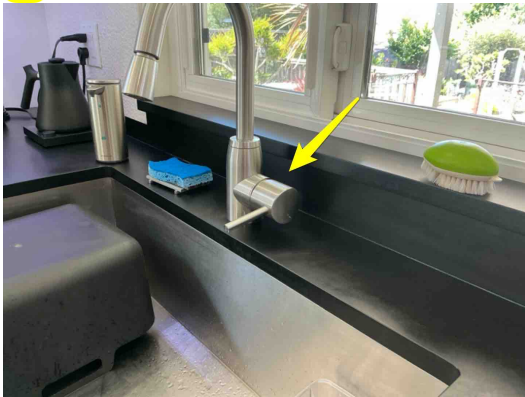
**SU 135:** Hot & cold reversed at the kitchen sink faucet.

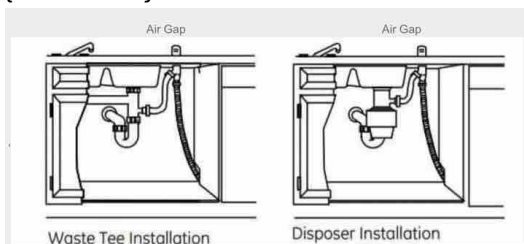
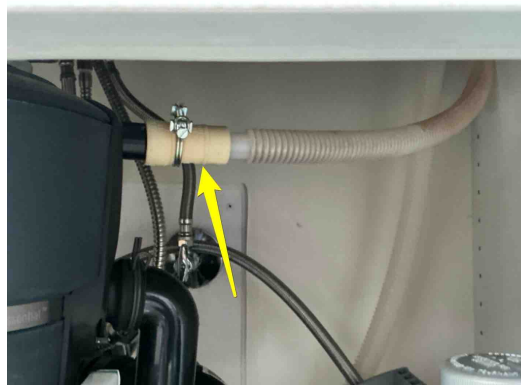
**SU 138:** Improper installation of the dishwasher drain hose. Missing the Air Gap Device at the dishwasher drain per minimum codes and standards (California does not allow for high-loop methods or direct waste connections). {CPC 801.2}

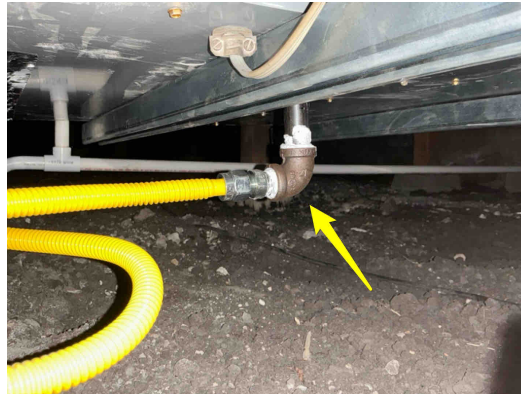
**UPG 200:** Missing the required installation of the sediment trap at the furnace gas piping at flex connection. Correction should be performed by a certified or licensed HVAC professional familiar with minimum requirements.

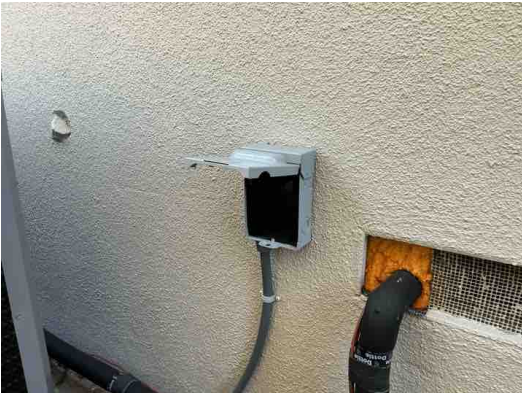
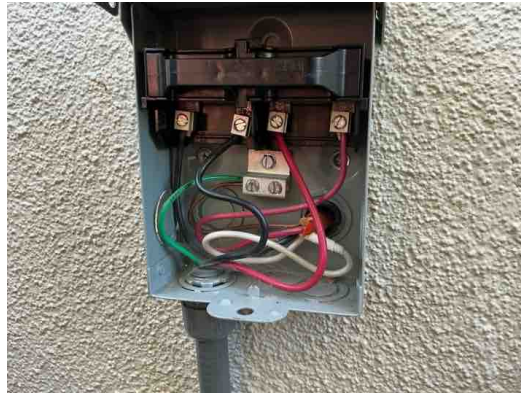
**E&C 210:** The exterior HVAC condenser service disconnect is not provided with GFCI protection. Current standards require GFCI protection for outdoor outlets supplying HVAC equipment (NEC 210.8(F), 2020 and newer). Recommend correction by a qualified electrician.

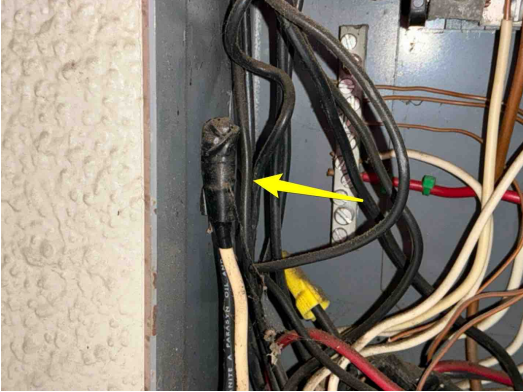
**SC 224:** A couple of unused wires in the MAIN ELECTRICAL PANEL found missing proper wire nuts. Repairs are recommended for safety to help prevent a short or shock. Contact a qualified professional.

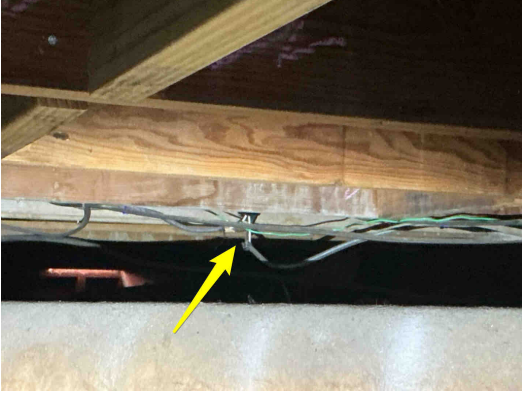
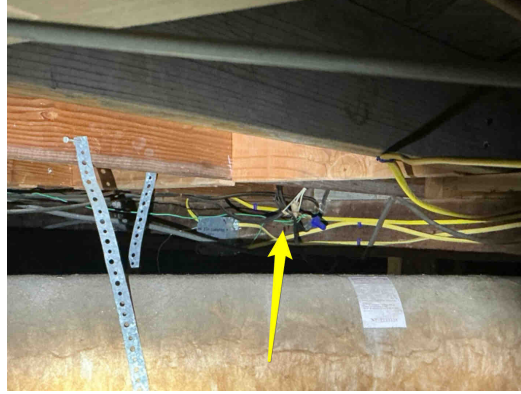
**SC 230:** Improper electrical wiring. Exposed electrical splices / wires not protected in a box with a cover:  
MULTIPLE IN THE CRAWLSPACE

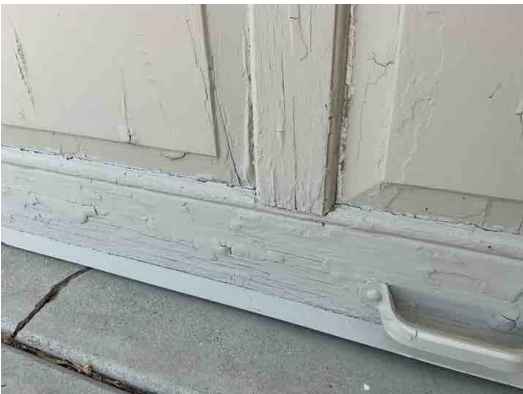
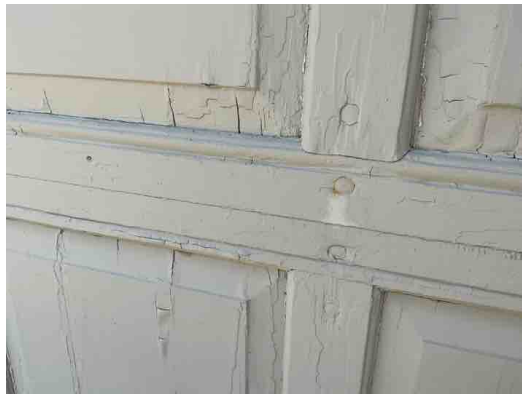
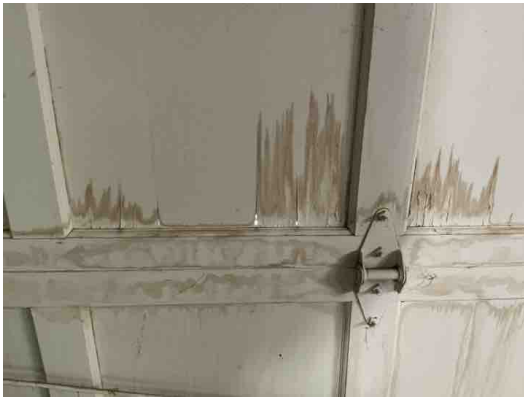
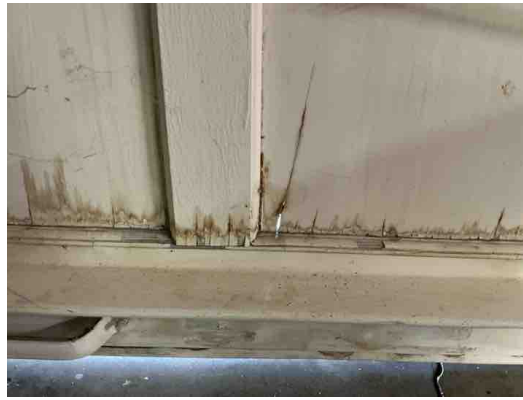
**E&C 253:** Some moisture stains & damage at garage vehicle door, door jam and/or trim. Refer to the termite report for additional comments and recommendations.

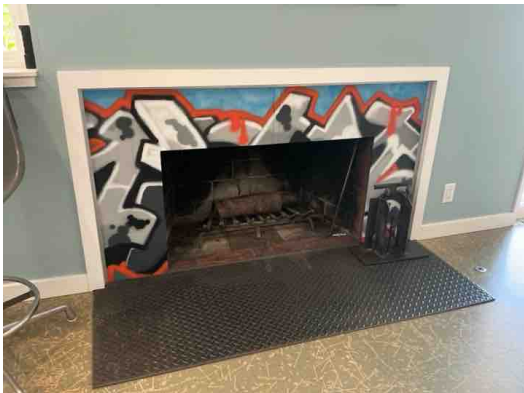
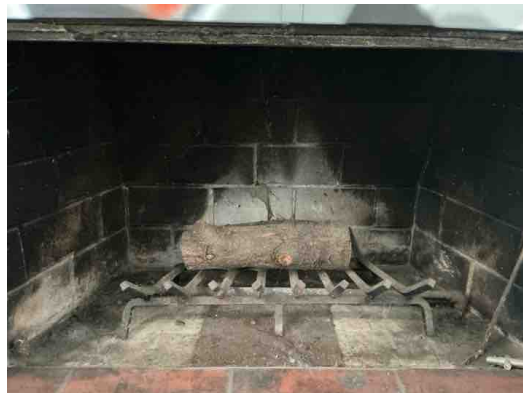
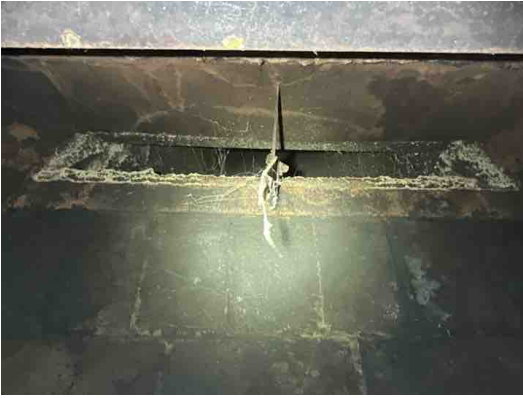
**260:** **DINING AREA**

**E&C 267:** Cracked and damaged bricks and/or mortar found at the back wall inside the DINING AREA fireplace firebox. General maintenance and/or repairs are warranted as cracks and separations can allow superheated gases to escape through the back wall and collect in the confined spaces of the chimney. Contact a qualified chimney sweep/professional to grind out and re-mortar cracked and separated areas for safety.

**MR DS 266:** Recommend cleaning & sweeping the fireplace and chimney by a qualified chimney sweep.

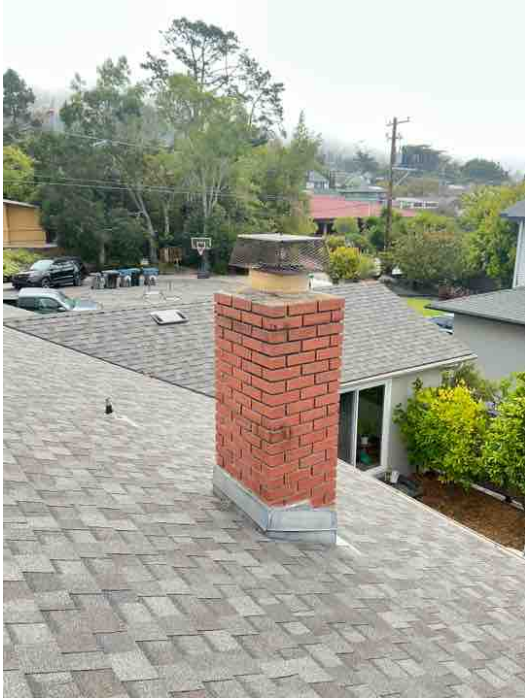
**268:** Photo of the DINING AREA Masonry Chimney

**MR 269:** Deteriorated sealant found at the mortar crown to flue connection located at the top of the DINING AREA fireplace chimney. Maintenance / caulking or sealing is recommended to help prevent water intrusion into the confined spaces within the masonry chimney.
