### *Inspection Report*

Address: 2925 Warm Springs Ln Templeton, CA 93465

04/05/2025

Inspector: Keith Vreeken, MCI, FCI  
P.O. Box 415 Templeton, CA 93465 O: 805.462.1978 C: 805.440.5050

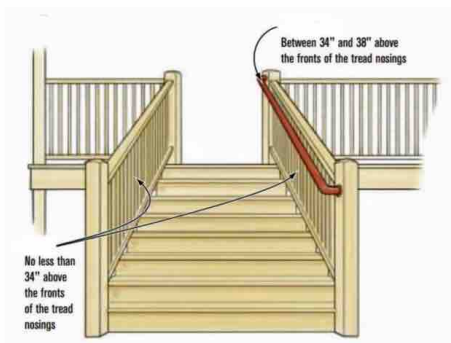
Example location

**SU 41:** Recommend a proper graspable handrail at the exterior stairway OFF THE BACKYARD PATIO for safety.

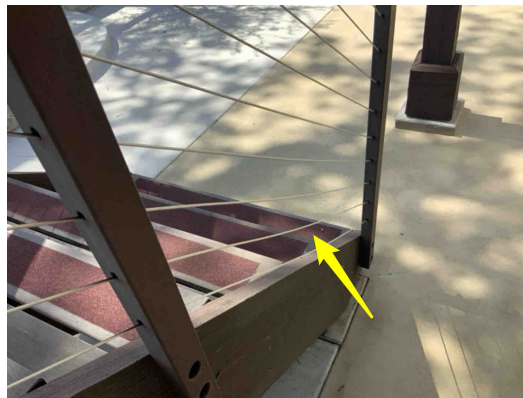
Example

**SC 45:** Some loose cable found at the guardrails at the exterior stairway TO THE UPSTAIRS UNIT OVER THE GARAGE

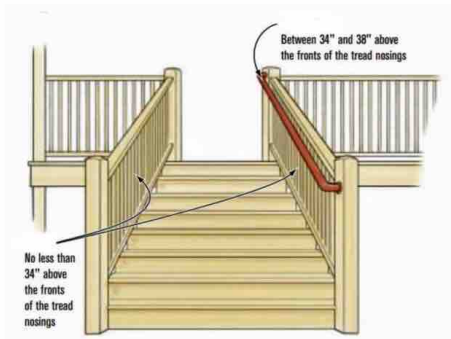
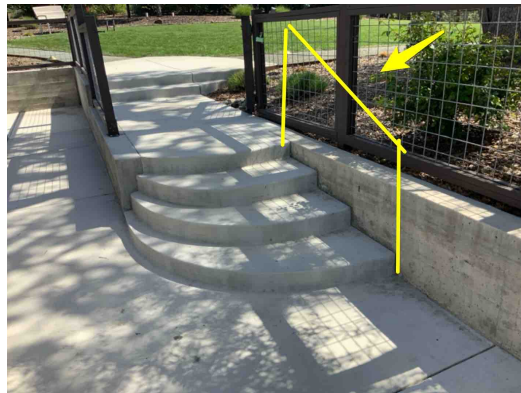
Example location

**SU 48:** Recommend a proper graspable handrail at the Concrete exterior stairway off the GARAGE sidewalk for safety.

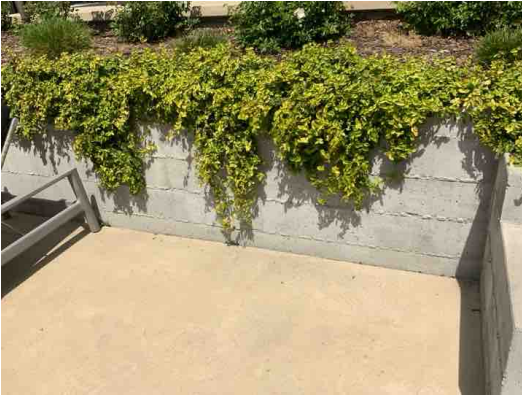
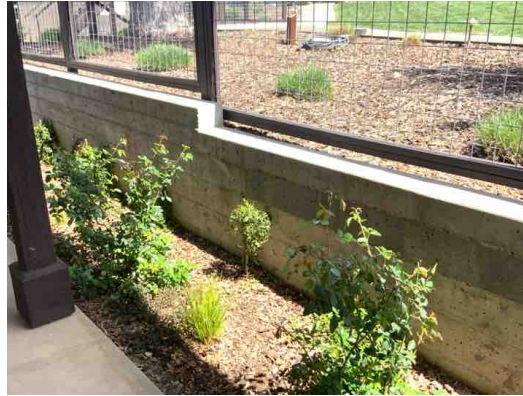
Example

**DS 57: Disclosure:** Some common cracks noted at areas of the masonry, stuccoed and/or concrete retaining walls.

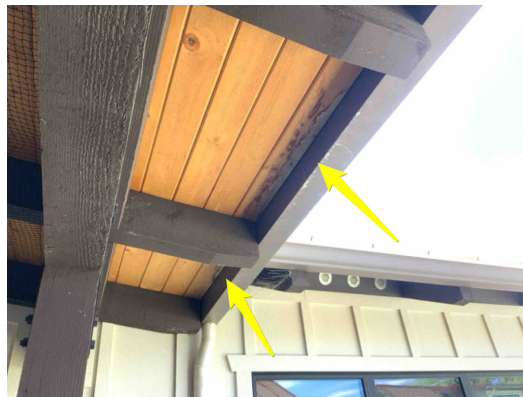
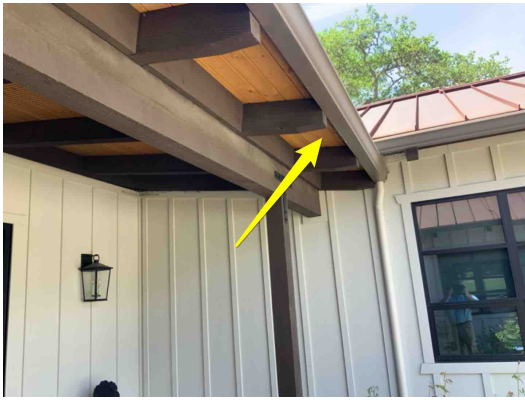
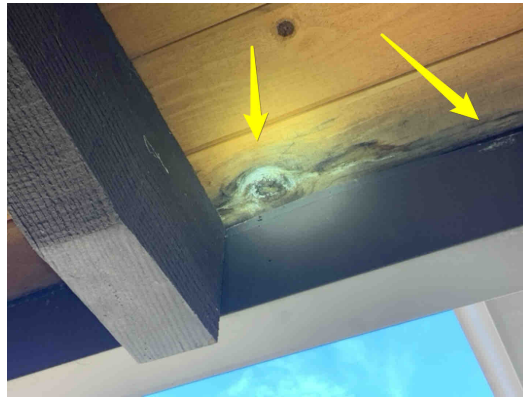
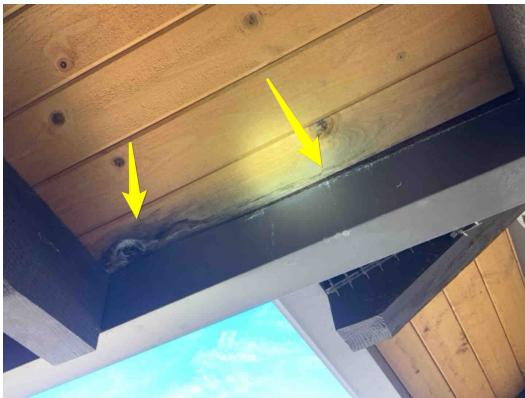
Example - at the front porch cover

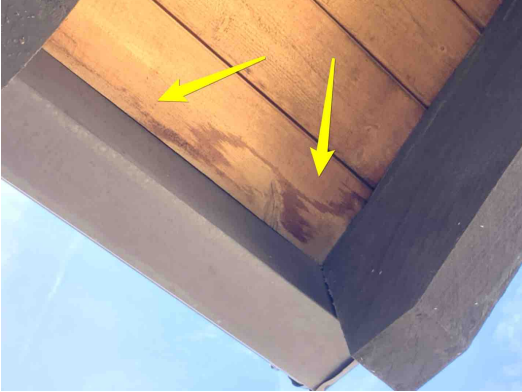
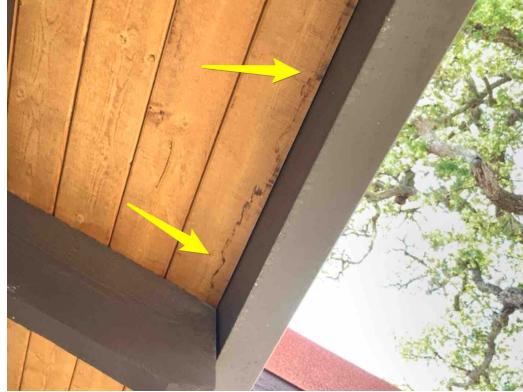
Example

**FI 66:** Suspected roof leaks. Evidence of moisture stains and/or damage at areas of the roof overhangs: Areas Around The Perimeter of the House and the Garage

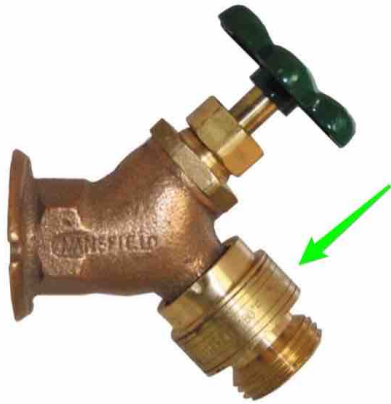
**UPG 88:** Anti-siphon valves recommended on exterior hose faucets where not installed.

Example of an anti-siphon valve on a hose faucet

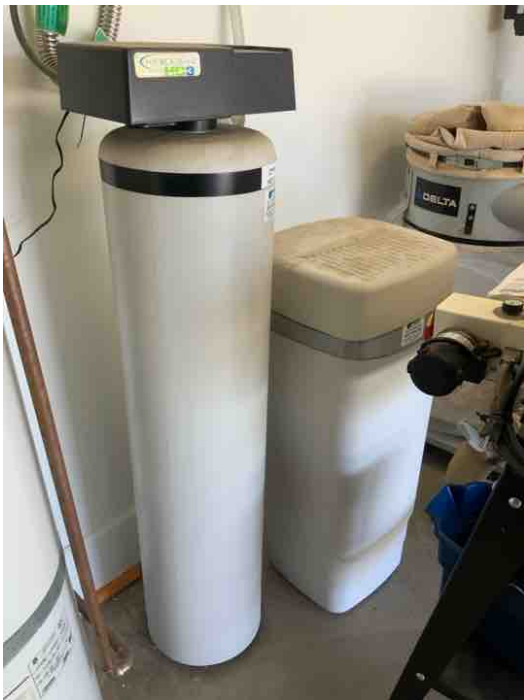
**MR DS 89:** Water softener installed in the Garage  
*Water quality not tested. Water softeners require continuous and ongoing maintenance. Please read owner's manual for recommendations. Water softener not tested for operation.*

**MR 90:** Recommend servicing water softener. Water softener found low on salt and dirty.

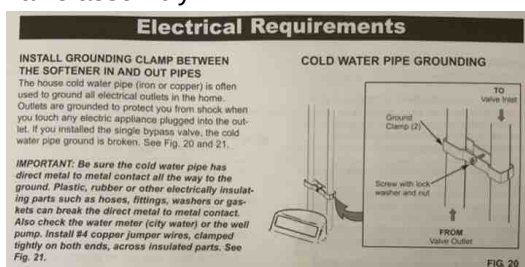
Example location

**SC 91:** Missing a proper bond jumper (ground connection) across the water softener pipes due to the plastic water valve assembly.

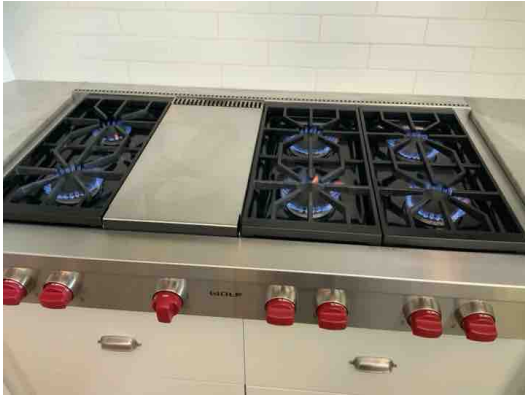
## COOKTOP

**141:** The cooktop is Natural Gas and operated when tested

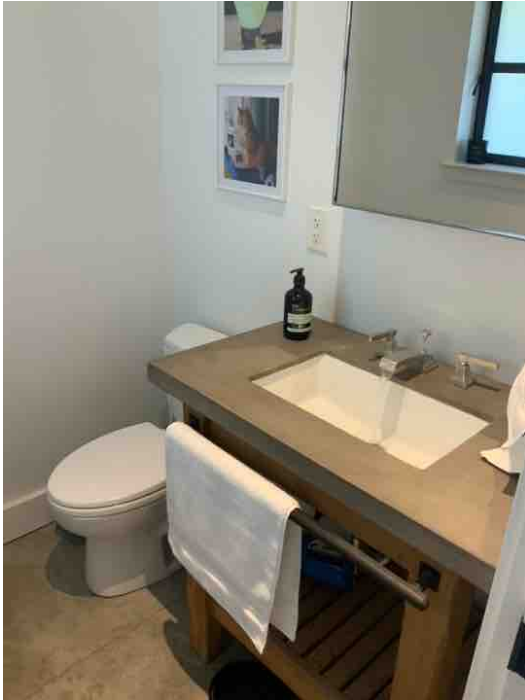
**155: LAUNDRY ROOM 1/2 BATHROOM**

**E&C 159:** Toilet loose at floor: LAUNDRY ROOM 1/2 BATHROOM

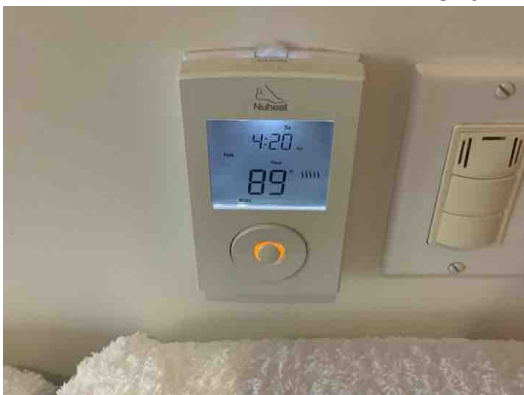
**165:** The electric radiant floor heating system operated when tested: PRIMARY BEDROOM BATHROOM

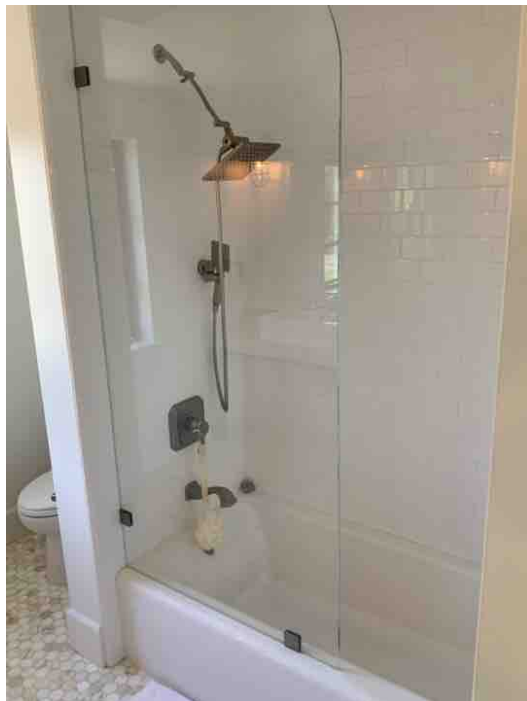
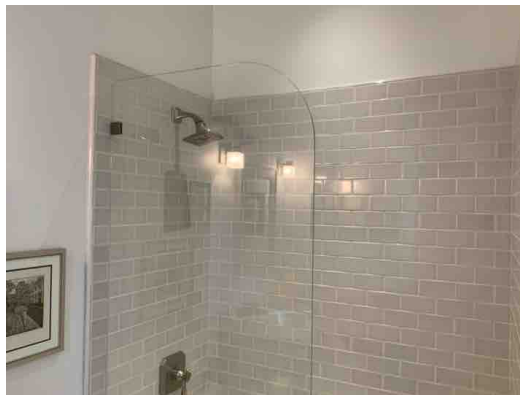
1. CASITA BATHROOM OVER THE GARAGE
2. GUEST BEDROOM BATHROOM

**SU 168:** Is it considered a potential hazardous installation to have an enclosure wall or glass enclosure panel in which it does not allow the occupant to reach and adjust the shower faucet temperature control valve from the opening without the potential of getting wet and scolded by hot water:

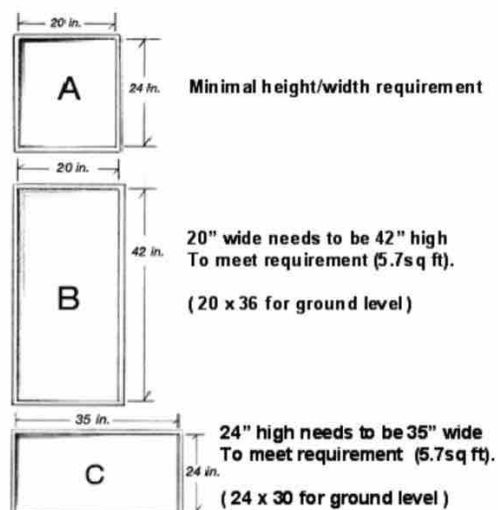
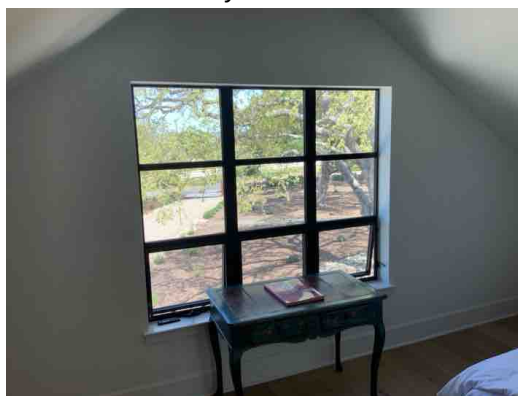
**SC 178:** Windows in the CASITA BEDROOM OVER THE GARAGE are too small and do not meet the current minimum fire egress standards. Upgrades recommended for safety.

Total window area needs to be 5.7 sq ft  
(5.0 for ground level)

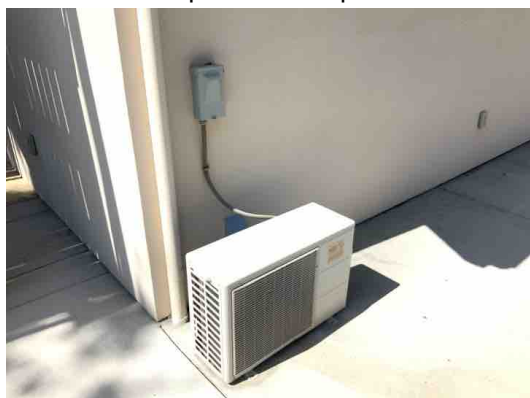
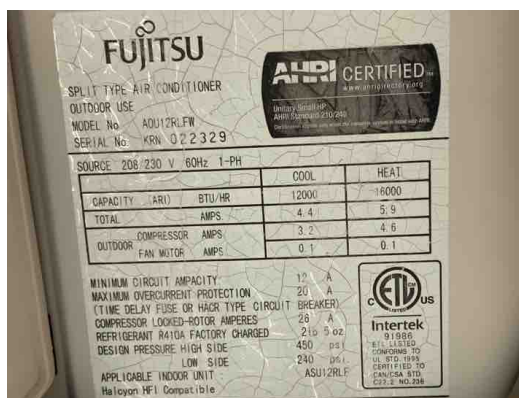
**189:** Location: GARAGE  
Heating Approx. BTU: 16,000  
Heating/ Cooling type: Electric Heat Pump / Mini-Split  
Cooling Size: 1 Tons  
Minimum Current Ampacity: 15  
Maximum Current Ampacity: 20  
Currently at: 20 Amps  
Refrigerant: R410A  
Date: 2023

**E&C 190:** Recommend sealing the hole or opening through the exterior wall where the Air Conditioner's refrigeration pipes enter the building. This will help prevent rodent, bug and /or water intrusion through this area as need per standards.

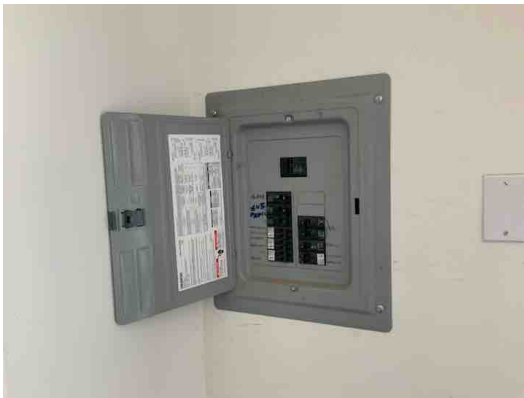
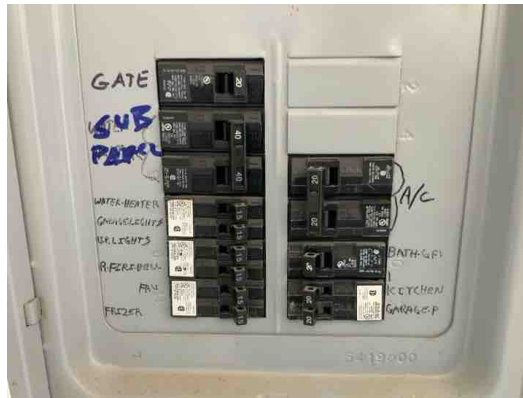
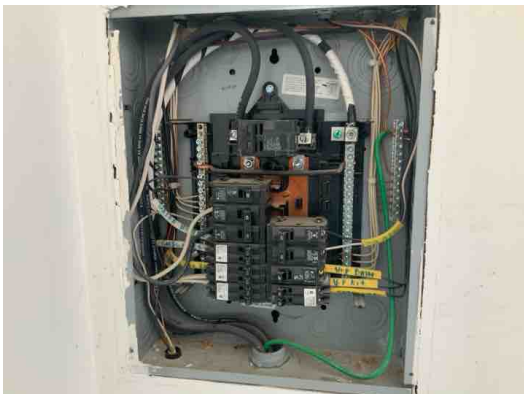
**216:** Location: **Garage**

**SC 217:** Electrical panel defect / Over-fusing (breaker found too large for wire), 15-amp wire on a 20-amp breaker in the GARAGE ELECTRICAL SUB PANEL.

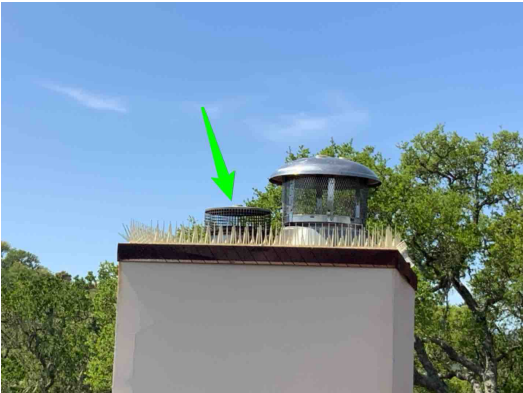
**241:** The EXTERIOR BACKYARD PATIO fireplace chimney.

**E&C 242:** The metal prefabricated fireplace chimney pipe and cap improperly terminates to low at the roof at the EXTERIOR BACKYARD PATIO. The pipe and cap should terminate a minimum of 10-12 inches above the chase per standards.
