## Inspection Services

### *Inspection Report*

Address: 2945 Hemlock Ave Morro Bay, CA 93442

08/29/2026

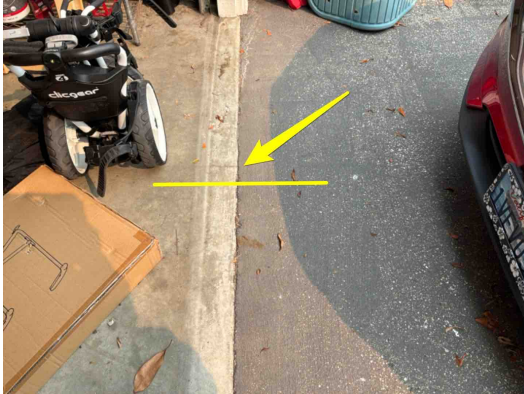
**DS 15: Disclosure:** Due to the slope and height of the driveway at the garage connection, some water intrusion into the garage may occur during certain weather.

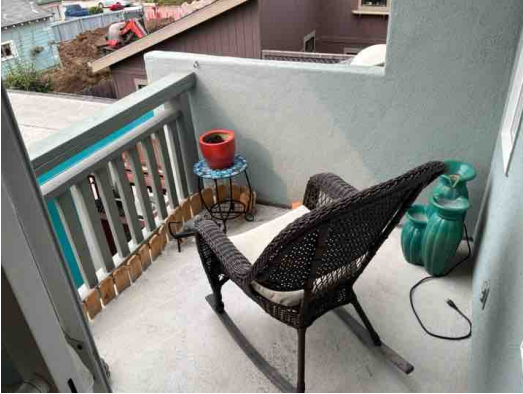
30: DECK LOCATION: **UPSTAIRS WATERPROOF DECK OFF THE KITCHEN**

**E&C 31:** Areas of deterioration, cracking and separations of the waterproof deck coating noted at areas of the **UPSTAIRS WATERPROOF DECK OFF THE KITCHEN**. Maintenance or repairs needed. Recommend further review and/or repairs by a certified or licensed waterproof deck coating professional familiar with minimum requirements.

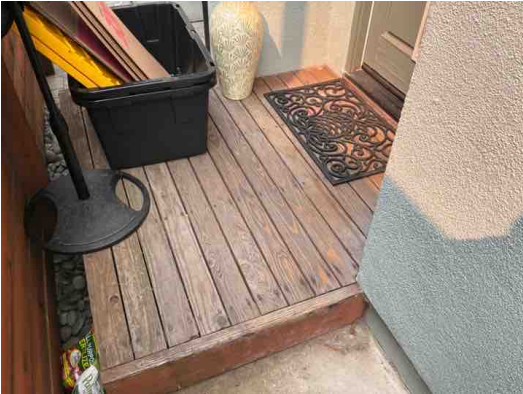
**33: DECK LOCATION:** FRONT ENTRY DECK

**MR 34: DECK CONDITION:** The FRONT ENTRY WOOD DECK appears within useful life. *Refer to the termite report for additional comments and/or recommendations.*

**DS 35:** *The underside of the FRONT ENTRY DECK deck was not visible or accessible due to at-grade construction. As a result, the condition of the deck framing and components could not be determined in concealed areas. Decks constructed at or near grade typically have reduced service life due to limited airflow, which can promote moisture retention and wood deterioration. Inspection was limited to visible surfaces only. Recommend further evaluation by a qualified licensed contractor.*

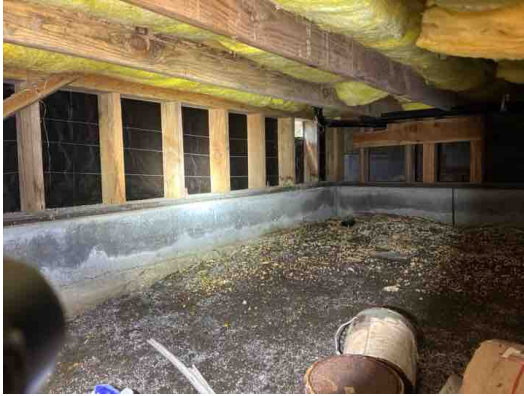
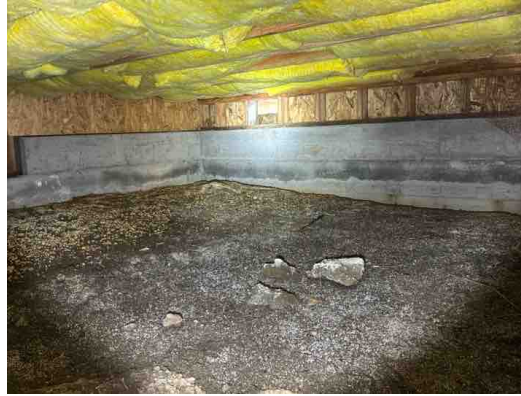
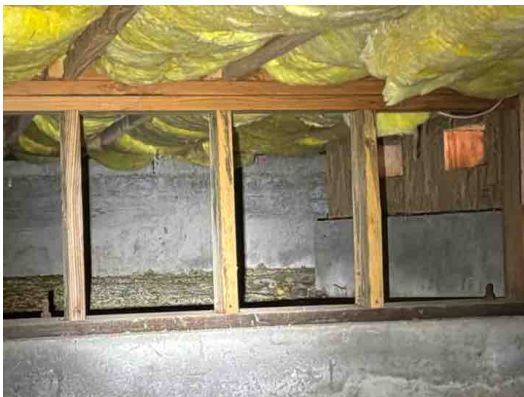
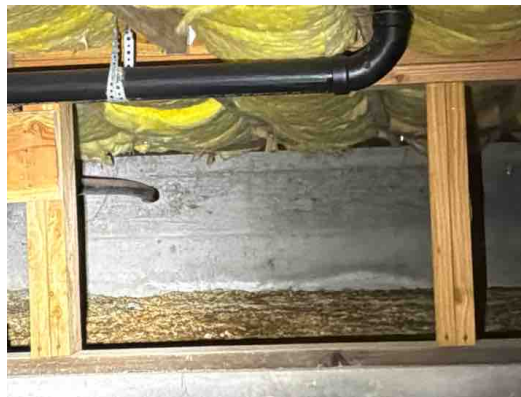
**DS** 41: **Disclosure:** Some typical and common cracks noted at visible areas of the perimeter foundation. Client is advised to measure and monitor cracks to determine if future movement occurs.

**FI** **DS** 42: Some typical cracks noted at areas of the concrete perimeter foundation system. Areas of cracks on the exterior should be documented and monitored as additional future movement may occur. If client or perspective homeowner has specific concerns as to cause, the current conditions and potential future issues, a licensed civil engineer should evaluate, document and provide information with regard to future potential conditions.

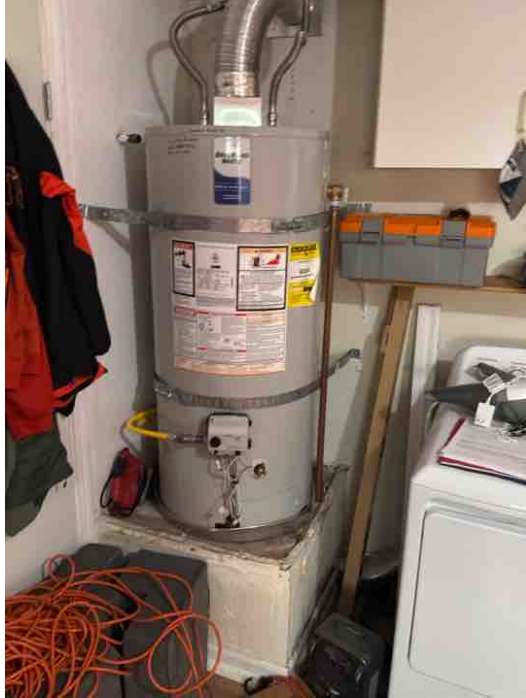
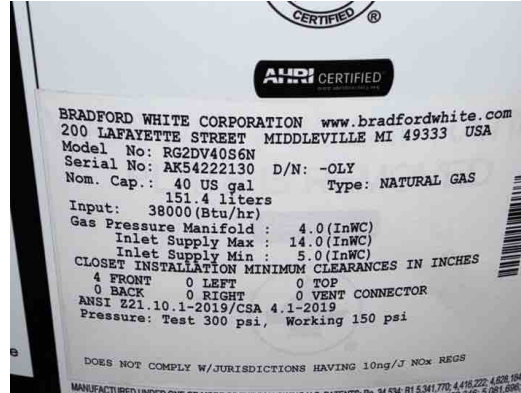
**SC 84: Water heater TPR (Temperature Pressure Relief) pipe found improperly terminating into the water heater catch pan.** This is considered a safety concern and warrants correction per minimum standards. Must terminate downward at the exterior at 6 to 24 inches from the ground.

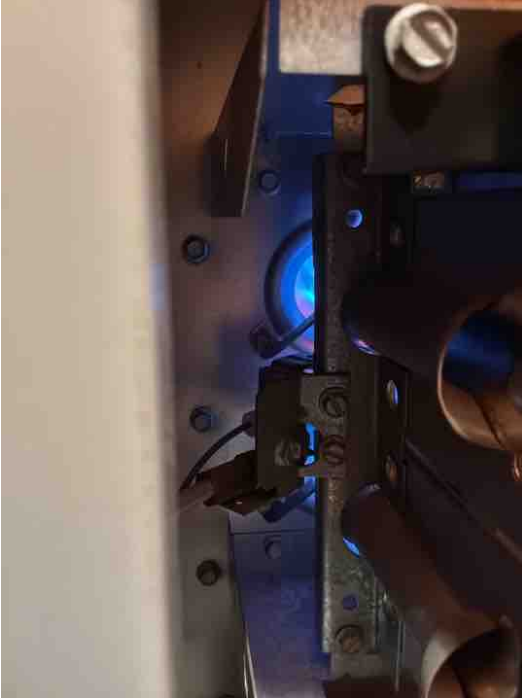
**DS 171:** "NOx" SCREENS found to be in good condition inside the furnace burn chamber.

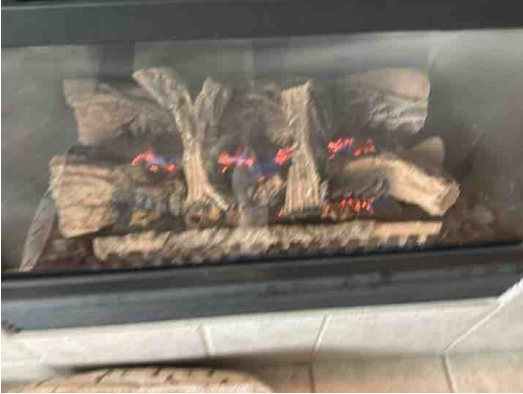
**206:** **GAS FIREPLACE CONDITION:** The FAMILY ROOM GAS fireplace operated when tested.

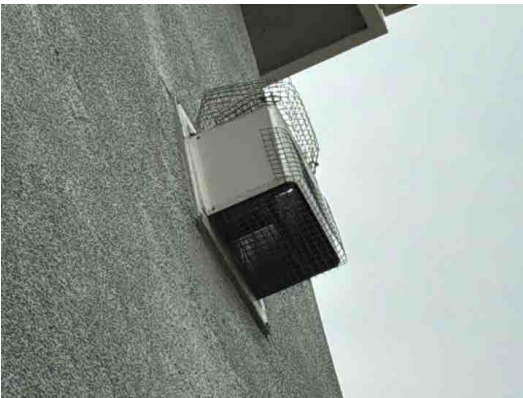
**208:** The FAMILY ROOM fireplace metal chimney pipe and cap above the roof appear serviceable and in good condition.
