Inspector: Blas Calvillo

130 Island View Drive, Lakeport, CA 95453

Inspection prepared for: Schad Schweitzer

Date of Inspection: 9/4/2026 Time: 09:00 AM

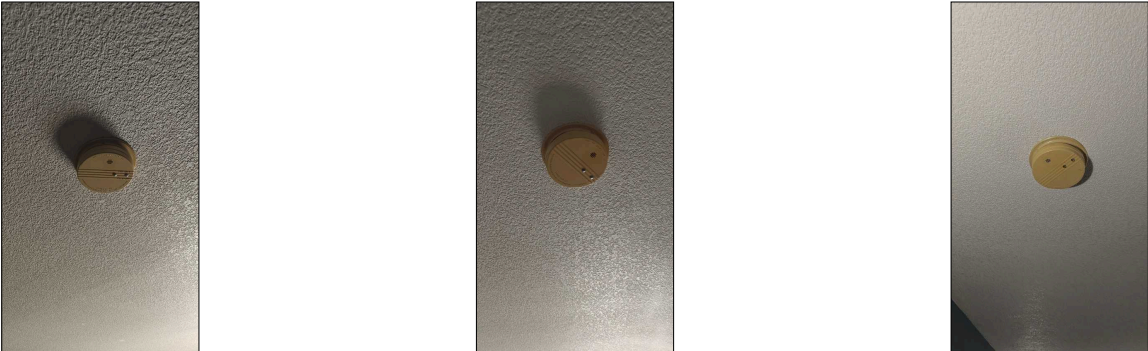
| Bedrooms | | |
|---|---|---|
| Page 18 Item: 6 | Smoke Detectors | <ul style="list-style-type: none"><li>• <b>Bedroom Smoke Detectors</b></li></ul> <p>The smoke detectors in the bedrooms exhibit multiple critical failures:</p> <p><b>Low Volume:</b> The two front bedroom smoke detectors are low audible when tested, meaning they do not produce a loud enough alert to safely wake occupants.</p> <p><b>Inoperable:</b> The Master bedroom smoke detector did not operate at all when tested using the built-in test button.</p> <p><b>Expired:</b> All of these units appear to be older than 10 years. Smoke detectors have a reliable service life of 10 years, after which their internal sensors degrade and become unreliable.</p> <p><b>Recommendation:</b> A qualified person should immediately replace all bedroom smoke detectors with new units. This is a high-priority safety hazard that compromises early fire warning for sleeping occupants.</p> |

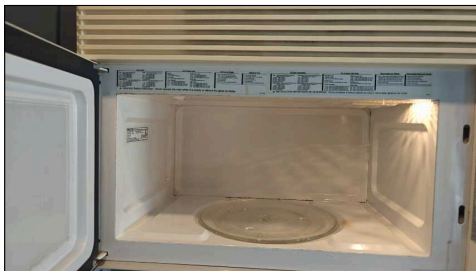
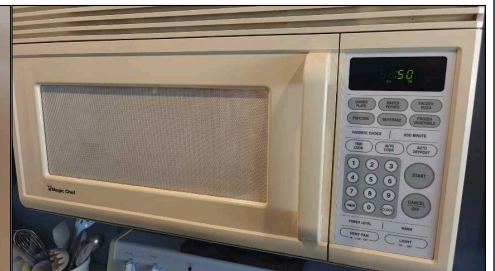
The microwave oven operated when turned on, but it makes an unusual buzzing sound during operation. An abnormal buzzing or humming noise typically indicates a failing internal component, such as the magnetron, high-voltage transformer, or cooling fan. Note that the unit was not fully tested for microwave energy leakage or heating efficiency.

**Recommendation:** A qualified technician should evaluate the appliance to determine the source of the noise, or the client should budget for a future appliance replacement.

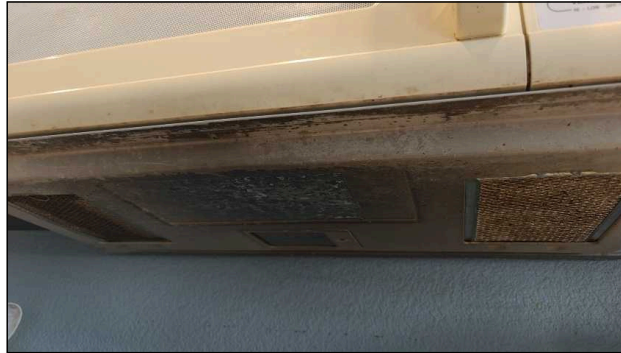
| Page 27 Item: 9 | Vent Condition | <ul style="list-style-type: none"><li>• <b>Kitchen Vent Hood</b><br/>The vent hood light did not operate when tested using normal operating controls. This may simply be due to a burned-out bulb, or it could indicate a faulty light switch, socket, or internal wiring issue.</li></ul> <p>Recommendation: Replace the bulb to verify operation. If replacing the bulb does not resolve the issue, a qualified person should evaluate and repair the light fixture or switch mechanism as needed.</p> |

The vent hood light did not operate when tested using normal operating controls. This may simply be due to a burned-out bulb, or it could indicate a faulty light switch, socket, or internal wiring issue.

**Recommendation:** Replace the bulb to verify operation. If replacing the bulb does not resolve the issue, a qualified person should evaluate and repair the light fixture or switch mechanism as needed.

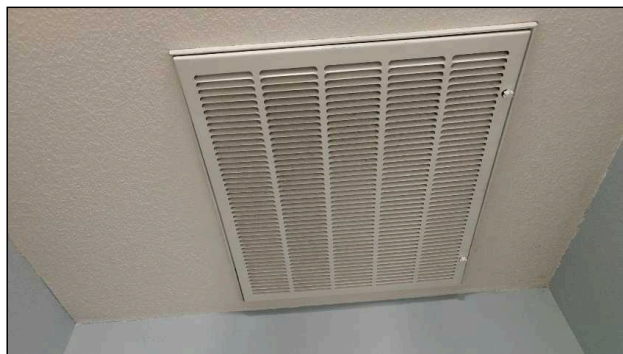
Page 32 Item: 3

The air filter located in the hallway ceiling return grille is dirty and restricted with dust and debris. A clogged air filter restricts airflow, which reduces the efficiency of the HVAC system, increases utility costs, and can cause the 2002 furnace to overheat and short-cycle, leading to premature component failure.

Recommendation: The air filter should be replaced immediately. Establish a routine maintenance schedule to inspect and replace the filter every 30 to 90 days to ensure optimal system performance and indoor air quality.

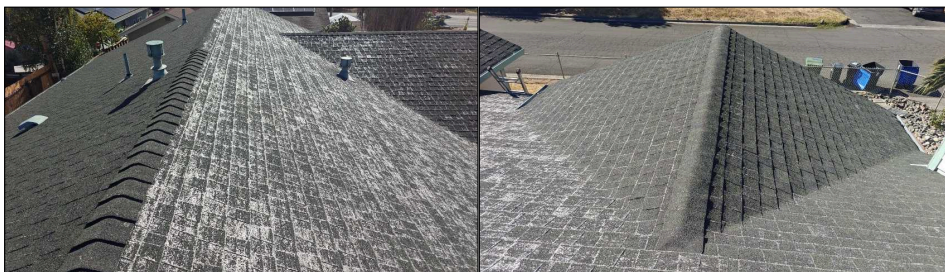
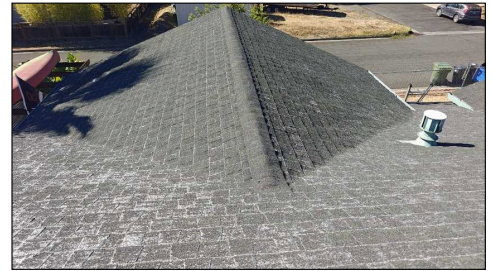
Roof Condition

Excessive granule loss was observed on the roof shingles, and the plumbing vent boots are torn. The loss of protective granules accelerates asphalt shingle deterioration from UV exposure, while the torn rubber boots create an active path for rainwater to leak directly into the roof framing and attic space.

**Recommendation:** A licensed roofing contractor should be contacted to evaluate the roof, replace the torn plumbing vent boots, and determine the remaining serviceable life of the shingles.

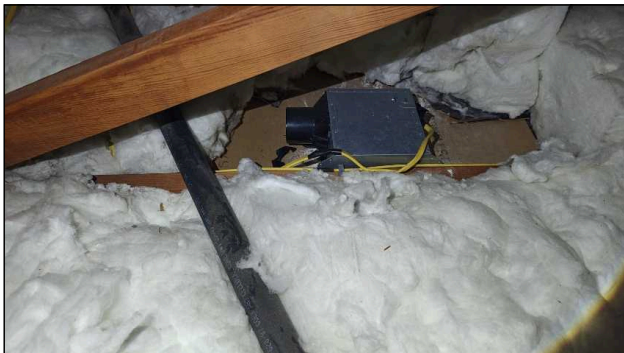
| Page 39 Item: 4 | Exhaust Vent | <ul style="list-style-type: none"> <li>• <b>Bathroom Exhaust Fan</b><br/>The bathroom exhaust fan is installed without any ducting, causing it to discharge warm, moist air directly into the attic space rather than to the exterior of the home. Venting moist air into an enclosed space can trap humidity, leading to condensed water accumulation, wood rot of structural framing, and accelerated mold growth.</li> </ul> <p>Recommendation: A qualified contractor or HVAC specialist should install a dedicated, insulated duct line that vents the exhaust fan directly to the exterior of the home through a proper roof or wall cap equipped with a backdraft damper.</p> |

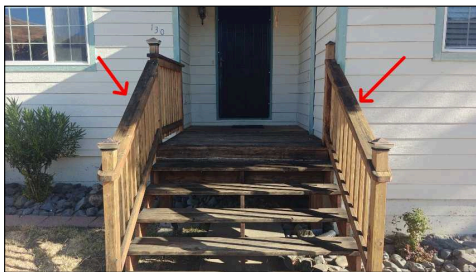
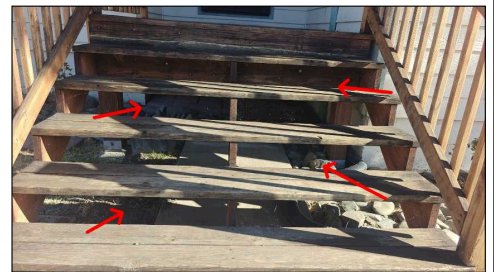
The deck installation exhibits multiple safety and structural defects that require immediate correction:

**Improper Handrails:** The deck stair handrails consist of flat 2x6 lumber, which does not provide a proper graspable profile required for safe grip.

**Open Risers:** The stair steps have open risers, which pose a trip and fall hazard, particularly for small children.

**Loose Guardrails:** The guardrails are loose, compromising the structural integrity of the safety barriers.

**Improper Ledger Attachment:** The ledger board is secured with deck screws. Standard deck screws lack the required shear strength to support the heavy loads of a deck and are prone to sudden failure.

**Recommendation:** A licensed structural contractor or deck specialist must be evaluated immediately. The ledger board must be retrofitted with approved structural thru-bolts or structural lag screws, the guardrails must be securely fastened, the stair risers should be enclosed (or reduced to less than 4 inches), and a properly graspable handrail must be installed to ensure safety and code compliance.

**Recommendation:** It is recommended to seal the newly installed Douglas fir deck boards with an appropriate exterior wood sealer or stain. Unfinished Douglas fir is vulnerable to UV degradation, moisture absorption, warping, and premature cracking if left unprotected against weather elements.

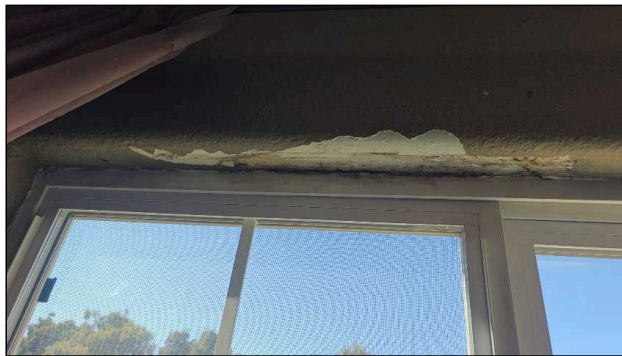
| Page 52 Item: 4 | Window Condition | <ul style="list-style-type: none"><li>• <b>Living Room Interior Walls</b></li></ul> <p>Moisture damage was observed on the drywall above the living room window. However, the affected area tested dry at the time of inspection when checked with a moisture meter. This suggests a past leak or an intermittent leak that occurs only during specific weather conditions, such as heavy or wind-driven rain.</p> <p>Recommendation: A qualified contractor should evaluate the exterior window flashing, siding, and roof area directly above this window to ensure the leak source has been permanently resolved. The damaged drywall should be repaired, primed, and painted.</p> |

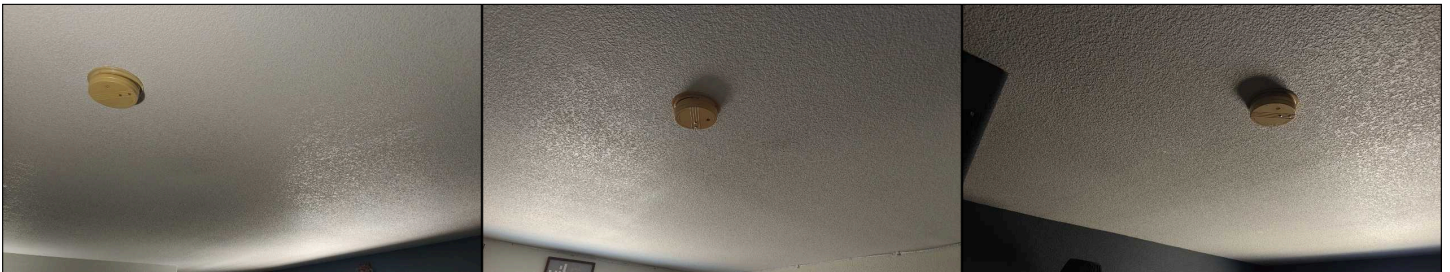
### 6. Smoke Detectors

The smoke detectors in the bedrooms exhibit multiple critical failures:

**Expired:** All of these units appear to be older than 10 years. Smoke detectors have a reliable service life of 10 years, after which their internal sensors degrade and become unreliable.

**Recommendation:** A qualified person should immediately replace all bedroom smoke detectors with new units. This is a high-priority safety hazard that compromises early fire warning for sleeping occupants.

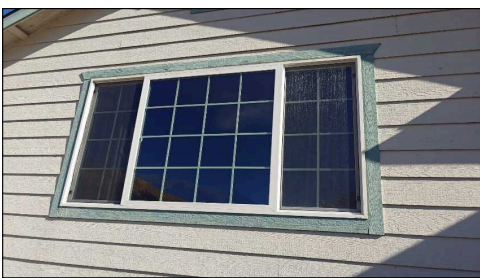
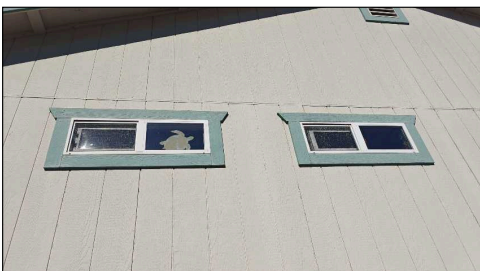
- Components appeared in satisfactory condition at time of inspection.

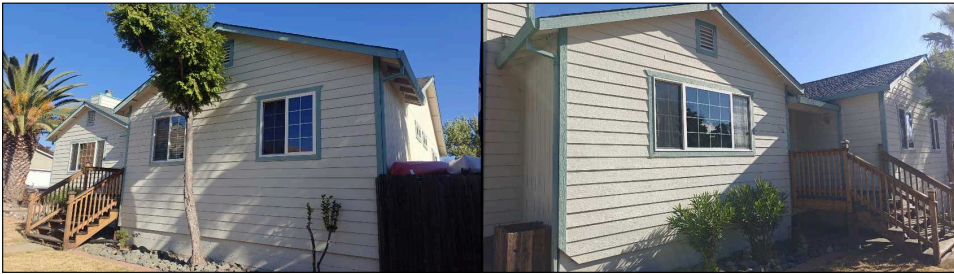
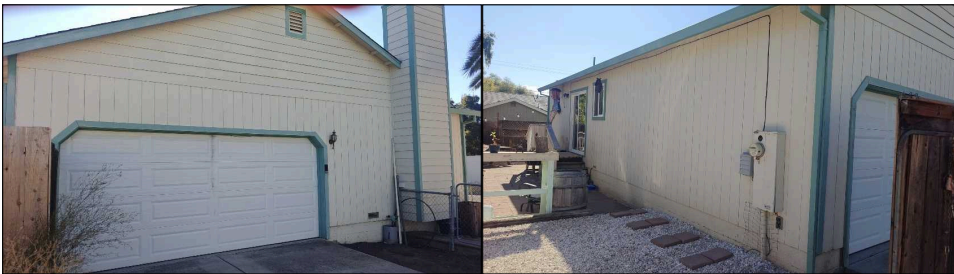
The composite wood siding appeared to be in good condition at the time of inspection, showing signs of normal weathering and no major structural defects, significant damage, or active rot.

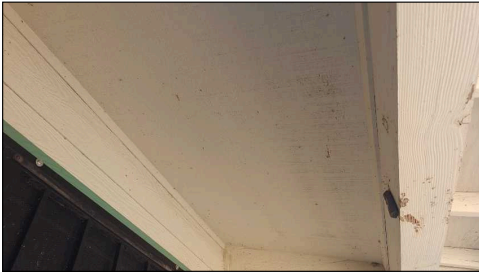
- The eaves appeared to be in good condition at time of inspection.

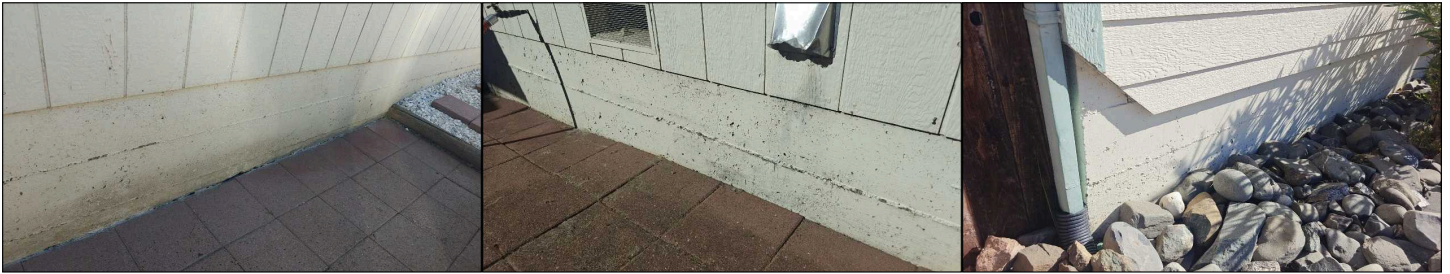
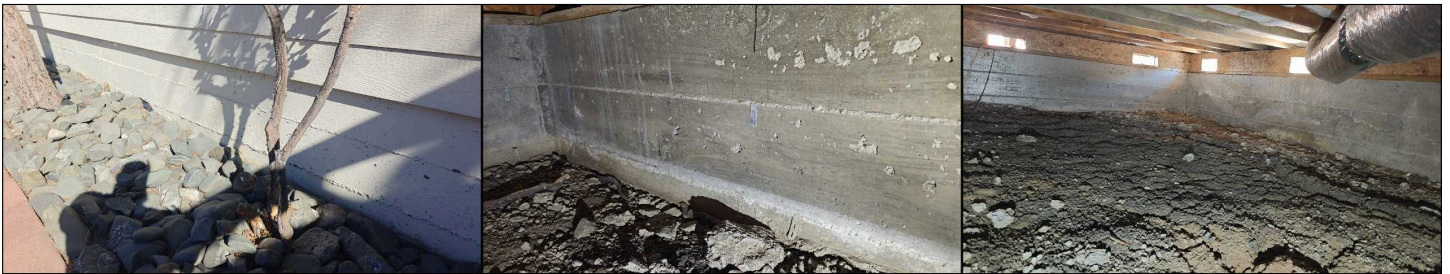
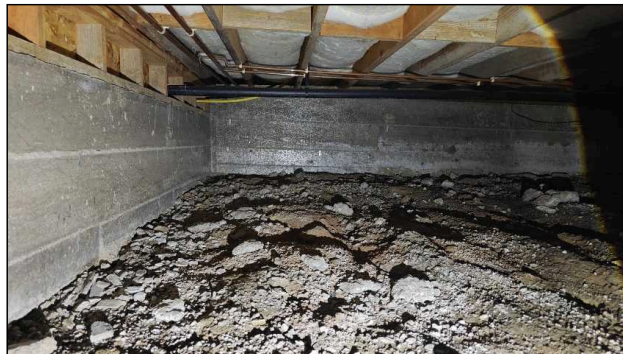
The concrete foundation perimeter appeared to be in good condition at the time of inspection, showing no signs of major structural cracking, displacement, or significant distress.

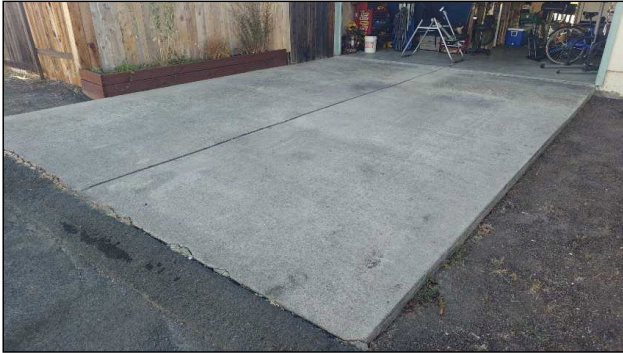
The concrete driveway and walkway appeared to be in good condition at the time of inspection, showing normal wear and no signs of major structural cracking, heaving, or significant displacement.

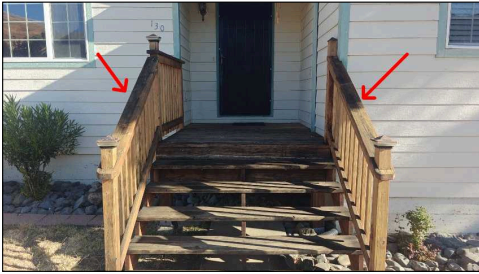
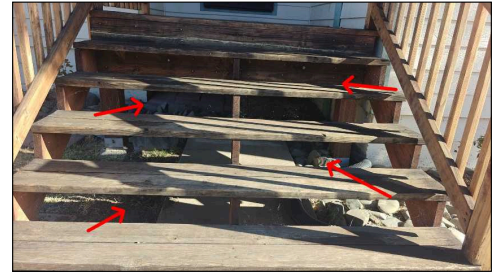
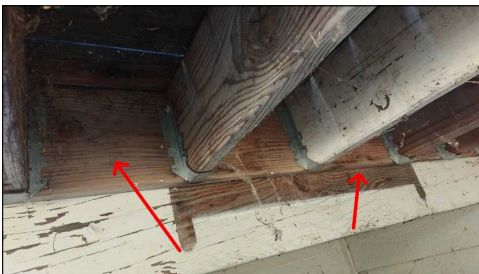
The deck installation exhibits multiple safety and structural defects that require immediate correction:

**Improper Handrails:** The deck stair handrails consist of flat 2x6 lumber, which does not provide a proper graspable profile required for safe grip.

**Open Risers:** The stair steps have open risers, which pose a trip and fall hazard, particularly for small children.

**Loose Guardrails:** The guardrails are loose, compromising the structural integrity of the safety barriers.

**Improper Ledger Attachment:** The ledger board is secured with deck screws. Standard deck screws lack the required shear strength to support the heavy loads of a deck and are prone to sudden failure.

**Recommendation:** A licensed structural contractor or deck specialist must be evaluated immediately. The ledger board must be retrofitted with approved structural thru-bolts or structural lag screws, the guardrails must be securely fastened, the stair risers should be enclosed (or reduced to less than 4 inches), and a properly graspable handrail must be installed to ensure safety and code compliance.

**Recommendation:** It is recommended to seal the newly installed Douglas fir deck boards with an appropriate exterior wood sealer or stain. Unfinished Douglas fir is vulnerable to UV degradation, moisture absorption, warping, and premature cracking if left unprotected against weather elements.

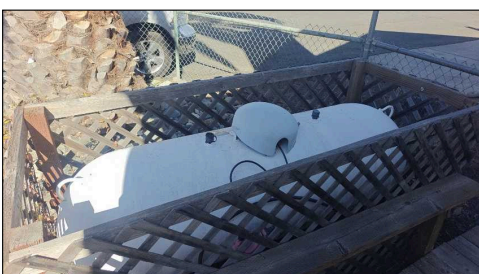
The gas shutoff valves located on the propane tank and on the gas line entering the home appeared to be in good condition at the time of inspection. The propane tank gauge indicated it is approximately 45% full.

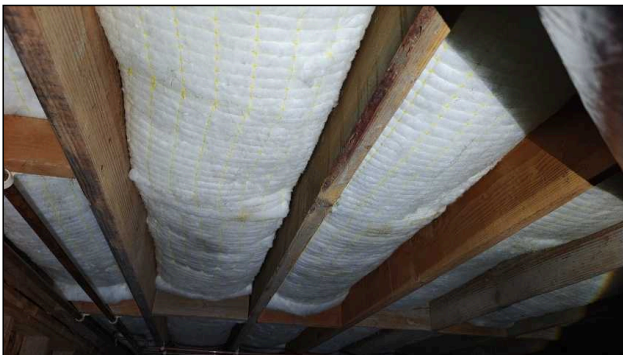
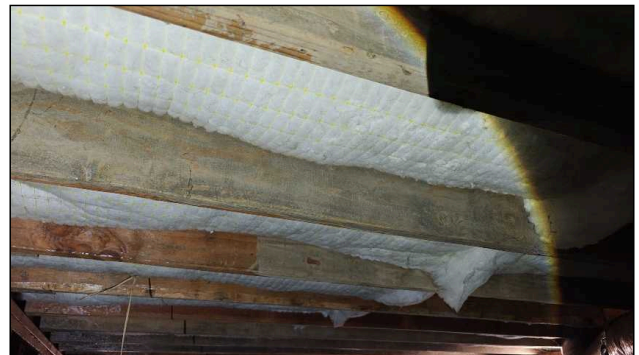
- The crawlspace insulation appeared to be in good condition at time of inspection.

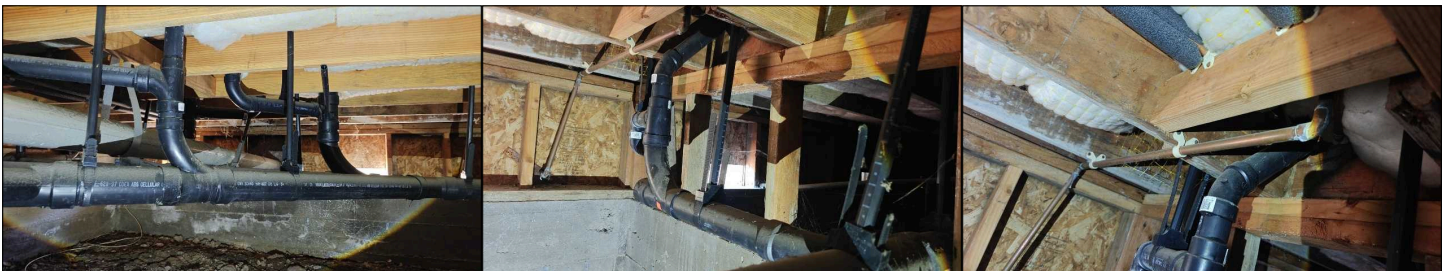
- **ABS** waste and copper water supply pipe appeared to be in good condition at time of inspection.

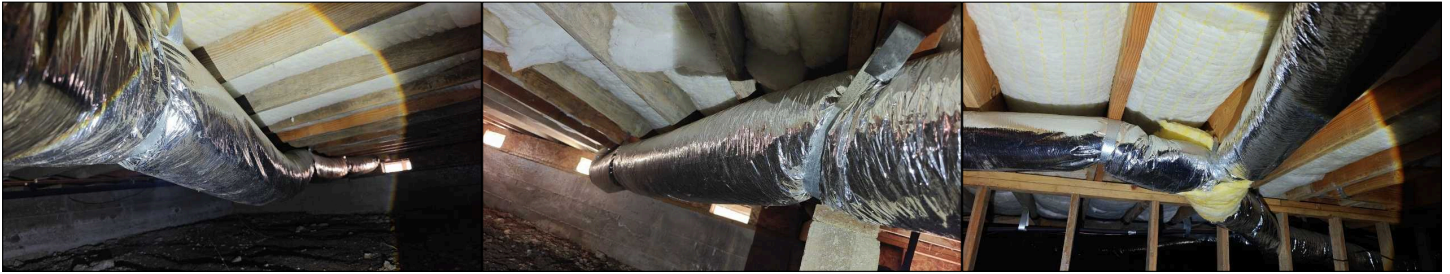
- The HVAC ducting appeared to be in good condition at time of inspection.

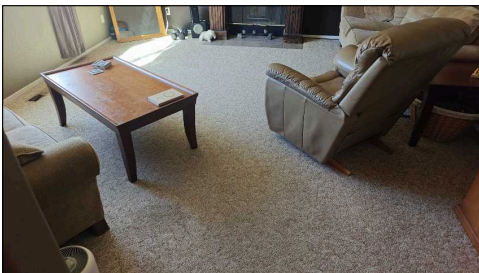
The visible portions of the living room carpets appeared to be in good condition overall, with some stains noted at the time of inspection.

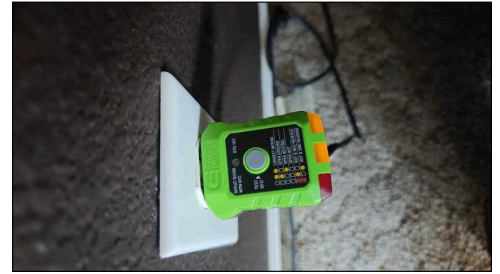
- The majority of grounded receptacles , were tested and found to be wired correctly.

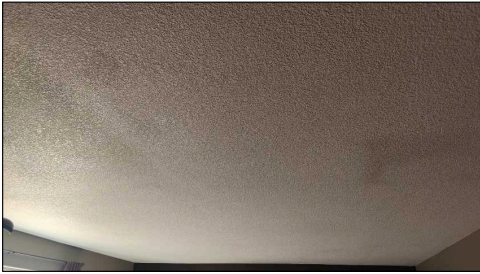
Moisture damage was observed on the drywall above the living room window.

However, the affected area tested dry at the time of inspection when checked with a moisture meter. This suggests a past leak or an intermittent leak that occurs only during specific weather conditions, such as heavy or wind-driven rain.

Recommendation: A qualified contractor should evaluate the exterior window flashing, siding, and roof area directly above this window to ensure the leak source has been permanently resolved. The damaged drywall should be repaired, primed, and painted.

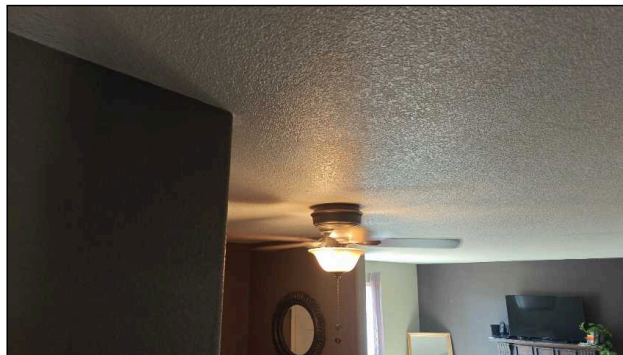
- Operated normally when tested, at time of inspection.
