# ***Cornerstone Inspection***

## **Property Inspection Report**

***9040 Caleta Ln, 93422, Atascadero, CA 93422***  
***Inspection prepared for: Chris Cucchiara***  
***Real Estate Agent: Chris Cucchiara - Keller Williams***

***Date of Inspection: 8/26/2026 Time: 9:00 AM***

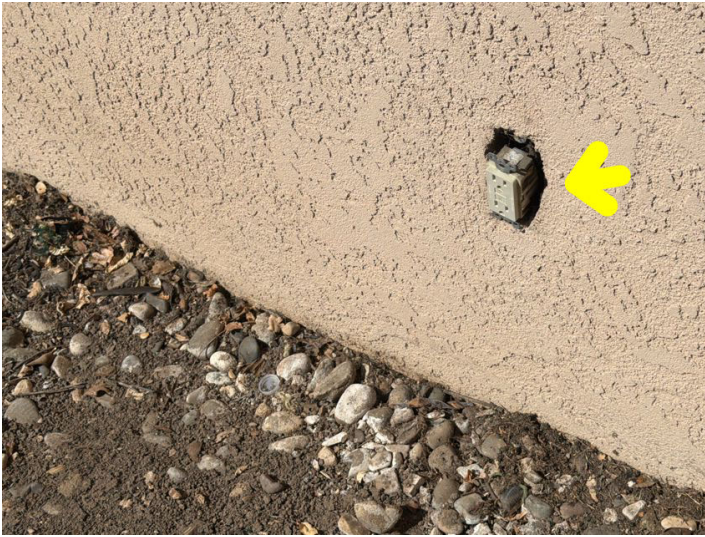
One or more outlets at the rear are not secure and should be evaluated and serviced by a licensed electrical contractor.

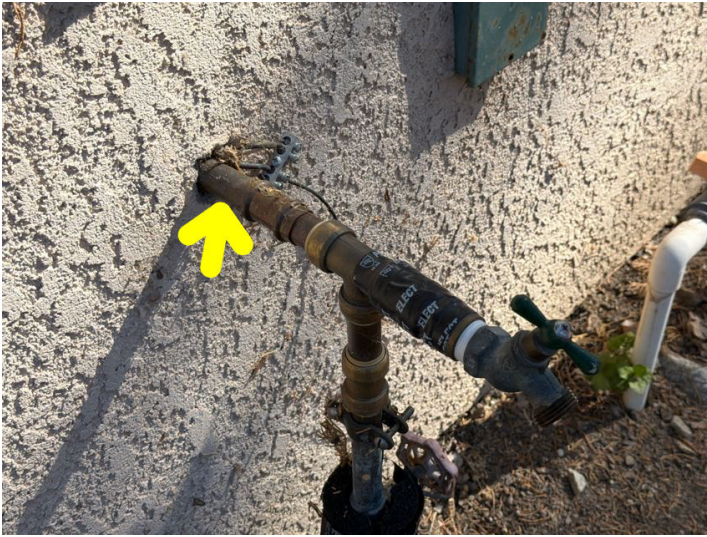
A hose bib on the right side is not fully secured and should be serviced by a qualified plumbing contractor.

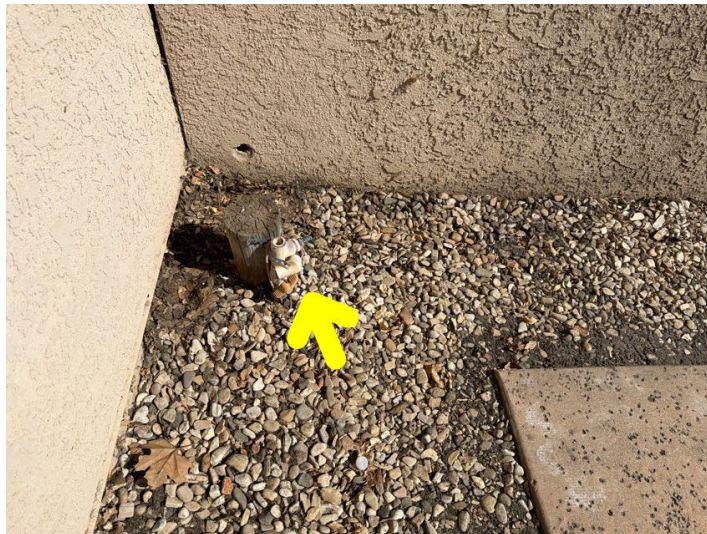
A hose bib on the rear is not functional or has been abandoned.

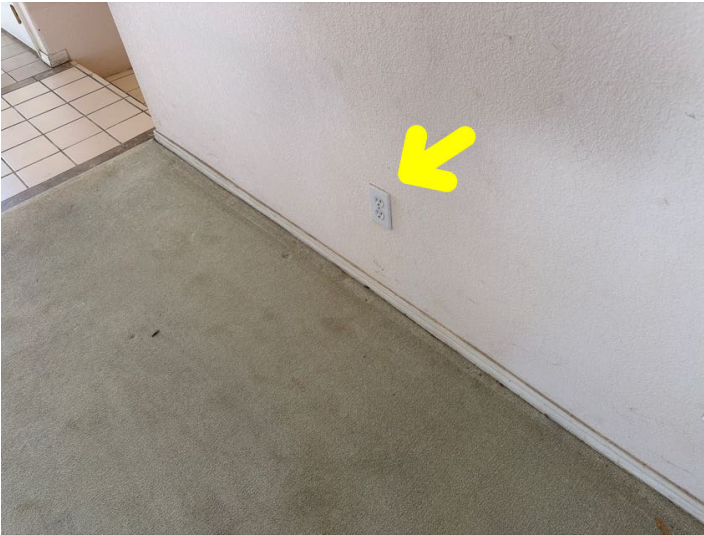
One or more outlets have an open-neutral, and should be evaluated and serviced by a licensed electrical contractor.

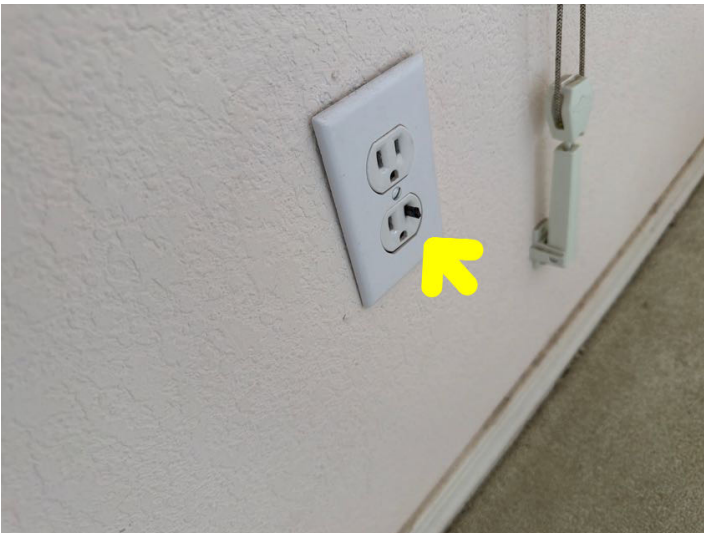
One or more outlets have an obstruction within, and should be evaluated and serviced by a licensed electrical contractor.

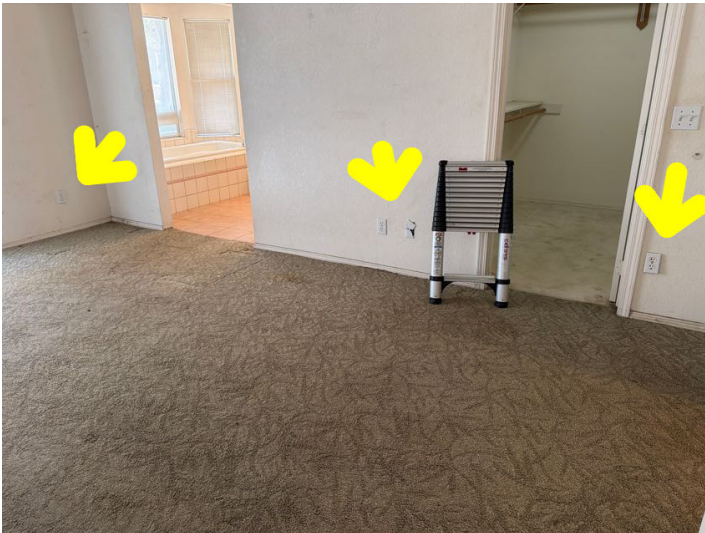
One or more outlets have an open-neutral, and should be evaluated and serviced by a licensed electrical contractor.

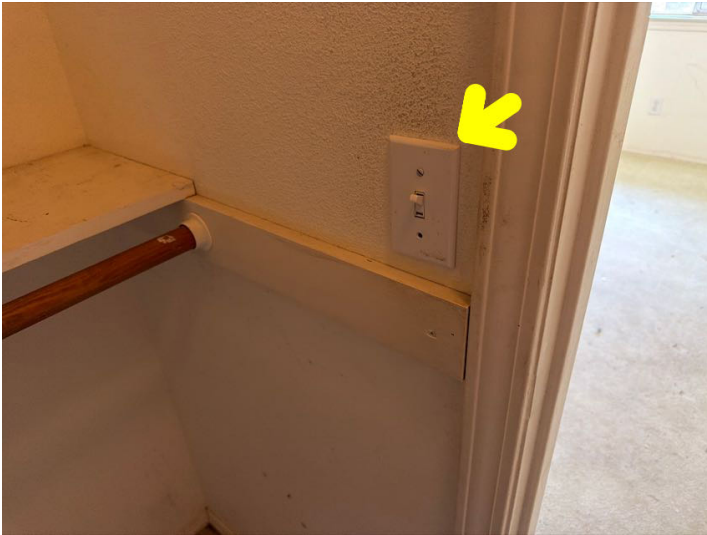
One or more light switches are not secure, and should be evaluated and serviced by a licensed electrical contractor.

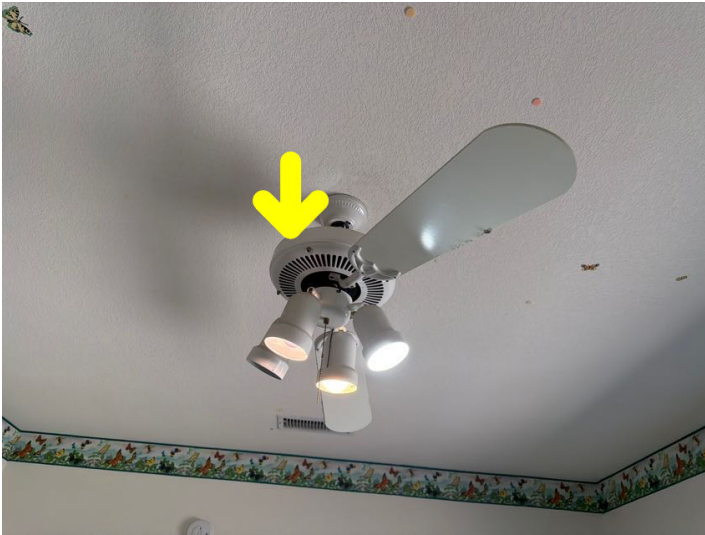
The ceiling fan is damaged and should be serviced.

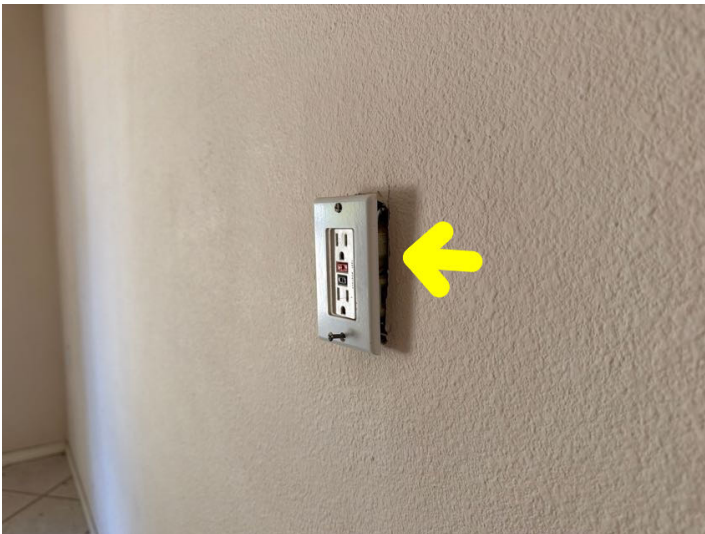
A GFCI outlet did not trip when activated and should be repaired or replaced by a licensed electrical contractor.

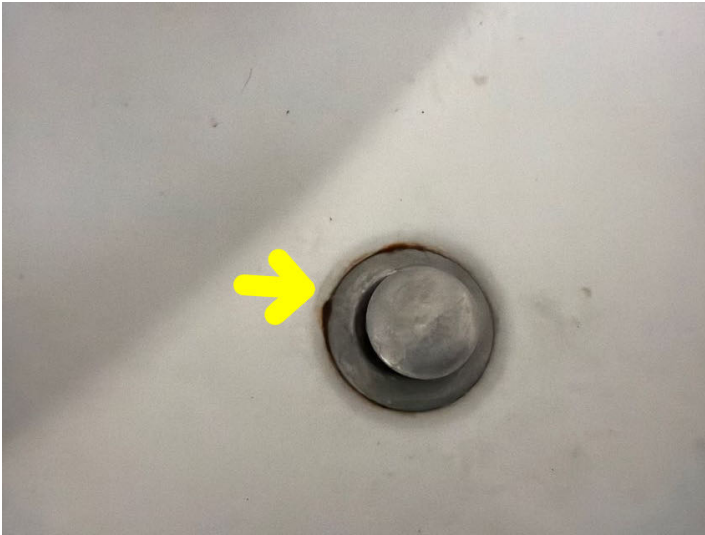
The bathroom sink has rusted at the drain or overflow inlet. It is not leaking, but will obviously be susceptible to leaks.

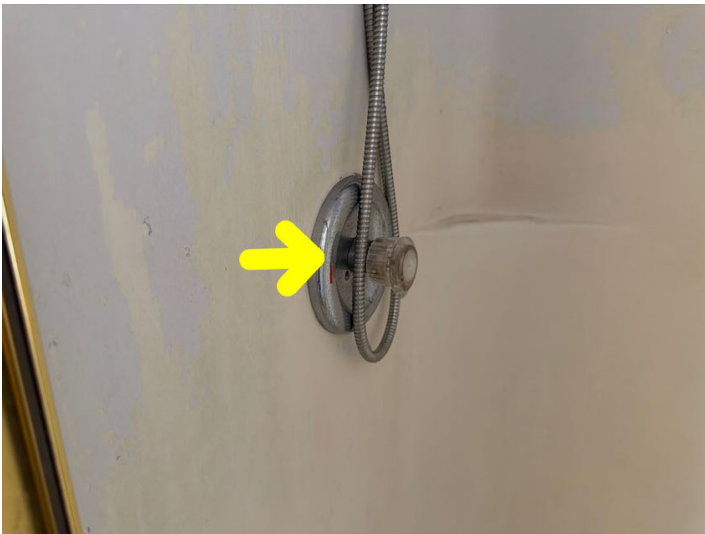
The shower valve handle is loose and should be serviced.

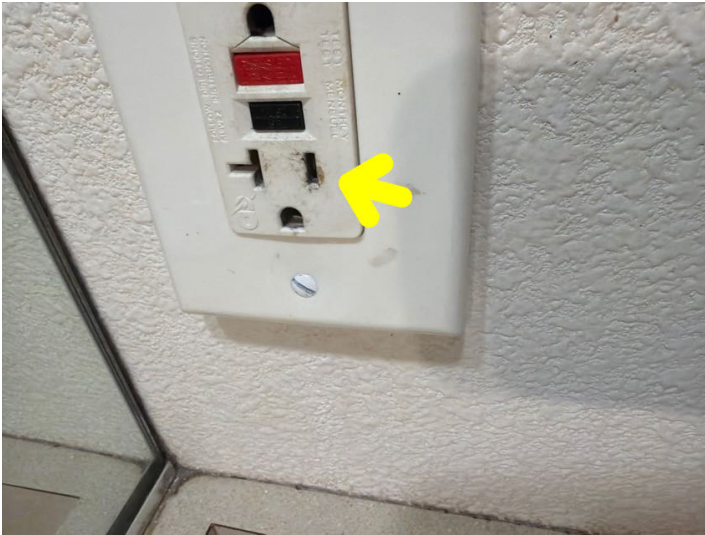
One or more bathroom sink outlets are damaged, and should be evaluated and serviced by a licensed electrical contractor.

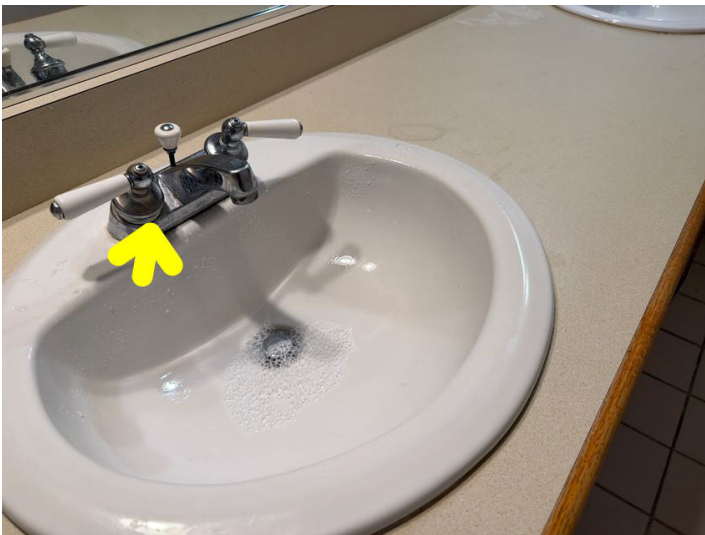
The sink faucets leak around the stem while in use, and should be repaired.

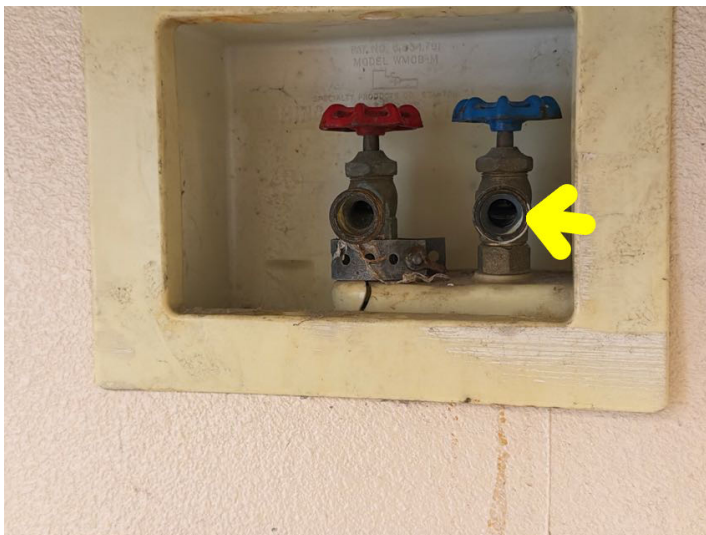
A water supply pipe or fitting is leaking and should be evaluated and serviced by a qualified plumbing contractor.

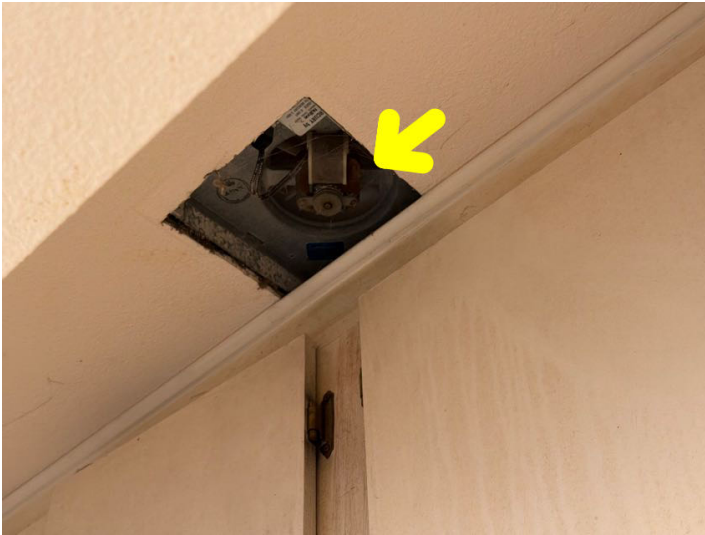
An exhaust fan is missing its cover and should be serviced.
