# Inspection Report

**Property Address:**  
1817-1819 Sunset Cliffs Blvd  
San Diego CA 92107

**Foresight Building Inspection**

| <b>Date:</b> 8/20/2026 | <b>Time:</b> 11:00 AM | <b>Report ID:</b> 3814 |

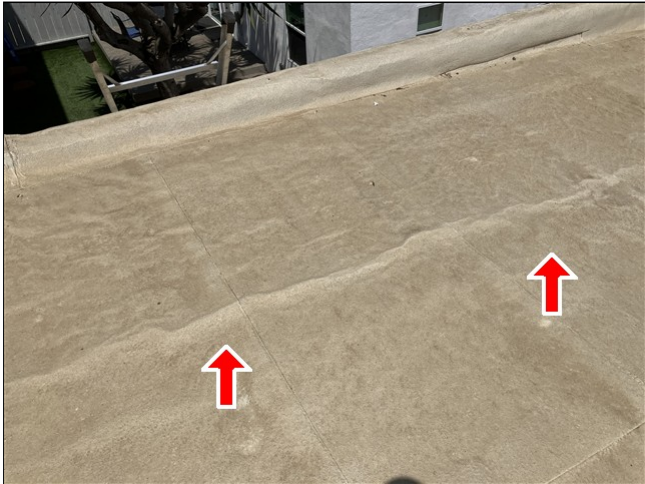
Visible defects were observed at areas of the roof covering . It is recommended to contact a licensed roofer for a complete evaluation of all roof defects and repair/replace as needed.

1.0 Item 9(Picture) 1817: roof covering defects visible

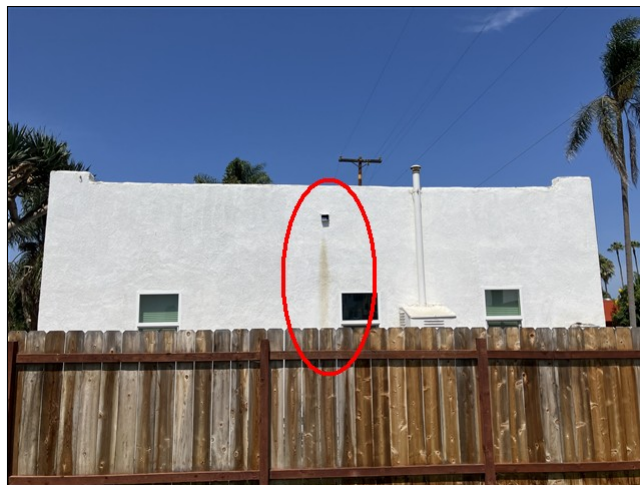
A properly designed and installed rain gutter system helps control water flow and keeps moisture away from the building system and its foundation. A rain gutter system or additional gutters to the existing system are a recommended upgrade.

1.1 Item 2(Picture) rain gutter upgrades recommended

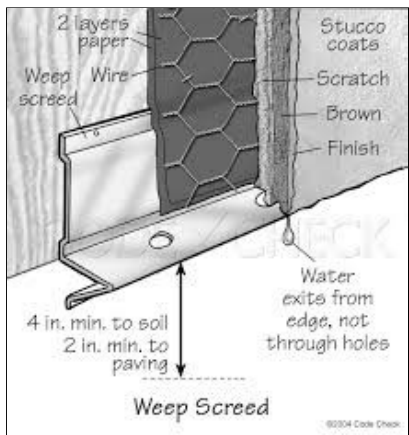
2.0 Item 1(Picture)

Plaster wall cladding systems (commonly referred to as stucco) have changed over the years as building materials and applications have improved. Because of the age the home, upgrading the stucco system is recommended. Consult with a stucco contractor for recommendations and upgrades.

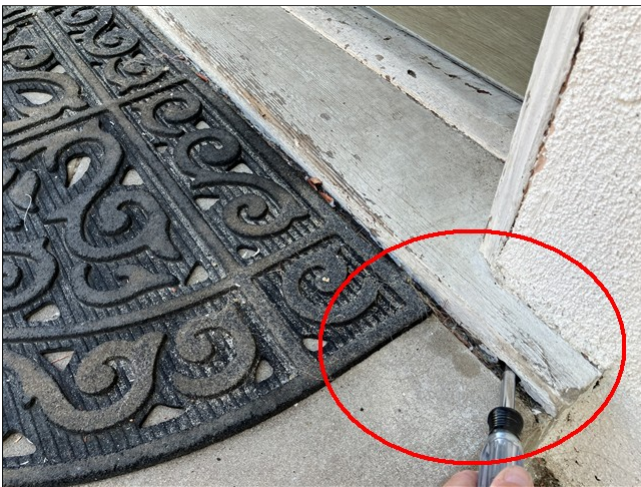
Evidence of possible wood-destroying organism (WDO) activity and/or damage was observed at the time of inspection. Conditions such as damaged wood, staining, debris, or other indicators may be consistent with current or previous WDO activity; however, this inspection is not a pest inspection and no determination is made regarding whether the activity is active or past. Concealed damage may also exist in inaccessible areas. Further evaluation by a licensed pest control or WDO specialist is recommended for identification, treatment recommendations, and determination of the extent of any damage or necessary repairs.

2.1 Item 3(Picture) 1817: possible WDO evidence or damage observed

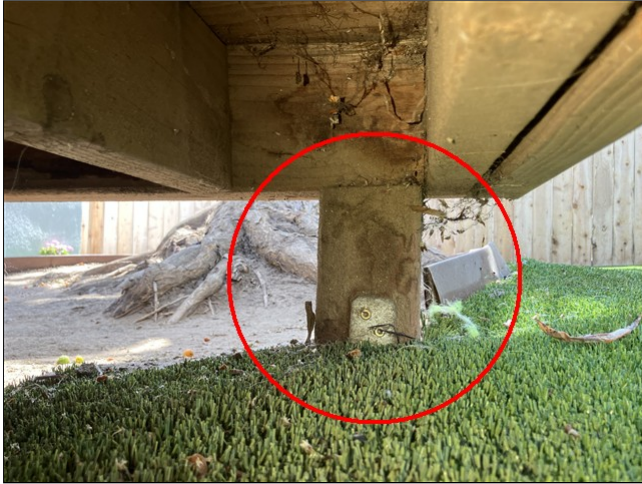
One or more defects were observed at areas of the exterior deck, stairs, or attached covering systems. It is recommended to have a licensed contractor evaluate these exterior systems and repair/replace as needed.

2.3 Item 1(Picture) 1819: substandard deck installation or building material was observed / recommend further evaluation

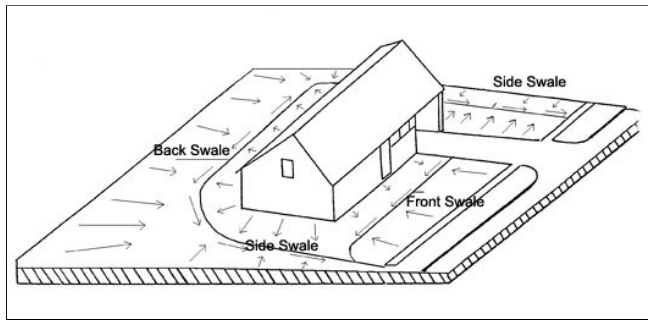
2.4 Item 1(Picture)

(1) Insufficient slope or potentially poor drainage was observed at areas of the driveway, walkways, or landscaping which can increase moisture related damages and defects to the structure. Drainage or landscaping corrections and improvements are recommended. It is recommended to contact a licensed landscaping contractor for evaluation and correction as needed.

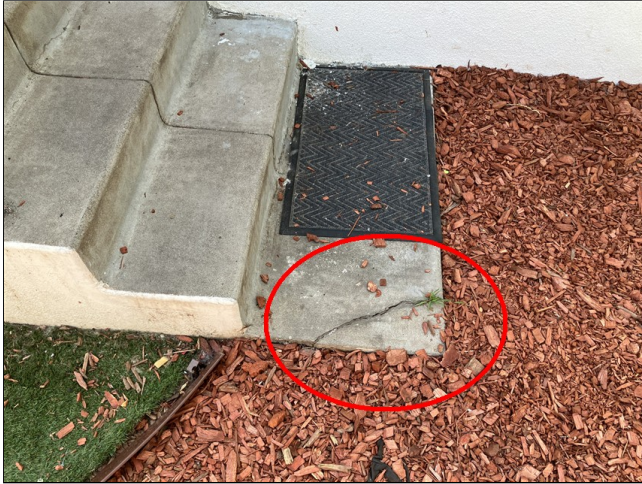
(2) Cracking, damage, or other visible defect was observed at areas of the exterior hardscape (driveway, walkway, stairs, patio, etc.). It is recommended to have these evaluated by a licensed contractor and repaired/replaced as needed.

2.4 Item 4(Picture) 1817: crack visible at concrete step

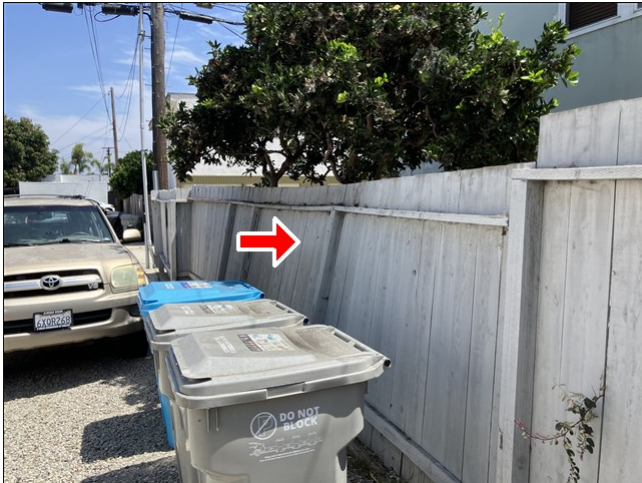
(1) Note: While fences, gates, or dividing walls are not inspected as part of the scope of the inspection, one or more defects were observed at the fence or gate system that should be evaluated by a qualified tradesman and repaired/replaced as needed.

2.6 Item 1(Picture) leaning fence next to driveway

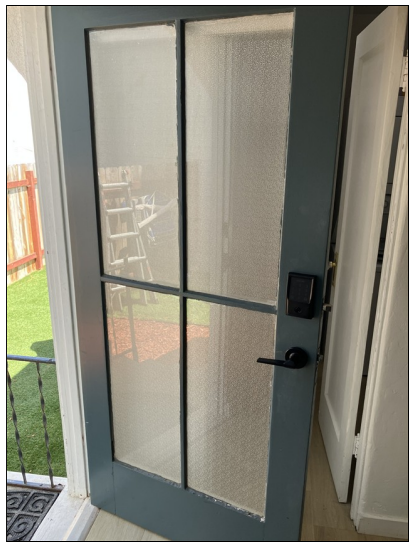
Because identification of safety glass is not always possible at the time of the inspection, due to the age of the window or glass door panes, safety glass may not be present. While safety glass may not have been required at the time of construction, as a safety upgrade, it is recommended to contact a glazing specialist for evaluation of any window or door panes that would now require safety glass and upgrade as needed.

2.6 Item 2(Picture) 1817:  
recommend evaluation and  
upgrade of any non-safety glass  
windows at appropriate locations

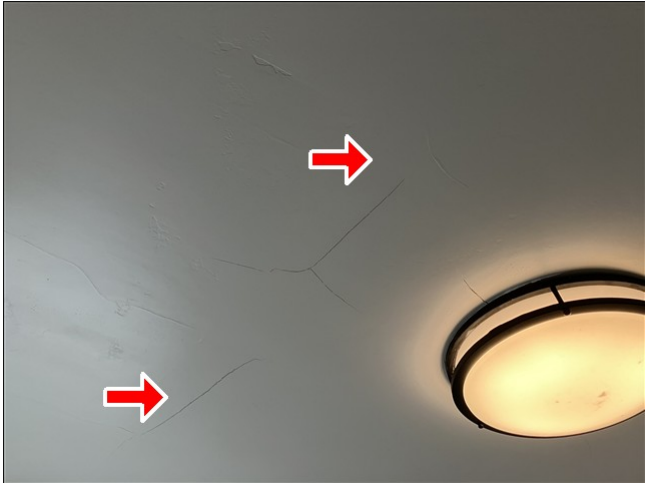
(1) Disclaimer: Cracks in the ceiling and/or walls may be a result from possible settling, movement, or defect that has occurred. This inspection is not meant to be a structural evaluation but an observation of visible physical defects. Only further evaluation and investigation from a qualified person can determine if non-visible defects are present and corrections as needed.

4.0 Item 1(Picture) 1819: cracks visible at ceiling

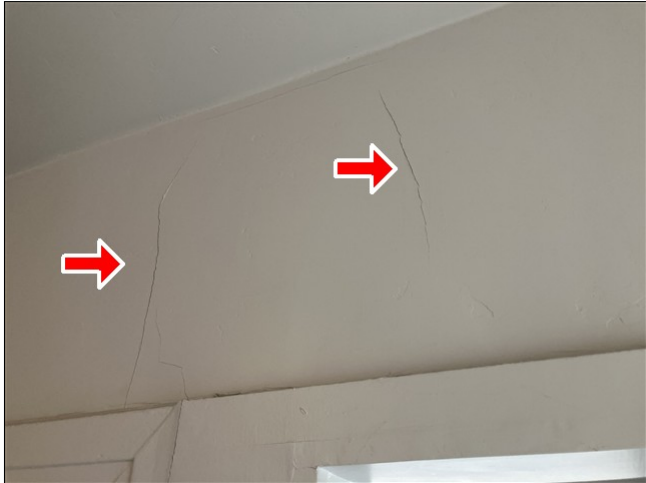
4.0 Item 2(Picture) 1819: cracks visible at ceiling

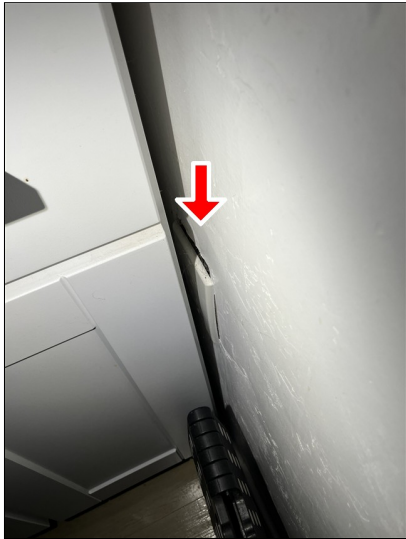
(2) Damages, missing drywall, or other defects to the walls or ceilings were observed. It is recommended to have these walls and ceilings evaluated by a qualified tradesman and repaired/replaced as needed.

4.0 Item 4(Picture) 1817 kitchen: gap visible around outlet

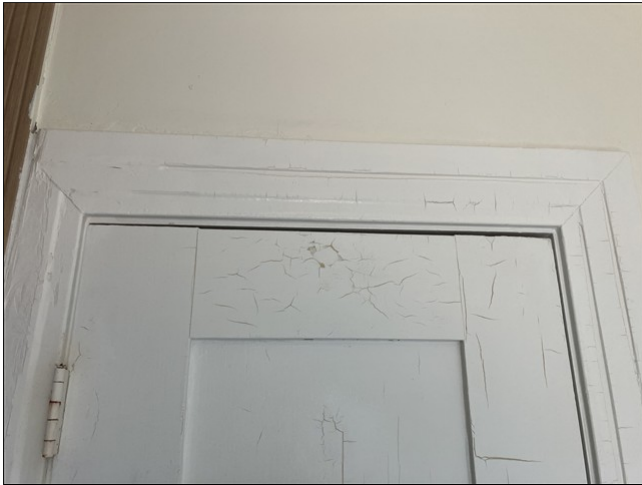
A representative number of doors was tested. One or more of the tested doors or hardware had signs of damage, defect, or did not operate properly when tested. It is recommended to have all doors and hardware defects evaluated and repaired/replaced as needed.

4.3 Item 1(Picture) 1819: bathroom door paint cracks/ defects visible

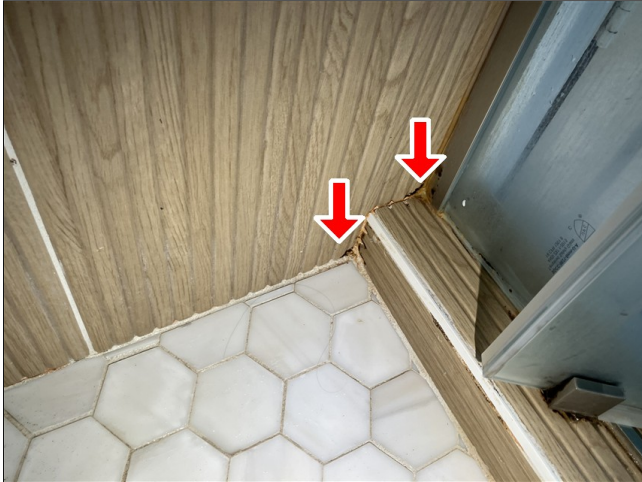
(1) The caulking or grout was missing, separated, or had other observable defect at areas of one or more of the tub/shower wall or floor systems. It is recommended to have these evaluated and repaired as needed.

4.6 Item 1(Picture) 1819: shower surround caulking or appropriate sealant maintenance/repairs needed

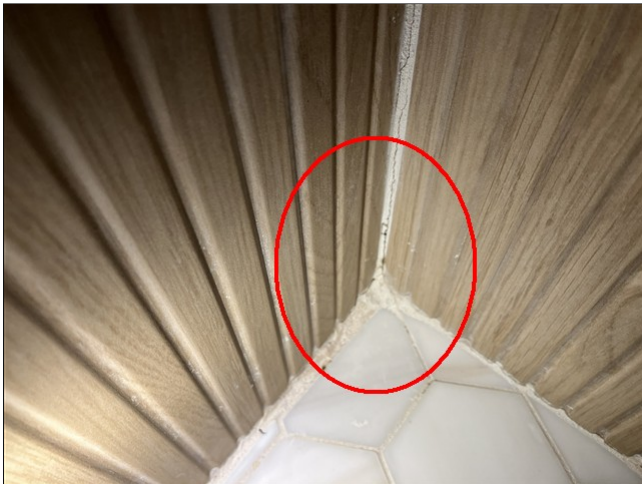
4.6 Item 3(Picture) 1819: shower surround caulking or appropriate sealant maintenance/repairs needed

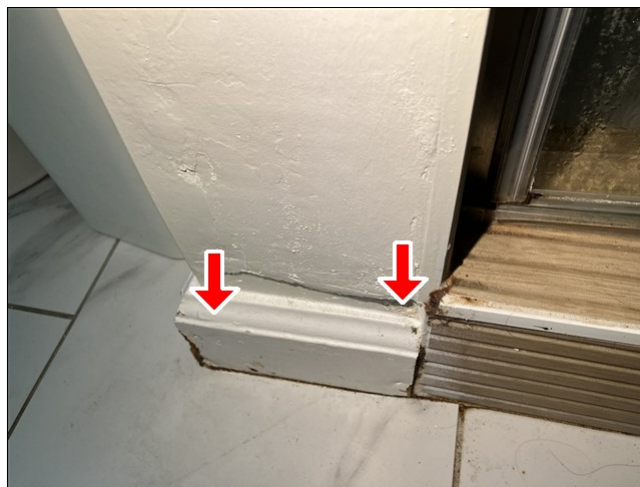
(2) Damage, stains, or other possible moisture related defects were visible around areas of the ceilings, walls, or floors. No moisture was observed at the time of the inspection. Further evaluation is recommended to determine the cause of the moisture related observations and correction as needed.

4.6 Item 5(Picture) 1819 bath: moisture stains or damage visible

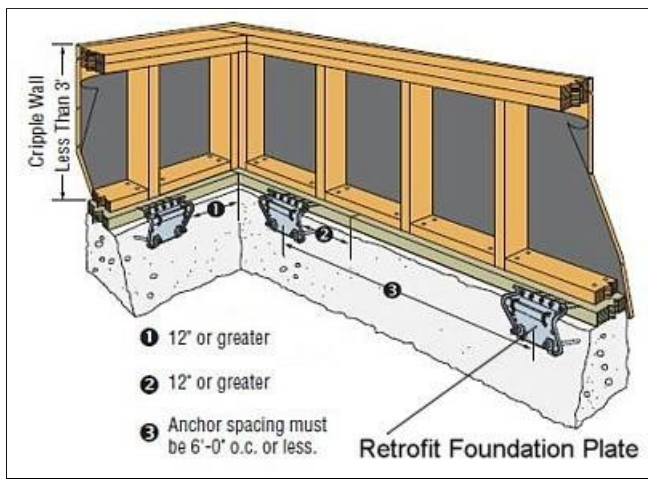
5.0 Item 1(Picture)

Foundation anchoring was not visible. While this may not have been required at the time of construction, foundation anchoring is an important component in preventing movement or other damages resulting from seismic activity. It is recommended to have this evaluated by a licensed contractor and upgraded as needed.

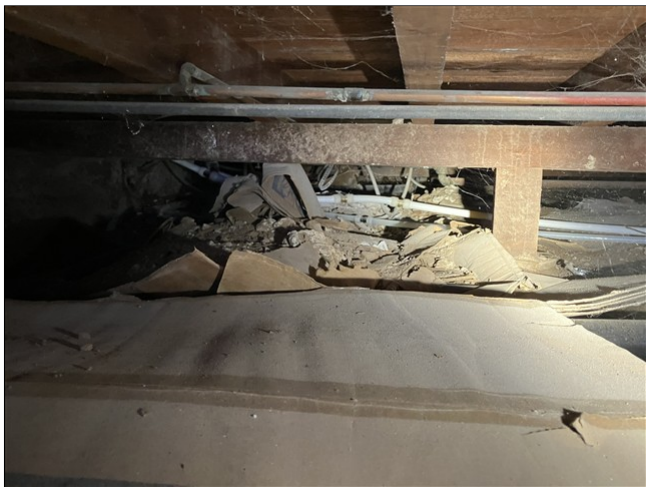
(2) There was debris (wood, cardboard, abandoned materials, etc.) observed in the attic or subfloor area. It is recommended to have all debris removed.

5.0 Item 5(Picture) 1819: debris visible in the subfloor area

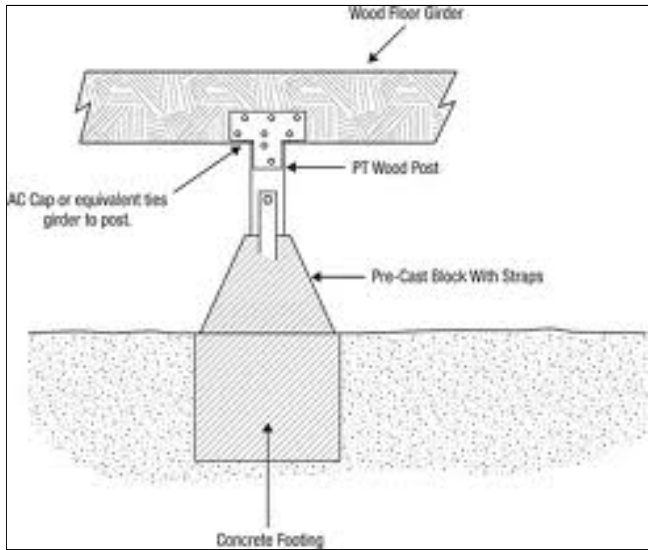
5.1 Item 1(Picture)

The foundation post and pier system appeared constructed conforming to the standards of the era it was built. However, these standards would not meet modern building standards, which have improved over the years to protect homes against natural and unnatural occurring stresses on the foundation such as settling, deterioration, or seismic activity. Metal strap connectors and shorter distances between posts are examples of these upgrades. It is recommended to contact and licensed contractor regarding upgrades to the foundation post and pier system.

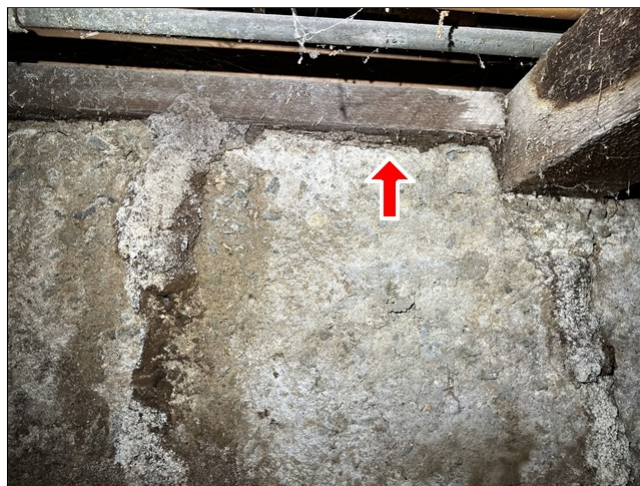
Damages, deficiencies, or other visible defects were observed at areas of the structural flooring system or components. It is recommended to have this evaluated by a licensed contractor and repaired/replaced as needed.

Evidence of possible wood-destroying organism (WDO) activity and/or damage was observed at the time of inspection. Conditions such as damaged wood, staining, debris, or other indicators may be consistent with current or previous WDO activity; however, this inspection is not a pest inspection and no determination is made regarding whether the activity is active or past. Concealed damage may also exist in inaccessible areas. Further evaluation by a licensed pest control or WDO specialist is recommended for identification, treatment recommendations, and determination of the extent of any damage or necessary repairs.

5.2 Item 2(Picture) 1819: possible WDO evidence or damage observed

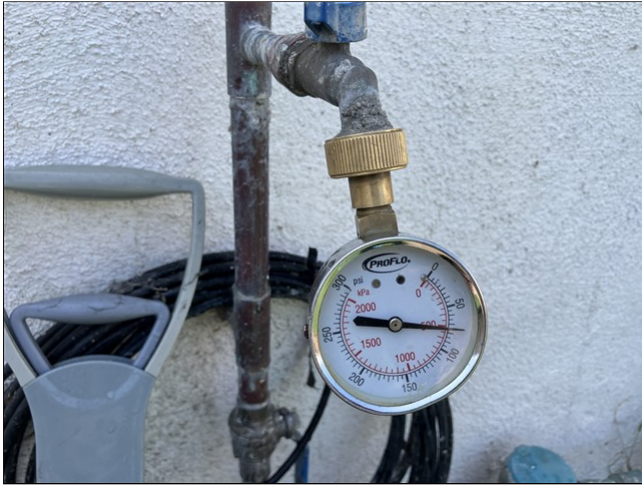
(2) No visible pressure regulator was observed. Where static water pressure in the water supply piping is exceeding 80 psi (552 kPa), an approved-type pressure regulator preceded by an adequate strainer shall be installed and the static pressure reduced to 80 psi (552 kPa) or less. It is recommended to contact a licensed plumber to evaluate and determine the necessity and appropriate location for the installation of a pressure regulator.

6.0 Item 5(Picture) 1817: no visible pressure regulator  
/ PSI tested at 75

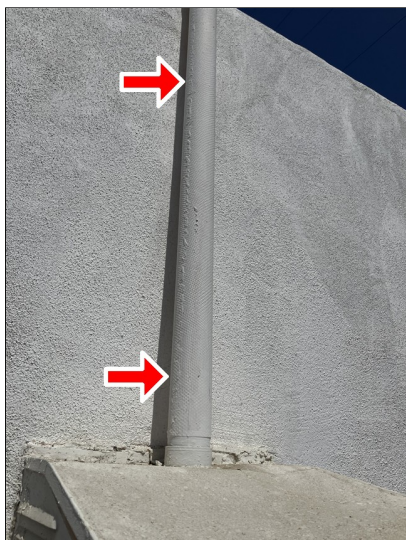
(3) The water heater draft hood or venting system was improperly installed, missing adequate screws at connections, or had other observable defect. All defects in the venting systems of hot water heaters should be treated as immediate

carbon monoxide safety hazards. It is recommended to have a safety and performance inspection of the venting system by a licensed plumbing company and repaired/replaced as needed.

6.2 Item 6(Picture) 1819: aged vent / materials installed before 1978 may contain asbestos

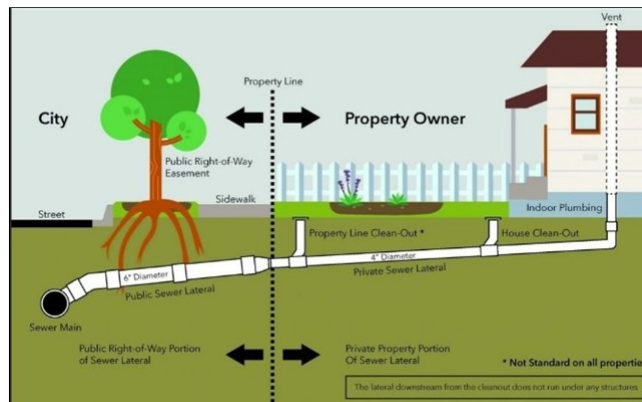
6.3 Item 2(Picture)

(1) Plumbing DWV (drain, waste, vent) systems may have hidden defects that can only be detected with further inspection from a qualified plumber who provides drain video/camera inspections. Because the scope of this inspection is limited to only visible and accessible systems and components, it is recommended to contact a licensed plumber for further inspection and evaluation.

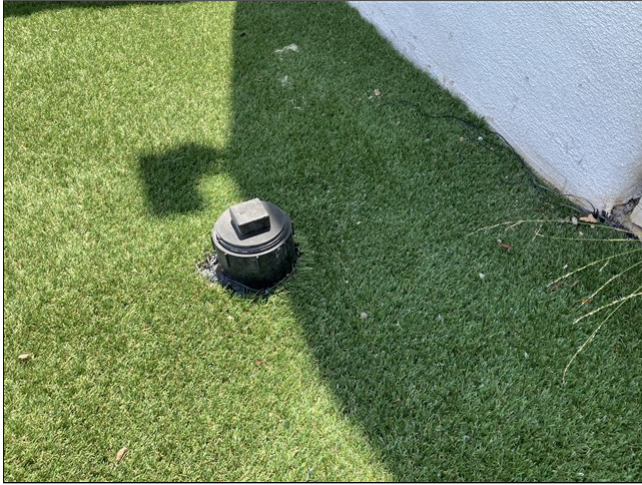
6.3 Item 3(Picture) 1817: sewer camera inspection recommended

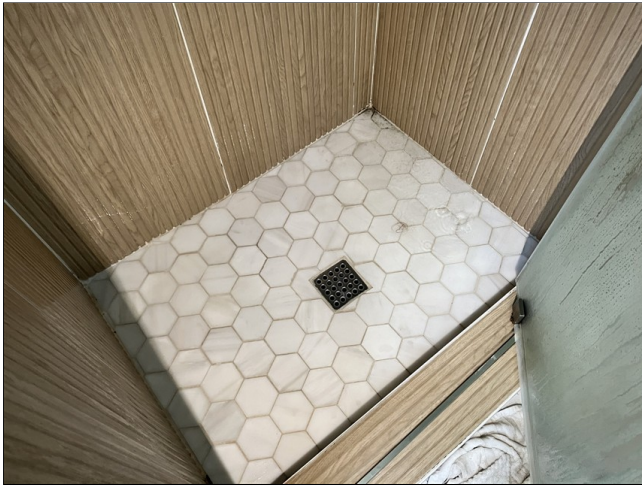
(2) The drainage at one or more of the sinks, tubs, or showers was slow or had other observable defect. It is recommended to have a licensed plumber evaluate and correct as needed.

6.3 Item 4(Picture) 1819: slow drainage observed at shower / debris in drain visible

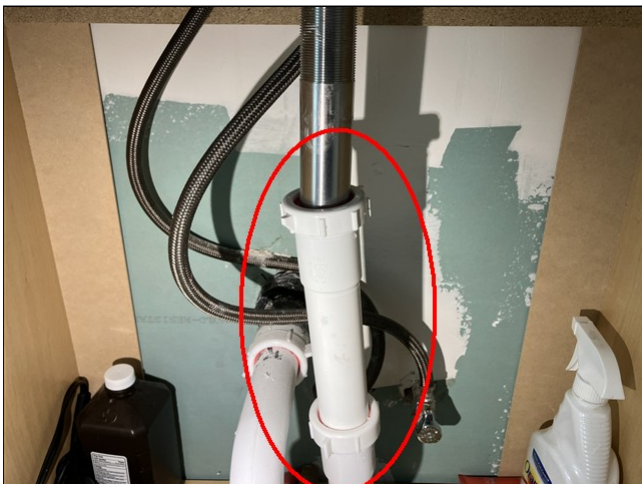
(3) There was damage, leaking, or other observable defect at one or more of the sink drain assemblies. It is recommended to have a licensed plumber evaluate and repair/replace as needed.

6.3 Item 6(Picture) 1819: bathroom sink drain was not installed properly

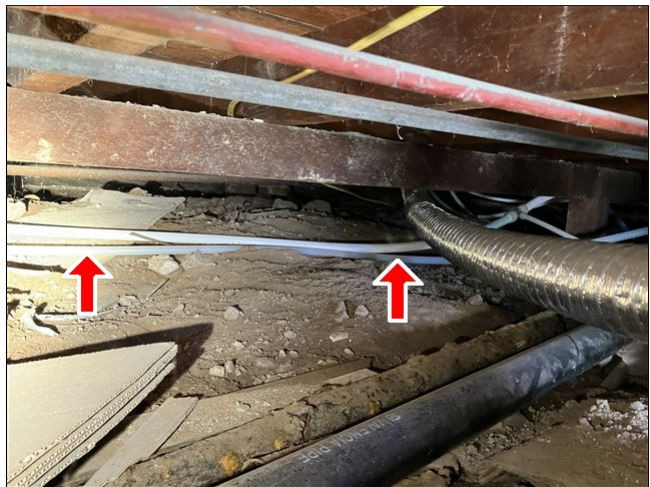
(1) Inadequate or improper water supply strapping was observed. It is recommended to have the water supply strapping evaluated by a licensed plumber and repaired/replaced as needed.

6.4 Item 2(Picture) 1819: water supply pipe was not properly strapped and supported off the ground

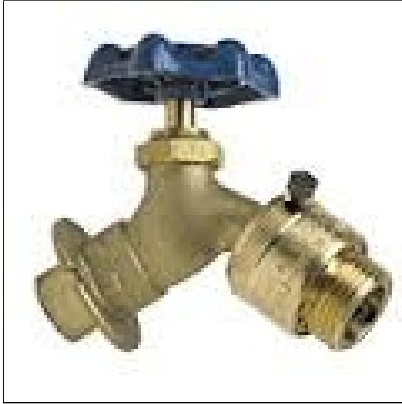
6.4 Item 4(Picture)

(2) One or more of the exterior spigots were missing an anti-siphon device (vacuum breaker). These prevent water intended for irrigation from siphoning back into the potable water system. It is recommended to have these installed.

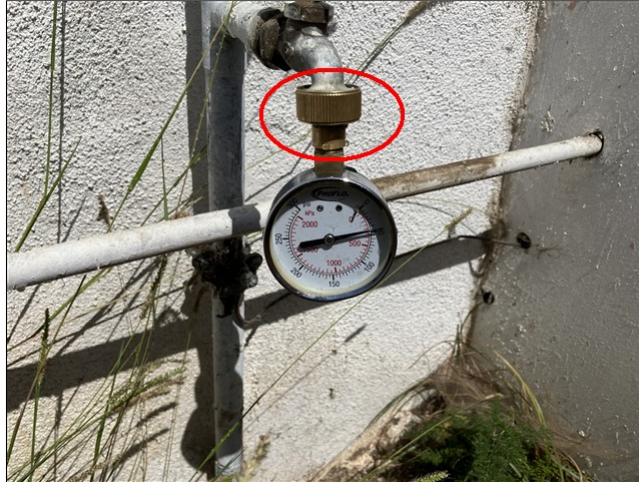
6.4 Item 5(Picture) 1819: missing vacuum breaker

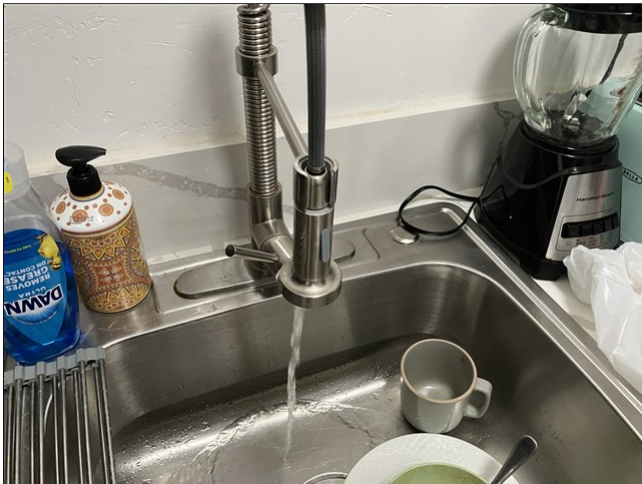
One or more of the plumbing fixtures (toilets, sinks, faucets, tub/shower valves, etc.) were loose, leaked during operation, or had other observable defect. It is recommended to have the fixtures evaluated by a licensed plumber and repaired/replaced as needed.

6.5 Item 1(Picture) 1817 kitchen: loose faucet / spray control button did not operate properly when tested

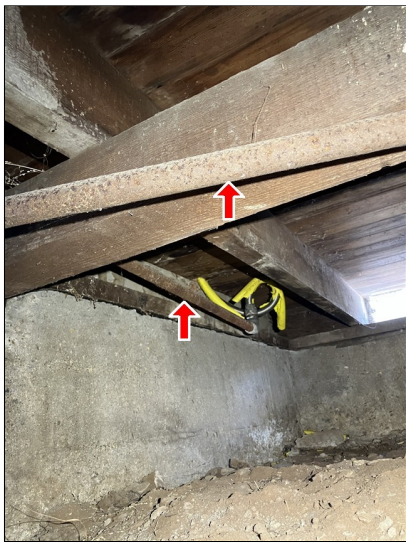
(1) The gas distribution piping appeared aged and may have exceeded or is near to exceeding its expected serviceable life. It is recommended to contact a licensed plumber to determine remaining life expectancy and replacement as needed.

6.6 Item 2(Picture) 1817: aged gas supply pipes observed

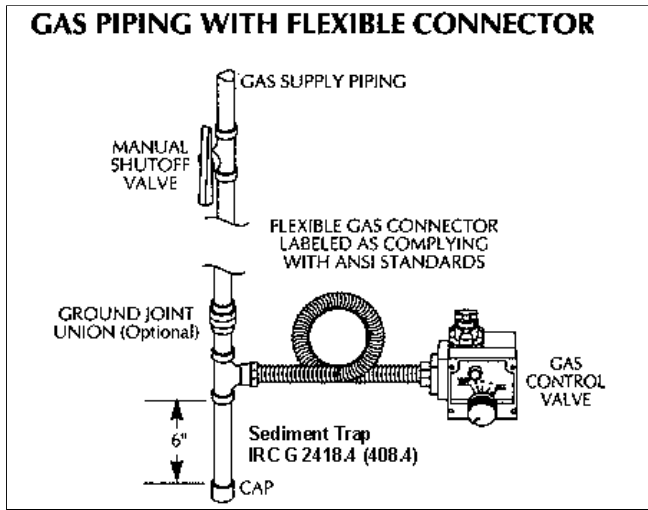
6.6 Item 4(Picture)

(2) There was a missing or improperly installed sediment trap after the gas supply valve to the water heater or furnace. One should be installed when a sediment trap is not incorporated as part of the appliance to prevent sediments in the gas line from entering the unit. It is recommended to have this evaluated by a licensed plumber and corrected as needed.

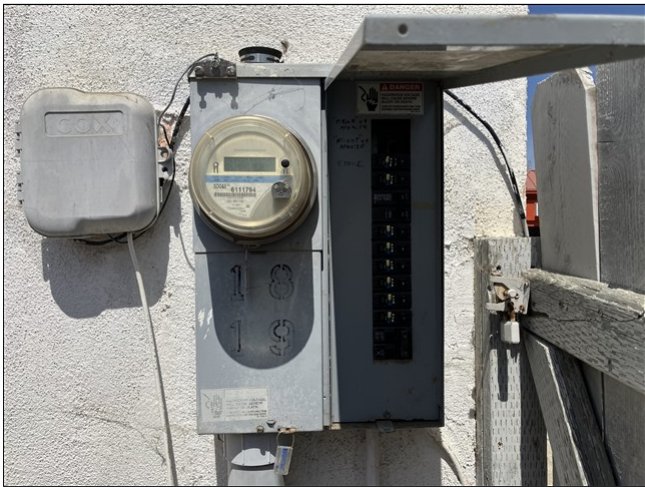
7.2 Item 1(Picture) 1819: electric meter and main disconnect

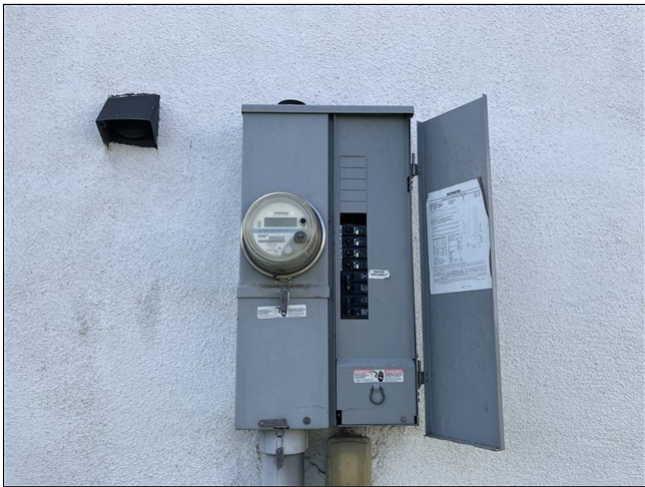
7.2 Item 2(Picture) 1817: electric meter and main disconnect

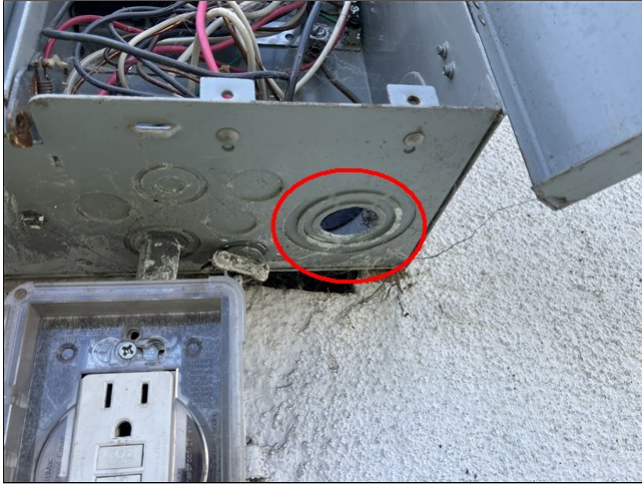
(2) There was one or more open knockouts in the electrical panel that should have an appropriate knockout plug installed.

7.3 Item 3(Picture) 1817: missing knockout plug

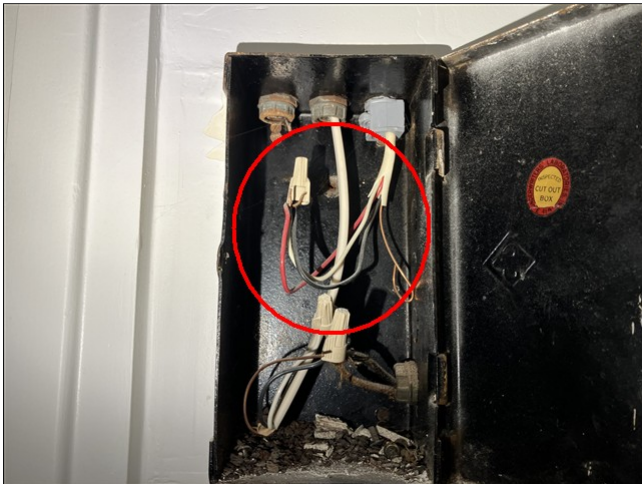
(1) Improper wiring method, damages, or other defects were observed at areas of the branch circuit wiring or breaker system. All electrical system and component defects should be considered safety hazards. It is recommended to have the systems evaluated by a licensed electrician and repaired/replaced as needed.

7.4 Item 1(Picture) 1819 bedroom closet: recommend further evaluation of exposed wire ends / box should be secured with a fastener

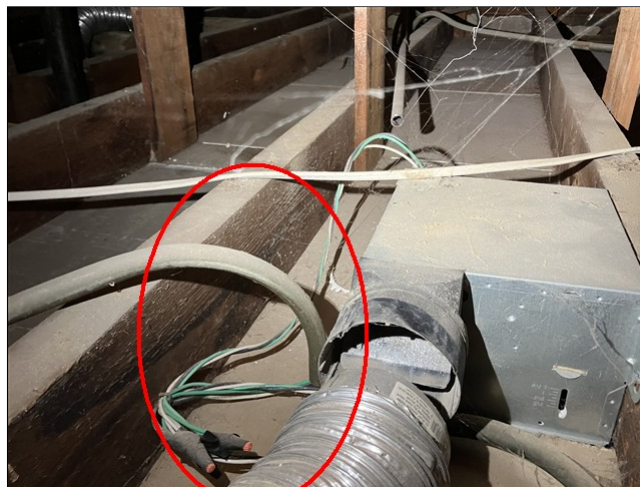
7.4 Item 4(Picture) 1817 attic: bath exhaust vent wiring was not properly installed

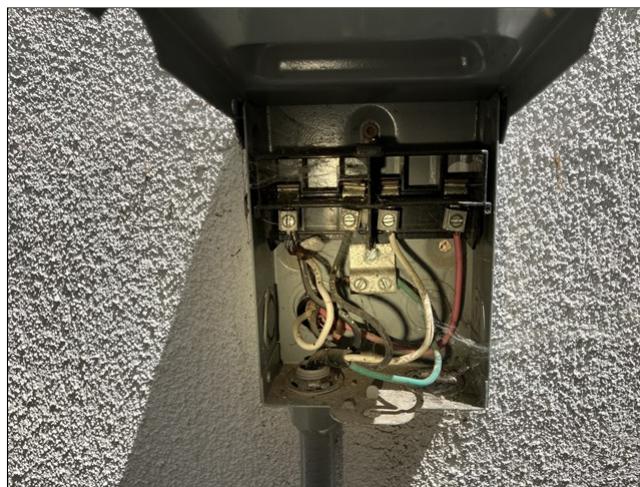
(2) Possible abandoned electrical system or components were observed. All possible abandoned electrical components should be evaluated by a licensed electrician to determine appropriate removal or corrections as needed.

7.4 Item 6(Picture) 1817: recommend further evaluation abandoned materials

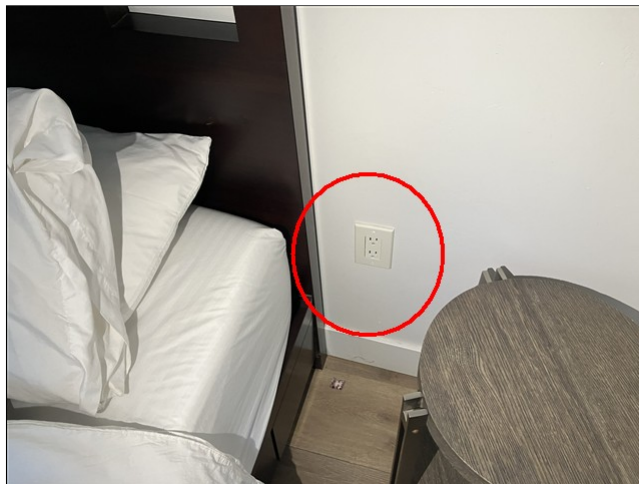
(1) Defects were observed at one or more of the outlets, switches, or fixtures. All electrical system and component defects should be considered safety hazards. It is recommended to have a licensed electrician evaluate all outlets, switches, and fixtures and repair/replace as needed.

7.5 Item 2(Picture) 1819 bedroom: loose outlet

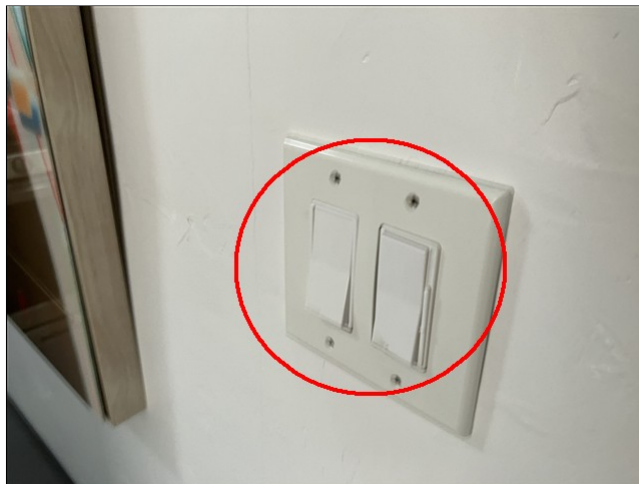
7.5 Item 4(Picture) 1817 kitchen: loose switch cover

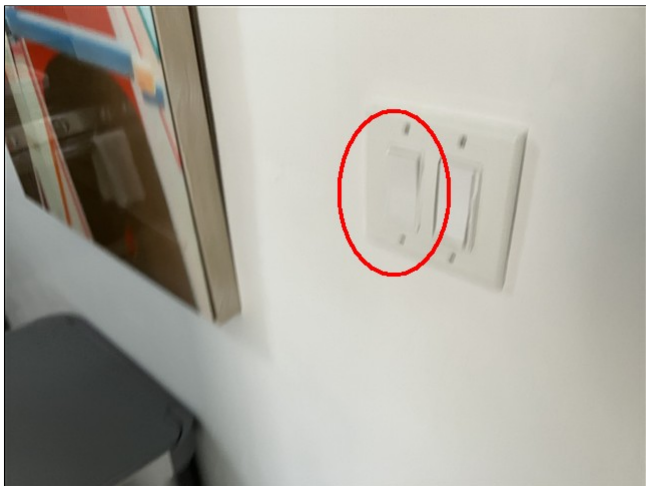
(2) While the inspector makes every effort to identify switches and their corresponding fixtures or receptacles, one or more were not identifiable. Further evaluation is recommended to identify and evaluate the corresponding fixture or outlet.

7.5 Item 7(Picture) 1817: switch and corresponding fixture or outlet were not identified

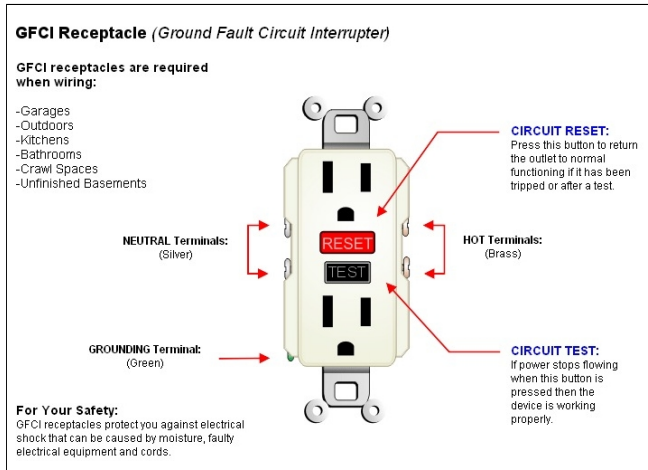
7.6 Item 1(Picture)

One or more outlets observed in the kitchen, bathroom, exterior, or garage did not appear to be GFCI protected. While this may have been acceptable at the time of construction, current standards require that all kitchen countertop outlets, bathroom outlets, exterior outlets, and garage outlets must be GFCI. Other auxiliary systems may also require GFCI outlets such as pool pumps, sumps, and jacuzzi jet motors. It is recommended to have a licensed electrician evaluate the appropriate GFCI locations and upgrade as needed.

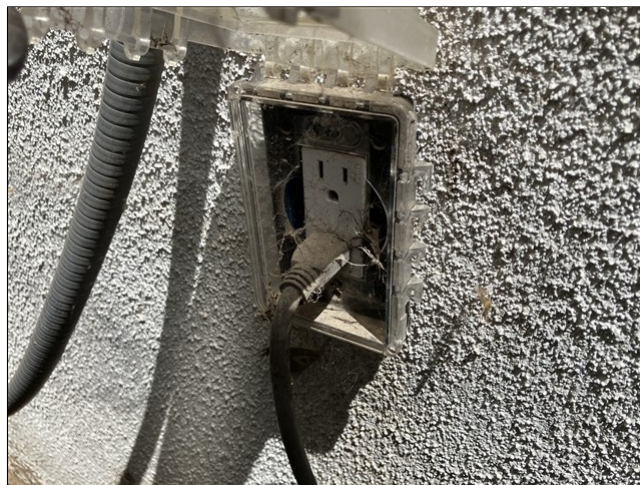
7.6 Item 4(Picture) 1817: recommend evaluation and upgrade of any non-GFCI outlets

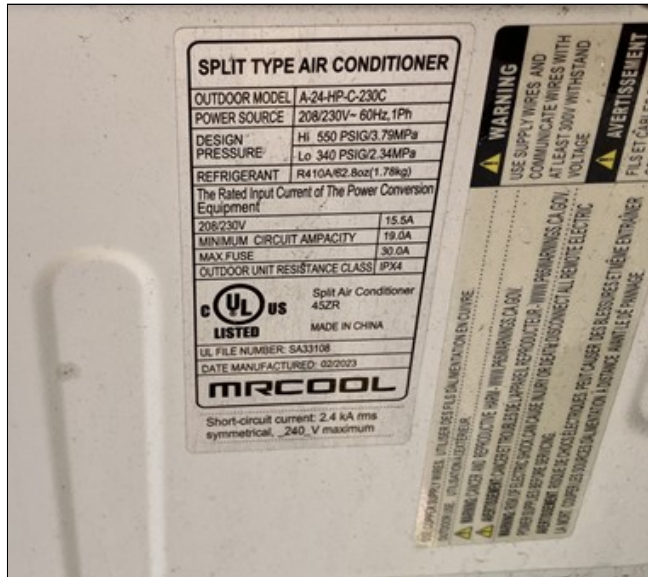
8.0 Item 2(Picture) 1819: mini-split condenser

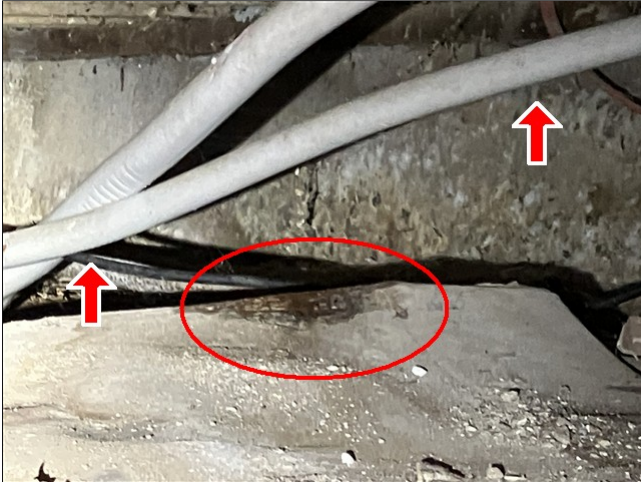
(2) Areas of the A/C condenser refrigerant and suction lines had observable defects or deficiencies. It is recommended to have a licensed HVAC technician evaluate and correct as needed.

8.4 Item 1(Picture) 1819: refrigerant/suction lines were not supported off the ground / condensation observed on cardboard debris (possible fungal activity visible)

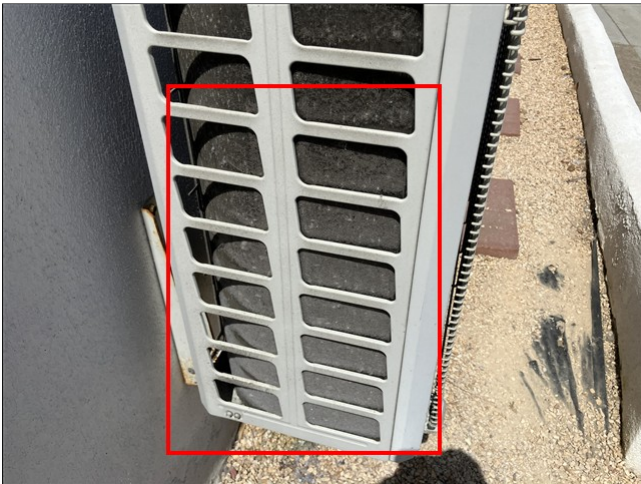
(3) There was damage, deterioration or other visible defect on the aluminum fins/coils of the A/C condenser unit. Damaged fins reduce the flow of air and the unit's efficiency. It is recommended to have an HVAC technician evaluate and repair/replace as needed.

8.4 Item 2(Picture) 1819: dryer lint debris visible on condenser fins

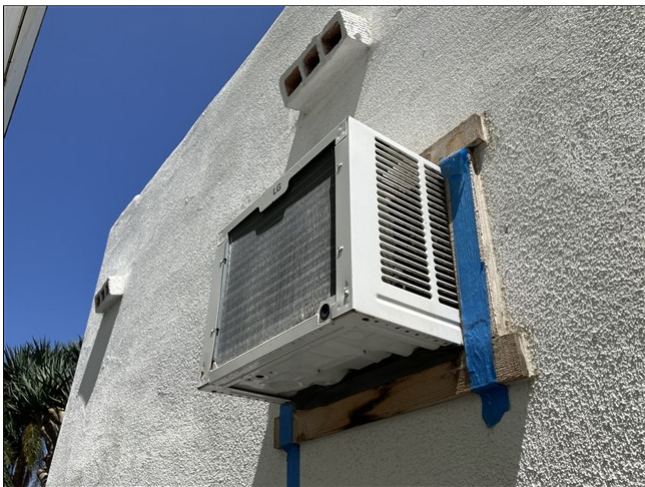
8.4 Item 3(Picture) 1817: wall a/c unit

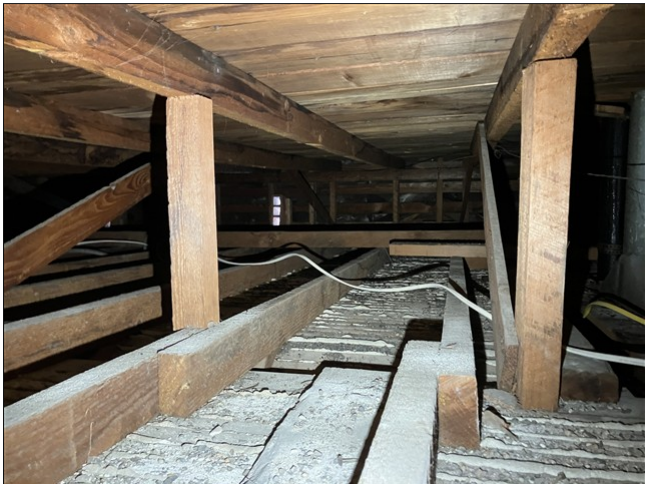
There was no attic insulation observed. An insulated attics helps prevent the escape of heat and cool air through the attic. This is a recommended upgrade.

9.0 Item 1(Picture) 1819: insulation upgrades recommended

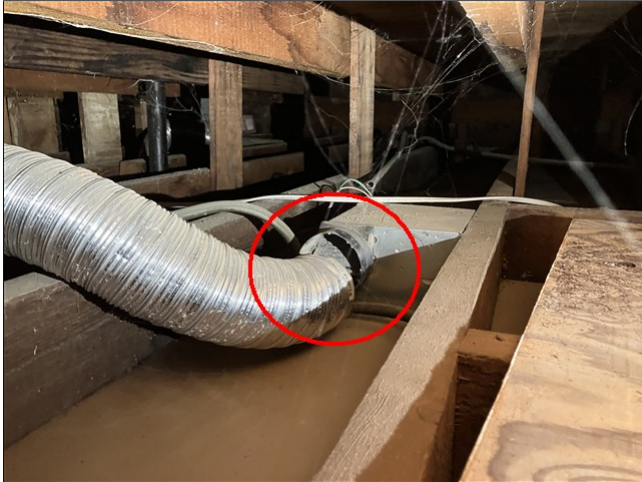
(3) Defects were observed at areas of the bathroom, laundry, or kitchen venting/ducting systems. It is recommended to have this evaluated by a HVAC contractor and repaired/replaced as needed.

9.1 Item 3(Picture) 1817 attic: bath exhaust vent duct disconnected

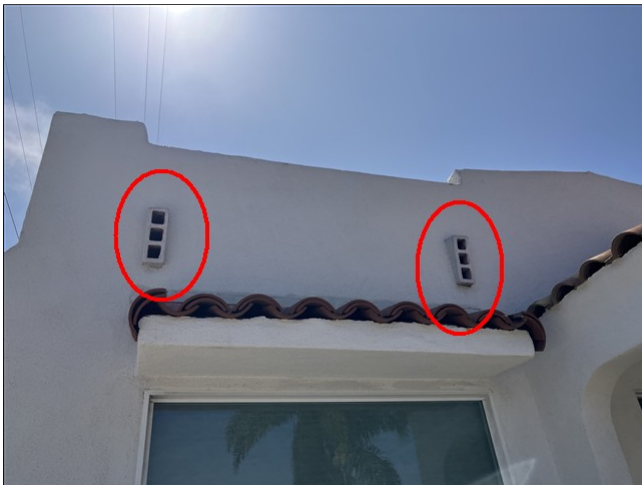
(1) One or more of the crawlspace, attic, or garage vent screens were missing, deteriorated, or had other observable defect. Vent screens help control pest intrusion. It is recommended to have all damaged or missing vents evaluated and repaired/replaced as needed.

9.2 Item 1(Picture) 1819: vent screens needed at attic vents

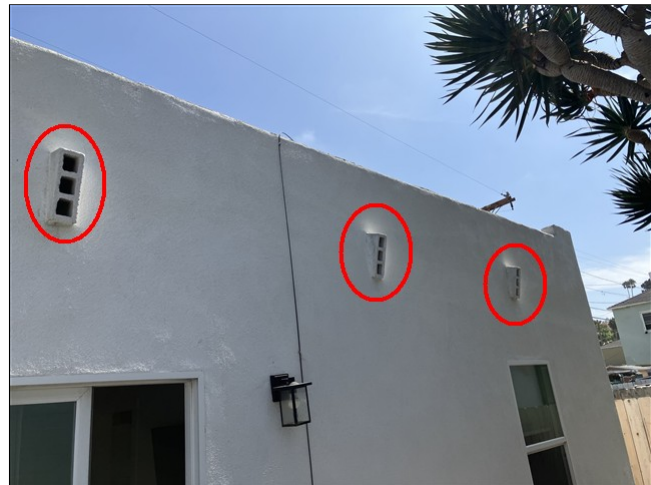
9.2 Item 2(Picture) 1819: vent screens needed at attic vents

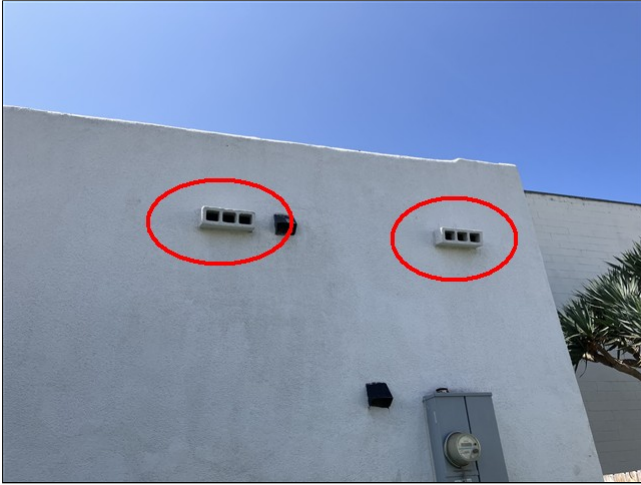
9.2 Item 3(Picture) 1817: vent screens needed at attic vents

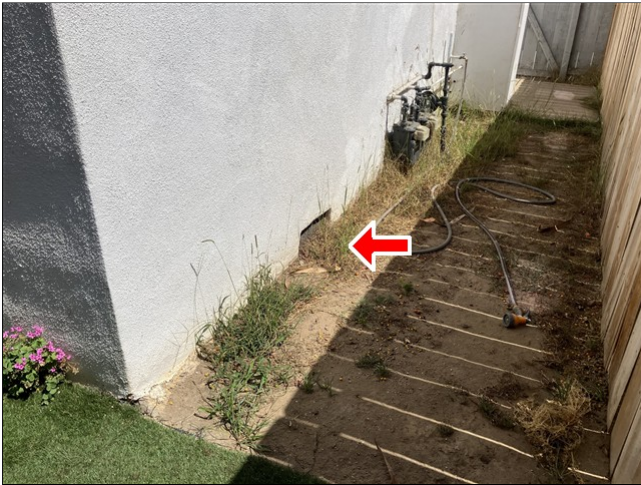
(2) One or more of the subfloor vents are below grade which increases the possibility for water intrusion into the subfloor area. It is recommended to have the vents evaluated by a licensed contractor and corrected as needed.

9.2 Item 4(Picture) 1819: vent appeared below grade level or was susceptible to moisture intrusion

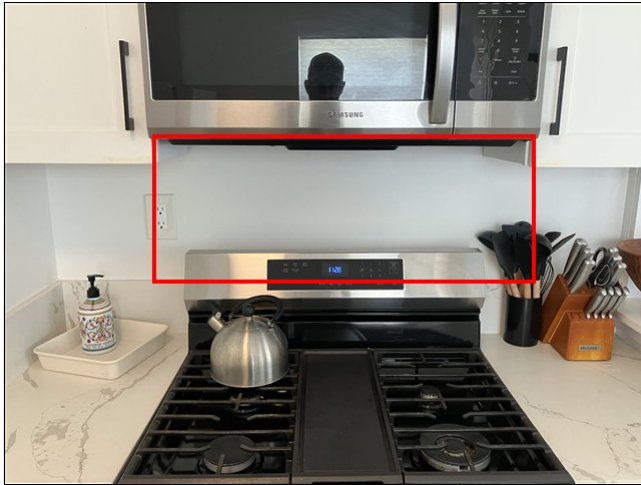
A non-combustible material is needed behind and on the sides of the range oven or stove-top. This can be stainless steel, tile, stone, or other suitable non-combustible material. It is recommended to have this evaluated and upgraded as needed.

10.1 Item 3(Picture) 1819: non-combustible backsplash needed behind range ovens and stovetops

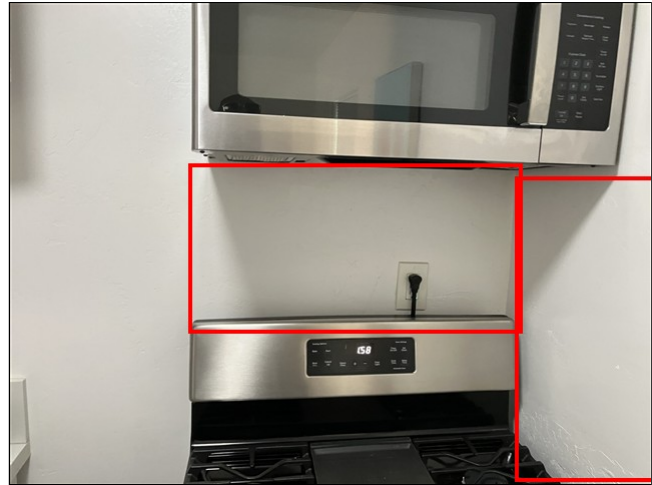
10.1 Item 4(Picture) 1817: non-combustible backsplash needed behind range ovens and stovetops

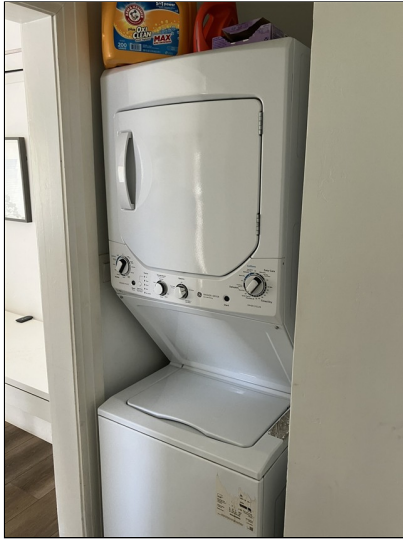
10.6 Item 1(Picture) 1819:  
hookups not visible for inspection

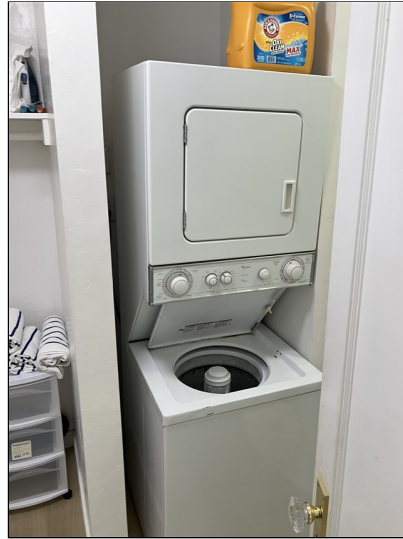
10.6 Item 2(Picture) 1817:  
hookups not visible for inspection

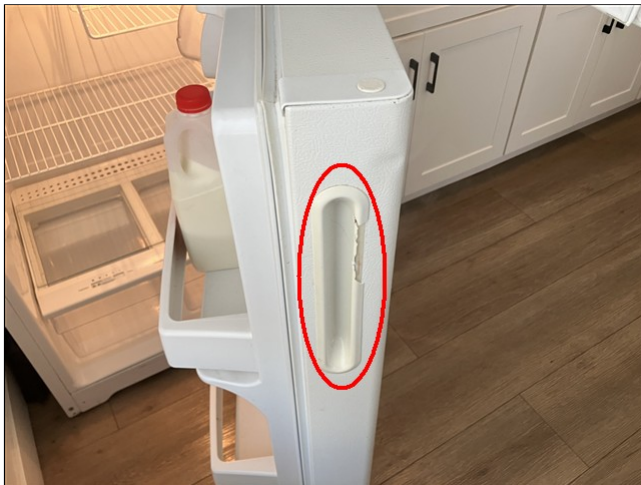
10.7 Item 1(Picture) 1819: fridge handle damage  
visible
