# ***Cornerstone Inspection***

## **Property Inspection Report**

***1301 Los Osos Valley Rd, Los Osos, CA 93402***

***Date of Inspection: 1/30/2026 Time: 9:00 AM***

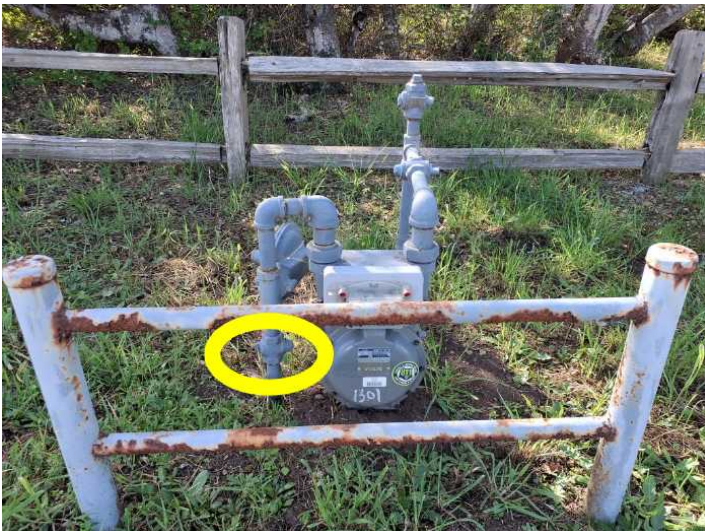
The gas main shut-off is located adjacent to the street.

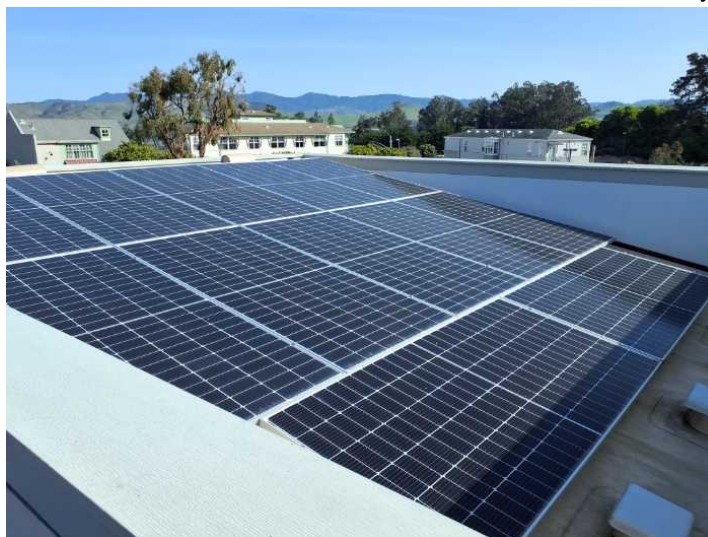
12 Panels on the roof

A photovoltaic solar system has been installed, which we do not have the expertise to evaluate. We recommend the sellers provide information regarding its installation, operation, and maintenance history. You may also wish to have it evaluated by a qualified specialist.

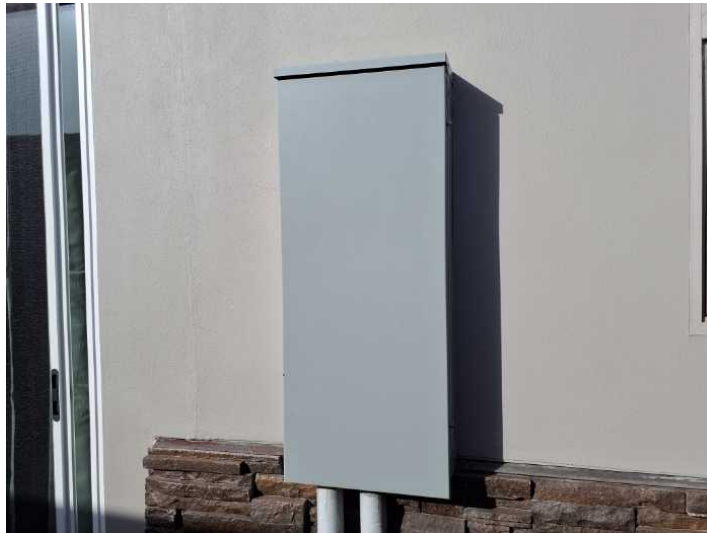
The sub panel is located at the left exterior side of the home.

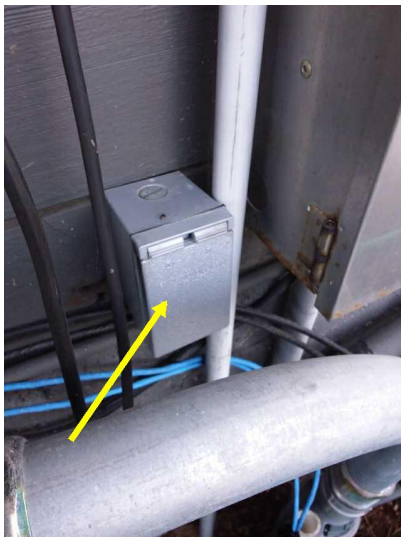
An outlet at the right side has an open-ground and should be evaluated and serviced by a licensed electrical contractor.

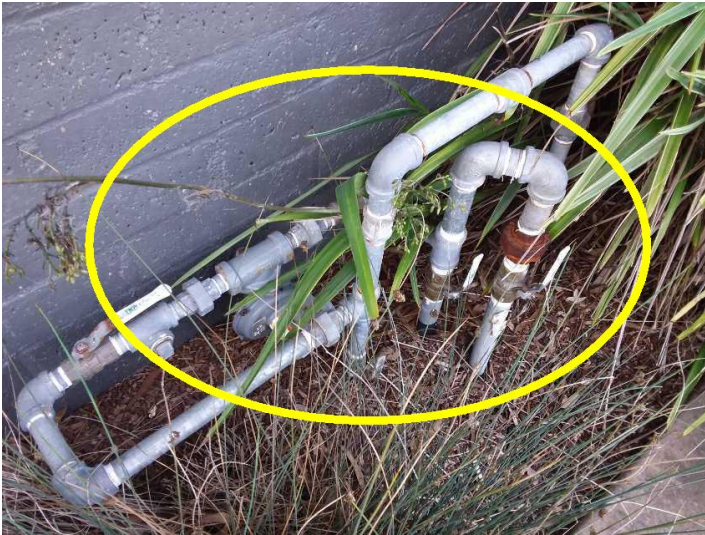
The gas main shut-off appears to be located on front of the home, unit or building.

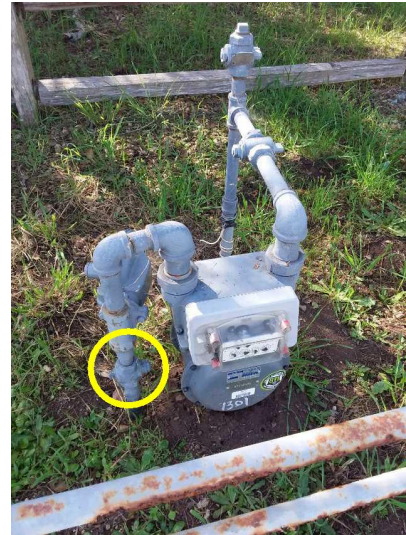
The gas meter and shut off are located at the street.

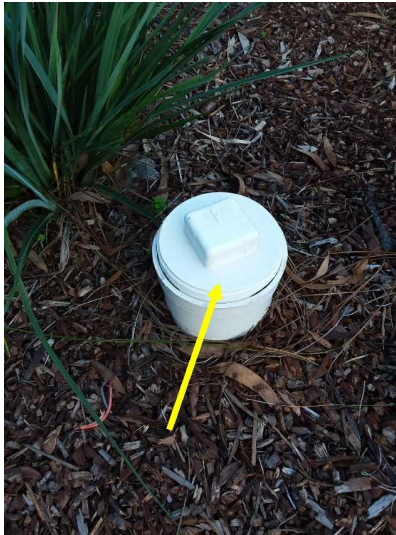
A clean-out is located at the front.
