## Inspection Services

### *Inspection Report*

Address: 4582 Via Santa Maria Santa Maria, CA 93455

09/16/2026

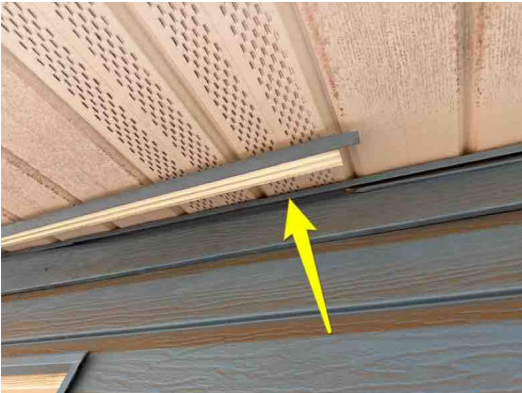
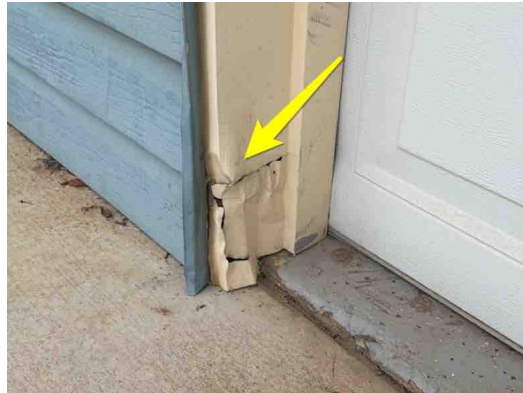
**E&C 35:** Areas of the exterior metal siding and/or trim were observed to be loose, damaged, improperly secured, or altered from the original installation. These conditions may affect the weather resistance of the exterior wall assembly and can allow moisture or pest intrusion. Recommend repair or replacement of affected materials as needed by a qualified contractor.

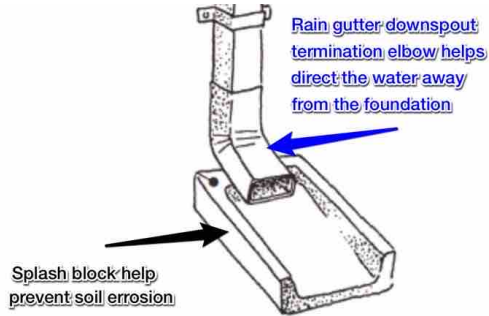
**MR 55:** Recommend splash blocks at the bottom of some rainwater downspouts to assist in proper flow of roof water away from the house and to help prevent soil erosion where not installed.

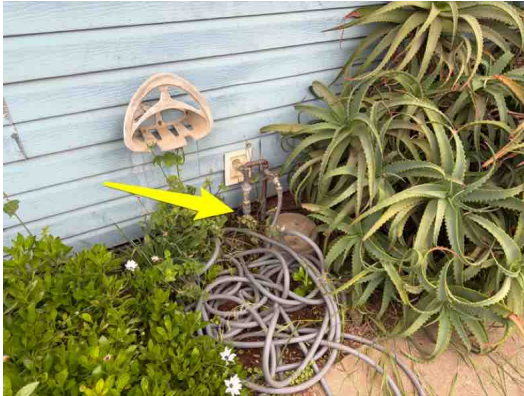
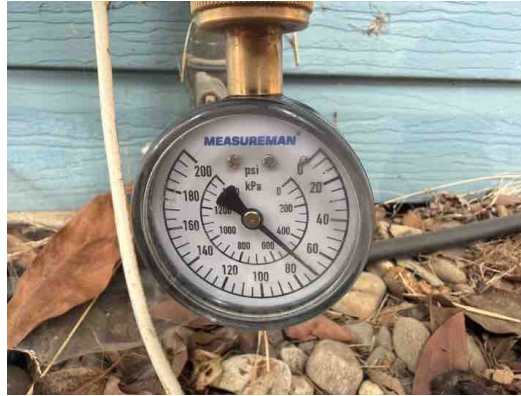
**Water Pressure** - Is At Approx. **70 +/- PSI**. Optimal water pressure is between 40 and 80 PSI.

1. **Pressure Regulator Installed:** NO
2. **An Automatic Leak Detection Device installed on the main water supply:** NO.

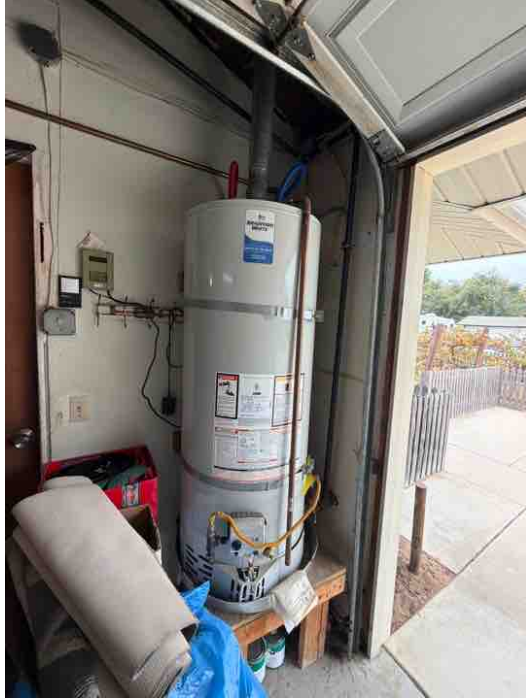
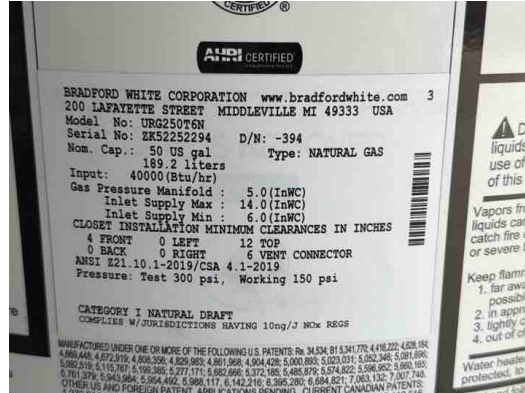
**Date:** 2023: *The average lifespan of this type of water heater is approximately 10 years. This water heater is approximately 3 years old. Water heaters can fail without warning and should be monitored and inspected regularly for leaks, corrosion, and other signs of deterioration.*

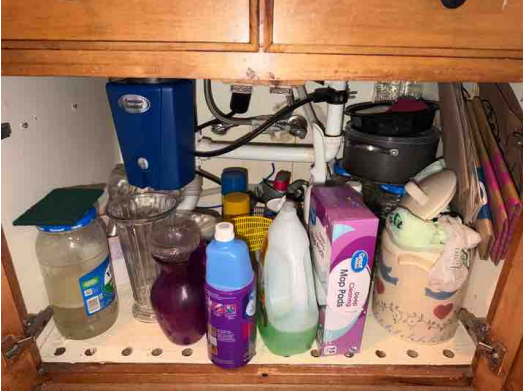
**FI 98:** Some corrosion found at waste pipe connections under the kitchen sink / evidence of past leaking.

**FI 99:** Some corrosion found at the water supply shutoff valves under the Kitchen sink / evidence of past leaking. Client should investigate further until satisfied as to the cause, condition and potential future issues. Correction Recommended.

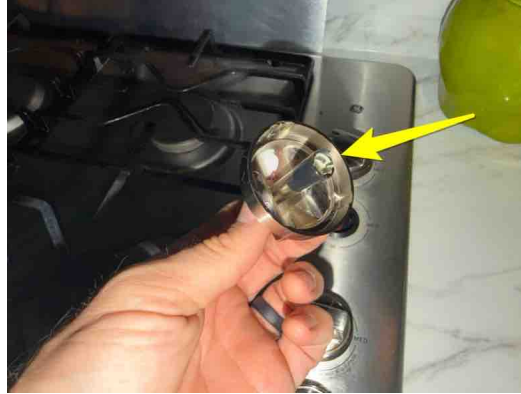
**SC** 109: Damaged / Deteriorated knobs at cook top.

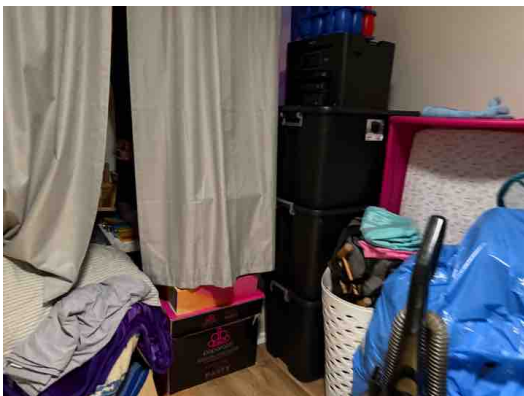
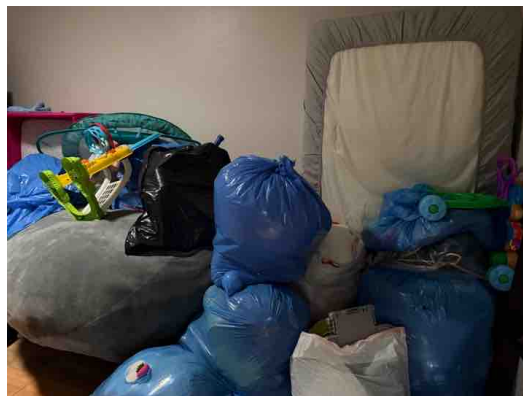
**FI DS 161:** Evidence of past ceiling and wall repairs and/ or alterations found throughout. Client should investigate further to satisfy themselves as to the cause and current conditions.

**DS 162:** Due to an excessive amount of personal items throughout the interior, portions of the interior including cabinetry, closets and other interior areas are not accessible, not visible and not inspected. A re-inspection is recommended once the home is vacant or access is made available.

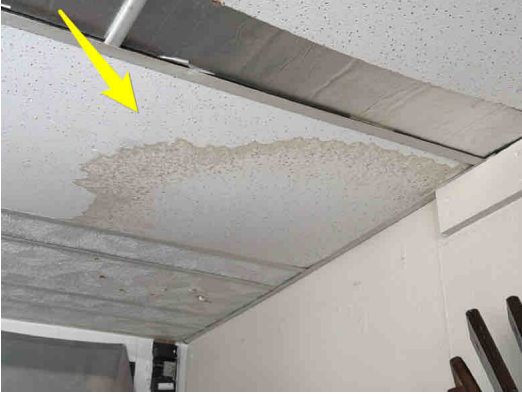
**FI 163:** Evidence of past moisture stains & damage at ceiling area in the SUNROOM. Recommend further review of the water stains to determine the cause, the current condition and if repairs are needed.

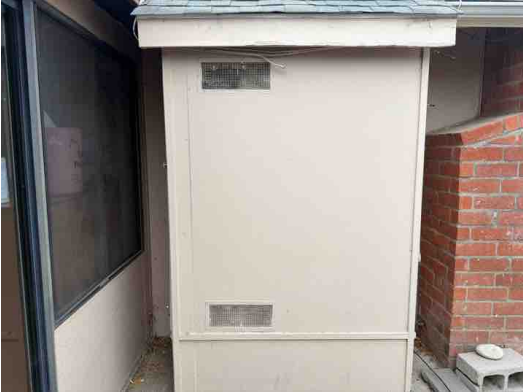
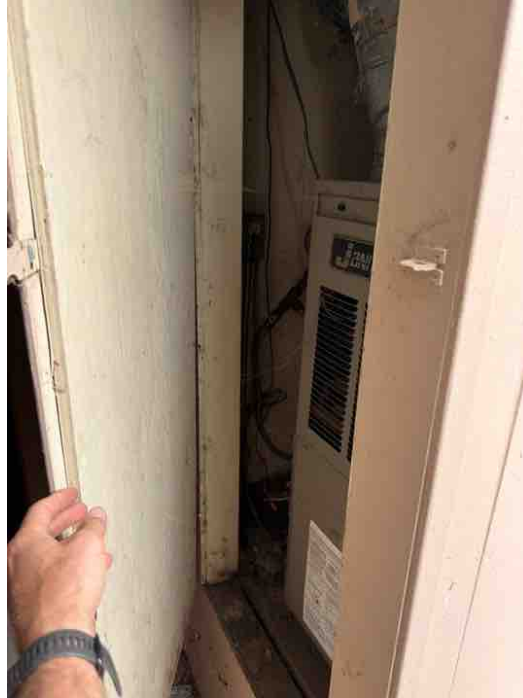
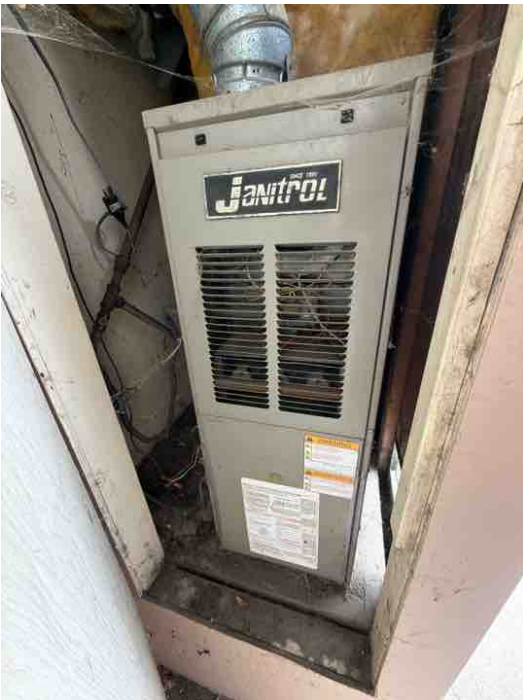
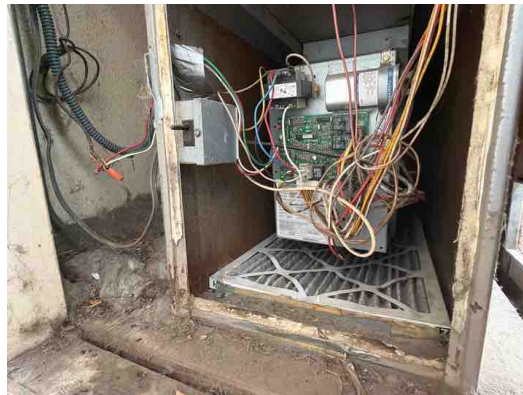
**UPG** 166: Missing the required 30" of clearances in front of the furnace per minimum installation standards. [CMC 304]

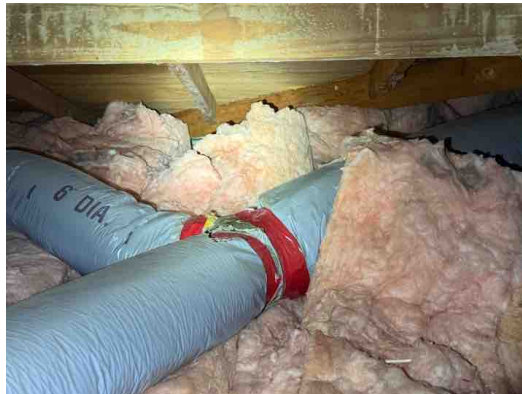
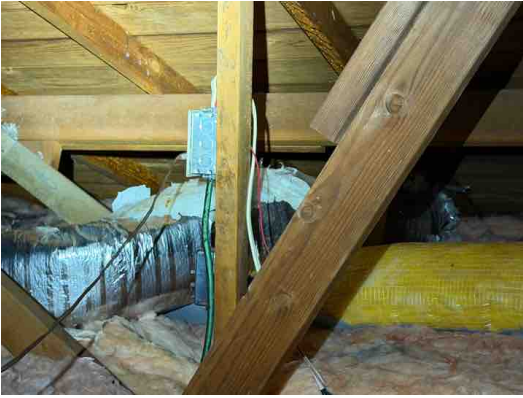
**171:** The heating/air distribution ducting in the attic appears to be improperly installed and includes numerous deficiencies, including questionable duct sizing/transitions, poor connections and support, and generally non-professional installation. The system was also observed to have poor airflow/performance. Due to the number and extent of defects, individual deficiencies are not listed. Recommend further evaluation of the entire duct system and necessary repairs or replacement by a licensed HVAC contractor.

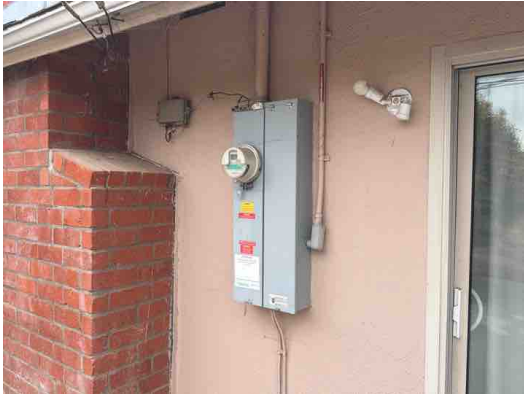
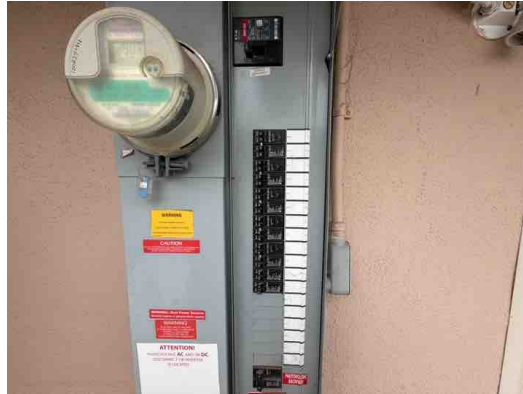
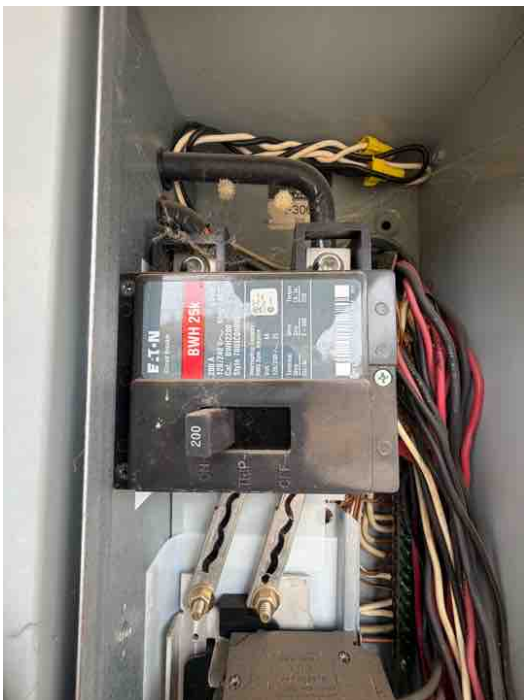
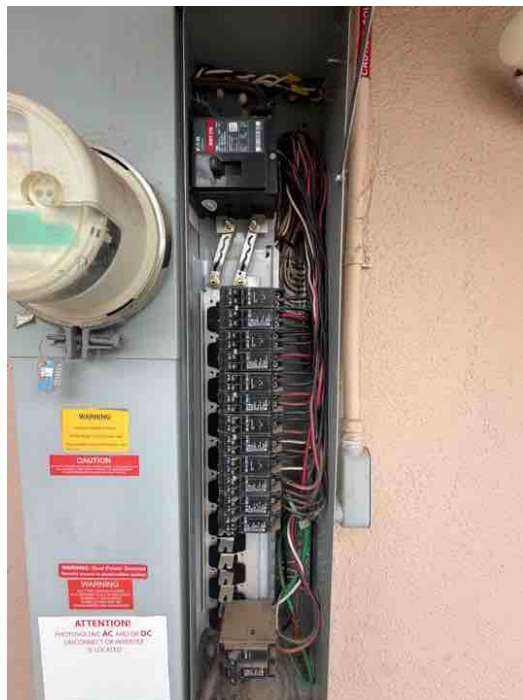
**177: MAIN ELECTRICAL PANEL CONDITION:** \*No visible wiring defects in the MAIN ELECTRICAL PANEL.

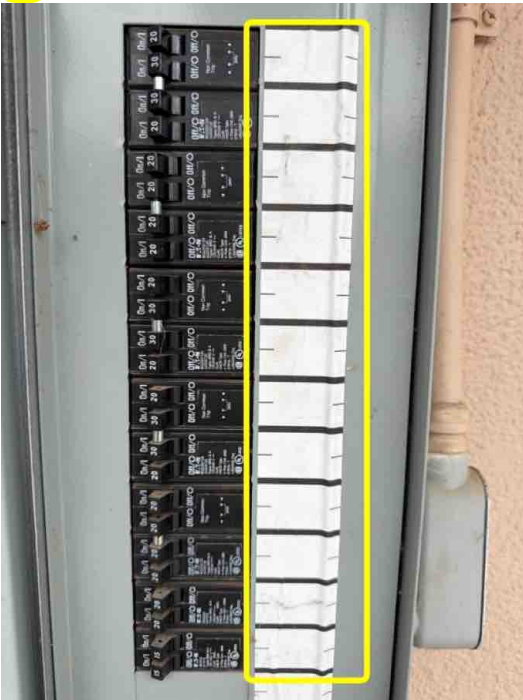
**SU 179:** The breakers in the MAIN ELECTRICAL PANEL are not labeled per standards.

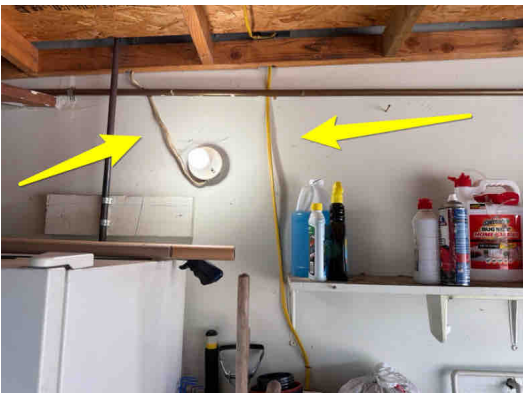
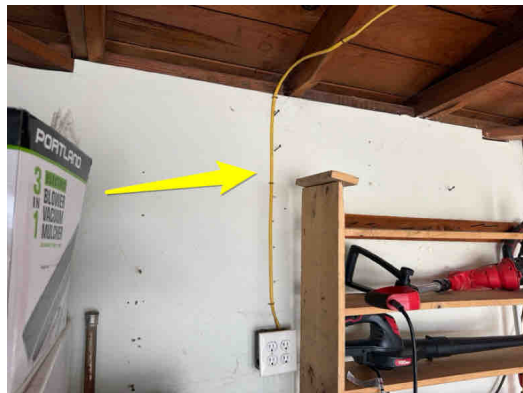
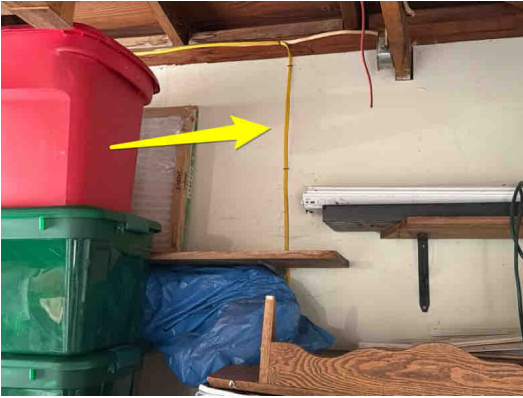
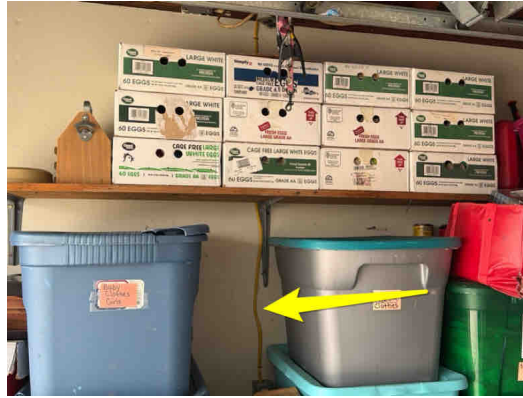
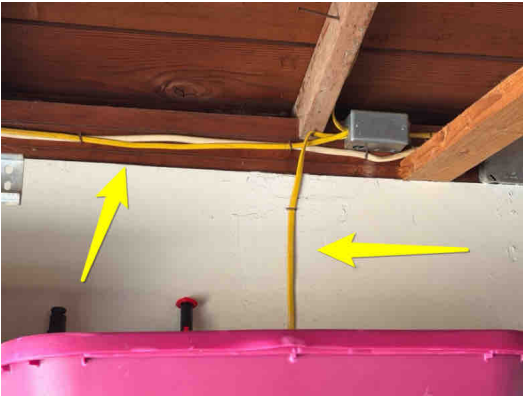
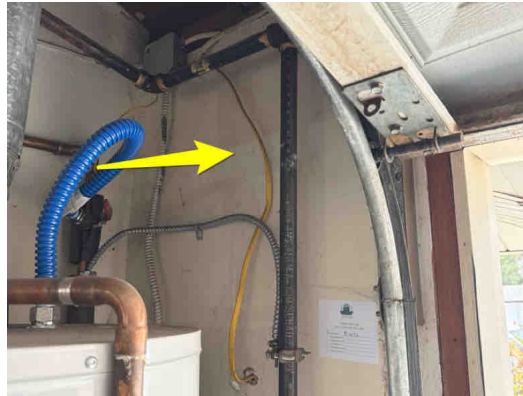
**SC 182:** Improper exposed electrical wiring, "Romex" improperly installed subject to physical damage, not in a conduit or raceway per standards: MULTIPLE LOCATIONS THROUGHOUT THE GARAGE  
NEC 334.15(B)  
NEC 300.4

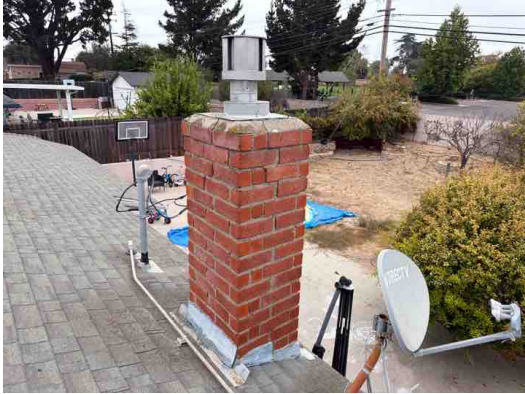
**210:** The LIVING ROOM fireplace chimney.
