# - INSPECTION REPORT -

**CHRIS RIPPY INSPECTIONS**

**1040 Trailview Ln, Corona, CA 92881, USA**  
**Inspection prepared for: Bill Williamson**  
**Real Estate Agent: Lisa Broder - Think Boutiq Real Estate**

**Date of Inspection: 8-24-2026**

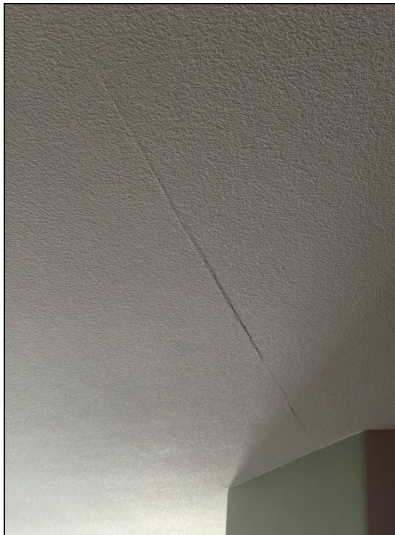
• Cracks were observed, which may be indicative of possible settlement.

Recommend further evaluation by a licensed professional to determine the cause and assess if any corrective measures as needed.

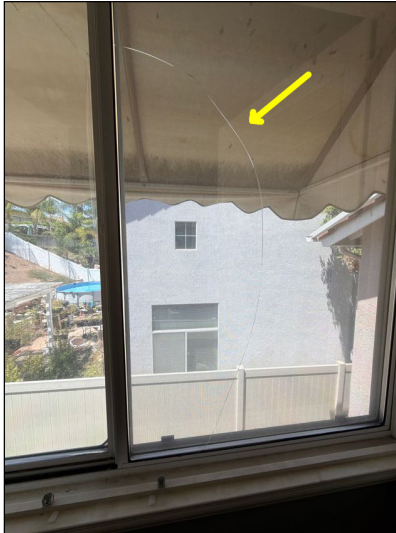
Crack

| Page 14 Item: 6 | Window Condition | 6.3. Cracked or broken window glass was observed. Recommend repair or replacement by a qualified professional to ensure safety and maintain proper function. Primary Bedroom |

6.3. Cracked or broken window glass was observed. Recommend repair or replacement by a qualified professional to ensure safety and maintain proper function. Primary Bedroom

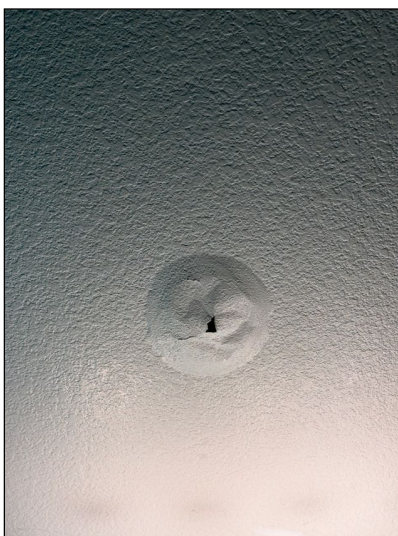
| Page 18 Item: 3 | Ceiling Condition | 3.2. Blistering paint observed. Upstairs Hallway Bathroom |

3.2. Blistering paint observed. Upstairs Hallway Bathroom

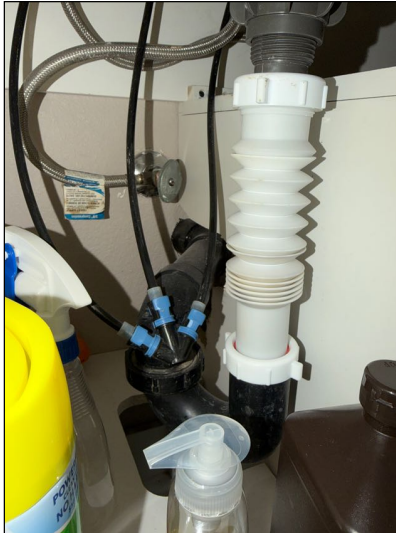
12.3. Flex drain observed, these are subject to frequent clogging.

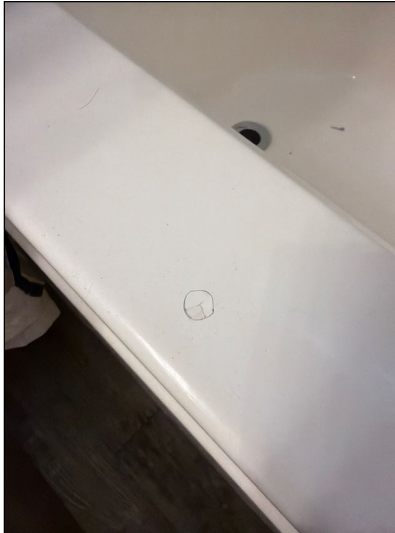
| Page 22 Item: 13 | Bath Tubs | 13.2. Bathtub: Chipping was observed along the upper edge/rim of the bathtub near the entry area. Recommend repair or refinishing as needed to prevent further deterioration. Downstairs bathroom. |

13.2. Bathtub: Chipping was observed along the upper edge/rim of the bathtub near the entry area. Recommend repair or refinishing as needed to prevent further deterioration. Downstairs bathroom.

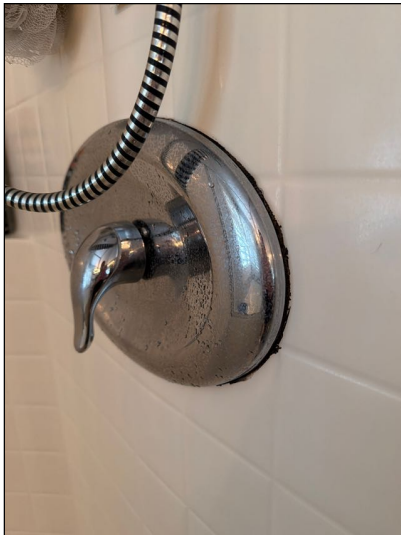
14.4. Loose escutcheon plates noted. These should be refastened and caulked to keep water from infiltrating the walls. Primary shower

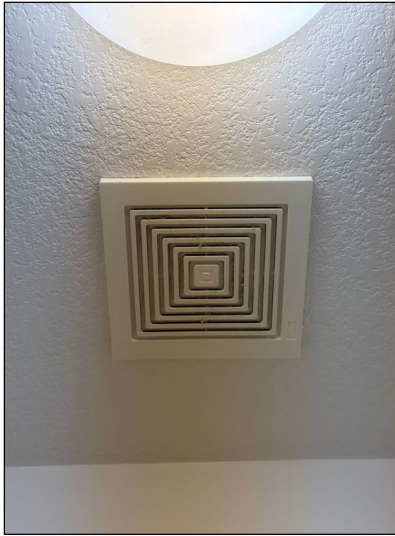
17.4. Fan covers appear to be dirty. Recommend cleaning for proper ventilation.  
Primary Bathroom, Upstairs Hallway Bathroom

17.5. Exhaust fan is noisy. Upstairs Hallway Bathroom

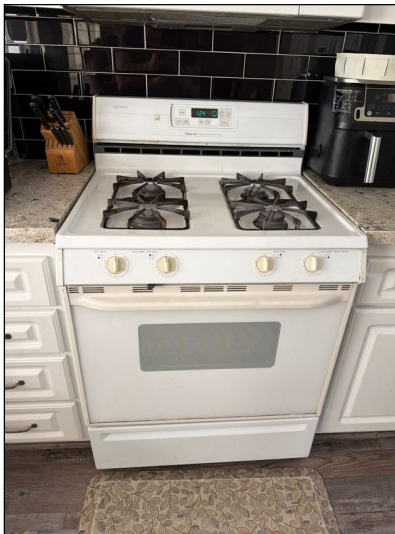
11.4. DEFERRED COST: Older unit. Please consult manufacturer for projected service life.

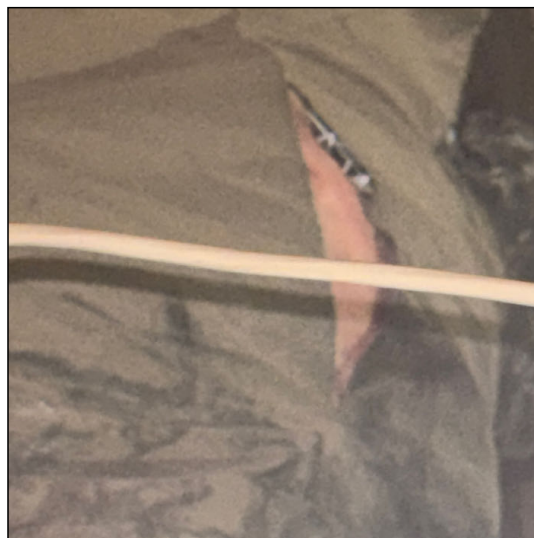
5.1. Torn outer bag insulation was observed at multiple HVAC ducts. Damaged duct insulation can reduce system efficiency and lead to condensation issues on duct surfaces. Recommend further evaluation and repair by a state licensed professional.

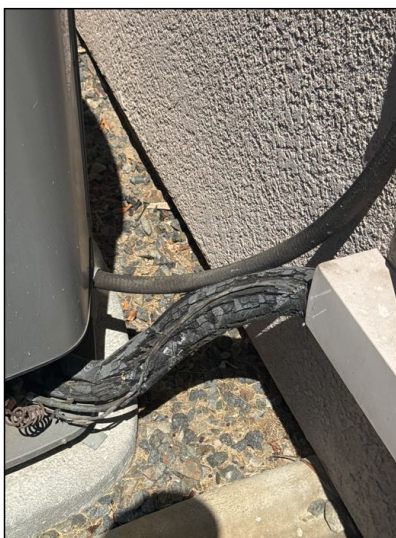
7.1. Deteriorated insulation at A/C unit.

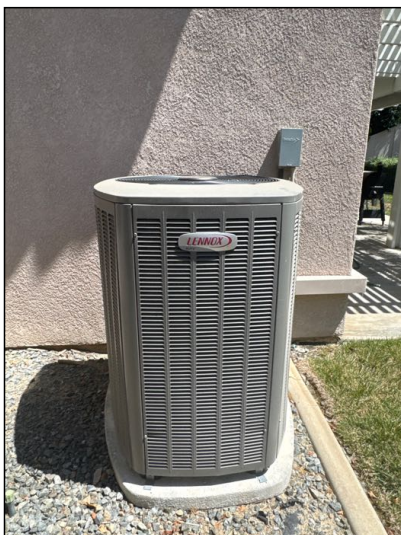
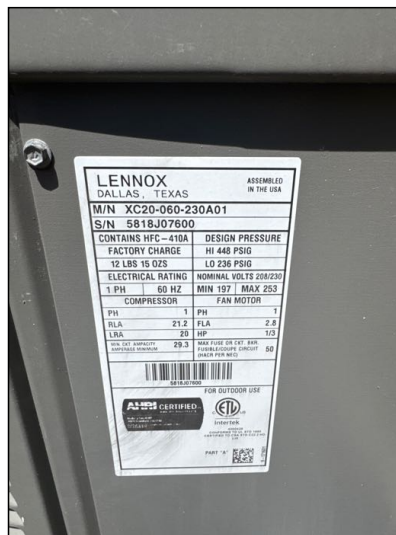
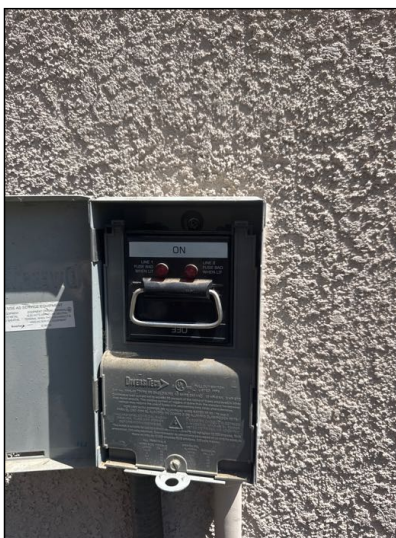
**8.2. Functional at the time of inspection. The typical temperature differential split between supply and return air in an air conditioner of this type is 15 - 20 degrees F. This system responded and achieved an acceptable differential temperature.**

**8.1. We recommend having your air conditioner serviced regularly by a state licensed professional to ensure things are in running order and help spot potential trouble.**

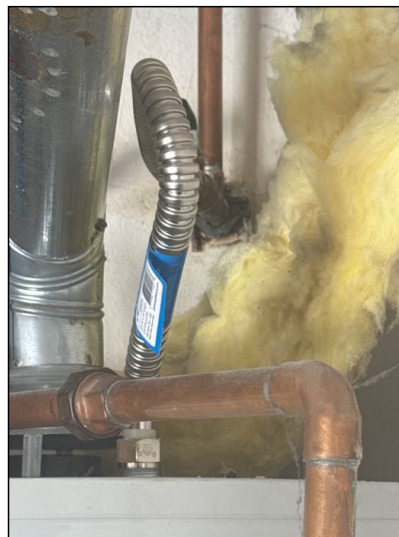
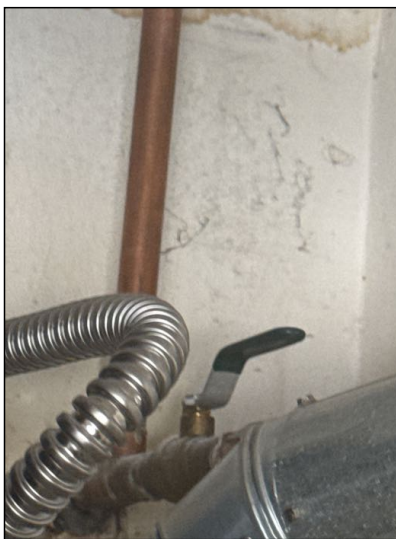
9.2. No expansion tank was observed at the time of inspection. Recommend checking local codes for requirement, and evaluation by a licensed plumber for installation as needed.

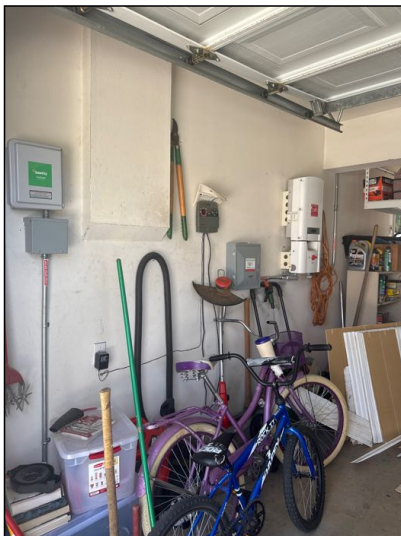
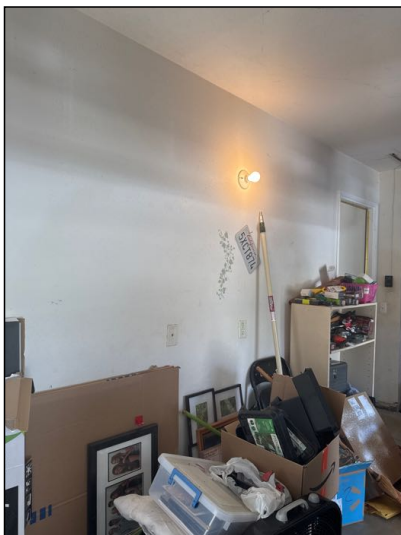
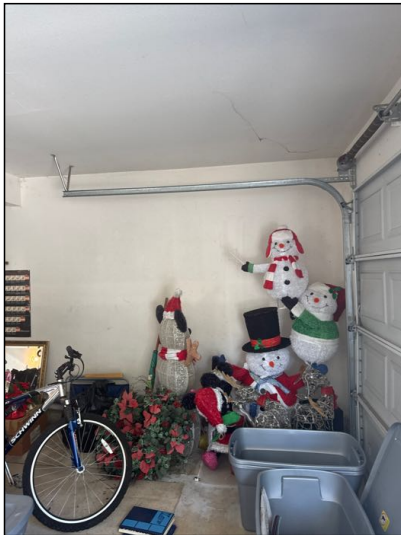
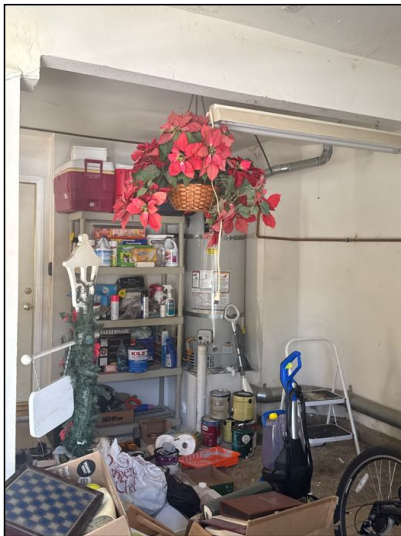
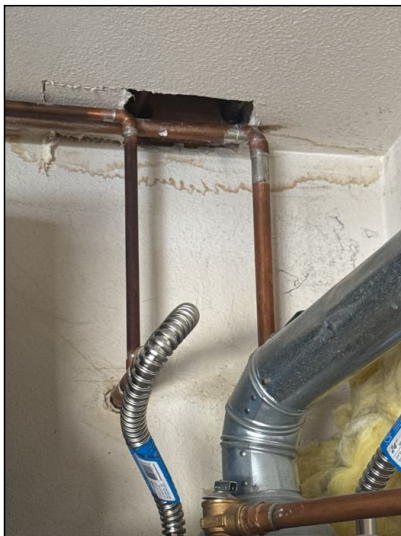
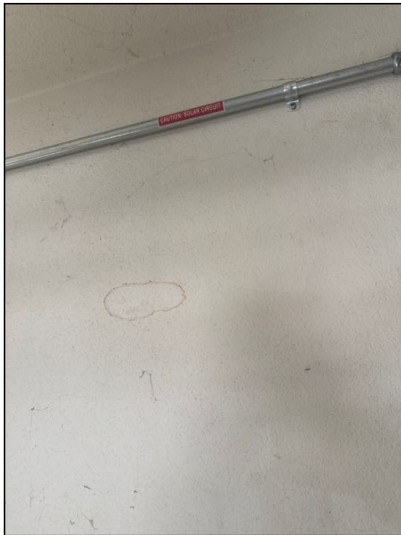
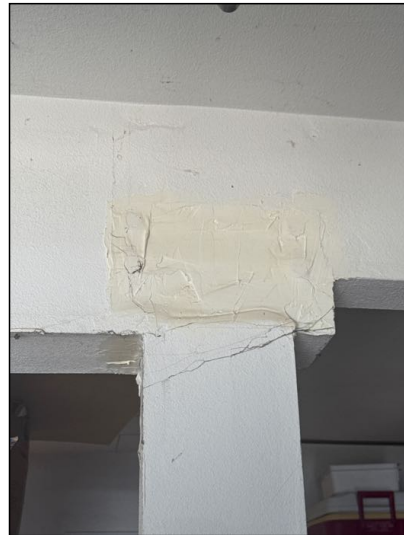
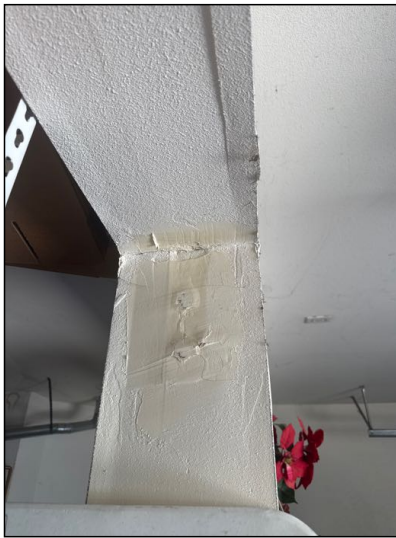
**1.3. Moisture staining was observed on the interior of the garage walls near the ceiling, in multiple areas, in the garage located below the second-story living space. This condition may indicate leakage from plumbing, HVAC condensate lines, or other sources within the floor assembly above. Recommend further evaluation and repair by a state licensed professional.**

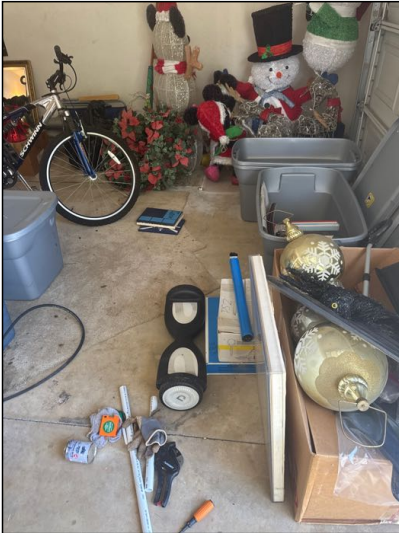
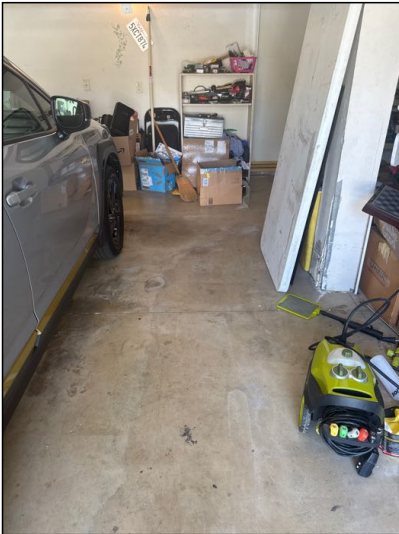
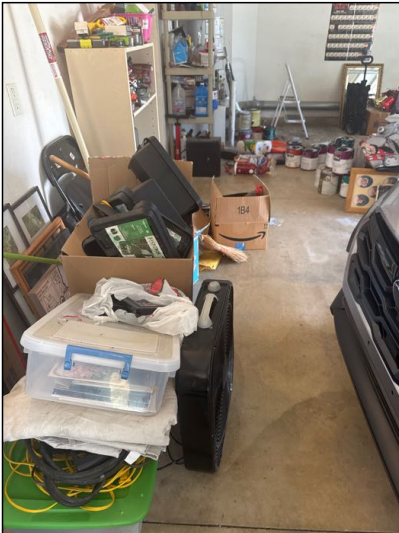
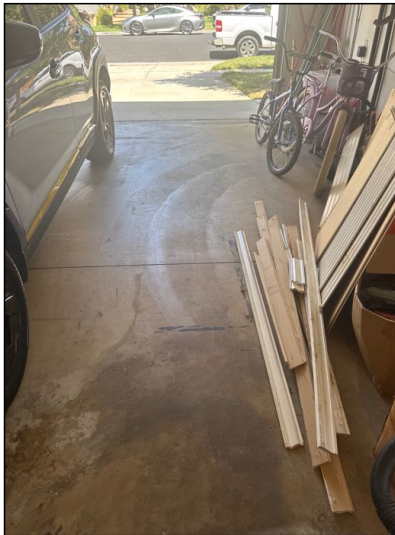
2.2. **Garage Floor:** Common cracks were observed in the garage floor. These appear consistent with normal shrinkage or settling and do not indicate a structural concern at this time. Monitoring for expansion or movement is recommended.

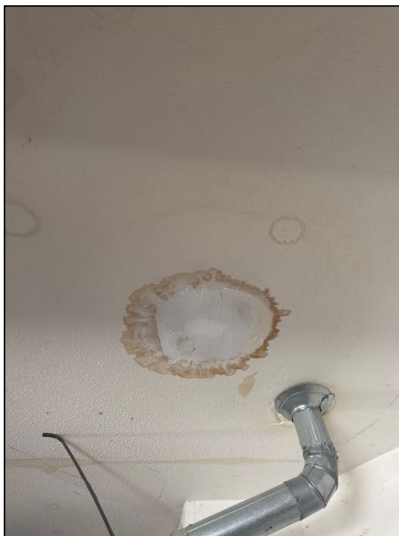
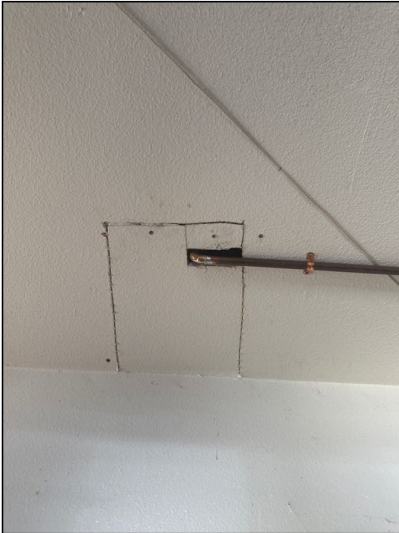
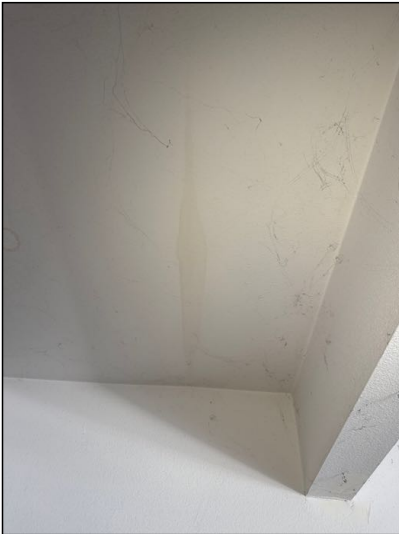
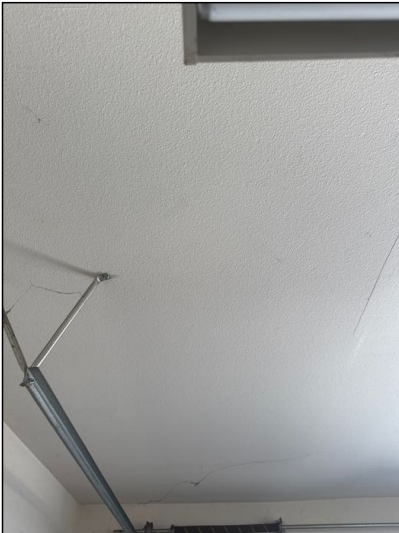
**3.3. Fire Separation:** A hole was observed in the garage ceiling, compromising the required fire-resistant barrier between the garage and the living space. This condition is considered unsafe and should be repaired by a qualified contractor to restore proper fire protection and occupant safety.

**3.4. Moisture Damage:** Staining and/or moisture-related damage was observed on the garage ceiling beneath the finished living space. The source of this condition and whether it is active or the result of a past event could not be determined during this visual inspection. Recommend further evaluation by a qualified, state-licensed professional to determine the source and perform any necessary repairs.

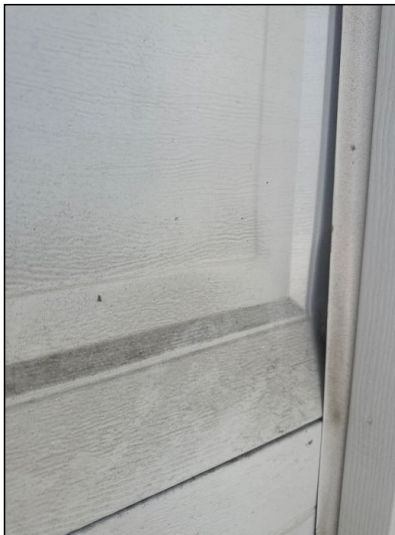
**8.2. Dents or Damage:** Dents or physical damage were observed on the metal garage door. This may affect alignment and smooth operation. Repair or replacement of damaged panels is recommended.

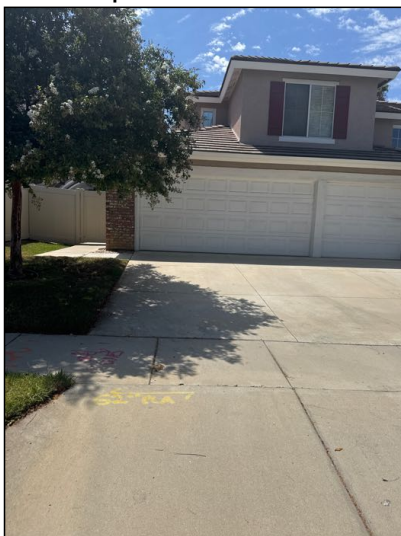
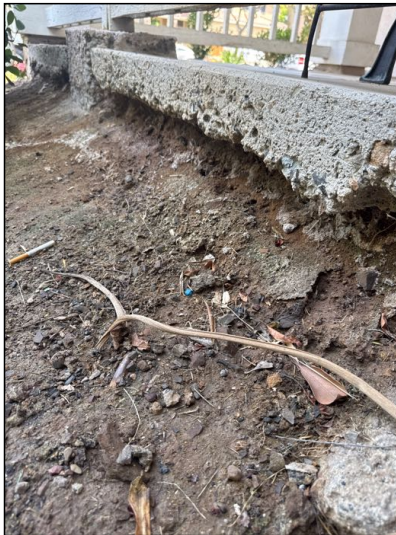
1.1. Common cracks were observed at the concrete surfaces. Further deterioration will occur as water expands and contracts due to temperature changes. Recommend sealing the cracks to prolong the life of the concrete.

1.4. Moderate cracks in driveway. Repair and / or monitor for expansion and development of trip hazards.

1.5. Moderate cracks in sidewalk. Repair and / or monitor for expansion and development of trip hazards.

1.6. Minor undermining of the concrete porch slab was observed at the front porch. This condition may be related to soil erosion or drainage and could worsen over time. Recommend evaluation and repair as needed by a state licensed professional.

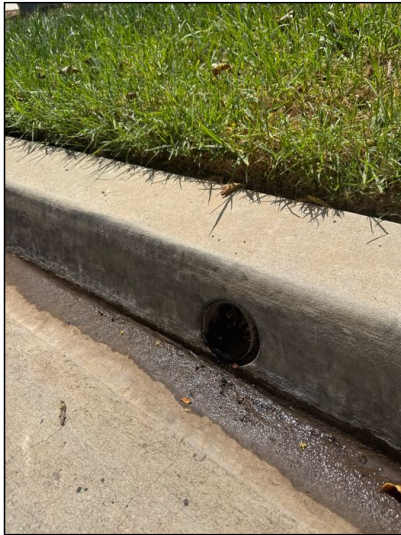
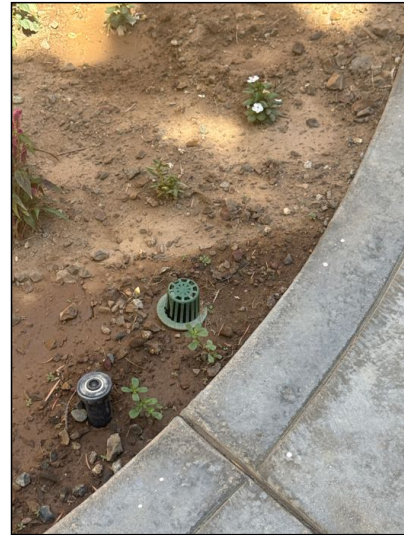
3.1. Drainage grates were observed on the property. Recommend further exploration to determine the extent of the system. Also recommend ongoing maintenance (cleaning, removing debris, etc.) to facilitate optimal performance of the system.

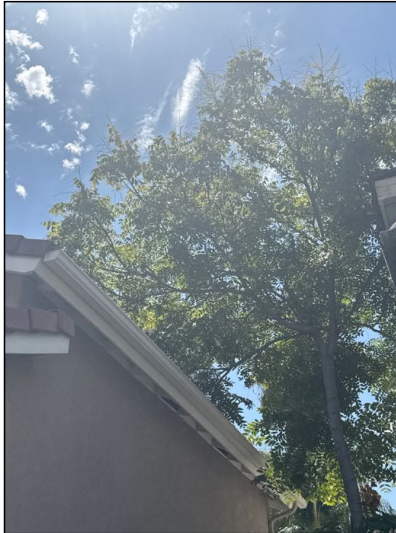
4.2. Tree branches overhanging roof and/or against siding. Trim trees that are in contact or proximity to home, as branches can abrade siding and damage roofing.

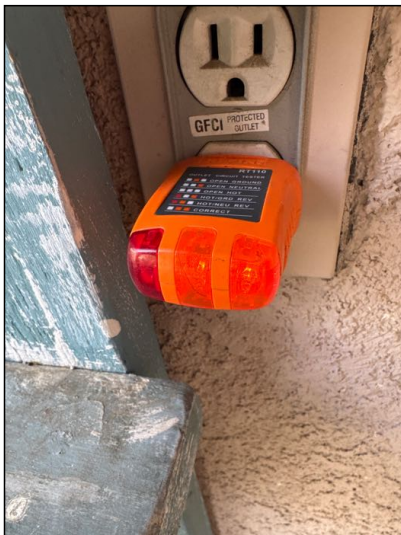
6.1. Exterior outlet is missing waterproof cover.

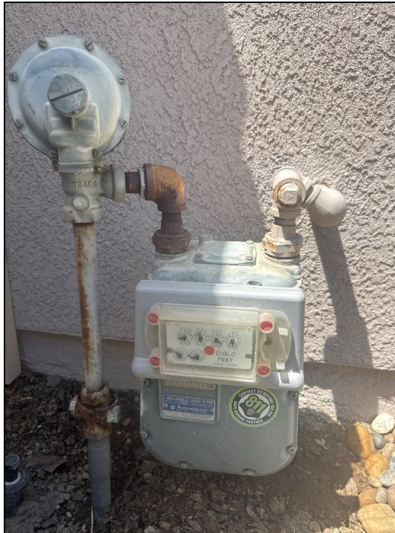
8.3. No seismic shut off valve present. Consult local codes.

8.1. **Recommend keeping a gas valve shutoff wrench close to the meter in case of an emergency.**

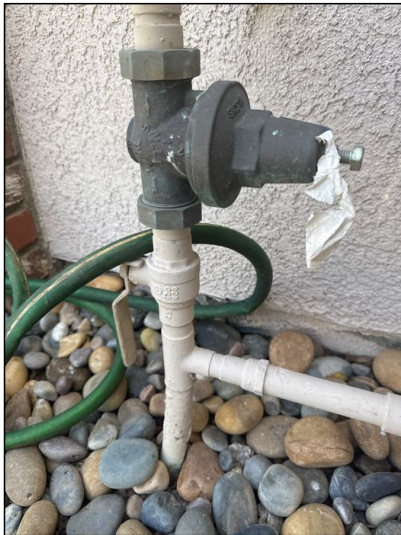
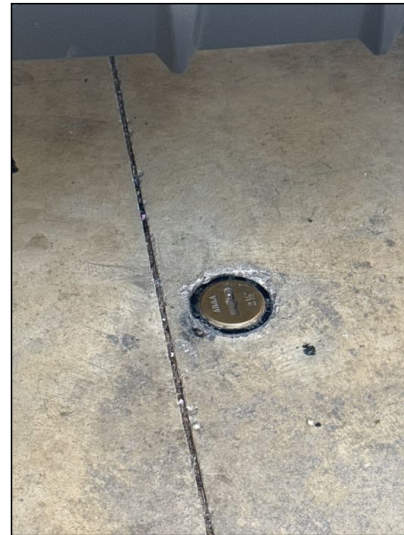
9.1. Pressure regulator noted.

9.2. Sprinkler system noted; client is advised to seek advice of a specialist in evaluating this system before use. The inspector recommends also consulting with seller for operation instructions if needed. Sprinkler systems are beyond the scope of a Home Inspection, due to most of its parts/piping not visible.

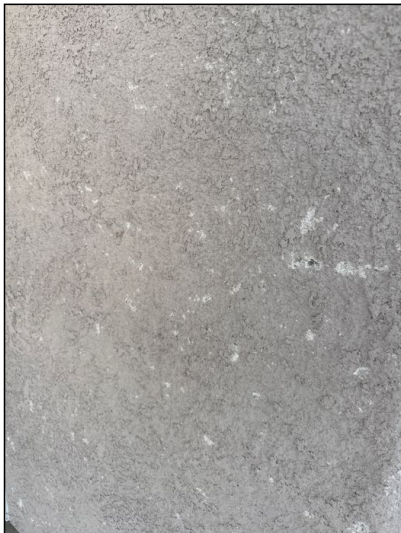
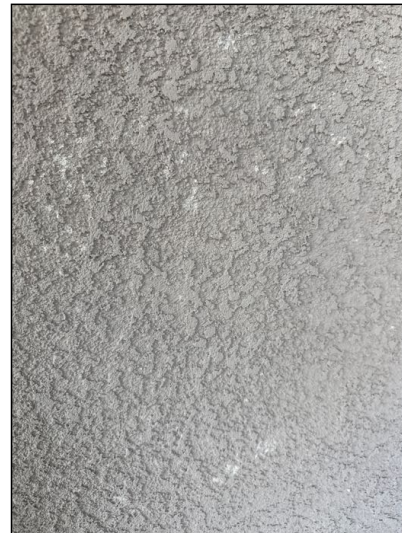
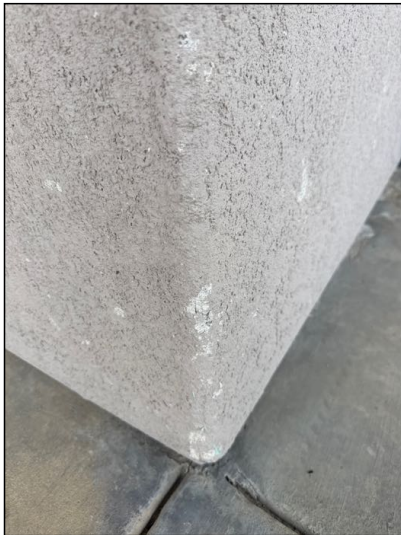
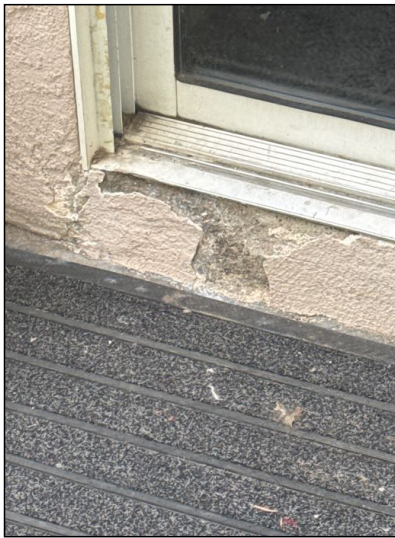
**12.3. Cracks in Stucco:** Cracks were observed in the stucco surface. These can allow moisture intrusion and should be sealed or repaired.

**12.4. Delamination or Bulging:** Areas of stucco appear to be bulging or separating from the wall. This may indicate hidden moisture damage and should be evaluated by a qualified stucco contractor.

**12.5. Impact Damage:** Chips, holes, or surface damage were observed on the stucco. These areas may allow moisture intrusion and should be repaired.

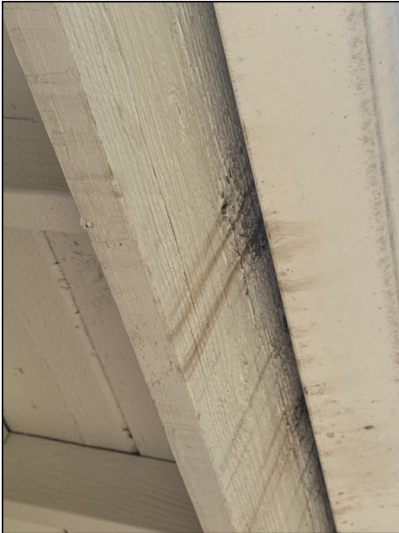
14.1. **Deteriorated or Rotted Wood:** Areas of rot or deterioration were observed at the eaves, soffits, or rafter tails. This condition is typically caused by prolonged moisture exposure and should be repaired or replaced as needed.

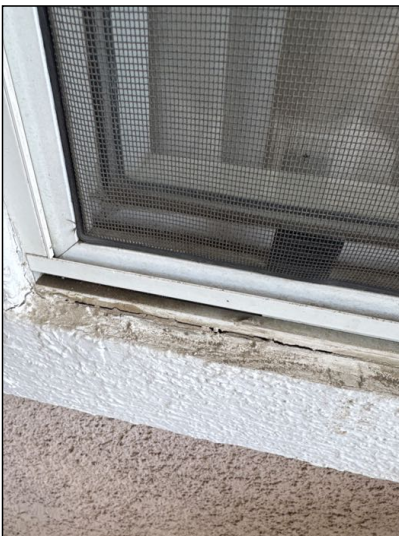
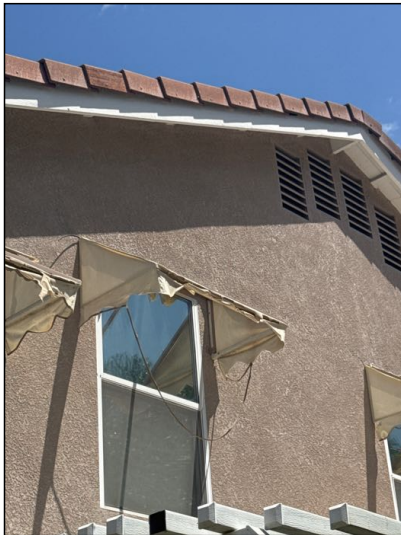
**16.1. Failed or Missing Caulking:** Caulking around the exterior window frame is cracked, deteriorated, or missing. This may allow moisture intrusion and should be resealed.

**16.2.** Awnings at multiple upper-story windows were deteriorated, with some torn from their framing. Recommend further evaluation and repair by a state licensed professional.
