### *Inspection Report*

Address: 1050 Santa Ynez Ave Los Osos, CA 93402

08/31/2026

Inspector: Taylor Vreeken, CCI

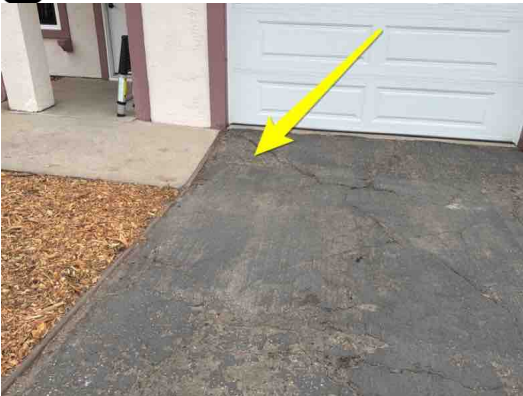
**DS 18:** Due to the slope of the driveway at the garage connection, some water intrusion into the garage may occur during certain weather.

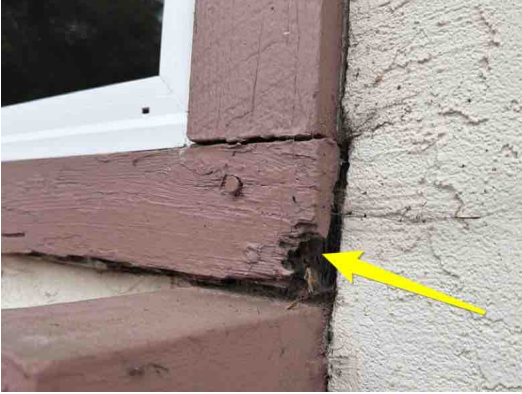
**E&C 40:** Some moisture and/or bug type damage & deterioration found at exterior areas such as eaves, fascia and/or trim. Refer to the termite report for locations and extent.

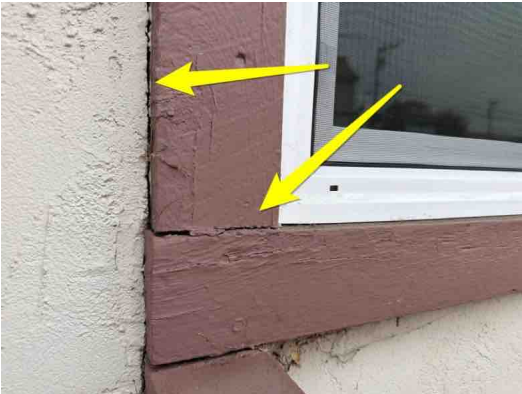
**MR 41:** Deteriorated, cracked, and separated caulking was observed at various exterior trim locations, including around doors, windows, fascia, and other exterior penetrations. Recommend maintenance and replacement of failed sealants to help prevent moisture intrusion.

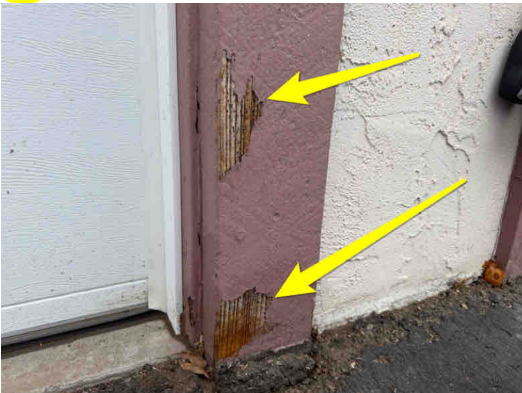
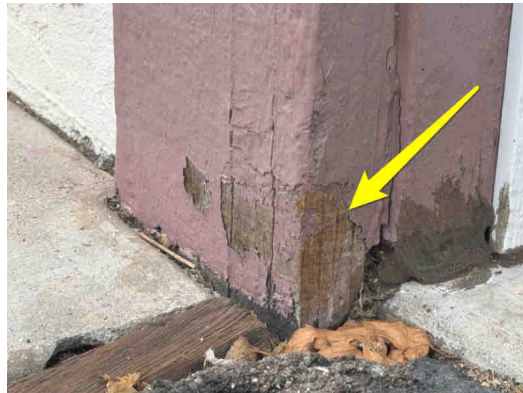
**MR 42:** Deteriorated paint or finish at areas of the exterior.

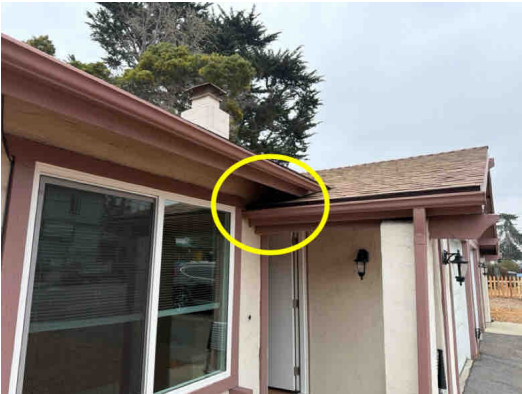
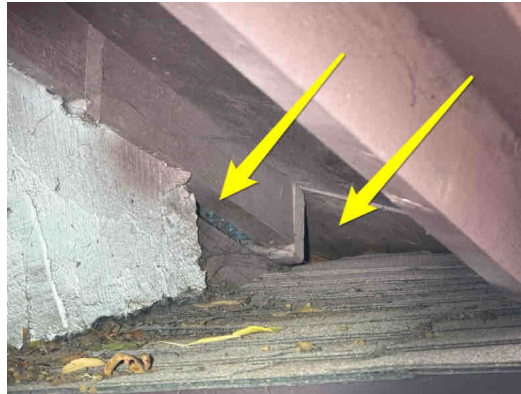
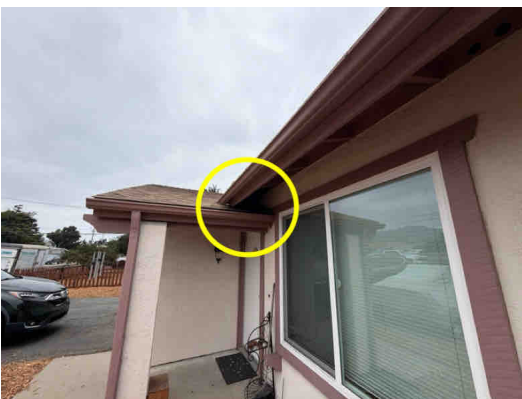
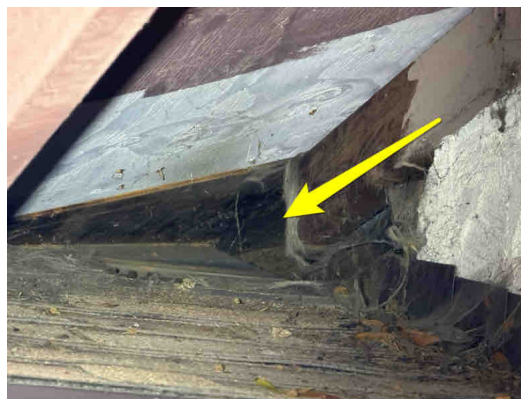
**E&C 73:** Unprotected openings into the attic or confined spaces from the exterior should be sealed or screened per standards to help keep rodents out of the attic.

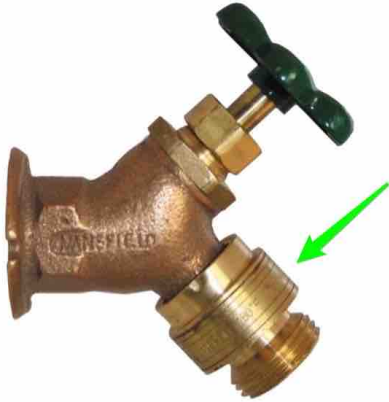
**UPG 81:** Anti-siphon valves recommended on exterior hose faucets where not installed.

Example of an anti-siphon valve on a hose faucet

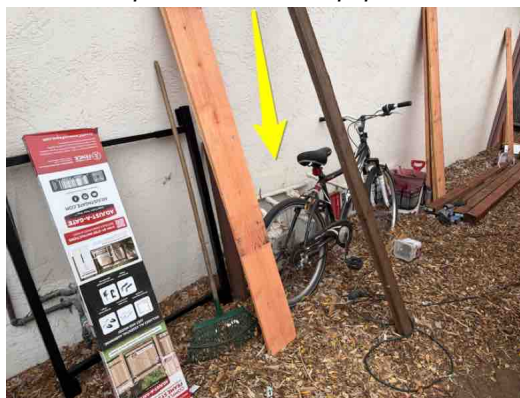
**86: Gas shut-off appears serviceable.**

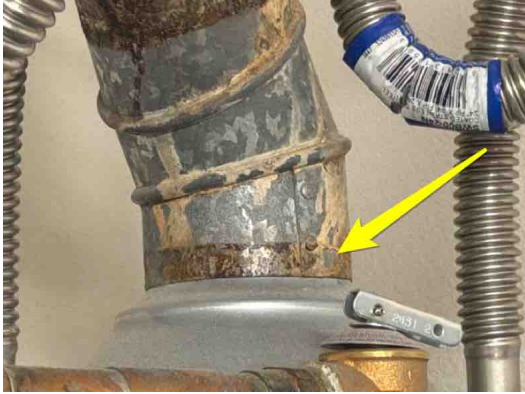
**SC 106:** Water heater vent connector pipe (single wall) is not properly fastened with the required 3-fasteners at the draft hood per standards.

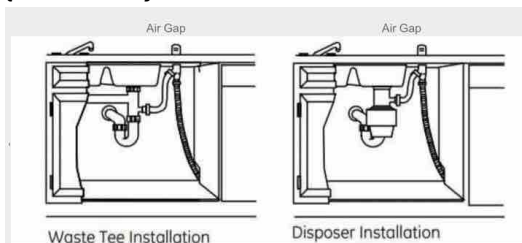
**SU** 120: Improper installation of the dishwasher drain hose. Missing the Air Gap Device at the dishwasher drain per minimum codes and standards (California does not allow for high-loop methods or direct waste connections). {CPC 801.2}

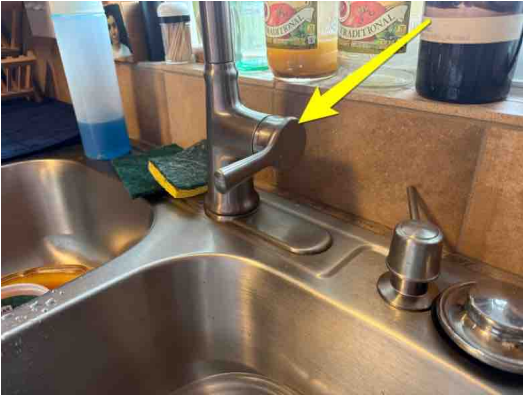
**133:** Hot & cold reversed at the kitchen sink faucet.

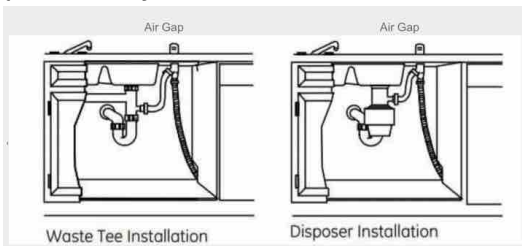
**SU 137:** Improper installation of the dishwasher drain hose. Missing the Air Gap Device at the dishwasher drain per minimum codes and standards (California does not allow for high-loop methods or direct waste connections). {CPC 801.2}

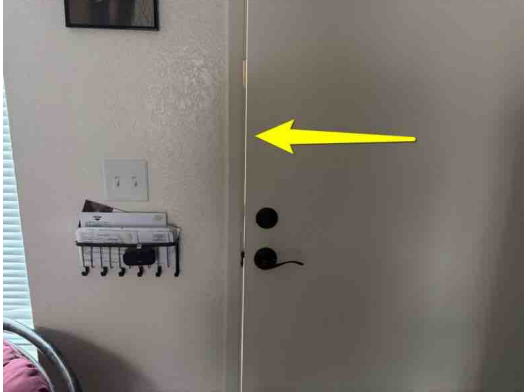
**MR 177:** Some visible daylight noted around the UNIT-B exterior front entry door. Adjustment and/or repair of the weather stripping is recommended to help prevent water and critter intrusion.

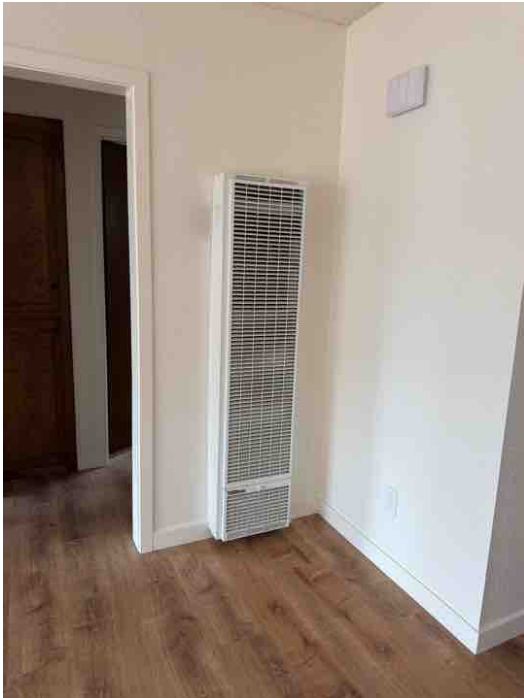
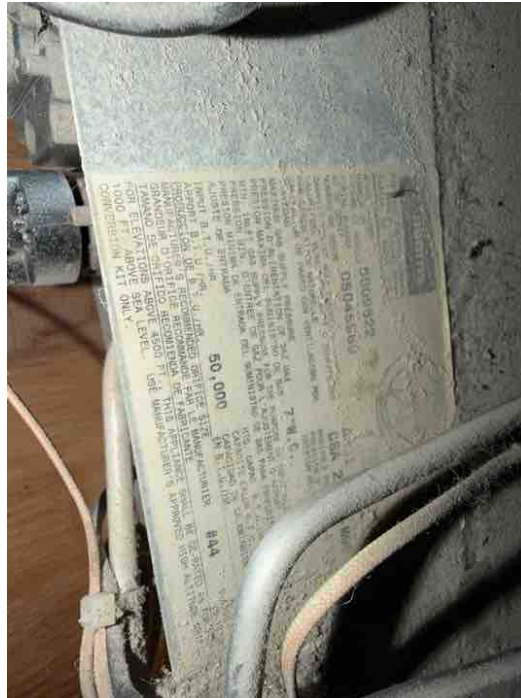
**198: HEATING SYSTEM CONDITION:** The heating system operated when tested.

**SU DS 201:** A Loose grill(s) found at the UNIT-A wall furnace which is considered a potential hazard.

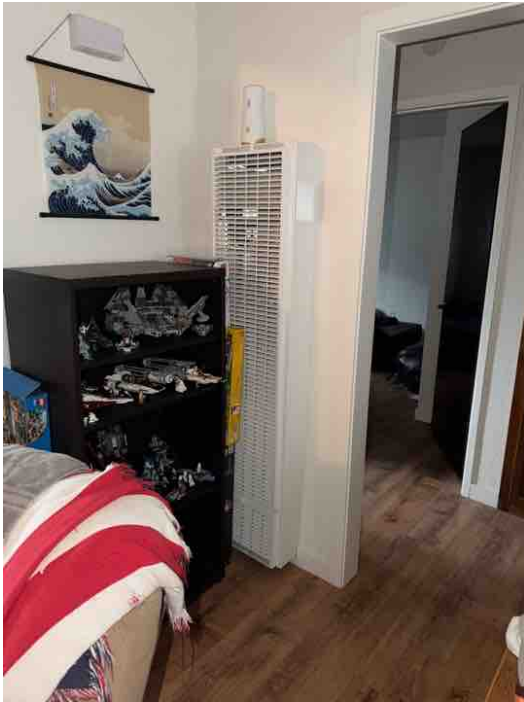
**FI 205: FURNACE CONDITION:** **The Furnace did not respond to thermostat controls.** Pilot was off and unit was not accessible for lighting. *Recommend confirmation of proper functionality fore the close of escrow.*

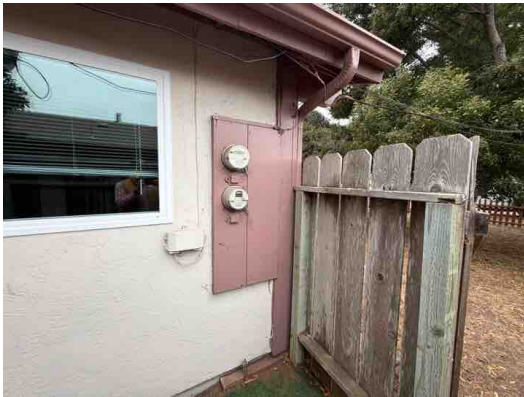
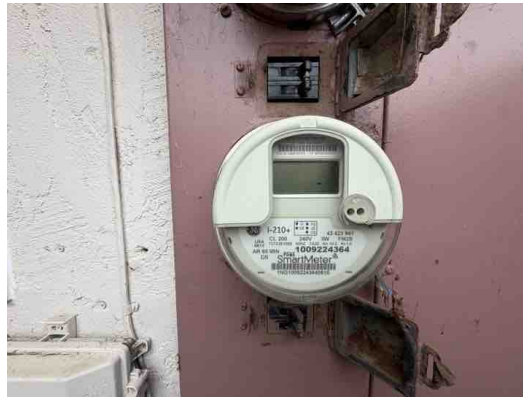
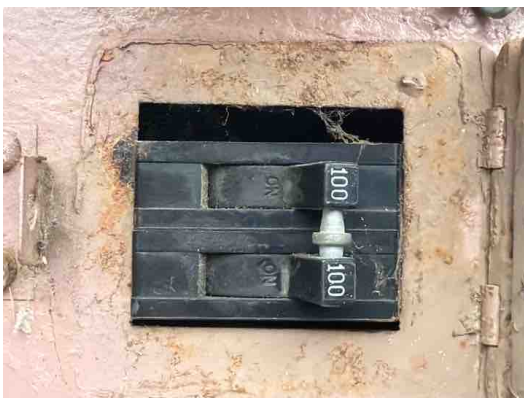
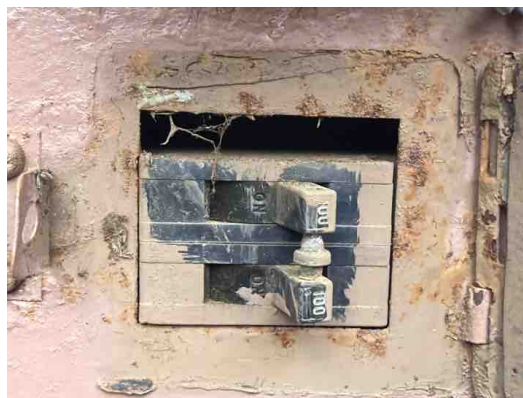
**209: MAIN ELECTRICAL PANEL CONDITION:** \*No visible wiring defects in the MAIN ELECTRICAL PANEL.

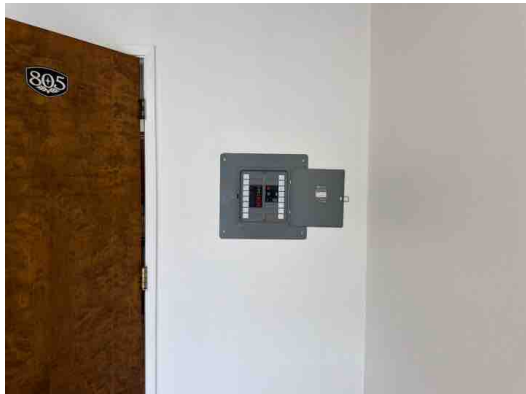
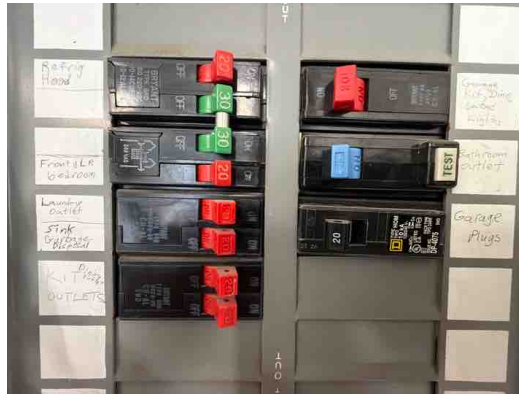
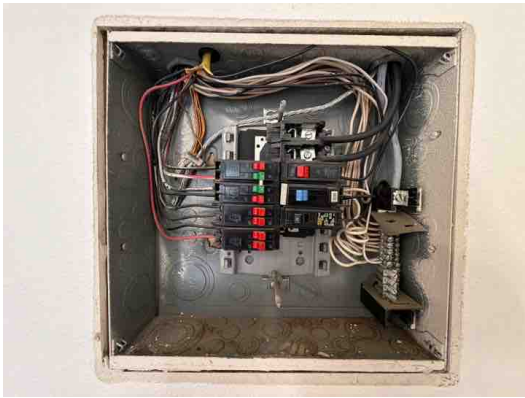
**217: PANEL CONDITION:** No visible significant electrical wiring defects noted in the ELECTRICAL SUB-PANEL.

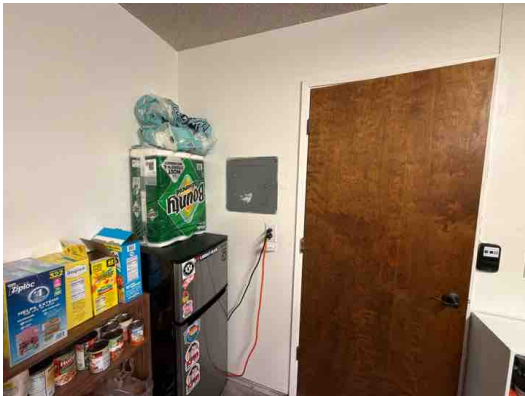
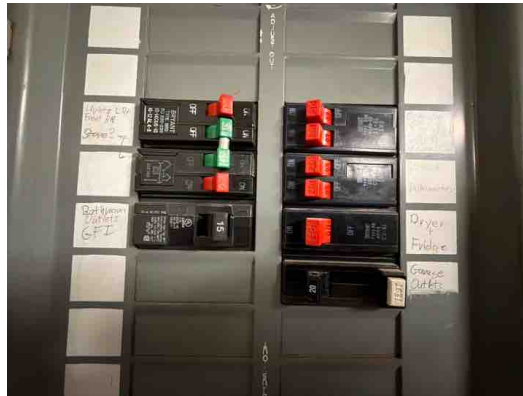
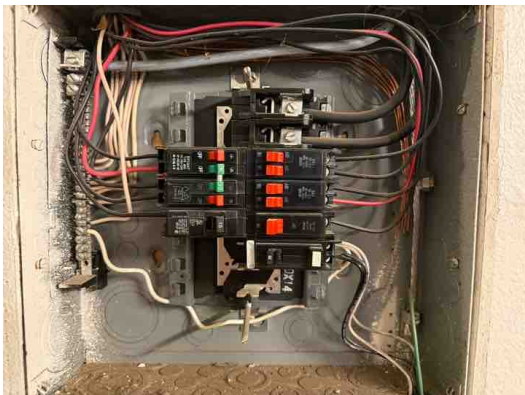
**SC 219:** Missing a fastener at the ELECTRICAL SUB PANEL dead front cover.

**SC 220:** Missing bushing clamp as wires are passing into the ELECTRICAL SUB PANEL.

**SC 221:** Improper installation of two wires on single-wire rated circuit breaker in the ELECTRICAL SUB PANEL.

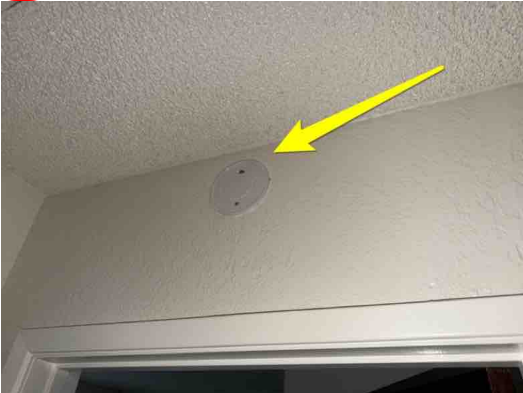
**SC 225:** Carbon Monoxide detector missing at the required location: UNIT-B BEDROOM HALLWAY

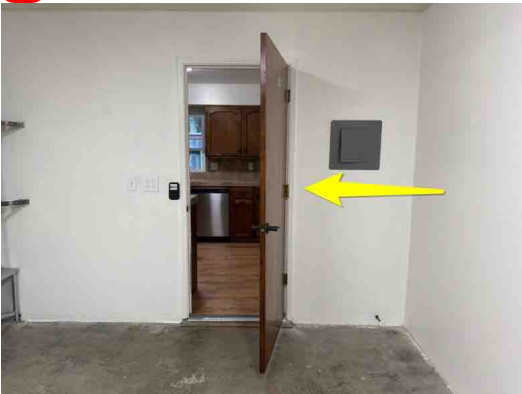
**SC** 230: Self-closer is non-operational at garage fire rated door to the living space.

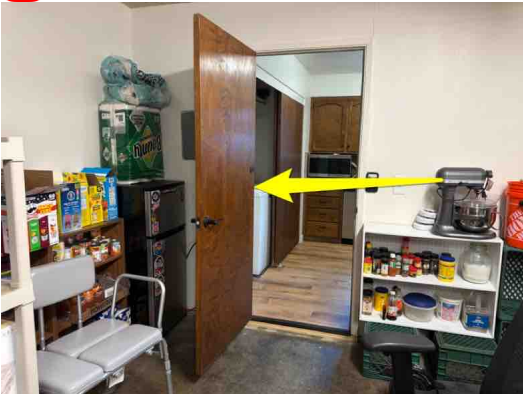
**SC 244:** Self-closer is non-operational at garage fire rated door to the living space.

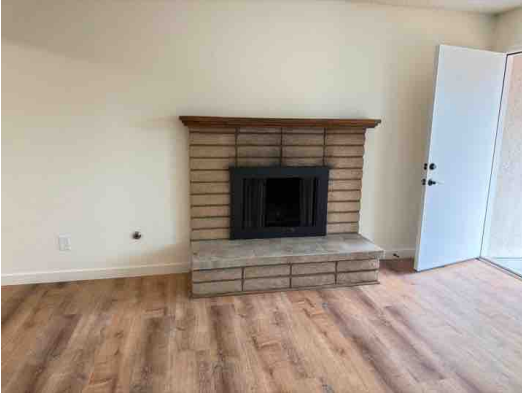
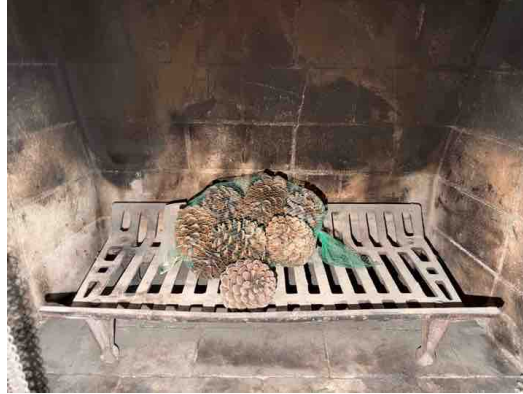
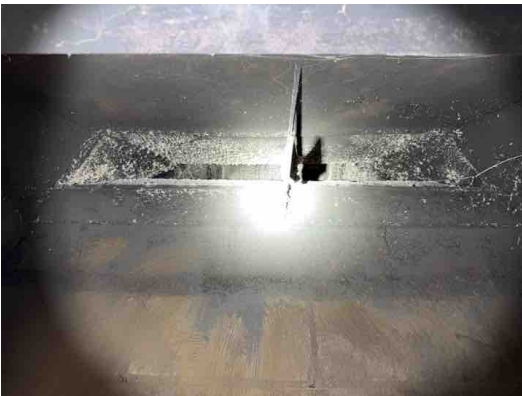
250: **UNIT-A**

**DS** 251: Level two camera chimney inspections are recommended for masonry fireplaces due to unknown and potentially hazardous conditions not visible inside the chimney flue or throat.

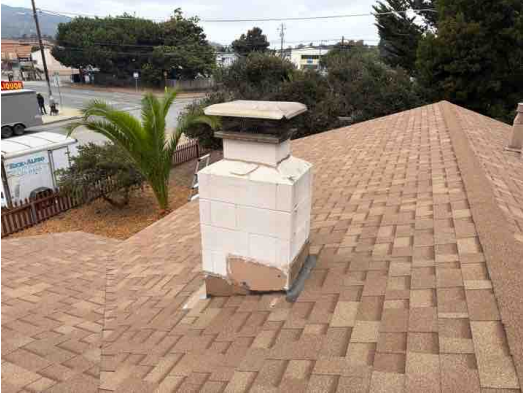
257: Photo of the UNIT-A Masonry Chimney

**SC FI 258:** Visible separations and missing mortar were observed at the joints between the clay flue liners within the UNIT-A masonry chimney. This condition may allow superheated gases to escape the flue and enter concealed areas of the chimney structure, potentially reducing system performance and safety. Recommend evaluation and repair by a qualified chimney contractor. Recommend a full Level II inspection with a camera and repair as needed by a licensed and certified Fireplace chimney sweep.

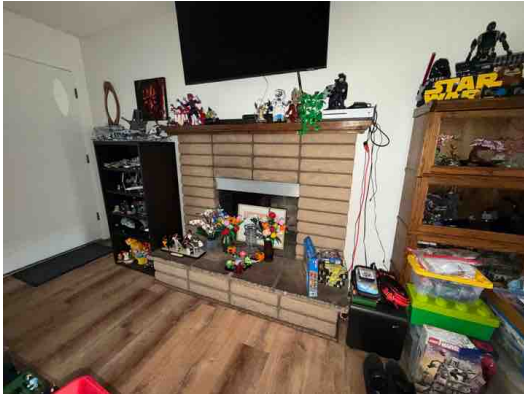
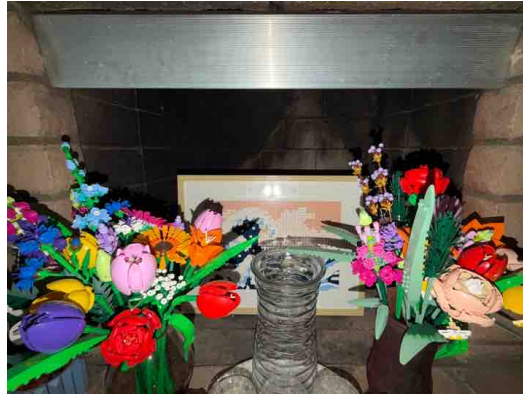
259: **UNIT-B**

**DS 260:** Level two camera chimney inspections are recommended for masonry fireplaces due to unknown and potentially hazardous conditions not visible inside the chimney flue or throat.

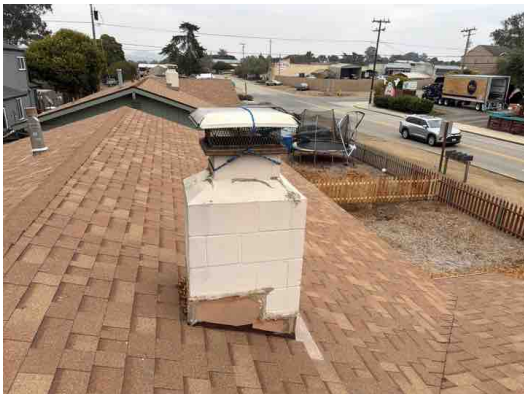
266: Photo of the UNIT- B Masonry Chimney

**SC FI 267:** Evidence of thermal shock cracking at the exterior of the UNIT-B fireplace masonry chimney. This is an indication that some damaged or excessive deterioration has occurred at the fireplace chimney flue liners, throat and/or firebox. Recommend scoping chimney with a camera to determine condition. (Fireplace should not use until proper corrections are performed).
