# Home Inspection Report

70 Shaul St., Clearlake Oaks, CA 95423

Tuesday August 4, 2026

1323

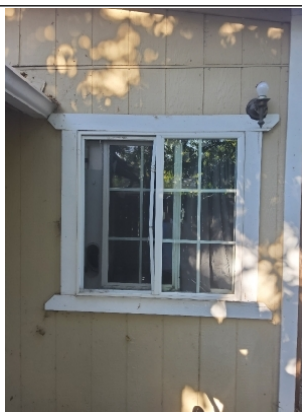
Bent screen, recommend replacing

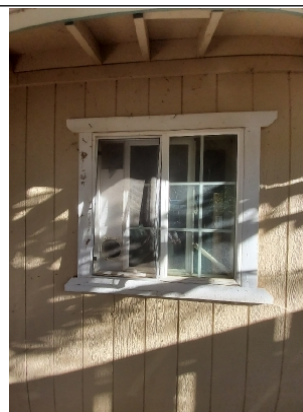
Bent screen, recommend replacing

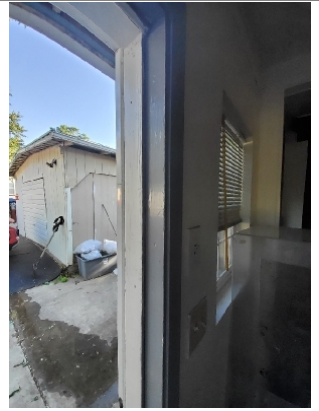
Missing weatherstripping,  
recommend installing

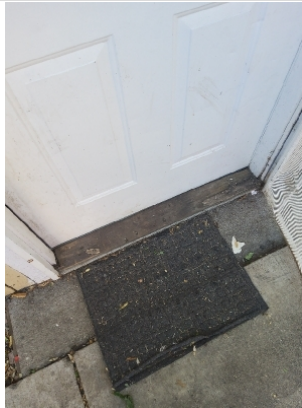
Recommend having threshold  
replaced by a licensed contractor

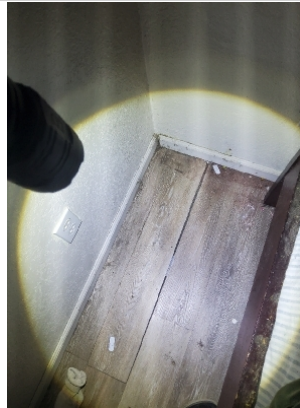
Disconnected flooring,  
recommend repair
