# PROPERTY INSPECTION REPORT

**FOUR POINT**  
HOME INSPECTION INC.

**190 Stonebridge Ln**  
**Inspection Prepared For: Tom Bremer**  
**Agent: -**

**Date of Inspection: 9/4/2026**

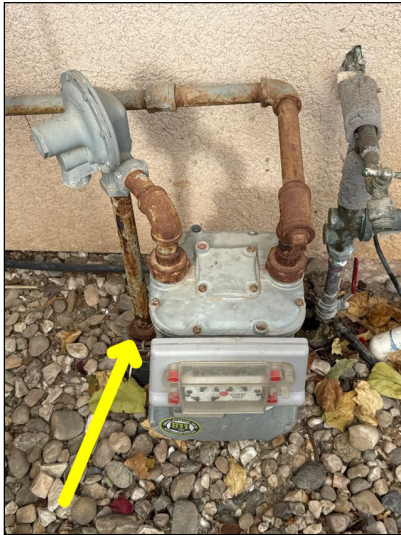
- The gas shut-off appeared to be in serviceable condition at the time of the inspection. Shut-offs were not operated, but were visually inspected.
- The home was located in an area known to experience significant earthquakes having a gas shut off tool readily available in an emergency is a recommended safety improvement.

Main gas shut off to the home.

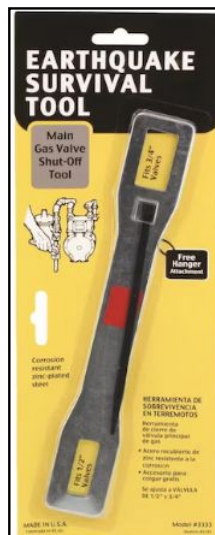
Having a gas shut off tool readily available in an emergency is a recommended safety improvement.

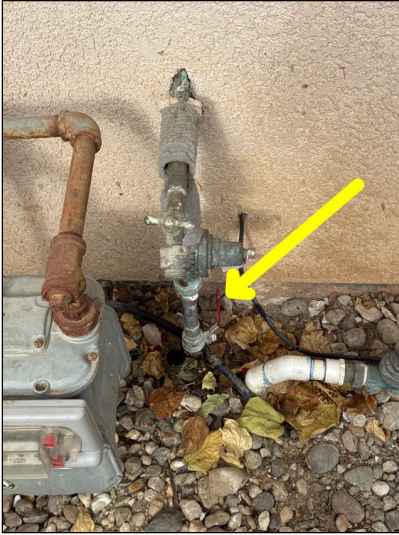
**Observations:** At the time of the inspection, the Inspector observed no deficiencies in the condition of the main water supply shut-off valve. It was not operated but was visually inspected.

Main water shut off to the home where the main water line enters the home.

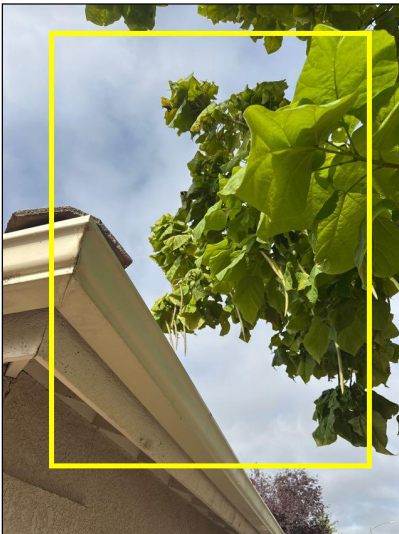
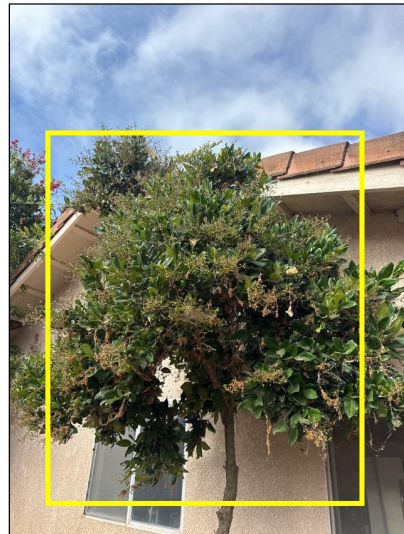
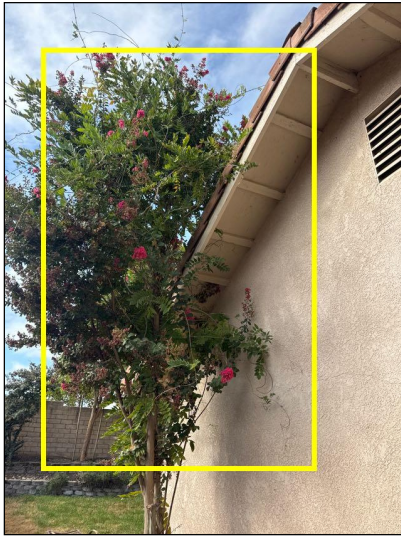
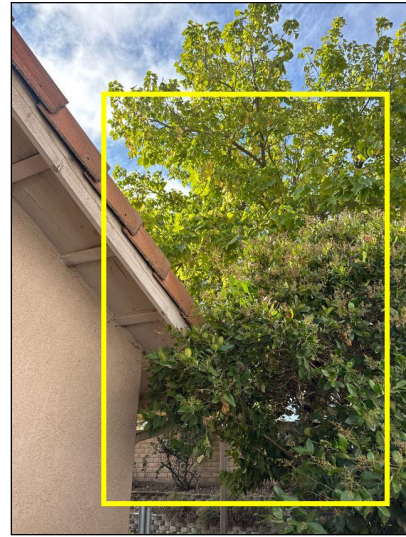
- **Monitor:** Vegetation in contact with the exterior walls should be cut back to avoid potential problems from moisture or insects.
- **Monitor:** Tree limbs within 10 feet of roof should be trimmed away to provide air and sunlight to roof, while minimizing debris & dampness.

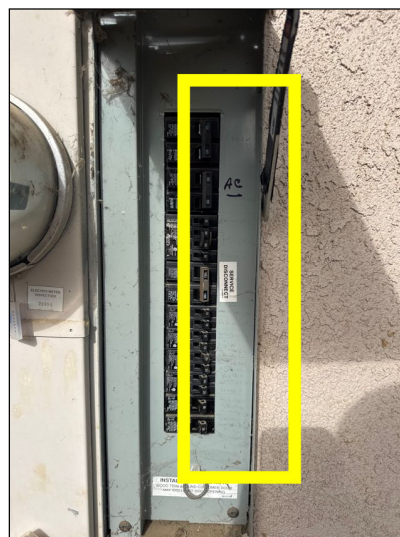
**Safety Improvement:** The Circuit Directory label identifying individual circuits at the service panel was illegible.

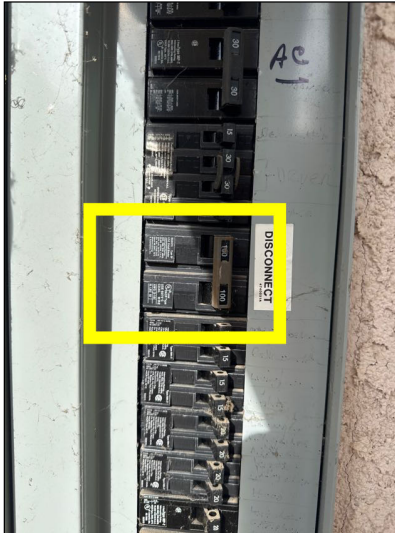
- The main amp breaker is rated at 100 AMPS.
- The Inspector observed no deficiencies in the condition of the electrical service disconnect. It was inspected visually but was not operated.

Main electrical shut off to the home

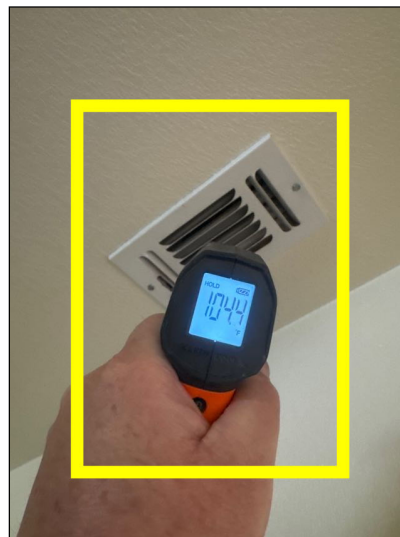
The supply air temperature at the registers should be 100 °F - 125 °F + to be considered running efficiently.

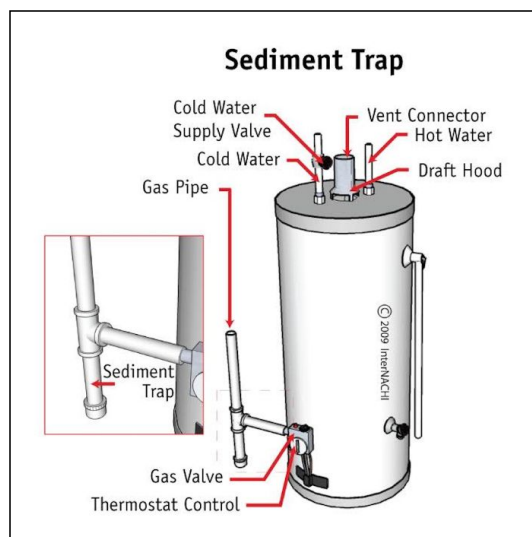
**Improvement:** The gas supply pipe contained no sediment trap.

The purpose of a sediment trap is to prevent sediment or debris particulates from entering and clogging the water heaters gas valve

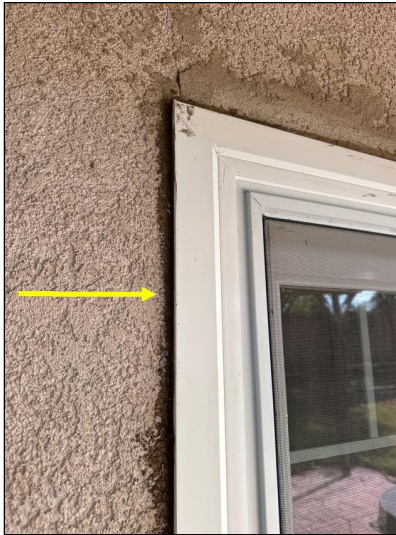
- The Inspector observed few deficiencies in the condition of the sliding glass doors.
- **Maintenance Needed:** Sealant around patio door was old, discolored, cracked, and needed maintenance to avoid potential moisture intrusion. The Inspector recommends maintenance be performed by a qualified contractor.
