## Home Inspection Report

**4011 Marron St**

**San Diego, CA 92115**

Inspected On: Mon, Sep 28 2026 at 8:00AM

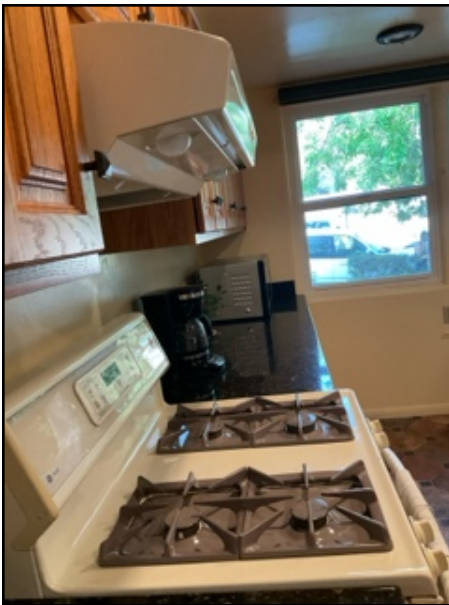
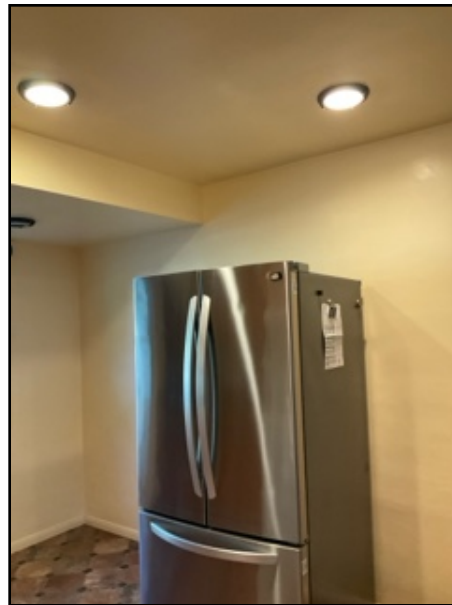
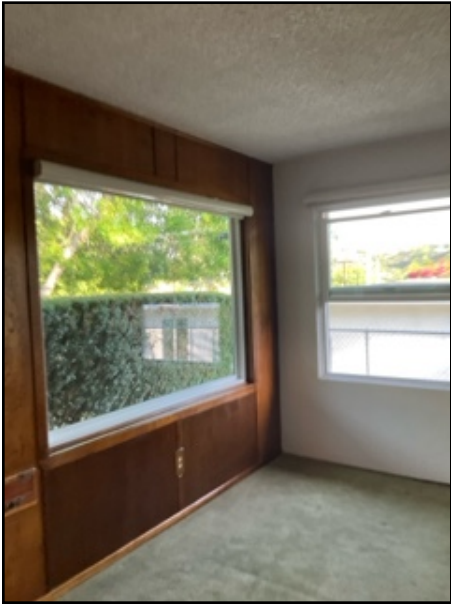
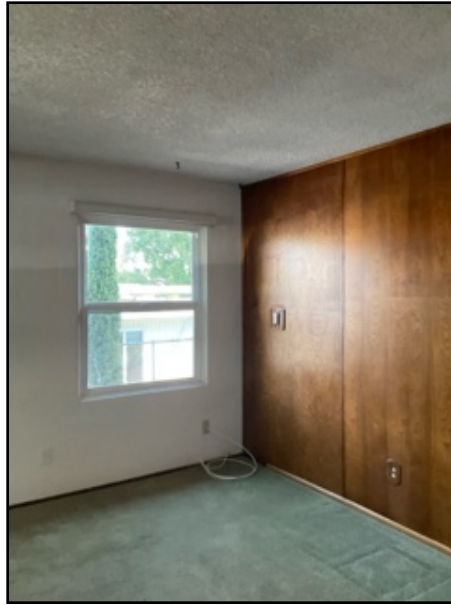
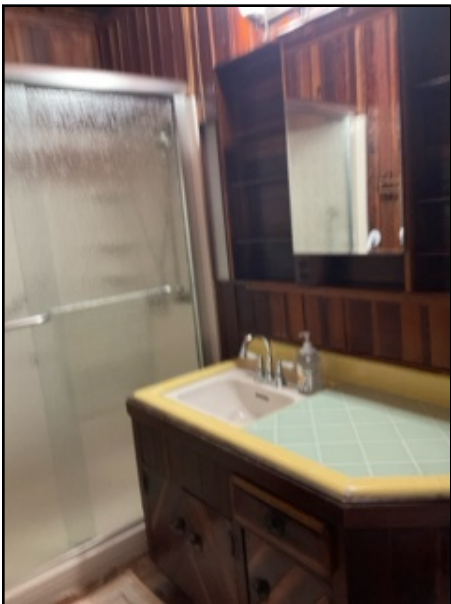
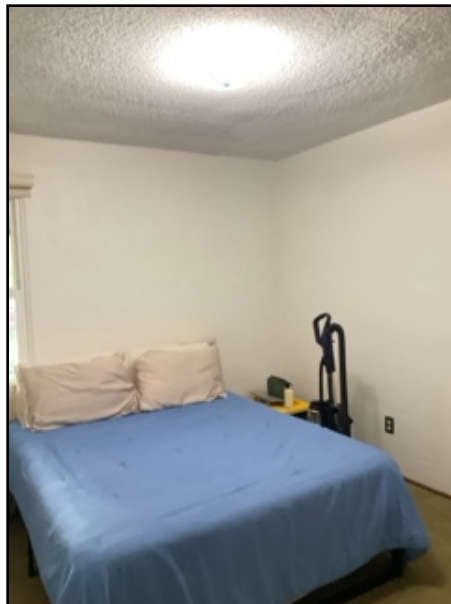
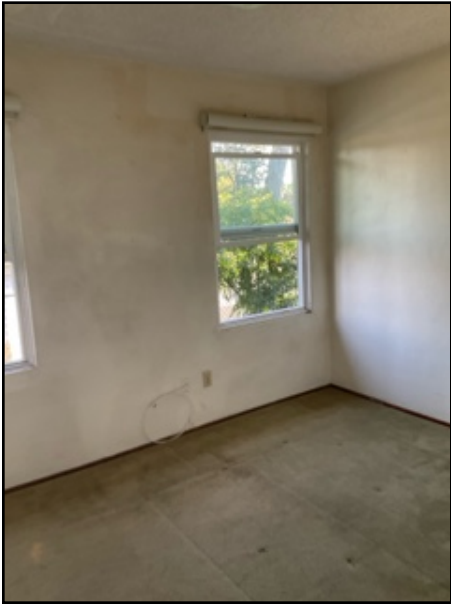
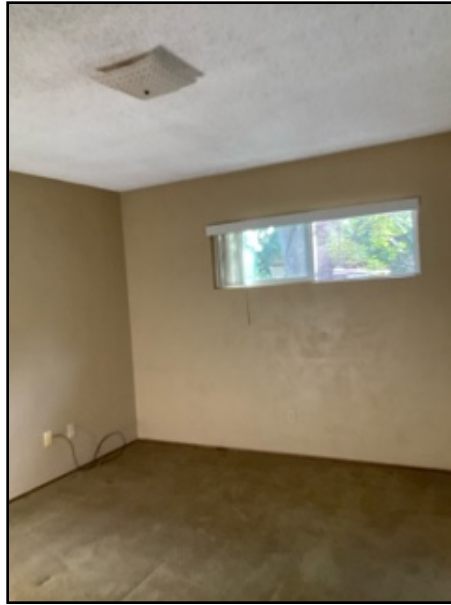
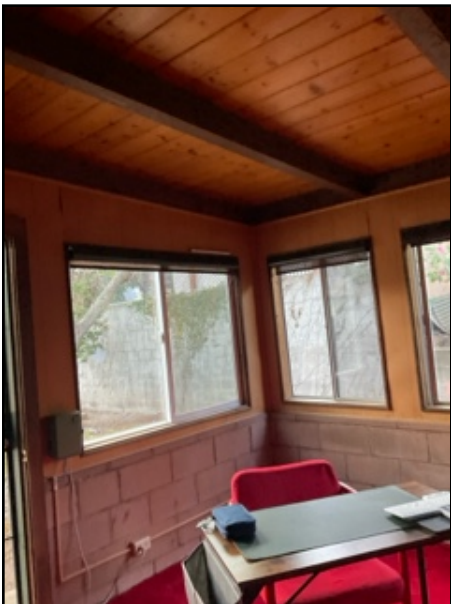
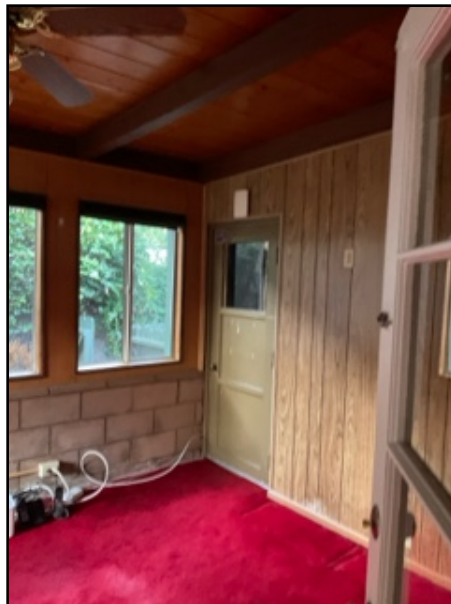
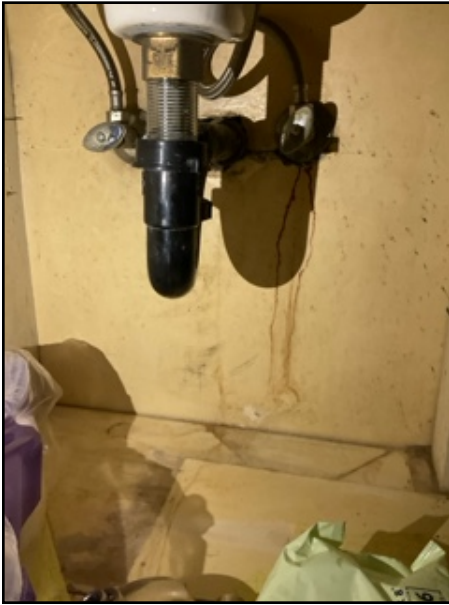
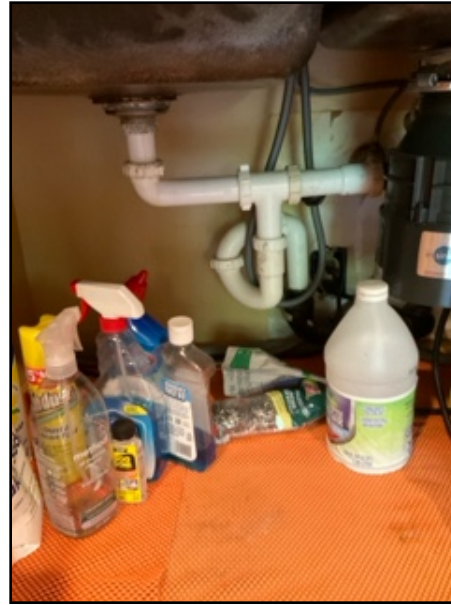
Personal property present at time of inspection, some areas and systems are not fully visible due to current occupants personal items.

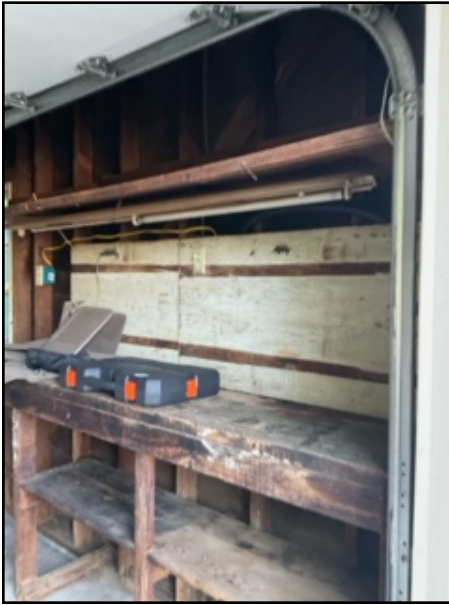
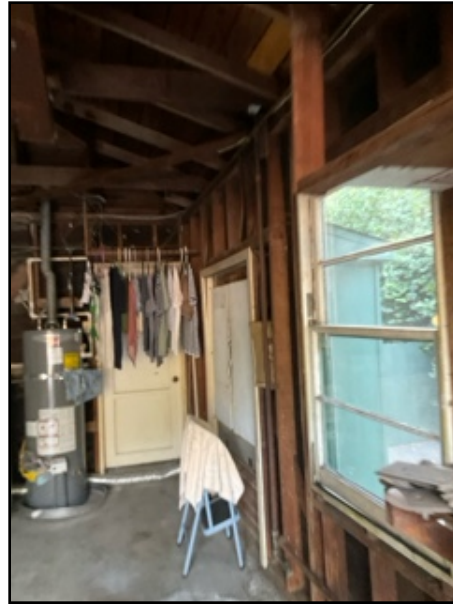
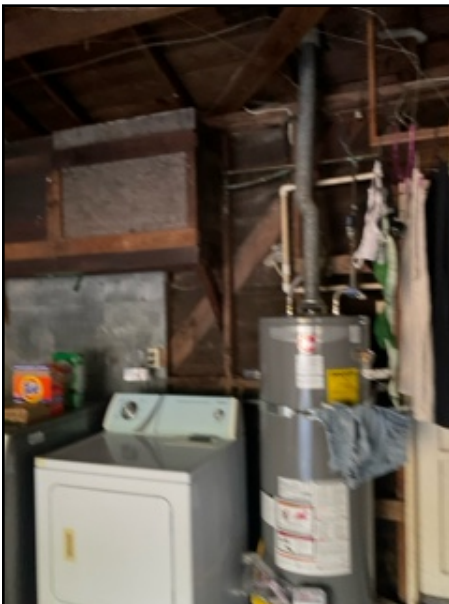
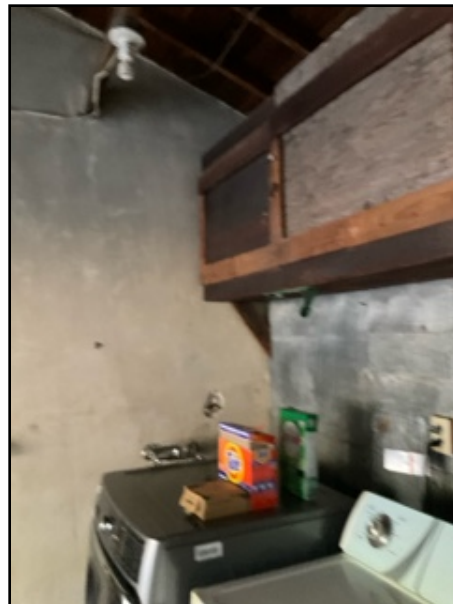
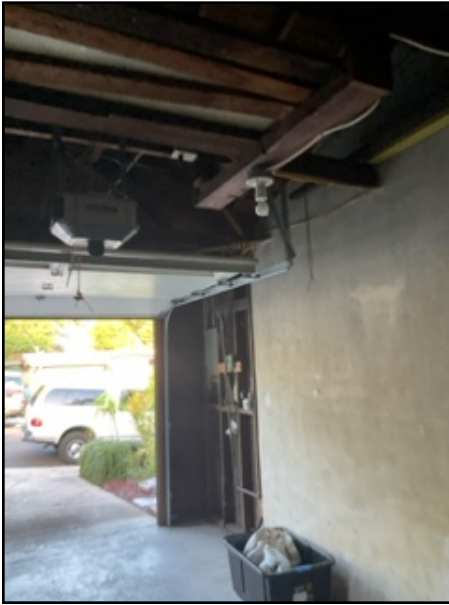
Personal belongings stored in garage prevented inspection of some aspects of the garage.

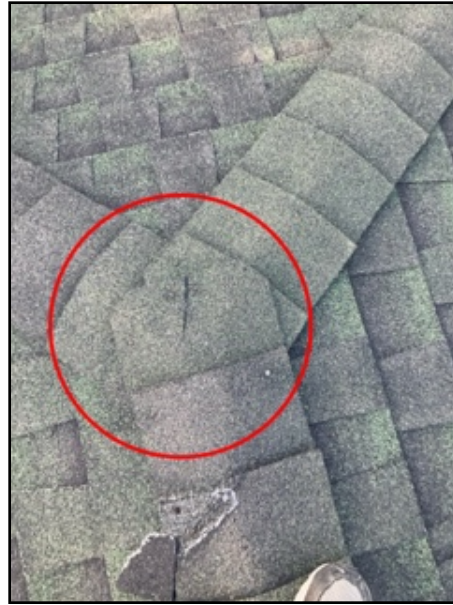
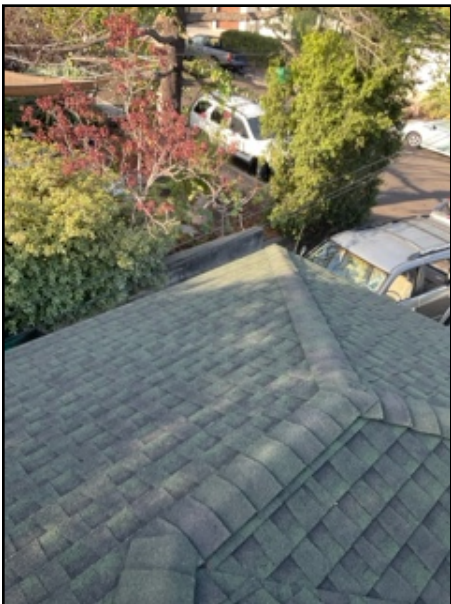
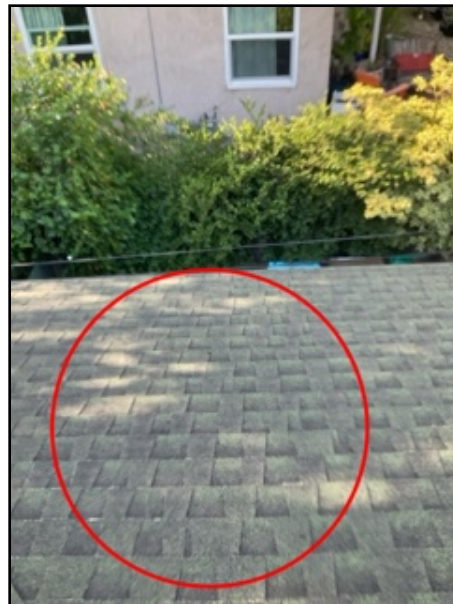
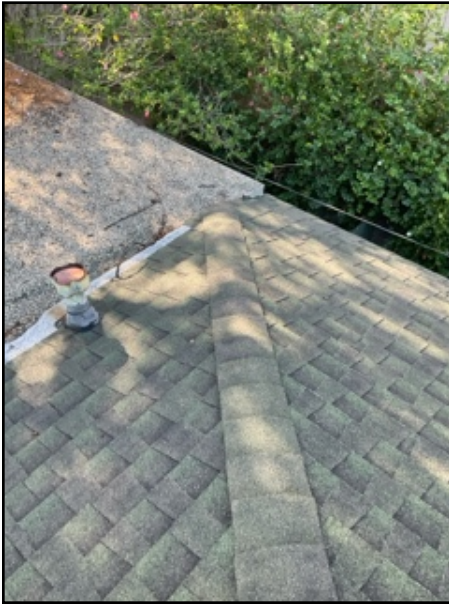
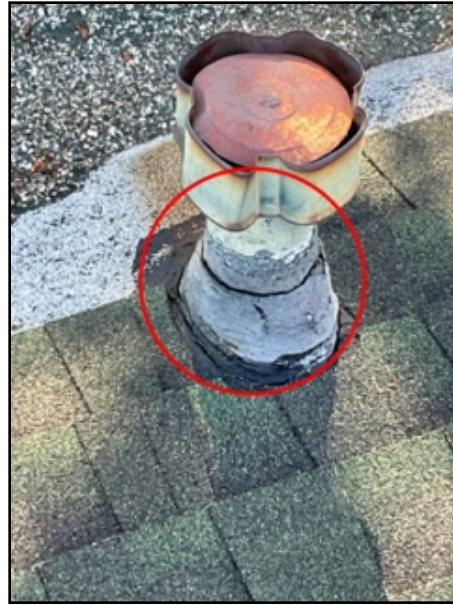
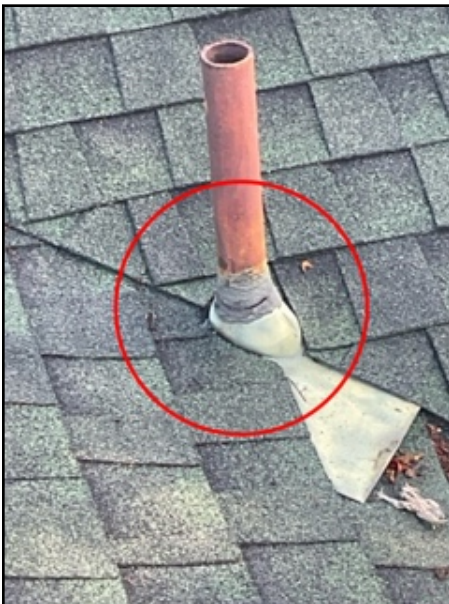
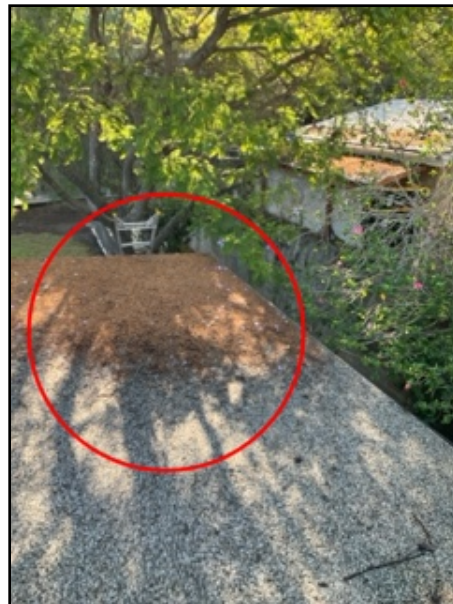
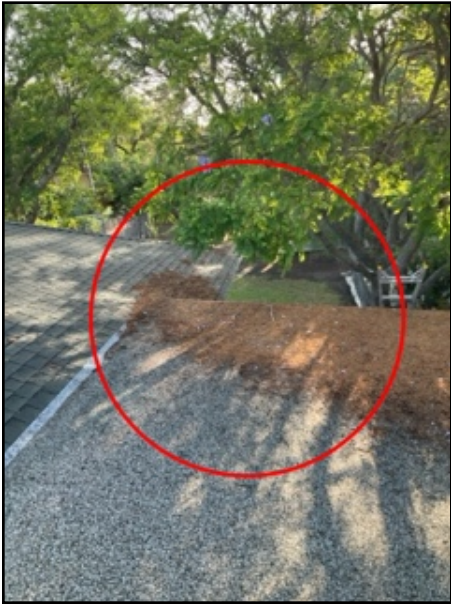
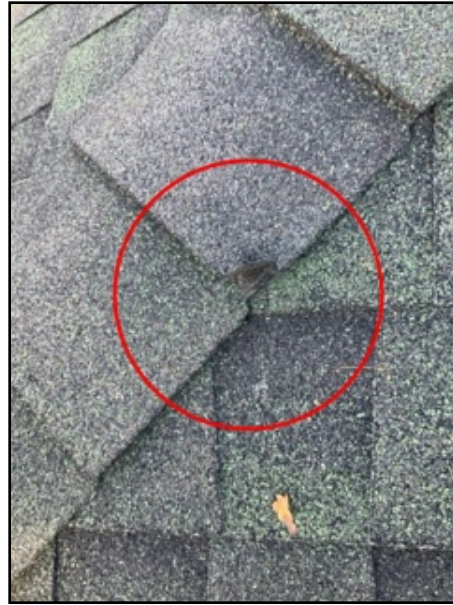
**REPAIR OR REPLACE:** Asphalt shingles noted as deteriorated at various locations. Torn shingle noted on ridge cap. Expose nails noted on ridge cap. Mastic around vent pipes noted as cracked and deteriorated. Fiberglass noted is showing around. Edges on southside. Tree debris noted on roof at various locations. As vouching goes noted as brittle. Have a more qualified professional to evaluate.

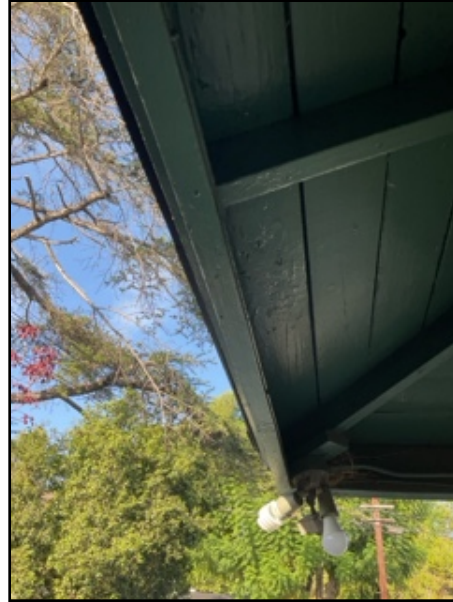
Figure 21-1

**Comment 21:**  
**FURTHER EVALUATION REQUIRED:** Evidence of possible wood destroying organisms / dry rot noted on soffit and/or fascia.

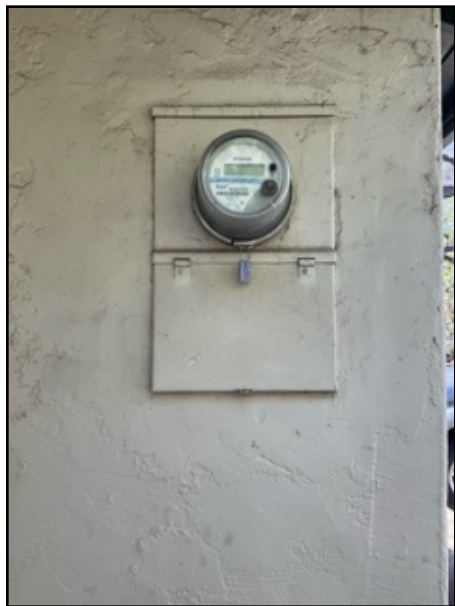
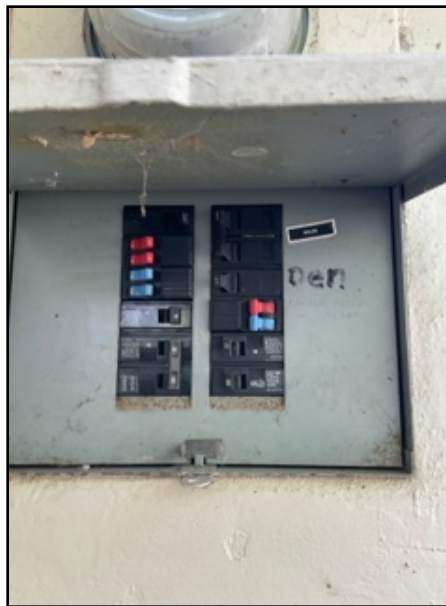
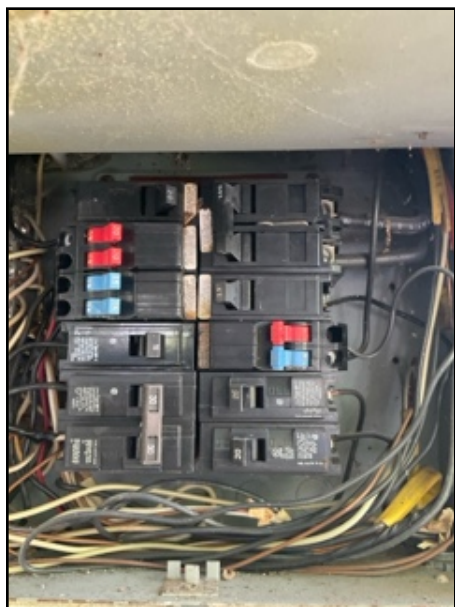
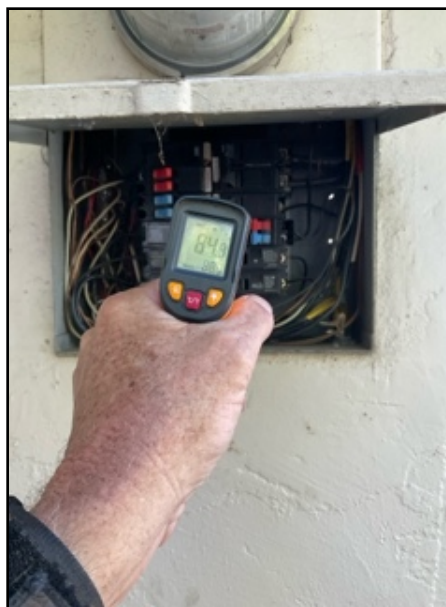
**Comment 24:**  
Service panel inspection pictures. A thermal scan was conducted and no significant hot spots were noted.

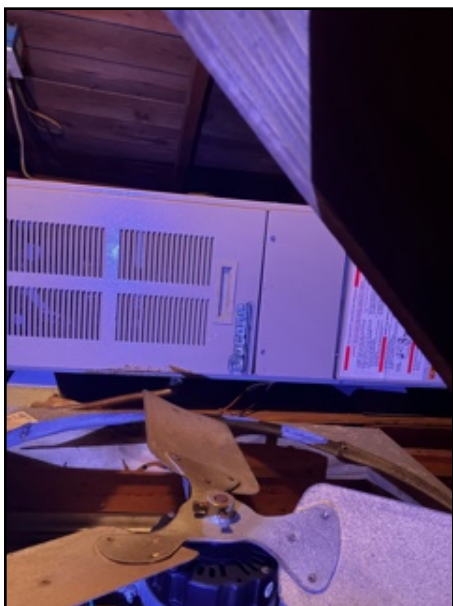
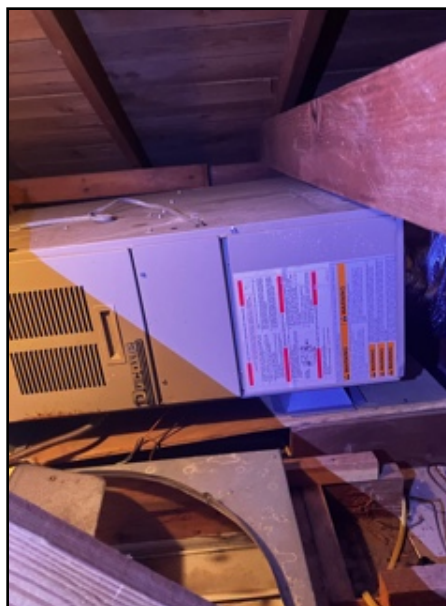
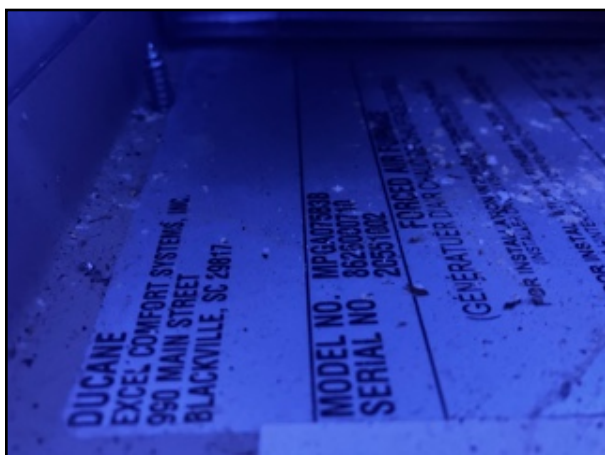
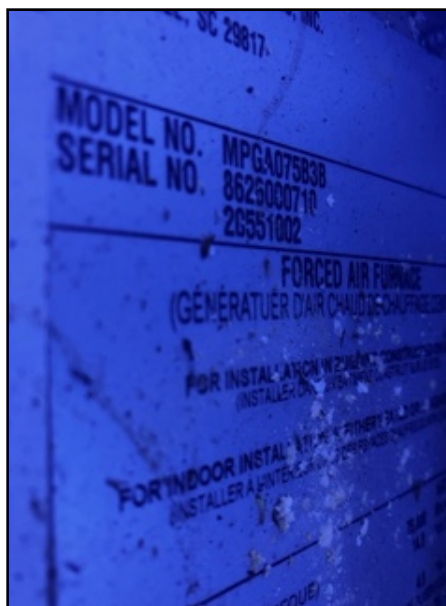
Comment 31:  
Heater data plate picture. 03/2007 mfg date

A licenced contractor should conduct an annual service and maintenance for furnaces over 10 years old.

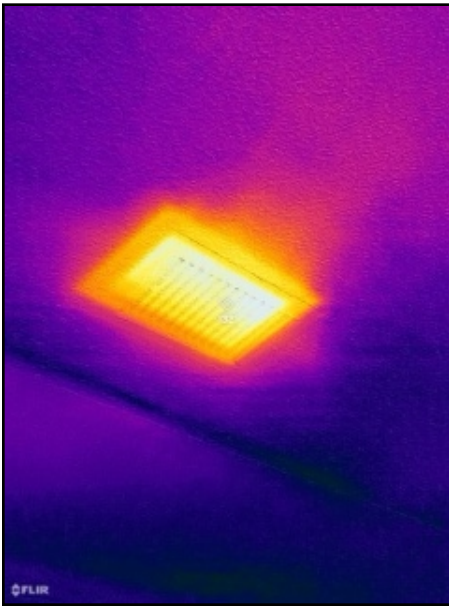
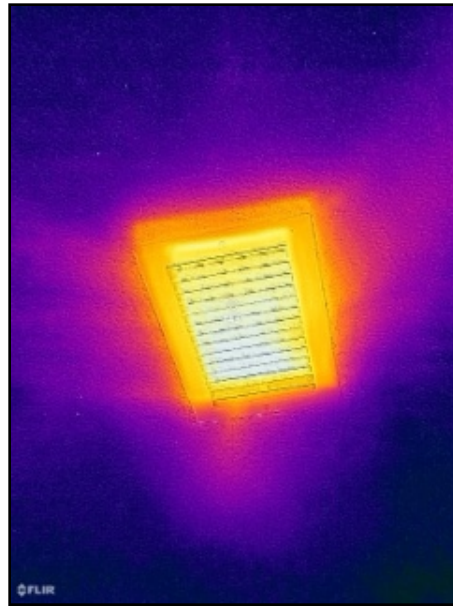
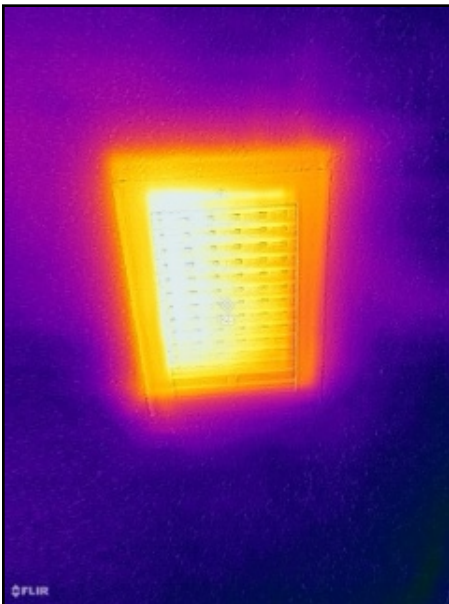
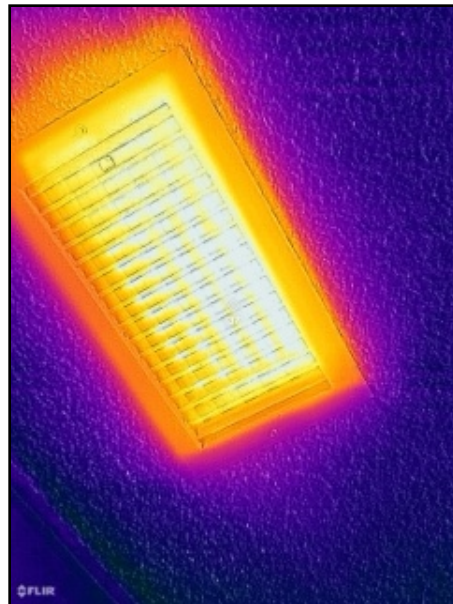
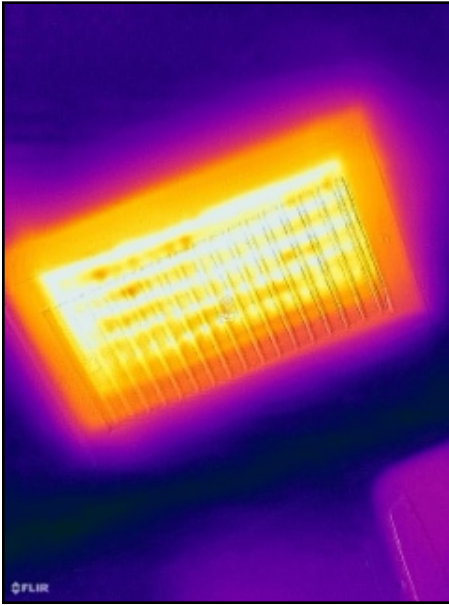
Comment 32:  
Heater outputs.

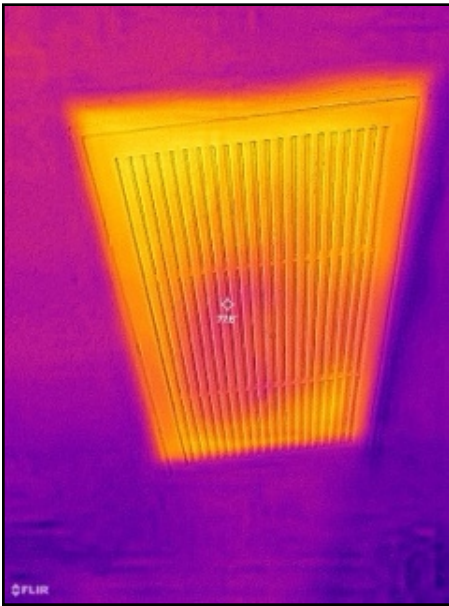
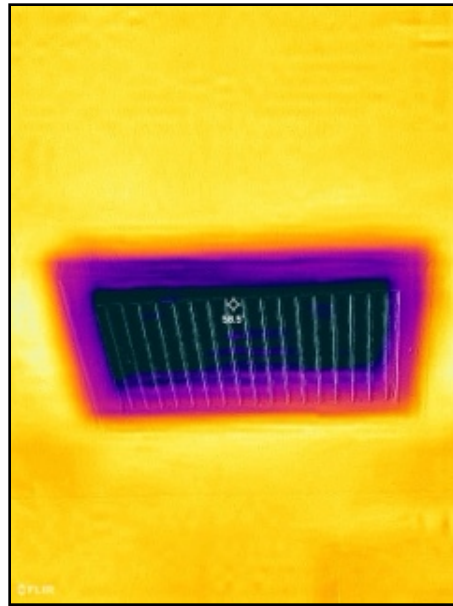
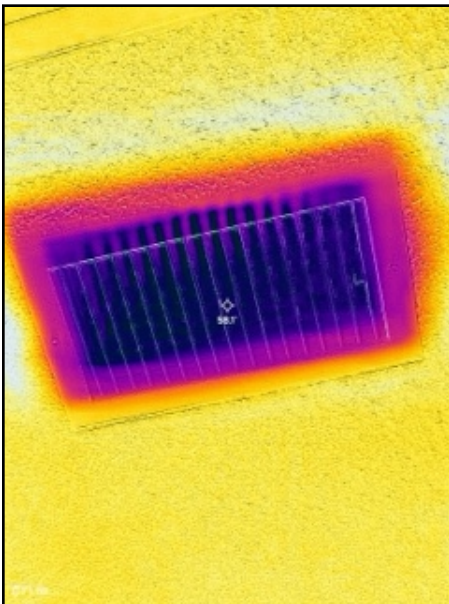
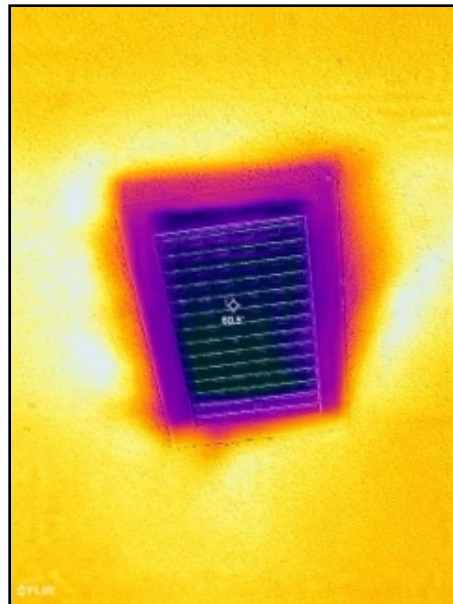
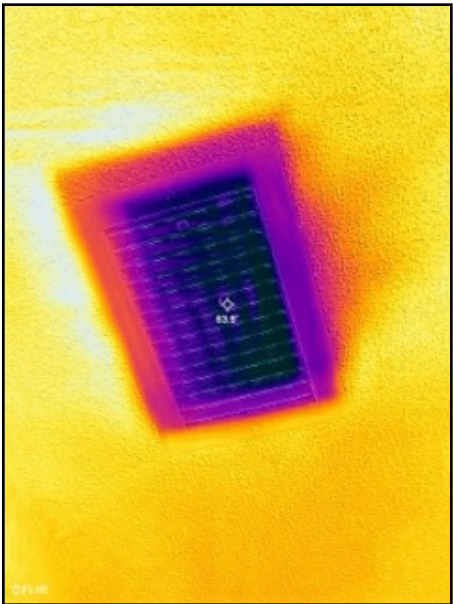
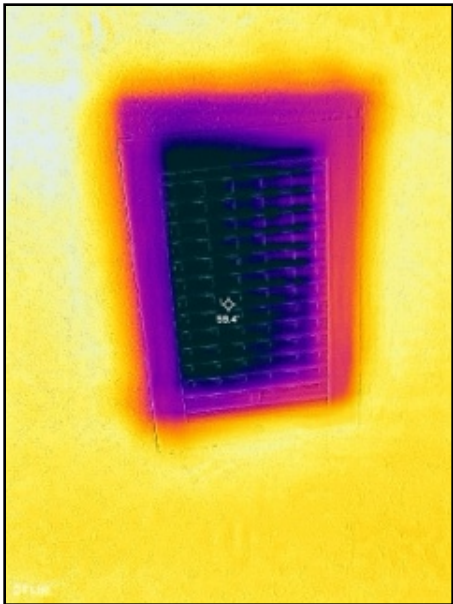
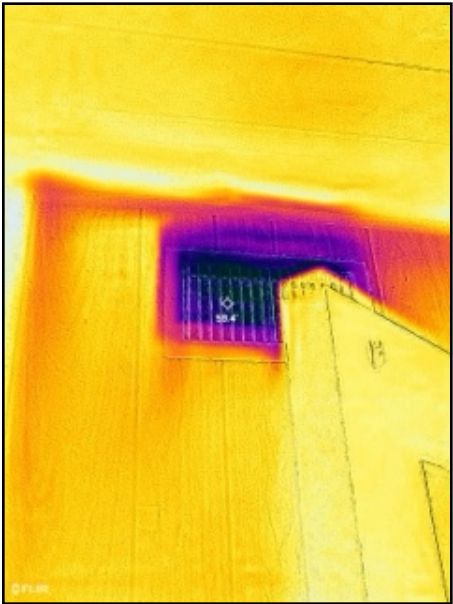
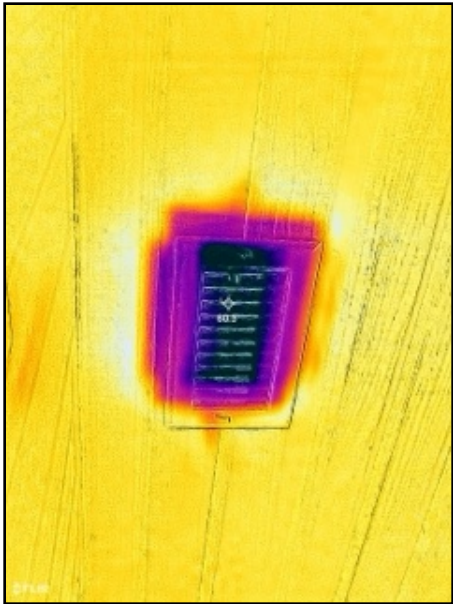
Comment 34:  
AC supply and outputs.

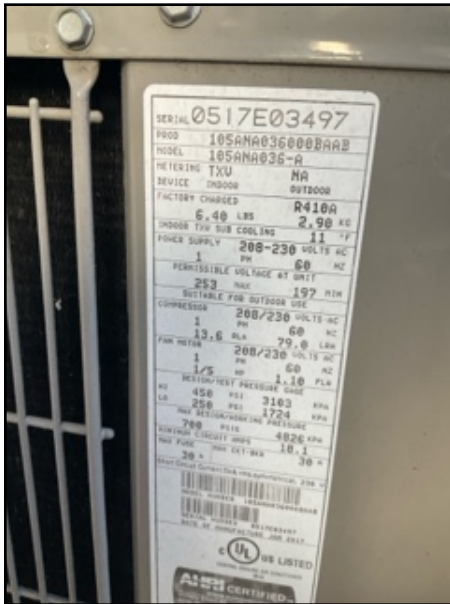
Figure 35-1

Comment 35:  
Condenser Data Plate Picture:.

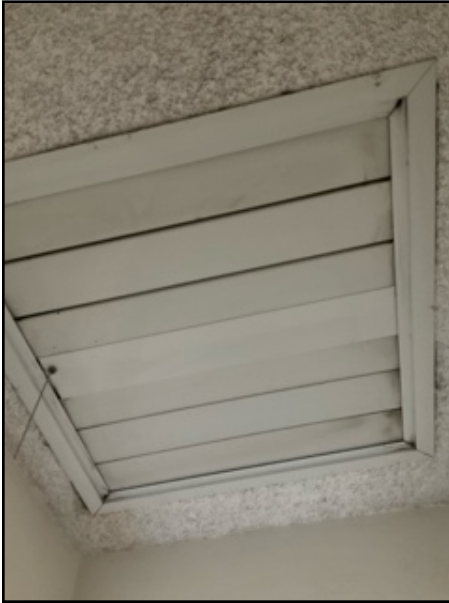
Figure 37-1

Properties equipped with a whole house fan and time of inspection.

A licensed contractor should conduct an annual service and maintenance for all air conditioners over 10 years old and heat pumps over 5 years old.

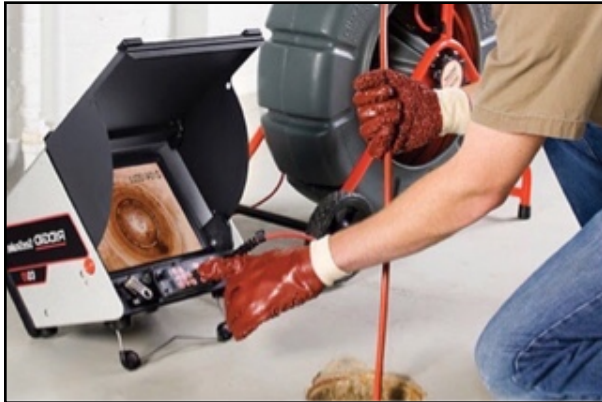
Figure 38-1

Visible and apparent leaks are noted under separate comments. In order to see the inside of drain lines the main sewer line may be inspected by a qualified technician with modern endoscopic video equipment.

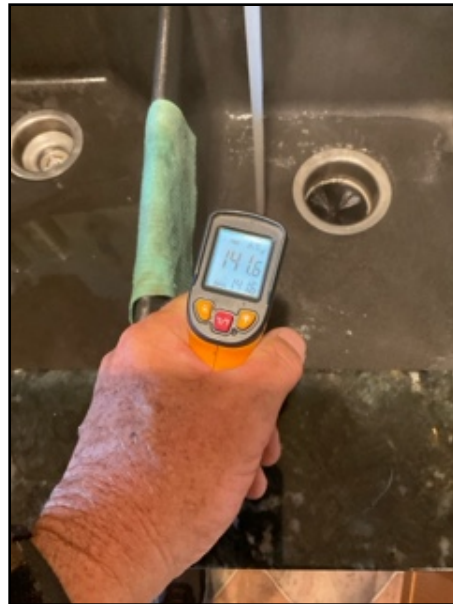
Figure 39-2

Water temperature was 141°F. Most appliance manufacturers recommend a temperature of around 120°F. Generally temperatures above 130°F are considered unsafe.

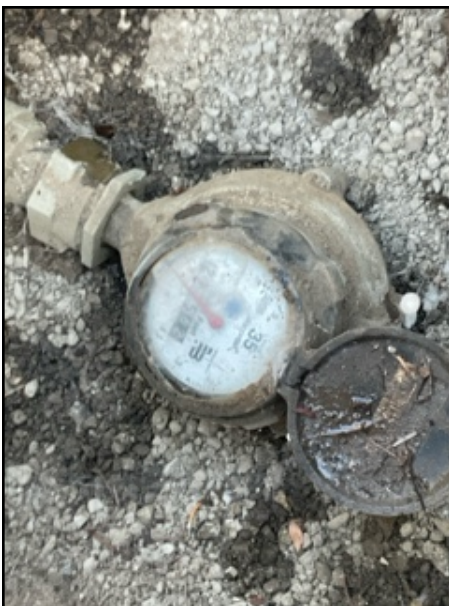
Figure 40-1

Comment 40:  
Main water meter with leak detector.

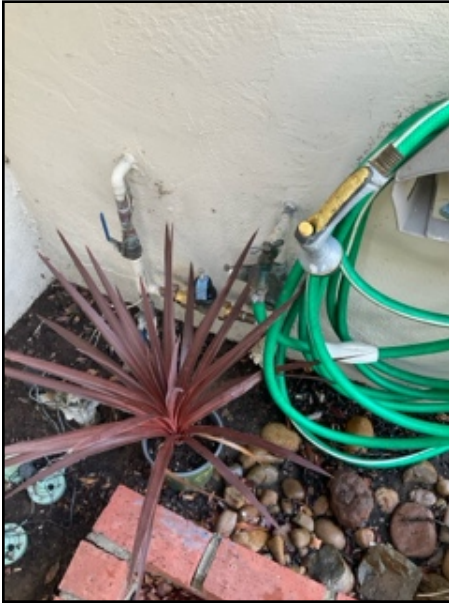
Figure 41-1

Comment 41:  
Main water shut off.

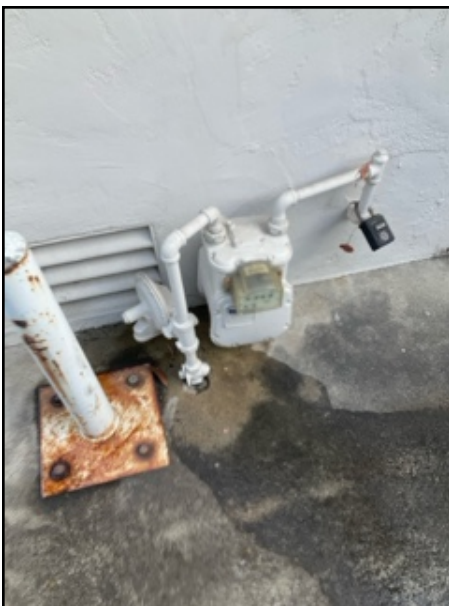
Figure 42-1

Comment 42:  
Main gas shut off.

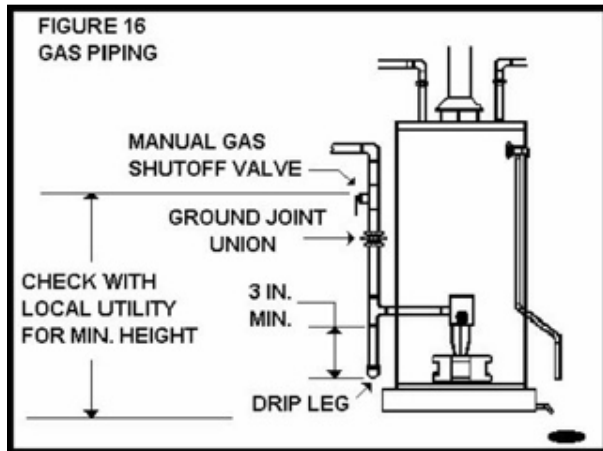
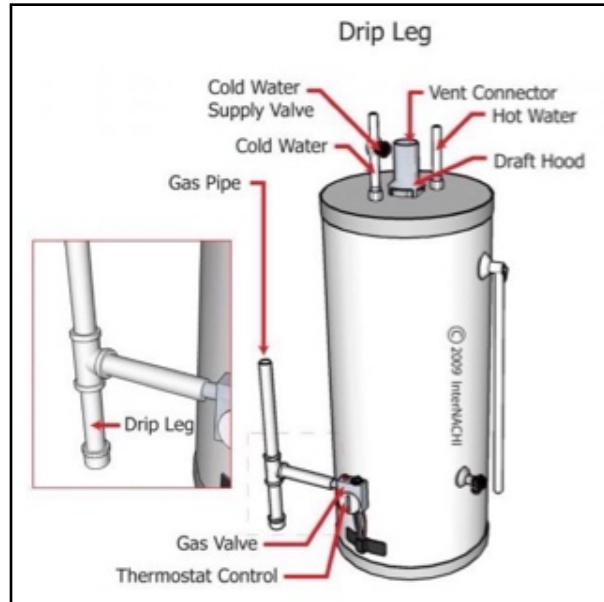
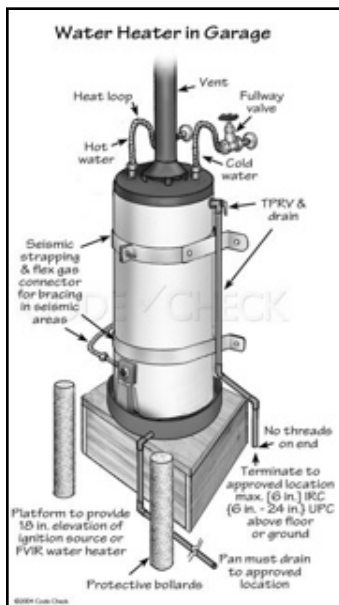
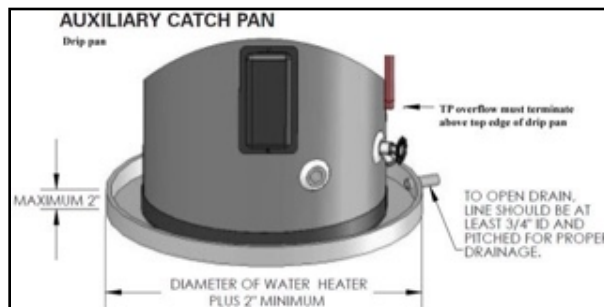
Examples of modern water heater installation requirements. Your water heater may have none, some or all of these components depending on when it was installed.

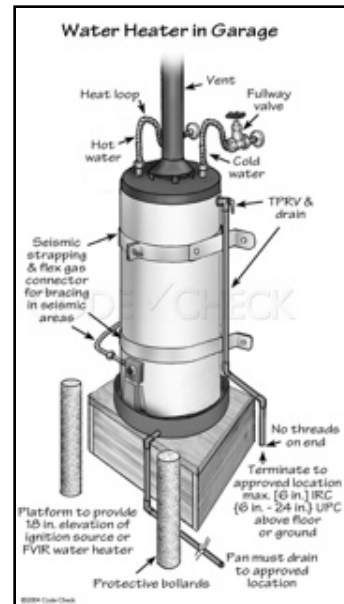
Figure 48-2

**REPAIR OR REPLACE:** Gas sediment trap noted not present or installed improperly at time of inspection. Sediment trap is designed to catch debris, rust, and moisture and gas line to help prevent clogging and/or damage to appliance burners and valves. Sediment trap should be installed as close as possible to the appliance inlet as possible.

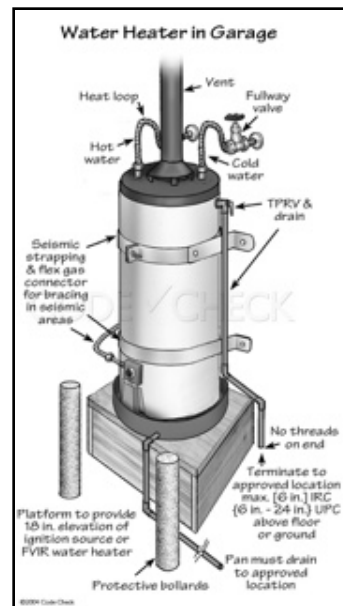
Figure 50-2

**REPAIR OR REPLACE:** Insufficient seismic strapping noted not installed or loose. Seismic straps are essential to prevent water heaters from tipping over during an earthquake, which can cause severe and costly damage including ruptured gas lines (leading to fire or explosion), water leaks and broken pipes. Seismic straps should be properly anchored and placed in the upper third and lower third of the tank.

Only one size mixed strap noted as installed.

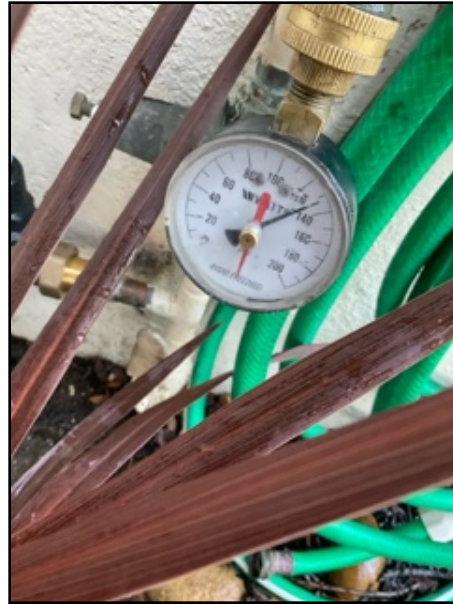
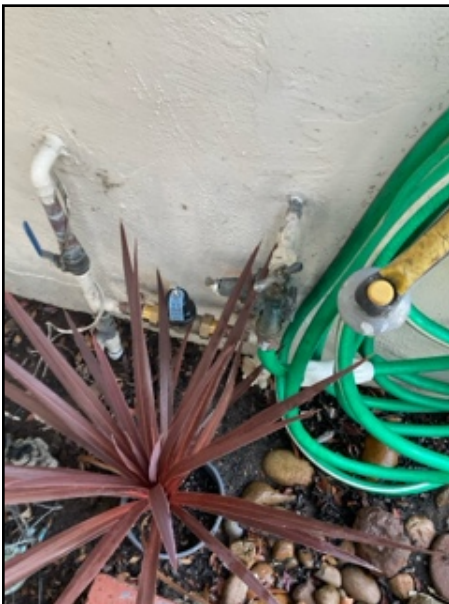
**REPAIR OR REPLACE:** Water pressure is 130 psi. Most appliance manufacturers recommend pressure to be set between 40 and 80 psi.

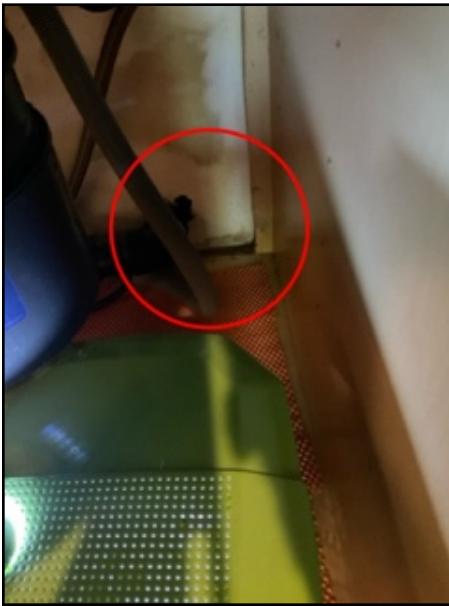
Figure 57-1

FURTHER EVALUATION REQUIRED: 1. Evidence of previous moisture intrusion and possible organic growth noted sink base cabinet.

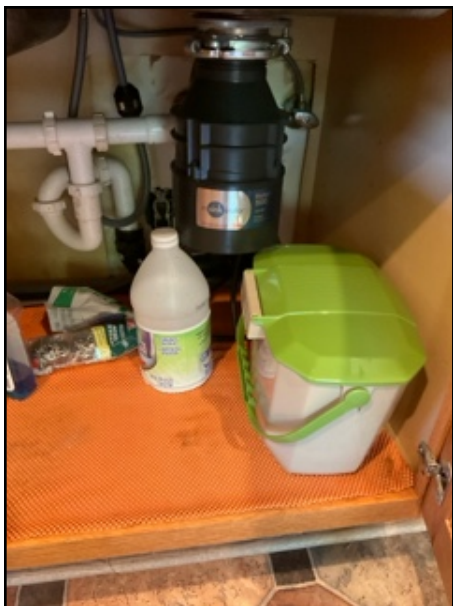
Figure 61-1

**Comment 61:**  
Garbage is supposed to be working.

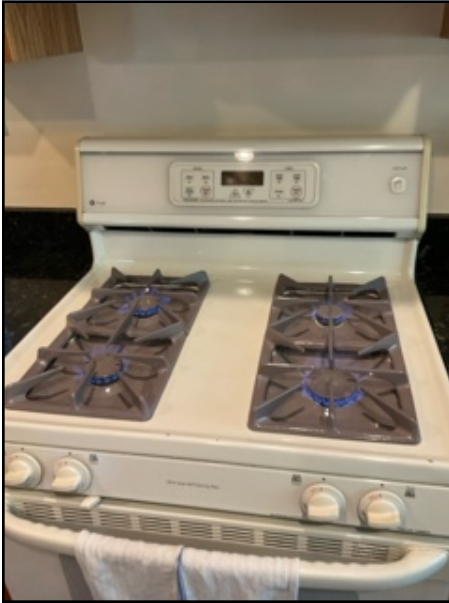
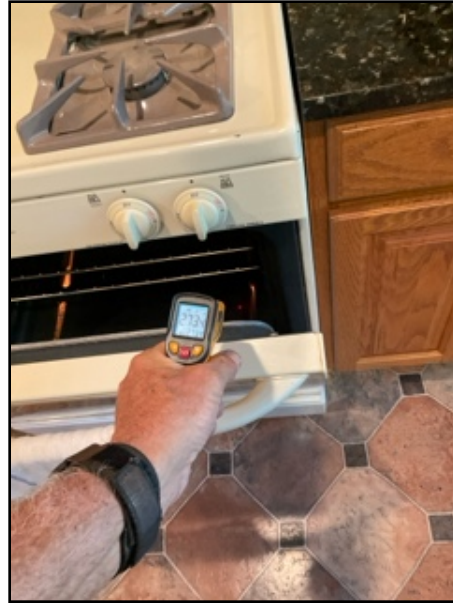
Comment 62:  
Range working.

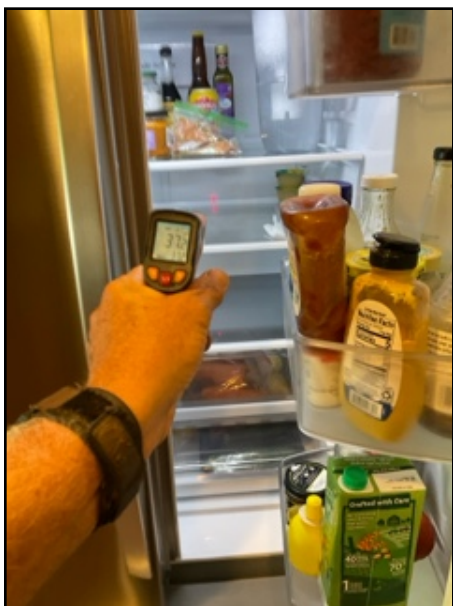
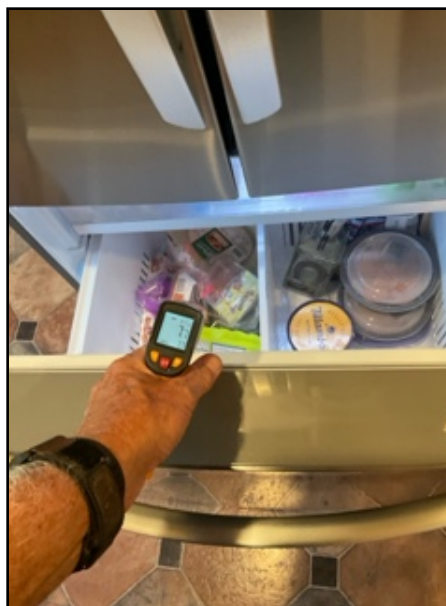
Comment 64:  
Refrigerator working.

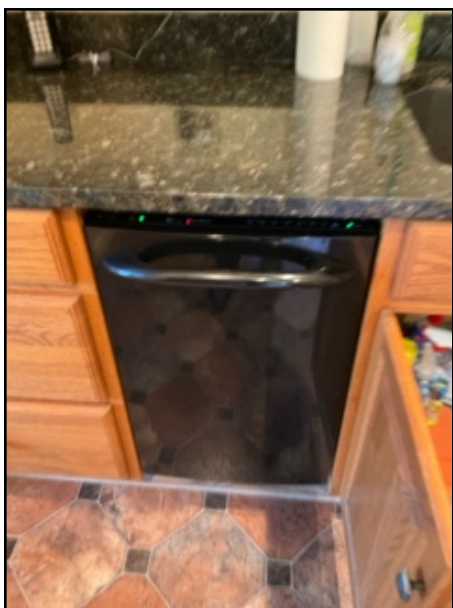
Figure 65-1

Comment 65:  
Dishwasher working.

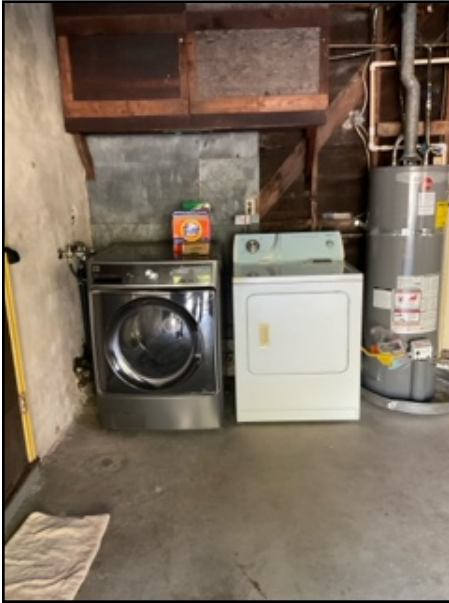
Figure 66-1

Comment 66:  
Laundry in garage.

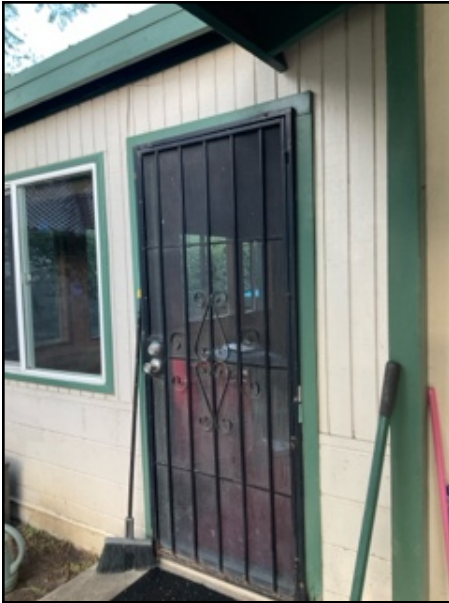
Figure 67-1

Apparent additions, extensions, or conversions are present. It is outside the scope of this inspection to determine if permits were obtained, if the space meets current code, and if the space is suitable for habitation.

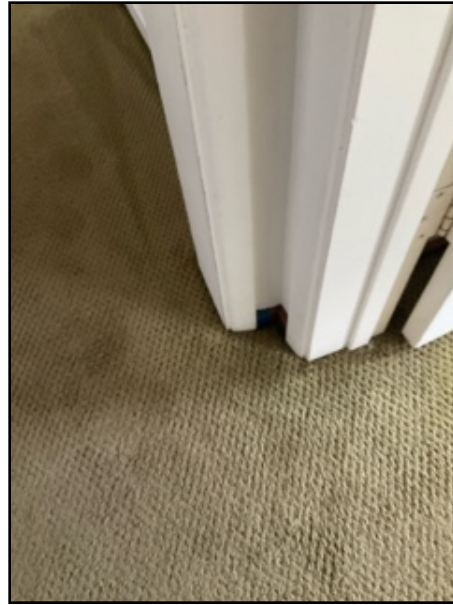
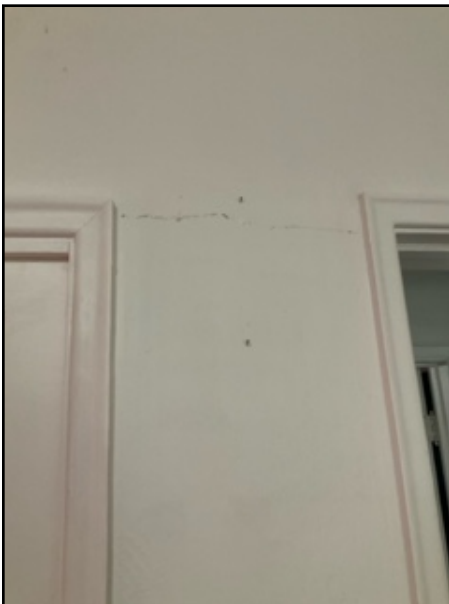
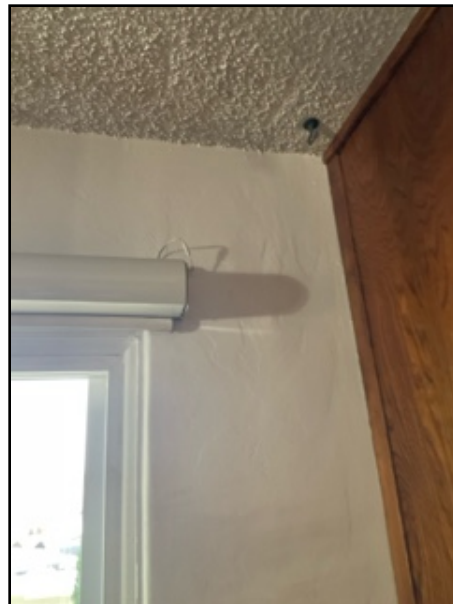
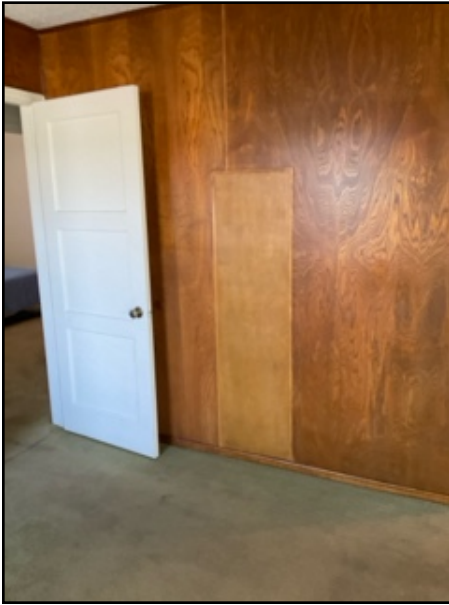
REPAIR OR REPLACE: Door handle to back bedroom noted as broken.

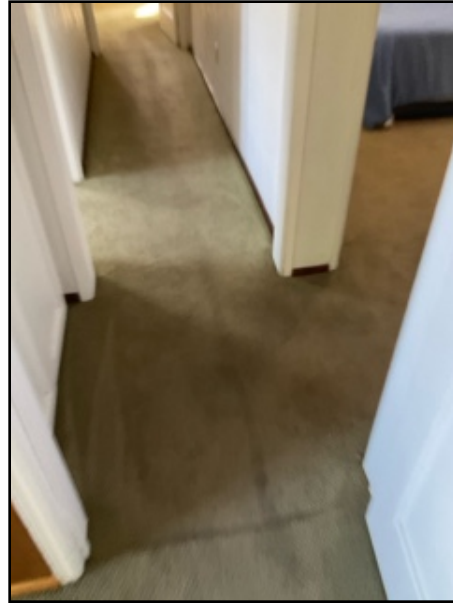
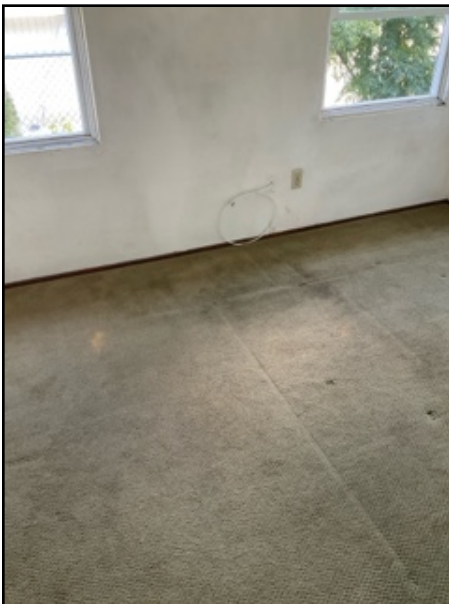
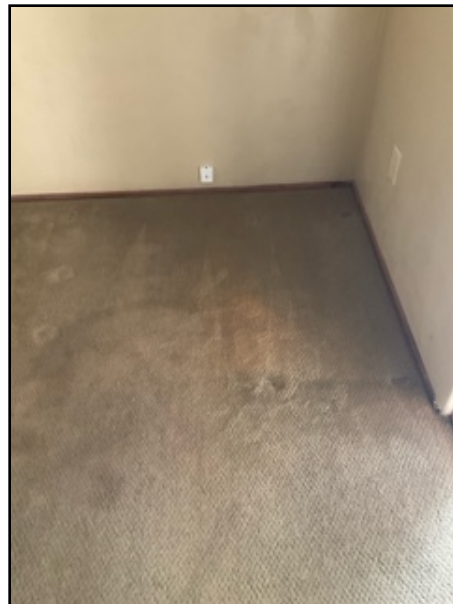
REPAIR OR REPLACE: Carpet noted as stained at various locations.

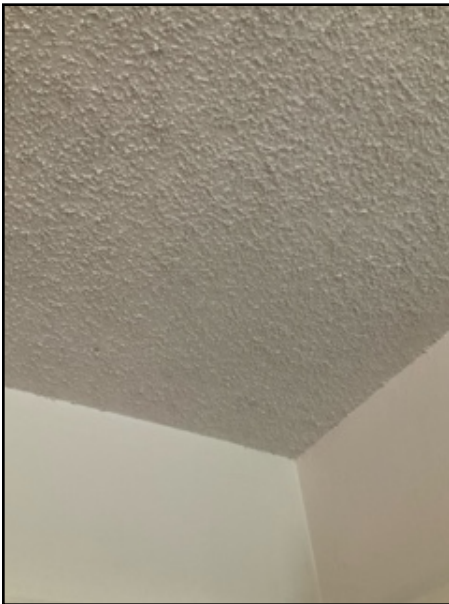
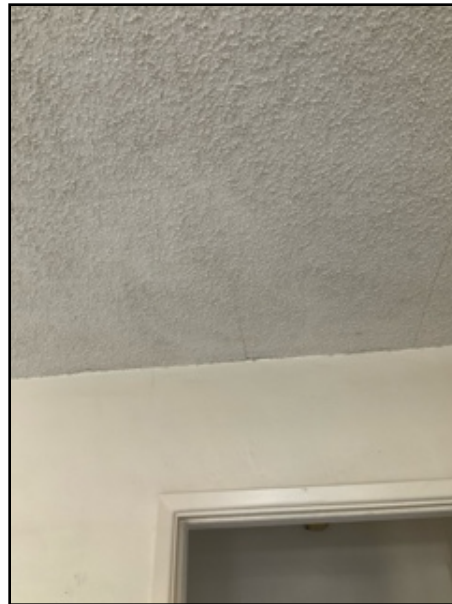
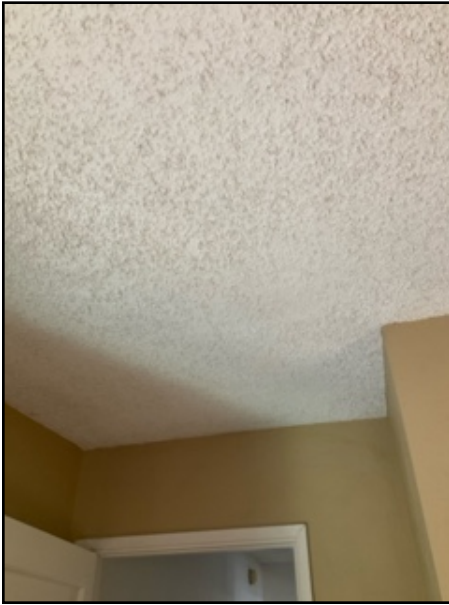
REPAIR OR REPLACE: Smoke detectors noted as not installed in any of the three bedrooms.

Per Section 72 of the National Fire Protection Association (NFPA) National Fire Alarm Signaling Code, smoke alarms must be installed on each habitable level, in every sleep room, and outside each sleeping area.
