## Home Inspection Report

**4011 Marron St**

**San Diego, CA 92115**

Inspected On: Mon, Sep 28 2026 at 8:00AM

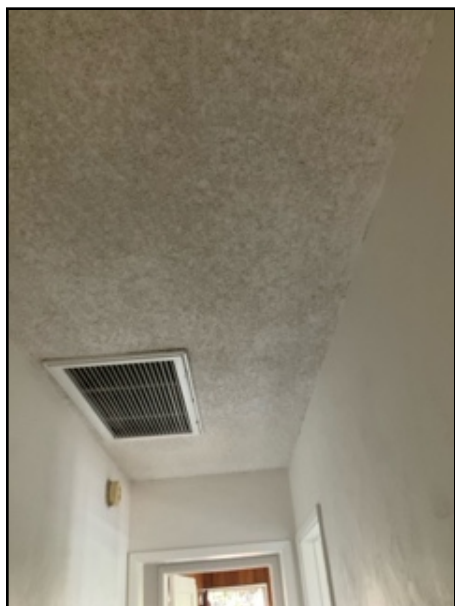
Figure 73-1

REPAIR OR REPLACE: Ceiling drywall noted as cracked in small bedroom. This is approximate area where furnace was installed in attic.

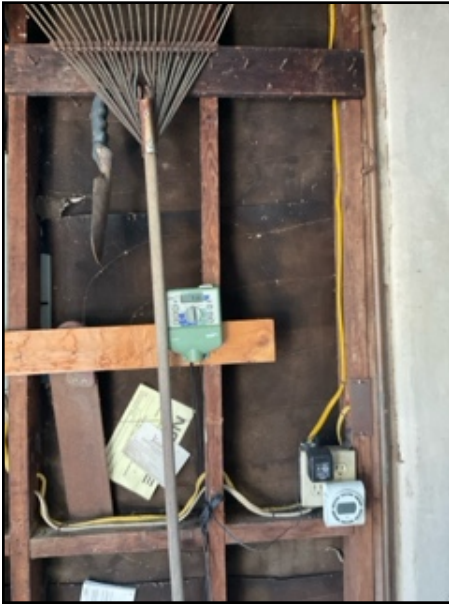
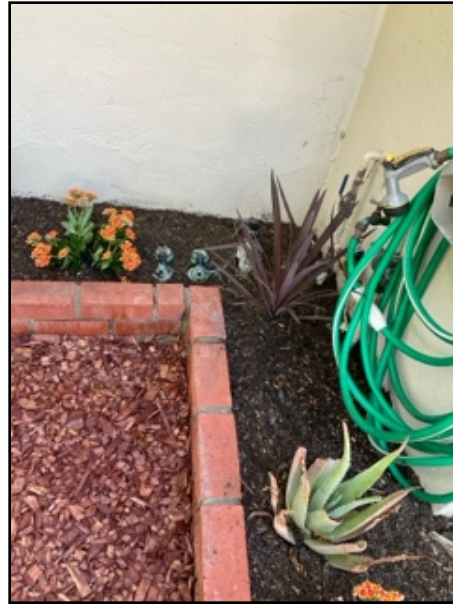
Lawn sprinklers were manually operated at valves. No apparent leaks or broken sprinkler heads were noted. It is beyond the scope of this inspection to inspect timers or non-visible electronic components.
