# PROPERTY INSPECTION REPORT

**FOUR POINT**  
HOME INSPECTION INC.

**904 Salida del Sol Dr**  
**Inspection Prepared For: Don Ellis**  
**Agent: -**

**Date of Inspection: 9/21/2026**  
**Year Built: 2005 Size: 3029**  
**Weather: Mild/Light rain**

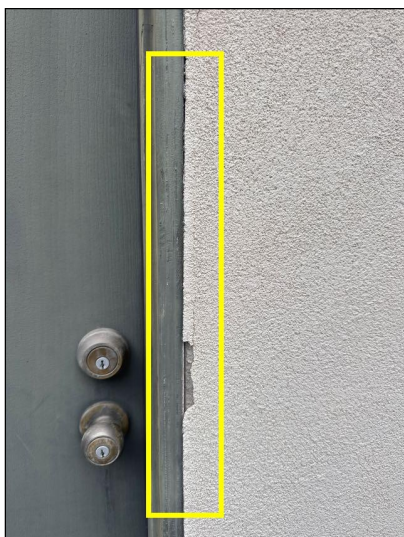
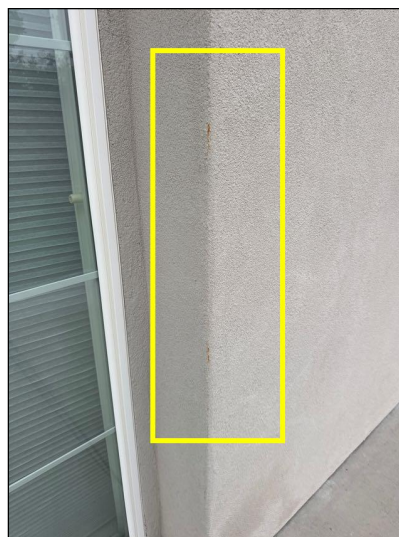
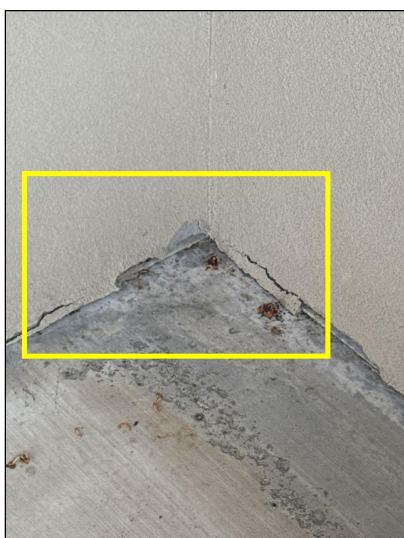
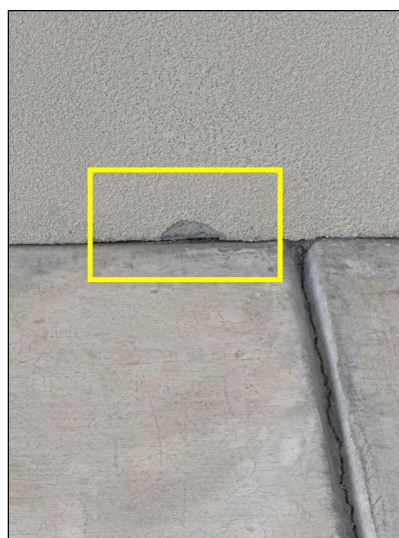
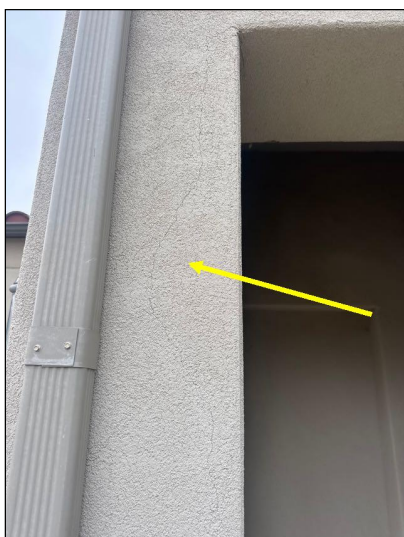
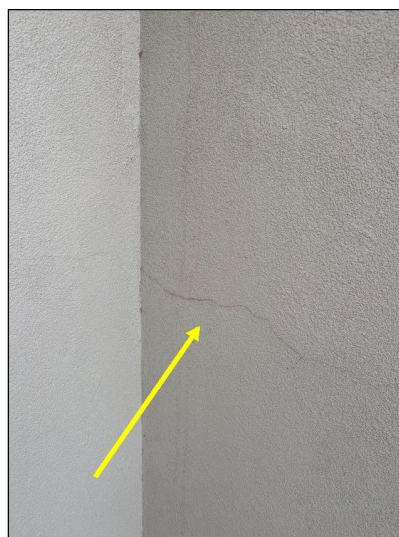
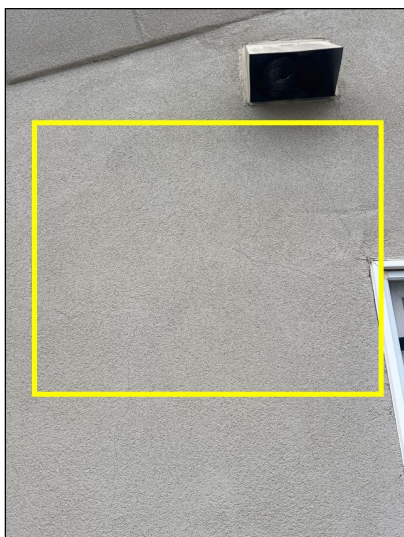
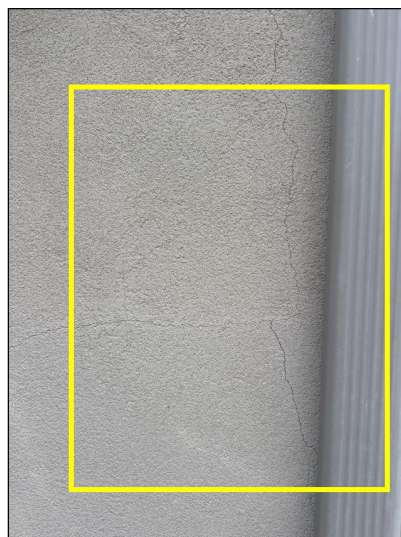
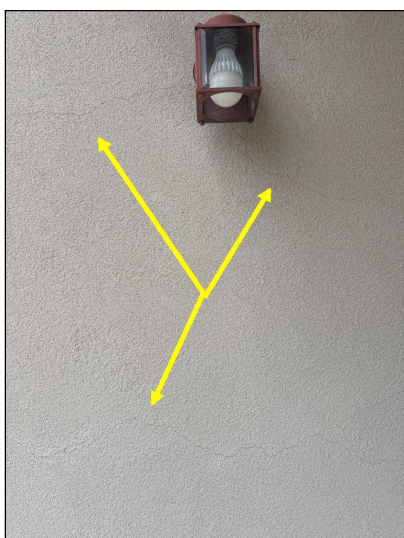
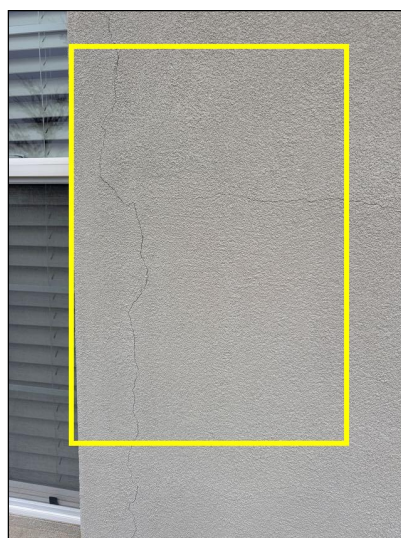
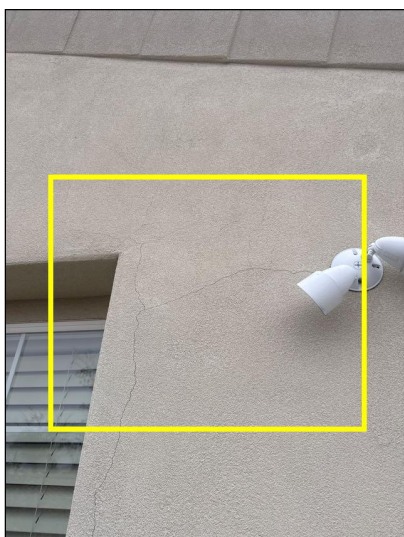
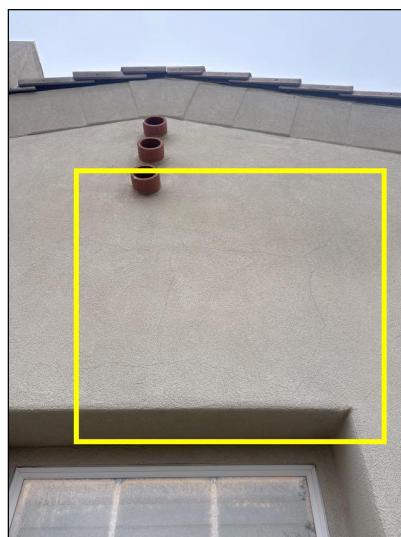
**Monitor:** The stucco covering exterior walls showed widespread moderate cracking. This type of cracking, called "thermal cracking" is a reaction to internal stresses created by stucco expansion and contraction caused by daily and seasonal temperature changes. This condition is made worse over time by exposure to moisture. Cracks exceeding 1/16-inch in width should be filled with an appropriate material to minimize future damage. Thermal cracking is common as stucco ages and minor cracks are a cosmetic concern. This type of cracking can be expected to continue slowly over time.

**Maintenance:** All gaps and holes in the stucco surface should be sealed to keep unwanted moisture out. Recommend having these areas sealed and painted. Continue to monitored as part of annual maintenance.

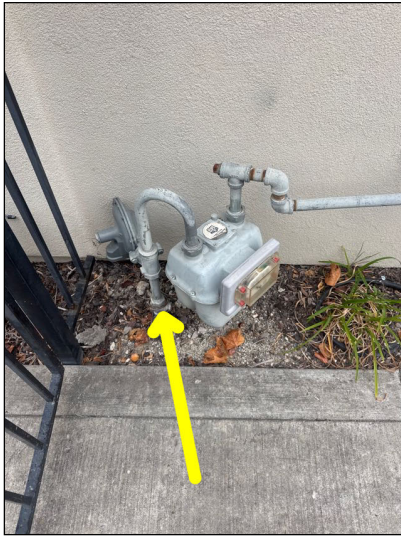
- The gas shut-off appeared to be in serviceable condition at the time of the inspection. Shut-offs were not operated, but were visually inspected.
- The home was located in an area known to experience significant earthquakes having a gas shut off tool readily available in an emergency is a recommended safety improvement.

Main gas shut off to the home.

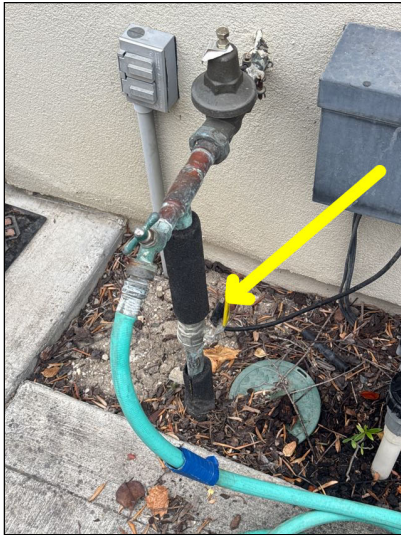
**Observations:** At the time of the inspection, the Inspector observed no deficiencies in the condition of the main water supply shut-off valve. It was not operated but was visually inspected.

Main water shut off to the home where the main water line enters the home.

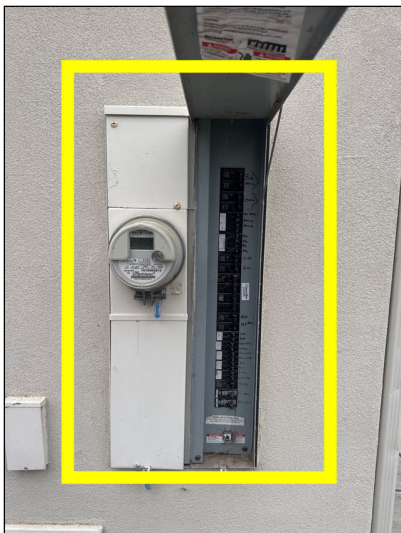
Main electrical service panel to the home.

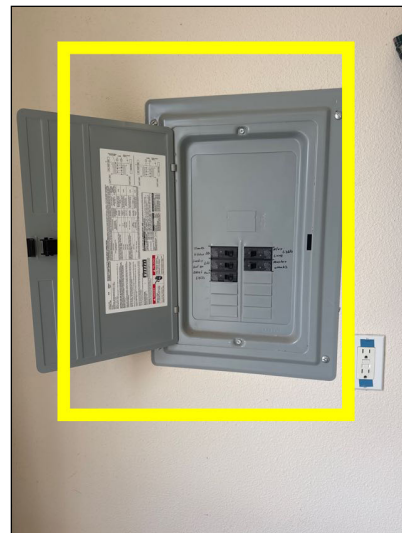
Sub panel to the home

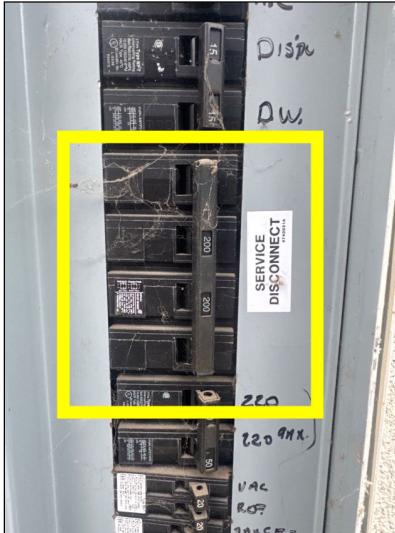
- The main amp breaker is rated at 200 AMPS.
- The Inspector observed no deficiencies in the condition of the electrical service disconnect. It was inspected visually but was not operated.

Main electrical shut off to the home

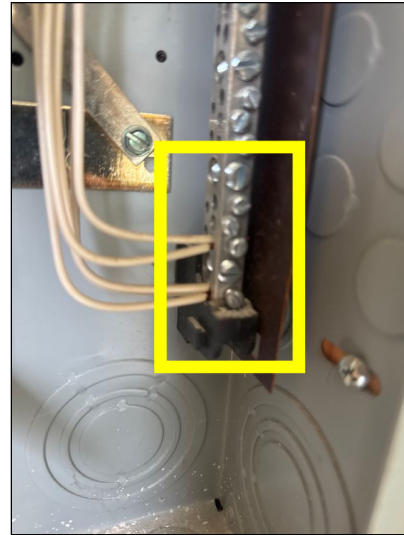
Multiple neutral conductors (white wire) from separate branch or separate feeder circuits cannot be installed in the same neutral terminal (lug screw)

| | Page 24 Item: 4 | Panel Wiring | Multiple neutral conductors (white wire) from separate branch or separate feeder circuits cannot be installed in the same neutral terminal (lug screw). The Inspector recommends correction by a qualified electrical contractor. |

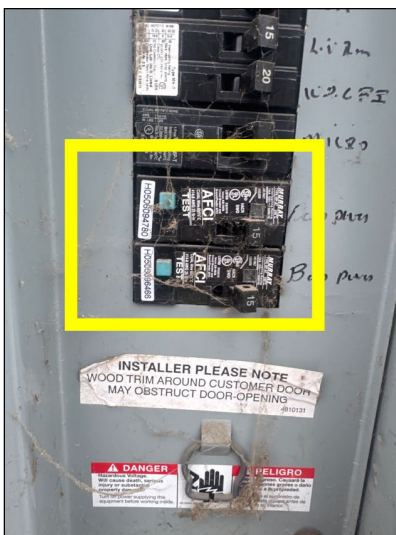
The arc fault circuit interrupter (AFCI) breaker(s) in the electrical panel properly responded to testing at the time of the inspection.

Note: AFCI circuit breakers installed at the main electrical panel.

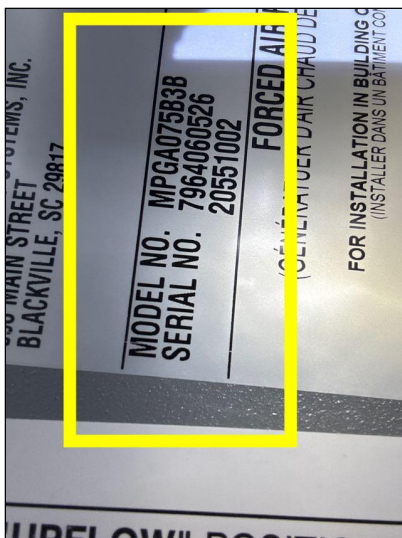
The furnace was plugged into an extension cord/power strip. Extension cords should not be used as permanent wiring. To provide power for this opener, the Inspector recommends that a dedicated electrical receptacle be installed at an appropriate location by a qualified electrical contractor.

Heater model and serial number

| | Page 27 Item: 2 | Heater Condition | The furnace was plugged into an extension cord/power strip. Extension cords should not be used as permanent wiring. To provide power for this opener, the Inspector recommends that a dedicated electrical receptacle be installed at an appropriate location by a qualified electrical contractor. |

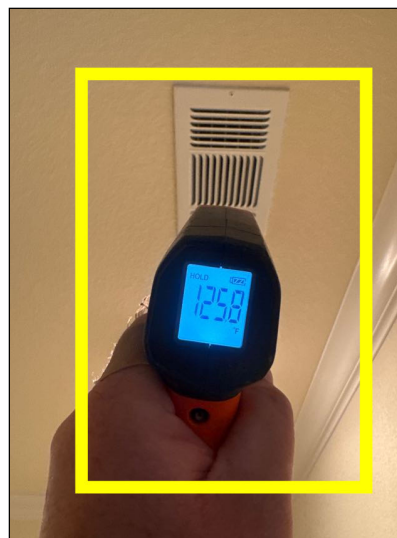
The supply air temperature at the registers should be 100 °F - 125 °F + to be considered running efficiently.

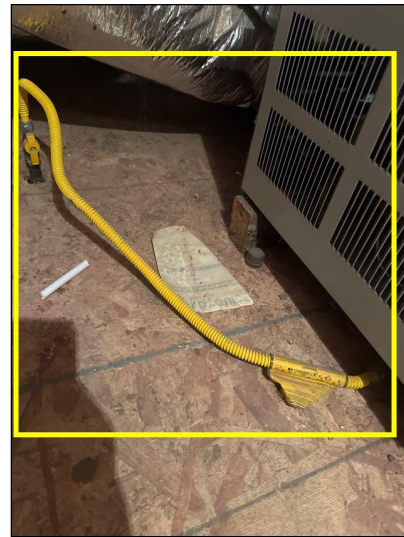
**Improvement:** The gas supply pipe contained no sediment trap.

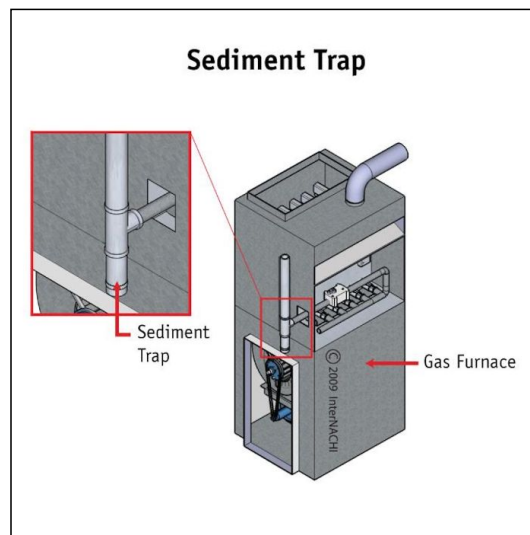
**Improvement:** The gas supply pipe contained no sediment trap.

The purpose of a sediment trap is to prevent sediment or debris particulates from entering and clogging the heaters gas valve.

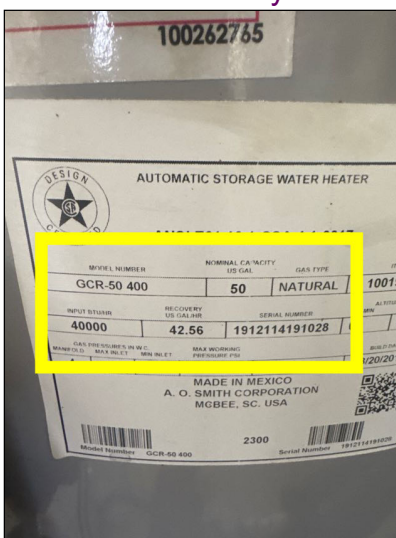
Water heater model and serial number

**Monitor:** "Sediment Knock" in tank noted at the time of inspection. Sediment buildup causes a popping noise, ""Sediment Knock"" the popping noise is steam bubbles escaping the sediment in the tank. This condition may decrease efficiency of the water heater.

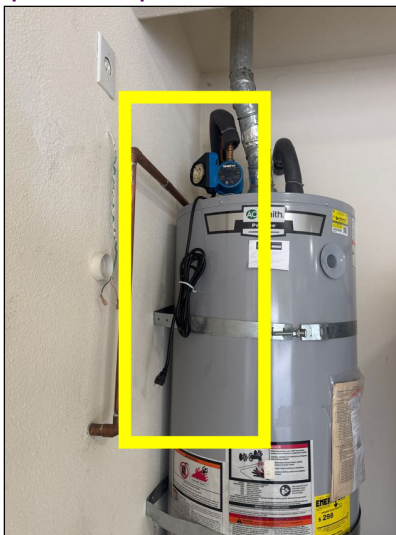
**Monitor:** The home had a hot water re-circulation system installed that was unplugged. You should ask the seller about this condition. The Inspector recommends that before the expiration of your Inspection Objection Deadline you consult with a qualified contractor to discuss options and costs for repair or replacement as needed.

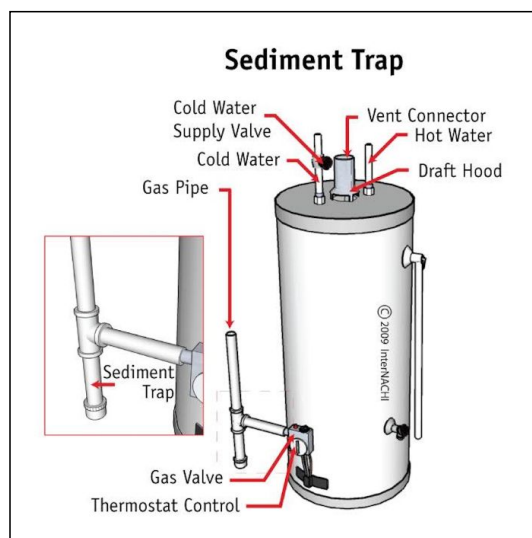
**Recommended Improvement:** The gas supply pipe contained no sediment trap. The purpose of a sediment trap is to prevent sediment or debris particulates from entering and clogging the water heater gas valve, which can cause the water heater to shut down. You may wish to consult with local contractor concerning the advisability of installing a sediment trap in the gas line.

**Improvement:** The gas supply pipe contained no sediment trap.

The purpose of a sediment trap is to prevent sediment or debris particulates from entering and clogging the water heaters gas valve

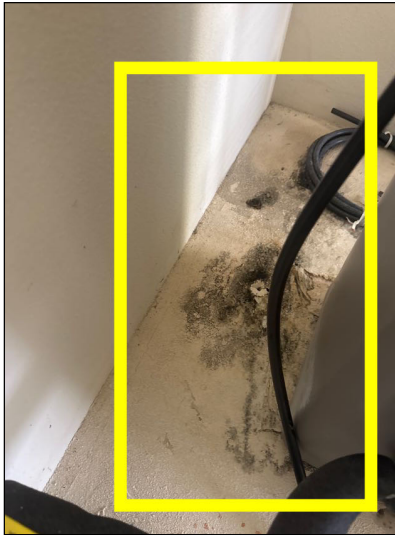
**Monitor:** Organic growth on the drywall near or around the water heater was visible at the time of the inspection. Confirming the presence of organic growth would require laboratory analysis. Usually this is damage from the old water heater leaking prior to it being replaced or the water softener was leaking. The moisture meter showed no elevated levels of moisture present in the area at the time of the inspection (Normal moisture is considered between 5-12%), indicating that the source of moisture has been corrected. Before the expiration of your Inspection Objection Deadline you may wish to consult with a qualified contractor to discuss options and costs for repair/re-painting the drywall.

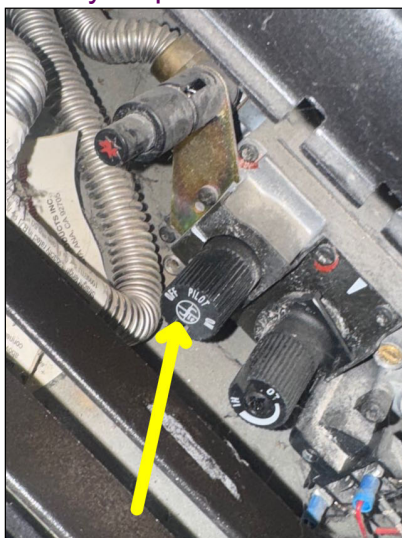
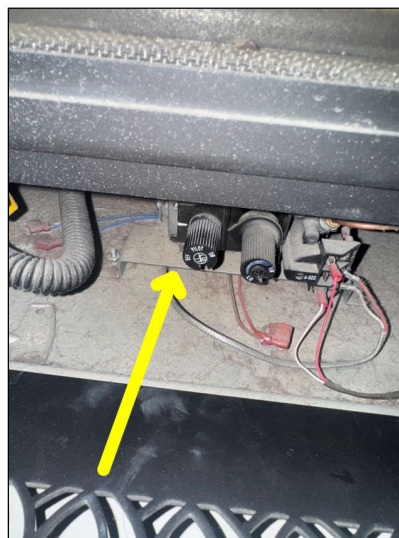
The fireplace in the Living Room, Family Room was turned off at the primary controls. Changing settings at the primary controls lies beyond the scope of the General Home Inspection. You should ask the seller to demonstrate the functionality of this fireplace or have it inspected by a specialist.

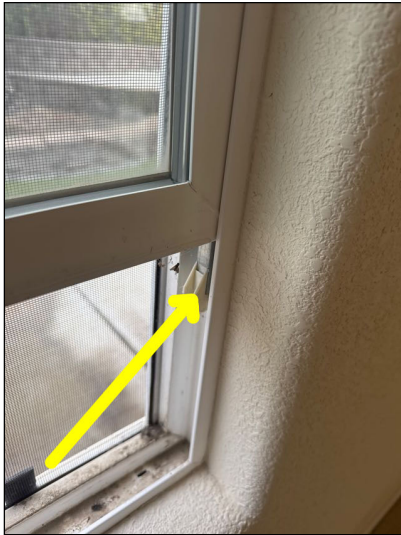
The sash bar has dropped out of place on a single-hung window
