# PROPERTY INSPECTION REPORT

**FOUR POINT**  
HOME INSPECTION INC.

**4158 Quarterhorse Way**

**Date of Inspection: 9/29/2026**

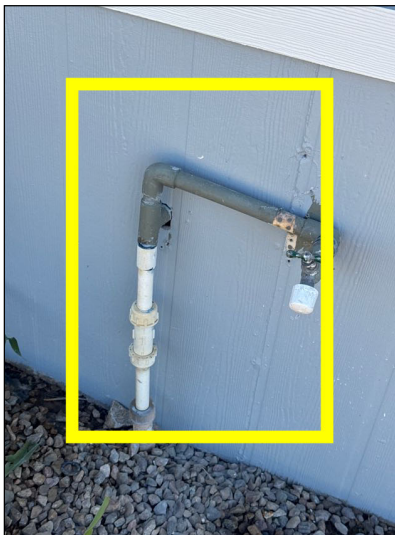
**Recommend Improvement:** The Inspector recommends that uninsulated main water supply pipe be insulated by a qualified contractor to save on water heating costs and to help prevent damage from freezing pipes.

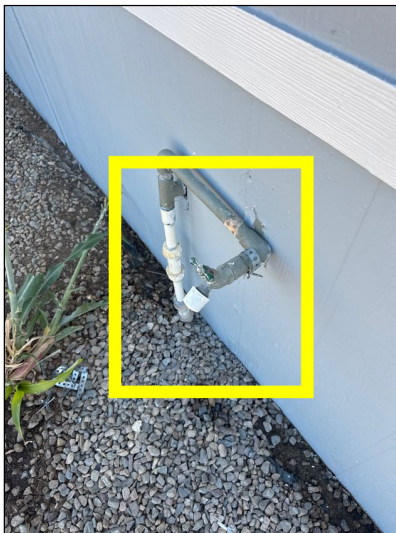
An exterior faucet at the Front of the house was leaking. The Inspector recommends repair by a qualified plumbing contractor.

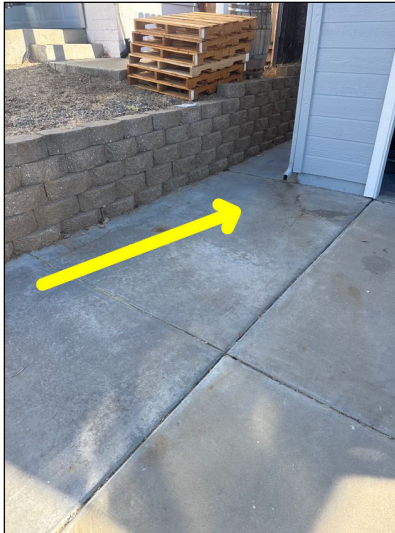
**Monitor:** The home's driveway has neutral or negative drainage that will route runoff from precipitation toward the garage and homes foundation. Although it appears the driveway has a drainage swale and/or a drain near the garage this area needs monitoring during heavy rain to prevent any moisture intrusion. The Inspector recommends that this area and any drains be kept clean at all times and if re-grading is needed to improve drainage we suggest doing so.

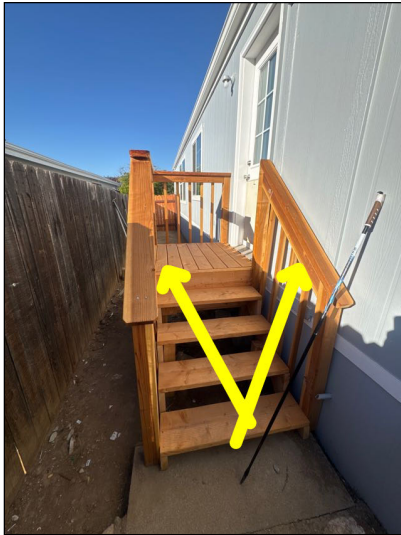
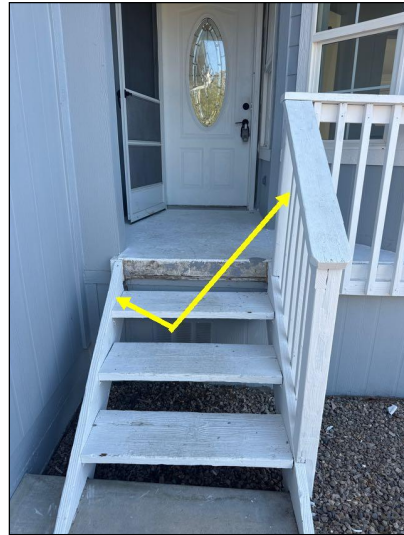
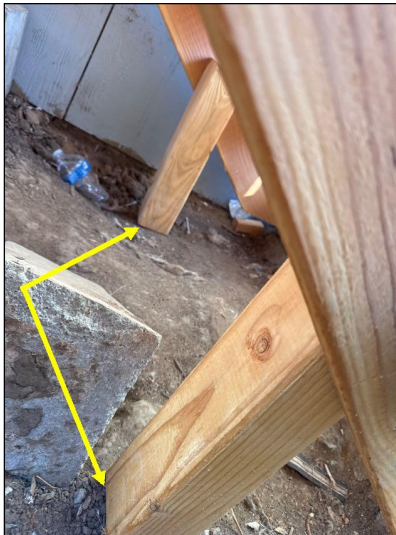
One or more posts which support this exterior stairway had contact with soil and appeared to be unstable at the time of the inspection. Wood in contact with soil will eventually decay, the decayed area will crush under the weight of the load it supports and the stairway will lose support in the area of any affected posts. This condition may eventually result in damage to the stairway or the development of unsafe structural conditions. The Inspector recommends that all posts supporting the stairway be protected from contact with soil.

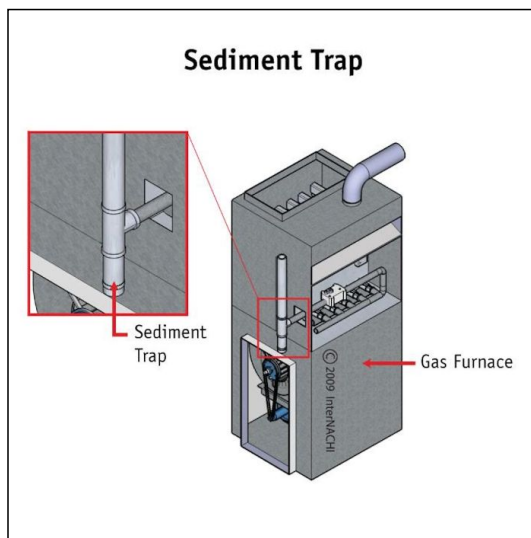
**Improvement:** The gas supply pipe contained no sediment trap.

The purpose of a sediment trap is to prevent sediment or debris particulates from entering and clogging the heaters gas valve.

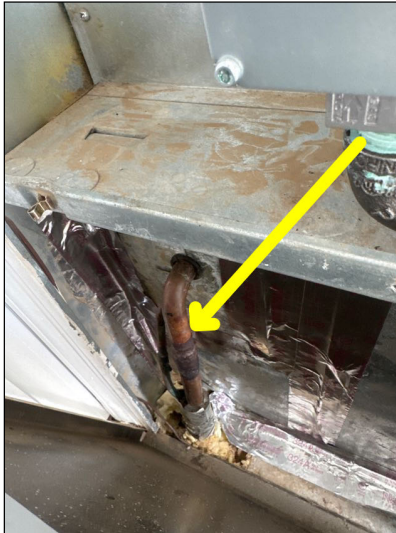
Condensation dripping from the air-conditioning suction (large, insulated) line at the furnace where the insulation has been removed or damaged. This should be repaired before moisture damage occurs to the furnace or area near the furnace.

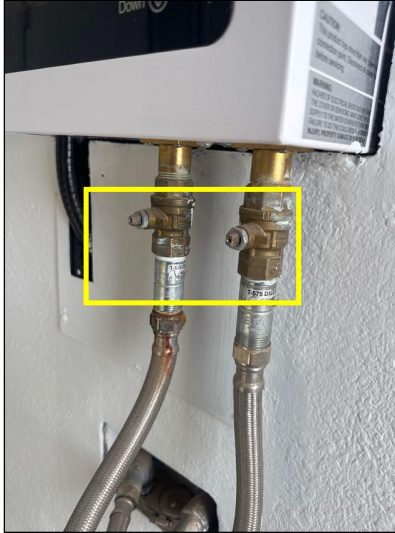
The water heater had broken shut-off valve handles. The inspector recommends installation of a proper shut-off be installed by a qualified plumbing contractor.

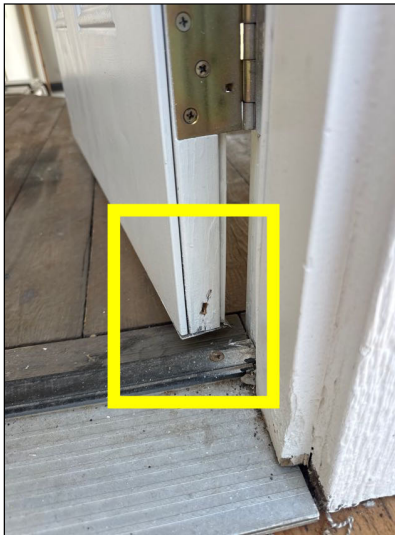
The exterior exit door in the garage had moisture damage, wood rot, observed. Refer to pest report for further details and repair damage as needed.

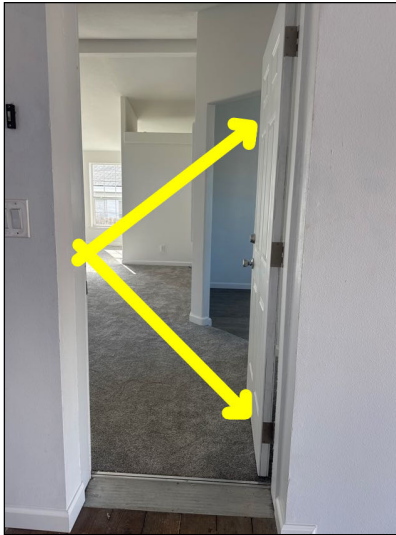
The door in the wall between the garage and the home living space did not have operable self-closing hinges as is required by generally-accepted current safety standards.

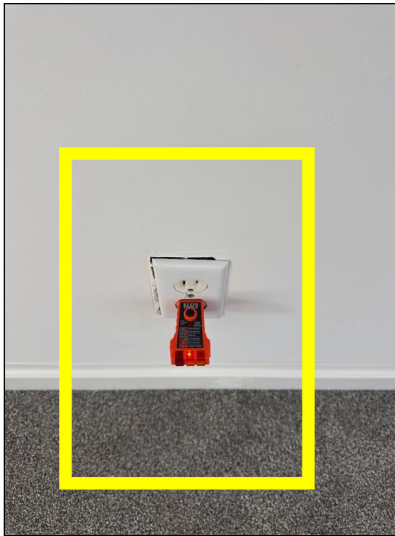
An electrical receptacle in the interior living space had an open ground. This outlet should be corrected by qualified electrical contractor.

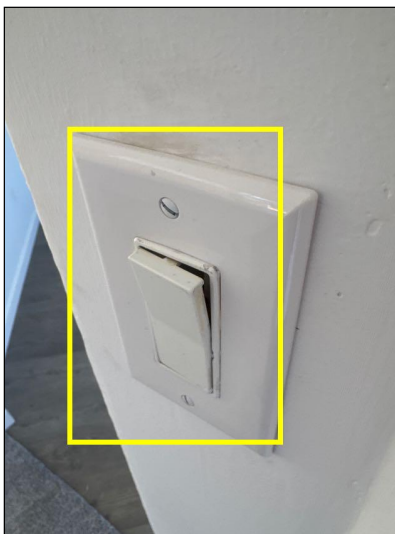
- At the time of the inspection, the Inspector observed few deficiencies in the condition or operation of the light fixture. Notable exceptions are listed.
- An interior light switch was damaged at the time of the inspection. This condition may be a potential fire hazard. The Inspector recommends correction by a qualified electrical contractor.

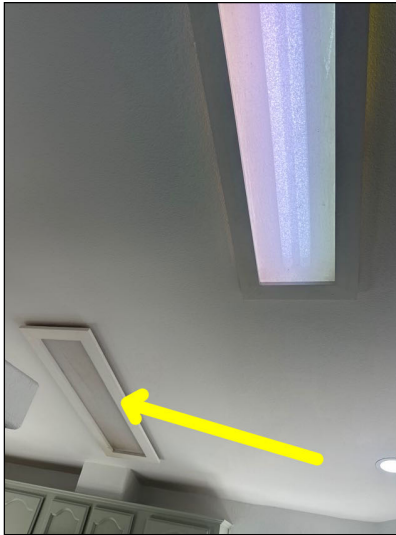
- **Monitor:** A ceiling light fixture in the kitchen did not respond to the switch. The bulb may need to be replaced or there may be a problem with the switch, wiring or light fixture. If after the bulb is replaced this light still fails to respond to the switch, this condition may be a potential fire hazard and the Inspector recommends that an evaluation and any necessary repairs be performed by a qualified electrical contractor.

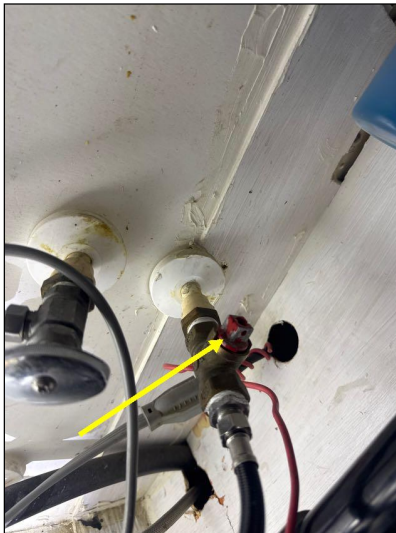
A water shut off was inoperable "broken/missing handle" beneath the kitchen sink. This condition will complicate faucet repairs and means that only water to this fixture can be turned off at the homes main water supply shut off. The Inspector recommends having a new water shut-off installed. All work should be performed by a qualified contractor.

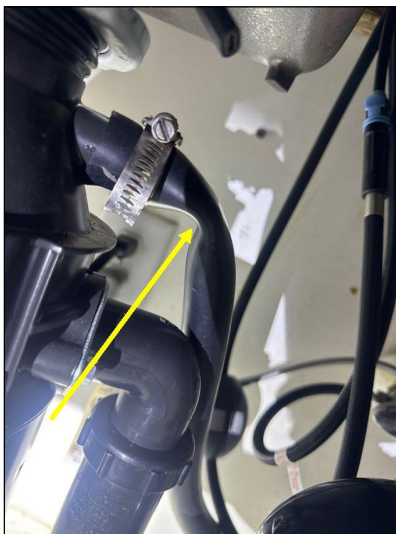
- Extension cord used as permanent wiring was visible for the dishwasher. This condition is a potential fire hazard. The Inspector recommends that any such wiring be removed and replaced with properly-installed, approved wiring by a qualified contractor.

- The dishwasher drain line is kinked. The inspector recommends repair by a qualified contractor.

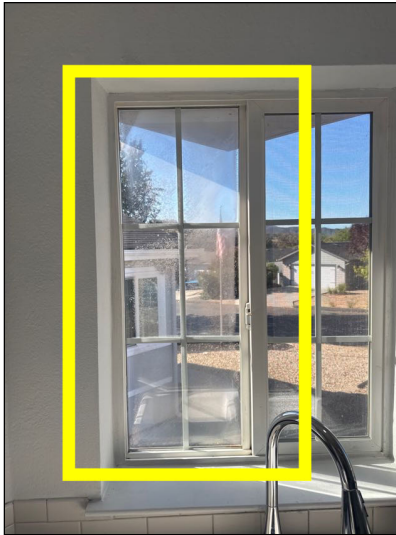
Although no condensation was visible at the time of the inspection, staining and etching of the glass at a window indicated a loss of thermal integrity. Etching of the glass from long-term exposure to condensation constitutes permanent damage. The Inspector recommends that before the expiration of your Inspection Objection Deadline you consult with a qualified contractor to discuss options and costs for replacement.

Staining and etching of the glass at the window indicated a loss of thermal integrity.

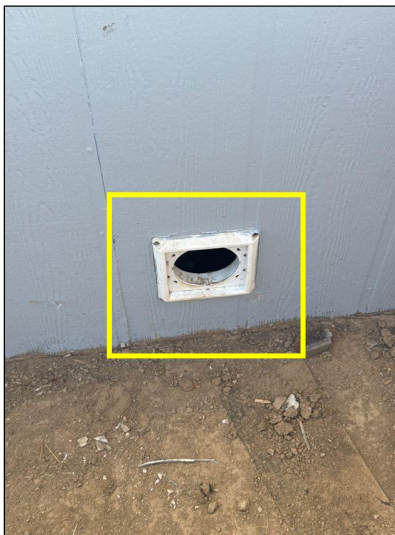
The dryer exhaust duct was missing the exterior cover. This condition may allow animal entry or the accumulation of debris related to animal nesting. The inspector recommends installation of a proper cover by a qualified contractor.

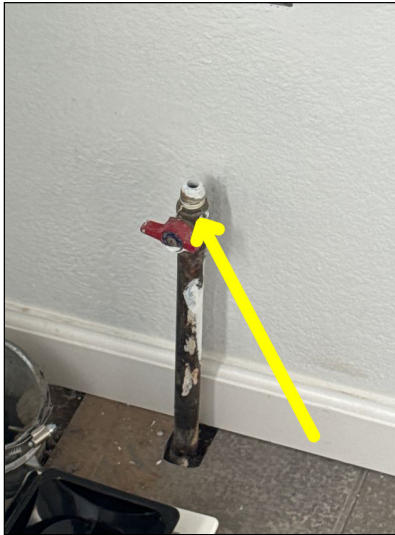
- **Safety:** A gas valve is present and in the off position. Recommend the valve is capped until valve is properly connected to an approved gas appliance. This will insure there is no accidental discharge of gas if the valve is accidentally opened.

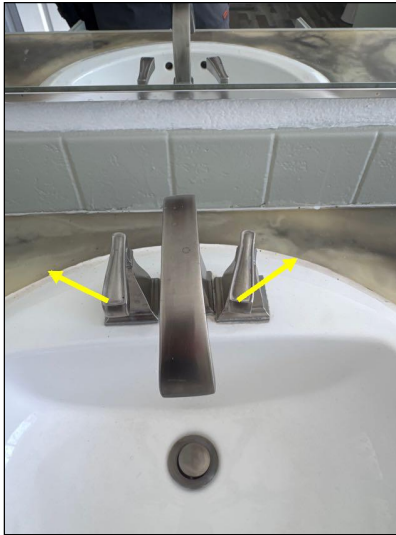
The sink in this bathroom the faucet handles are installed backward.

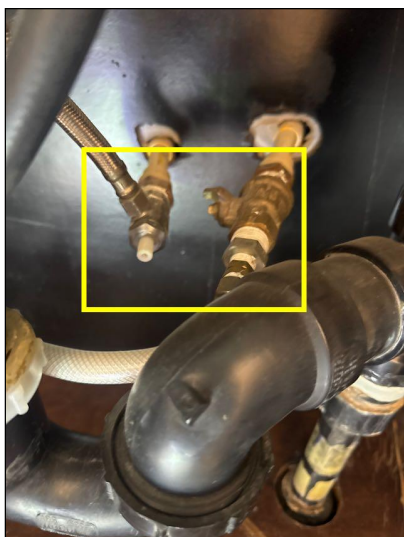
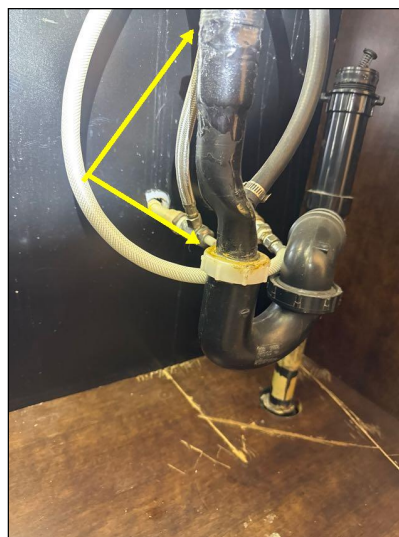
Leaking connections at the trap assembly beneath the bathroom sink should be repaired to avoid future/additional damage to the cabinet floor and possibly the wall/floor structures below. The Inspector recommends repair by a qualified plumbing contractor.

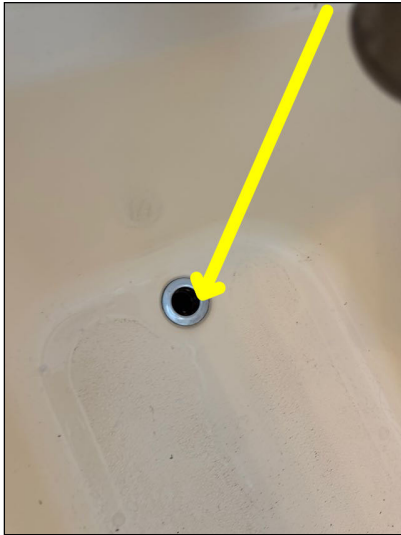
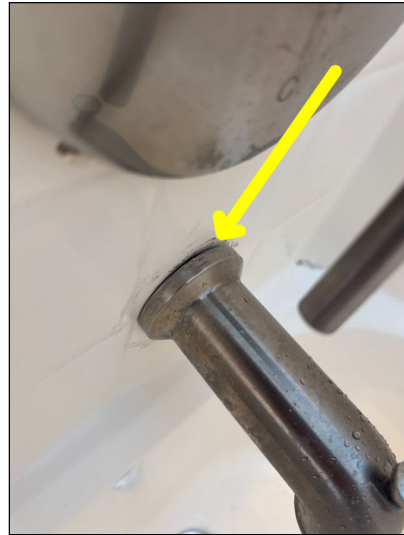
The tub in this bathroom had an inoperable stopper. The Inspector recommends service by a qualified contractor.

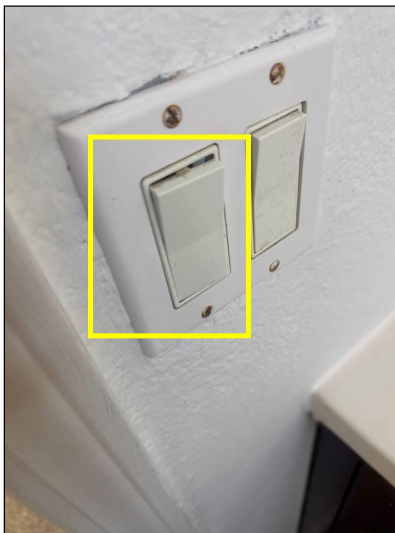
- An interior light switch in the bathroom was damaged at the time of the inspection. This condition may be a potential fire hazard. The Inspector recommends correction by a qualified electrical contractor.

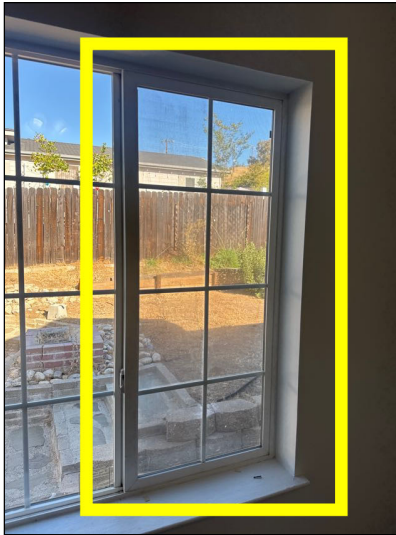
Although no condensation was visible at the time of the inspection, staining and etching of the glass at a window indicated a loss of thermal integrity. Etching of the glass from long-term exposure to condensation constitutes permanent damage. The Inspector recommends that before the expiration of your Inspection Objection Deadline you consult with a qualified contractor to discuss options and costs for replacement.

Staining and etching of the glass at the window indicated a loss of thermal integrity.

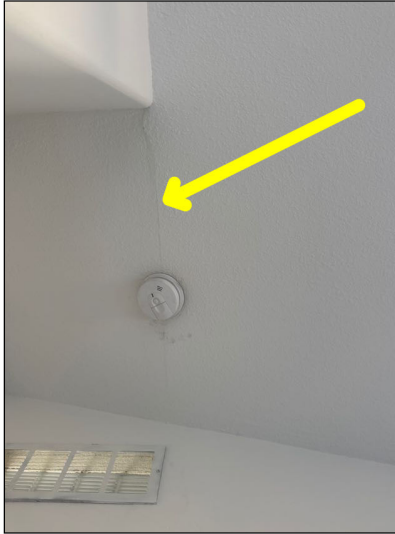
- The bedroom ceiling appeared to be in serviceable condition at the time of the inspection.
- **Monitor:** Normal settlement cracking was visible in interior ceiling at the time of the inspection. This cracking appeared to be consistent with that caused by normal settlement. Settlement typically takes place in the first few years after original construction, and then stops. Cracks can be repaired and sealed, but may reappear over time with temperature and humidity levels.

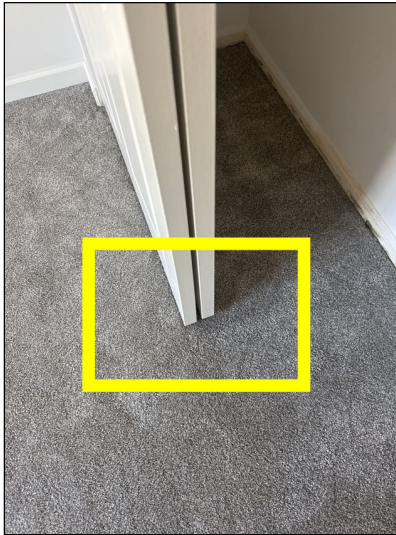
- The closet is in serviceable condition.
- **Safety:** The closet door has no door stop to keep doors from swinging in and out. This could allow the doors to fall off the track and injure a person. The inspector recommends that the proper hardware is installed by qualified contractor.

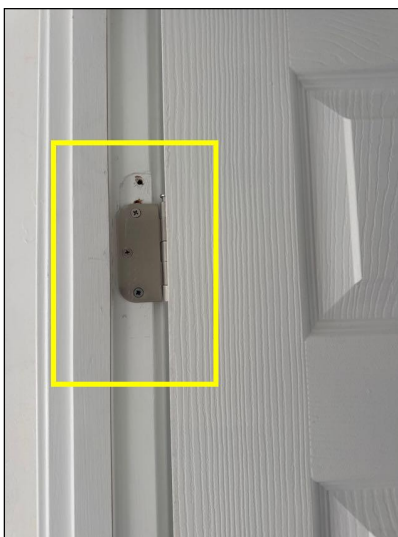
- The door to this bedroom was improperly installed and was difficult to close. The Inspector recommends stop adjustment or door replacement by a qualified contractor.
