## Inspection Services

### *Inspection Report*

**Address: 1000 Santa Maria Ave Los Osos, CA 93402**

**04/16/2026**

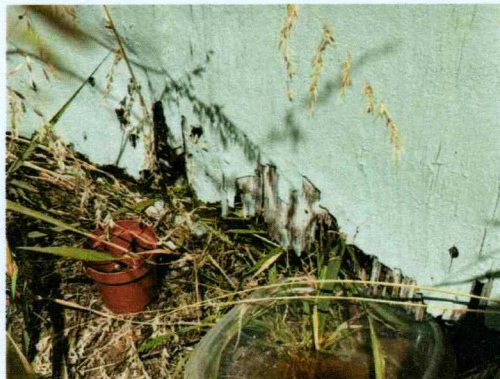
**E&C 20:** Some moisture and/or bug-type damage and deterioration found at areas of the exterior wood siding and/or trim. Refer to the termite report for additional comments, recommendations, locations and extent.

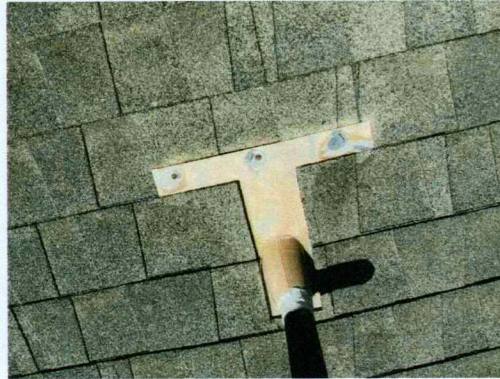
**E&C MR 45:** Exposed, Loose and Lifting nails at flashings at areas of the roof. Recommend tightening or replacing loose nails and sealing all exposed nails at areas of roof flashings.

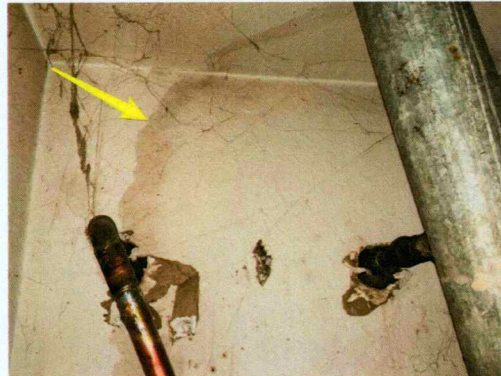
**FI** 76: **Disclosure:** Dry Moisture stains noted at areas around the water heater at the platform and/or enclosure.

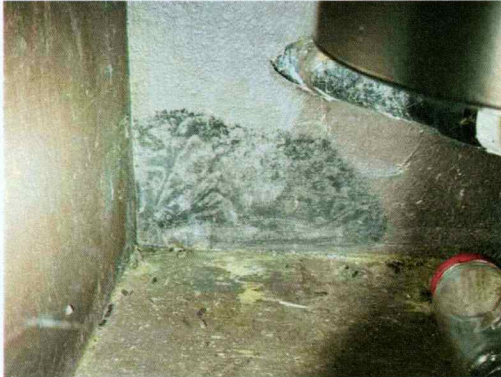
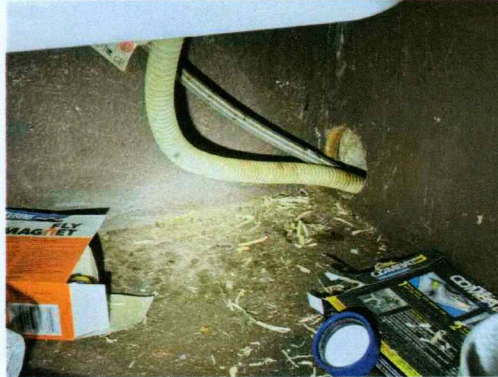
**SC FI 90:** Some moisture stains and damage in the cabinetry below the kitchen sink. Some visible mold growth noted. Contacted qualified remediation professional for evaluation and correction.

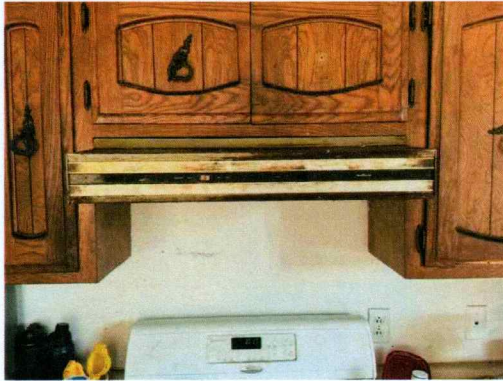
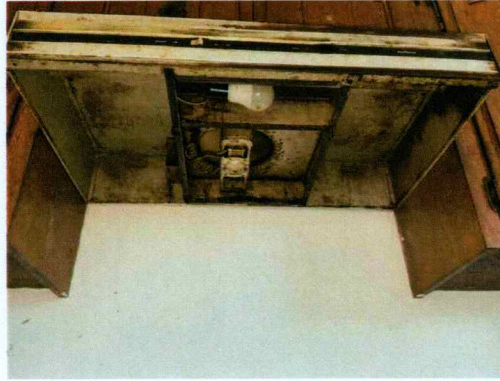
**MR 99:** Kitchen cooktop exhaust hood filter is missing.

**E&C MR 100:** Kitchen cook top exhaust hood light non-operational / damaged missing switch.

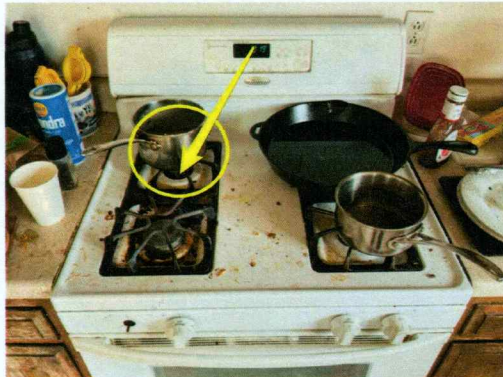
**E&C 102:** The BACK LEFT Cook top burner did not operate or ignite properly when tested. Recommend cleaning / servicing.

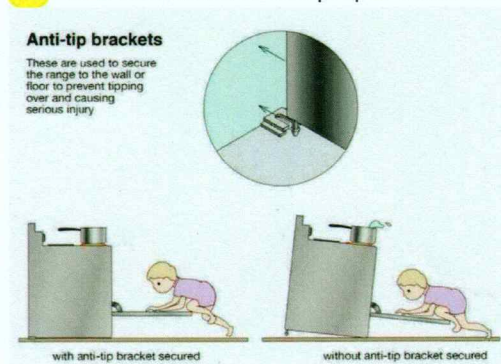
**SU 104:** Recommend the proper installation of an anti-tilt bracket at the freestanding range.

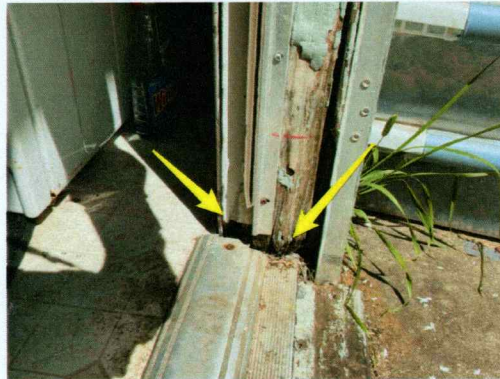
Damaged door jam

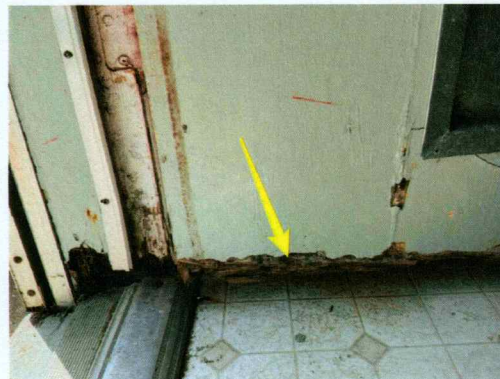
Damaged wood door

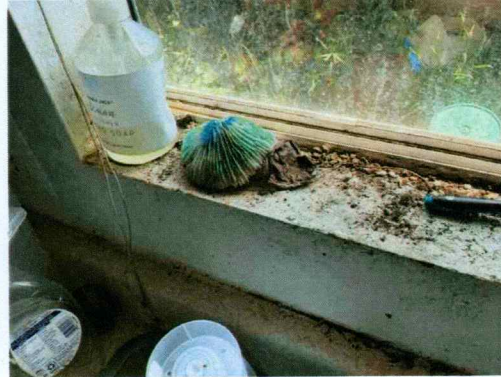
**FI 144:** Moisture stains and/or damage on the inside at some window sills. Refer to the termite report for additional comments and recommendations.

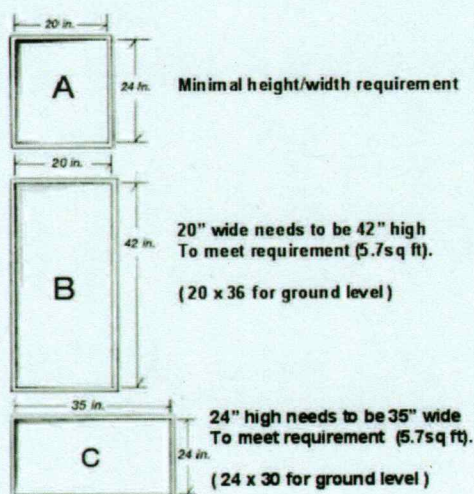
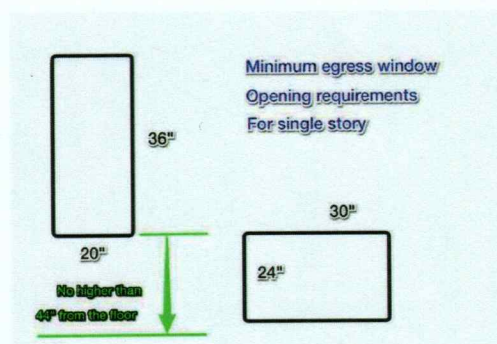
**SC 145:** Windows in the bedrooms do not meet the current minimum fire egress standards:

1. PRIMARY BEDROOM
2. BEDROOM-1

Total window area needs to be 5.7 sq ft  
(5.0 for ground level)

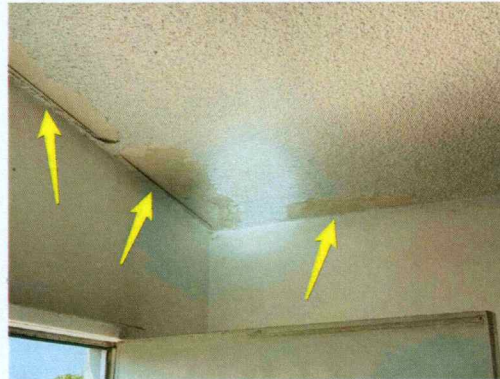
**FI 156:** Evidence of past moisture stains & damage at ceiling area in the ABOVE THE FRONT ENTRY DOOR. Recommend further review of the water stains to determine the cause, the current condition and if repairs are needed.

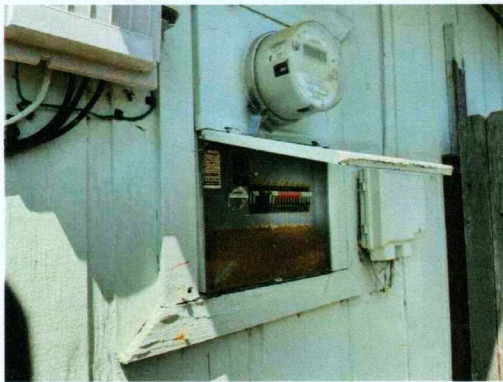
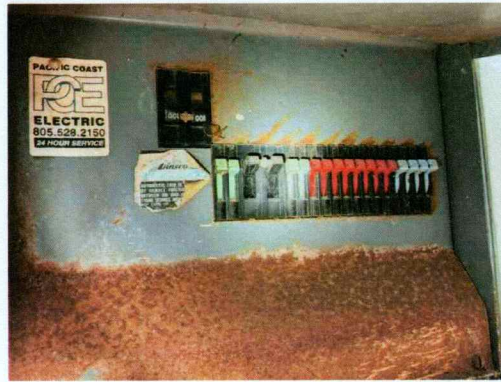
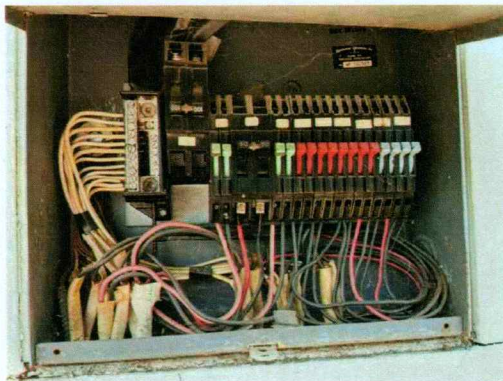
**UPG 164:** Some older "Zinsco / GTE Sylvania" electrical panels as installed as the Main Electrical Panel on this property have been known to be problematic. Client is advised to research as well as have a licensed electrician familiar with the Zinsco / GTE Sylvania specific issues evaluate the panel and certify the safety of the panel or replace if needed.
