## PROPERTY INSPECTION REPORT

1005 Alexandria Dr  
San Diego, CA 92107

10/01/2026

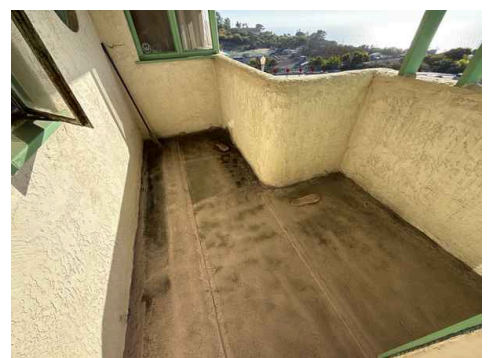
### **SUBSTRUCTURE NOT EVALUATED**

The sub structure could not be evaluated and further evaluation may be desired.

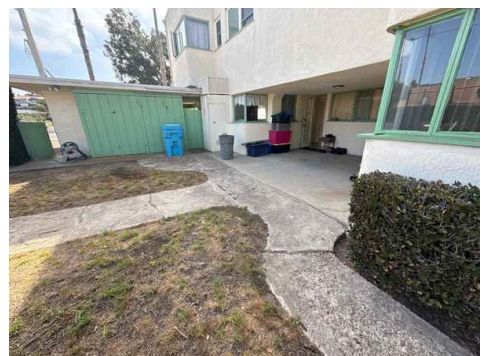
## 4.2.2 Drainage or Grading

**PLANTER NOT SEPARATED FROM STRUCTURE**

Recommend monitoring.

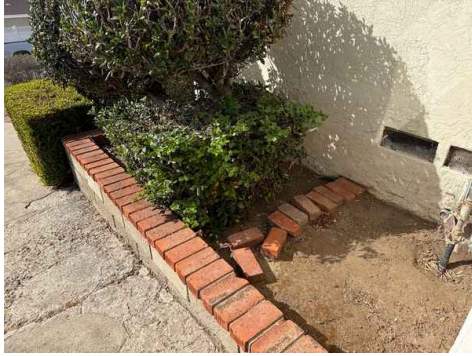
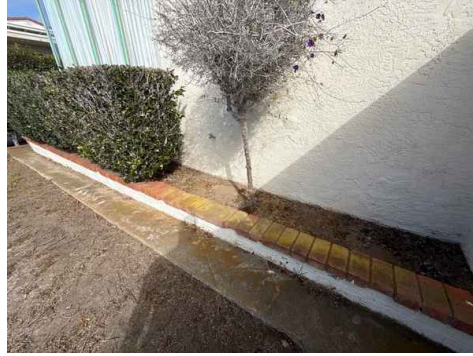
## 4.4.1 Exterior Walls / Trim

**DAMAGED STUCCO**

Contact a qualified professional.

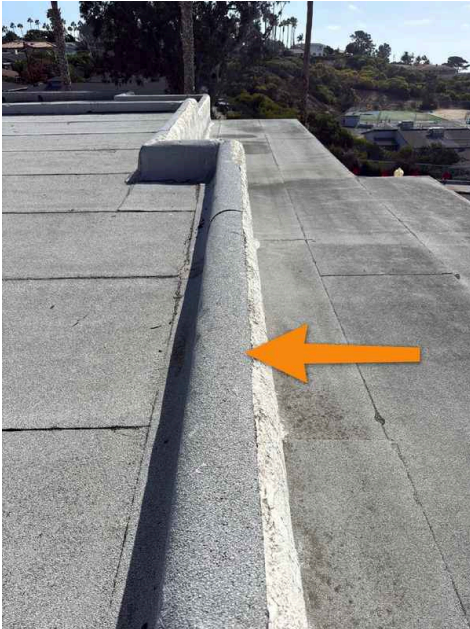
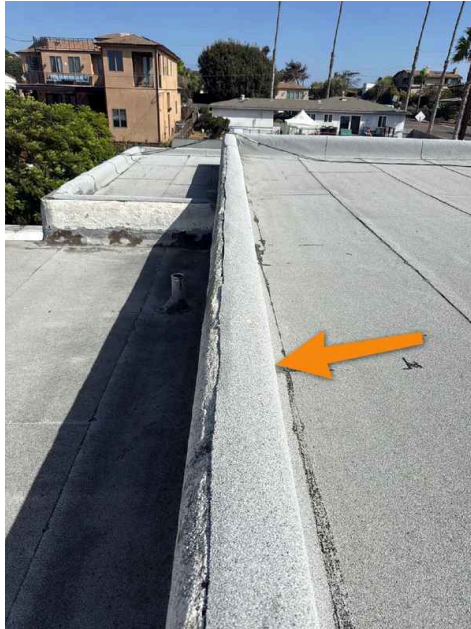
### 6.3.1 Flashings

#### ROOF TO WALL FLASHING

Contact a qualified professional.

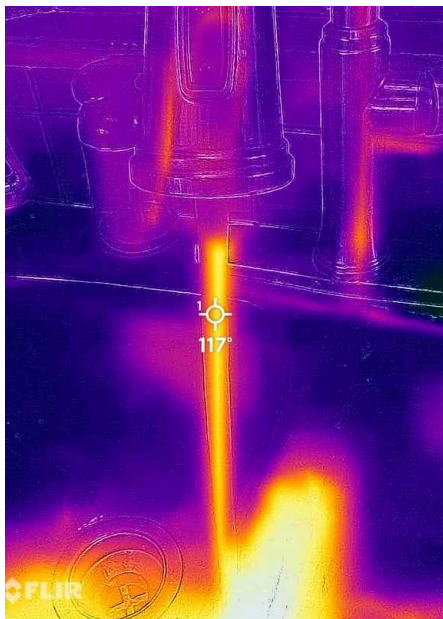
## Water Heater(s): Thermal Image - Water Heater Operational

Thermal image of the water heater producing hot water.

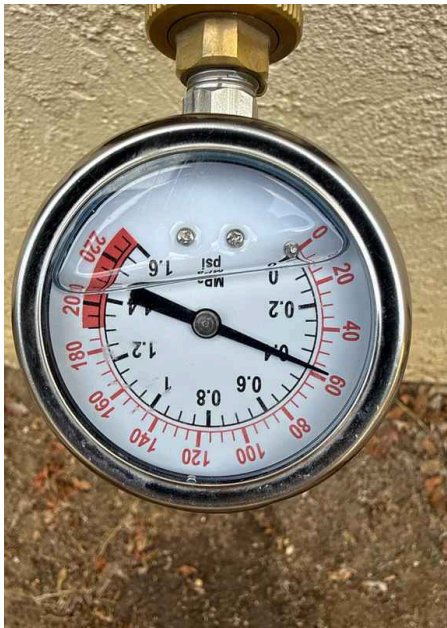
50-60 PSI

View of water pressure at the time of the inspection. 50 to 80 PSI is acceptable 60 to 75 PSI is ideal.

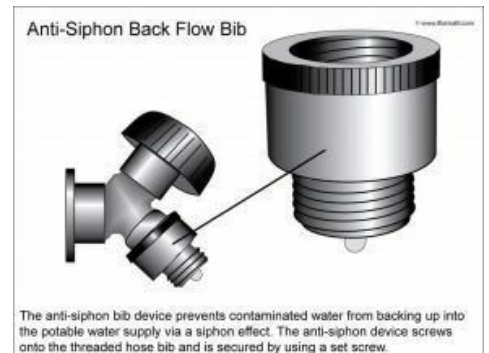
**HOSE BIB MISSING BACKFLOW PREVENTER**

Backflow prevention devices were missing at one or more hose bibs. These devices reduce the likelihood of gray water entering the potable water supply. We recommend installing these devices where necessary.

Contact a handyman or DIY project

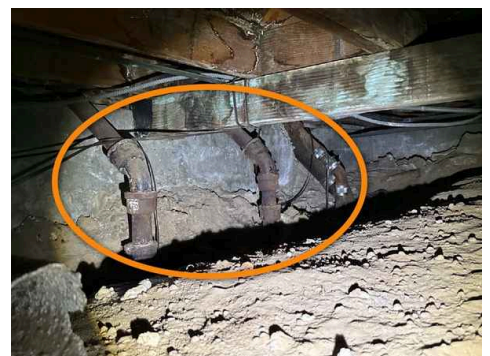
## 8.4.1 Drain, Waste, &amp; Vent Systems

**CAST IRON CORRODED**

Cast Iron pipes are showing rust and corrosion due to age. They appear to be at the end of their useful life. Recommend further evaluation by a licensed plumbing contractor before the end of your contingency period to determine repairs necessary at this time.

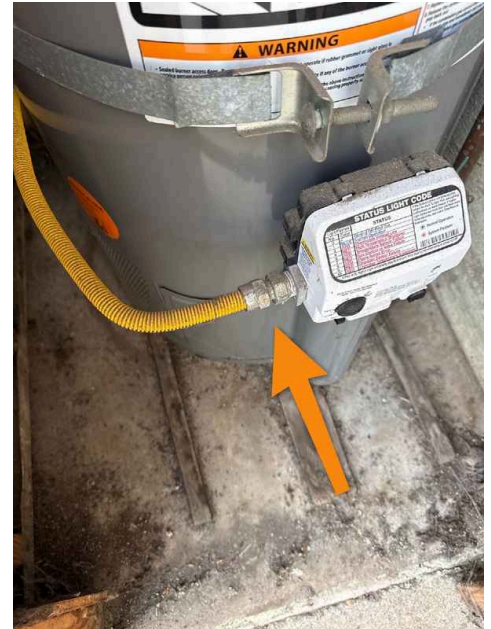
**SEDIMENT TRAP MISSING**

The gas line for the water heater is missing a sediment trap. Recommend further evaluation and repair by a licensed plumber.

Contact a qualified professional.

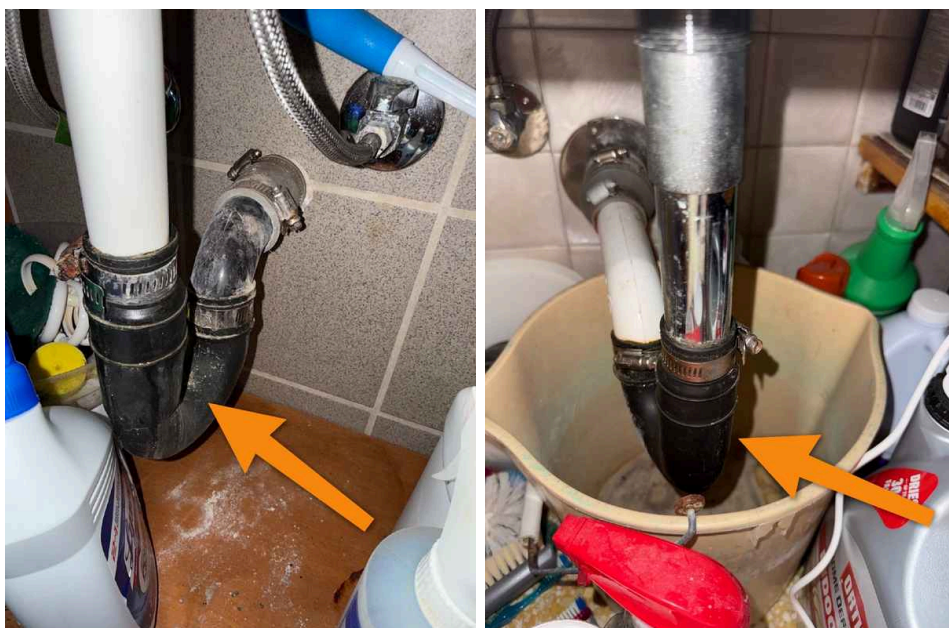
## 8.6.1 Sinks / Fixtures

**SUBSTANDARD DRAIN REPAIR**

Substandard repairs were noted at the sink drains in one or more locations (tape, sealant, or other non-standard components). A qualified plumber is recommended to make repairs according to standard building practices.

Contact a qualified plumbing contractor.

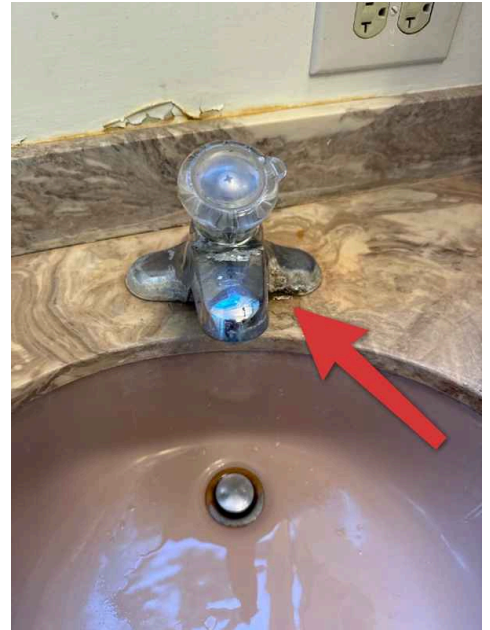
## 8.6.2 Sinks / Fixtures

**FAUCET LEAK**

Faucet noted leaking. Recommend further evaluation by a licensed plumber and repair as needed.

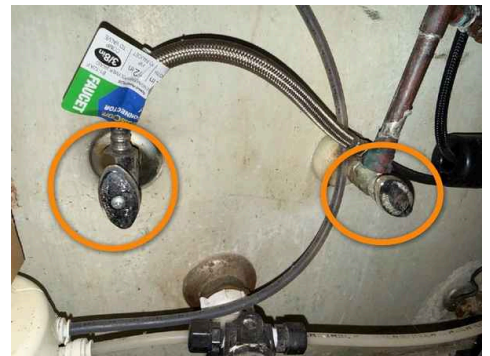
## 8.6.3 Sinks / Fixtures

**OLD ANGLE STOP(S)**

Old or original angle stops are installed at some or all sinks and toilets. We recommend replacing all of these older angle stop valves with new valves and braided steel supply lines to avoid leaks.

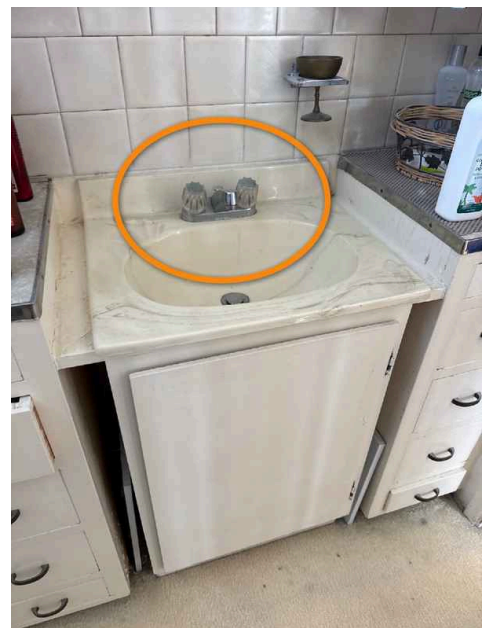
## 8.6.4 Sinks / Fixtures

**FIXTURE NOT PROPERLY OPERATIONAL**

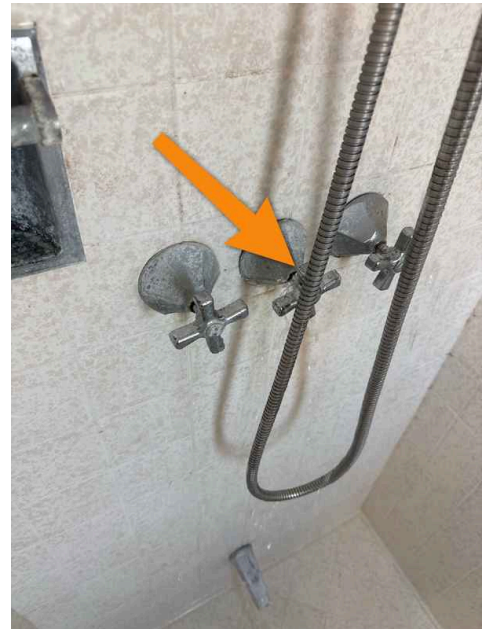
## 8.7.1 Bathtubs / Showers

**LEAKS AT HANDLE**

One or more tub and/or shower handles were leaking. Recommend repairs be made by a qualified licensed plumber.

Contact a qualified plumbing contractor.

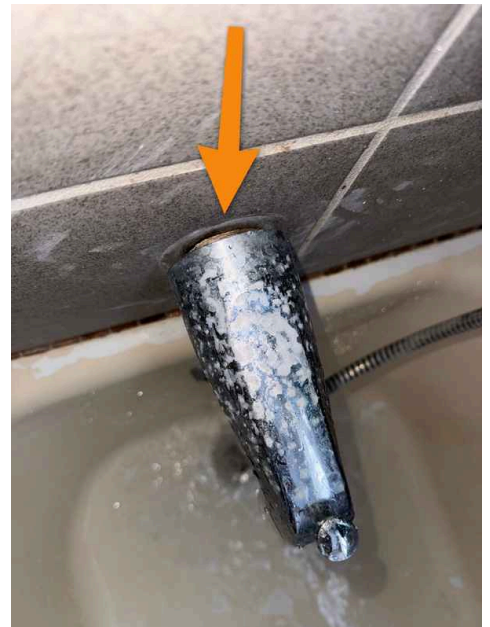
## 8.7.2 Bathtubs / Showers

A gap was noted between tub/shower parts and the wall. Gaps are too large to seal with caulking. Recommend having plumber re plumb parts close to wall and seal. Determining if water damage exists behind any wall, floor or ceiling surface is beyond the scope of a home inspection.

Contact a qualified professional.

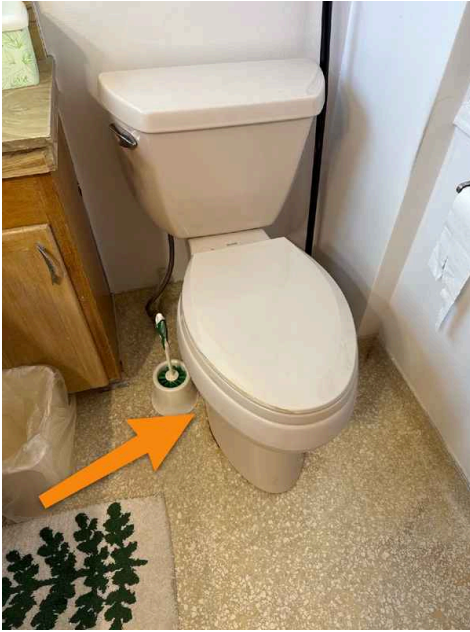
## 8.8.1 Toilets

**TOILET LOOSE**

Contact a qualified plumbing contractor.

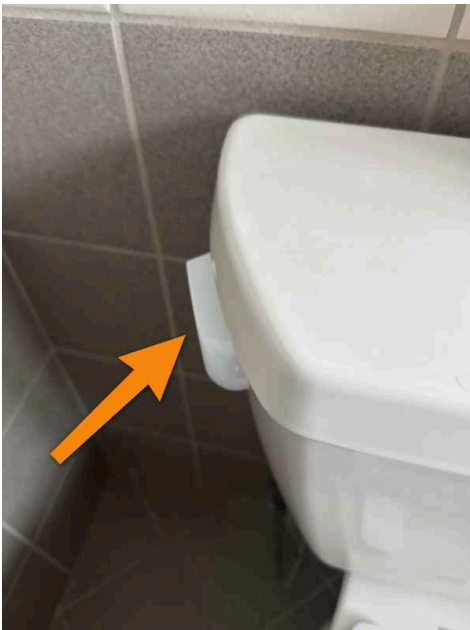
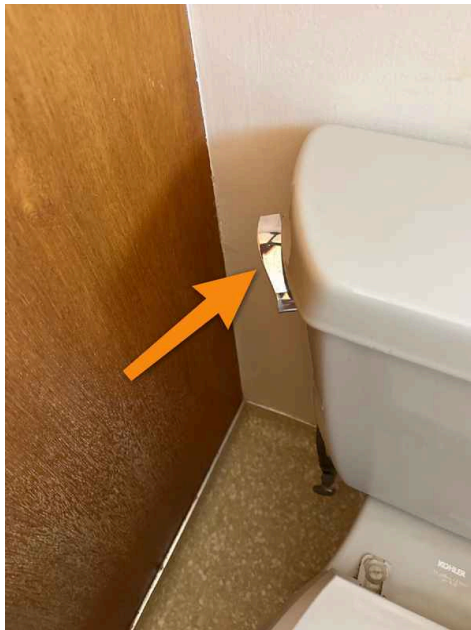
### 8.8.2 Toilets

#### **HANDLE CAN GET STUCK DOWN**

One or more handles can get stuck down and let the water to continually run. Correction is recommended.

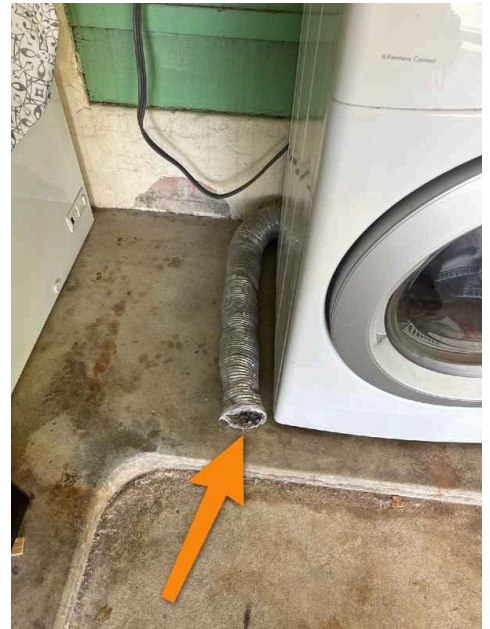
### 8.9.1 Laundry

#### **DISCONNECTED DRYER VENT**

Contact a qualified professional.

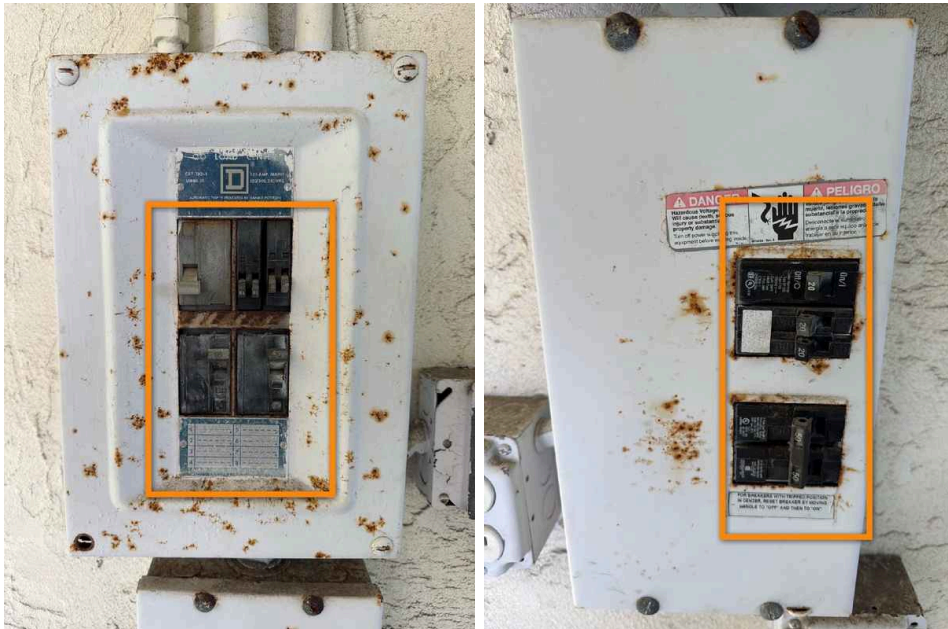
## 9.4.1 Breakers &amp; Panel Wiring

**BREAKERS NOT LABELED PROPERLY**

Contact a qualified professional.

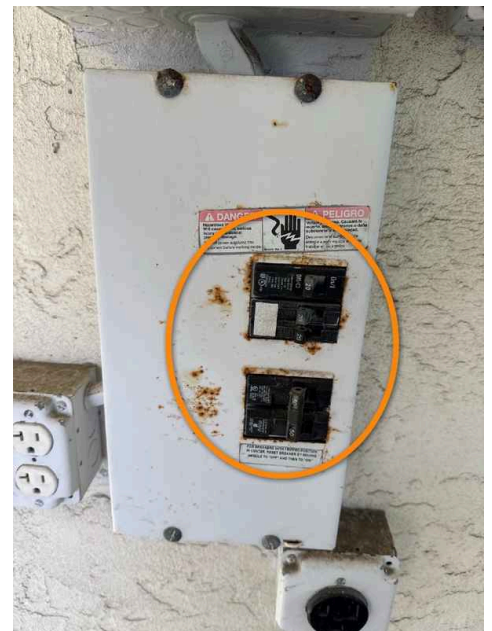
#### 9.4.2 Breakers & Panel Wiring

##### **BREAKERS TRIPPED / OFF**

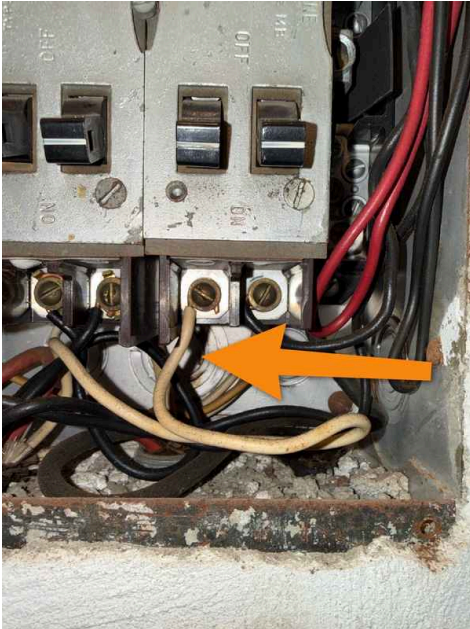
#### 9.4.3 Breakers & Panel Wiring

##### **WHITE WIRE(S) USED AS HOT CONDUCTOR(S)**

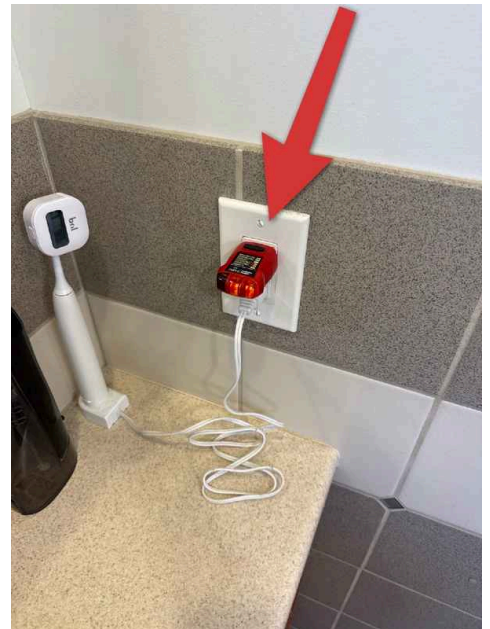
#### 9.5.1 GFCI / AFCI Protection

##### **GFCI DID NOT TRIP WHEN TESTED**

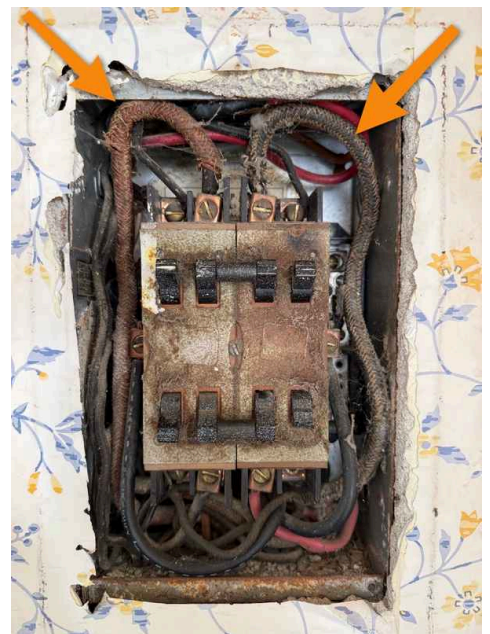
Cloth covered wiring was found at one or more locations. This wiring jacket on this type of wiring becomes brittle with time and when disturbed, can literally break apart by bending or pulling. The rubber sheathing can become brittle, crack, or fall off, which can cause arcing. Recommend a qualified electrician evaluate all cloth covered wiring and repair as needed.

Contact a qualified electrical contractor.

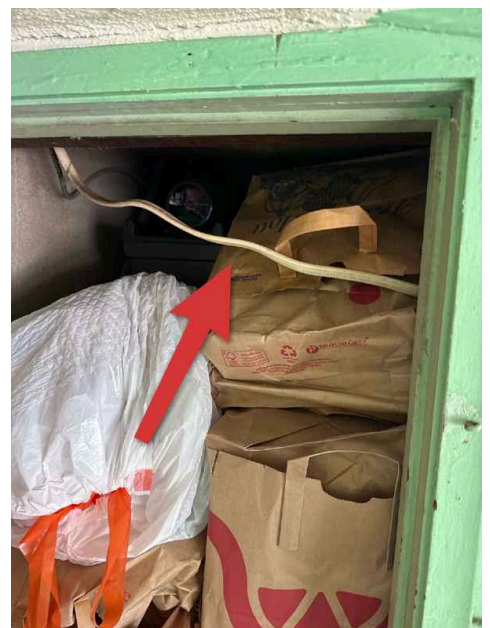
## 9.6.2 Electrical Wiring

**EXPOSED WIRING NOT IN CONDUIT**

Exposed wiring was noted at one or more wall or ceiling surfaces that could easily be damaged. This is a safety concern if used below 7 feet. Exposed wire is normally installed in conduit for protection. A qualified electrician is recommended to install conduit as needed.

Contact a qualified electrical contractor.

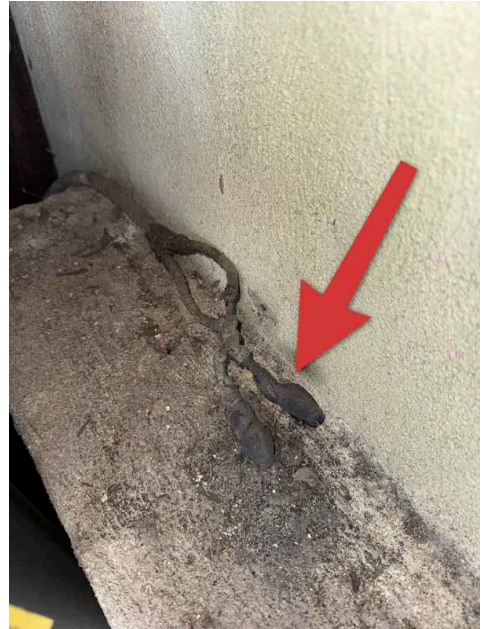
## 9.6.3 Electrical Wiring

**OPEN SPLICE**

Open wire splices were observed at one or more location. All Romex connections must be enclosed in a covered junction box that is secured to a framing member of the house. Recommend further evaluation by a licensed electrical contractor before the end of your contingency period to determine repairs possible at this time.

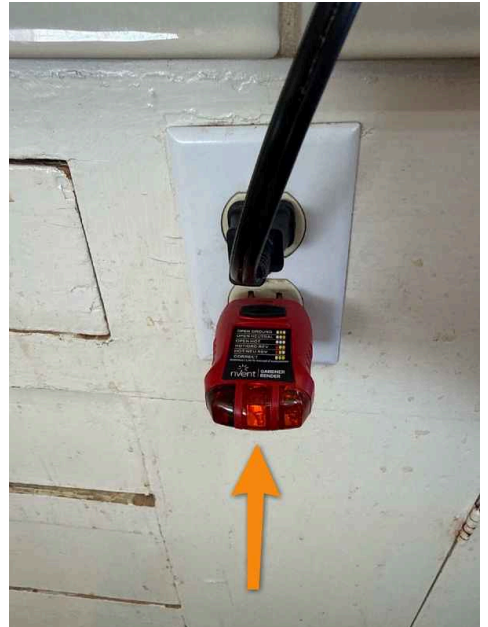
## 9.7.1 Outlets / Switches / Lighting / Fans

**OPEN GROUNDED OUTLET(S)**

Non grounded three prong outlets were present in one or more areas. Recommend repair by a licensed electrician.

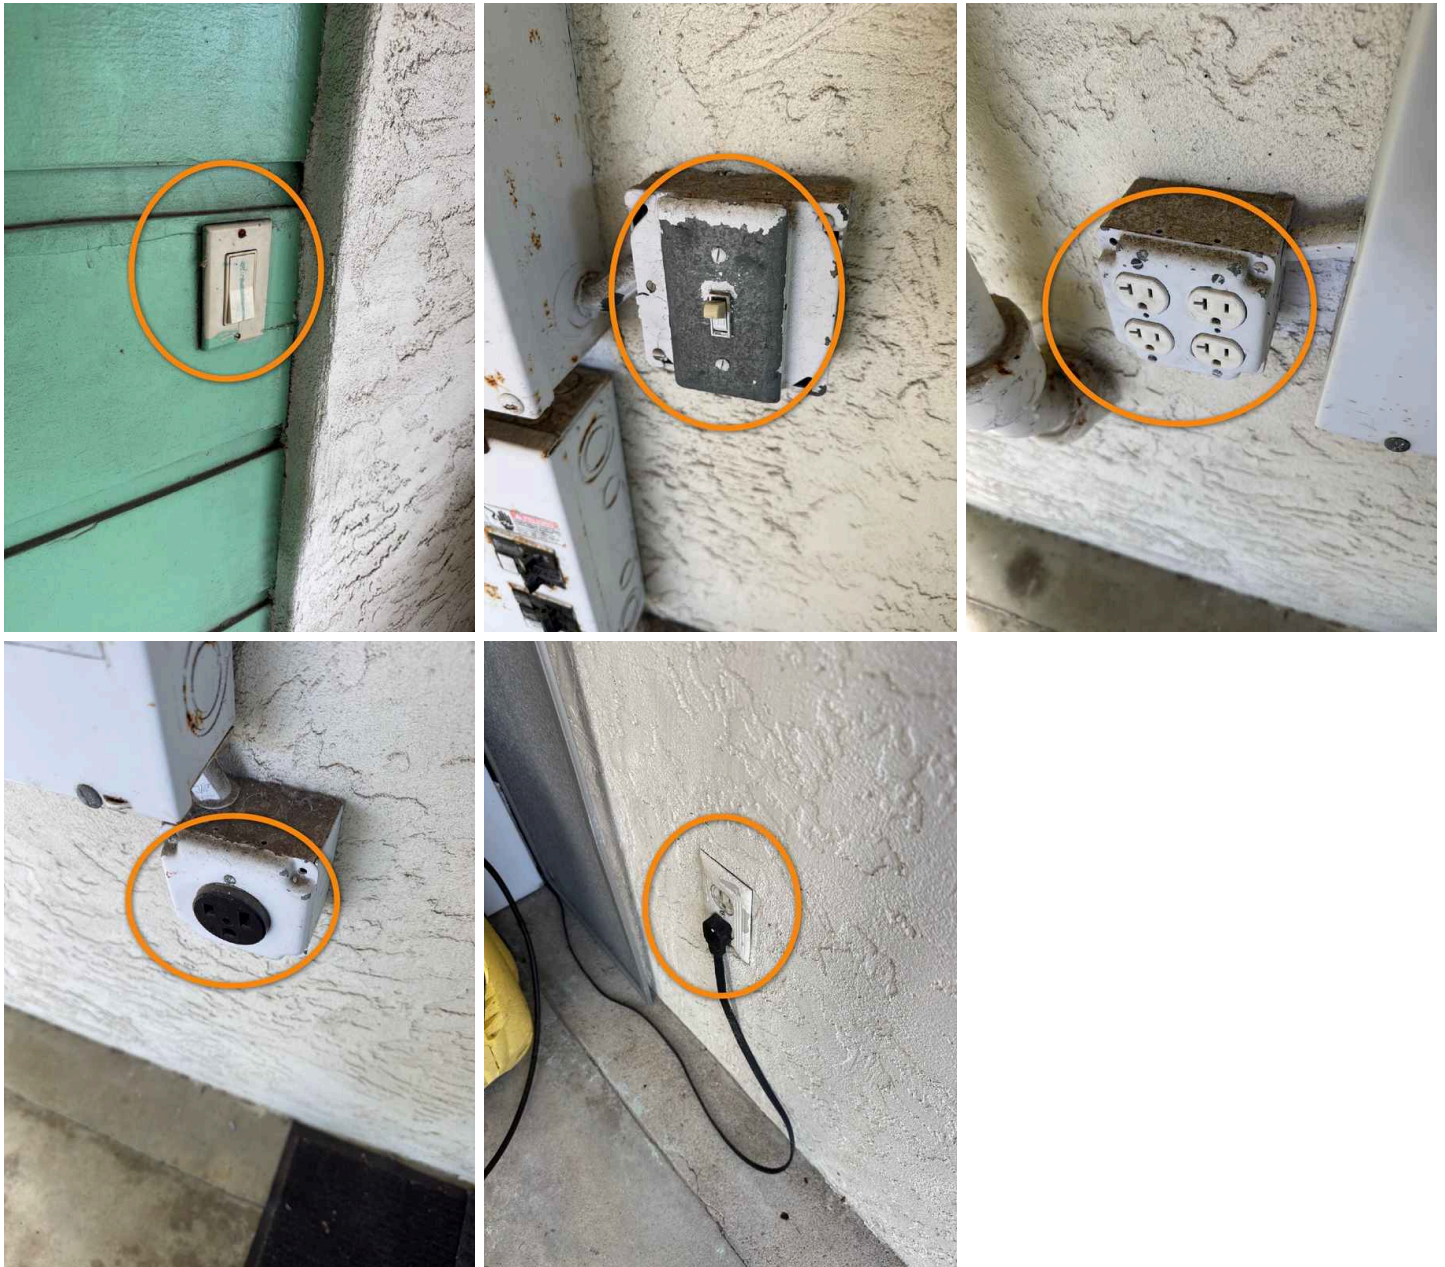
## 9.7.2 Outlets / Switches / Lighting / Fans

**MISSING WEATHER COVER**

Missing weather cover noted at one or more exterior outlets and/or switches. Recommend correcting and advise repair by qualified professional.

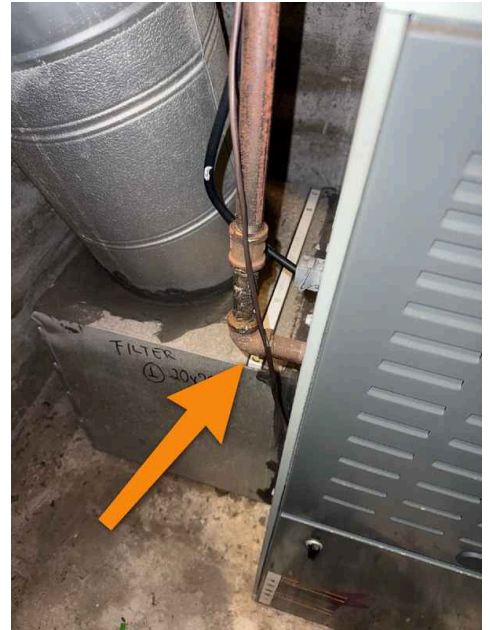
**DRIP LEG ( SEDIMENT TRAP ) MISSING**

The furnace is not equipped with a sediment trap (drip leg). We recommend further evaluation by a licensed HVAC contractor and correction as needed.

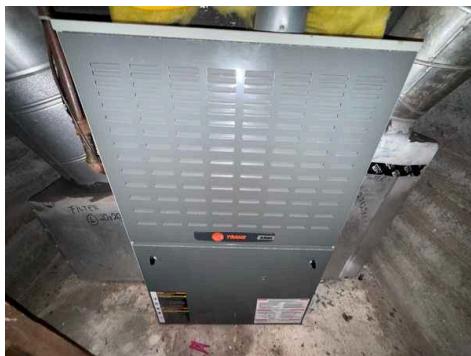
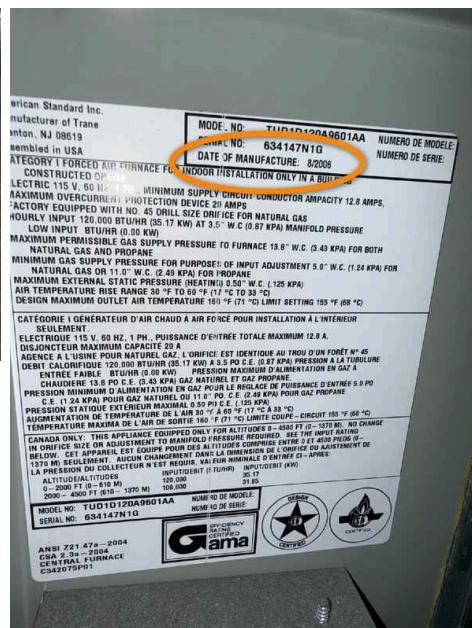
## 10.2.2 Heating (Forced Air)

**NEAR OR AT LIFESPAN (FORCED AIR)**

The estimated useful life for most forced air furnace(s) is typically 15-20 years, but they often exceed this in Southern California's mild climate. This furnace seems to be nearing or past its lifespan, making replacement or major repairs imminent. Consider budgeting for replacement and schedule an evaluation within the contingency period. A home warranty is also advisable.

Recommend monitoring.

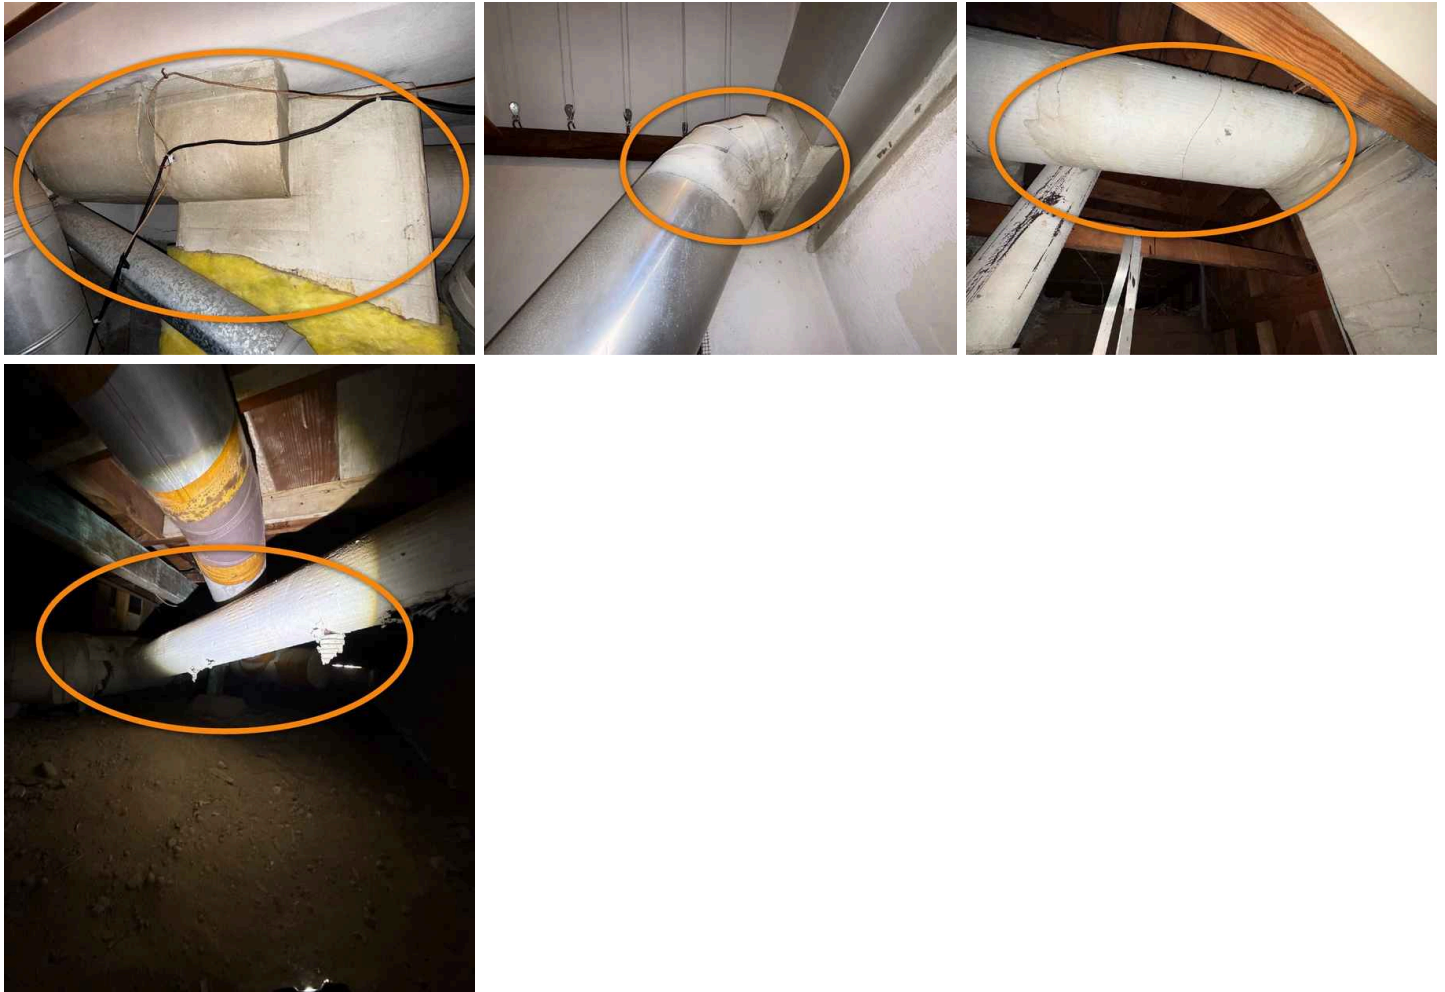
## 10.3.1 Ducts and Registers

**WHITE MATERIAL - POSSIBLE ASBESTOS**

A white material was noted in one or more areas which could contain asbestos. Removal is recommended for added safety.

Contact a qualified environmental contractor

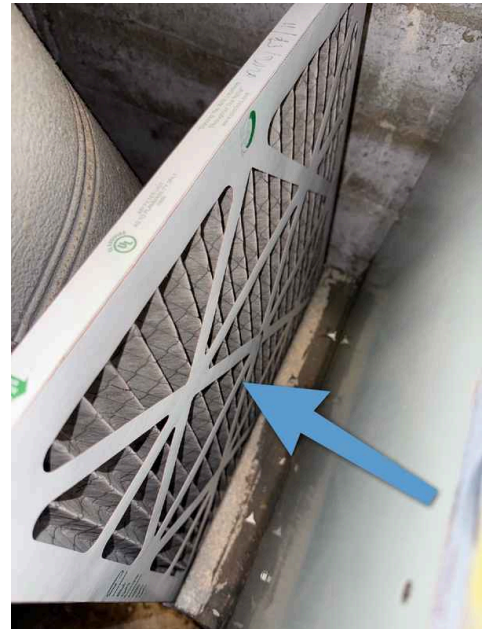
The heating and/or cooling system's air filters were found dirty at one or more locations. To ensure efficiency, they should be cleaned and appropriately sized. Recommend addressing this by cleaning, repairing, or replacing the filters as necessary.

## Recommended DIY Project

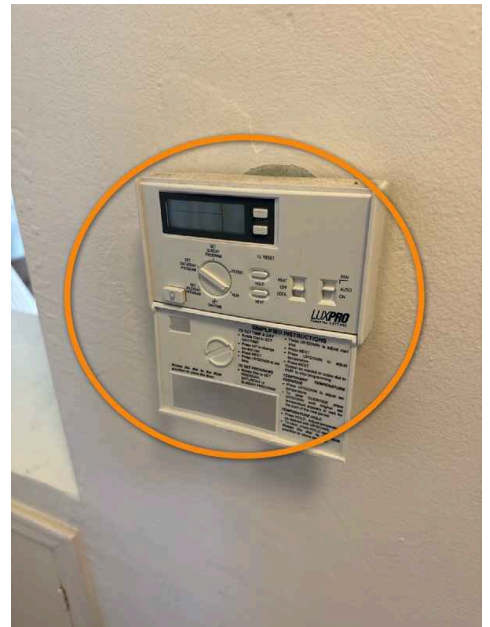
## 10.4.2 Filter(s) &amp; Thermostat(s)

**THERMOSTAT INOPERABLE**

Thermostat was inoperable. Due to this, the HVAC system could not be operated. Recommend further evaluation and repair as necessary by a qualified HVAC contractor.

Contact a qualified HVAC professional.

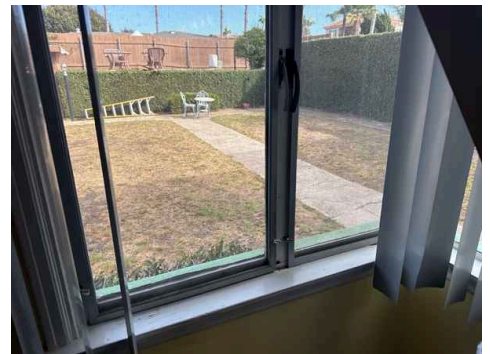
11.4.4 Windows

**CRANK HANDLES MISSING**

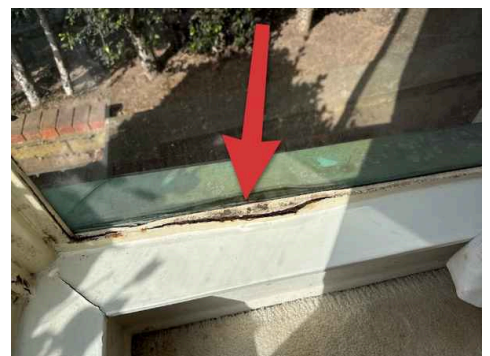
11.4.5 Windows

**MOISTURE INTRUSION NOTED**

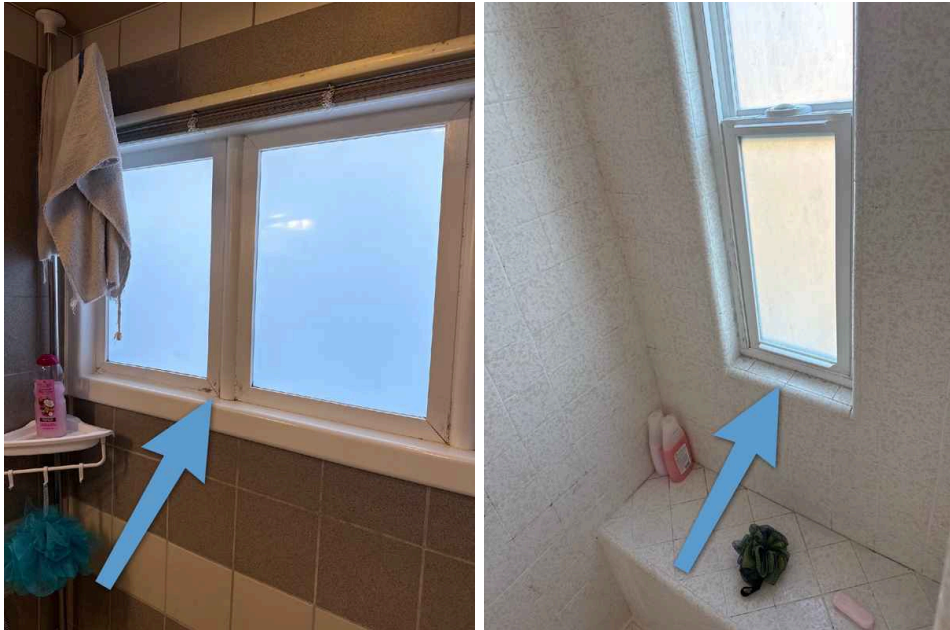
11.4.6 Windows

**WOOD WINDOW(S) IN SHOWER**

Contact a qualified professional.

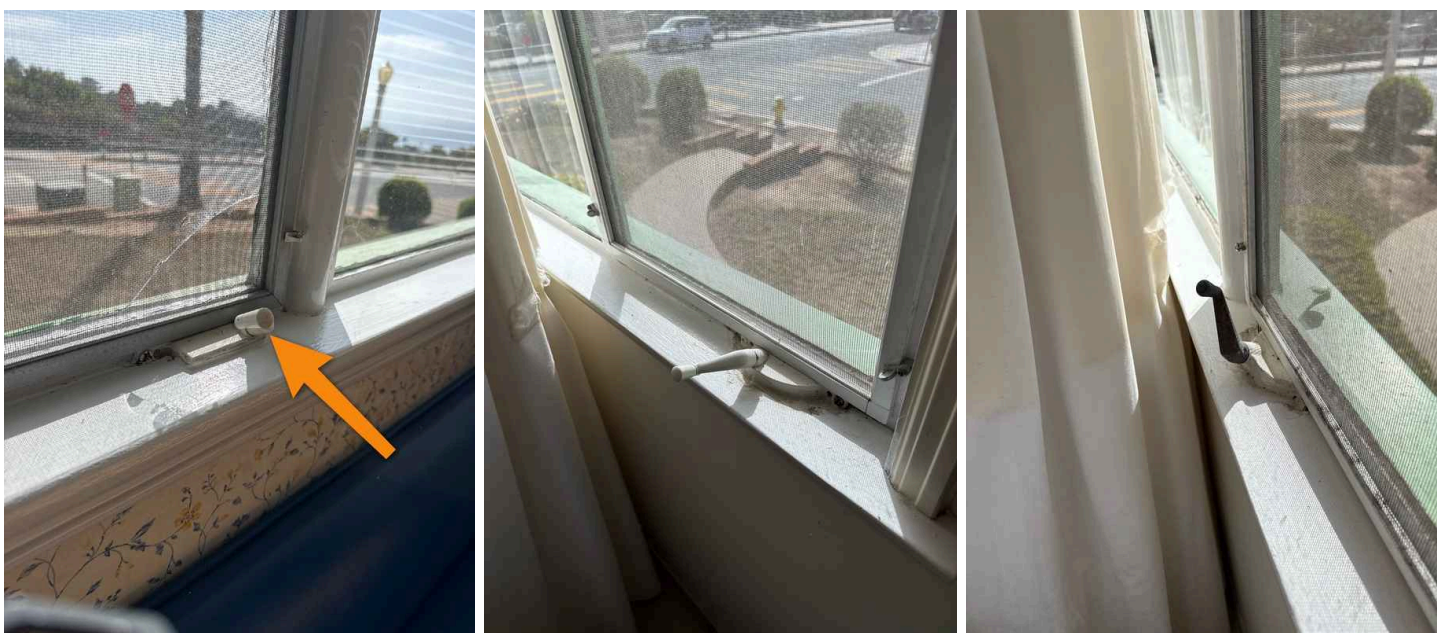
#### 11.4.7 Windows

### **CRANK(S) NOT OPERATIONAL**

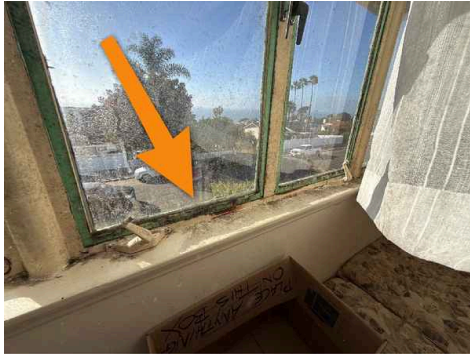
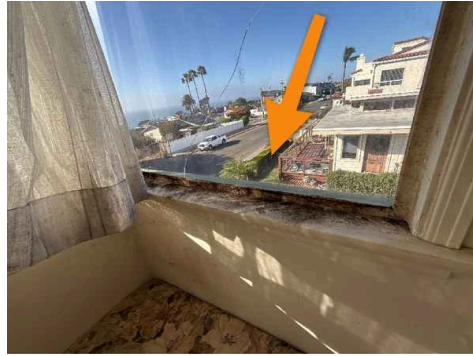
## 11.4.8 Windows

**RUST AT FRAMES**

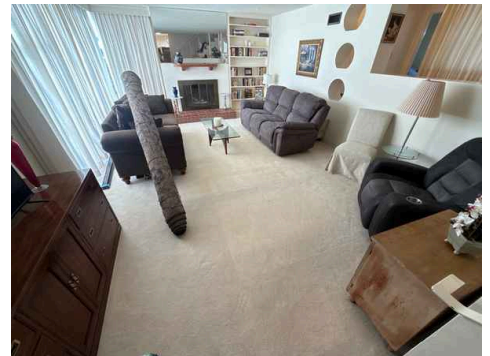
## 11.7.1 Floors

**WORN CARPET**

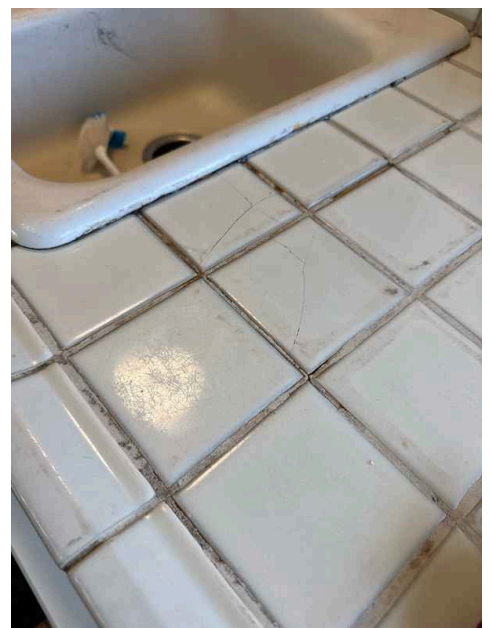
## 11.8.1 Countertops &amp; Cabinets

**CRACK(S) AT COUNTERTOP**

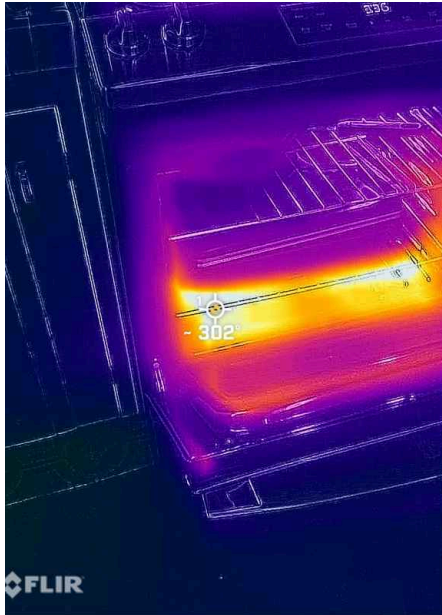
**Range/Oven/Cooktop: Thermal  
Image of Oven Working**

Thermal image of the oven working. This unit appeared functional.

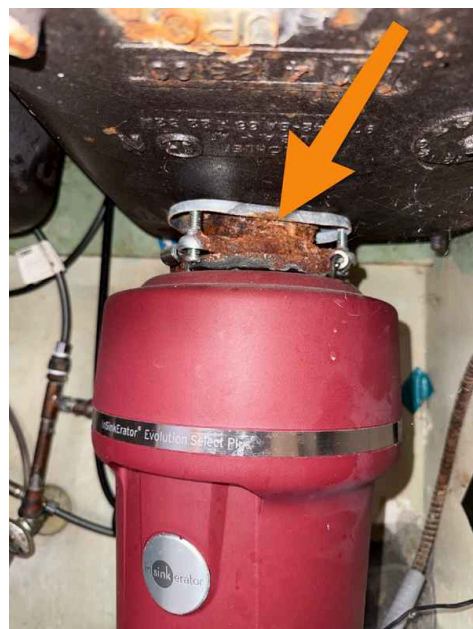
### 12.5.1 Garbage / Food Disposal

#### RUST AT DISPOSAL FLANGE

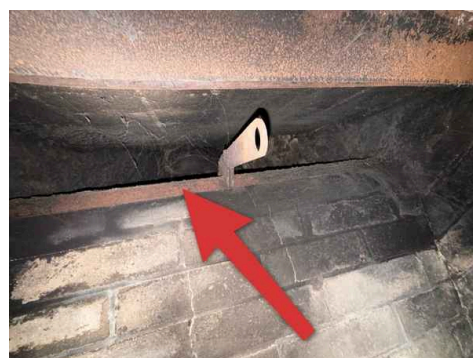
#### **DAMPER CLAMP MISSING**

The fireplace is not equipped with a damper clamp as required by today's safety standards. They are required whenever gas is supplied to a fireplace to prevent the damper from closing completely. We recommend installing a damper clamp as a safety upgrade.

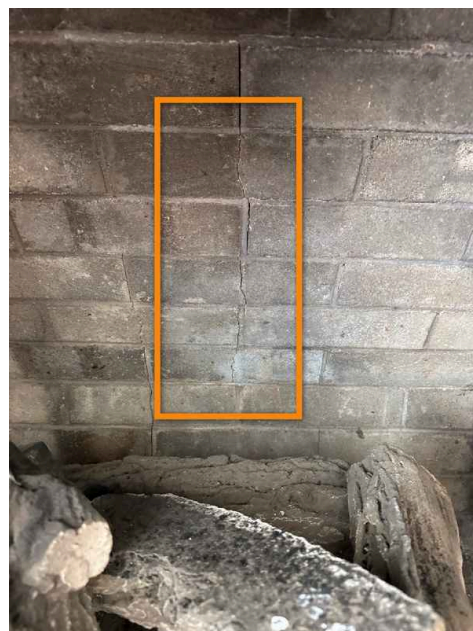
### 13.1.2 Fireplaces, Stoves & Inserts

#### **BRICK / STONE CRACKED / DETERIORATED / MISSING - FIREPLACE FACE**

Brick and/or stone at the face of the fireplace is cracked, deteriorated and/or missing. Recommend repairs be made by a qualified person.

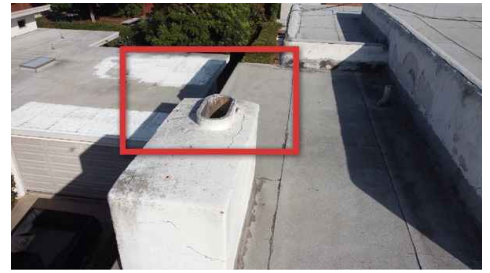
### 13.2.1 Chimney(s)

#### **NO SPARK SCREEN AND/OR RAIN CAP**

To prevent fireplace embers from leaving the chimney, a spark screen or rain cap is needed at one or more chimney flues. A spark screen will also prevent pests and debris from entering the chimney. A rain cap is essential in preventing corrosion, damage and/or rust in the flue and firebox. A qualified professional is recommended to install a spark screen and/or rain cap where needed.

Contact a qualified chimney contractor.

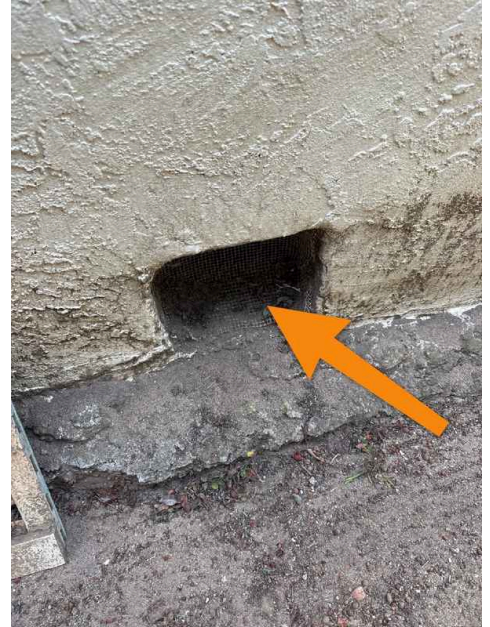
### 13.2.2 Chimney(s)

#### **ASH DUMP DOOR MISSING**

Ash dump door was missing. Correction is recommended.

Contact a qualified fireplace contractor.

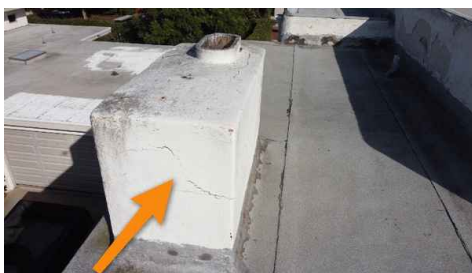
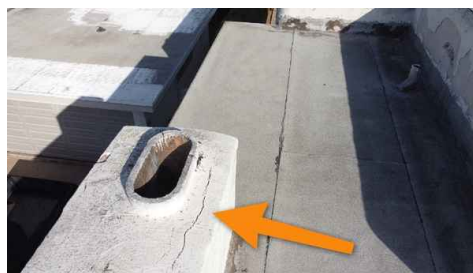
### 13.2.3 Chimney(s)

#### **STUCCO CRACK(S)**

Stucco cracks were present on the chimney. Recommend repair by a qualified contractor.

Contact a qualified professional.

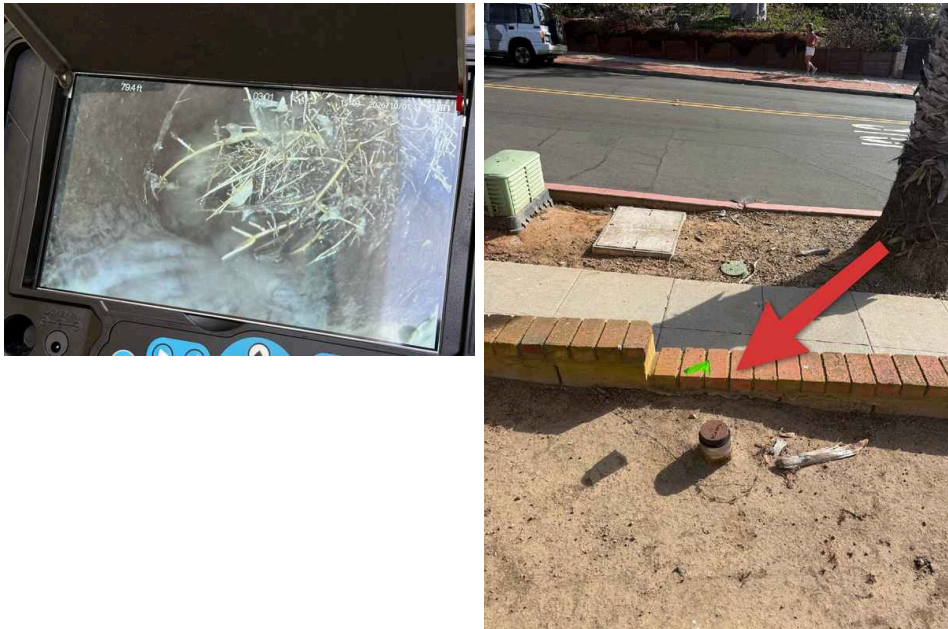
Root intrusion was noted in one or more locations which is commonly the result of a damaged drain line. A qualified plumbing contractor is recommended to evaluate and estimate repairs prior to the end of your contingency period.

Contact a qualified plumbing contractor.
