### *Inspection Report*

Address: 2325 Warm Springs Ln Templeton, CA 93465

10/03/2026

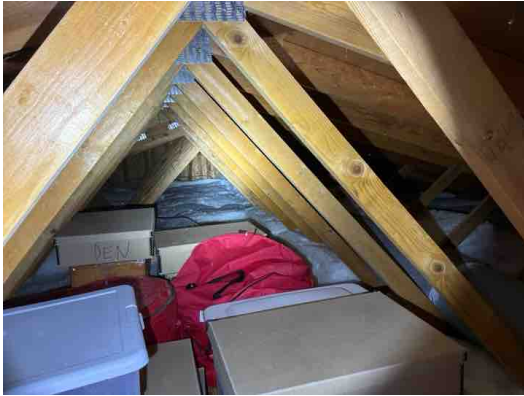
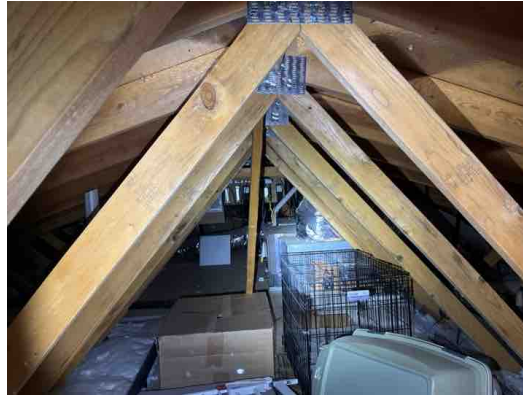
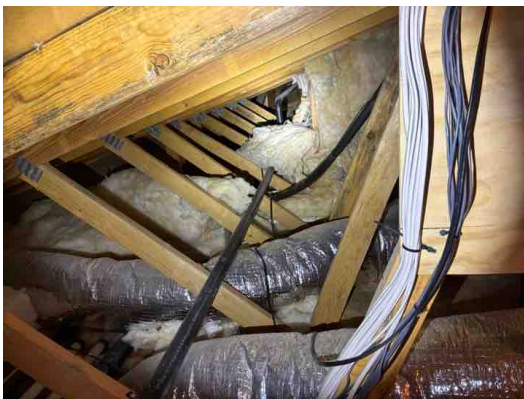
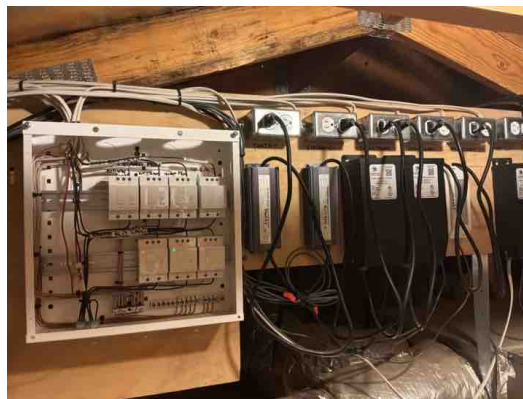
51: **ATTIC ACCESS LOCATION:** Laundry Room, Garage, Primary bedroom closet, and Front entry

52: **VISIBLE ATTIC FRAMING:** No noted framing defects found in the accessible and visible areas of the attic.

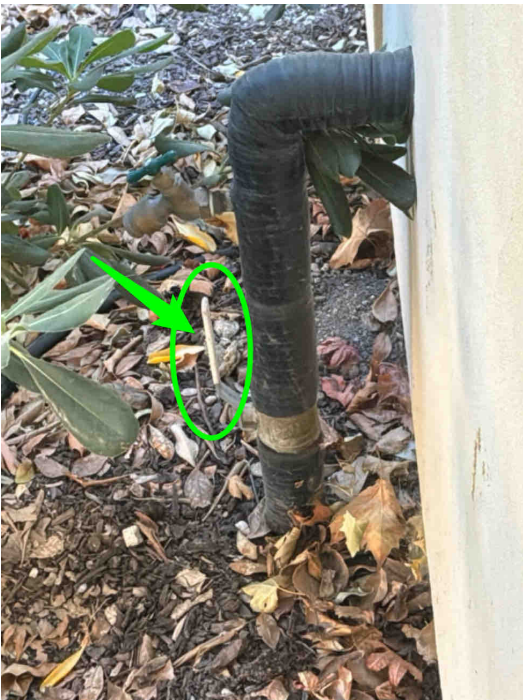
Main water shutoff valve

**Water Pressure** - Is At Approx. 60 +/- PSI. Optimal water pressure is between 40 and 80 PSI.

1. **Pressure Regulator Installed:** NO
2. **An Automatic Leak Detection Device installed on the main water supply:** NO.
