## Inspection Services

### *Inspection Report*

Address: 90 Villa Ct Pismo Beach, CA 93449

07/23/2026

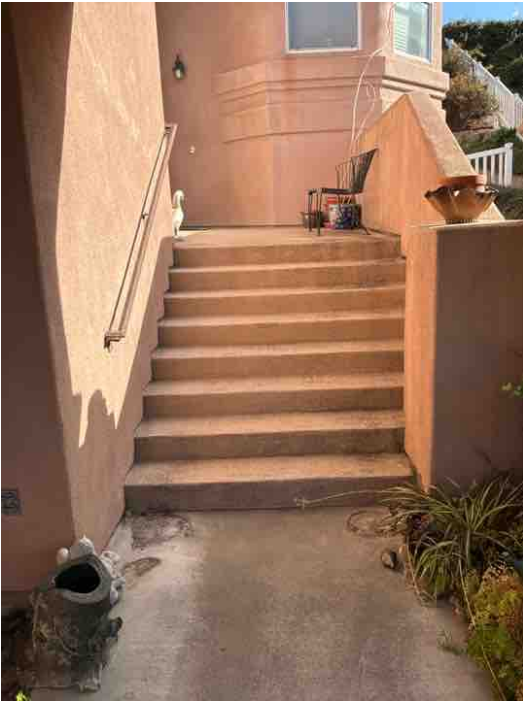
**36: Type & Location:** Wood Framed Exterior Waterproofed Stairway: OFF THE FRONT ENTRY

**E&C 37:** Moisture-type damage & deterioration found at areas of the exterior wood frame framed waterproof stairway: OFF THE FRONT ENTRY. Suspected leaking of the waterproofing. Recommend additional review by a licensed waterproof decking contractor. Refer to the Termite report for additional details and recommendations.

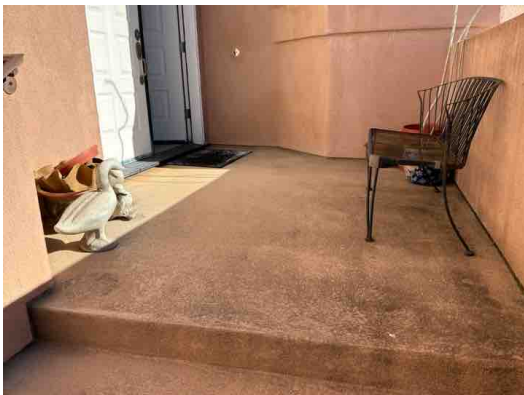
42: DECK LOCATION: **FRONT ENTRY WATERPROOF DECK**

**FI 43:** **WATERPROOF DECK COATING CONDITION:** The FRONT ENTRY waterproof deck appears to be nearing or at the end of its useful life. Visible water stains and damage at the wood framing on the underside of the decking.

Recommend review a replacement by qualified waterproof decking contractor.

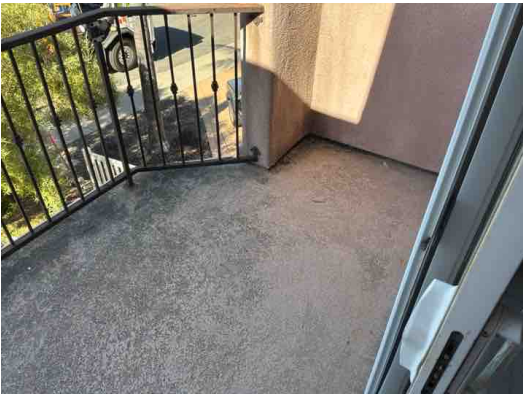
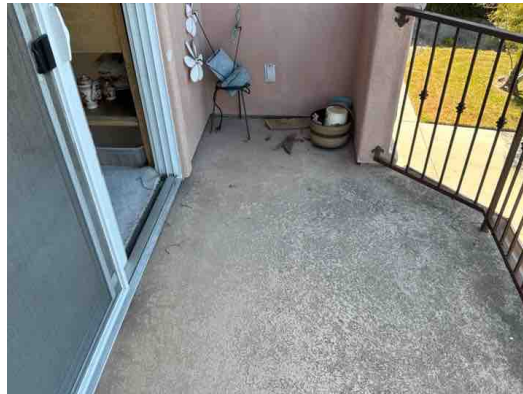
46: DECK LOCATION: **WATERPROOF DECK OFF THE DINING ROOM**

**FI 47:** **WATERPROOF DECK COATING CONDITION:** The WATERPROOF DECK OFF THE DINING ROOM appears to be at the end of its useful life, with some visible damage.

Recommend review a replacement by qualified waterproof decking contractor.

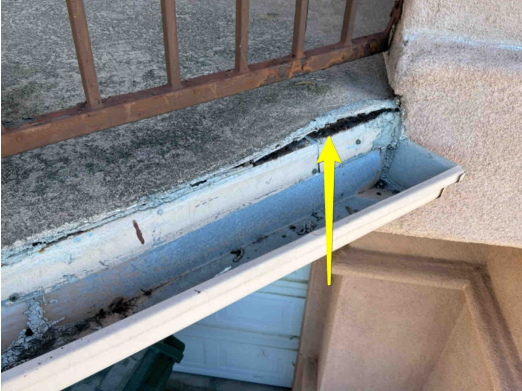
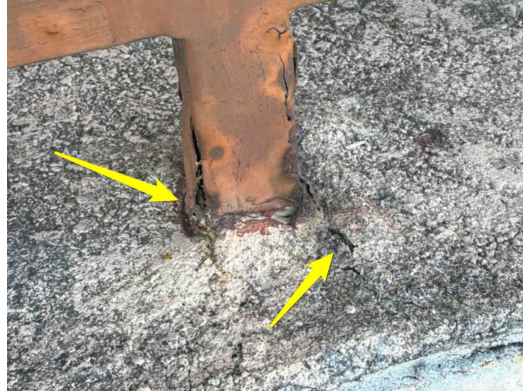
**E&C 48:** Some rust deterioration and/or damage noted at areas of the metal railings at the WATERPROOF DECK OFF THE DINING ROOM. Maintenance repair or upgrades are recommended for safety.

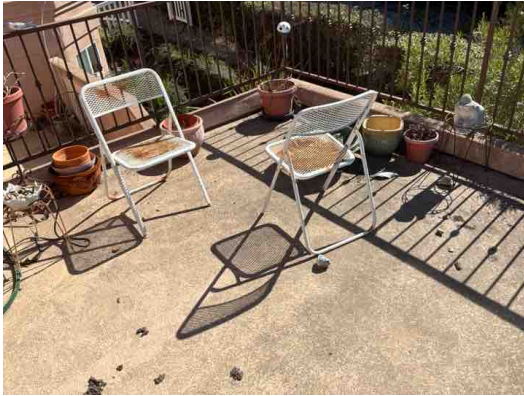
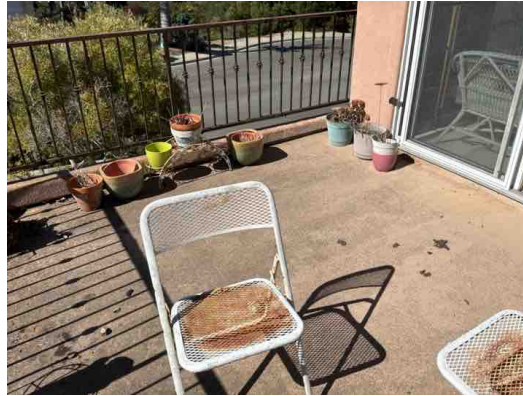
49: DECK LOCATION: **WATERPROOF DECK OFF THE FAMILY ROOM**

**FI 50:** **WATERPROOF DECK COATING CONDITION:** The **WATERPROOF DECK OFF THE FAMILY ROOM** appears to be at the end of its useful life, with visible damage at the waterproofing with suspected leaking and damage at the structural framing.

Recommend review a replacement by qualified waterproof decking contractor.

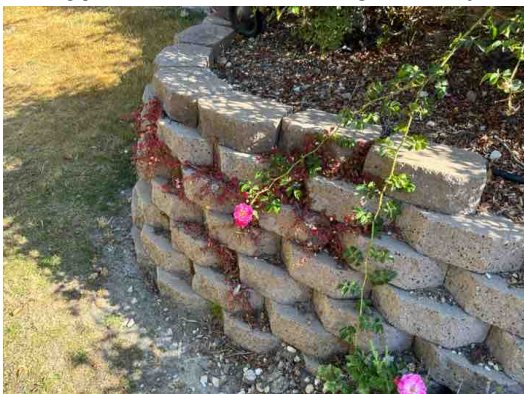
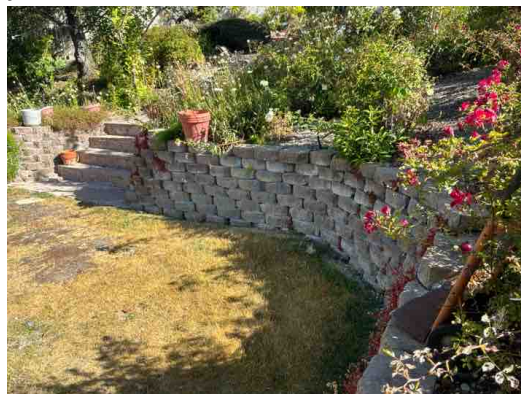
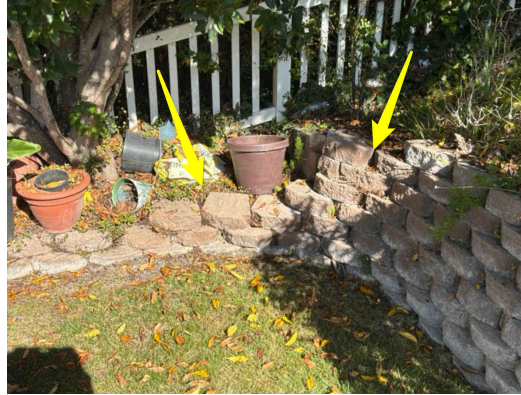
**FI 58:** Areas of some unusual leaning visible at areas of the stacked interlocking retaining wall system at the BACKYARD. This is indicative of a failure and/or an improper installation of the interlocking system. Client is advised to contact a qualified Civil engineer and/or a qualified contractor to evaluate the current condition and make appropriate corrections as needed.

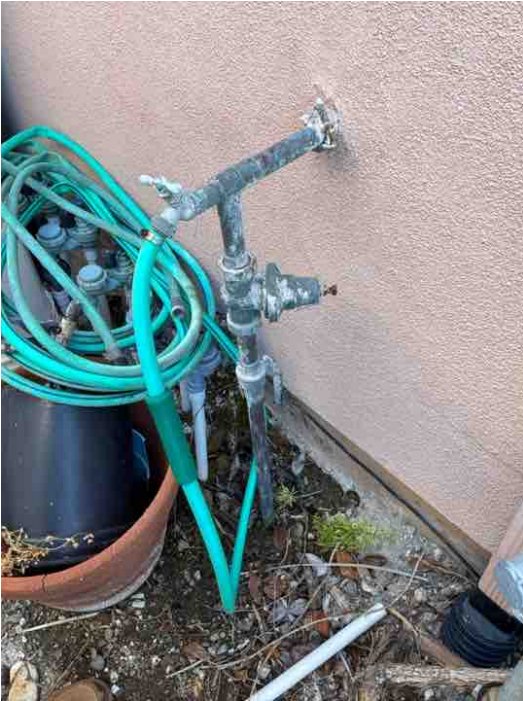
**Water Pressure -** *Is At Approx. +100 +/- PSI. Optimal water pressure is between 40 and 80 PSI.*

**E&C 81: Excessive water pressure** (above the maximum of 80-psi, **currently at: +100 +/-psi** ). Recommend the adjustment or repair of the pressure regulator.

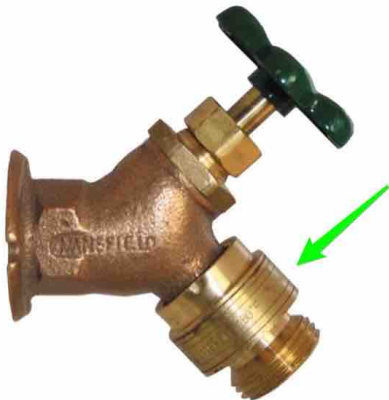
**UPG 87:** Anti-siphon valves recommended on exterior hose faucets where not installed.

Example of an anti-siphon valve on a hose faucet

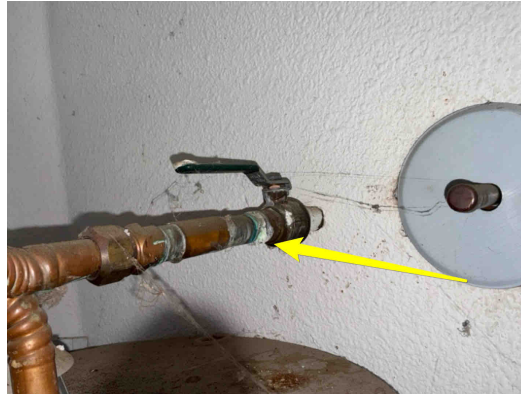
**E&C 105:** Evidence of past leaking with corrosion at the COLD water supply shut-off valve at the water heater. Recommend corrections by a licensed plumber.

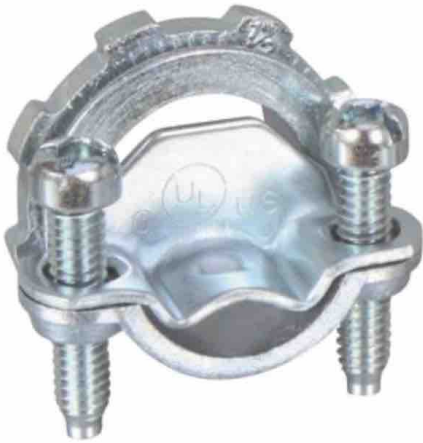
**SC 116:** Missing a proper electrical wire-bushing clamp at bottom of kitchen sink disposal.

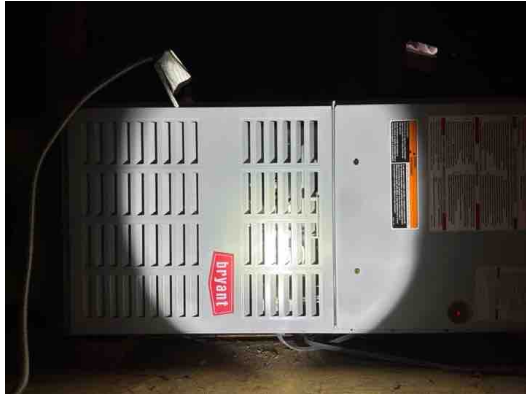
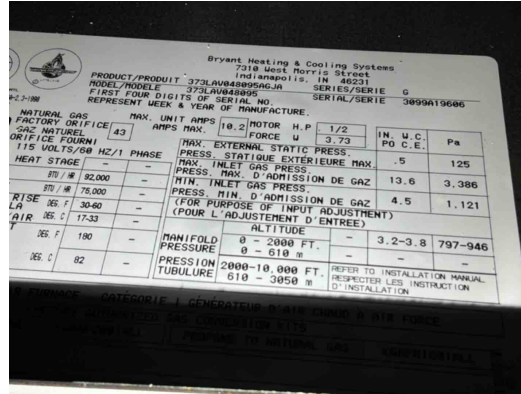
DATE: **1999** The average life of this type of furnace is +/- 30-35 years. This furnace is approximately 27 years old .

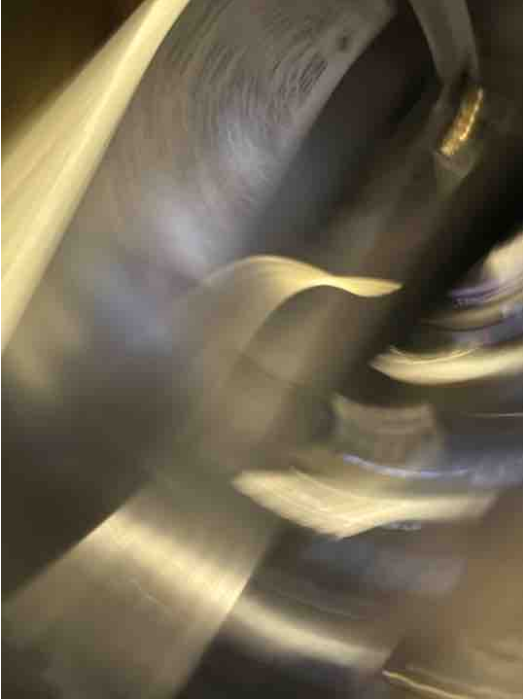
**182:** The visible areas of the furnace vent piping appears serviceable. *However, the furnace vent pipe is not fully visible.*

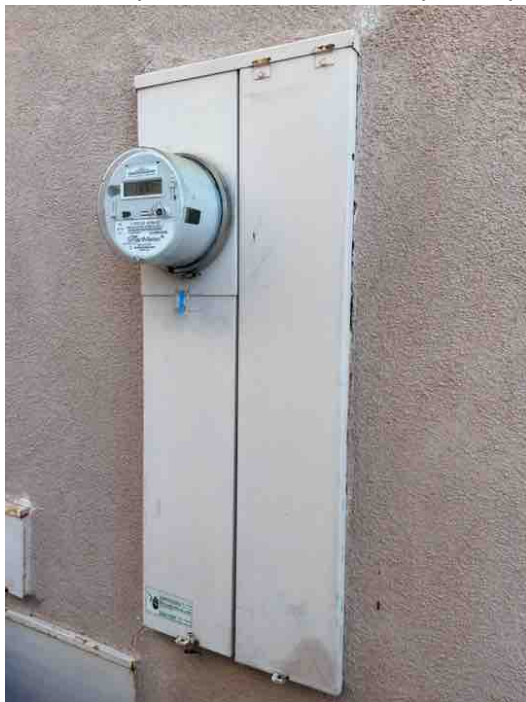
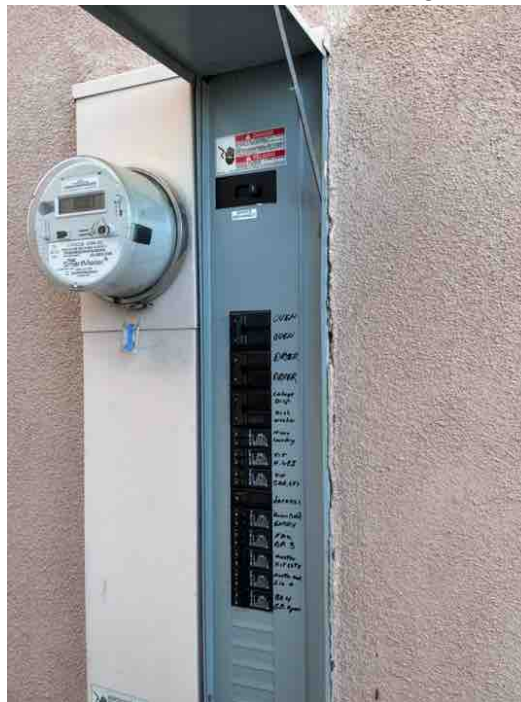
**SU 191:** Recommend the installation of GFCI and AFCI outlet protection, Vacancy Sensors and Humidistat switches in all locations as a safety upgrade per California current standards.

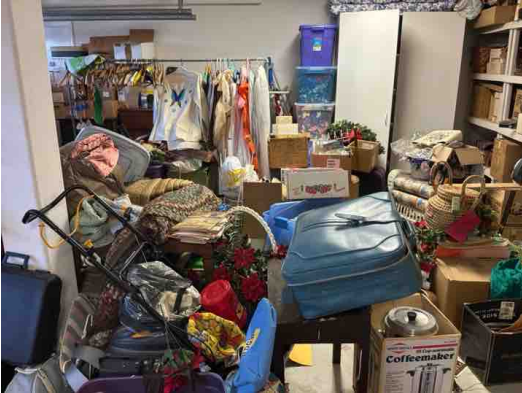
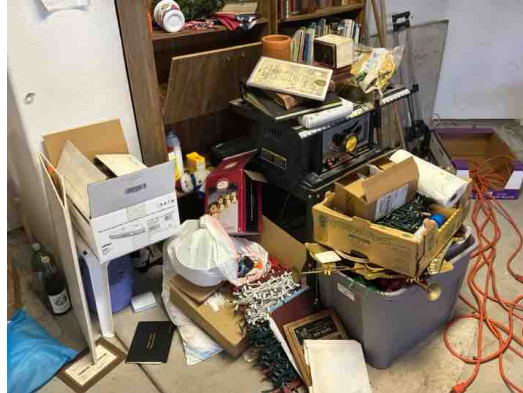
**DS 199:** Due to an excessive amount of stored items and/or cabinetry in the garage, the majority of the garage walls and/or floor, is not accessible, not visible, nor inspected. A re-inspection is recommended once access is made available.

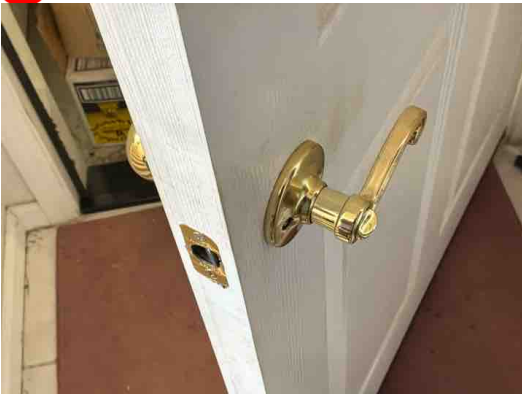
**E&C 203:** The Door knob found down operation of the garage fire door to the living space.

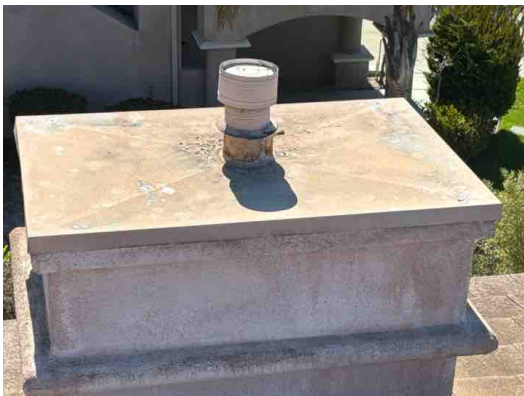
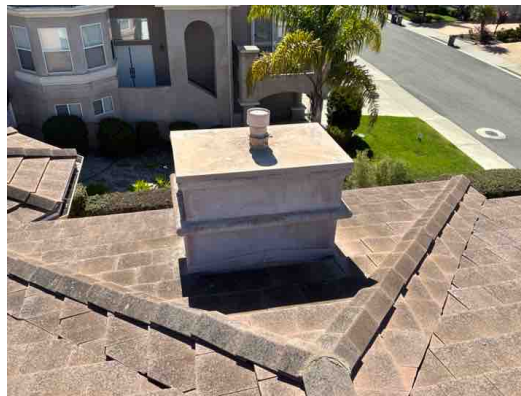
215: The FAMILY ROOM fireplace metal chimney pipe and cap above the roof appear serviceable and in good condition.
