# HOME INSPECTION REPORT

**5343 Caminito Mindy, San Diego, CA 92105**

**Report Number:** 2026010925KM

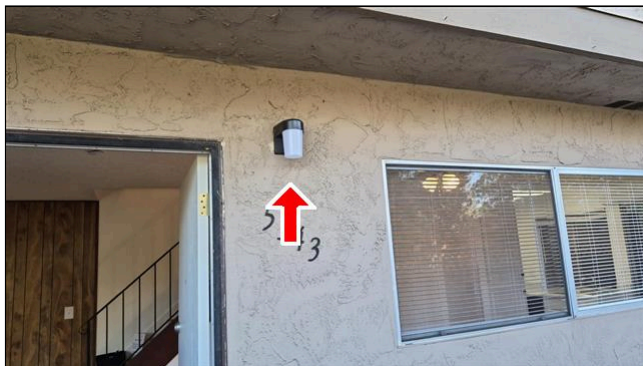
4.5 Item 1 (Picture)

(1) Light fixtures throughout the home are installed on the bathroom GFCI outlet circuits. Suggest further review by a qualified electrician to isolate GFCI circuits from the interior lighting.

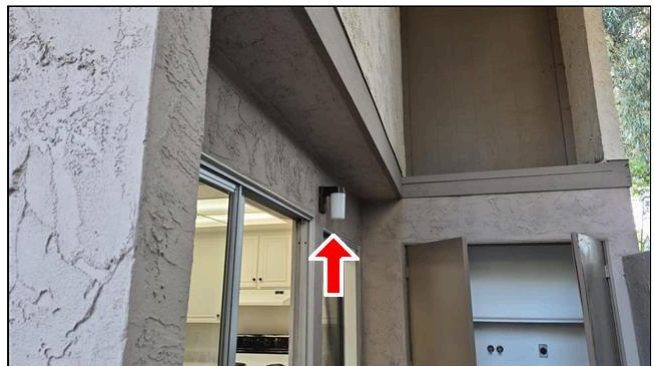
4.5 Item 2 (Picture)

(2) Light fixtures did not respond to test or bulbs are out at front/right exterior (these lights may be operating on timer/sensor equipment). Suggest correcting/verifying.

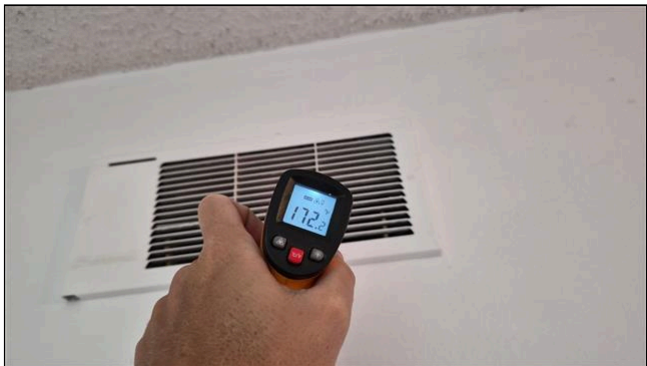
7.0 Item 1 (Picture)

(1) Units were tested using normal operating controls and provided heat at the service registers. Servicing and regular maintenance of the components is necessary to prolong the service life of the system.

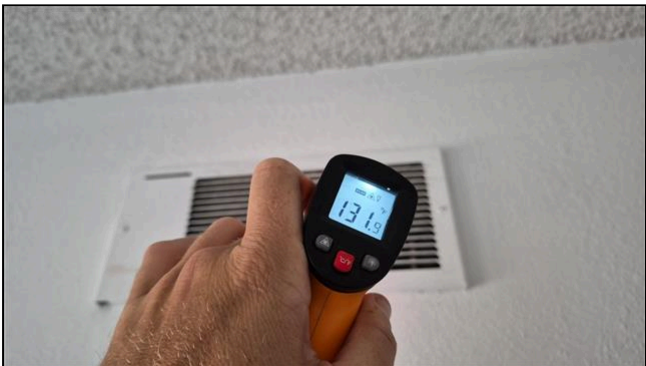
7.0 Item 2 (Picture)

(2) Electric heater coils are covered in dust/debris. Recommend maintenance.

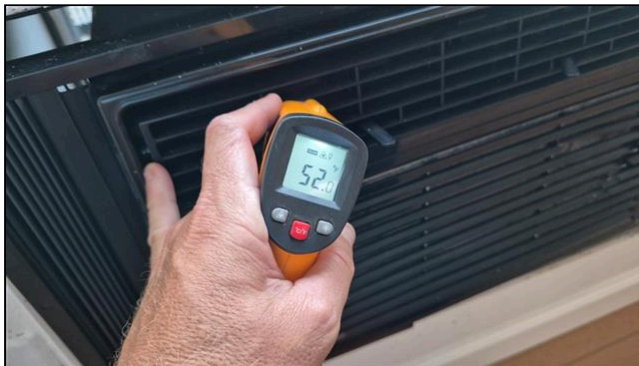
7.1 Item 1 (Picture)

(1) Window/wall cooling unit was operable at the time of inspection. Our inspection was limited to testing the basic operation of cooling and/or heating settings.

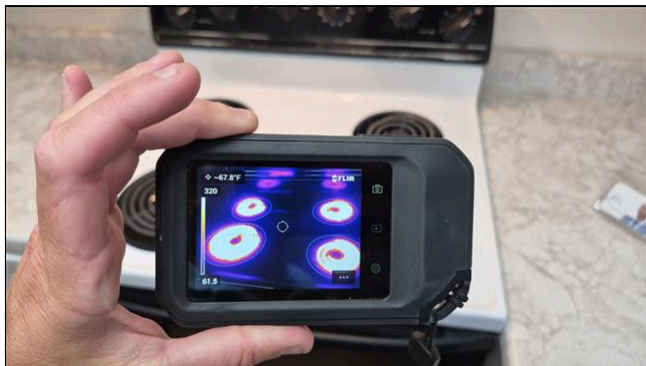
8.4 Item 1 (Picture)

A visual observation and basic function testing of the appliances was performed and run in normal modes only. The client is advised to verify condition of all modes and functions, prior to the end of the contingency period.

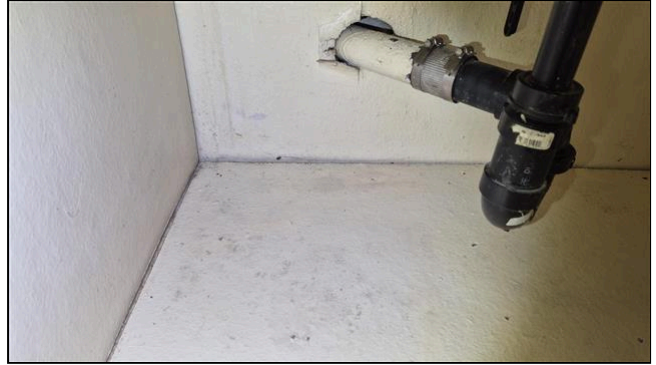
9.4 Item 2 (Picture)

(1) Moisture damage observed at bathroom vanities. Moisture/leaking was not detected at time of inspection. Suggest repair/replacement of moisture damaged components.

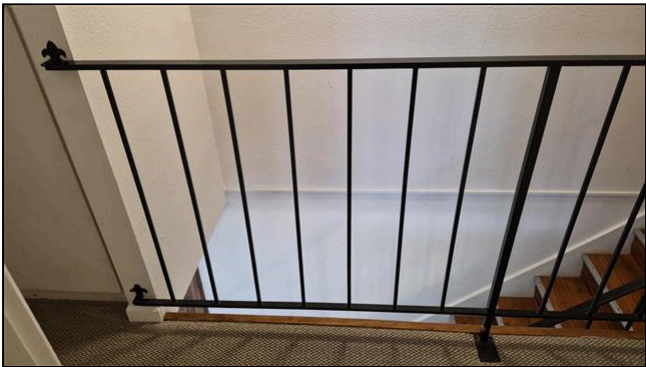
9.5 Item 2 (Picture)

The baluster spacing is wider than current standards recommend (4") at the 2nd level and stair railings - safety concern. Recommend correcting.
