### *Inspection Report*

Address: 43 Buena Vista Ave San Luis Obispo, CA 93405

10/05/2026

Inspector: Taylor Vreeken, CCI

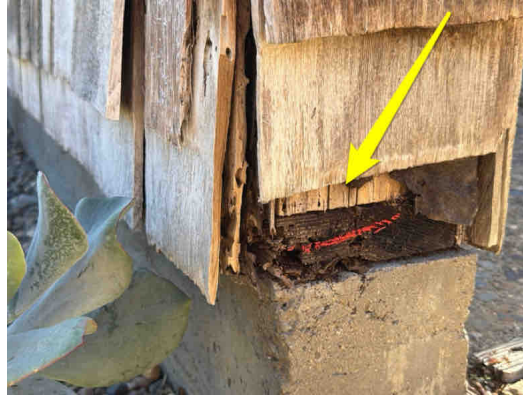
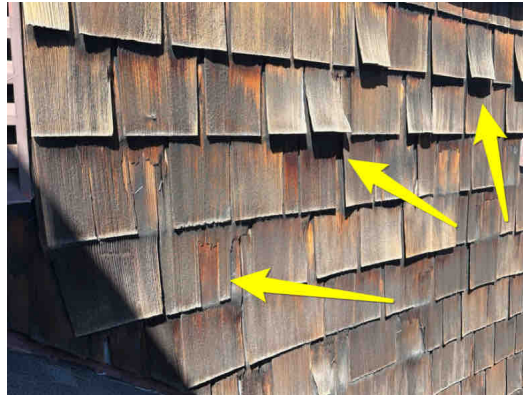
**E&C** **FI** **28:** Exterior wood shingle siding found heavily weathering/ deteriorated, with multiple areas of damage/deterioration. Too many individual defects and locations to list. Referred to termite report. Contact a qualified professional evaluation and repairs/replacement.

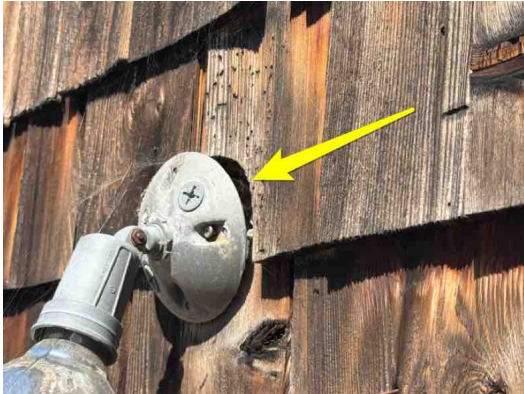
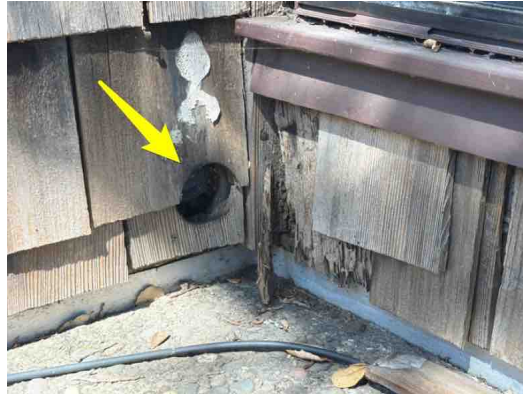
**MR 29:** Recommend sealing holes in exterior walls to prevent water intrusion around areas such as unused open holes in the exterior siding and trim, exterior light fixtures, around exterior electrical boxes and covers, and where utility pipes and/or wires pass through the exterior walls. Have a qualified painter or licensed professional evaluate the entire exterior and seal openings where needed.

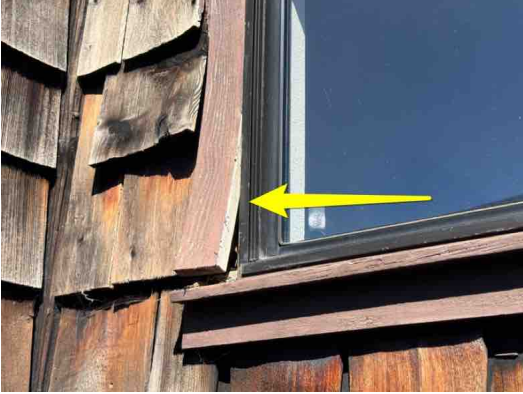
**E&C** **FI** **33:** Some loose, damaged or missing trim noted at some areas of the exterior. Contact an appropriate professional to correct all areas of the exterior as needed.

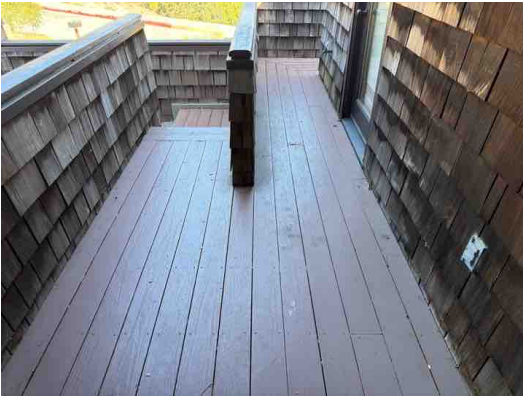
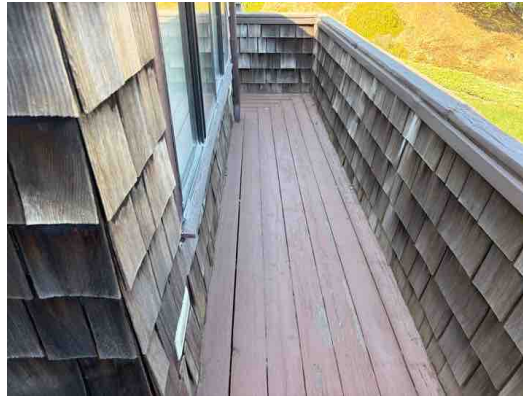
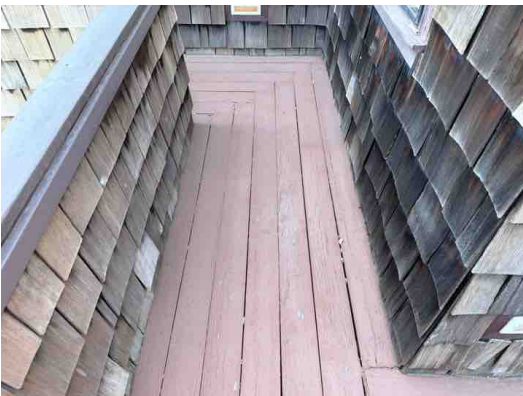
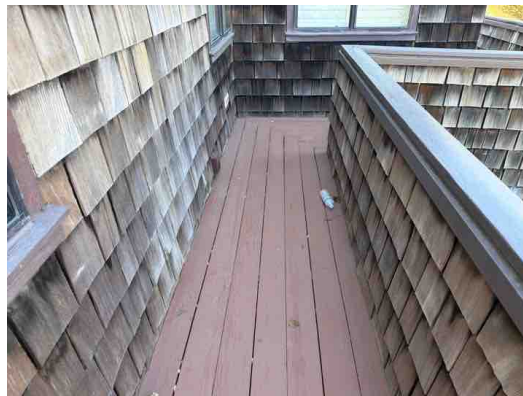
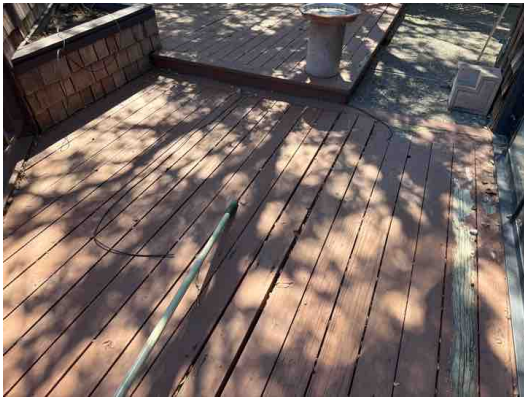
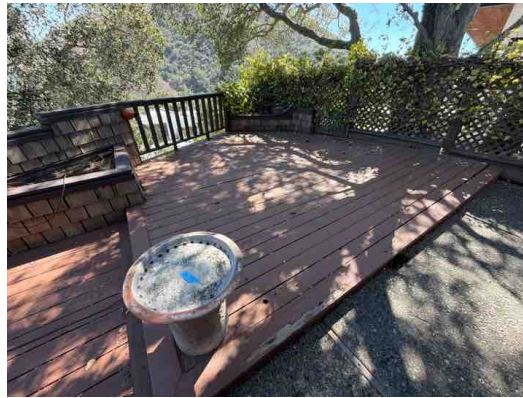
**E&C SC FI 35:** The NORTHWEST, NORTH, AND NORTH EAST WOOD DECKS have moderate to heavy moisture damage, structural settlement, and appear to be at the end of serviceable life. Too many individual defects and locations to list. Contact a qualified contractor for evaluation and repairs or replacement.

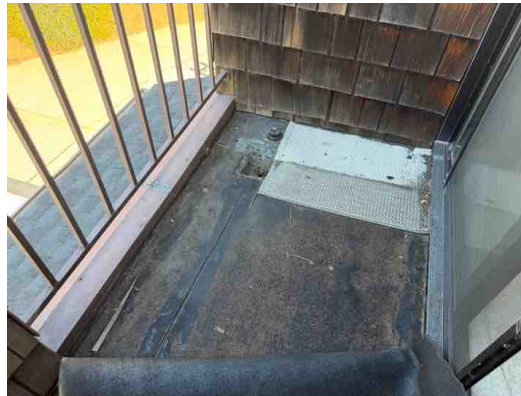
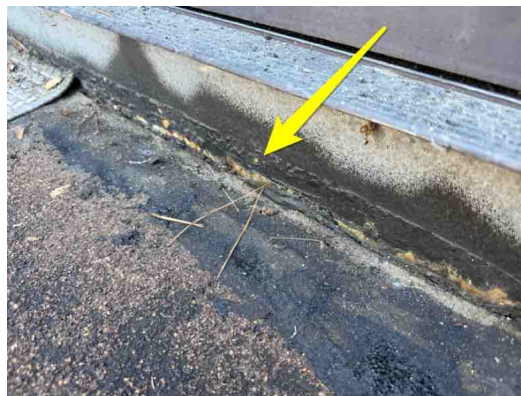
**E&C SC FI 36:** Both waterproof deck assemblies are heavily deteriorated and exhibit numerous defects, including cracked, separated, patched, and deteriorated waterproofing materials; areas of exposed/damaged underlying decking; deteriorated or improper perimeter/transition flashing; debris accumulation; and improper or deteriorated drainage components. Drain covers are missing, and a secondary/overflow drain at one deck is capped/covered. Evidence of moisture staining was also observed below portions of the decks. Due to the extent of deterioration and numerous defects, the waterproof integrity of these assemblies is considered compromised, and concealed moisture damage may be present that is not visible during a non-invasive inspection. Recommend comprehensive evaluation and repair/replacement as necessary by a qualified waterproof-deck/roofing contractor, including evaluation of the underlying sheathing/framing for moisture-related damage.

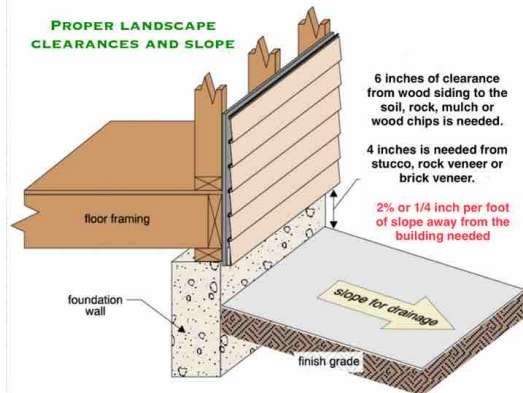
**MR UPG 38:** Evidence of ponding water was observed in areas of the property at and/or near the home in some planter areas. Recommend improving site drainage and landscape grading and/or adding proper underground drainage as needed to help direct water away from the structure and off the property.

**MR 39:** Areas of insufficient slope of the soil away from the building along some areas of the perimeter foundation. A proper slope of the soil, patios and walkways should allow for water to flow freely away from the building, not allow water to flow against areas the foundation edges and water should not allow for ponding of water in areas near or at the foundation as this can cause erosion and/or settling of the foundation system.

**MR 40:** Soil level found high along areas of the perimeter of the foundation and exterior siding (recommend 6 inches from the bottom of the exterior siding to dirt, rock, mulch or wood chips).

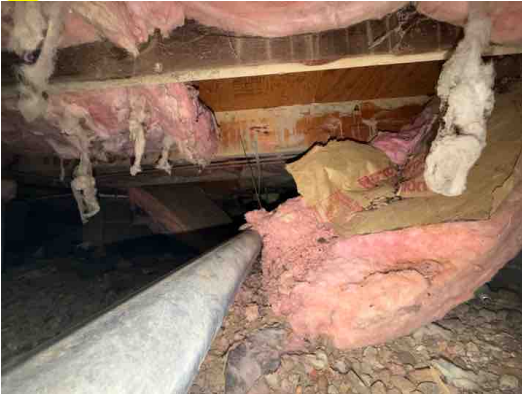
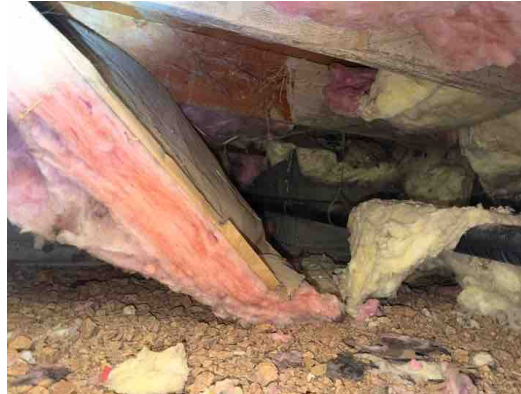
**MR 49:** Some loose, hanging or missing insulation in areas of the crawlspace.

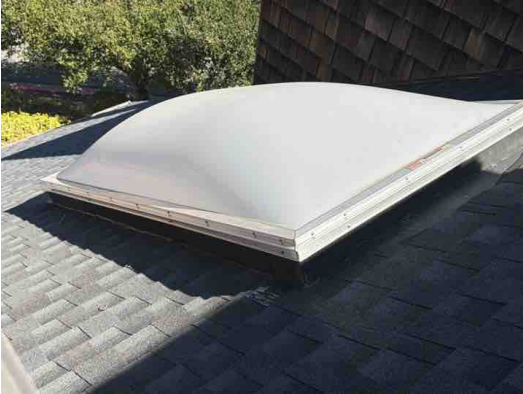
**MR 63:** The lower Skylight appears to be in good physical condition - *Skylights are not water tested, visual inspection only.*

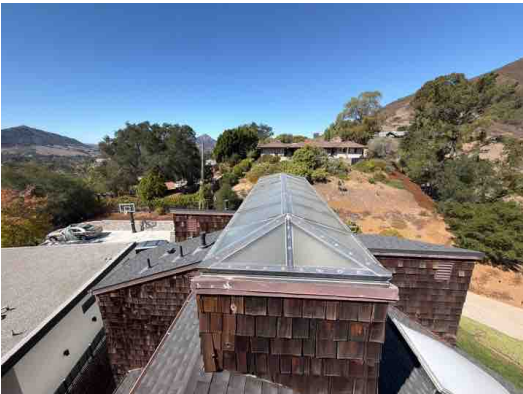
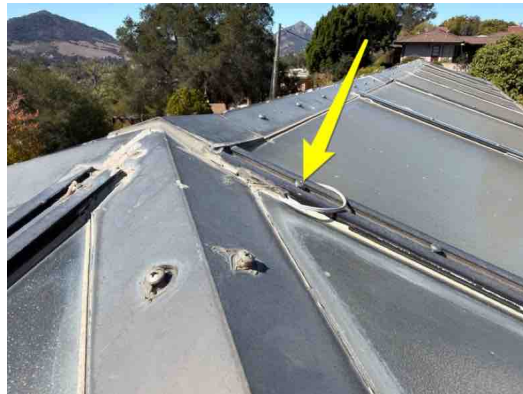
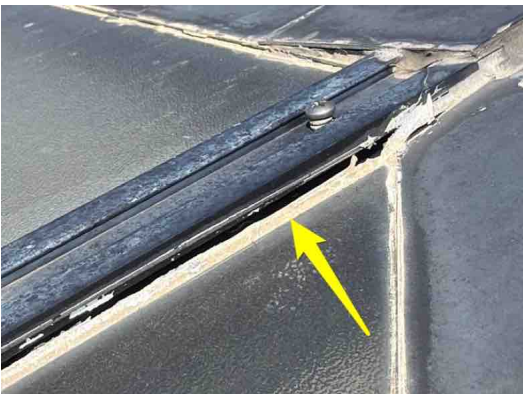
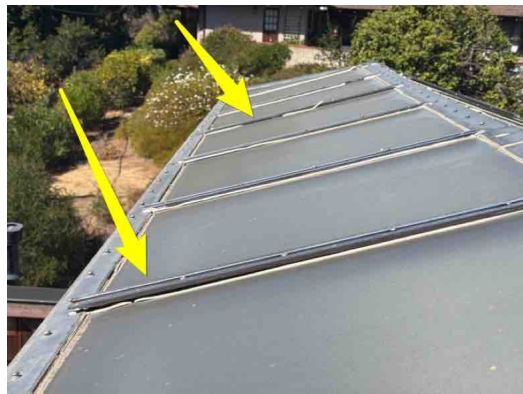
**E&C 64:** The large upper roof field-installed/custom skylight shows widespread deterioration and deferred maintenance, including deteriorated/missing sealant, separation and lifting at glazing/metal components, and numerous loose/backing-out fasteners. These conditions may compromise the skylight's weather resistance and increase the potential for water intrusion. Due to the custom construction and numerous areas requiring attention, recommend comprehensive evaluation, servicing, and repair by a qualified roofing/skylight contractor familiar with custom glazing systems.

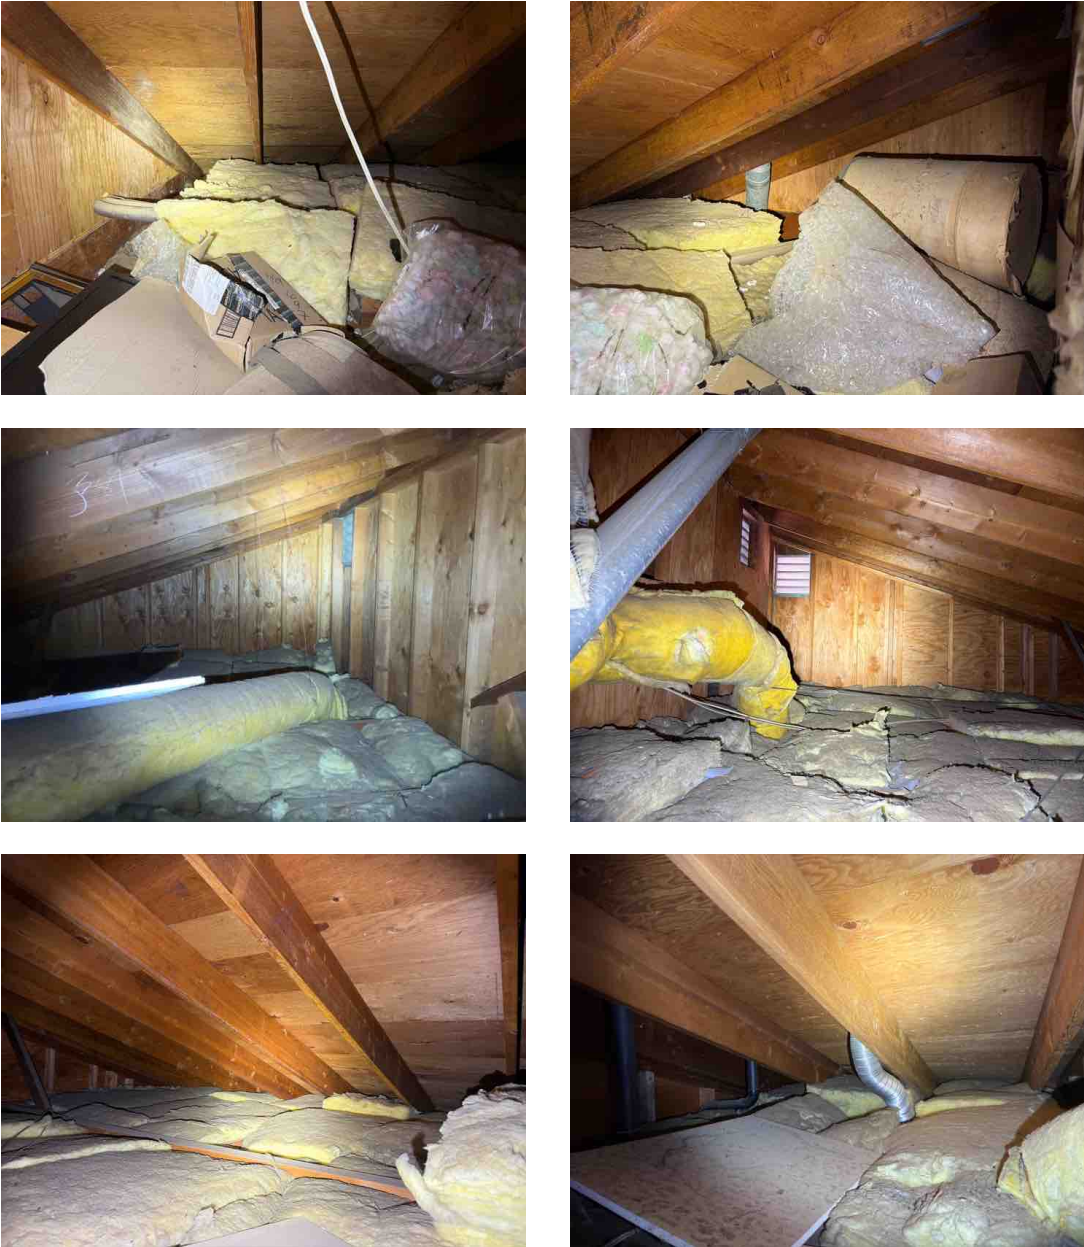
## 72: Attic Photographs

**SU** **DS** **71:** The current attic framing is older and does not meet current structural or seismic standards; however, it appears to be in generally serviceable condition at the time of inspection for its age.

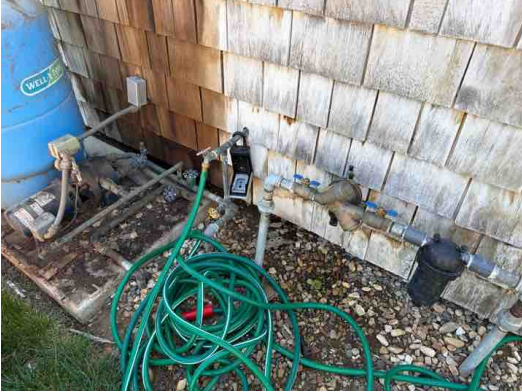
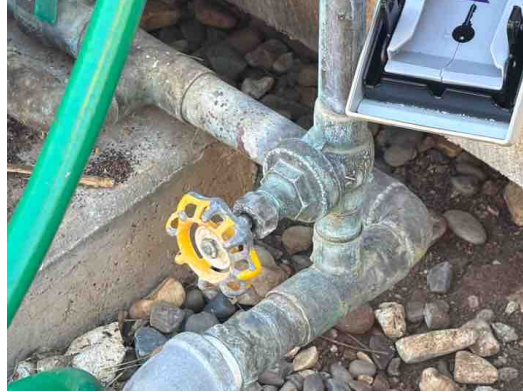
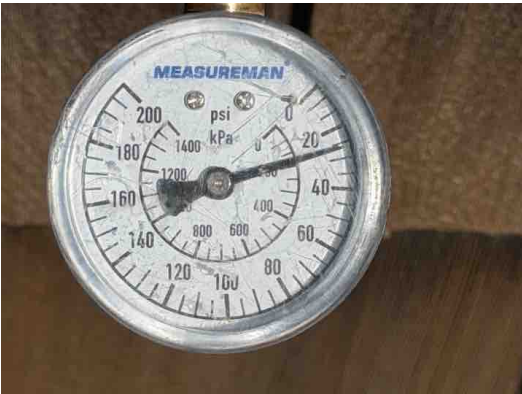
**E&C 76:** The water booster pump system does not appear to be operational. Recommend further evaluation by a licensed plumbing contractor familiar with booster systems.

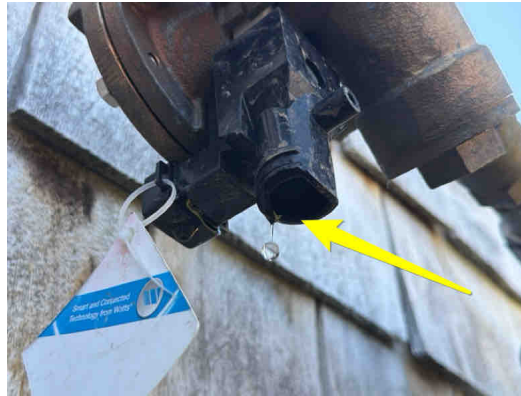
**E&C 82:** Active water leak found at NORTH EXTERIOR BACKFLOW PREVENTER DEVICE. Recommend further evaluation and repairs by qualified plumbing professional.

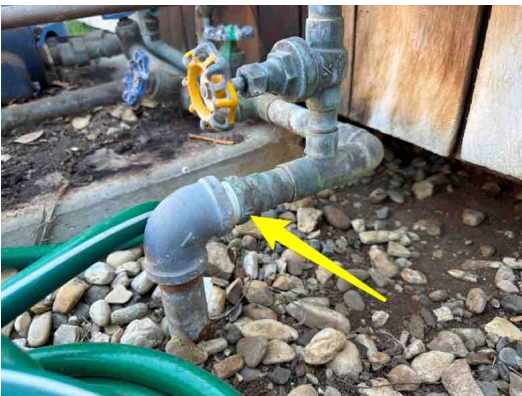
**E&C 83:** An improper copper to galvanized pipe cross connection: north exterior by the booster pump This can cause electrolysis and damage the piping. Recommend repairs by a certified or licensed plumbing professional familiar with minimum standards.

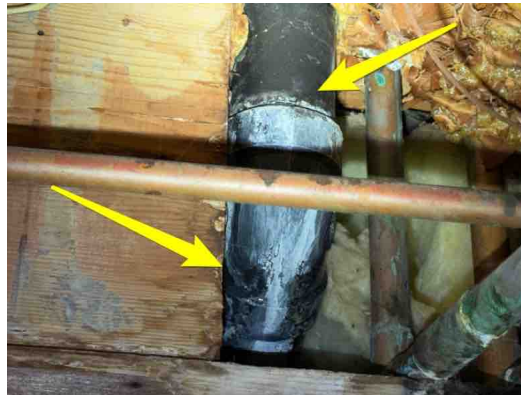
**E&C FI 89:** Active water leak(s) found in the waste pipe in the crawlspace: BELOW THE LAUNDRY AREA HALF BATHROOM. Have plumber check all waste piping throughout the crawlspace for any additional leakage.

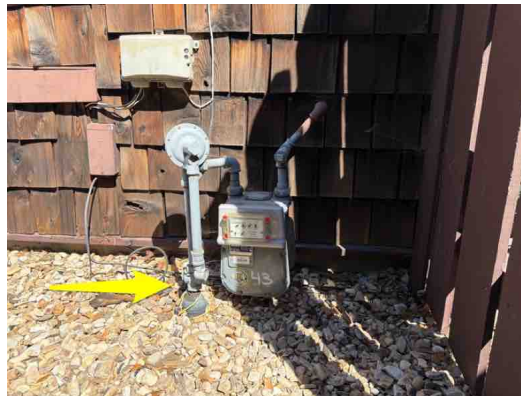
**91: Gas shut-off appears serviceable.**

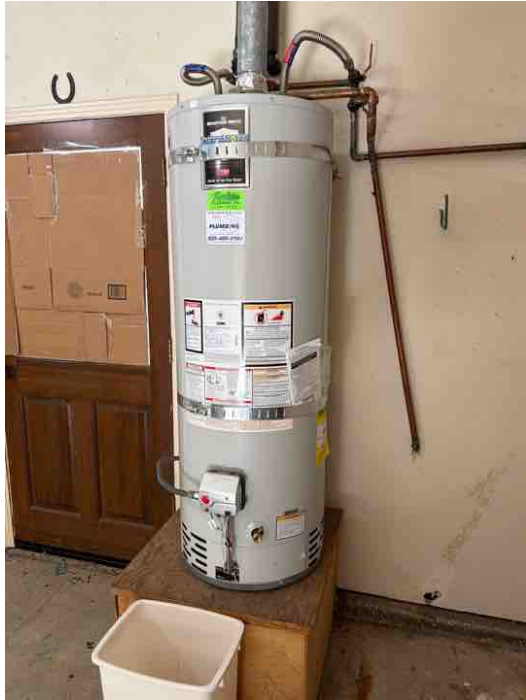
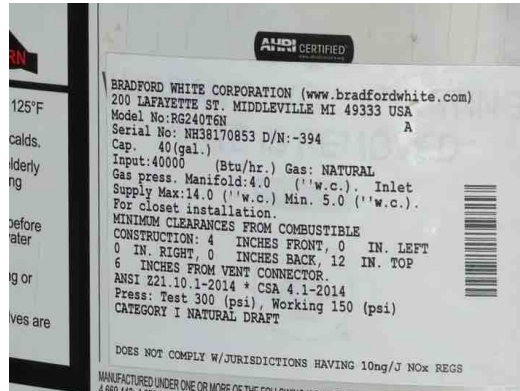
**SC 99:** Water heater vent pipe too close to combustibles as it passes through the drywall. Proper corrections are recommended per standards. Contact a qualified plumber.

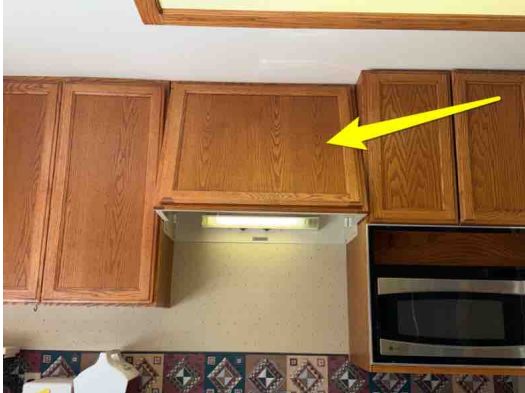
**E&C 119:** Kitchen cook top exhaust hood FAN found non-operational or not operating properly.

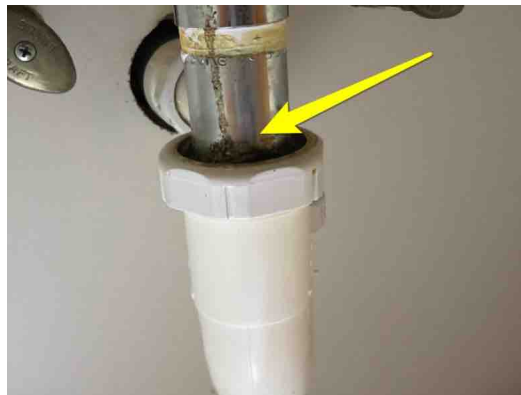
**FI 141:** Some corrosion found at water supply piping and waste piping connections under the bathroom sinks / evidence of past leaking.

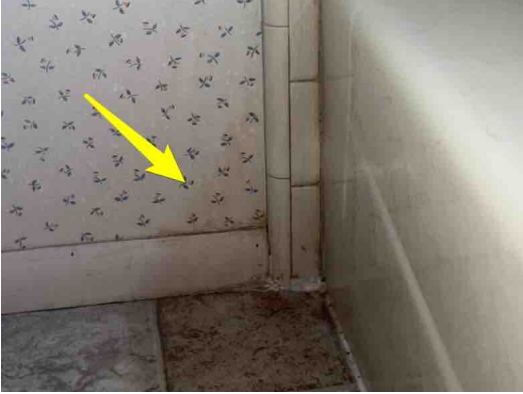
**FI** 149: Moisture stains & damage to walls, baseboards and/or floor outside shower: UPSTAIRS HALL BATHROOM

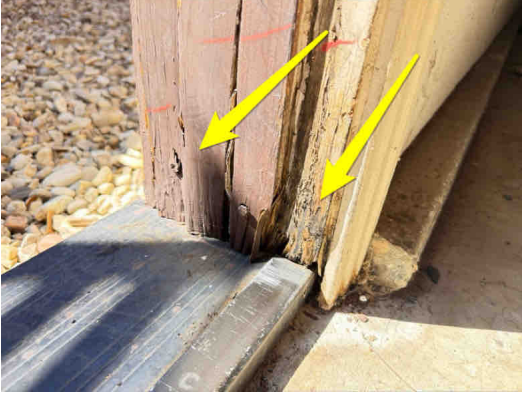
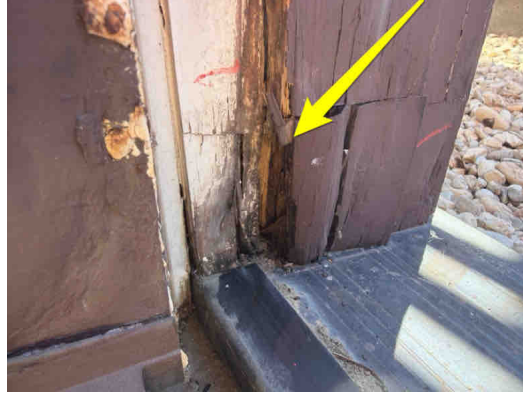
**E&C 157:** Moisture damage noted at multiple exterior wood doors, door jams, and/or trim components. Refer to termite report for extent and location locations.

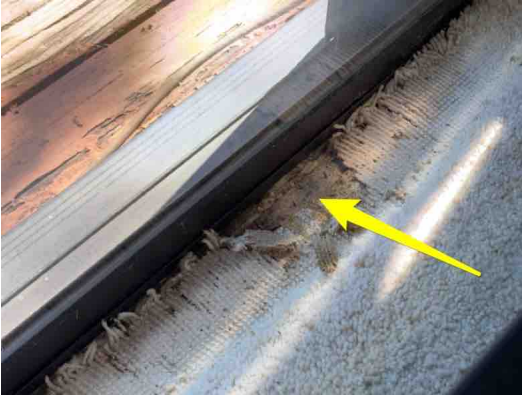
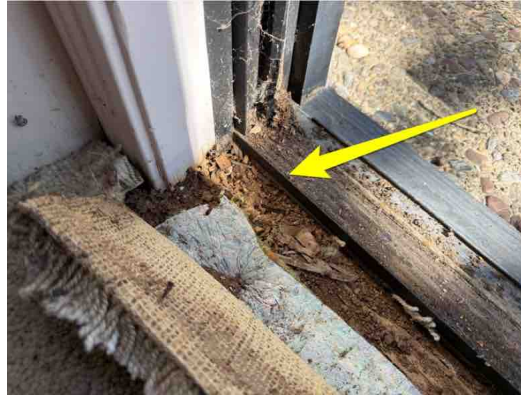
**FI 158:** Evidence of past water intrusion from around threshold area from exterior sliding glass door with stains and/or damage: LIVING ROOM and DINING AREA

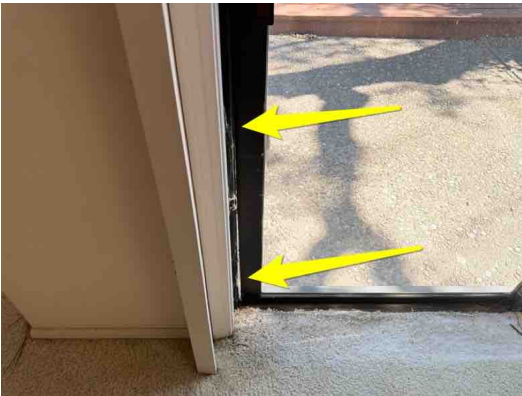
**E&C 160:** The DINING AREA sliding glass door found out of alignment and not plum with the jamb. Contact a qualified professional for evaluation and maintenance or repairs.

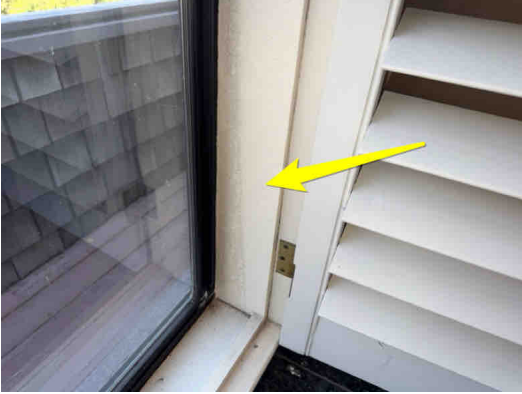
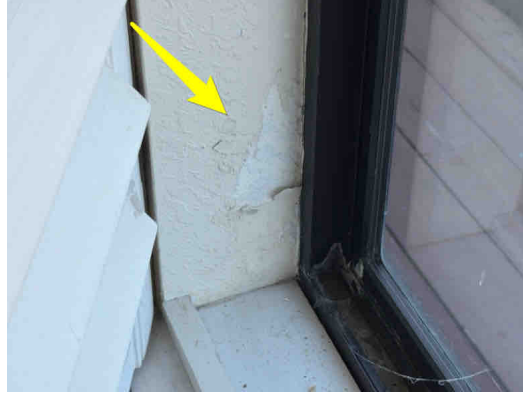
**FI 165:** Moisture stains and/or damage on the inside at some window sills. Refer to the termite report for additional comments and recommendations.

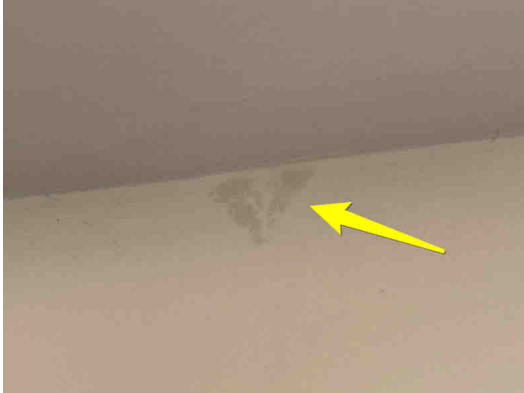
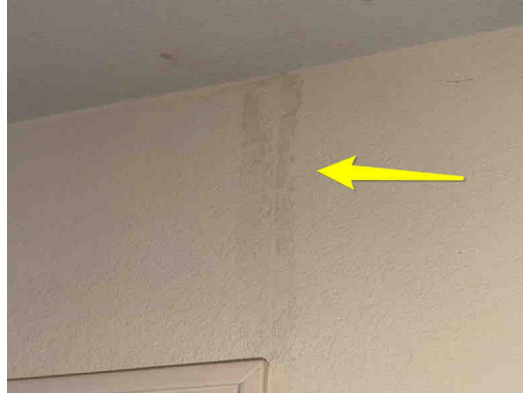
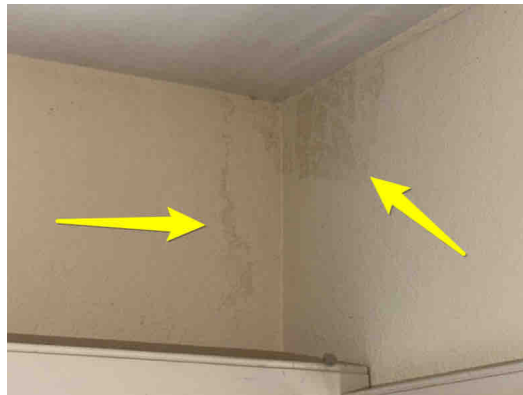
**FI 174:** Evidence of moisture stains and/or damage at the walls throughout the interior. Too many individual locations to list. Recommend further review of the water stains to determine the cause, the current condition and if repairs are needed.

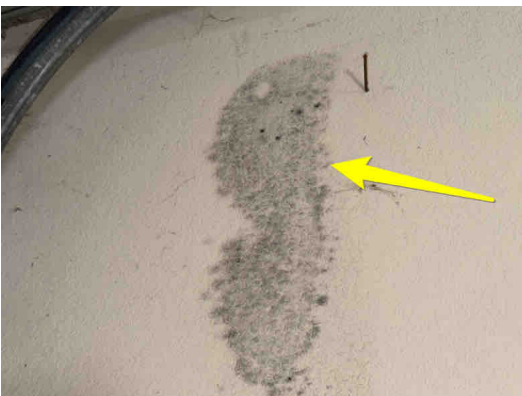
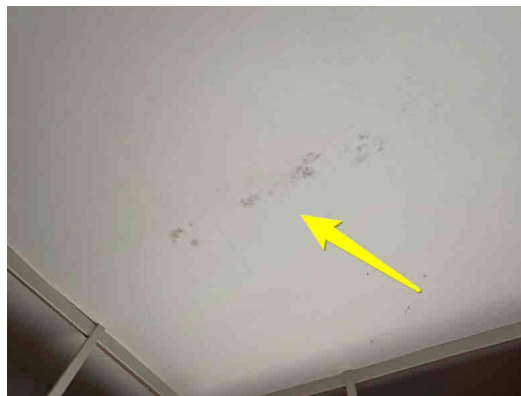
**SC FI 175:** Evidence of past moisture stains & damage with some visible mold growth on areas of the drywall: IN THE GARAGE BELOW THE UPPER WATERPROOF DECK and ADJACENT ROOFING. Recommend additional review by a qualified remediation professional. Recommend further review to determine if stains are current or old and if repairs are needed.

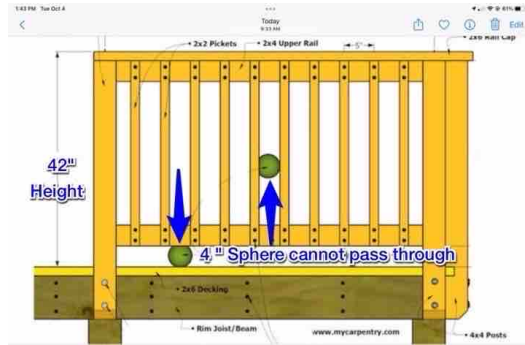
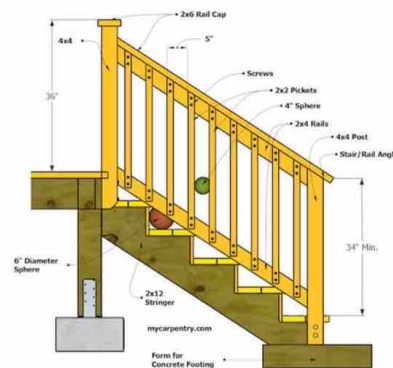
**179: Disclosure:** Openings in railings at the stairway and loft do not meet current standards. Safety upgrades are recommended. Today's standard requires a maximum of 4-3/8 inches between the stairway railing pickets for safety at the stairway treads and 4 inches at the landings and banisters.

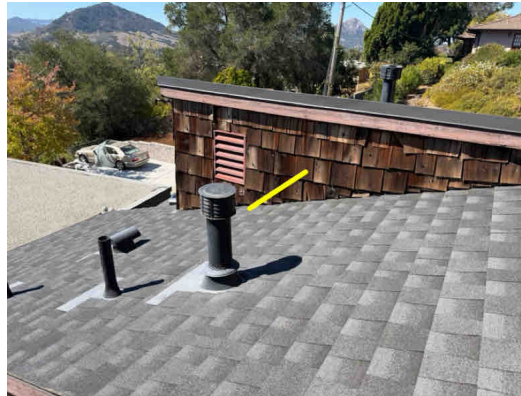
**SC 184:** The Furnace vent pipe terminates too low at roof. This can negatively affect the drafting of the furnace. A vent pipe within 8 feet of a headwall is required to terminate 24 inches above the upper roof. Contact a qualified plumbing professional familiar with minimum safety requirements for recommendations, repairs or upgrades.

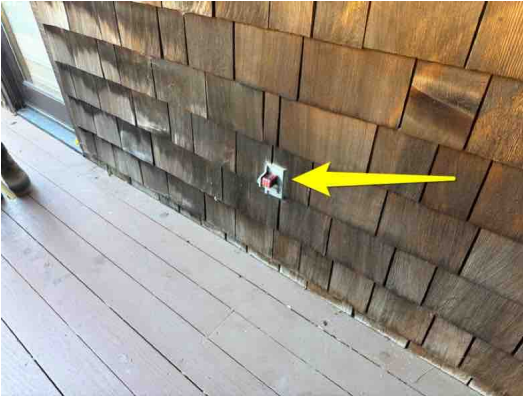
**SC 194:** Three-prong electrical outlets did not test properly grounded: EXTERIOR NEAR ENTRY. Have electrician check all outlets for proper grounding.

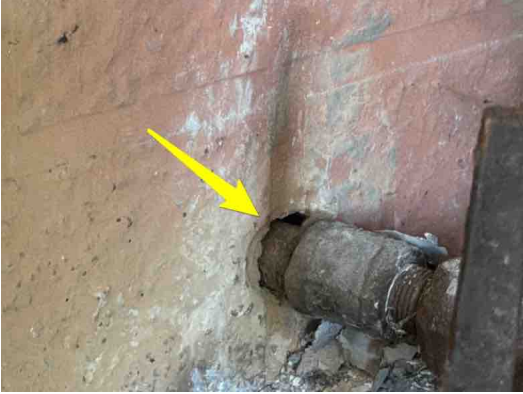
**SC 231:** Recommend sealing the opening around the gas pipe through the sidewall inside the LIVING ROOM fireplace for safety per standards.
